# Pictures of Pipeline Material and Construction Quality Issues

**PHMSA**  
**June 15, 2012**

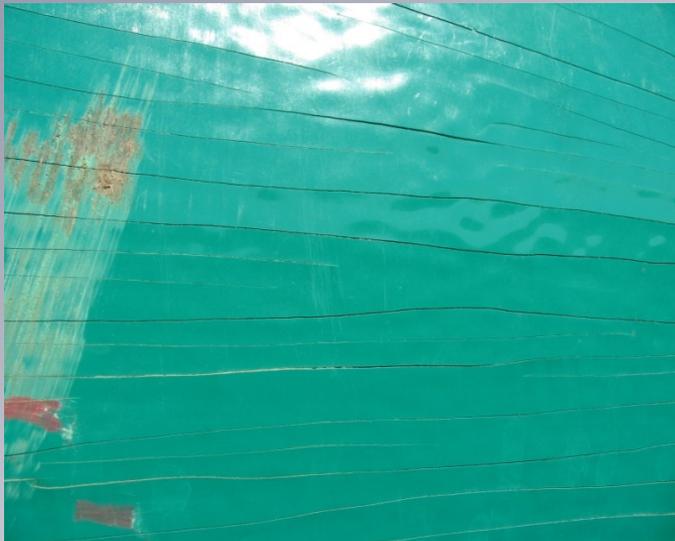
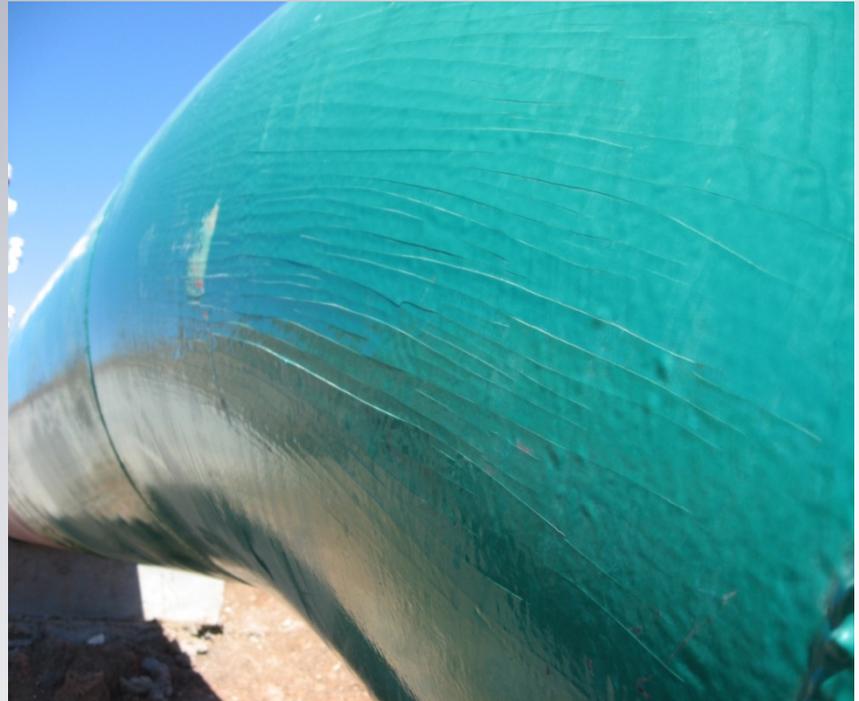
# Fittings - low strength

- Coating is cracking due to expansion of fitting during testing

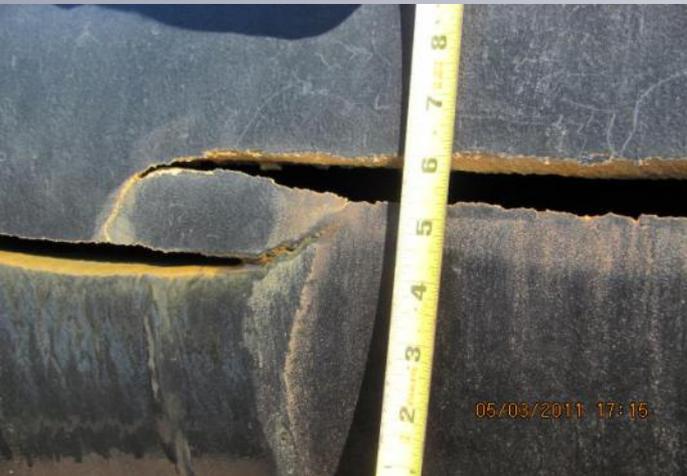
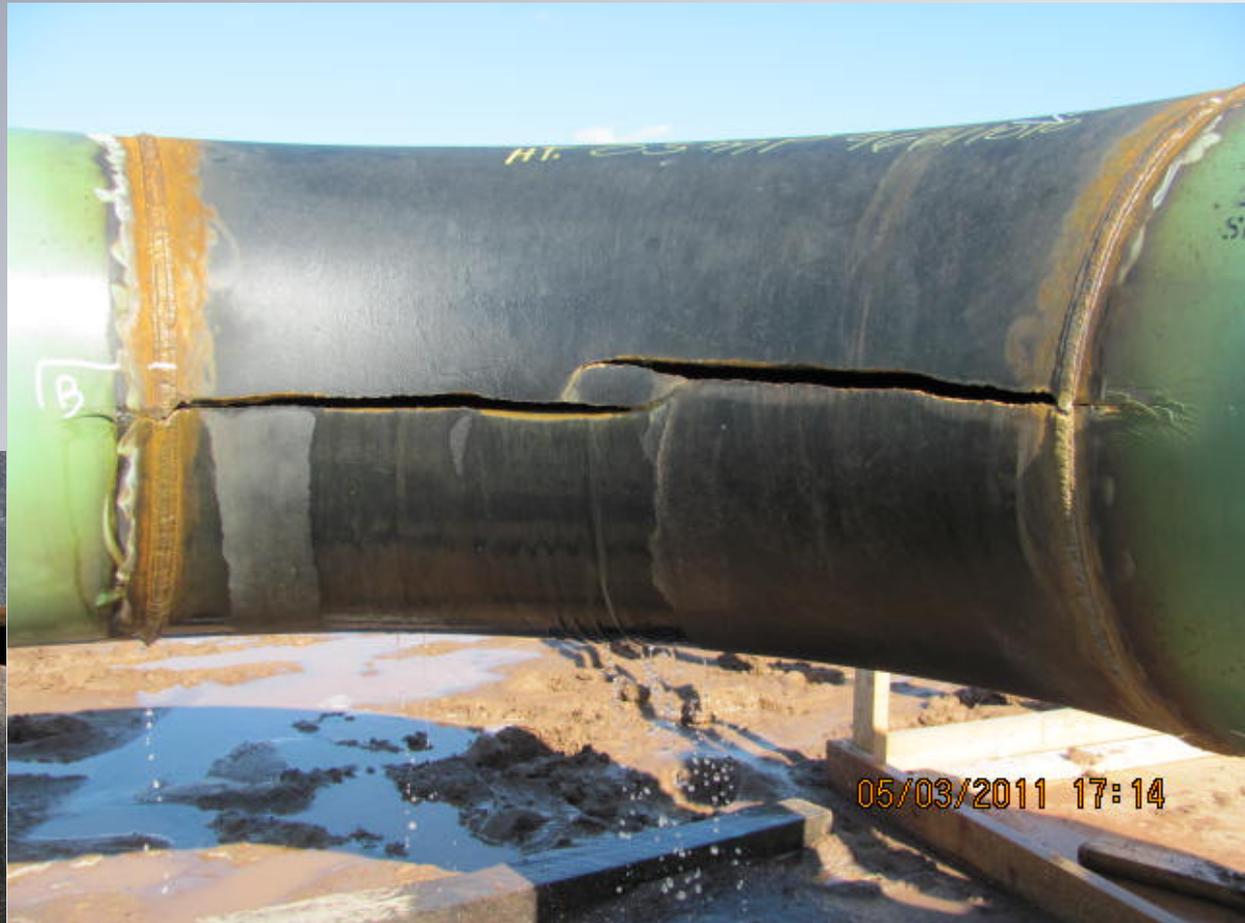
# Fittings – pressure test failure

**Hydrotest failure  
at 80% of test  
pressure**

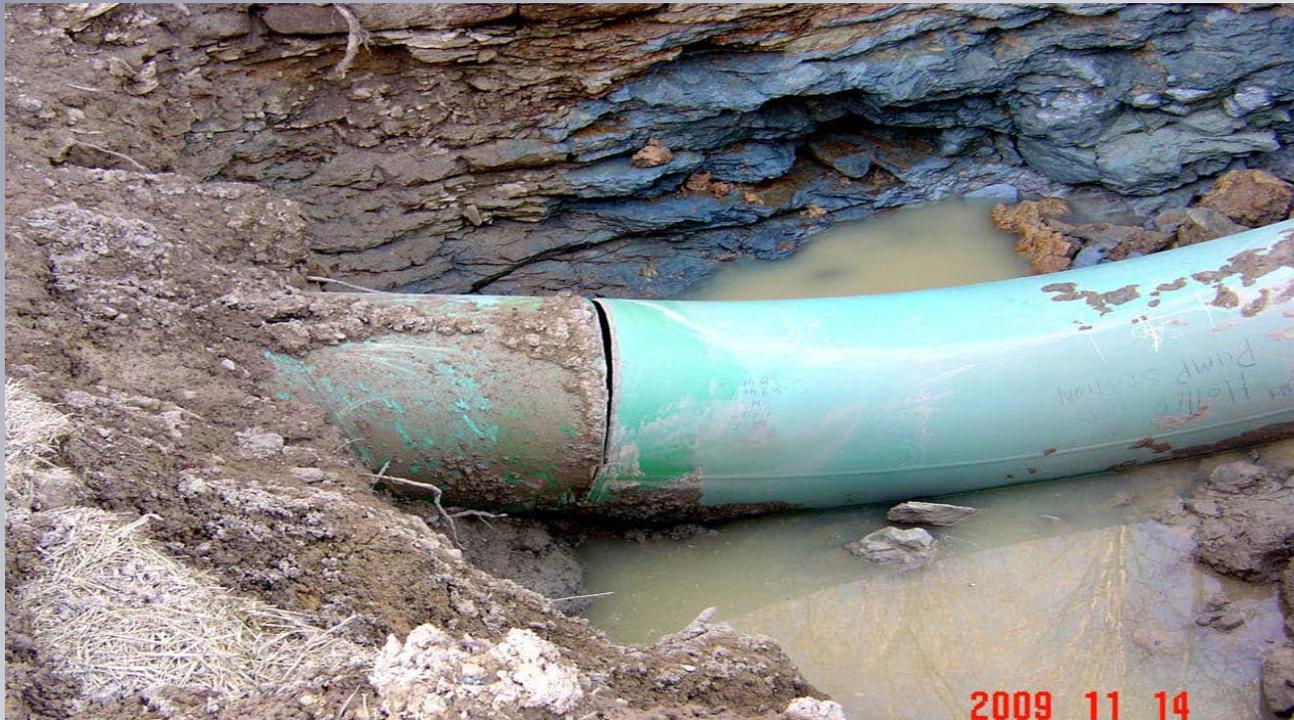
# Hot Bend – bevel alignment

- Welding, NDT, Transitions, & Alignment
- Cut Induction Bends

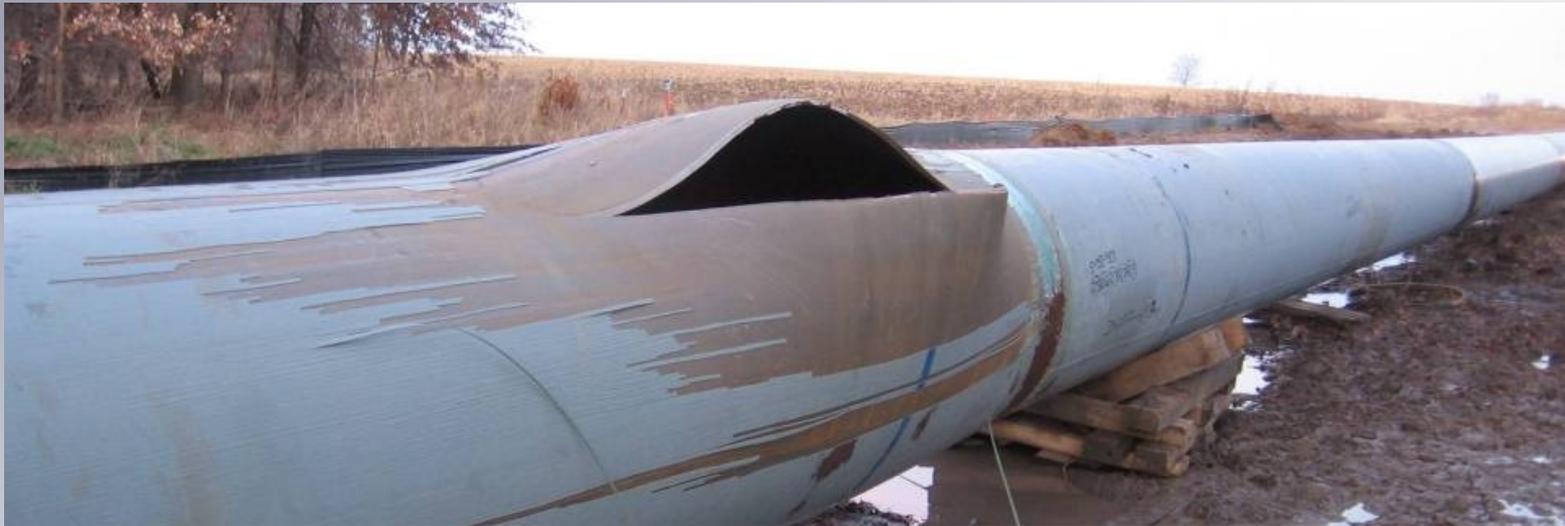
# Pipe – low strength

- **Low strength pipe**
  - **Inconsistent mechanical properties**
  - **PHMSA Advisory Bulletin (PHMSA 2009-1048)**

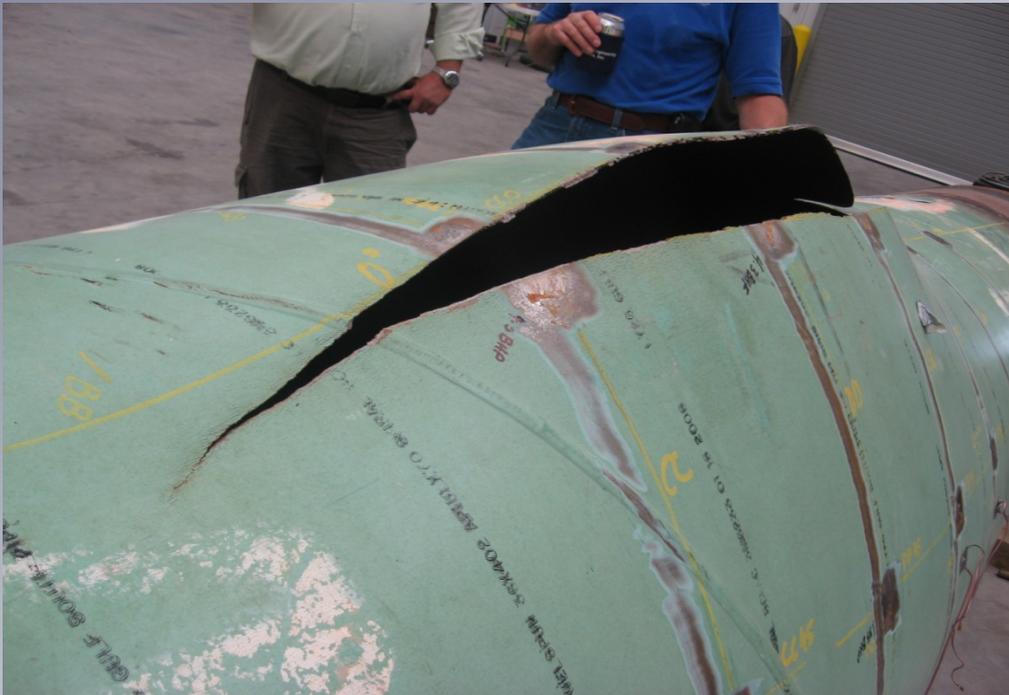
# Pipe – low strength

- Low strength pipe

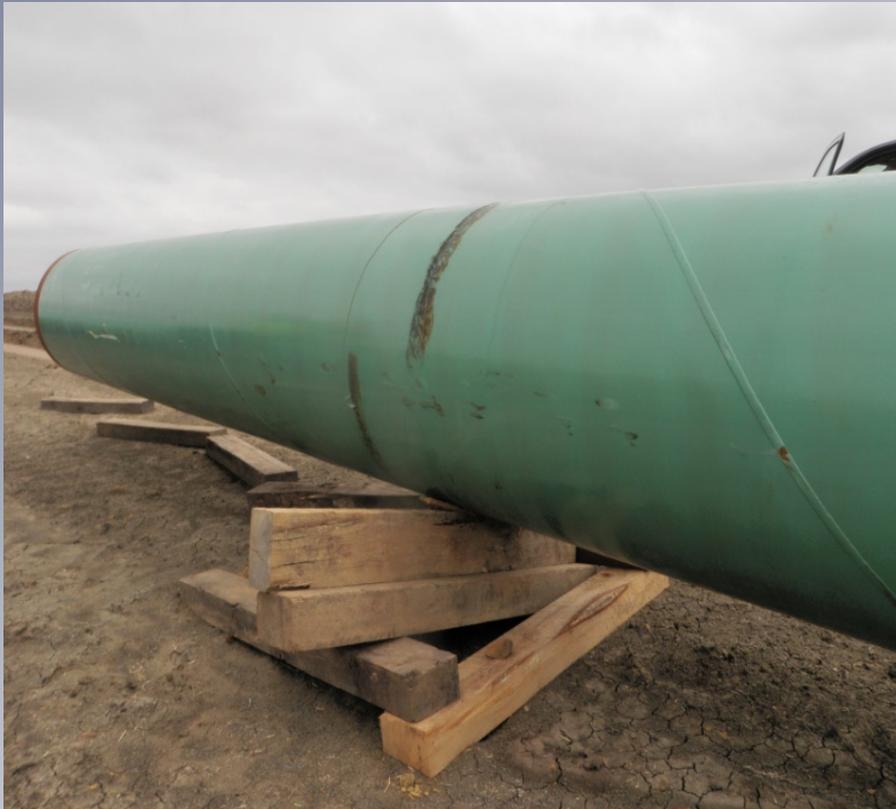
# Coatings – application & handling

- **Poor Factory Application of Fusion Bonded Epoxy (FBE) coating**
- **199 jeeps on pipe joint**

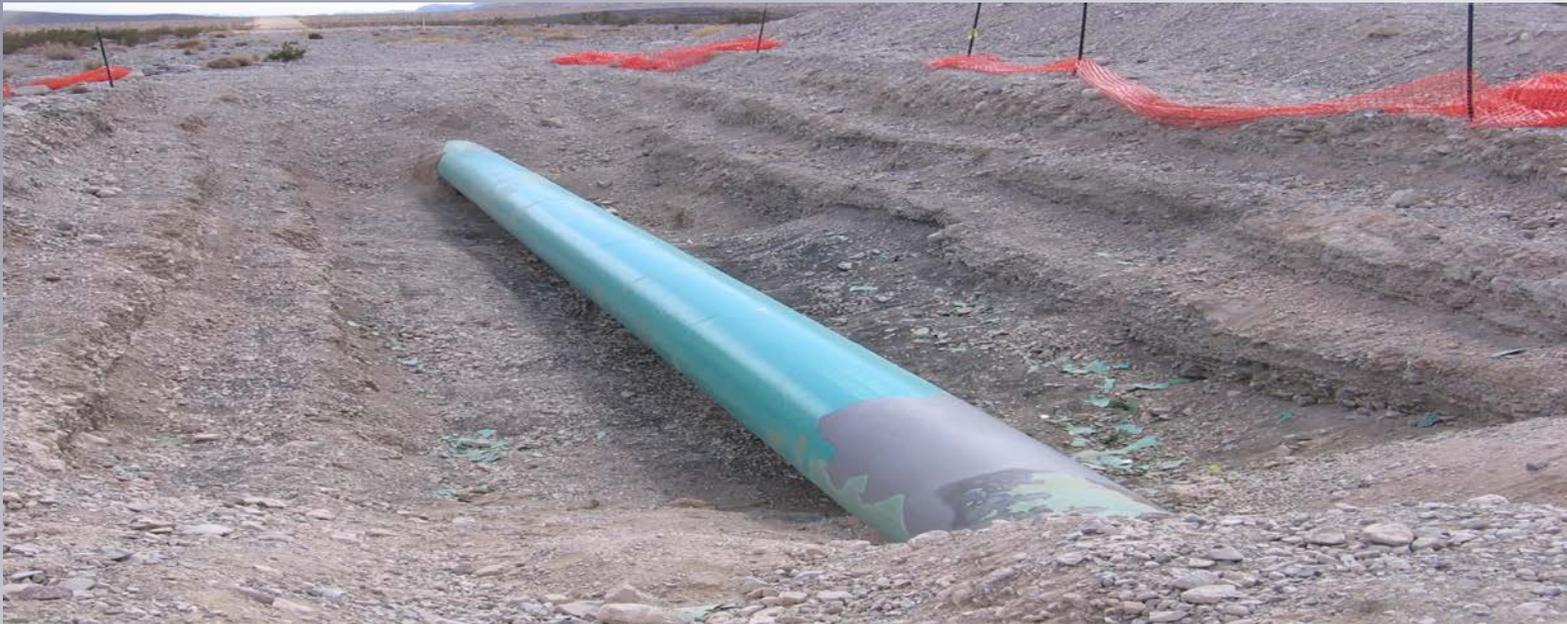
# Coating - application

- **Coating Disbondment**

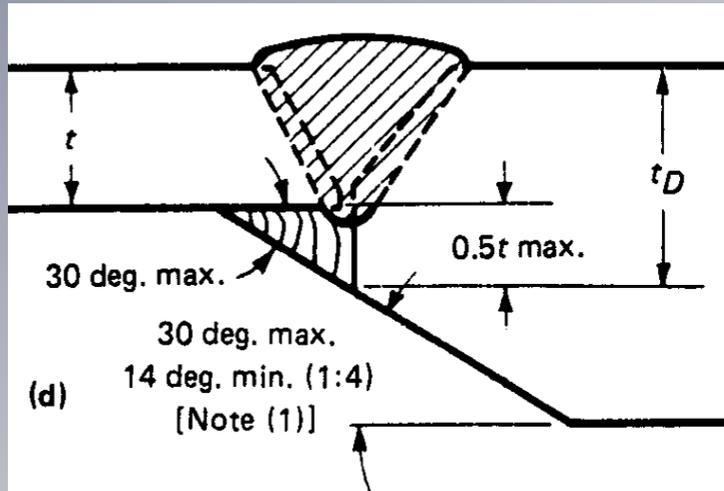
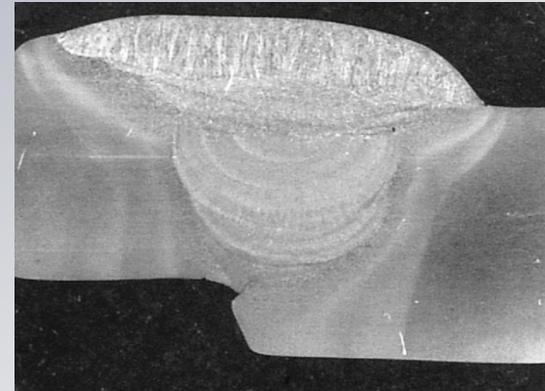
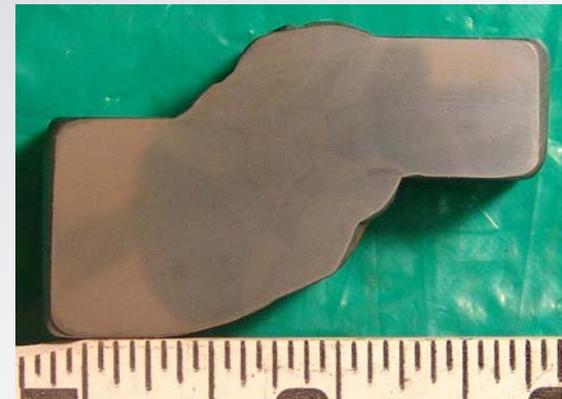
# Pipe – bevel alignment

- Weld Transitions

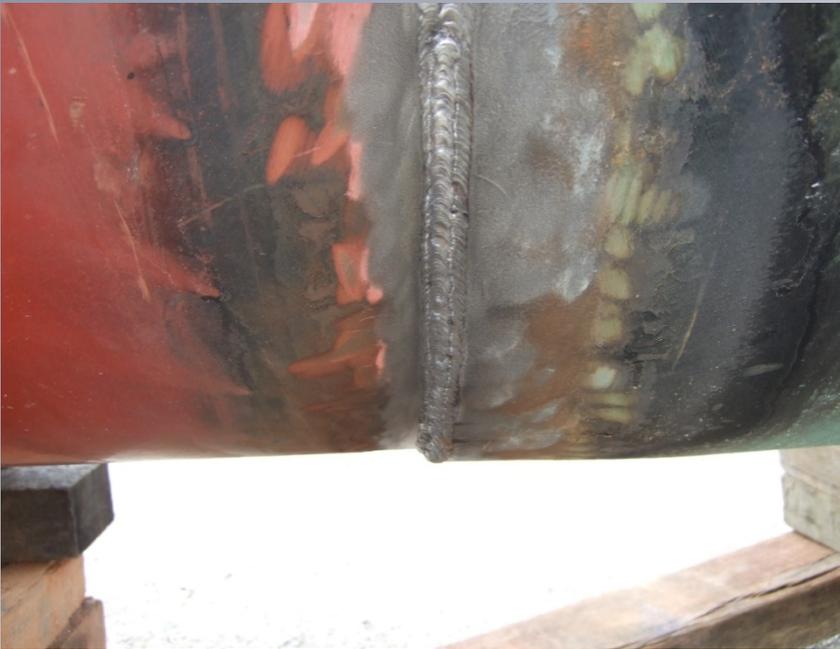
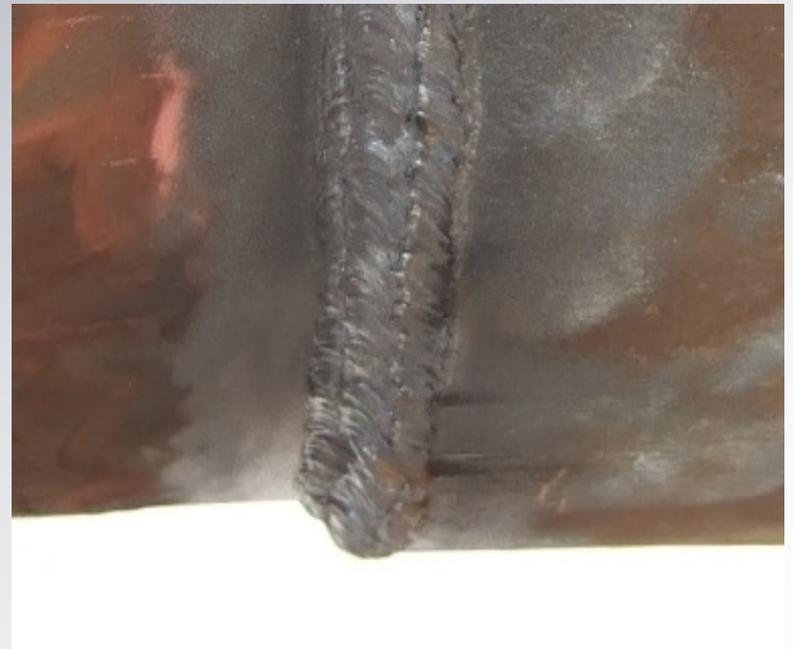
# Pipe – bevel alignment

- **Weld misalignment (high-low)**

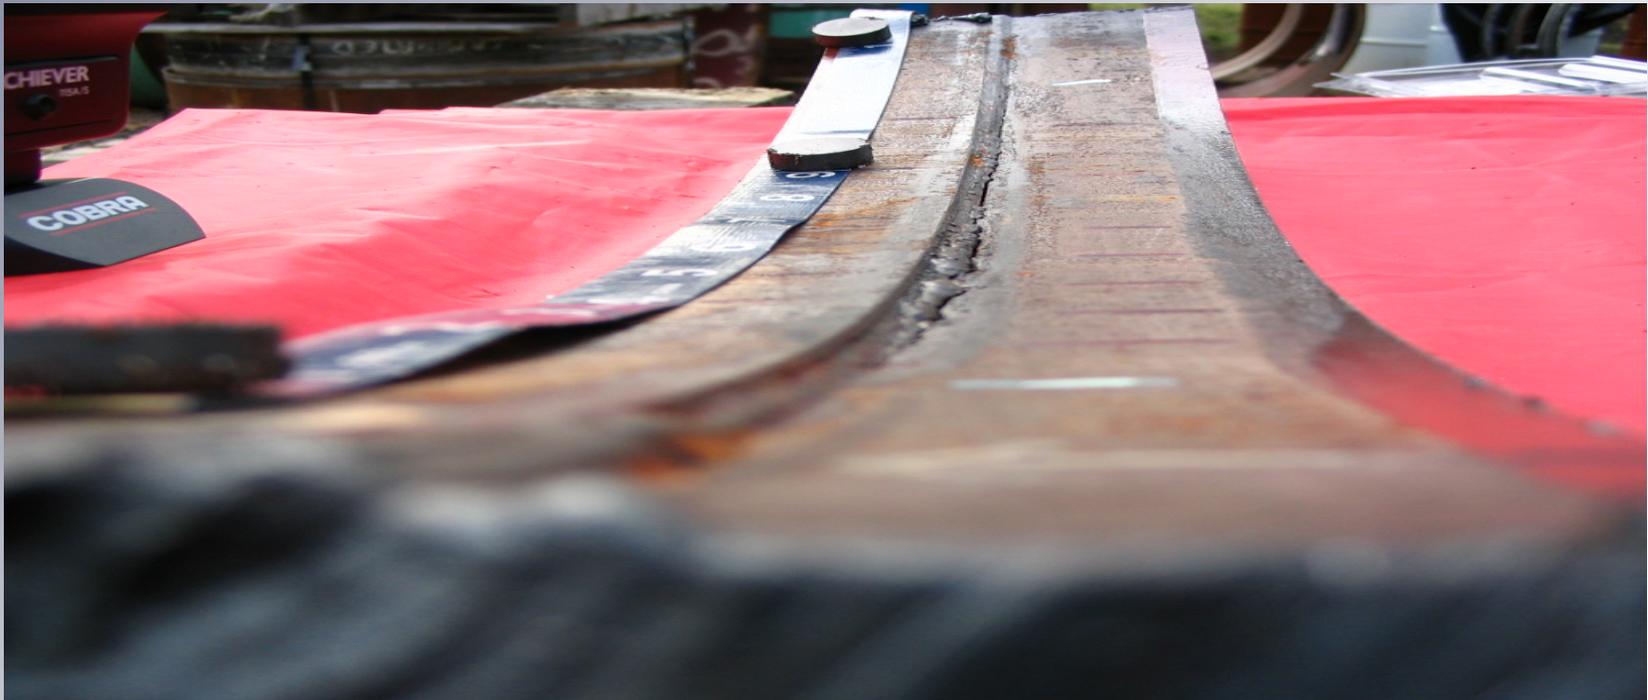
# Pipe – flat spot on bevel

- Pipe bevel ends and alignment – high/low
- Flat spot on pipe at girth weld bevel

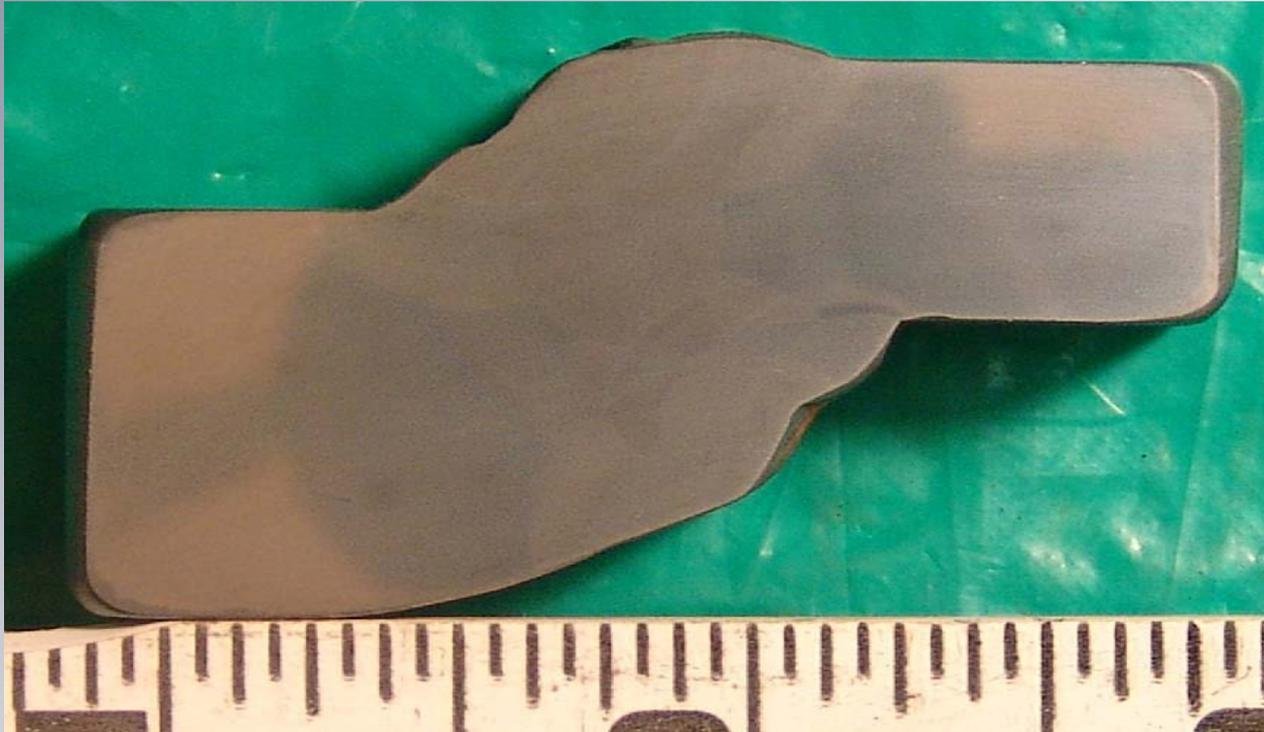
# Construction Issues

- **Pipe Alignment – does it meet standards for API 1104**
