Re: CPF No. 2-2007-1004H
Proposed Amendment No. 1 to the 1/26/07 Corrective Action Order (CAO)
Mechanical and Metallurgical Testing and Failure Analysis

Subject: Evaluation of 18-inch Girth-Weld Failure

We appreciate the opportunity to be of service to you and El Paso Corporation. This letter report presents the findings from our analysis of the failure of an 18-inch x 0.312-inch, Grade X52 pipeline segment that leaked at the girth weld and was provided to Stress Engineering Services, Inc.

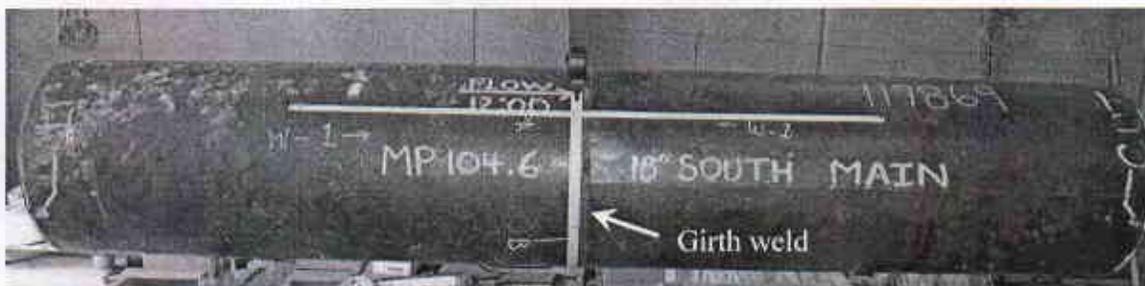
Sample 1 was examined closely for overall condition and the presence of any irregularities (Figure 1). A square-shaped protrusion $\frac{1}{4}$ inch wide by $\frac{1}{8}$ inch high was present for the full length of each joint, which is typical for an A.O. Smith flash butt weld. The surface of the pipe was covered with a black primer with the exception of a triangular area 3 by 3 inch on one side of the girth weld (Figure 4). Along the edge of the weld cap was a band of what appears to be erosion that reduced the wall thickness. There were no signs of corrosion or mechanical damage on the OD of the pipe.

Figure 1. Photograph of pipe Sample 1 as received, containing the girth weld that leaked. Scale shown is in inches.

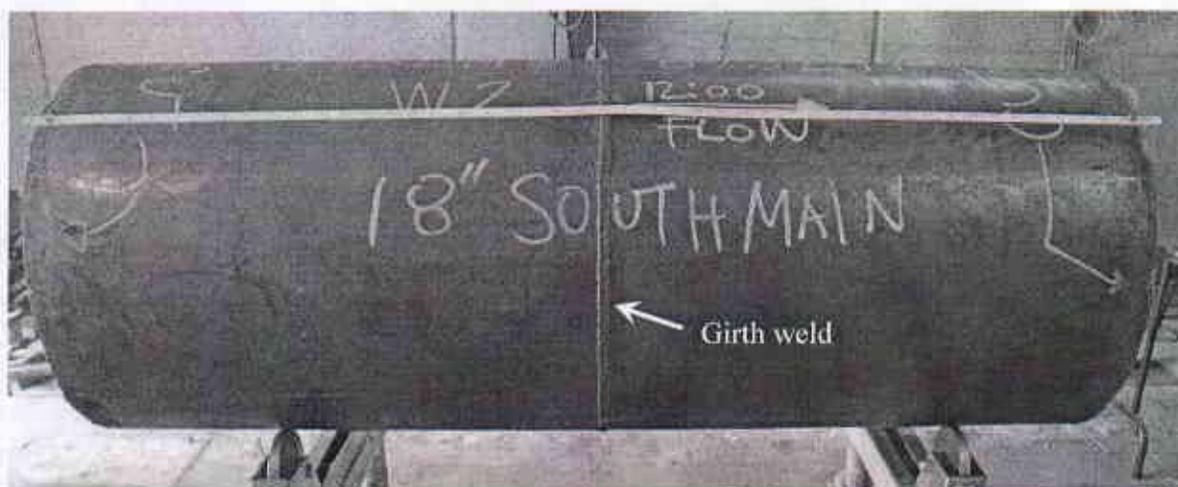
Sample 2 (Figure 2) was next examined closely for overall condition and for any irregularities. A flash butt weld typical of A.O. Smith pipe was observed running the length of both pipe segments. The outer surface of the pipe was covered with a black primer, and there were no signs of corrosion or mechanical damage on the OD of the pipe.

Figure 2. Photograph of pipe Sample 2 as received. Scale shown is in inches.

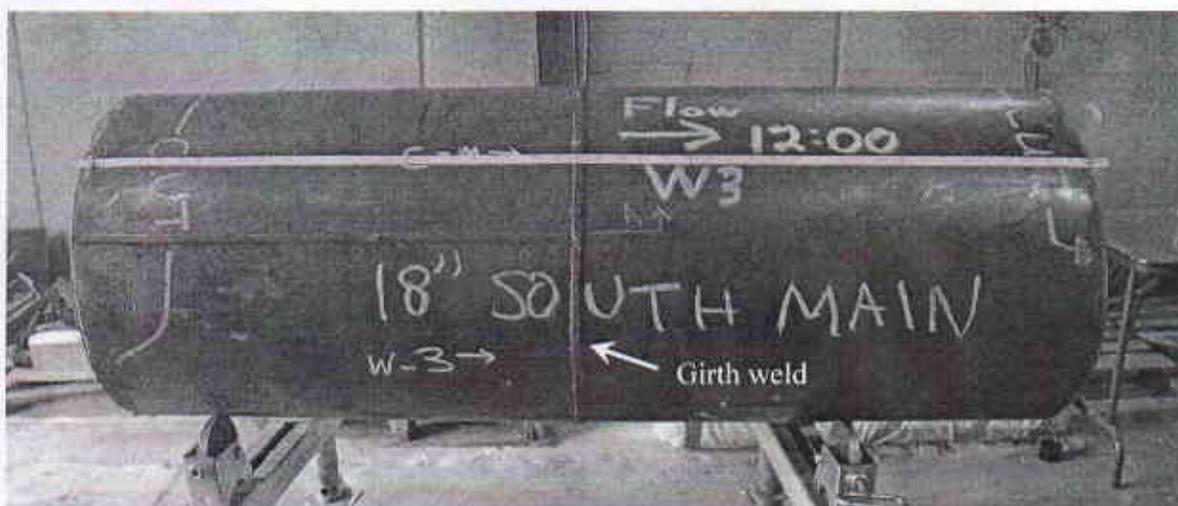
The outer surface of Sample 3 (Figure 3) was also examined closely for overall condition and any irregularities. As in the other samples, the long seam was an A.O. Smith flash butt weld. The OD surface of the pipe was also covered with a black primer, and there were no signs of corrosion or mechanical damage.

Figure 3. Photograph of pipe Sample 3 as received. Scale shown is in inches.

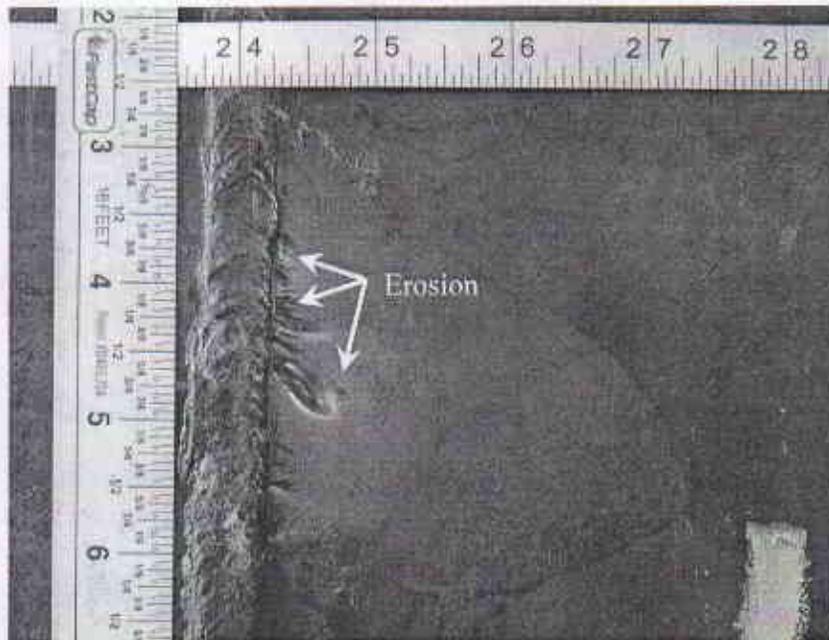
It is not possible to determine exactly when each phase of the cracking occurred. The erosion of the pipe adjacent to the cap is unusual and suggests that a leak had been present for some time. Hydrostatic testing before placing a pipeline in service is effective in finding leaks resulting from construction. The gas test used in this case would not be as effective and is not effective at finding small leaks. There is also a narrow band of what appears to be recent crack extension. This crack extension allowed additional gas to leak, apparently allowing sufficient gas to migrate to the surface to be detectable. This most recent crack extension occurred following record drought for several months followed by a short period of heavy rain which was reported in the region. Changes in moisture content in the soil are known to increase stresses on pipelines, and may have caused the recent crack extension.

Figure 4. Photograph of area that appears to be eroded adjacent to the girth weld. Scale shown is in inches.

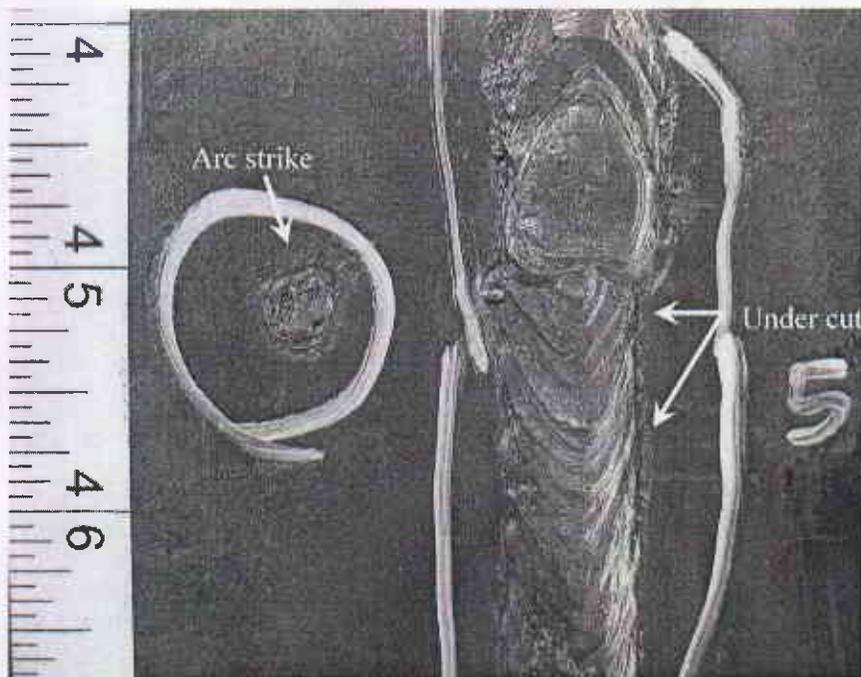
The girth-weld cap area was visually examined for welding imperfections. The following imperfections were observed (Figures 5 and 6):

- Arc-strike (arc-burn)
- Undercut
- Misalignment of the pipe ends (1/16 inch maximum)

Figure 5. Photograph of Sample 1 showing workmanship imperfections (under-cut and arc-strike of weld). Scale shown is in inches.

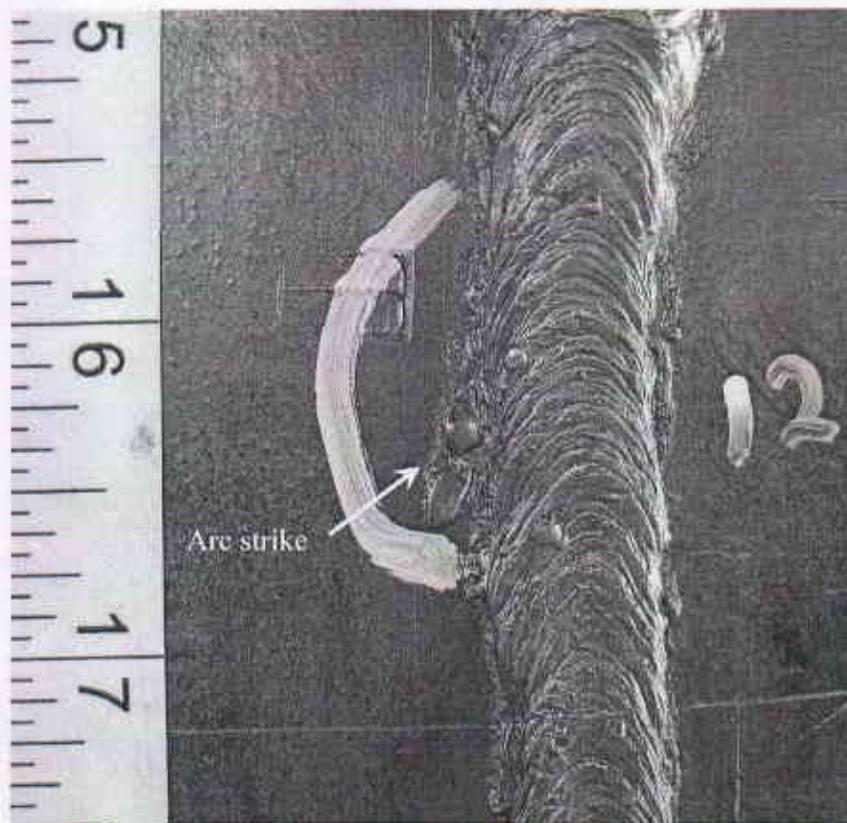
Figure 6. Photograph of Sample 1 showing workmanship imperfection (arc-strike of weld). Scale shown is in inches.

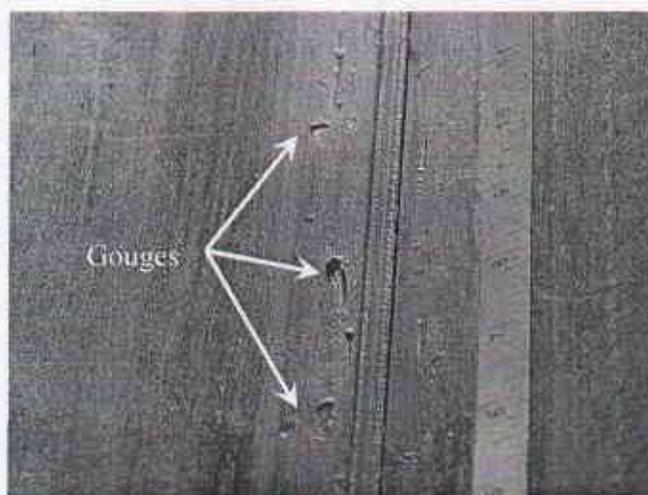
During examination of the ID of the pipe before it was cut, SES found the pipe to be free of corrosion and coated with a thin layer of what appeared to be condensate or engine oil. It was also noted that there was a line of small gouges parallel to the long seam (Figure 7).

Figure 7. Photograph of Sample 1 imperfections in pipe adjacent to long seam weld. Scale shown is in inches.

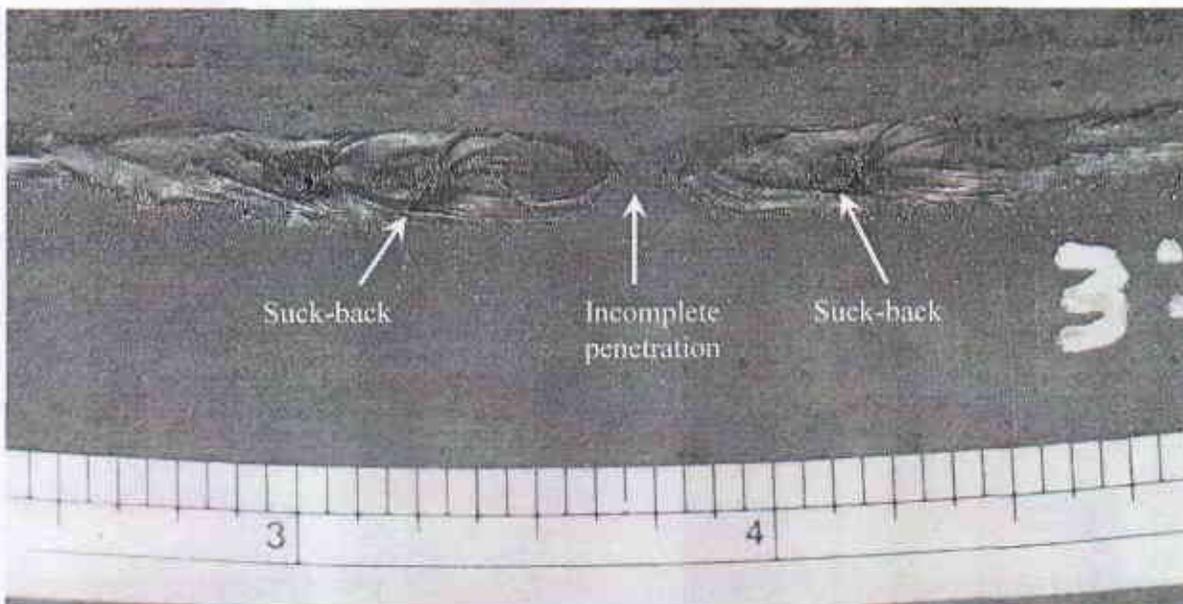
Following release from El Paso personnel, SES cut an 8-inch long ring containing the girth weld from Sample 1. The root region of the girth weld was then examined, which revealed the following imperfections (Figures 8 through 10):

- Cracking was visible on the ID of the pipe near the root of the weld
- Unrepaired burn-through
- Lack of penetration
- "Suck-back"

Visual examination of the girth weld clearly showed that the root pass has several imperfections. The most significant was the unrepaired burn-through. The short segments of lack of fusion were also significant. However, only the lack of penetration was associated with the crack and it is unlikely this imperfection alone would have resulted in a through-wall failure.

Figure 8. Photograph of root of girth weld in Sample 1. Lack of penetration is clearly visible. Scale divisions are 1/16th inch.

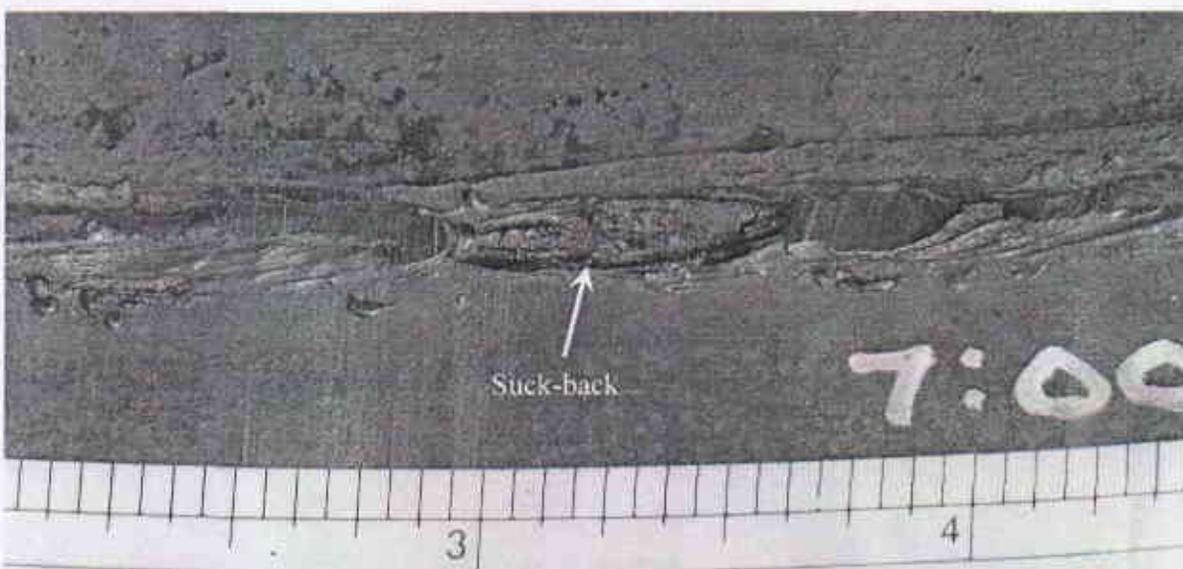
Figure 9. Photograph of root of girth weld in Sample 1. "Suck-back" is clearly visible. Scale divisions are 1/16th inch.

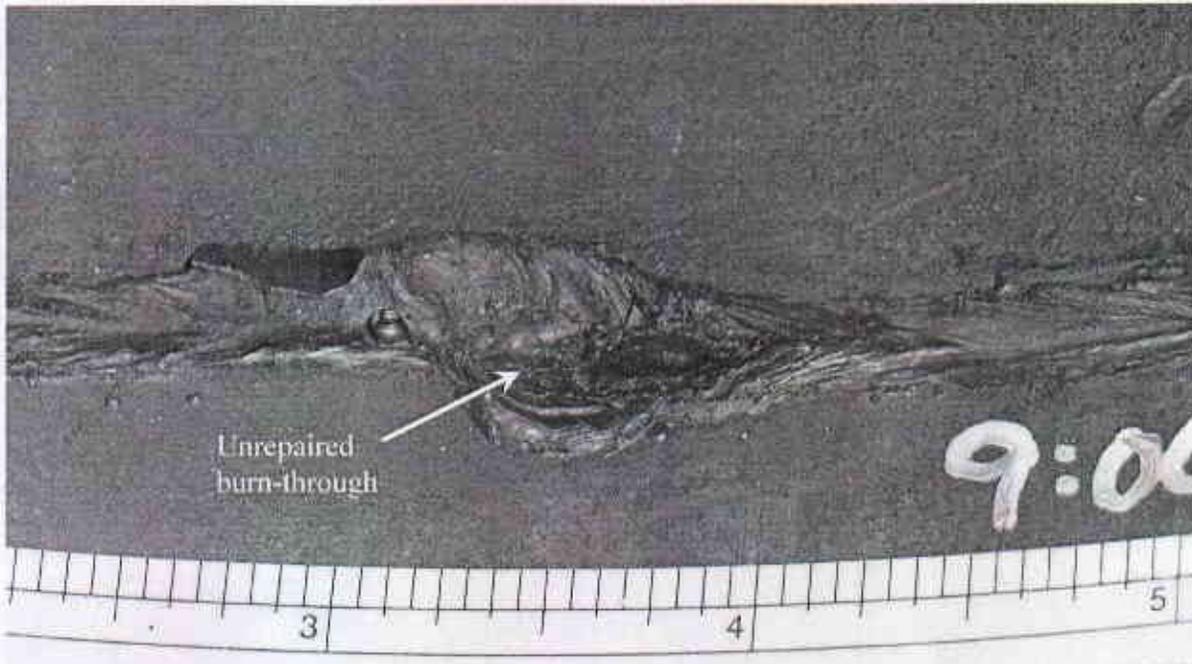
Figure 10. Photograph of root of girth weld in Sample 1. Unrepaired burn-through is clearly visible. Scale divisions are 1/16th inch.

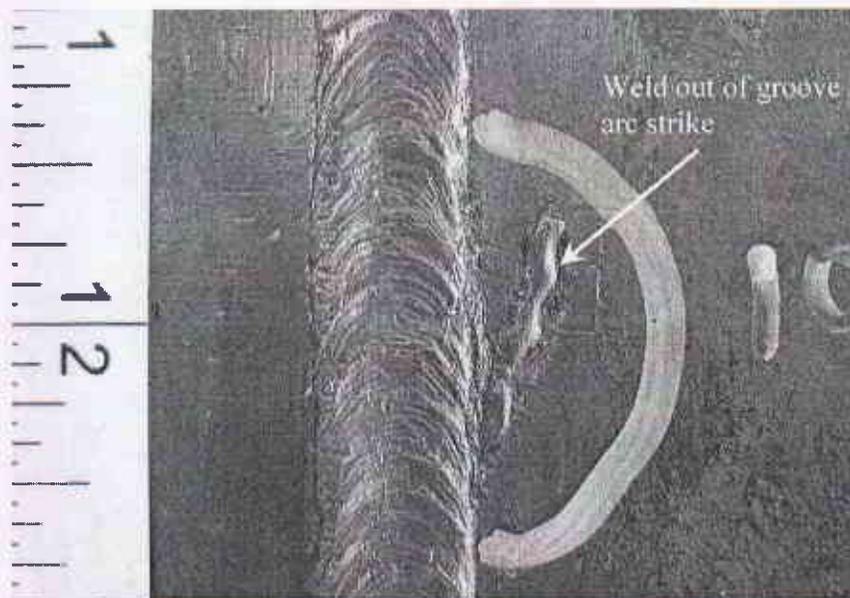
The girth-weld cap area of Sample 2 was visually examined for welding imperfections. The following imperfections were observed (Figures 11 through 13):

- Arc-strike (arc-burn)
- Undercut
- Hammer strike marks
- Misalignment of the pipe ends (1/16 inch maximum)

Figure 11. Photograph of root of girth weld in Sample 2. Arc-strike or out of groove weld is clearly visible. Scale divisions are 1/16th inch.

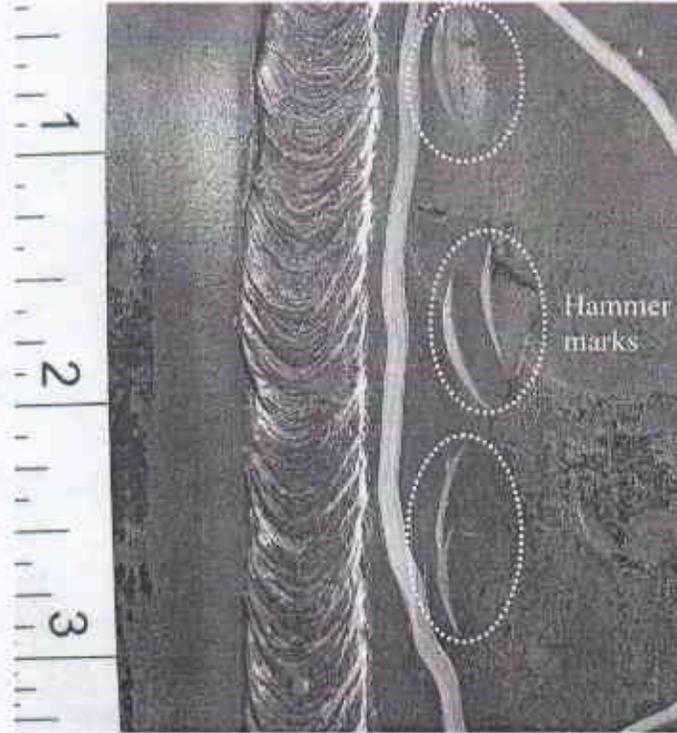
Figure 12. Photograph of root of girth weld in Sample 2. Hammer marks are clearly visible. Scale divisions are 1/16th inch.

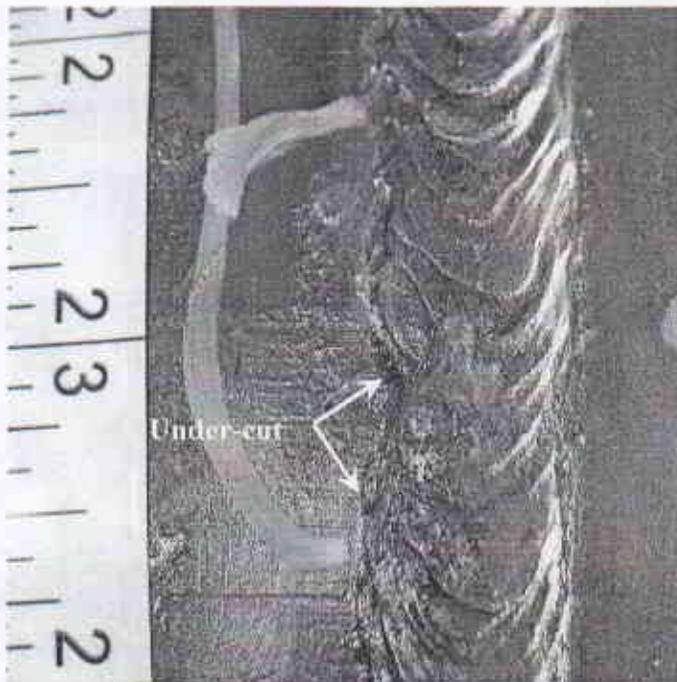
Figure 13. Photograph of root of girth weld in Sample 2. Under-cut is clearly visible. Scale divisions are 1/16th inch.

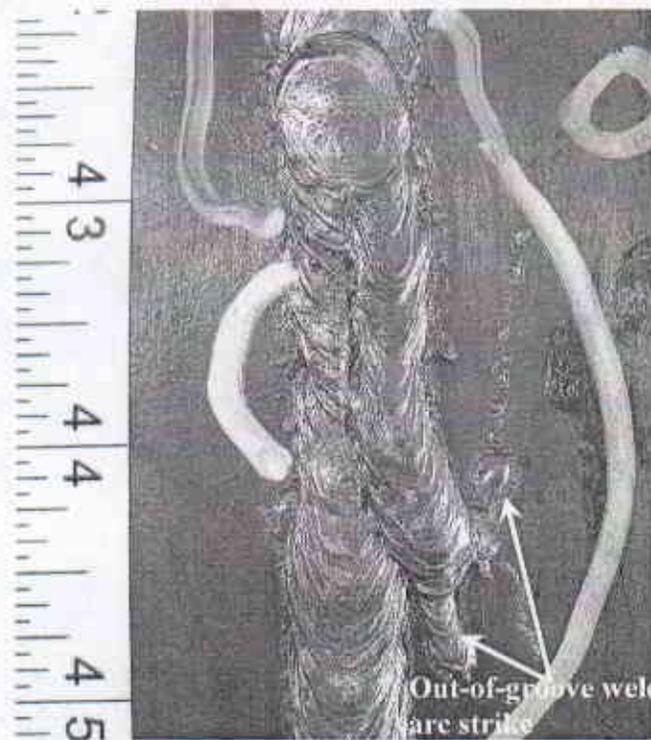
The girth weld cap area of Sample 3 was visual examined for welding imperfections, with the following observed (Figures 14 and 15):

- Arc-strike (arc-burn)
- Undercut
- Misalignment of the pipe ends (1/16 inch maximum)

Figure 14. Photograph of root of girth weld in Sample 3. Arc strike and out-of-groove weld are clearly visible. Scale divisions are 1/16th inch.

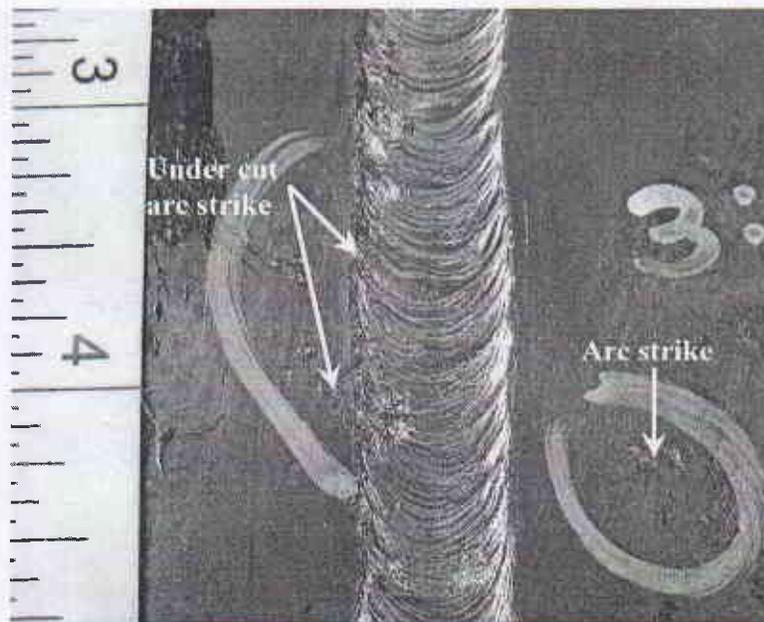
Figure 15. Photograph of root of girth weld in Sample 3. Arc strike and under-cut are clearly visible. Scale divisions are 1/16th inch.

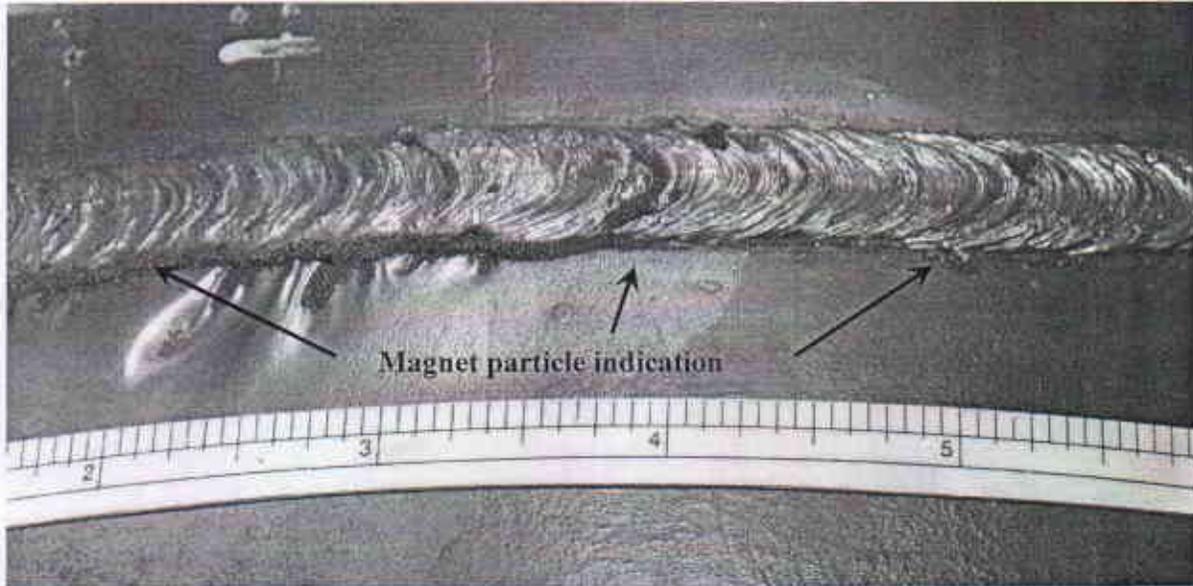
The girth weld in the ring cut from Sample 1 was inspected via magnetic-particle inspection (MPI) for indications of imperfections (Figures 16 and 17). MPI revealed a crack-like indication on the OD and ID at the same circumferential location as the erosion on the OD. The shape and angle of the cap pass with respect to the pipe made it difficult to discern indications of cracking from the tight corner created by the weld cap and OD of the pipe. Similarly, the root shape at some locations made it difficult to define the length of the crack. It was clear that indications of

cracking were present both on the ID and OD of the weld, but the precise extent was difficult to discern.

Figure 16. Photograph showing magnetic particle indication of crack-like indication on OD of Sample 1. Scale divisions are 1/16th inch.

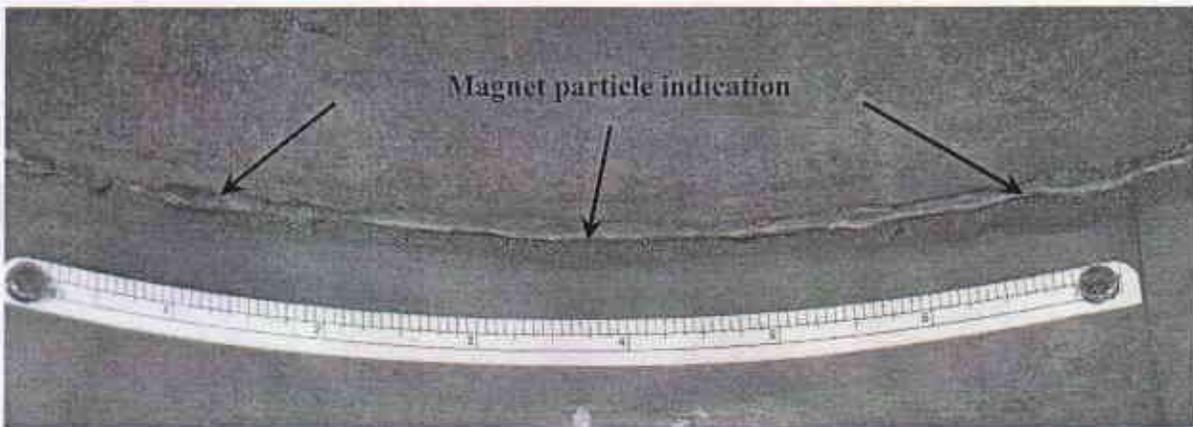
Figure 17. Photograph showing magnetic particle indication of crack-like indication on ID of Sample 1. Scale divisions are 1/16th inch.

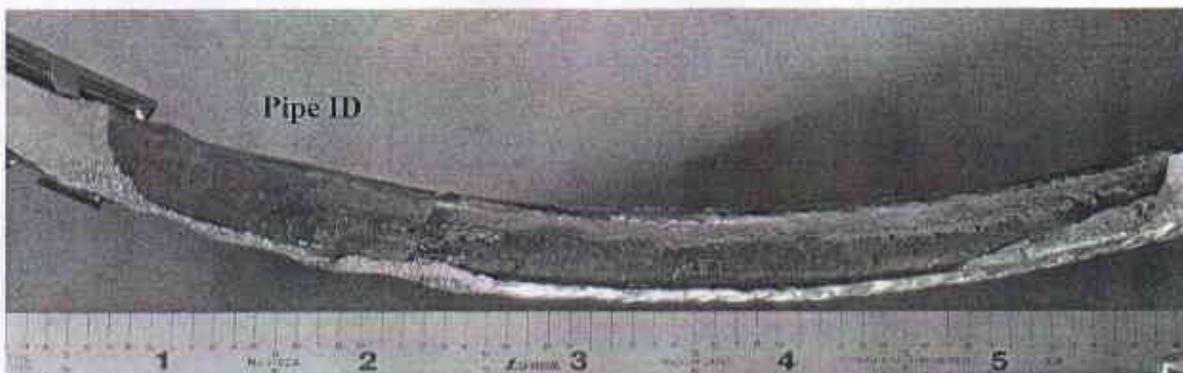
SES examined the fracture first with low-power magnification (less than 5X) using a stereoscope (Figures 18 and 19). Much of the fracture surface was smooth with very few fracture features.

Figure 18. Photomicrograph showing fracture after crack was broken open. Scale divisions are 1/10th inch.

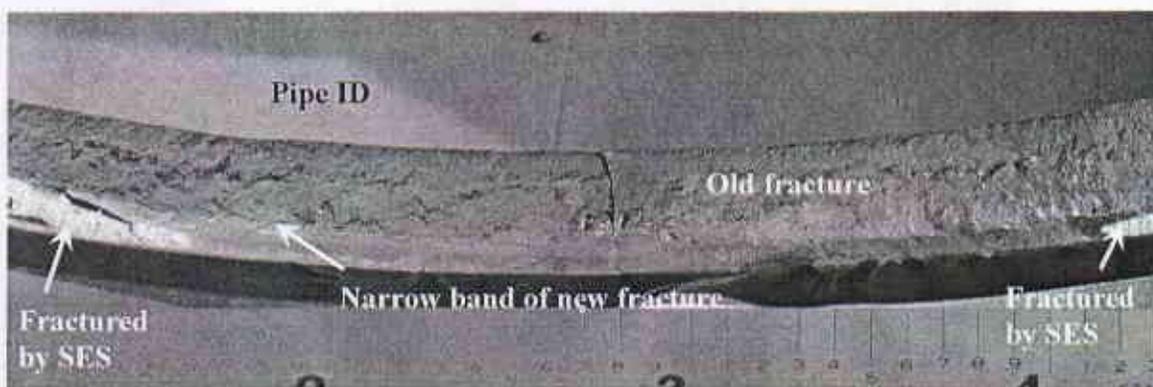
Figure 19. Photomicrograph showing fracture after crack was broken open. Scale divisions are 1/10th inch.

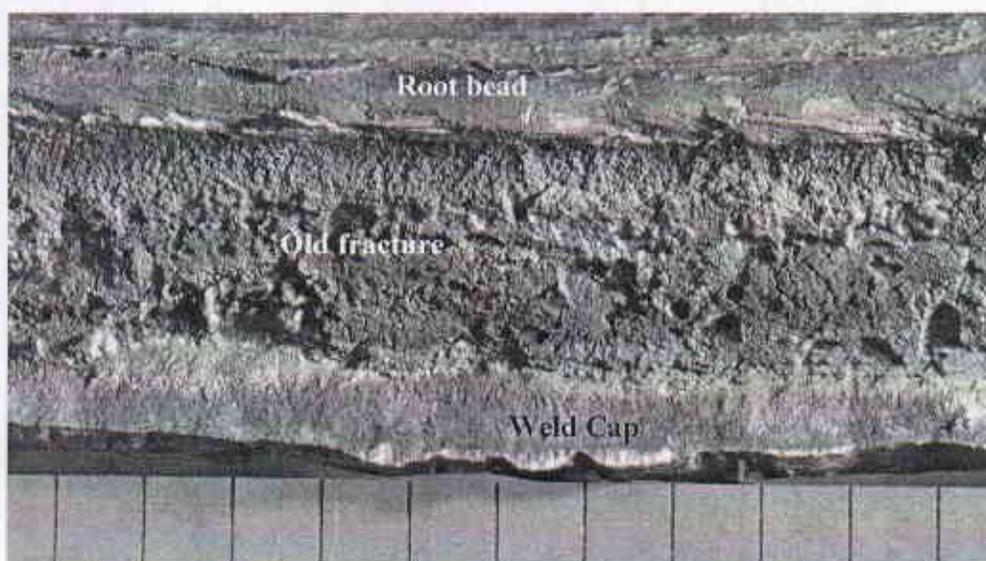
Fracture features that were present suggested that the weld contained slag and gas pockets before the fracture occurred (Figures 20 and 21).

Figure 20. Photomicrograph showing fracture after crack was broken open and before cleaning. Scale divisions are 1/10th inch.

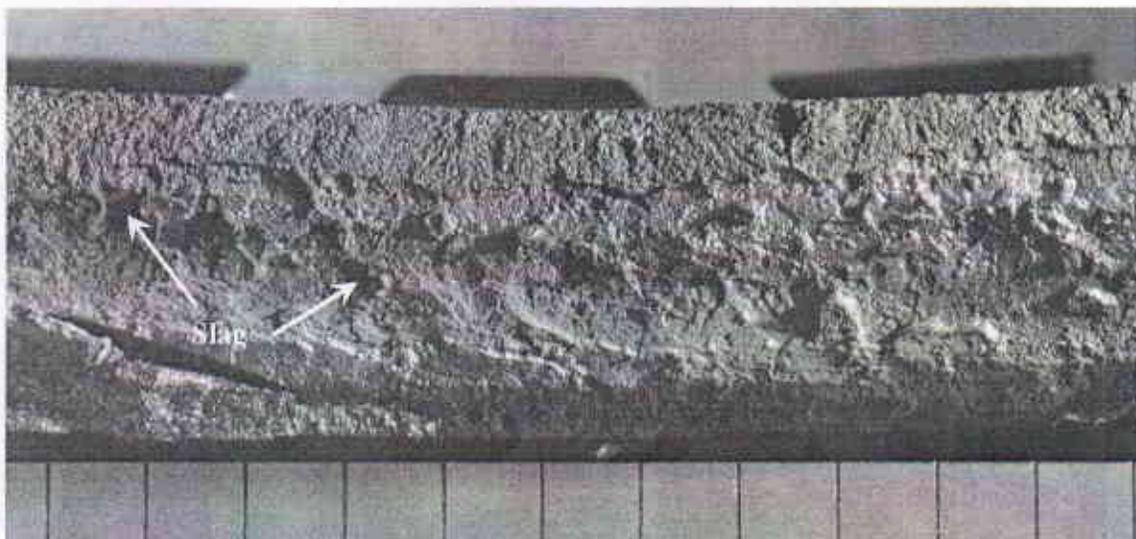
There were also signs that the fracture propagated through the weld in stages. The fracture appeared to initiate at the ID. There were then one or two extensions of the crack, as well as an apparently recent crack extension, near the OD surface (Figure 21 and 22).

Figure 21. Photomicrograph showing fracture after crack was broken open and before cleaning. Scale divisions are 1/10th inch.

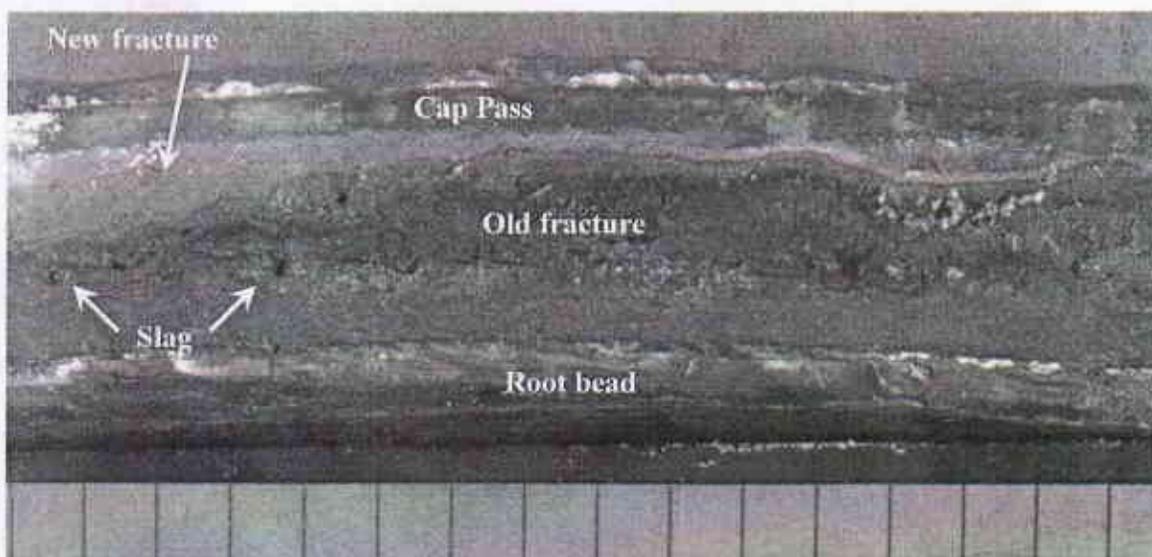
Figure 22. Photomicrograph showing fracture after crack was broken open after cleaning to remove light oxides. Scale divisions are 1/10th inch.

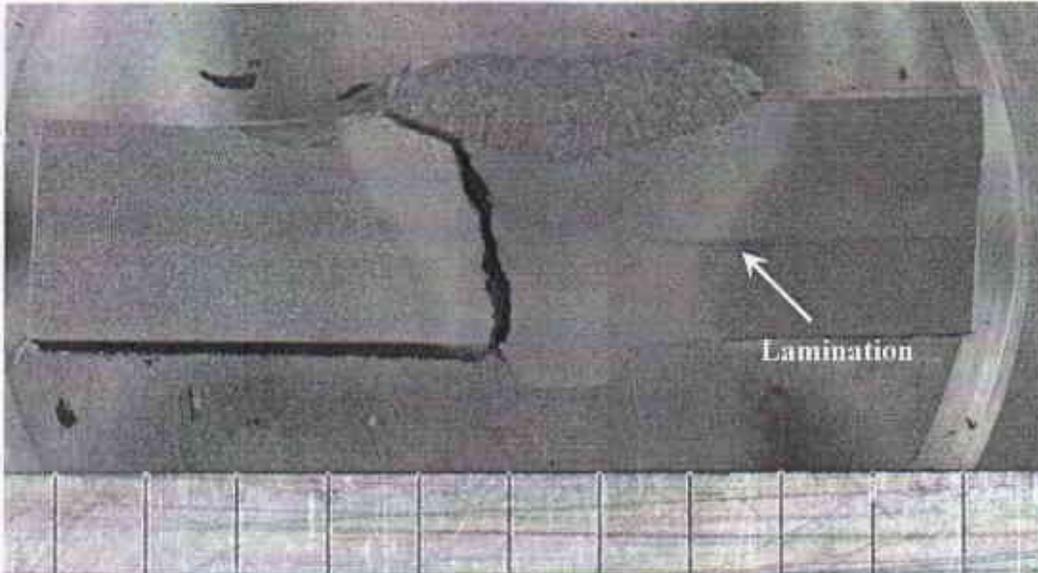
A metallographic cross-section was prepared at the apparent crack origin (Figure 23). The most notable feature seen in the metallographic section was a lamination in the plate material on one side of the girth weld (Figure 24). The cross section also showed good alignment of the cap weld and several points along the fracture. There were also wide gaps where the fracture did not fit together as well.

Figure 23. Photomacrograph showing fracture after crack was broken open. Scale divisions are 1/8th inch.

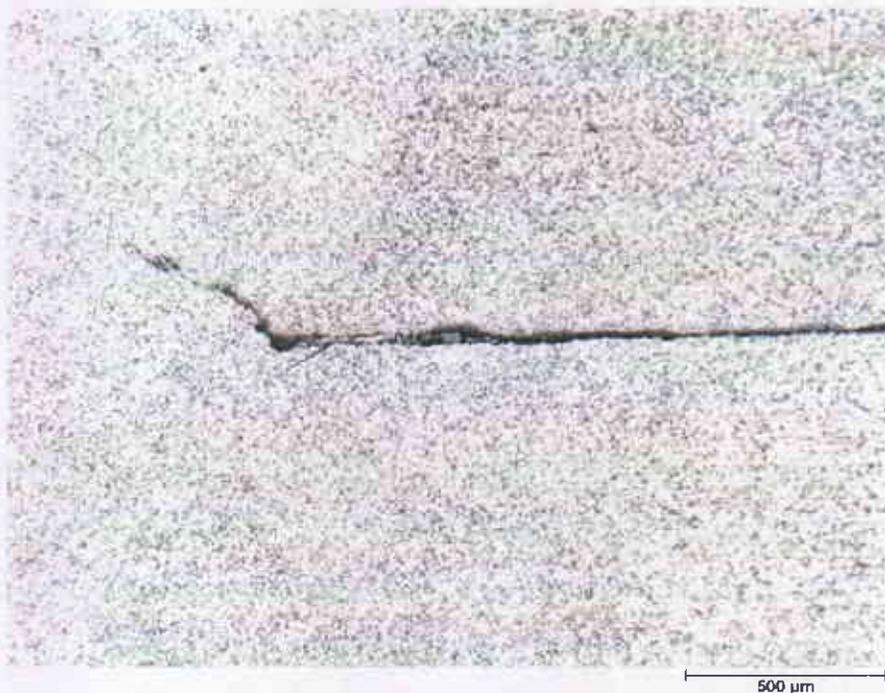
Laminations are considered defects by API when they are present in the weld bevel because they are a source of welding imperfections. When the weld pool contacts a lamination, the liquid metal picks up impurities and gases which are often deposited in the weld when it solidifies. This is believed to have occurred in this girth weld. The hot pass and first fill pass imperfections were created by the lamination, and further reduced the integrity of the girth weld. The compromised weld likely cracked during laying of the pipeline into the open ditch, at which time large bending stresses are often created. The gas test following construction, which is the highest hoop stress the pipeline likely experienced, could have contributed to or caused additional crack extension.

Figure 24. Photomicrograph of pipe at weld plate intersection showing lamination in plate. This microstructure is typical of pearlite ferrite structure.
Nital Etchant
Original Magnification 40X

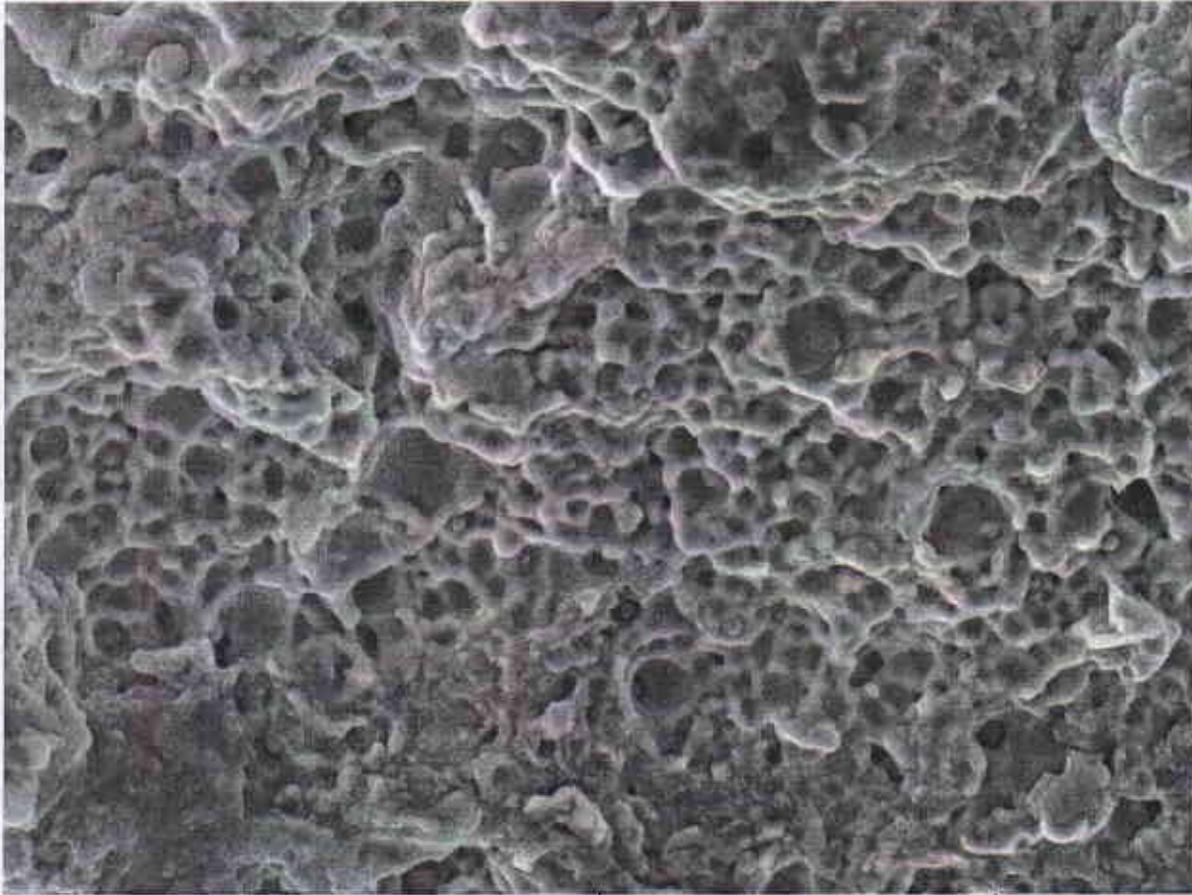
The fracture was examined using a scanning electron microscope (SEM) to confirm the mode of fracture. Much of the fracture was corroded or eroded over time. The fracture appears to have initiated as a ductile fracture (dimpled), but now has a smooth appearance (Figure 25). The recent fracture surface, which covers a relatively small percentage of the area, has a typical ductile, dimpled rupture appearance (Figure 26).

The SEM examination confirmed that the cracking occurred in at least two phases. The first phase occurred several years ago. This conclusion is supported by the smooth fracture appearance seen on the fracture surface and confirmed in the SEM. The second phase of cracking occurred very recently. This is again confirmed by SEM examination.

Figure 25. SEM photograph showing fracture surface. The fracture has a typical dimpled rupture appearance with smooth edges. The smooth edges are likely the result of corrosion or erosion.

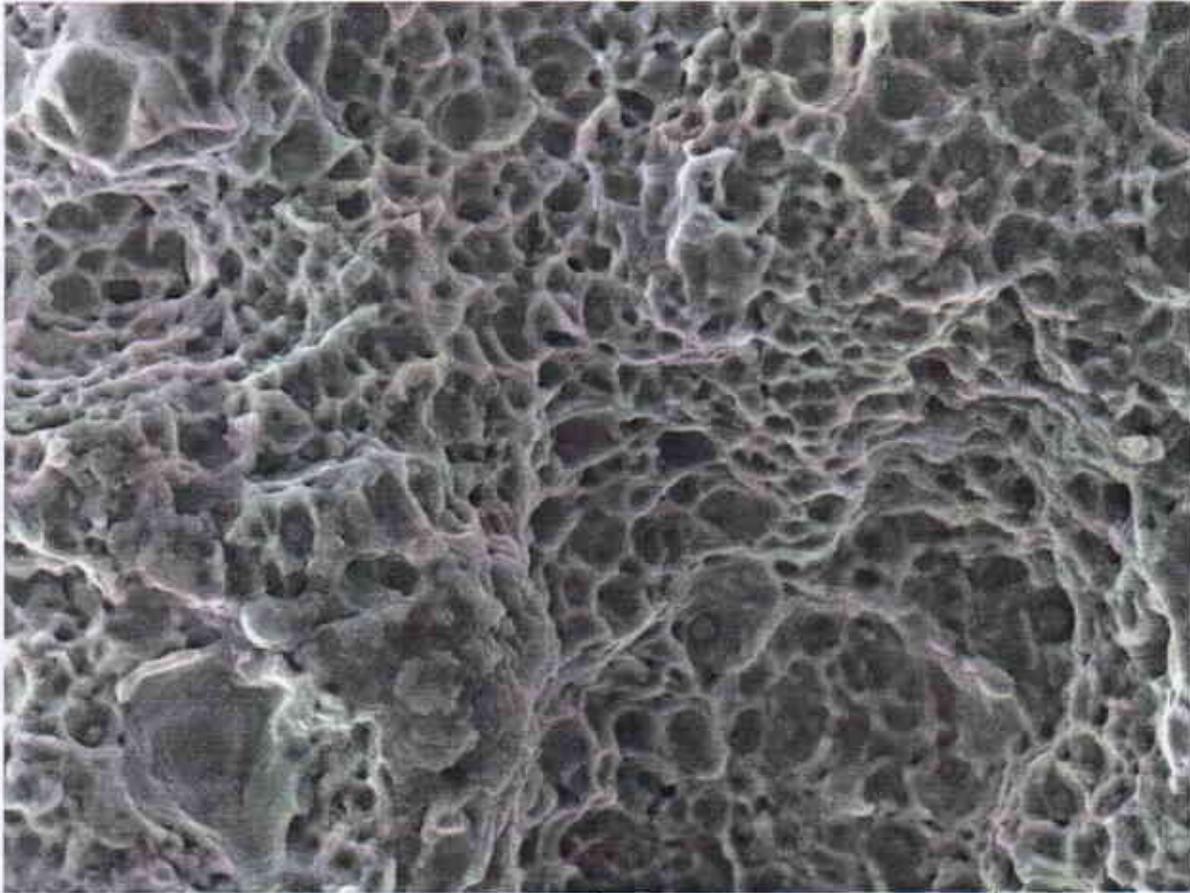
Figure 26. SEM photograph showing fracture surface. The fracture has a typical dimpled rupture appearance.
