**ConocoPhillips
Pipe Line Company**

RE: CPF No. 5-2009-5013

Item.1 §195.54 Accident reports.

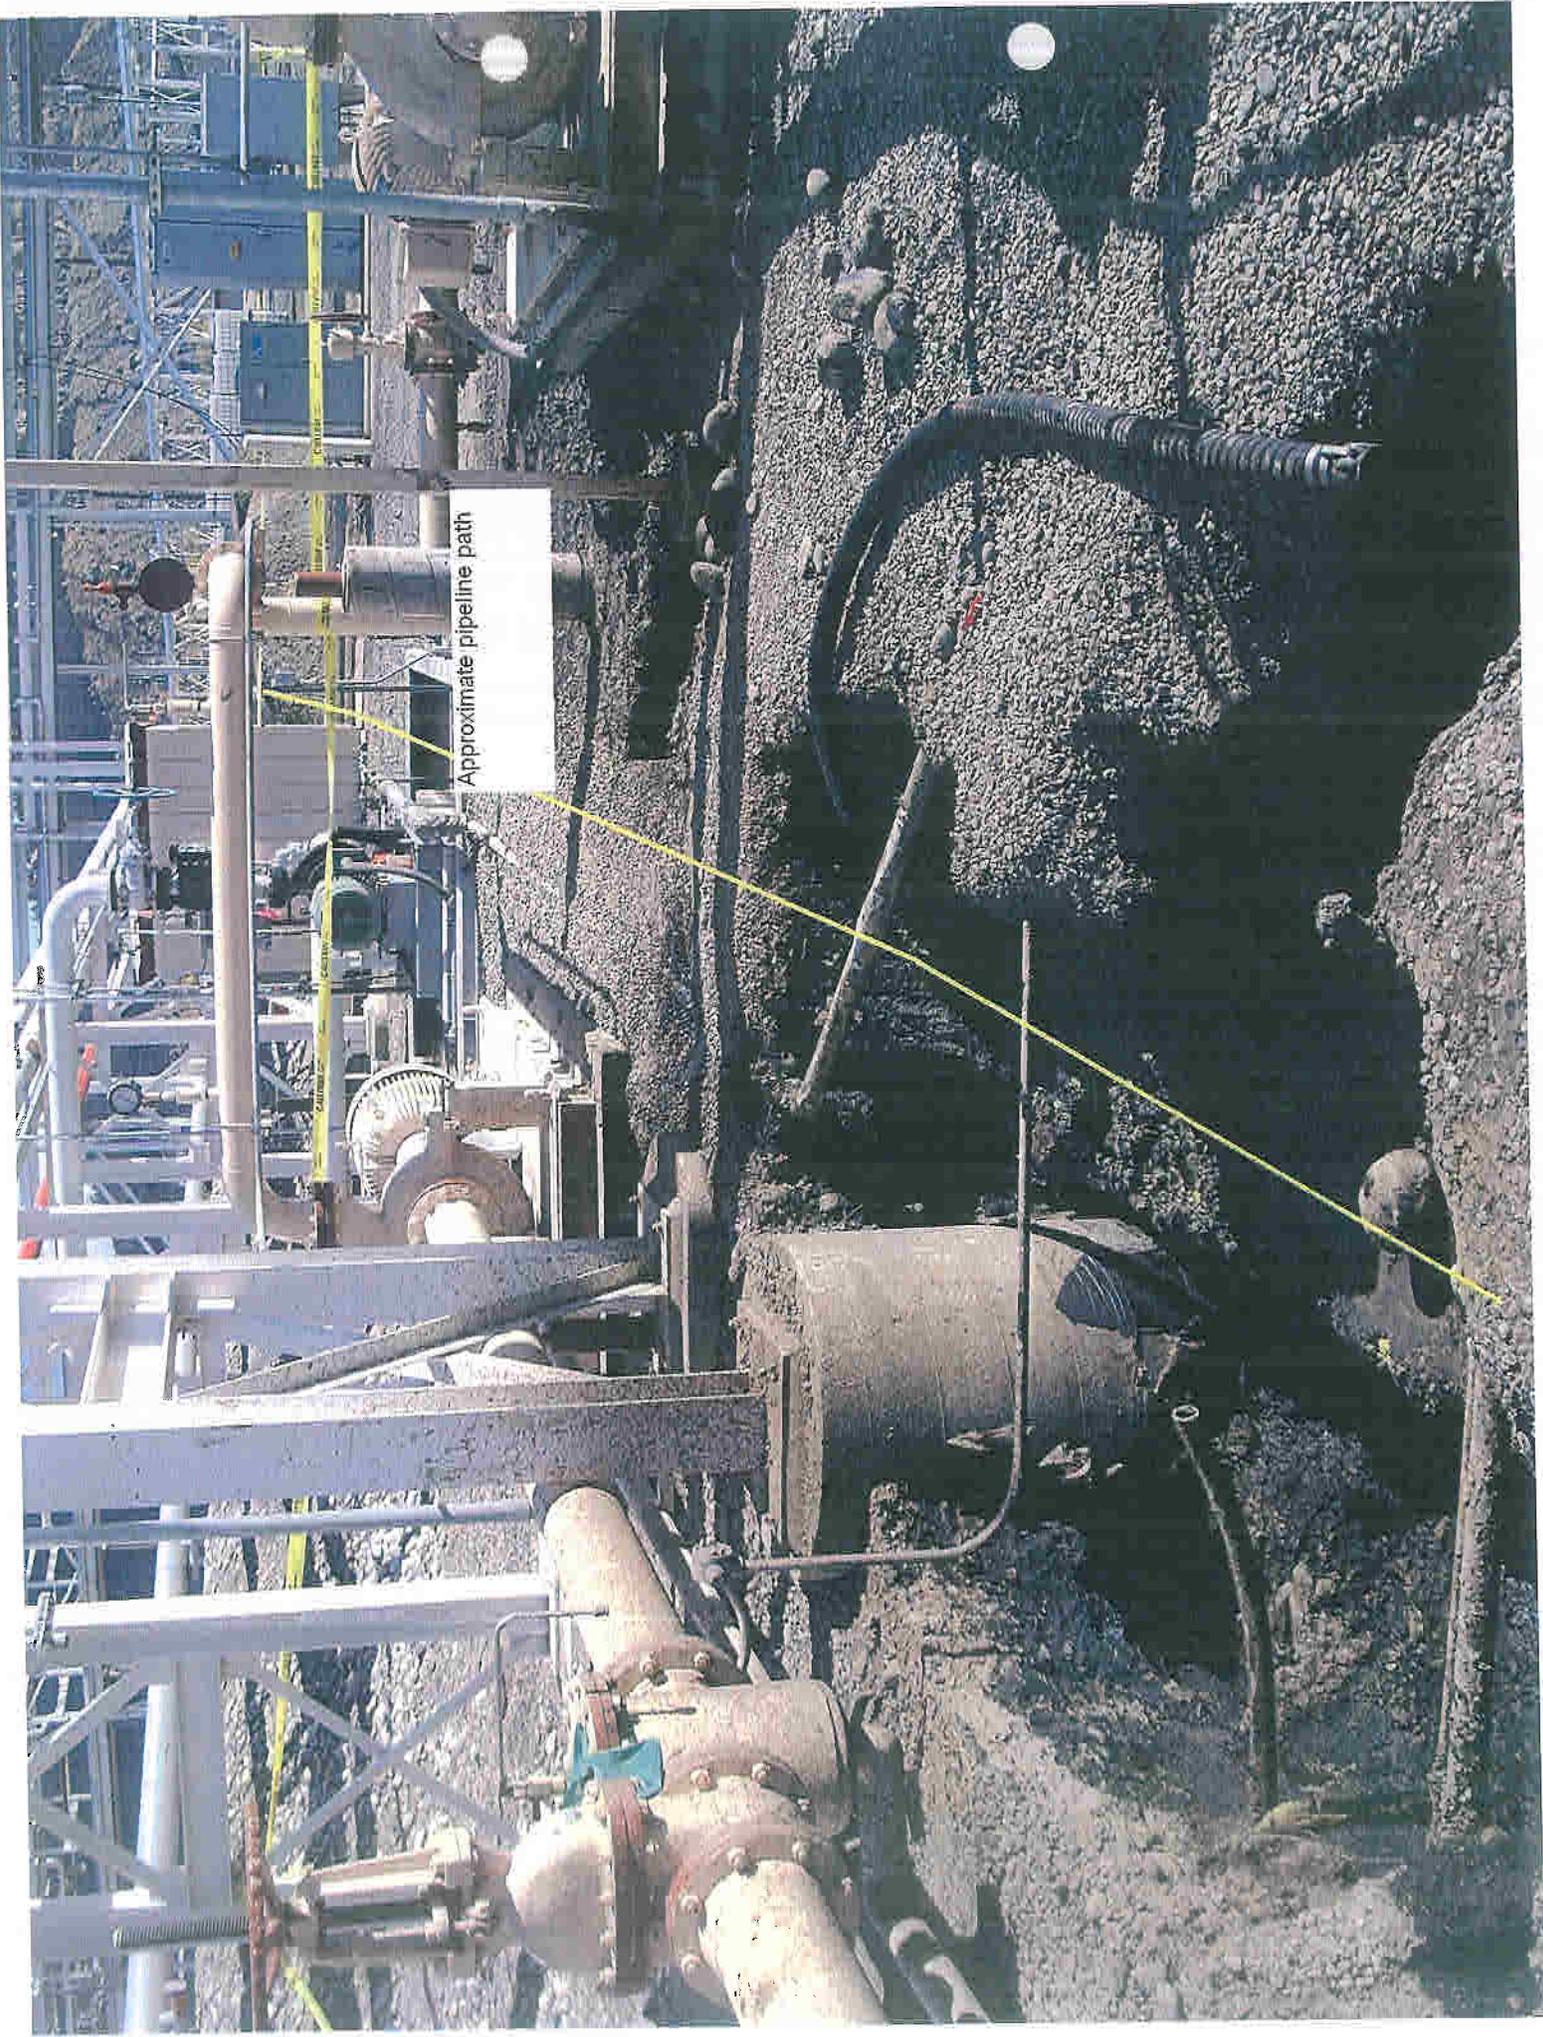
Approximate pipeline path
