SECTION 7
STRESS REPORT

STRESS ENGINEERING SERVICES, INC.

Subject: Pipe Survey and Coupon Tests

This letter report describes the results from the survey of the samples from P.O.P. Line 25. The line was tested in June 2001 and the samples were shipped to Stress Engineering Services (SES). When received at SES, the barnacles were cleaned from the pipe, photographs of the pipe were taken, and the pipe was stored in our outside lot.

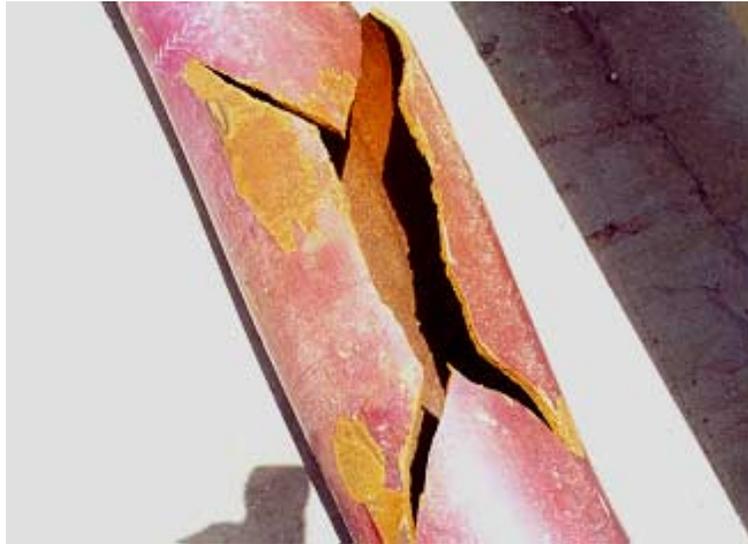
Figure 3. Fractured Pipe As-received (View 1)

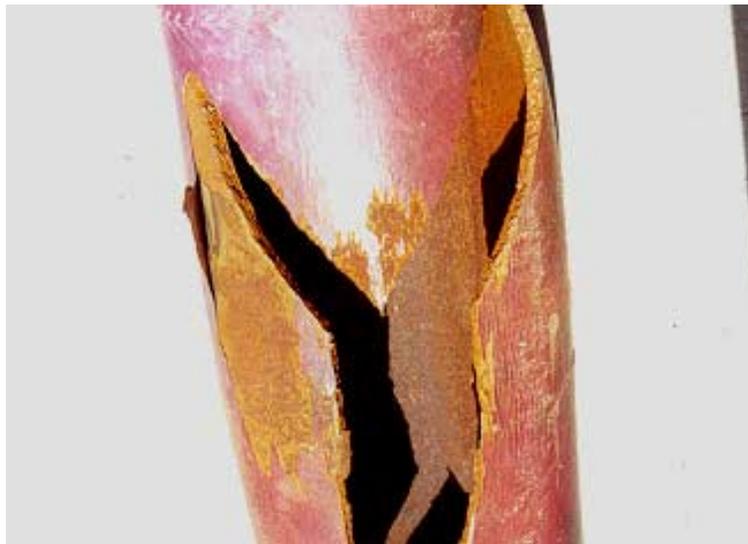
Figure 4. Fractured Pipe As-received (View 2)

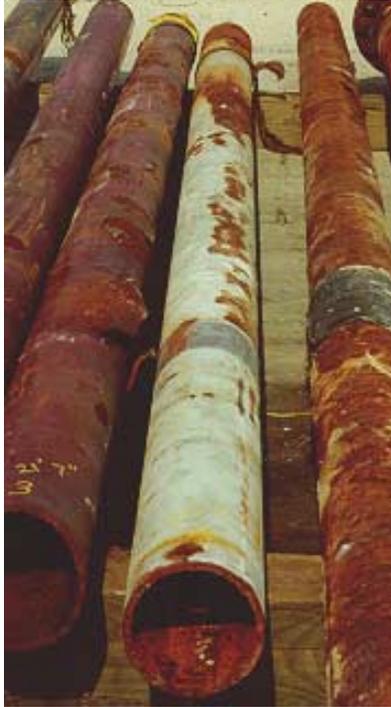
Pipe 4 View 1

Between H and I from the 12” mark to the 17” mark deep pitting and heavy corrosion found. Buffed small area and took UT Thk. Reading at location. Base wall was .474 and pitted area was .361 for a difference of .133. Photo’s taken.

Between J and K, Weld and immediate surrounding area heavily scaled with wall loss. Photo’s taken.
