**Technology Transfer Demonstrations and Post-Mortem Testing of Cast Iron
and Steel Pipe Lined with Cured-in-Place Liners (CIPL)**

**Final Report
(Public Version)**

**HE Stewart, TD O'Rourke, BP Wham, AN Netravali, C Argyrou, X Zeng,
and TK Bond**

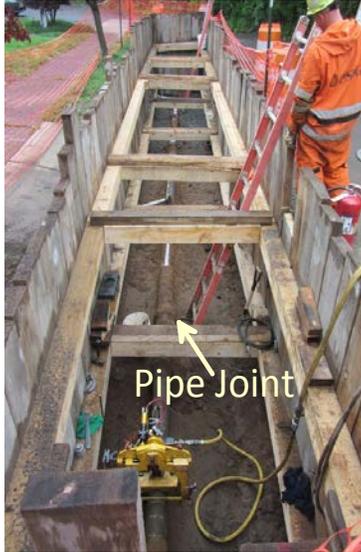
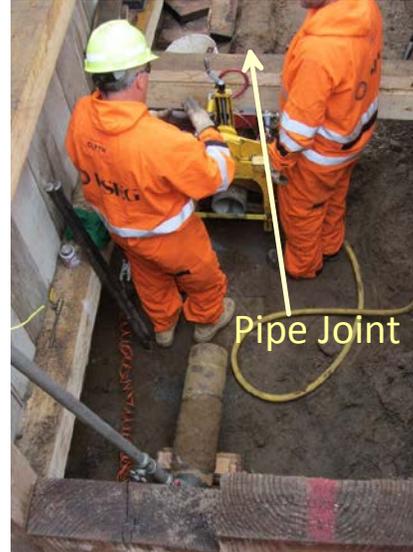
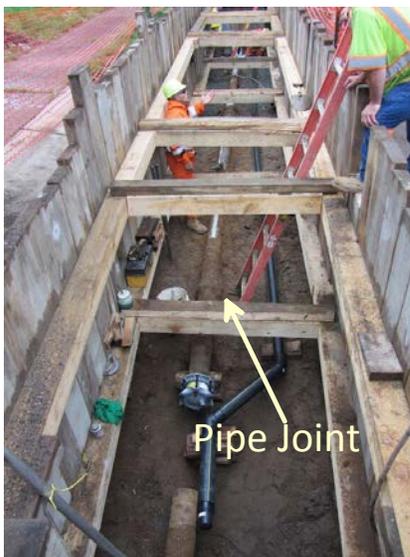
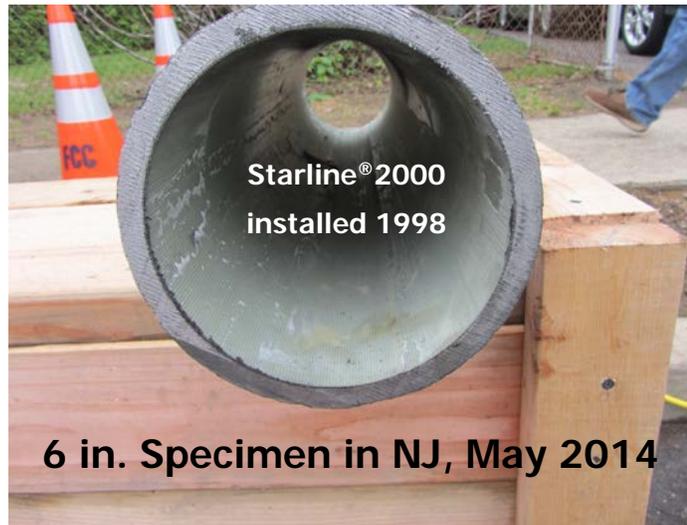
Figure 4.1. Pipe Retrieval from PSE&G Site in Elmwood Park, NJ

Figure 4.1(a) – (c) shows the excavation and CI pipe at Elmwood Park, NJ. The CI joint is shown in the figures. This was a live gas cut-out. The PSE&G CI line was operating at a low pressure of about 15 in. of water column (102 kPa.) Figure 4.1(d) shows a pipe section immediately after removal. The lining appears very clean with no obvious defects after 16 years of service.

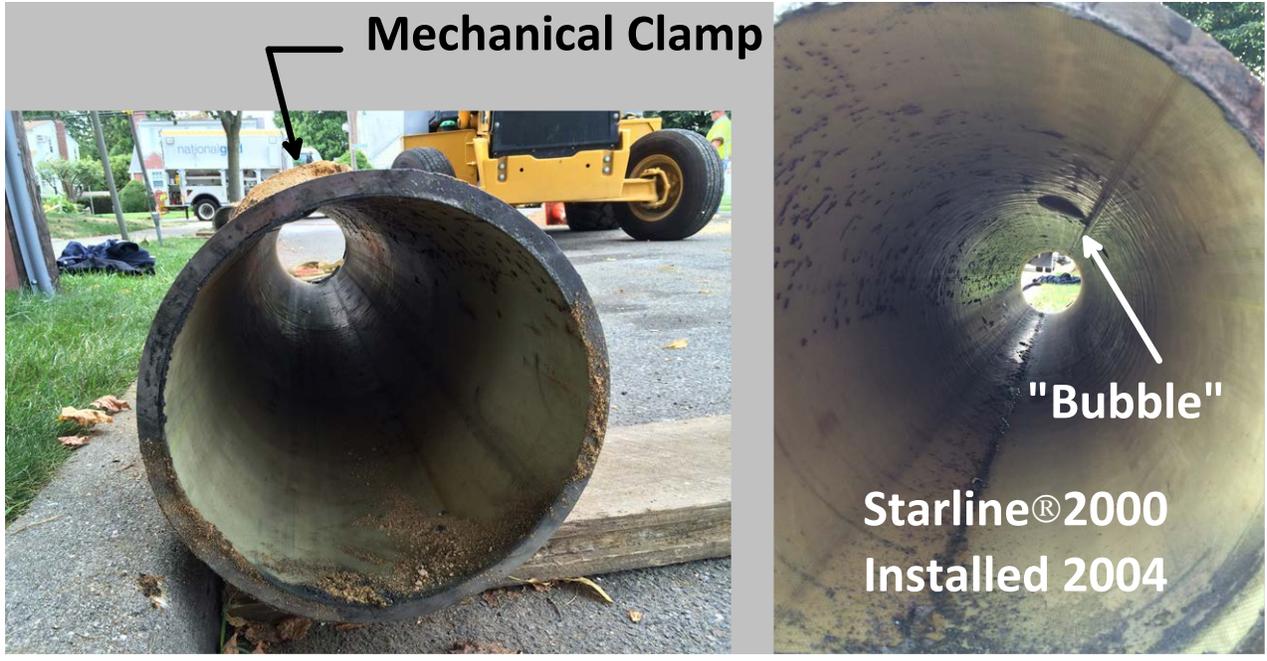
Figure 5.2 Twelve-in. (300-mm)-Diameter Cast Iron Joint after Field Retrieval

Figure 5.1(a) – (c) show the excavation and CI pipeline at South Garden City. The CI joint is shown in the photos. The National Grid CI pipeline was operating at 60 psig (414 kPa) pressure. Figures 5.2(a) and (b) show two views of a pipe section immediately after removal. Figure 5.2(a) shows the location of the mechanical clamp on the pipe joint. Figure 5.2(b) shows a “bubble” feature, or local protrusion of the liner, at a joint near the pipe crown. The visual appearance of the pipe interior appears quite clean. Figure 5.3(a) shows the pipe joint after field retrieval, with corrosion and scale apparent on the mechanical clamp. Figure 5.3(b) shows the joint after it had been cleaned carefully and de-scaled in the laboratory.

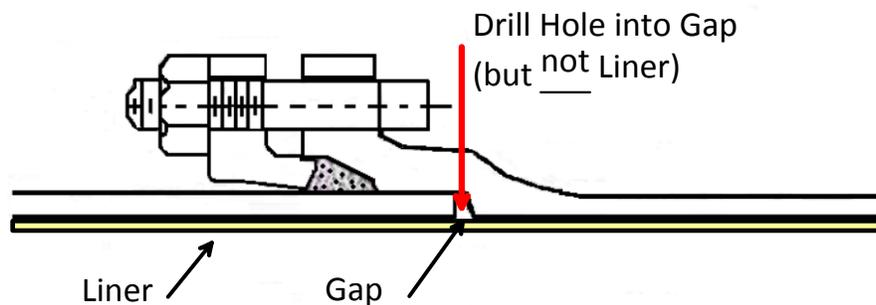
Figure 5.14. Drilling into 12- in. (300)-mm-Diameter CI Bell

Following the entire set of mechanical aging tests on Specimen 12-1, a pressure verification test was conducted to assure that the liner had not ruptured during the test. Before the pressure testing, a test hole was drilled into the cast iron bell. This is shown schematically in Figure 5.14. The purpose of the drilled hole was to ensure that, if the liner was ruptured, gas would leak through the rupture and out the drilled hole during pressure testing. If the hole had not been present a non-leaking rubber sealing gasket could have prevented any observable liner leak. The pipe was pressure tested to the operating pressure of 60 psig (414 kPa) in roughly 10 psig (7 kPa) increments.

There was no leakage. Then the pressure was increased to 90 psig (620 kPa). Again there was no leakage.

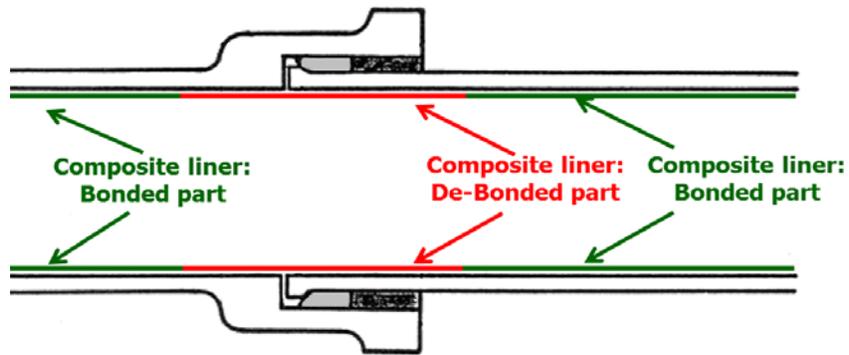
Figure 6.12. Typical Bell and Spigot CI Pipe Joint with Composite Liner Showing both Bonded and De-Bonded Sections of the Pipe after Mechanical Aging Tests

As mentioned previously, during the mechanical aging (thermal contraction/expansion) process, part of the debonded liner showed visual damage. Close inspection of the specimens indicated that the polyester yarns were damaged while the polyurethane membrane remained intact. Most of the polyester yarn damage occurred during the first thermal contraction/expansion cycle, and was likely caused by the high rate of the test that was completed in just 2-4 hours, about 4 orders of magnitude faster than the natural cycle of a few months.

A longitudinal cross-section through typical bell and spigot CI joint with liner is shown in Figure 6.12. When thermal contraction of the CI pipes occurs, the two adjoining pipe sections are pulled apart and maximum tensile stress and strain are exerted on the liner at the gap between the bell and the spigot. The liner, while stretching, generates shear stresses at the CI pipe/liner interface at that location. This results in the CI pipe/liner interfacial failure in the shear mode. As a result, shear is viewed as the primary mode of CI pipe/liner interfacial failure. The debonded region of the liner has been observed to be within one diameter across the joint gap.
