### Final Financial Report

Prepared by: CC Technologies, Inc.

**Evaluation and Validation of Aboveground  
Techniques for Coating Condition Assessment**

FEBRUARY 28, 2006

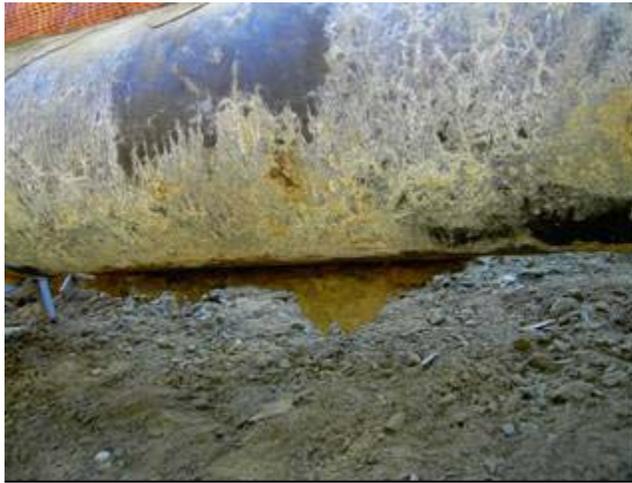
Figure 14: Indications 1 & 2: From dig stake distances 36' to 46', coating was entirely disbonded on the underside of the pipe.

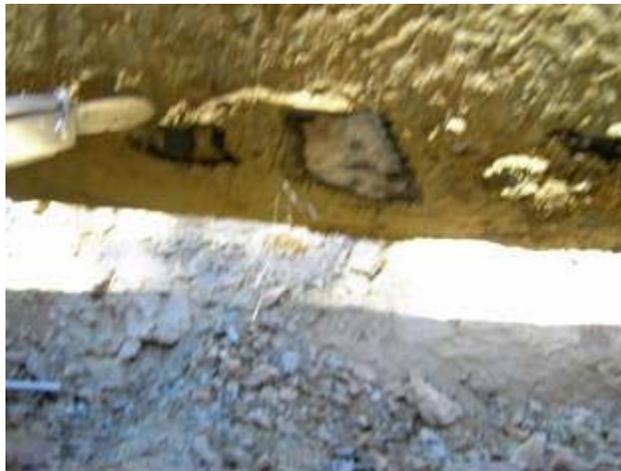
Figure 15: Indication #3: There were 3 small (~3" diameter) disbonded patches just above the 6 o'clock position on the pipe

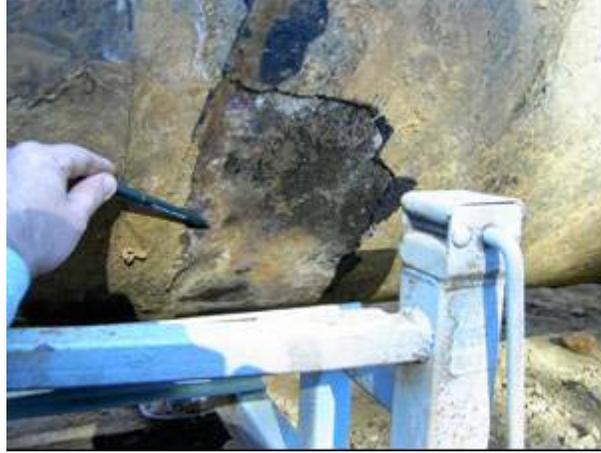
Figure 16: Indication #4: A large disbonded area about 1 square foot total, from 6 o'clock to 9 o'clock on the pipe.

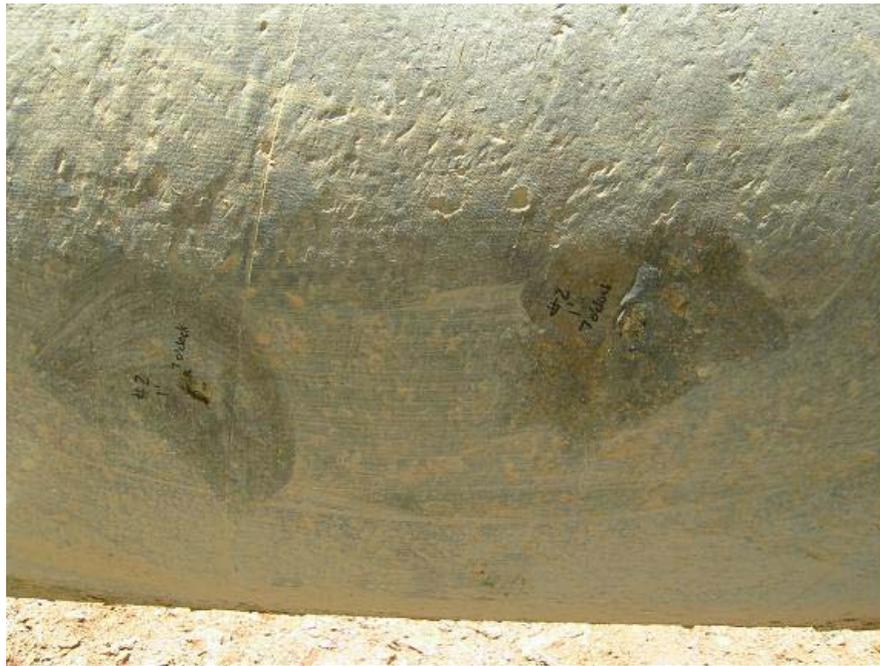
Figure 17: Indication 2A-1: 2 small gash marks at the 7 o'clock position

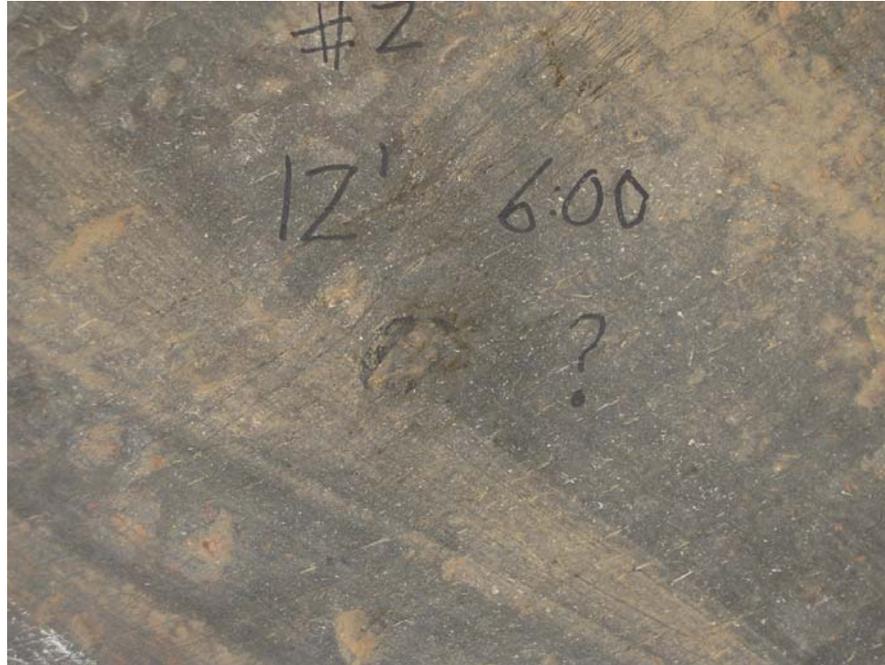
Figure 18: Indication 2A-2: One mark at 6 o'clock position

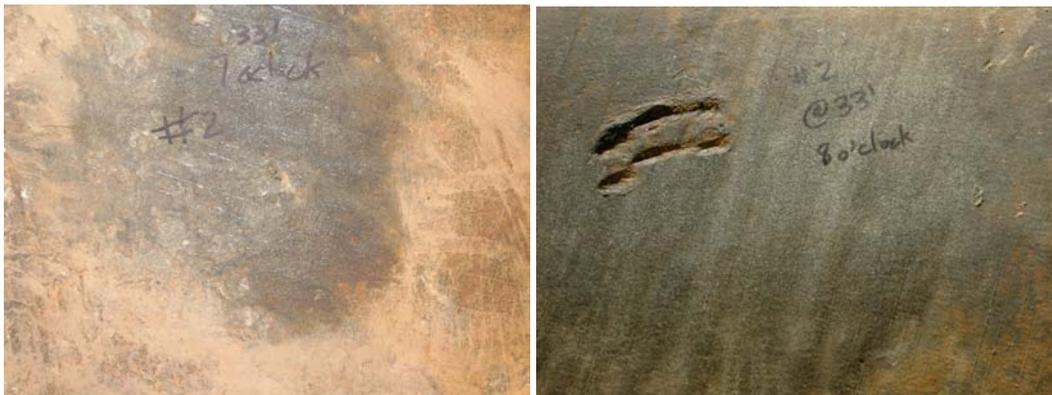
Figure 19: Indication 2A-4: Two marks at the 7 and 8 o'clock positions

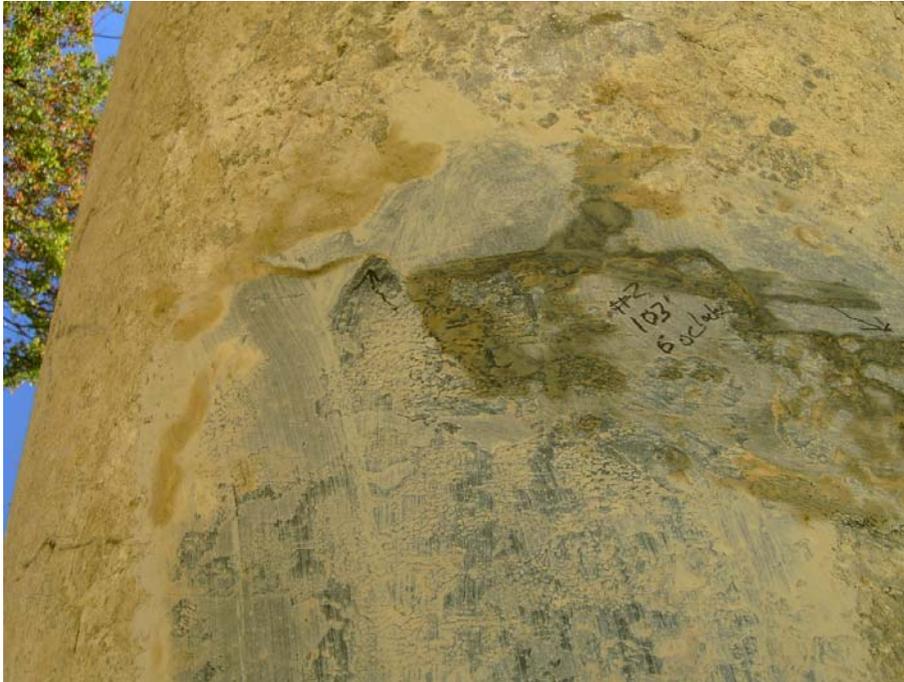
Figure 20: Indication 2A-5: A seam was noticed at 6 o'clock, but no obvious holiday

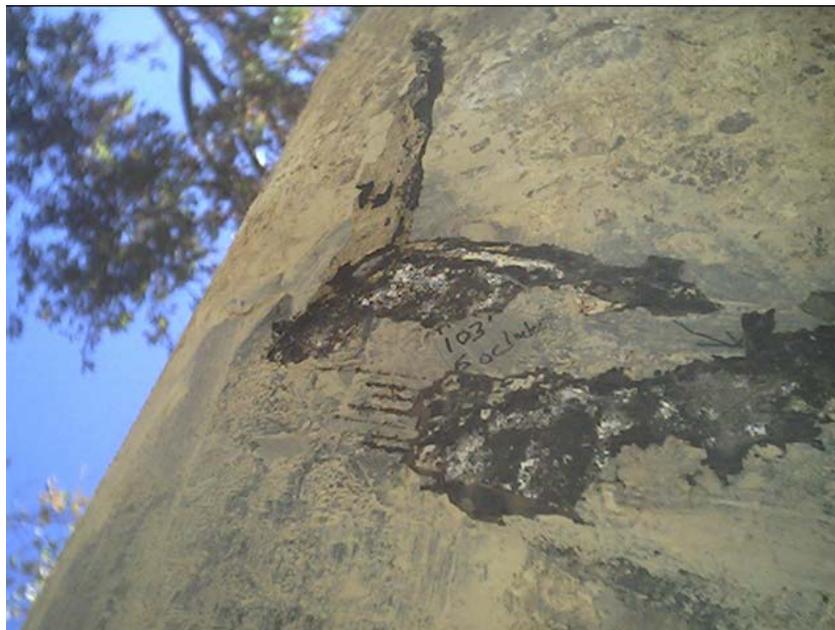
Figure 21: Indication 2A-5, after the coating was removed by a pocket knife.

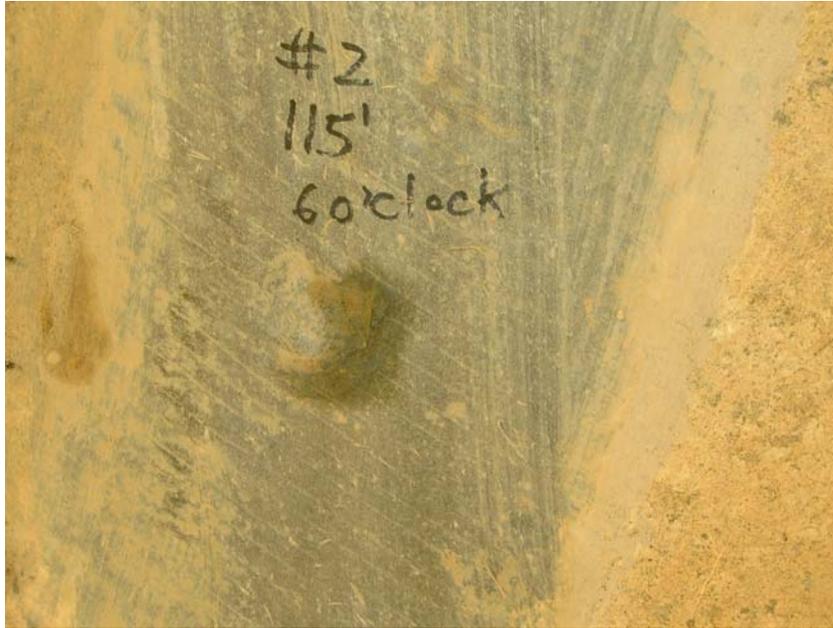
Figure 22: Indication 2A-6: small “ding” at 6 o’clock

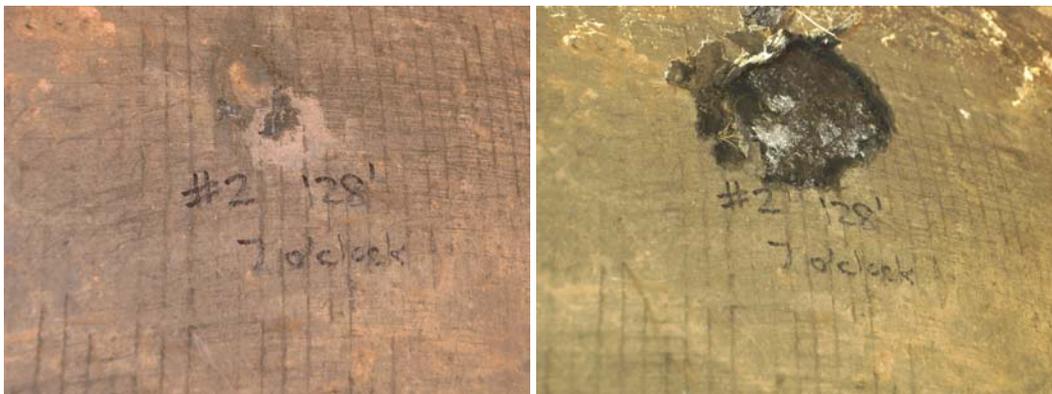
Figure 23: Indication 2A-7 (a) as-noted, and (b) calcareous deposits noted after coating removal

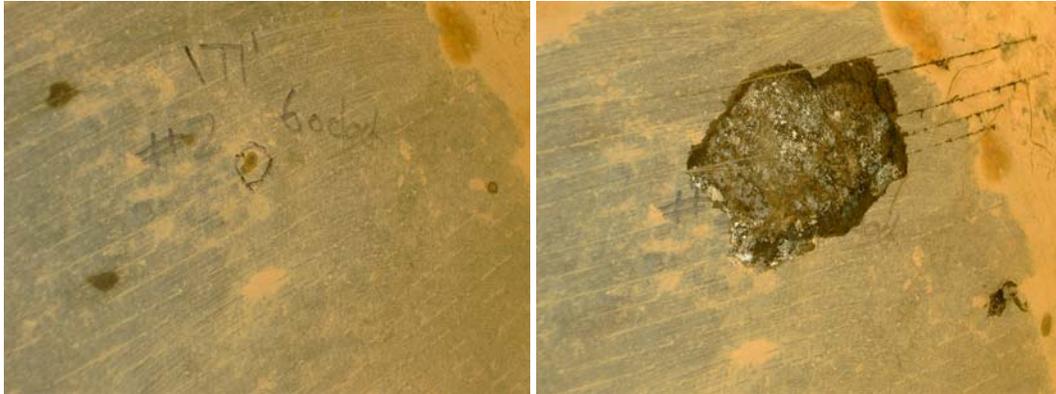
Figure 24: Indication 2A-9 (a) as-noted, and (b) calcareous deposits noted after coating removal

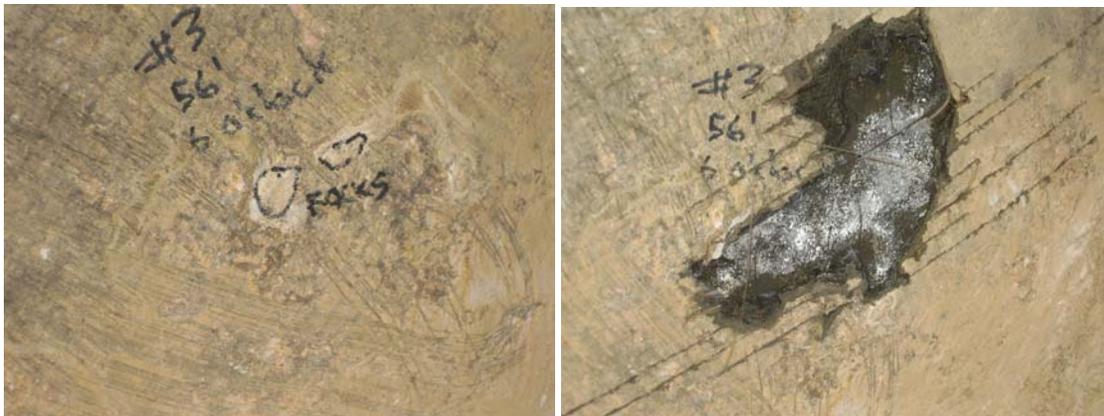
Figure 25: Indication 2B-1 (a) as-noted, and (b) calcareous deposits noted after coating removal

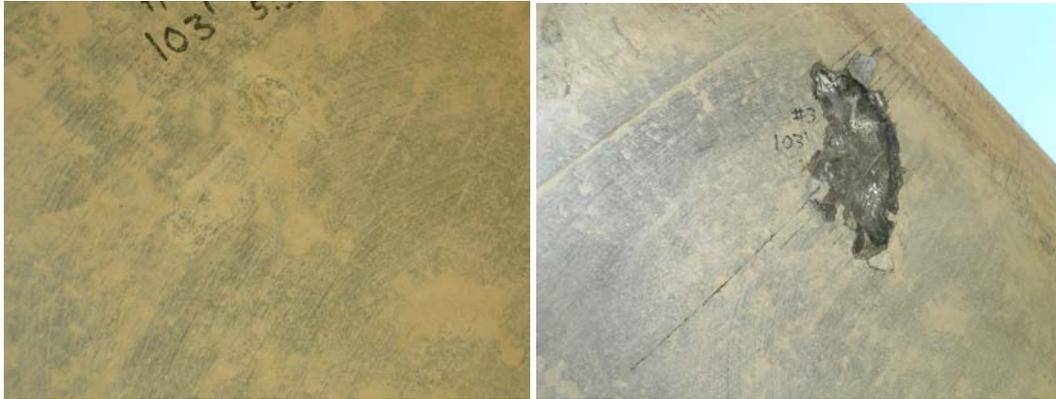
Figure 26: Indication 2B-3 (a) as-noted, and (b) calcareous deposits noted after coating removal

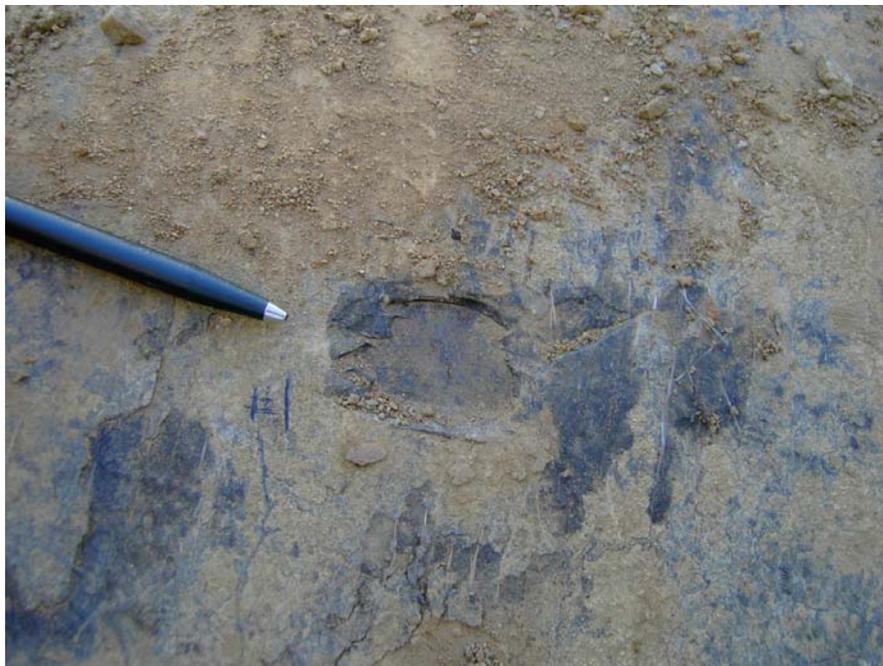
Figure 27: Site 1, undetected holiday, 1" diameter hole at 1 o'clock, 125'

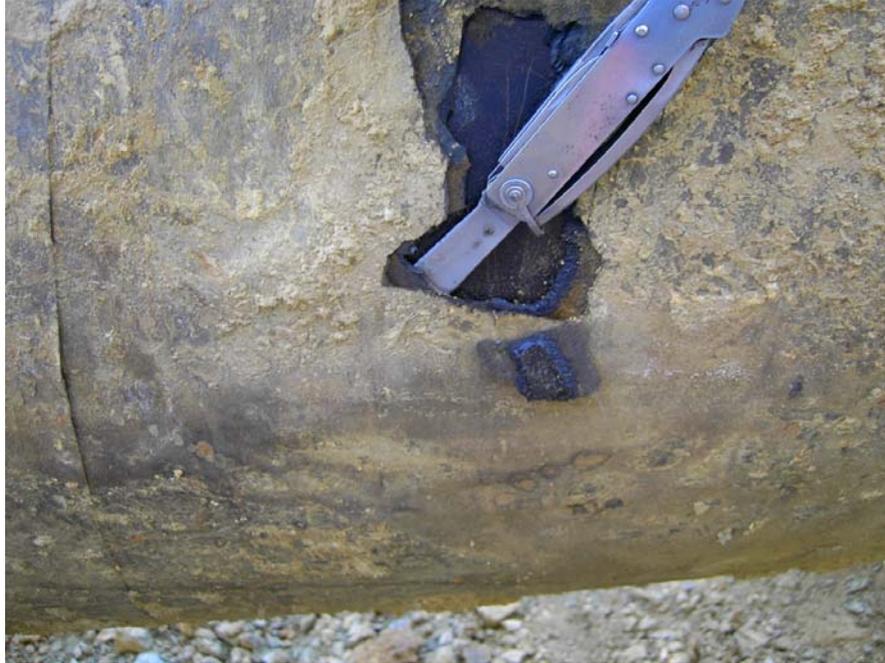
Figure 28: Site 1, undetected holiday, 2 o'clock position, 72' from dig stake

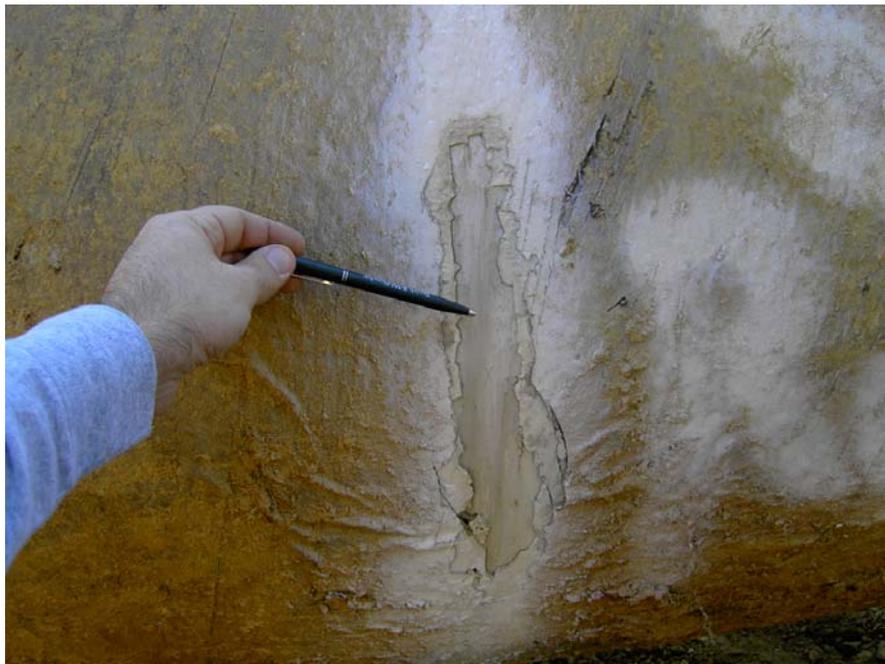
Figure 29: Site 1, undetected holiday, 3 o'clock position at 50'

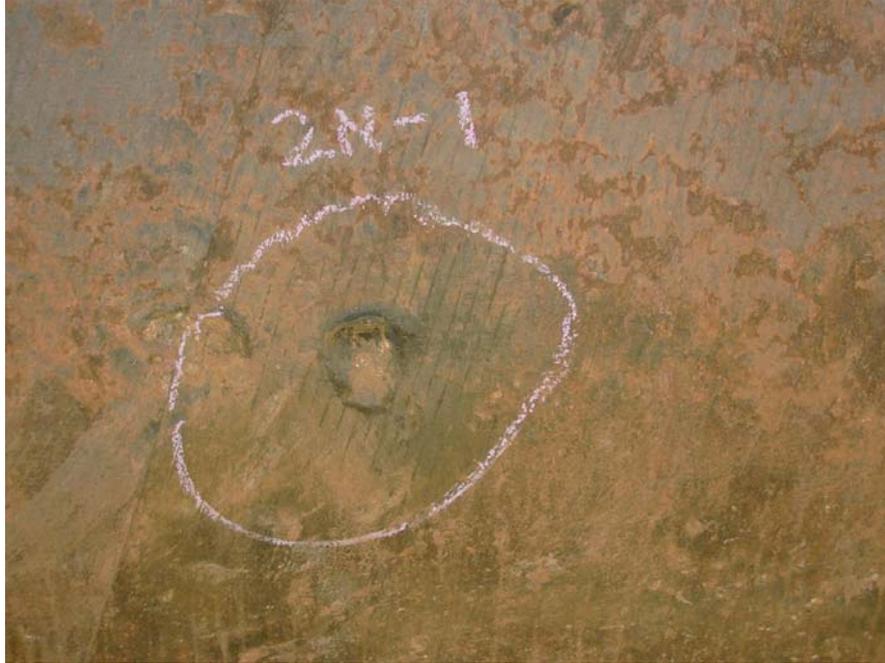
Figure 30: Site 2a, undetected holiday, 10 o'clock position, 1/4" diameter holiday @ 3'

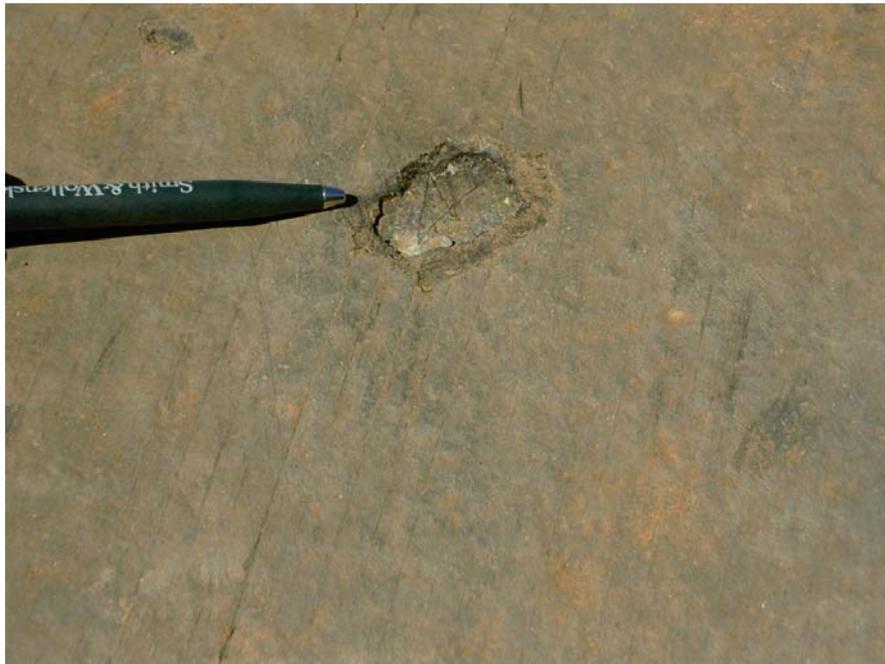
Figure 31: Site 2a, undetected holiday, 11 o'clock position, 1" diameter at 8' from dig

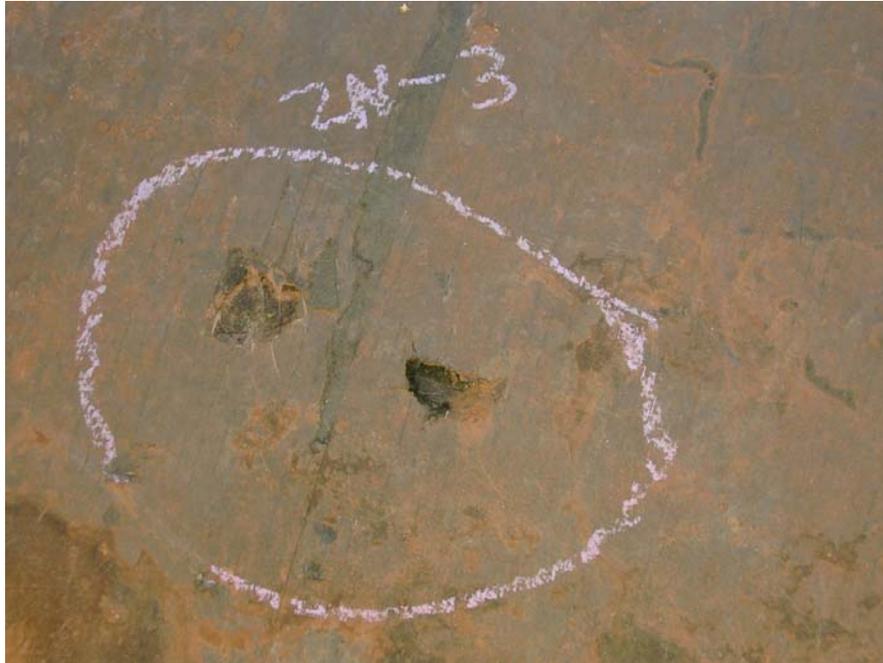
Figure 32: Site 2a, undetected holiday, 1" diameter hole at 7 o'clock, 44' from dig stake

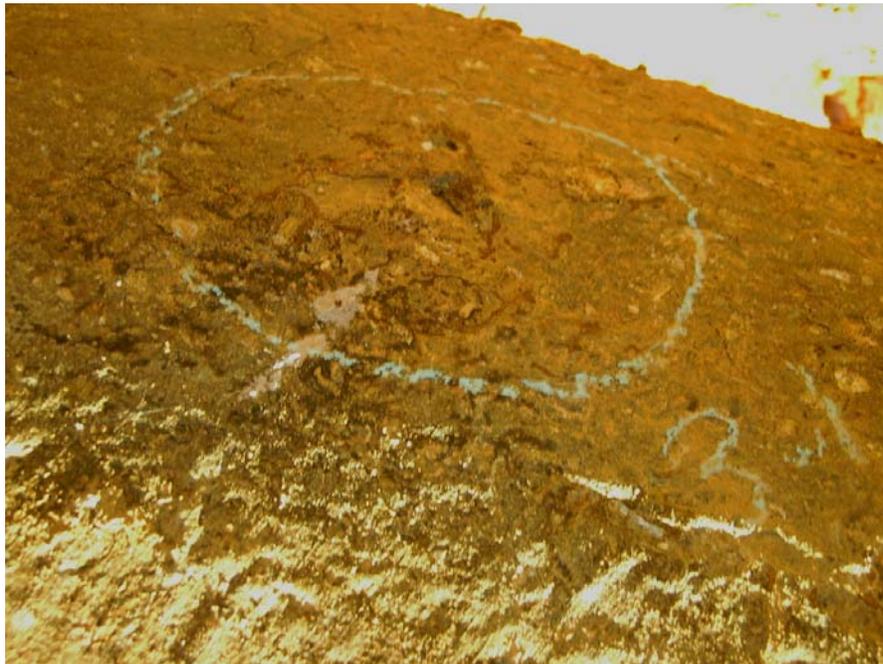
Figure 33: Site 2b, undetected holiday, 7 o'clock position, 1/4" gouge at 9'6" from dig stake

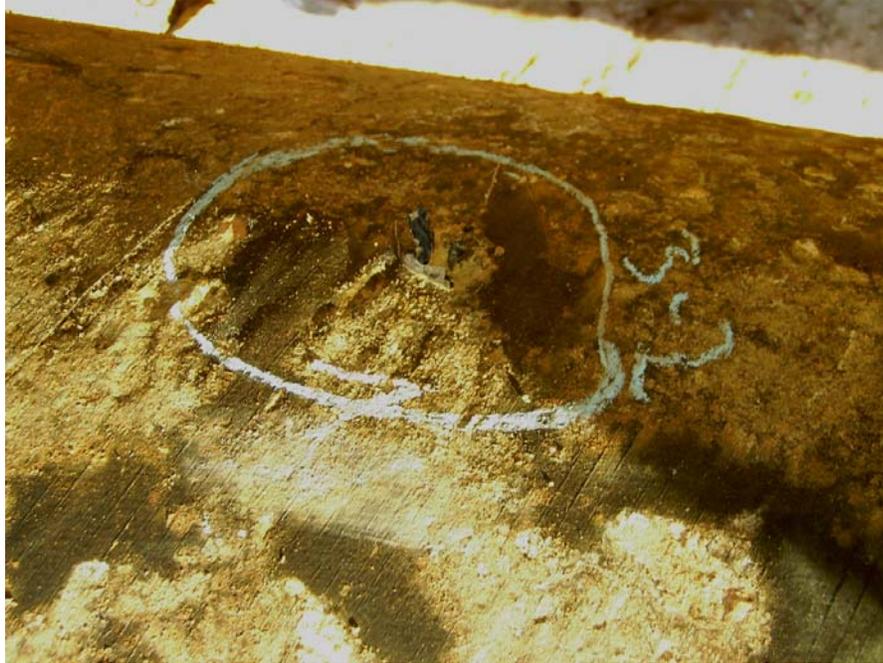
Figure 34: Site 2b, undetected holiday, 7 o'clock position,  $\frac{1}{4}$ " gouge, 17' from dig stake

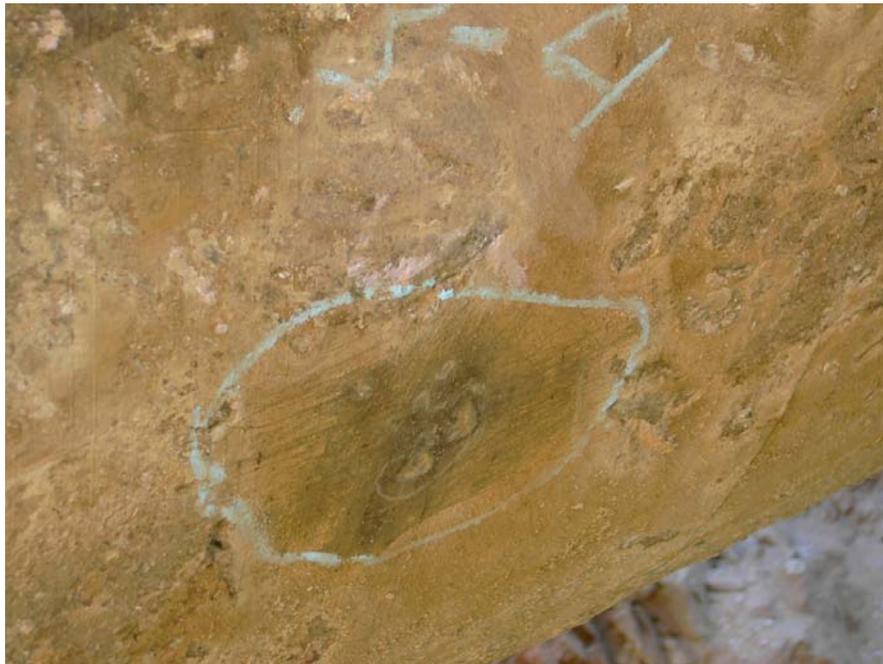
Figure 35: Site 2b, undetected holiday, 5 o'clock position, 2 parallel gouges at 47' from dig stake

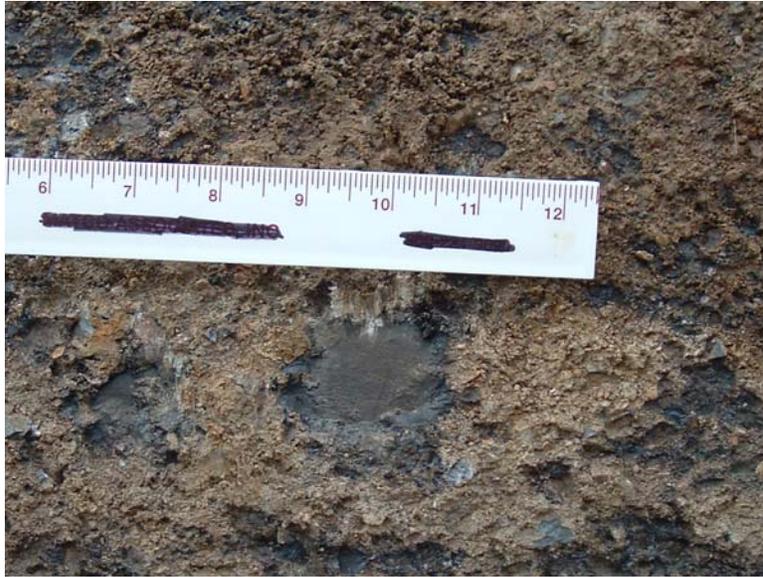
Figure 36: Holiday indication 3a-1 (indicated by DCVG, ACVG) at 10 o'clock position

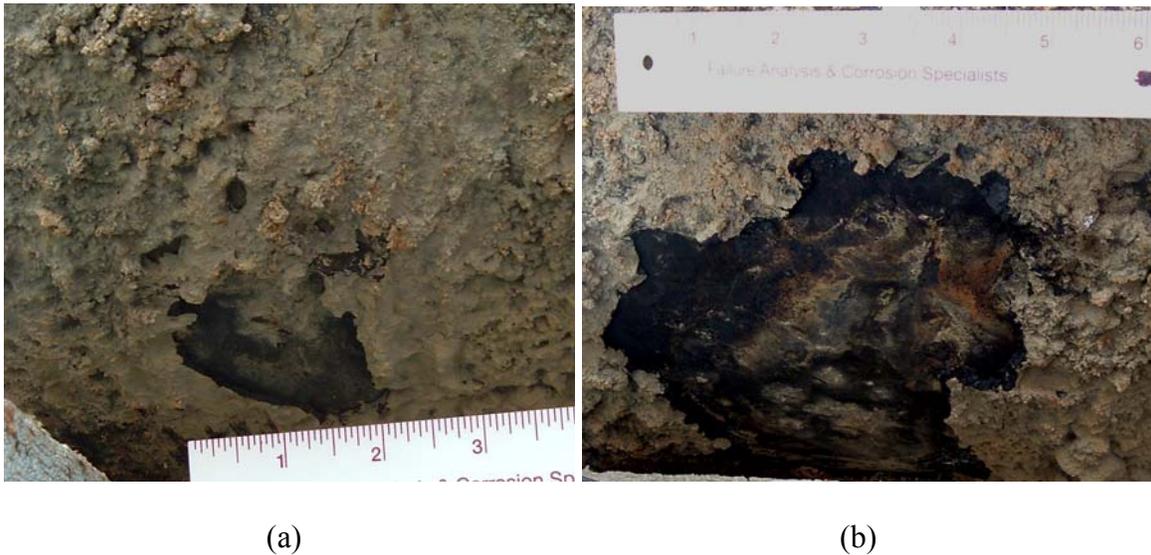
Figure 37: Holiday indication 3a-2 (indicated by DCVG, ACVG, Pearson) at 6 o'clock position (a) as-found after excavation, and (b) after removing unbonded coating

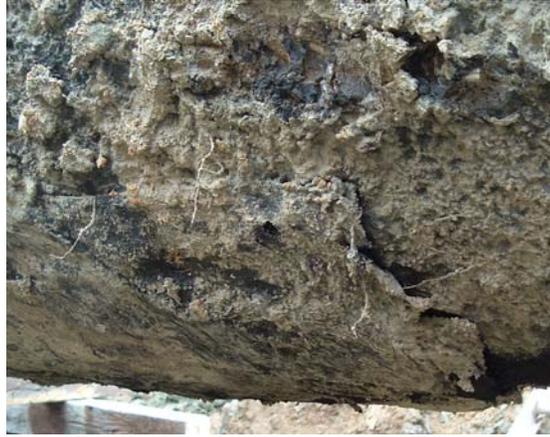
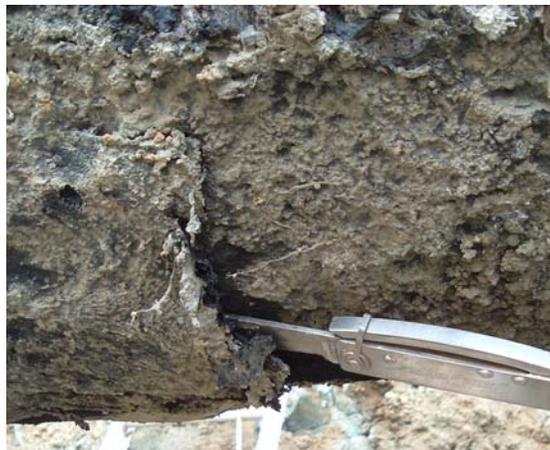
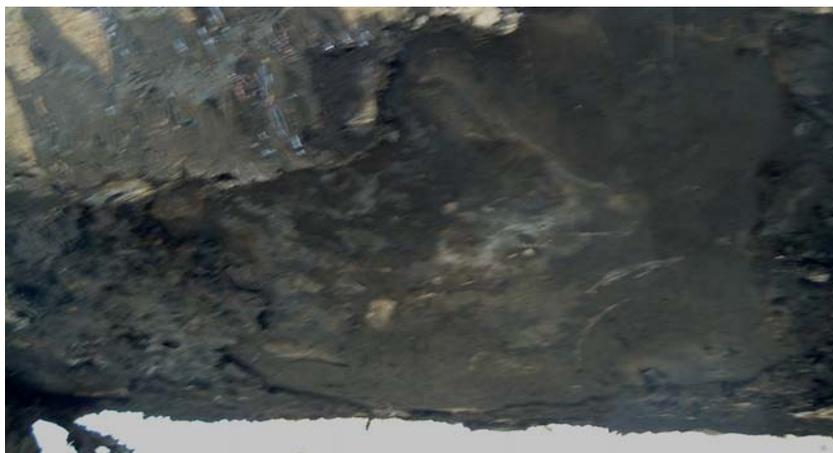
Figure 38: Indication 3a-3, a coating overpatch near the 6 o'clock position, (a) as uncovered, (b) after prodding, and (c) after patch was removed

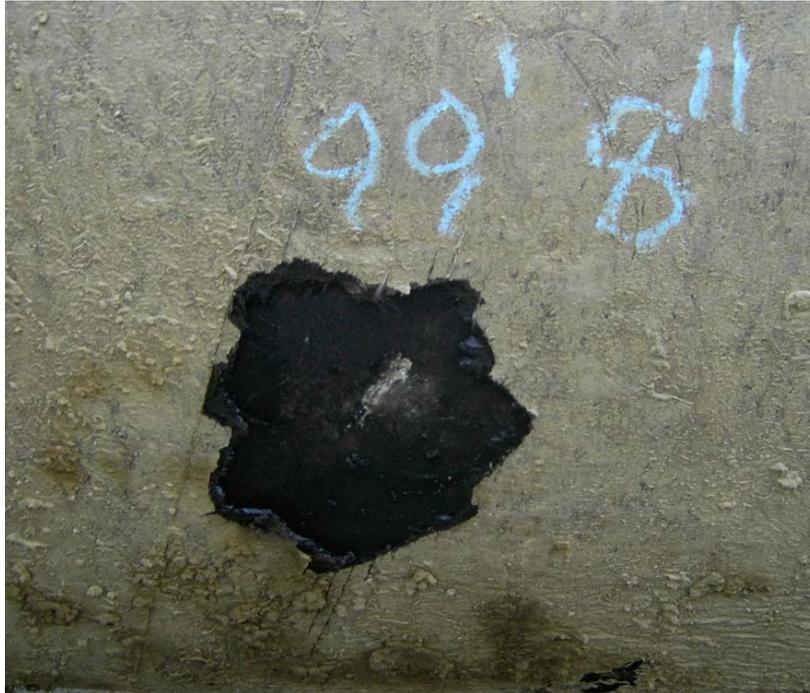
Figure 39: Holiday near 3b-1 found by DCVG, ACVG, 2 o'clock position

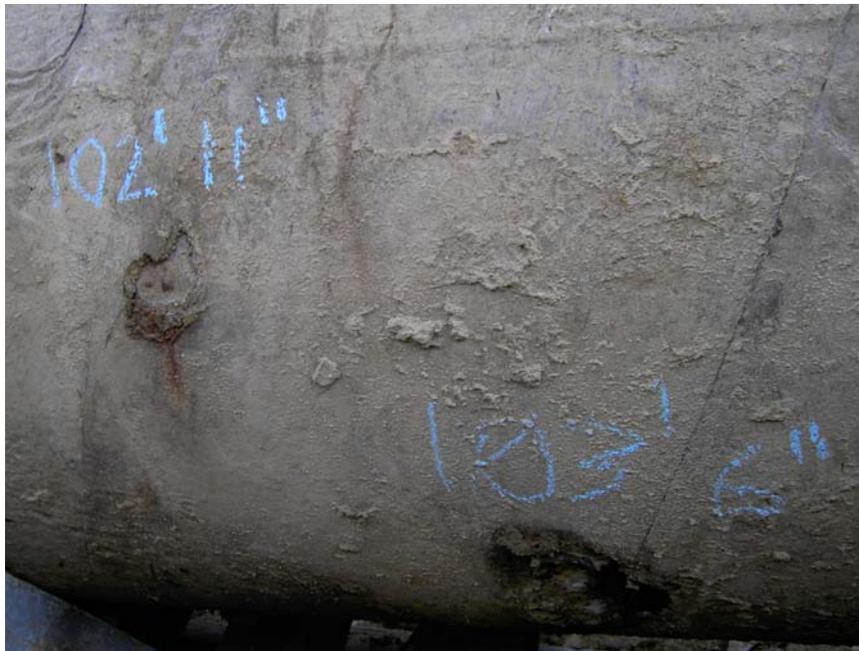
Figure 40: Defects found near 3b-1 indication, 8 o'clock position

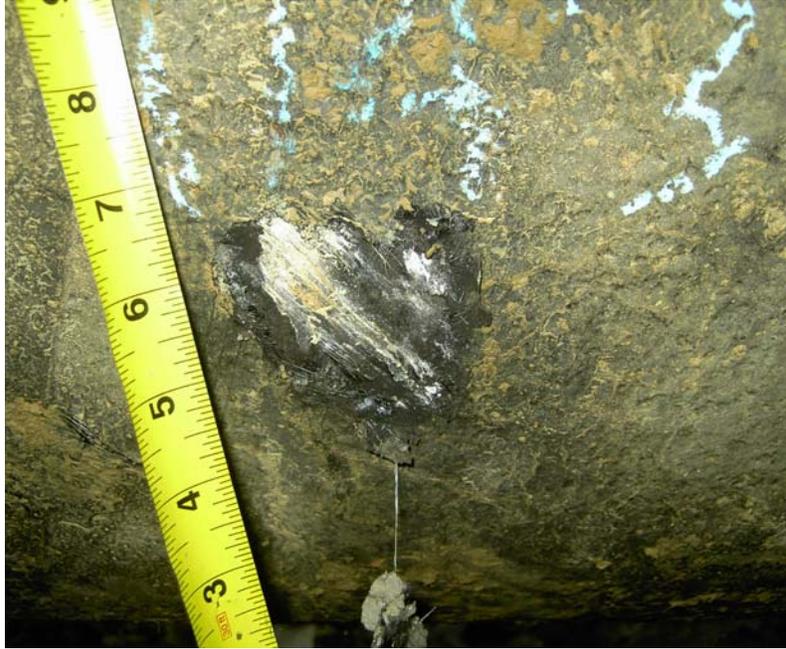
Figure 41: Indication 3b-2 at 114', 9 o'clock position

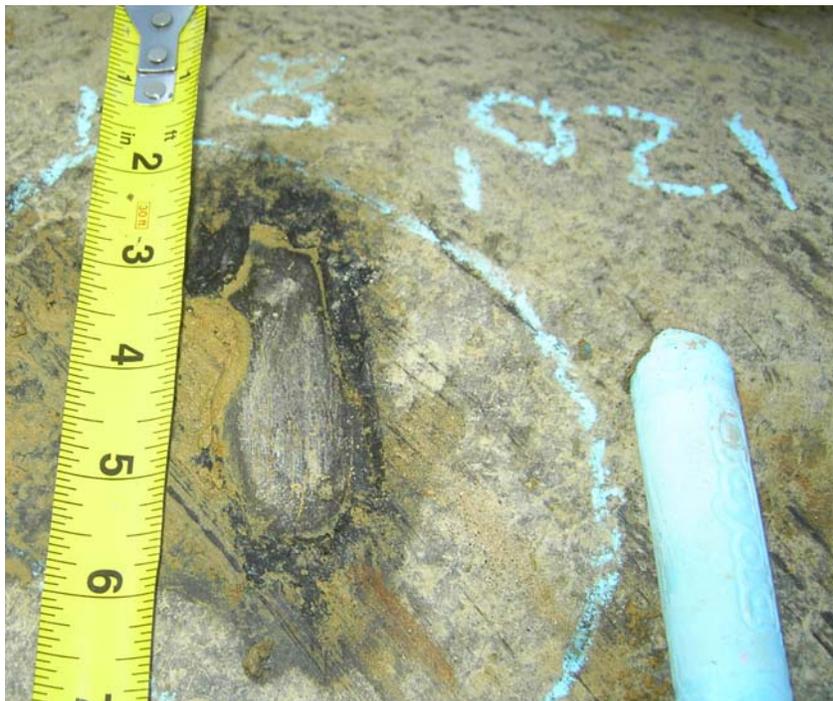
Figure 42: Indication 3b-3, 12 o'clock position

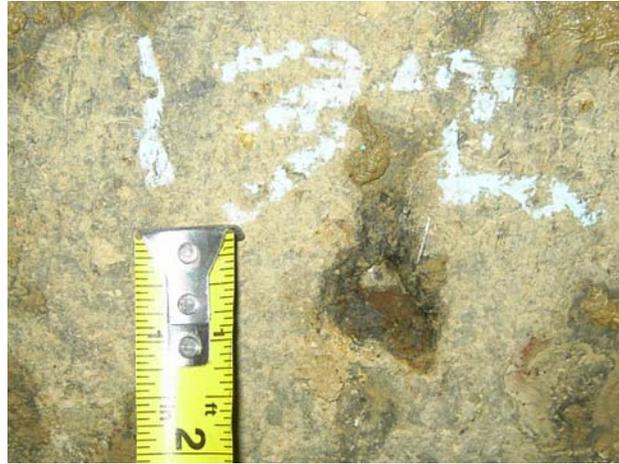
Figure 43: Indication 3b-4, 10 o'clock position

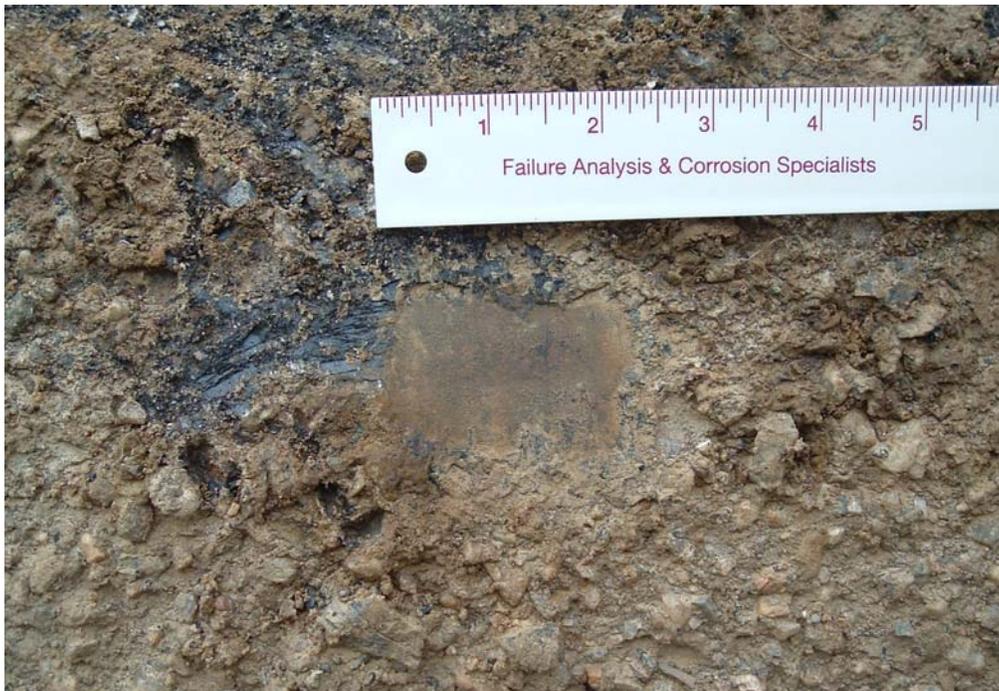
Figure 44: Holiday from site 3a not indicated during survey, 10 o'clock position  
(14')

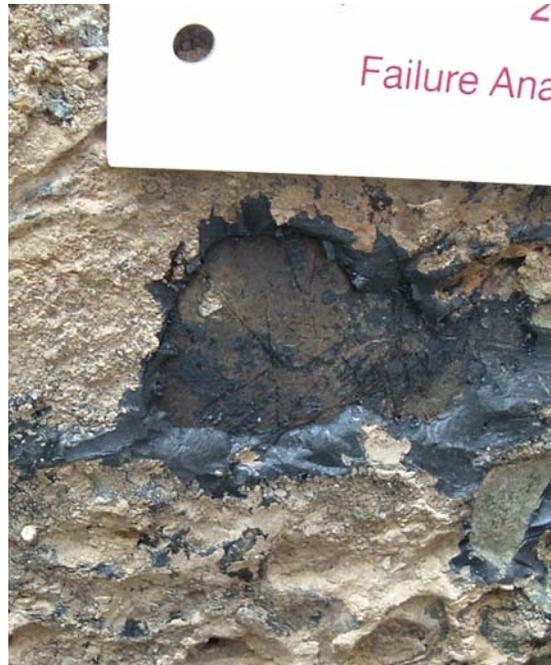
Figure 45: Site 3a undetected holiday at 28', 8 o'clock position

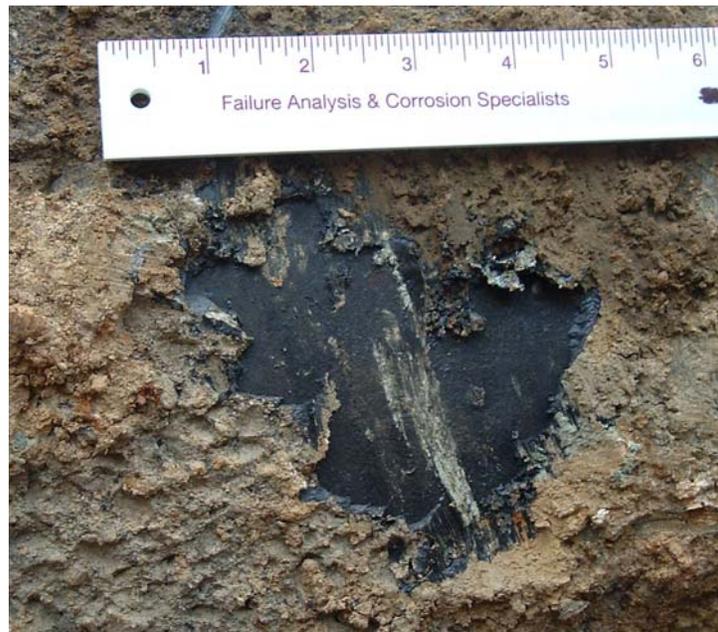
Figure 46: Site 3a undetected holiday at 52', 9 o'clock position

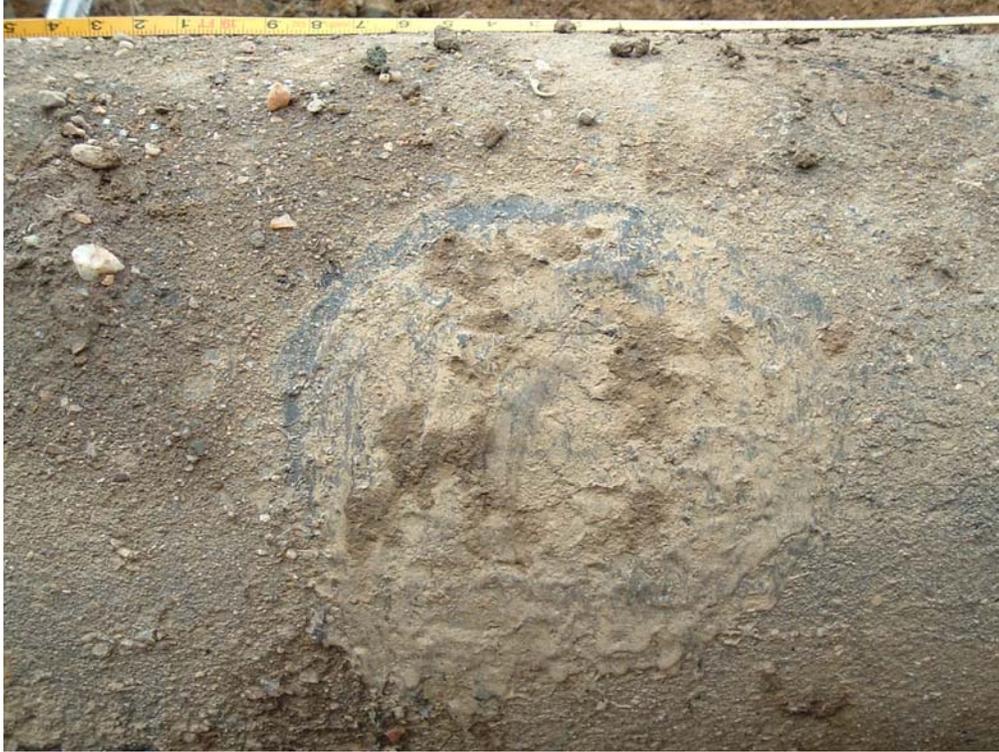
Figure 47: Site 3a large circular holiday not detected by survey, 9 o'clock position (possible patch?) at 18'

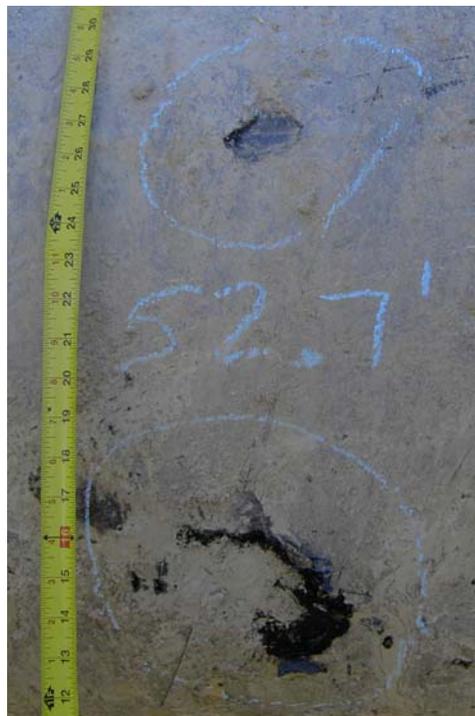
Figure 48: Site 3b undetected damage found at 53', 8 and 10 o'clock positions

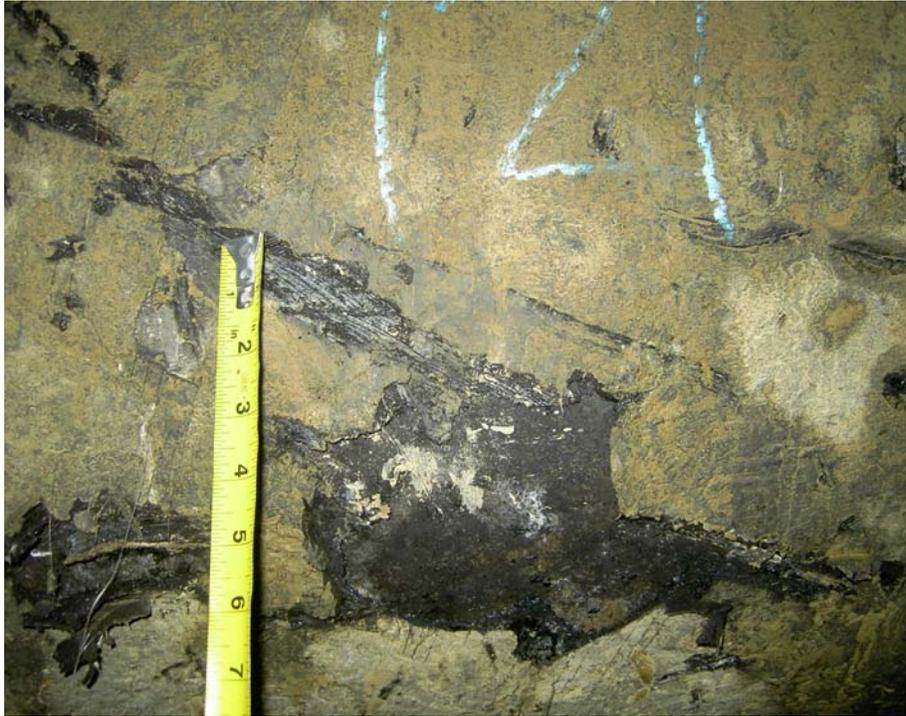
Figure 49: Site 3b undetected damage found at 140', 7 o'clock position

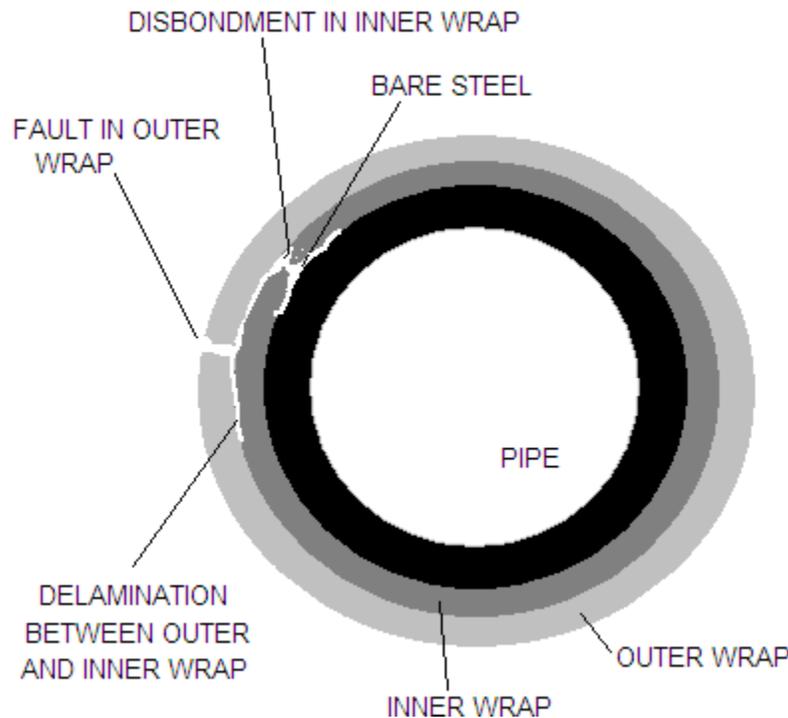
The visual examinations performed at all sites were, in some cases, misleading. The “apparent” size of each defect did not always correlate to the bare area on the pipe which was discharging current during the surveys. This is best represented in Figures 20-21. In Figure 20, the coating fault appeared to be very small and did not appear to expose bare steel. After removing some poorly bonded coating at this location, calcareous deposits were noted on the steel underneath, implying that there was in fact bare exposed steel in this location which was drawing CP current, despite the lack of visual evidence of an “open” holiday. Similar observations were noted at multiple indications.

The use of a holiday detector during the visual examinations likely would not have produced any different results, because the bare steel area was not directly exposed to the soil, as shown schematically in Figure 50.

Figure 50: Representation of common coating fault in double layer wrap (asphalt enamel and coal tar enamel) systems

Groundwater took a tortuous path to reach the steel, and unless the groundwaters were still present during the visual examination, the electrical conductive pathway

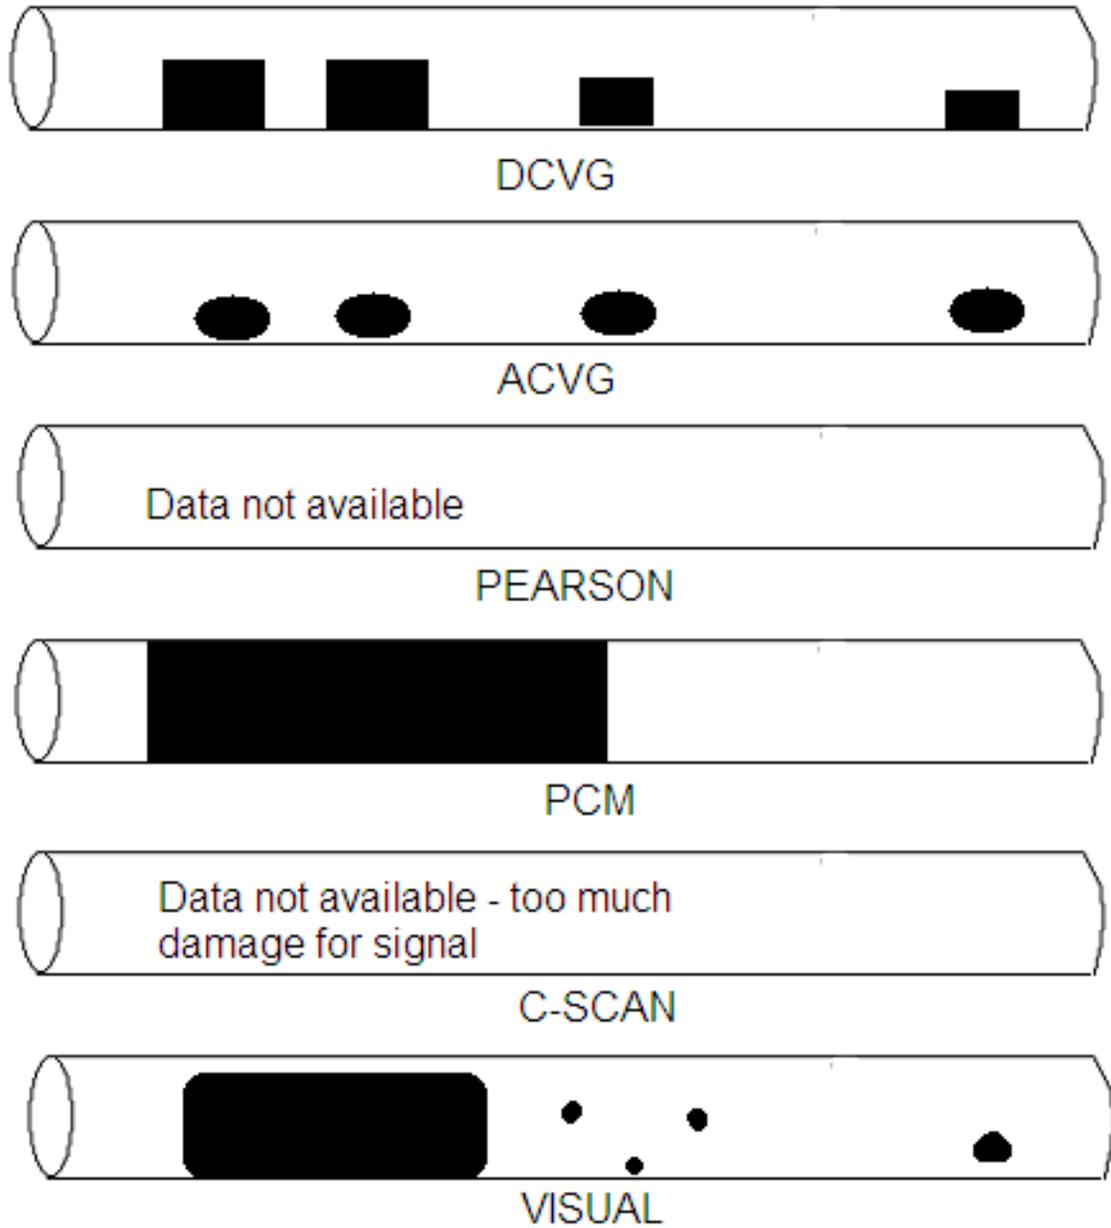
PCM appeared to be appropriate for large areas of disbondment, such as that shown in Figure 51. The DCVG and ACVG signals for these regions appeared to indicate several defects rather than the one large disbonded area that was present. Beyond this example, PCM provided only non-specific data at uncertain locations along the pipe. Observing PCM results on Test Sites 2a and 2b suggests that 50 ft spacing for current readings generated inconsistent current attenuation data and thus did not pinpoint individual coating indications.

Figure 51: Comparison of techniques from Site 1. The black areas represent either the size of the coating fault (from surveys) or the area of exposed steel (from visual exam).
