### Final Financial Report

Prepared by: CC Technologies, Inc.

**Evaluation and Validation of Aboveground  
Techniques for Coating Condition Assessment**

FEBRUARY 28, 2006

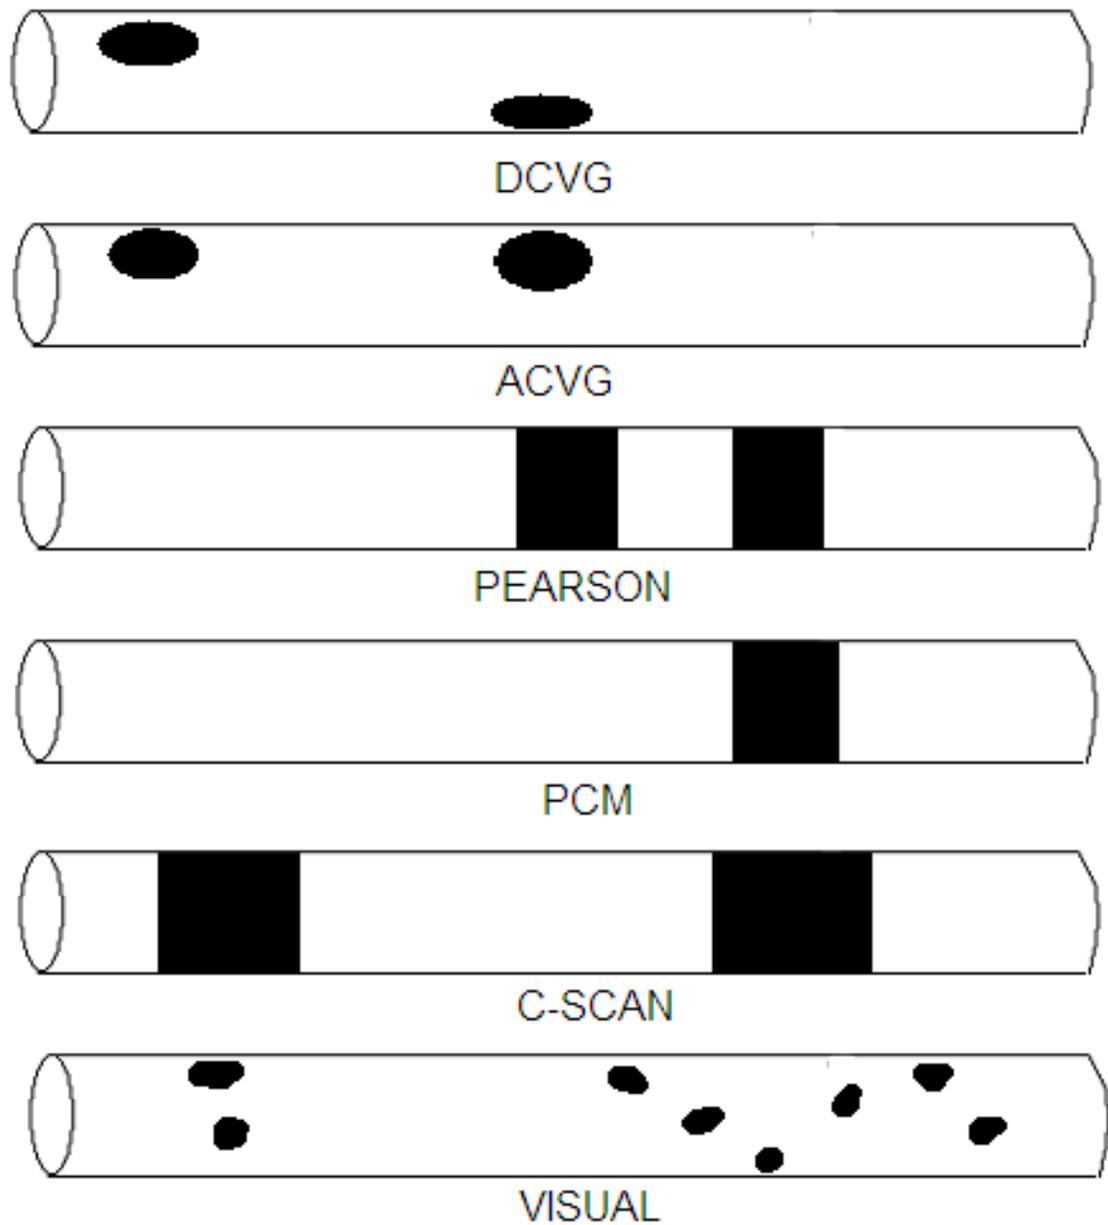
Also, the current attenuation values (mB/m) obtained by PCM and C-Scan tools did not coincide with observed coating condition and no consistent relationship could be established. However, on test Site 3a (Figure 54) the PCM survey reported 2 indications not reported by the other tools that were validated during excavation. On this Test Site C-Scan on close interval current mode also reported an indication not reported by the other tools and was validated during excavation.

Figure 54: Comparison of techniques from Site 3a. The black areas represent either the size of the coating fault (from surveys) or the area of exposed steel (from visual exam).
