Quarterly Report – Public Page

Date of Report: October 31, 2008

Project Title: Nonmetallic Joint Quality Assessment

Prepared by: Gas Technology Institute

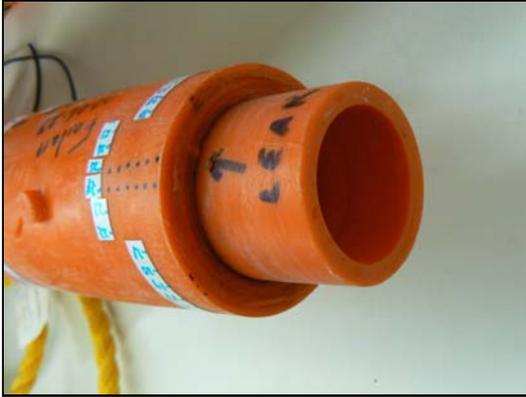
Photograph of tee showing location of leak

Ultrasonic measurements on the leg of the socket tee with a leak show lack of fusion along a narrow channel parallel to the pipe axis. The location of the channel agrees with the position marked as the leak. The waveforms have a peak in amplitude at the time corresponding to the round trip travel time between the sensor and the socket tee/pipe interface. The amount of reflection from the interior pipe wall is reduced as would be expected because wave energy has been lost at the fusion interface.

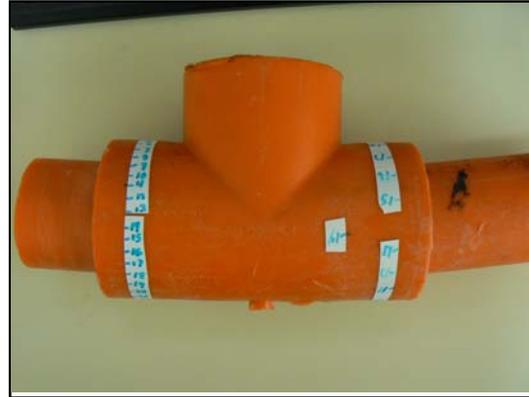
Photograph of socket tee and angled pipe

Measurements were taken around the circumference of the socket tee with the misaligned pipe. The waveforms show reflection from the fusion interface indicating poor fusion quality and a reduction in amplitude from the reflections from the pipe interior surface. There is variation in the time of arrival of the reflections from the inner pipe wall due to the different path lengths caused by the slanted pipe. Similarly, ultrasonic measurements were made on the leg of a tee with a cracked socket tee. Those ultrasonic measurements showed that the crack sloped toward the body of the tee as the crack went deeper into the fitting.
