<p>Base Metal at 100X Magnification</p>	
<p>DEFECT #G08-5 2-inch scrape with moved metal and 0.31 inch residual dent</p>

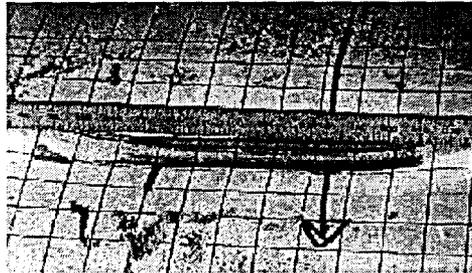
<p data-bbox="678 993 976 1024">Photograph of Defect</p>

<p data-bbox="591 617 1058 653">Base Metal at 100X Magnification</p>	
<p data-bbox="95 821 337 852">DEFECT #G08-6</p> <p data-bbox="95 856 541 926">4-inch scrape with moved metal and shallow denting</p>
