# Risk Identification and Mitigation Strategies using ILI and ITD Inspection for Vintage ERW/EFW pipe

**David Katz - Principal Engineer**  
**Larry Legendre – Supervisor**  
**Asset Integrity**  
**The Williams Companies**  
**August 2014 Chicago**

## NATURAL GAS TRANSMISSION: Crack Management Pipe Body and SEAMS

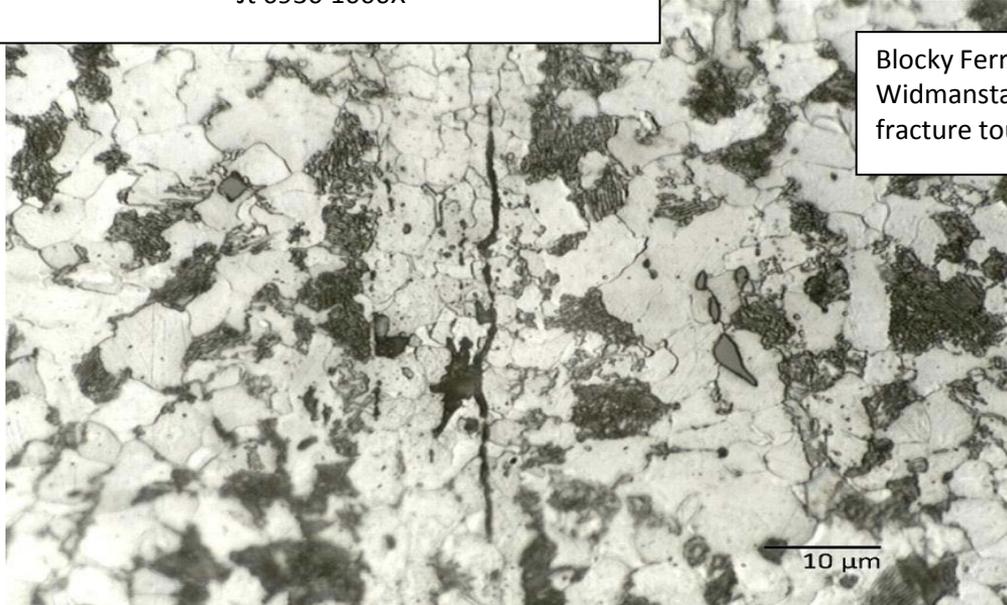
Jt 6930 1000X

### Lack of Fusion in Weld Seam

Blocky Ferrite observed rather than more brittle acicular or Widmanstatten Ferrite, which, in part, accounts for higher fracture toughness and higher burst test pressures.

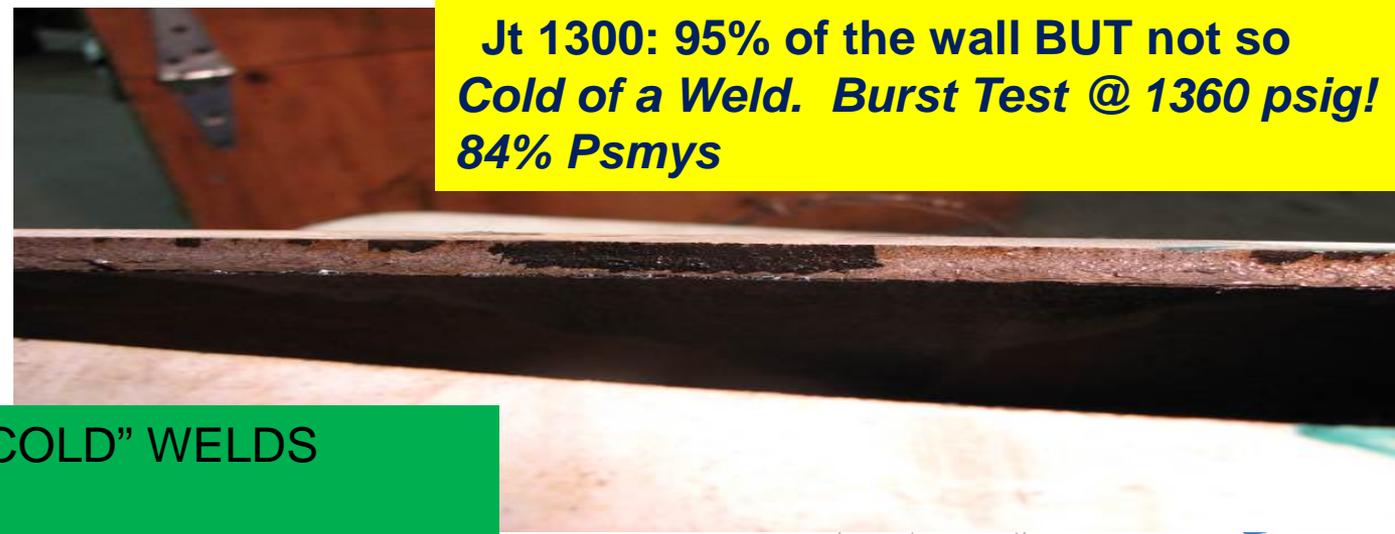
**Jt 1300: 95% of the wall BUT not so Cold of a Weld. Burst Test @ 1360 psig! 84% Psmys**

Cannot call these "COLD" WELDS

**Burst 1889 psig, 116% 15% depth**

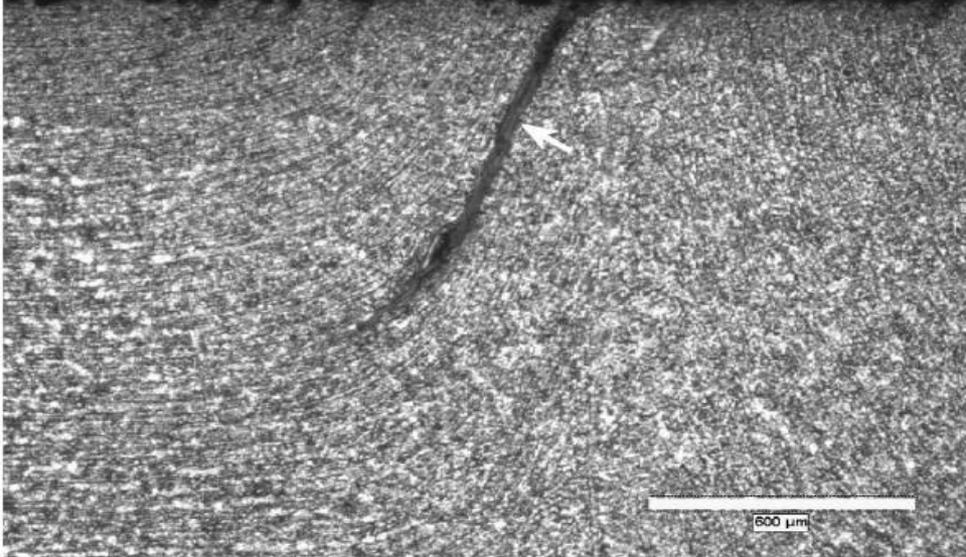
Figure 15

**Non Injurious Hook Crack**

Photomicrograph of a cross section of a hook crack, arrow, at the outside surface adjacent to the ERW fusion line.

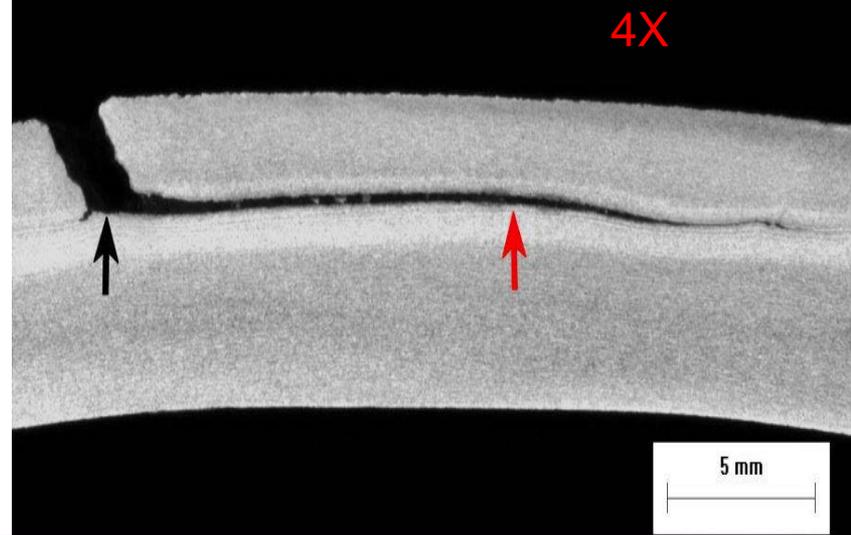
**Cross section of a longitudinal crack, black arrow, and lamination, red arrow**

**Weak Bond Line?**

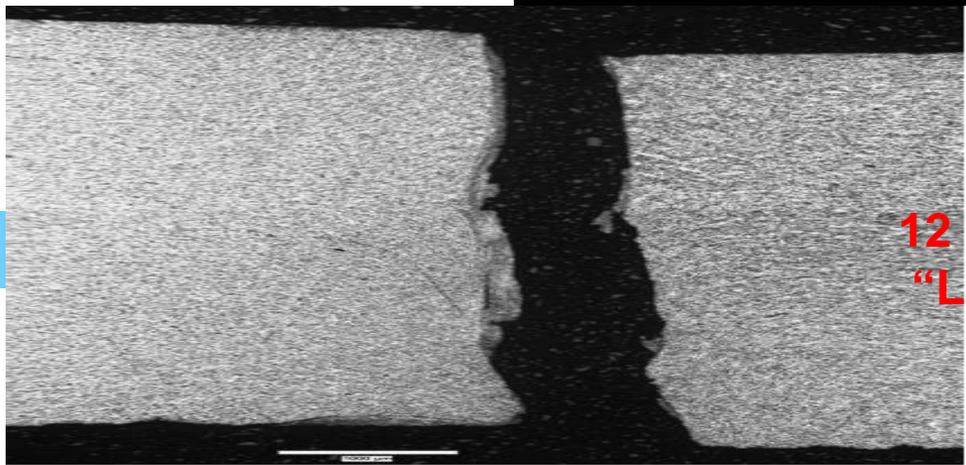
**Burst 1754 psig, 108%**

**12 % depth  
"Lukewarm" Weld**

Pipe No. 1  
15X  
Nital Etch  
surface showing a weakly

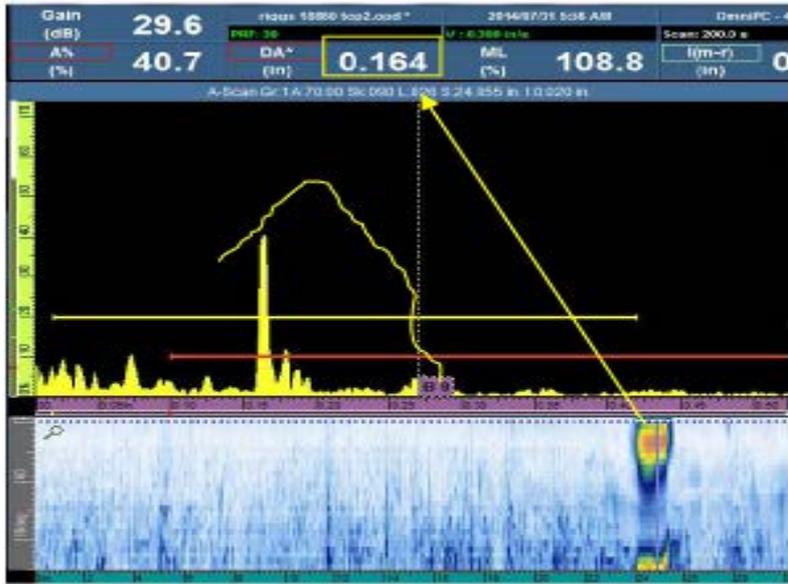
ID connected feature depth 0.164"

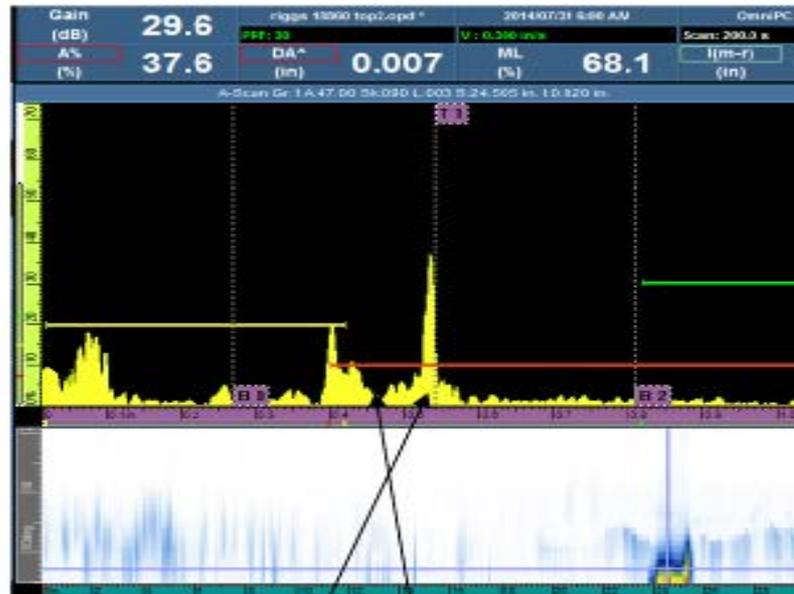
OD & ID connected features

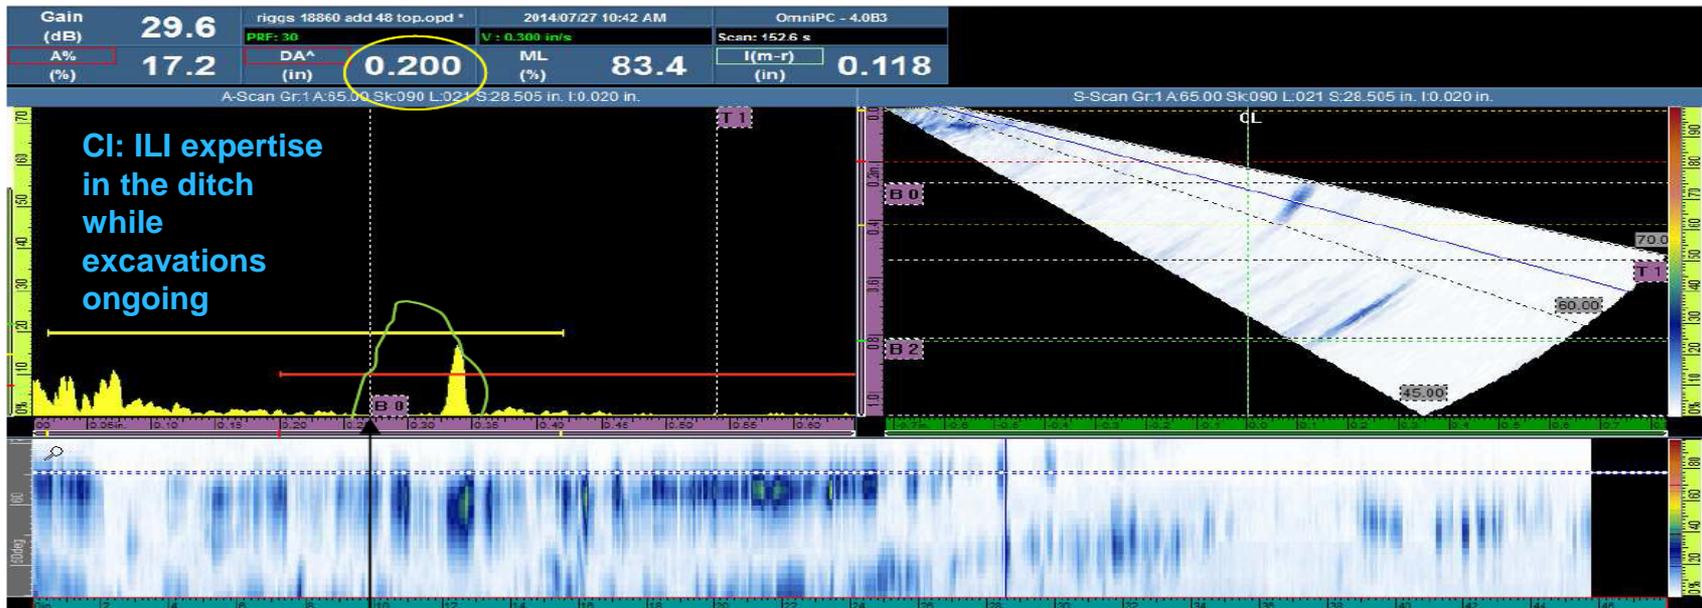
ID connected flaw, 0.200" from OD surface or 0.069" deep.

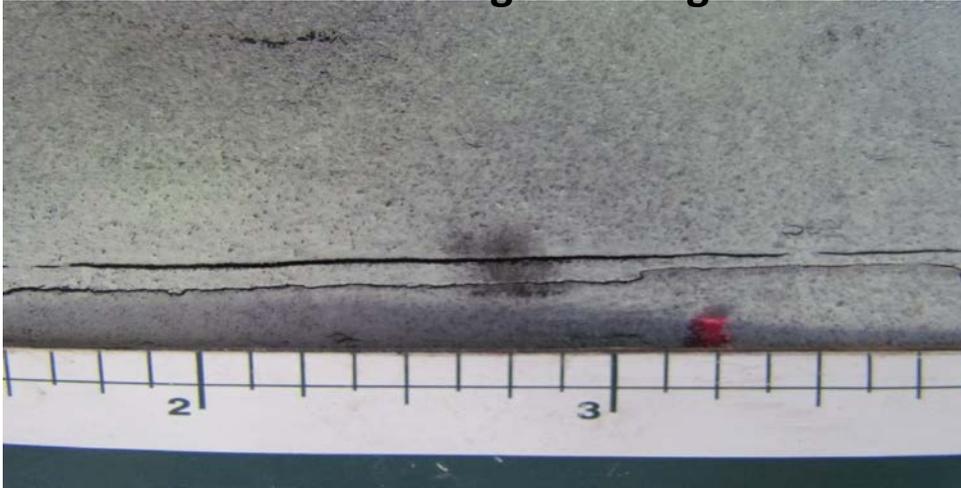
Cracking deviating from an axial plane
