U.S. Pipelines and Logistics

Re: CPF 3-2009-5009

BP Pipelines (North America) Inc. is writing in response to the above referenced notice of probable violation and proposed civil penalty received in our offices on July 20, 2009, regarding the pipeline safety inspections of BP Pipelines' facilities in Ohio the weeks of November 12, 2007 and February 25, 2008.

Title: Slab Gate Valve Cold Weather Maintenance

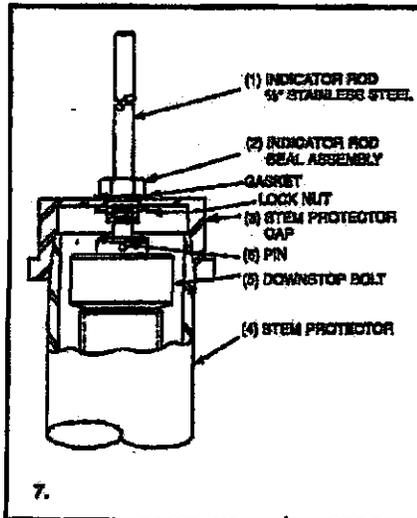
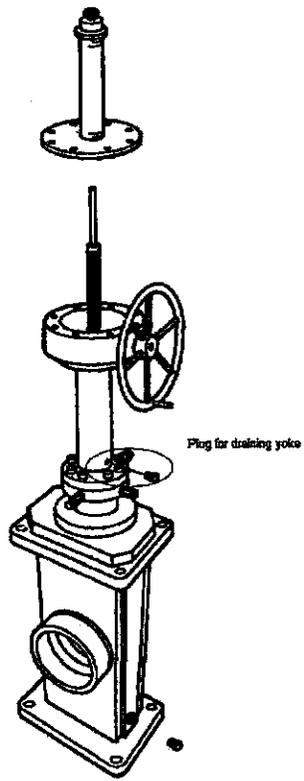
7) FIELD CONVERSION OF POSITION INDICATOR ROD AND SEAL ASSEMBLY

Background: Position indicators on mainline slab gate valves have been identified as a potential leak path for rain. Water in the stem, gear box and yoke area may freeze in cold weather and prevent the valve from operating or contribute to overstressing the hand wheel/gearbox when attempting to close a frozen valve.

Detail: On rising stem slab gate valves, an indicator rod extends above the top of the valve providing visual indication of the valve position as required by DOT regulations. The indicator rod is attached to the top of the valve stem and slips through a seal in the stem protector. The seal design varies and can be as simple as a rubber grommet on early valves. Through normal wear or abnormal wear caused by excessive painting of the stem indicator rod, the seal becomes damaged and allows rain to enter the valve stem area. A retrofit kit is available for M & J valves to replace the indicator rod seal. The retrofit kit is shown in the attached figure.

In the event that water does enter the valve stem/gearbox/ yoke assembly it can be drained by removing the plug at the bottom of the yoke as shown in the figure below. A new job plan for the cold weather maintenance of mainline block valves has been generated that includes draining the yoke.

- If a retrofit kit for the indicator rod seal is available from the manufacturer, the kit should be installed on all mainline slab gate valves
- Regions that experience freezing weather conditions for more than a day or two should follow the cold weather slab gate job plan - VLVB1880 to minimize the amount of trapped water in the stem/gearbox/yoke area.
- When painting a slab gate valve with a stem position indicator rod take care to mask the indicator rod to prevent the build-up of paint which could damage the seal or grommet, and to remove the masking after painting.

A new improved position indicator rod and seal assembly consisting of a $\frac{1}{2}$ " stainless steel rod (1), a self aligning seal assembly (2), and new stem protector cap (3) are available in conversion kit A-147735.* Upon receipt of the kit,

- 7.1 Remove stem protector (4) and cap (3) as a unit.
- 7.2 Remove indicator rod retainer pin (6) from downstop bolt (5).
- 7.3 Replace old anodized aluminum rod with new $\frac{1}{2}$ " stainless steel rod. Replace pin (6). (M-3 and M-33 valves will require replacement of down stop bolt in addition to the indicator rod.)
- 7.4 Screw new cap (3) with integral seal assembly (2) onto existing stem protector (4). (M-3 and M-33 will require new stem protectors.)
- 7.5 Slip stem protector (4) with new cap (3) over the new indicator rod (1) and screw to operator housing.
