RE: Notice of Probable Violation (CPF 4-2009-1018)

This letter is in response to your most recent July 6, 2009 notice of probable violation and proposed compliance order. Please find the information and documentation enclosed representing the corrective actions taken to meet the proposed compliance order referenced above.

Bart Bean  
Operations Manager  
West Texas Gas, Inc.  
7517 Canyon Drive  
Amarillo, Texas 79110

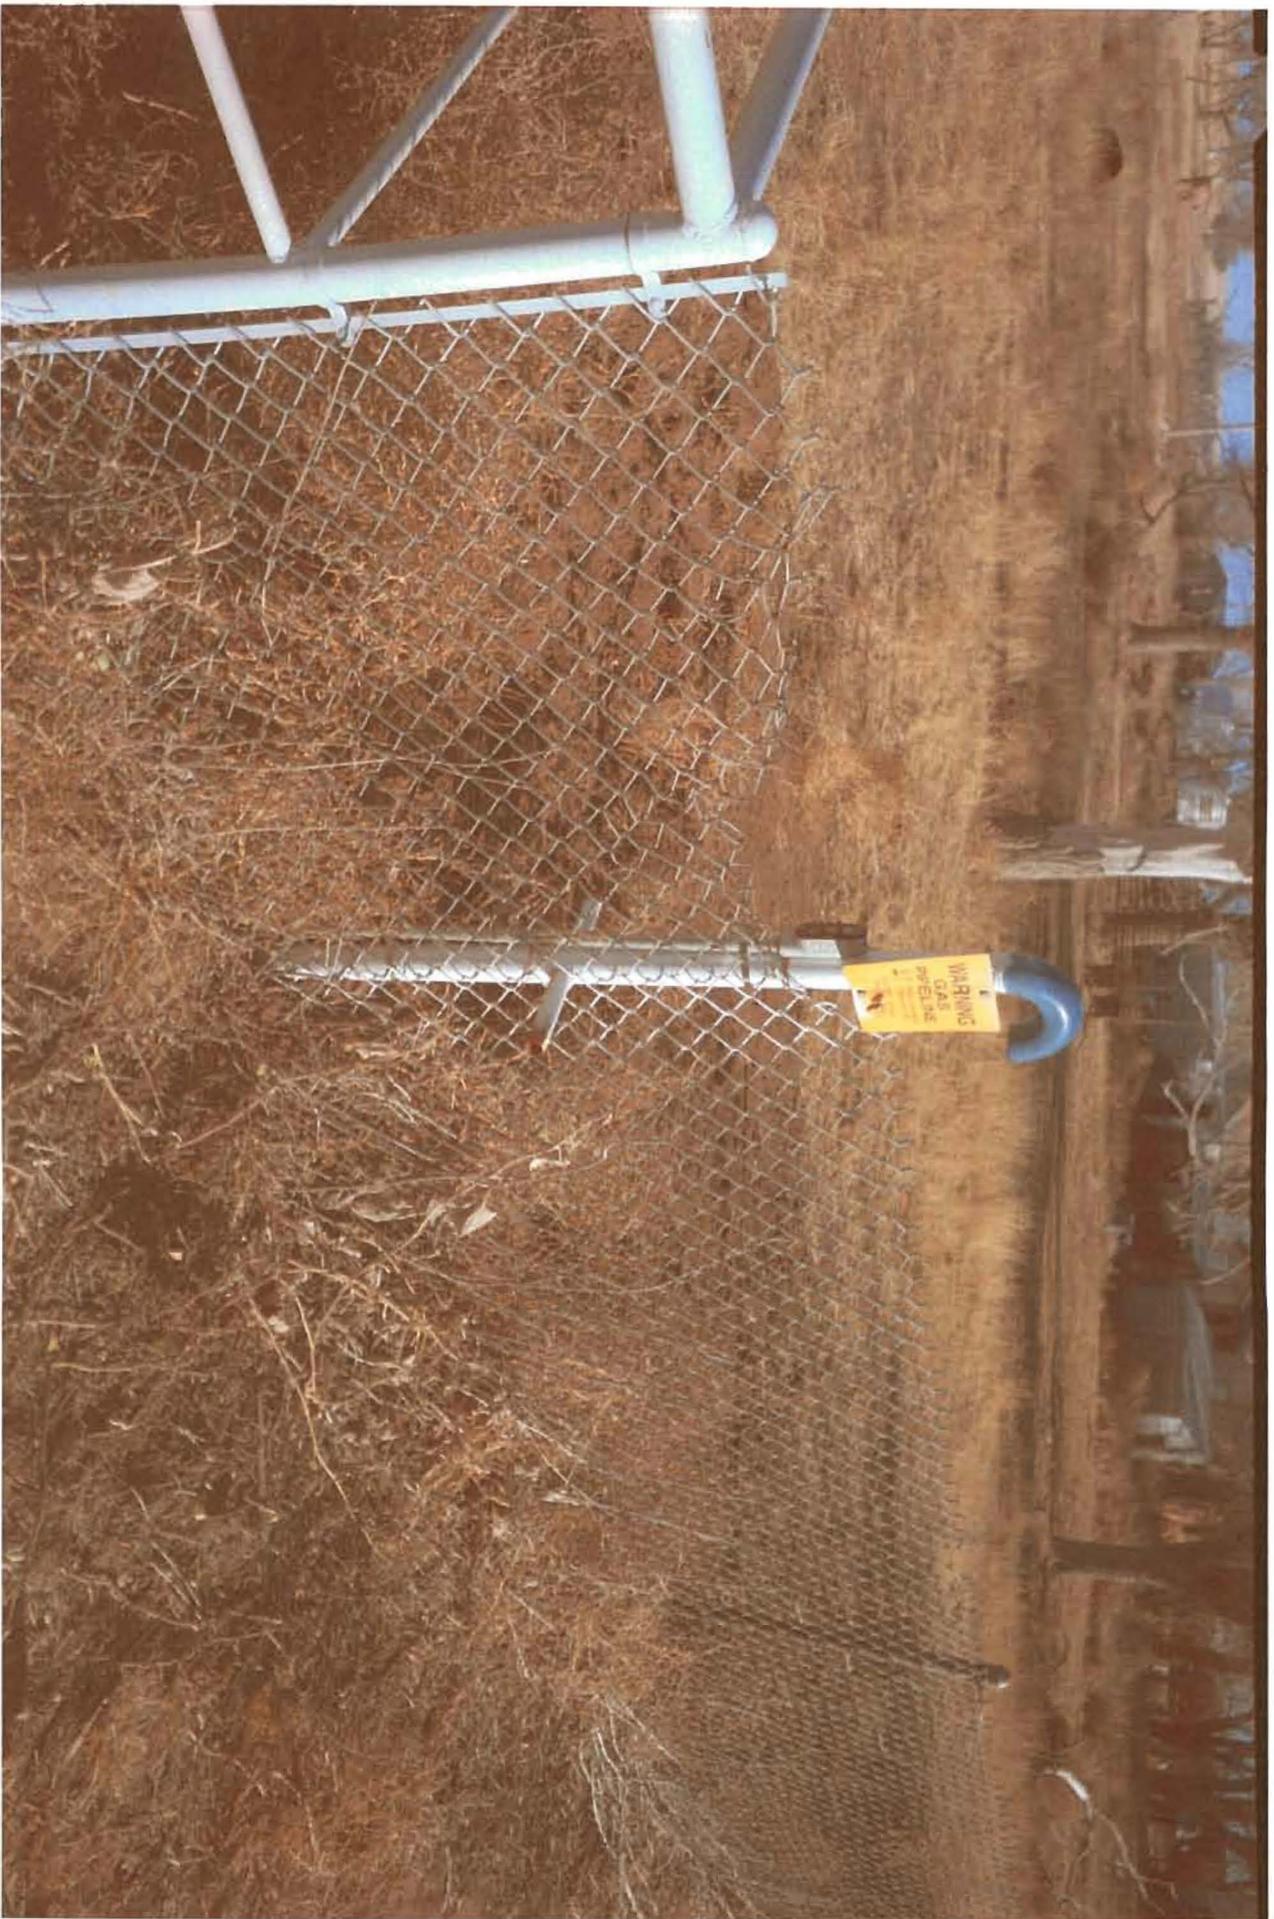
# 12  
411 NEW MEXICO

Cased Road Crossings:        PNM tap – picture #12  
   Felt tap - picture #11  
   Highway 56 crossing – picture # 5  
   El Paso crossing – picture # 1

Cased road crossings at the listed sites below have been excavated, test leads/stations have been installed and readings have been recorded and records are now available for future review and monitoring. (See corresponding pictures enclosed)

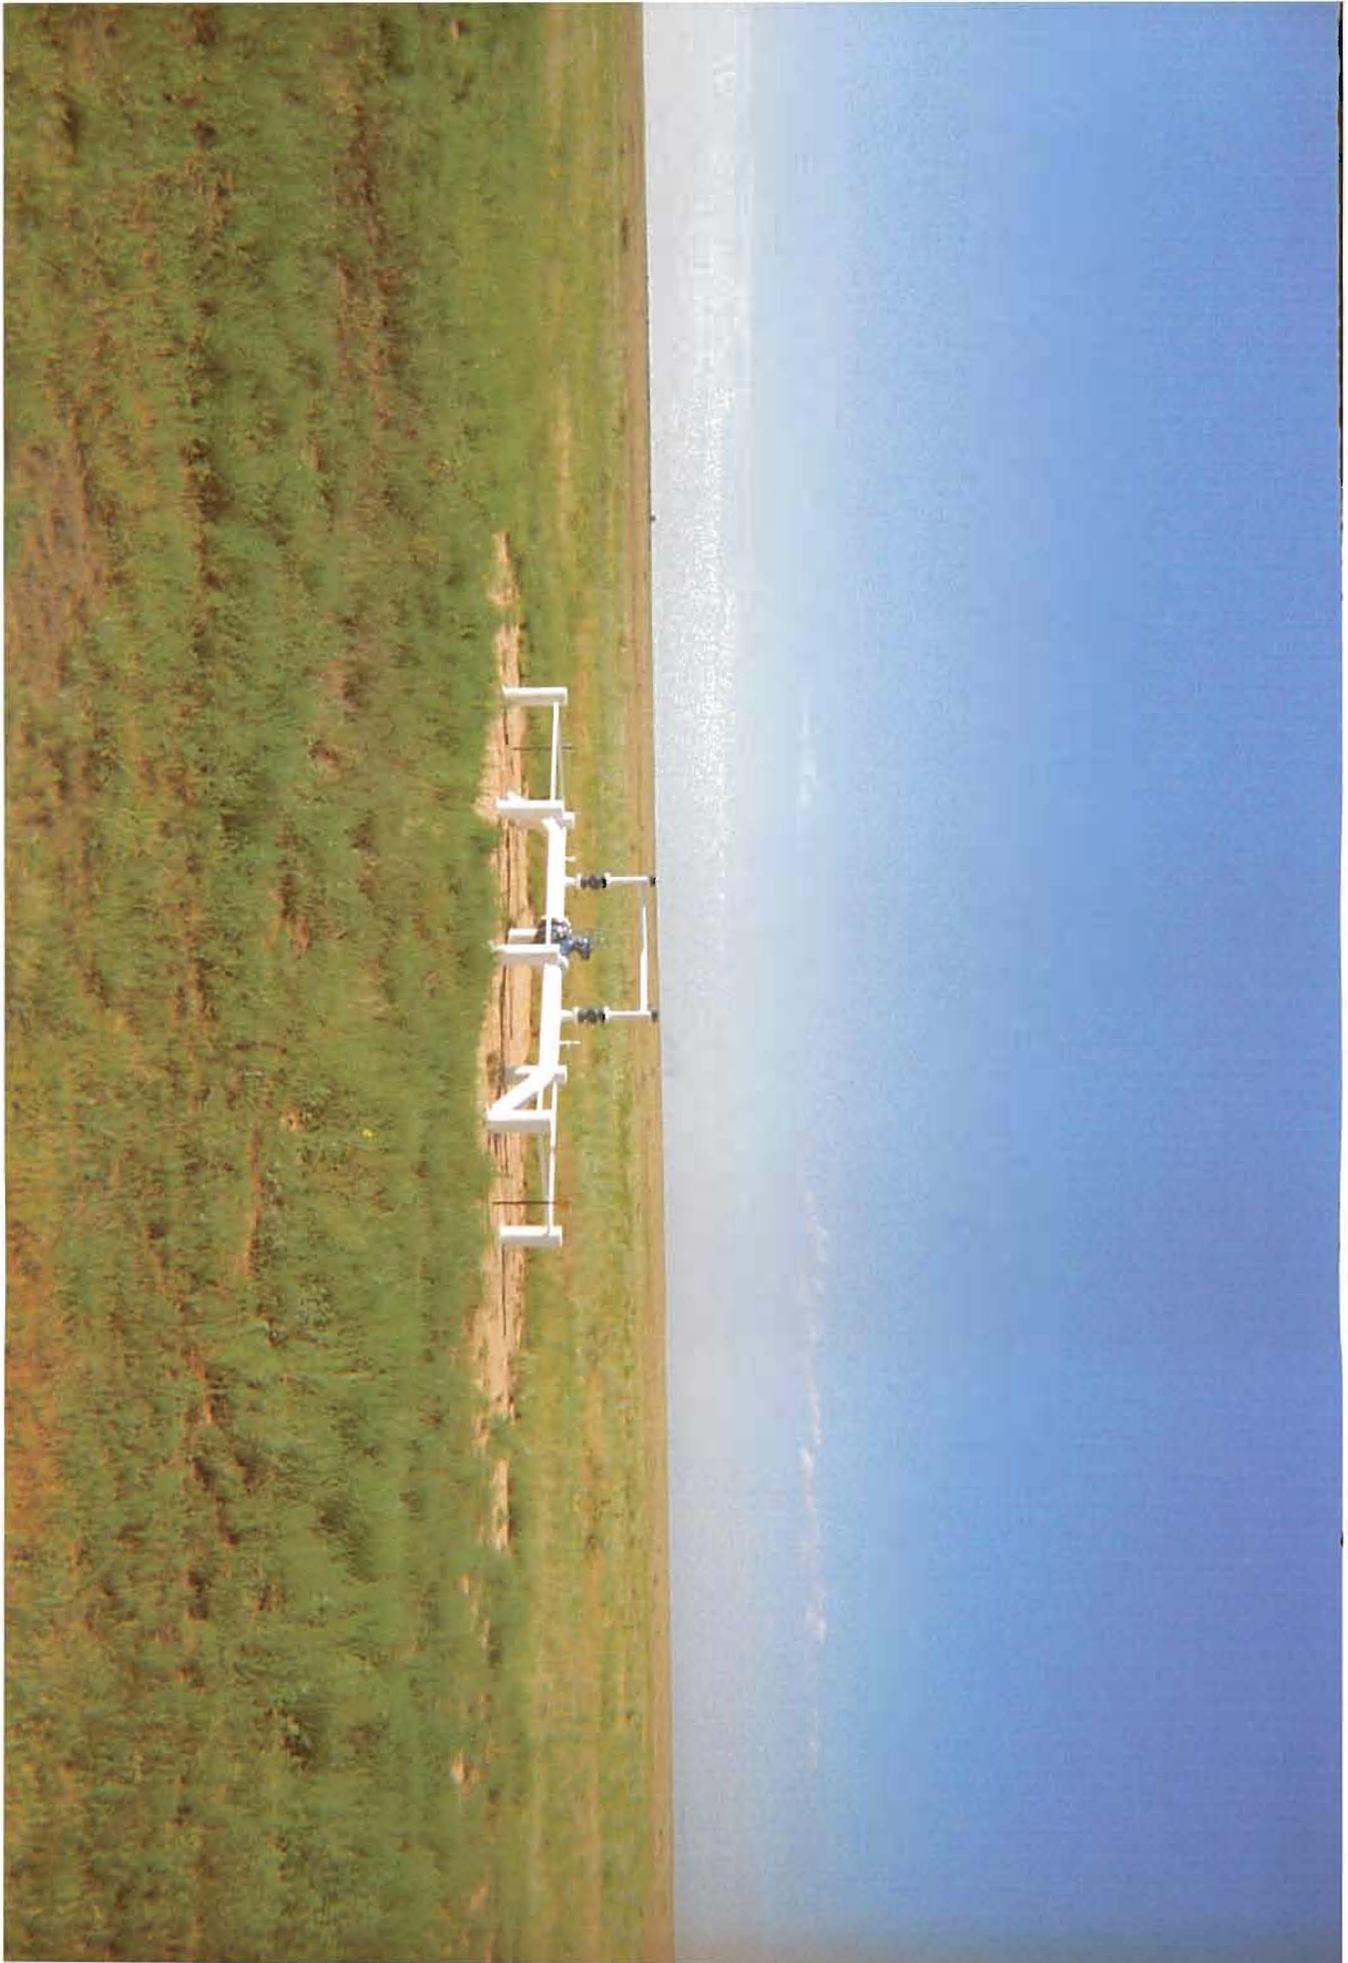
WOMBLE

Womble Tap Valve:	Pipe barricade installed.
Brewster Check Station:	Additional pipe barricade installed.
Perico Regulator Station:	Chain Link Fence around entire station - Locked
Carter Block Valve:	Pipe barricade installed
El Paso Check Station:	Chain Link Fence around entire station – Locked
Kitchens Block Valve	Cement valve box and lid - Locked

The valve and operating device to open or close each valve along the pipeline is now protected from tampering and damage. Locks, barricades and/or fences have been added where needed.

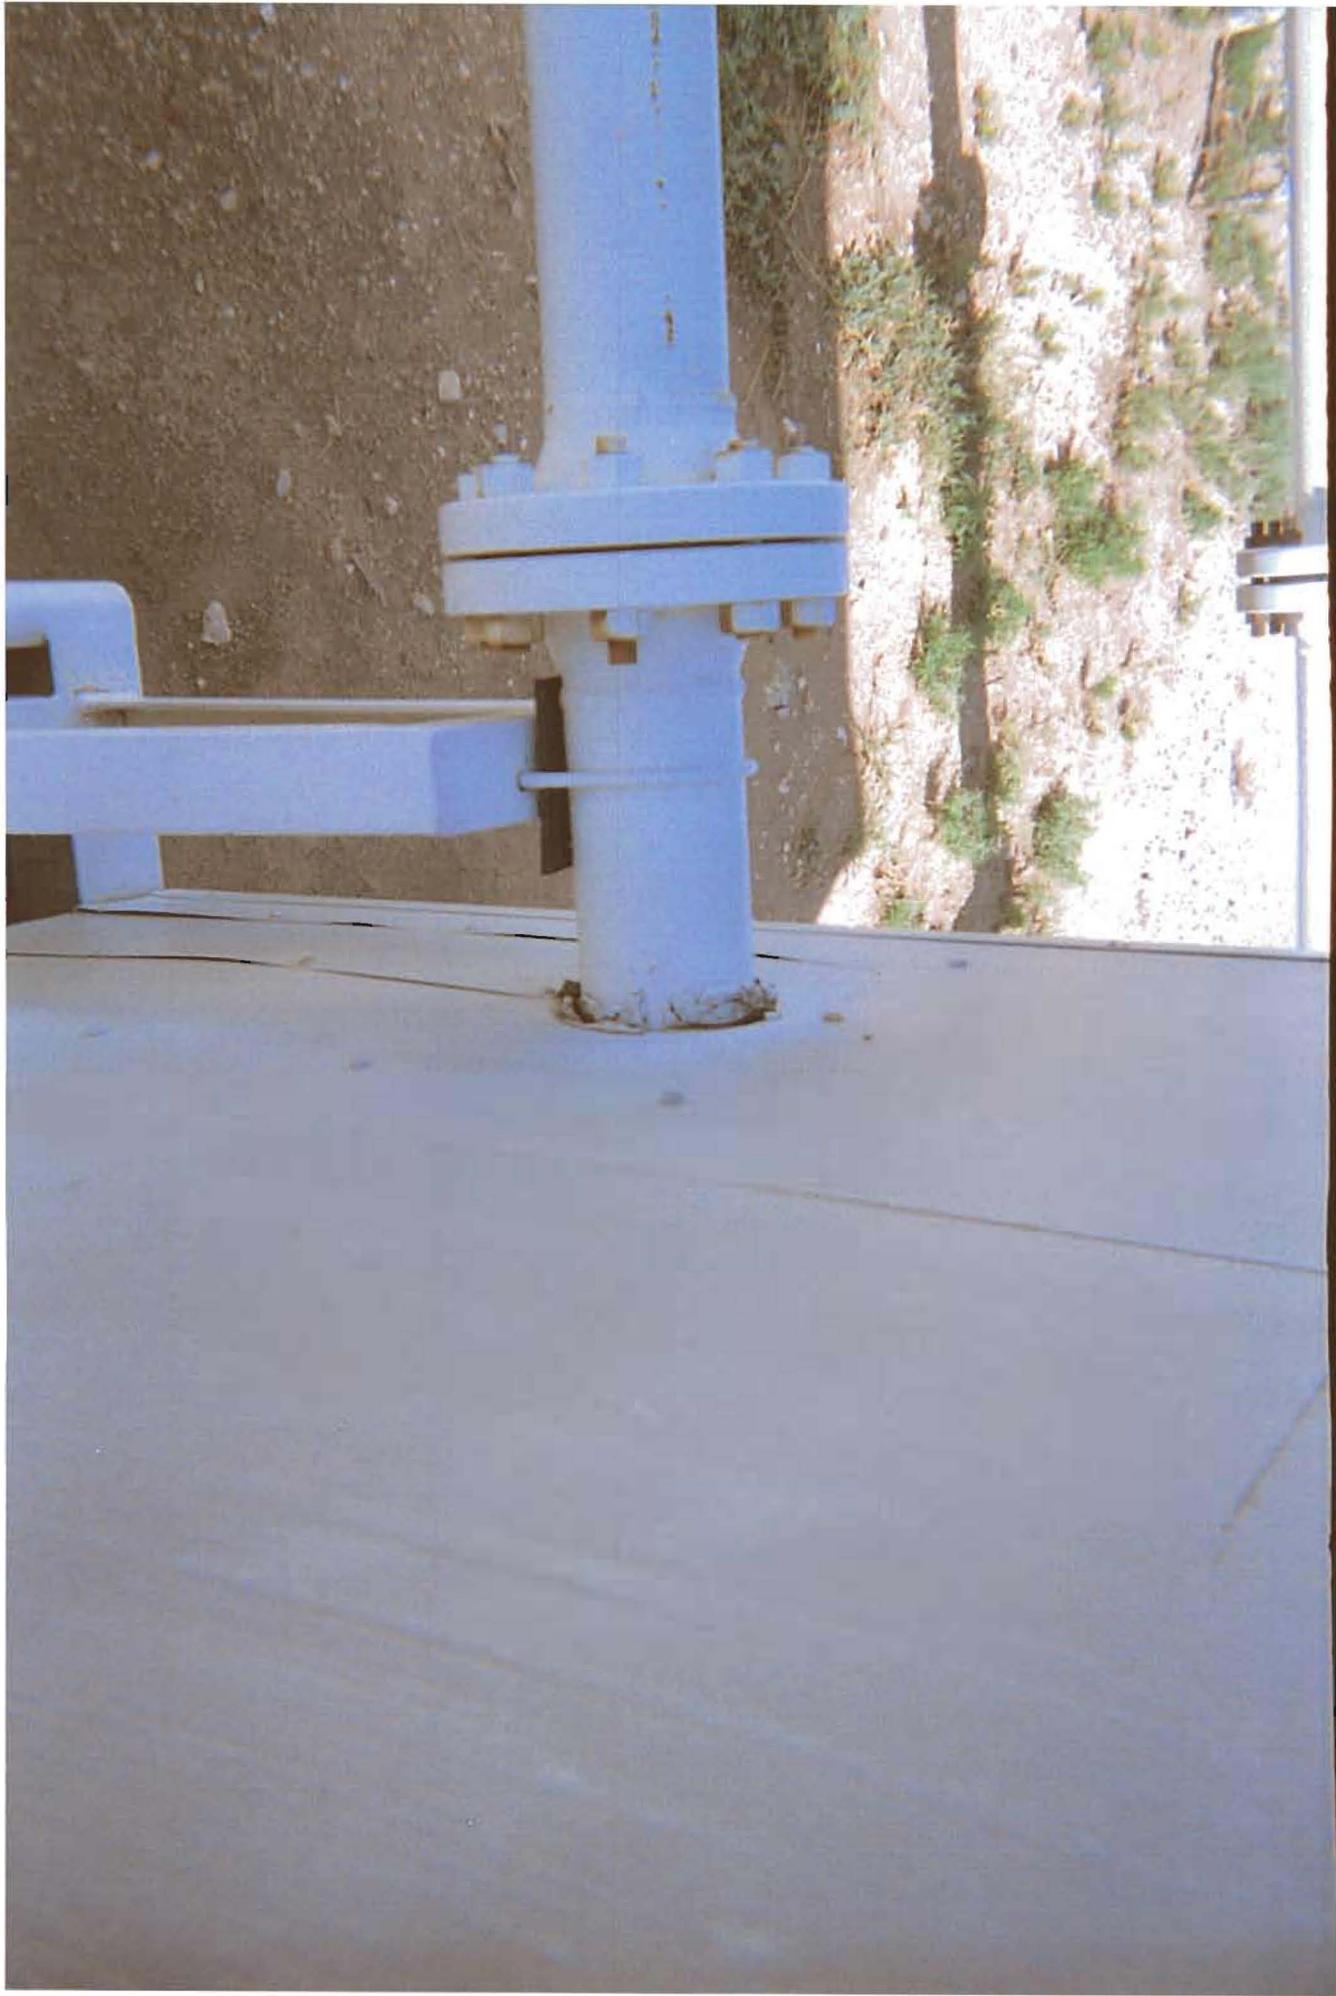
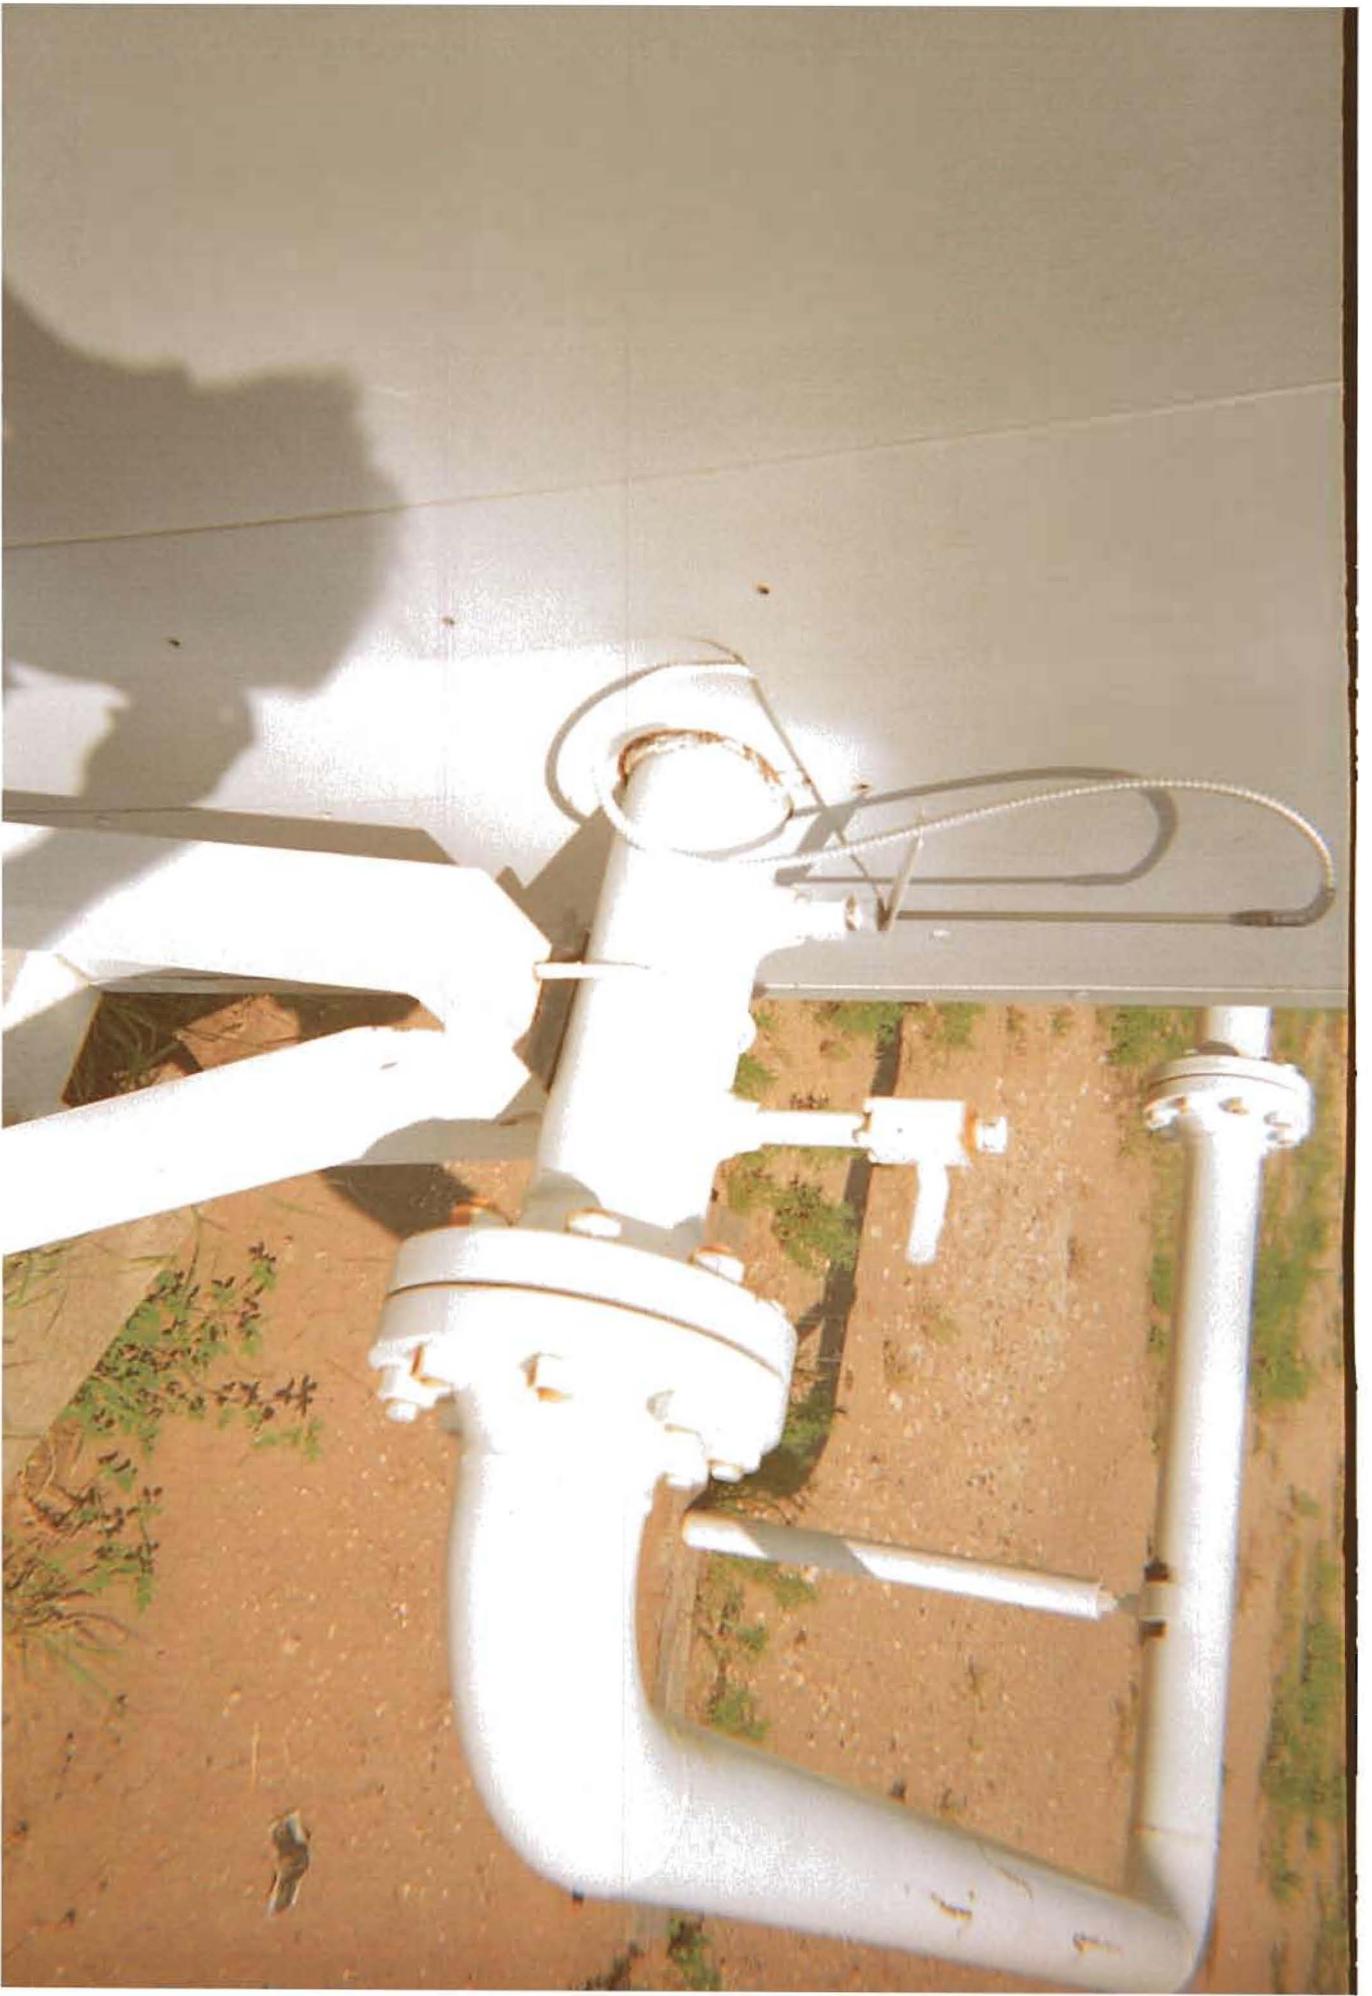
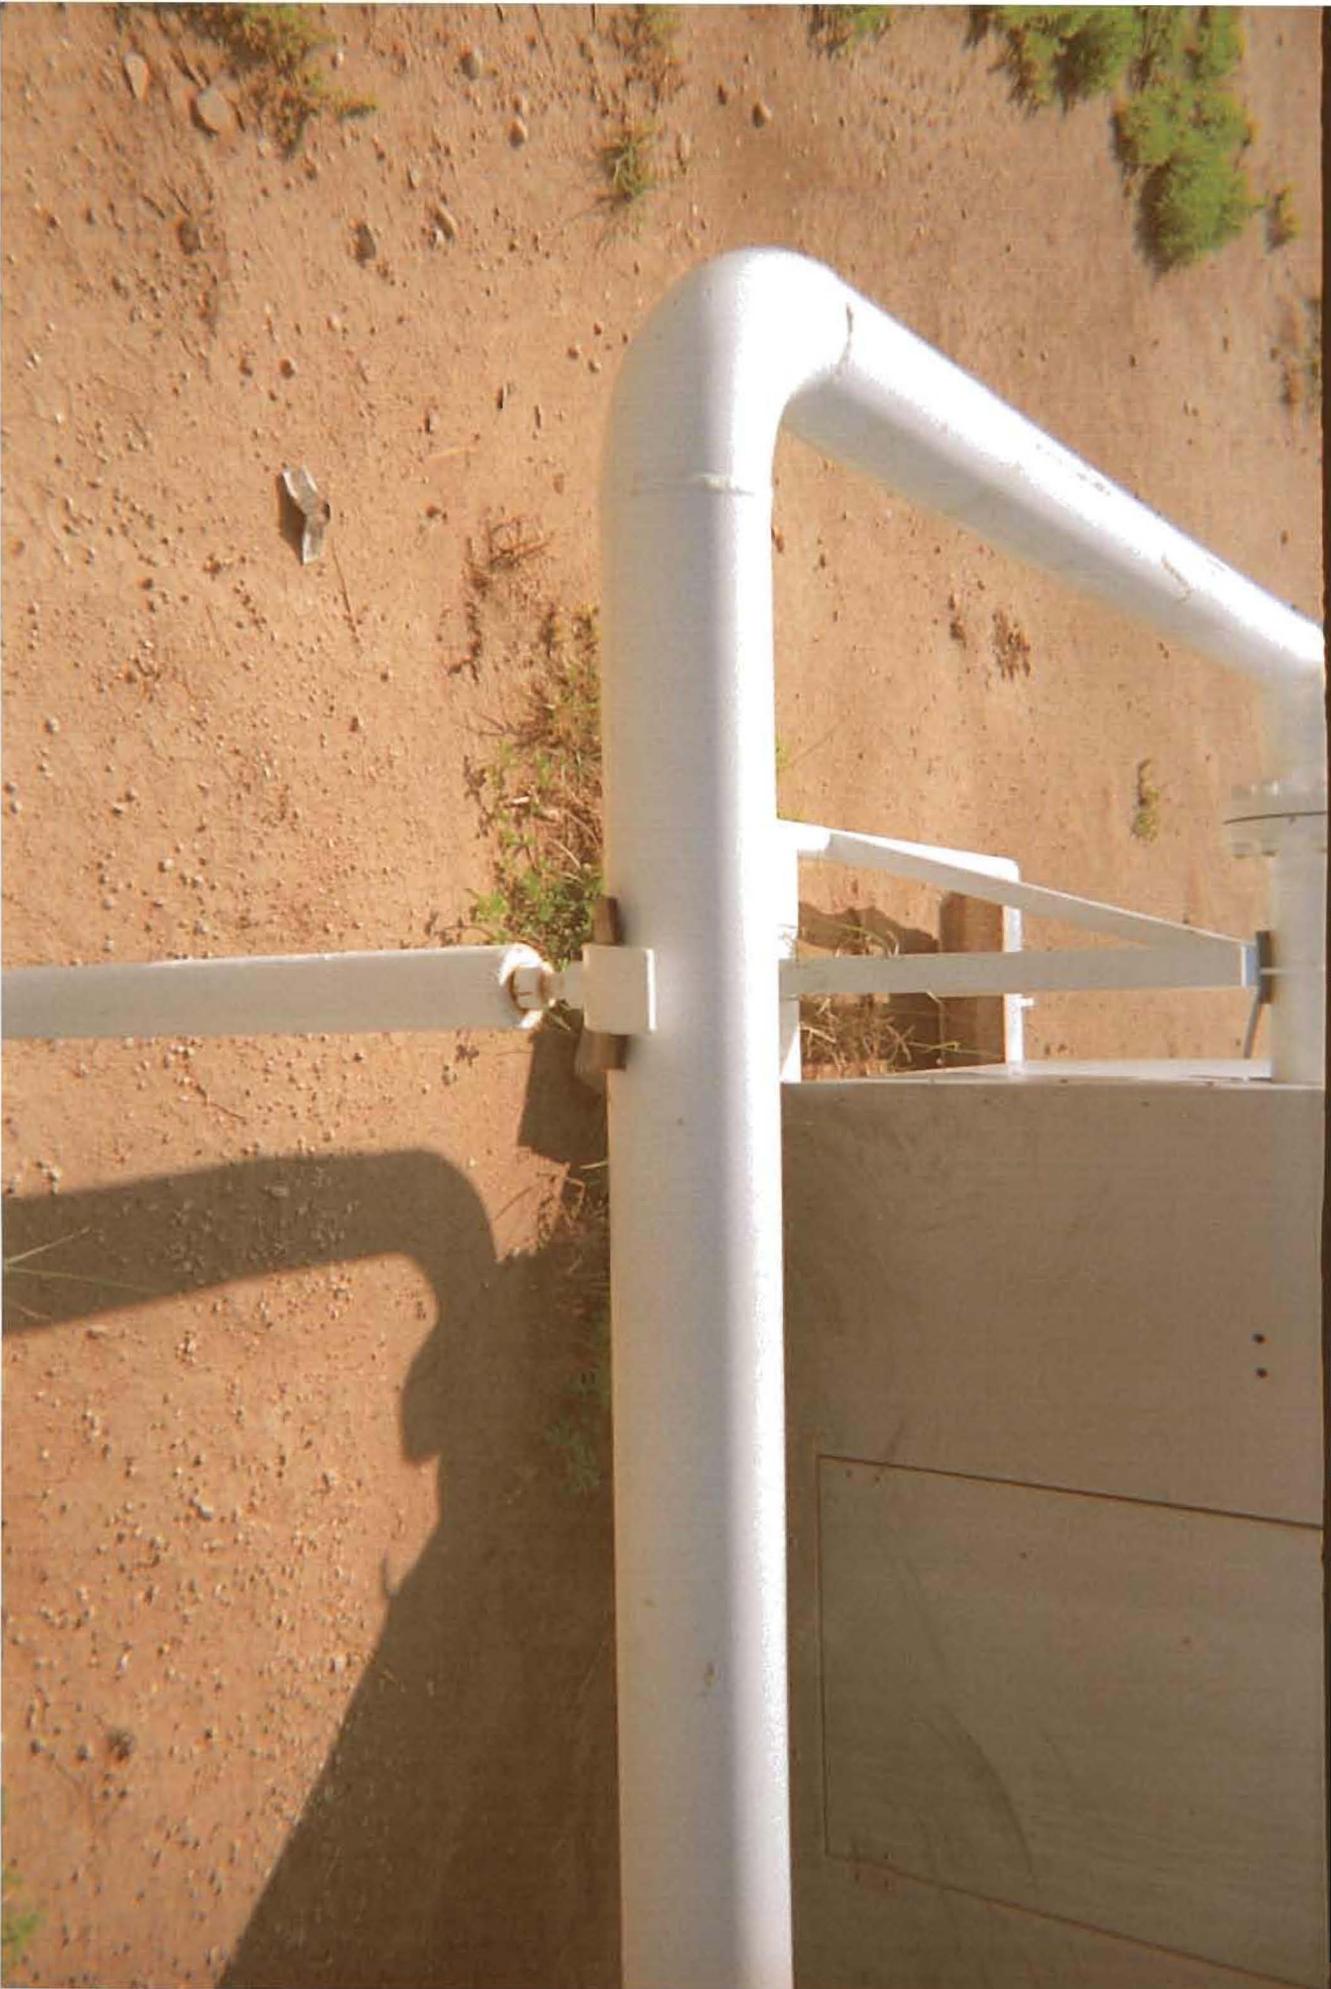
VALLEY FARMERS

*Found minor paint corrosion at Corizzo setting  
Found no insulation between pipeline supports and pipe  
at the Valley Farms, Brewster, and Perico settings*

Corrective action has been taken to eliminate active corrosion at the pipe supports at several locations listed below: Pipe at support area has been cleaned recoated and insulation material added between pipe and support. See pictures enclosed that represent the corrections made.

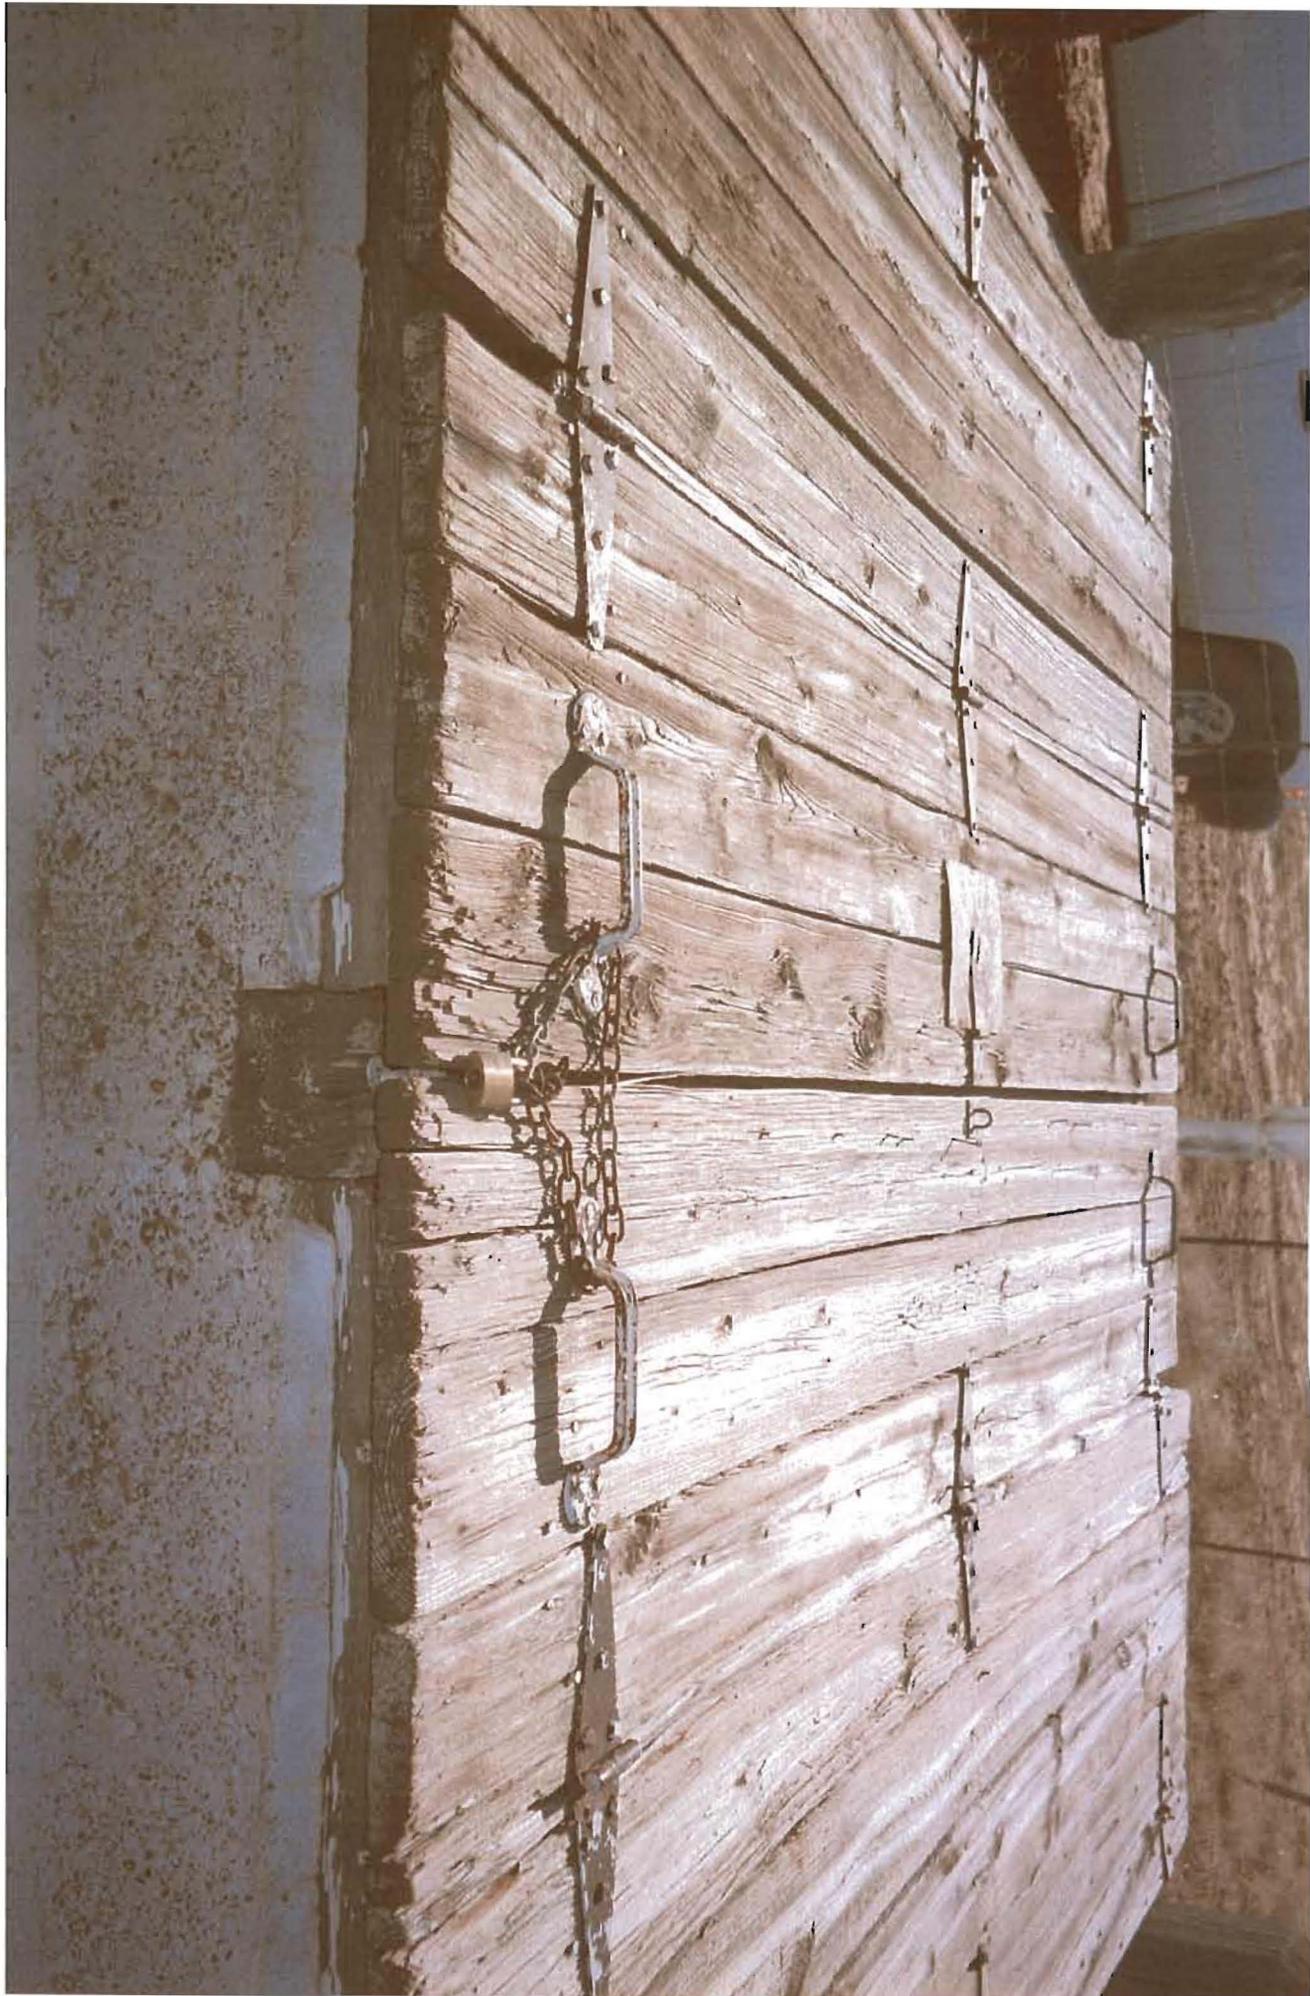
KITCHENS VALVE BOX

Locking device at the "Kitchens Valve Box" has been locked to prevent unauthorized access. (See picture enclosed)
