**Transaction Agreement DTRS56-02-T-0007  
Modification #4 (Aug 31, 2004)**

**DOE National Energy Technology Laboratory Technology  
Demonstration Program**

**Battelle - West Jefferson Facility  
Blind Guided Wave Verification Exercise  
Report of Results**

**September 13 – 17, 2004**

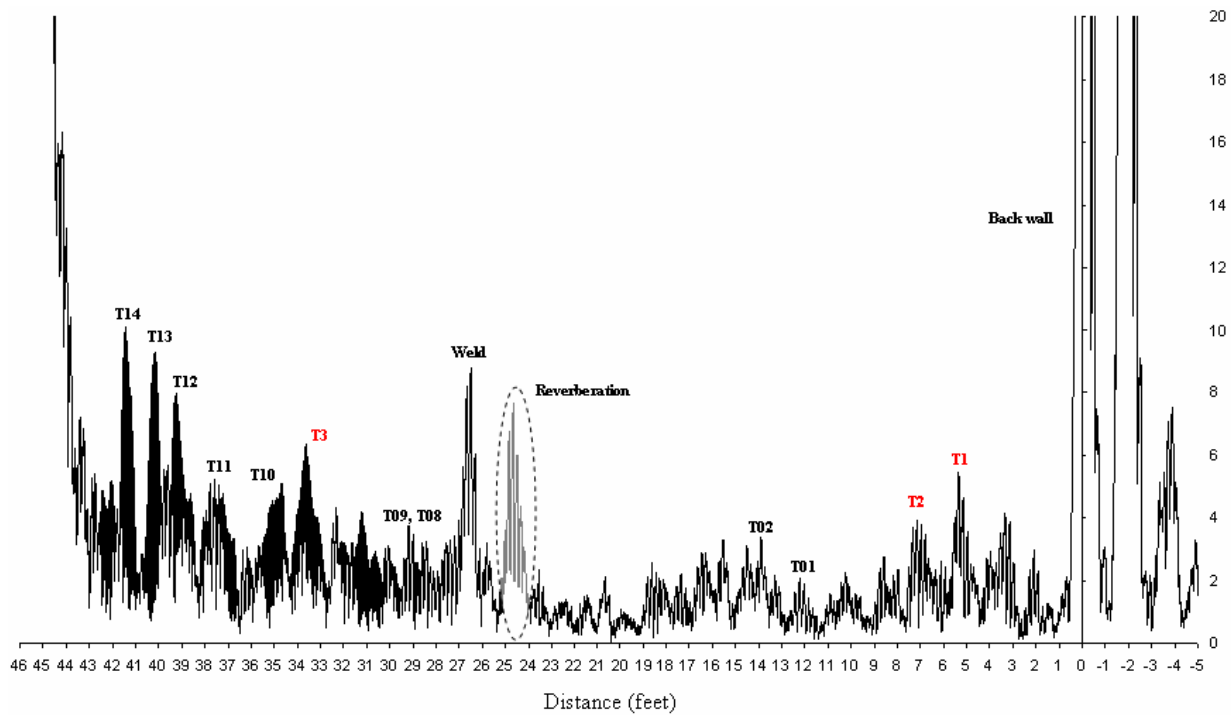
**Figure3. Frequency scans of machined defects pipe showing responses from grading regions. Red indicates calibration regions.**

Because the distribution of ultrasonic energy within a pipe wall is highly frequency-dependent, guided waves with different excitation frequencies have different sensitivities to defects. Frequency tuning is able to help achieve a relatively high defect sensitivity. Therefore, frequency tuning experiments were carried out as the first step in our tests. The envelope of signal amplitude variation with excitation frequency is shown in Figures 3 and 4. The axial locations of defects can be determined from these figures.

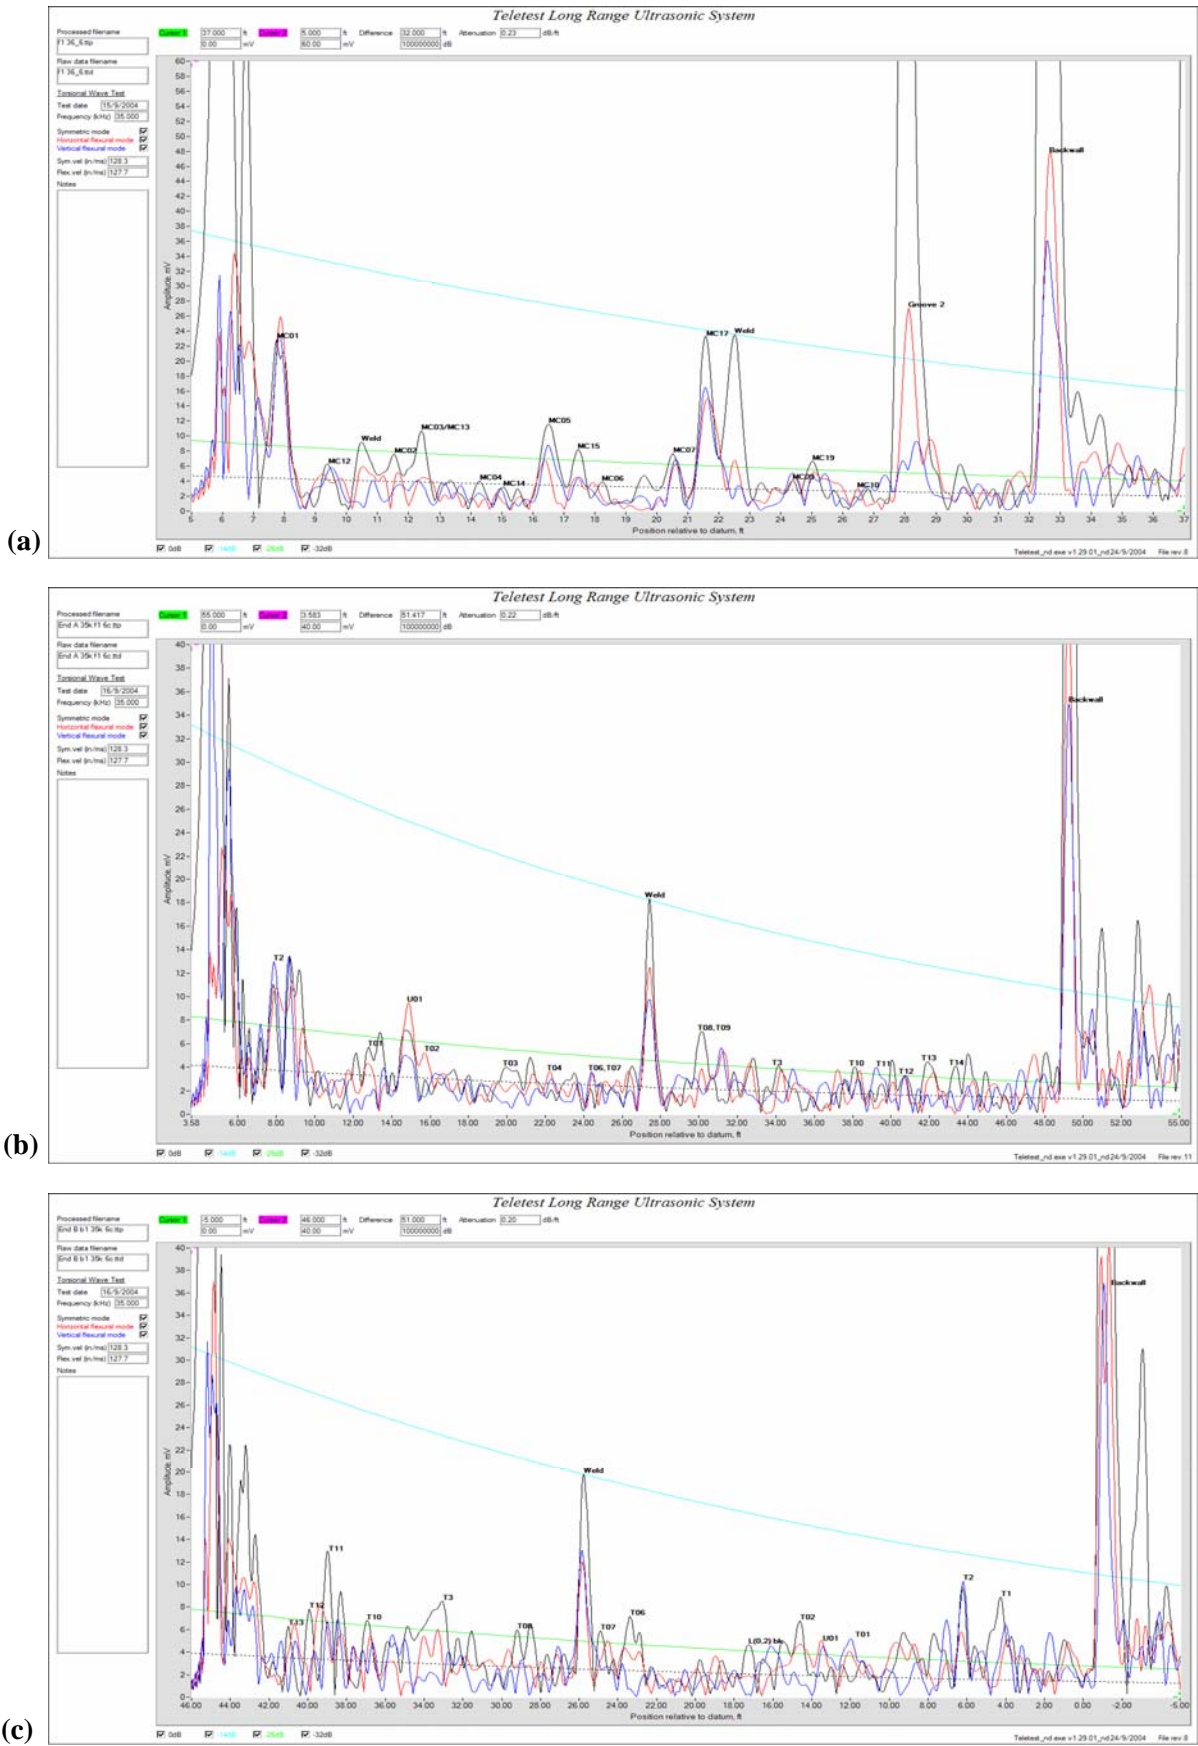
**Figure 4. Frequency scan of natural corrosion defects pipe showing responses from grading regions. Red indicates calibration regions.**

The inspection results for the machined defect pipe clearly show the exact axial and circumferential locations of the defects. Although the widely distributed corrosion in the natural defect pipe makes diagnosis of each individual area difficult, we can distinctly determine that the pipe is heavily corroded with four corrosion regions: 1) [2 feet ~9 feet], 2) [11.5 feet ~18 feet], 3) [28 feet ~ 36 feet], and 4) [37 feet ~41 feet]

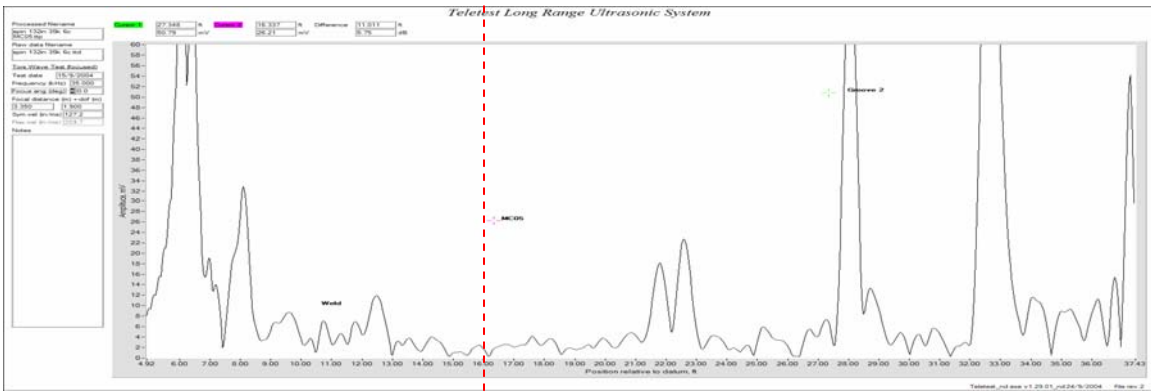
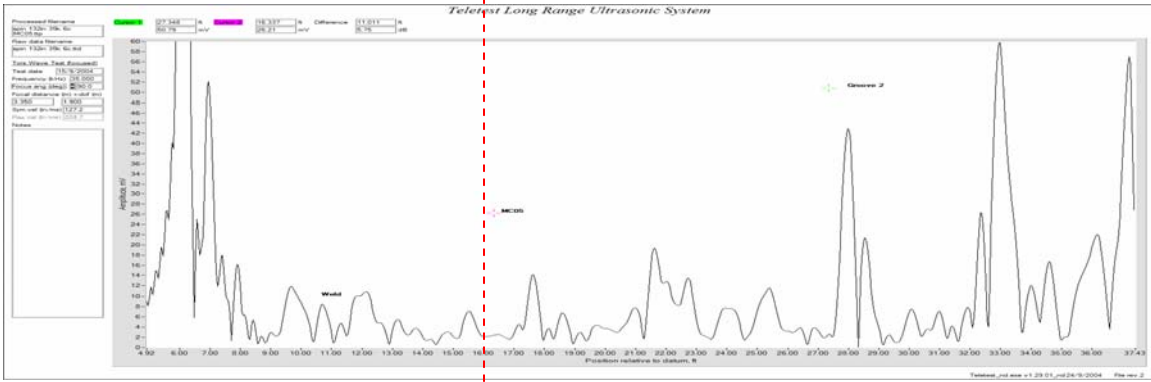
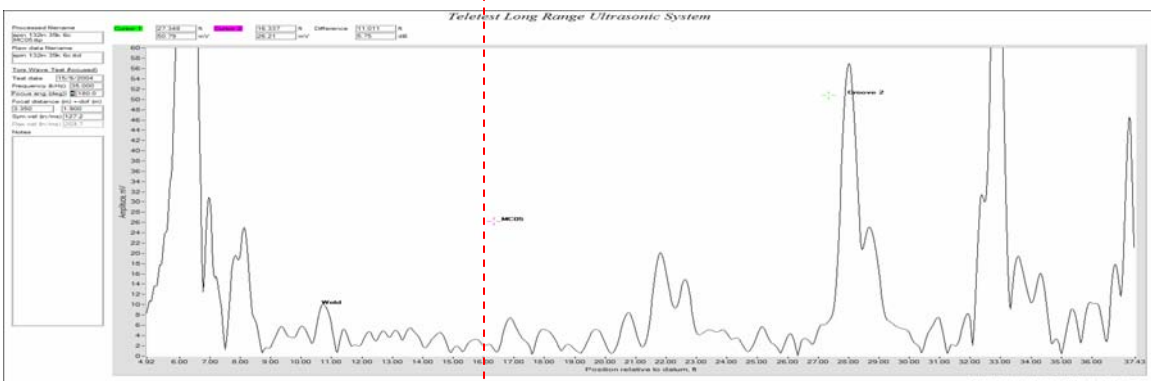
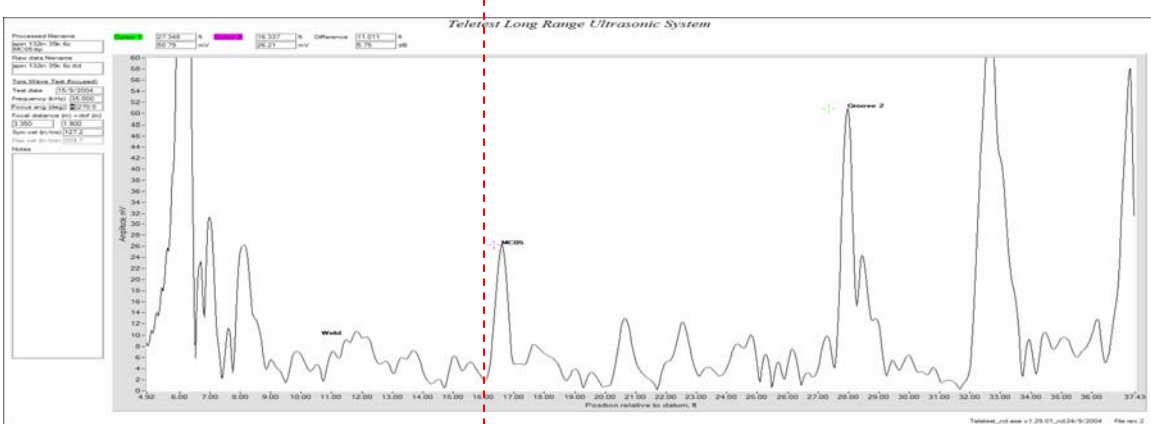
**Figure 6. 35 kHz torsional responding signals excited at pipe end A of manufactured defect pipe when focusing at MC05 region at (a) 0°, (b) 90°, (c) 180° and (d) 270°. Red dash line indicates the expected location of the front edge of the MC05 signal.**

The phased array focusing technique can improve the energy impinging onto a defect as well as reduce the energy elsewhere around the circumference. Hence the focusing technique can not only improve sensitivity but also reduce the false alarm rate. In addition, focusing can provide an estimation of the circumferential position of a defect. In our experiments, we moved the focal spots around the pipe at all the assigned inspection regions. Our estimations of the defect location and approximate sizing are listed in Table 1-6. If the echoes from the defects were above the -26 dB level (referenced to the back wall amplitude), we called them "significant" defects; if the echoes from the defects were visible but below this level, we called them "insignificant" defects. There were no recognizable defect echoes in the so-called "clean" areas. Research on a method to utilize focusing phenomenon for defect sizing is still underway. Hence, the defect sizes estimated here are approximate. Axisymmetric inspection results with the T [0,1] (1<sup>st</sup> torsional) mode at 35kHz are displayed in Figures 5(a)-(c). A sample focusing inspection result can be seen in Figures 6(a)-(d). Figure 6 shows that there is a defect (MC05) located at 270° at 16.1' from the pipe end A. By comparing to the

axisymmetric signal in Figure 5, we observed that the amplitude of the defect echo increased by 6dB when focusing on the defect.
