Dominion Transmission, Inc.
445 West Main Street, Clarksburg, WV 26301-2450
Mailing Address: P.O. Box 2450
Clarksburg, WV 26302-2450

June 28, 2012

RE: Notice of Probable Violation CPF 1-2012-1015

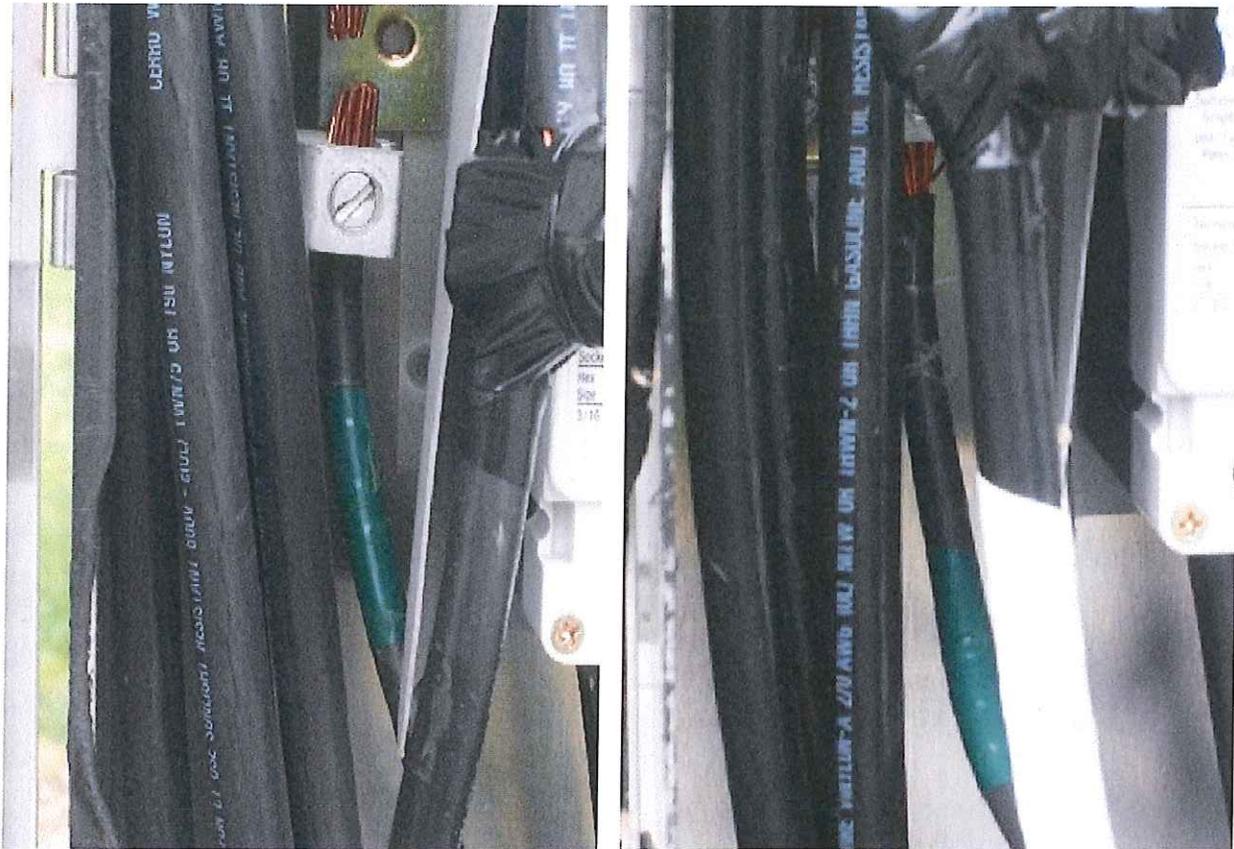
Figure 1.

At the time of WV PSC inspection, no grounding conductor was observed for the micro-turbine generators. The operator failed to comply with the referenced NEC Articles as these articles address the application of grounding conductors and systems installed for the micro-turbine generators housings."

Compressor Station. The evaluation revealed that these devices are indeed equipped with grounding conductors (identified with green tape, in conformance with Article 250.119(A)(2)(c) of the NEC), as evidenced in Figure 1 below. For this reason, DTI respectfully requests the withdrawal of Item #1, and the associated proposed civil penalty.

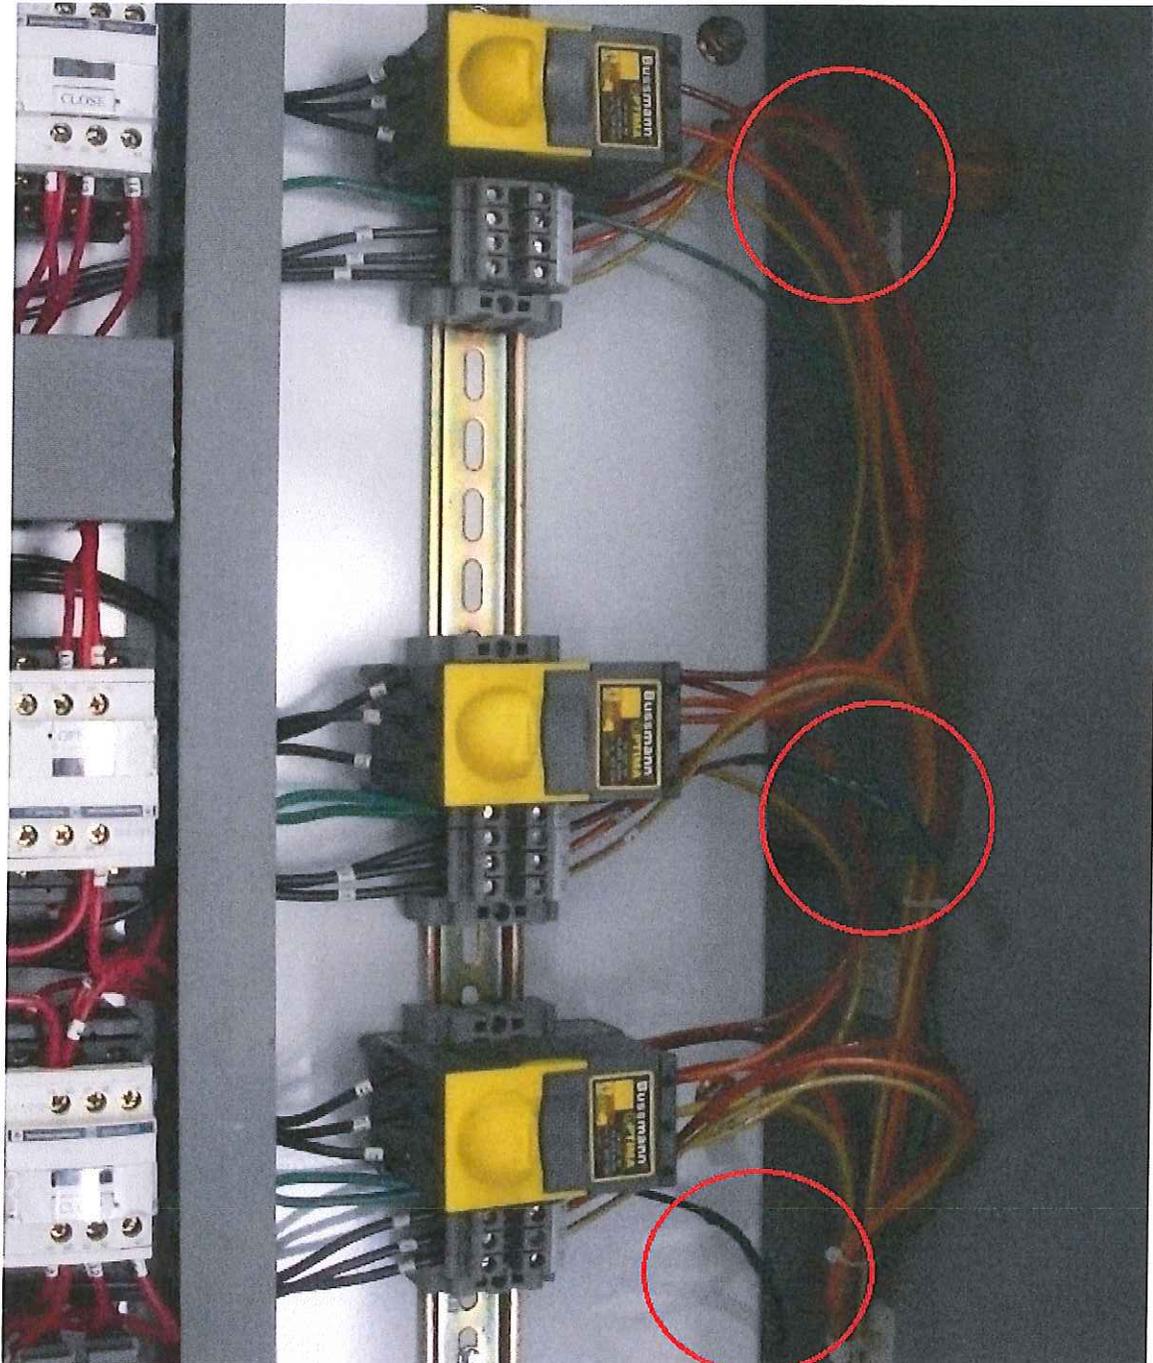
Figure 2.

DTI failed to have grounding conductors with a continuous outer finish that is either green or green with one or more yellow stripes. The grounding wires for the motor control center for the suction, discharge, & bypass of compressor engine number 1 in the Bridgeport Compressor Station had a red continuous outer finish.”

bypass of compressor engine number 1.” That evaluation revealed that the wires in question are marked with green tape (see Figure 2 below, grounding conductors circled in red), which adequately identifies them as grounding conductors. For this reason, DTI respectfully requests the withdrawal of Item #4, and the associated proposed civil penalty.
