CPF No. 1-2015-1018

Item 1. §192.163 Compressor stations: Design and Construction.

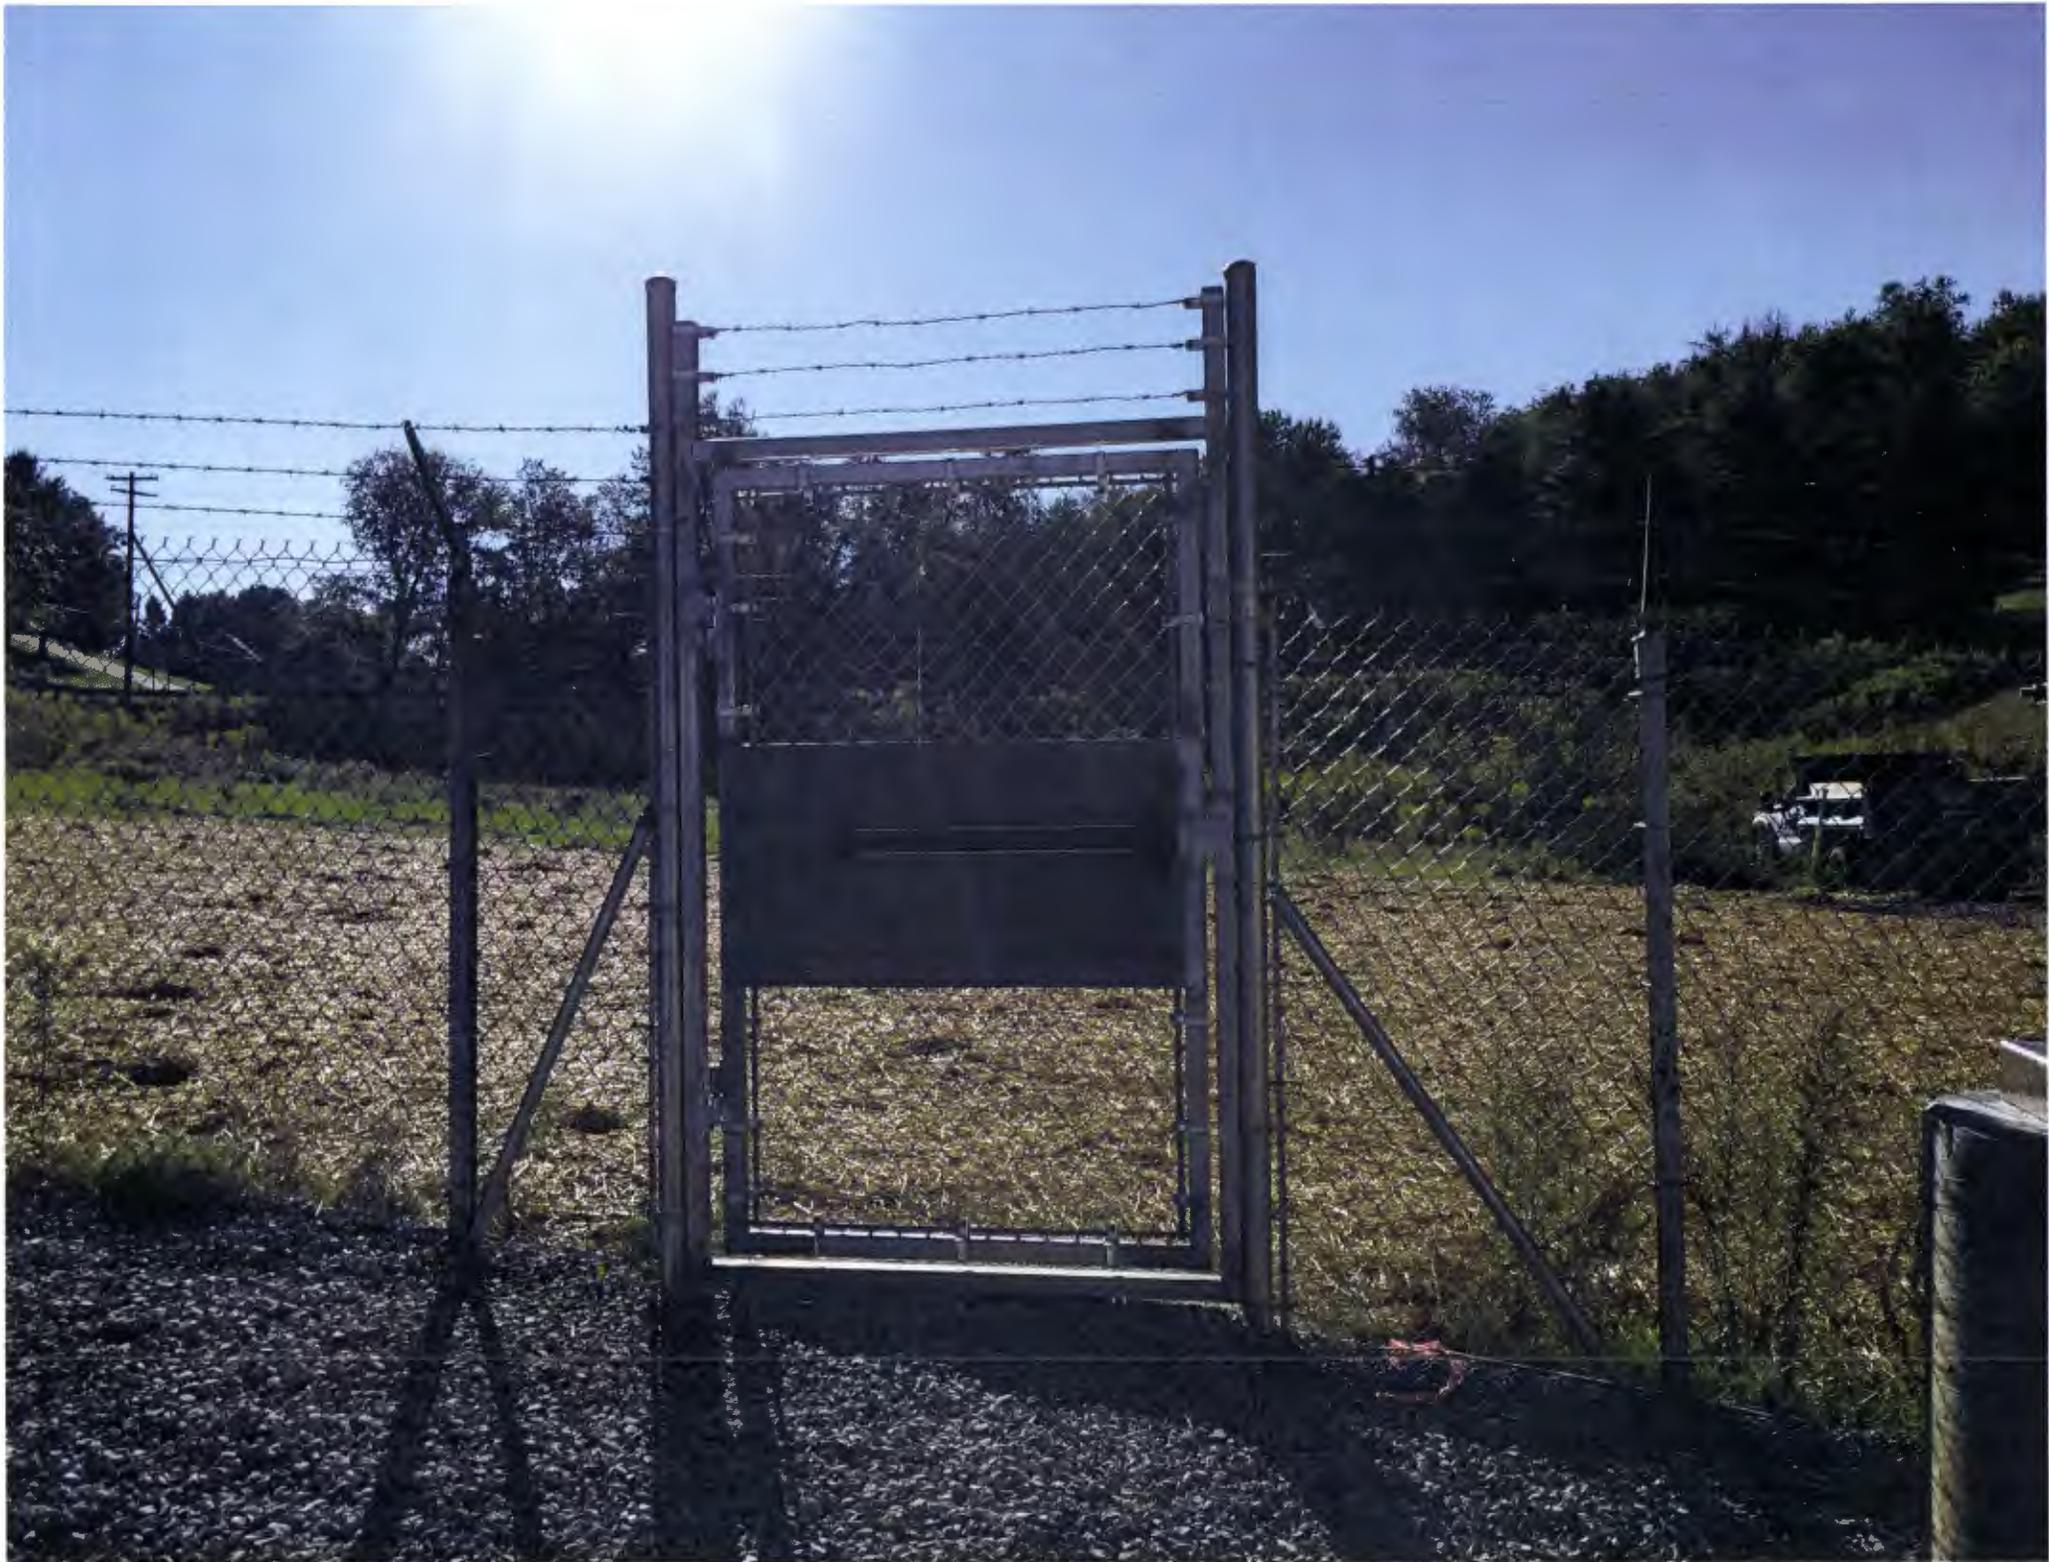
- a. EQT had some minor construction work being completed at the station in September 2015. The fence for the east side of the station was removed. When the fence was rebuilt a new escape gate was added, attachment 1. Attachment 2 shows the gate on the west side of the compressor station. Both will provide a convenient opportunity for escape to a place of safety as required by §192.163(d).
