Re: CPF No. 2-2007-1004H
Proposed Amendment No. 1 to the 1/26/07 Corrective Action Order (CAO)
Mechanical and Metallurgical Testing and Failure Analysis

May 22, 2008

Subject: Evaluation of 18-inch Girth-Weld Failure

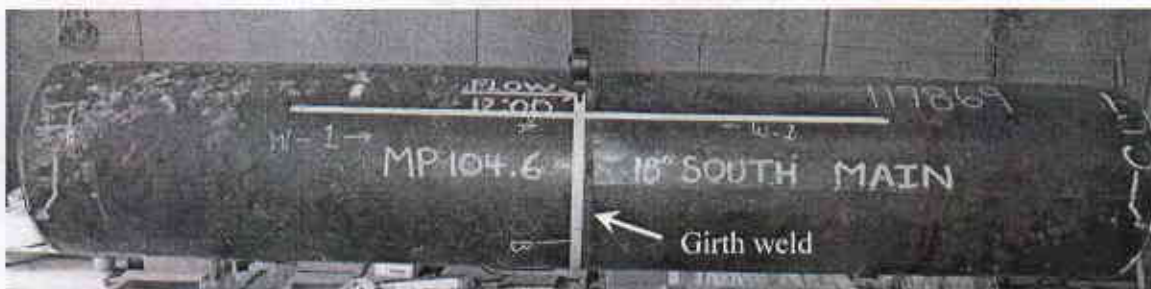
Sample 1 was examined closely for overall condition and the presence of any irregularities (Figure 1). A square-shaped protrusion $\frac{1}{4}$ inch wide by $\frac{1}{8}$ inch high was present for the full length of each joint, which is typical for an A.O. Smith flash butt weld. The surface of the pipe was covered with a black primer with the exception of a triangular area 3 by 3 inch on one side of the girth weld (Figure 4). Along the edge of the weld cap was a band of what appears to be erosion that reduced the wall thickness. There were no signs of corrosion or mechanical damage on the OD of the pipe.

Figure 1. Photograph of pipe Sample 1 as received, containing the girth weld that leaked. Scale shown is in inches.

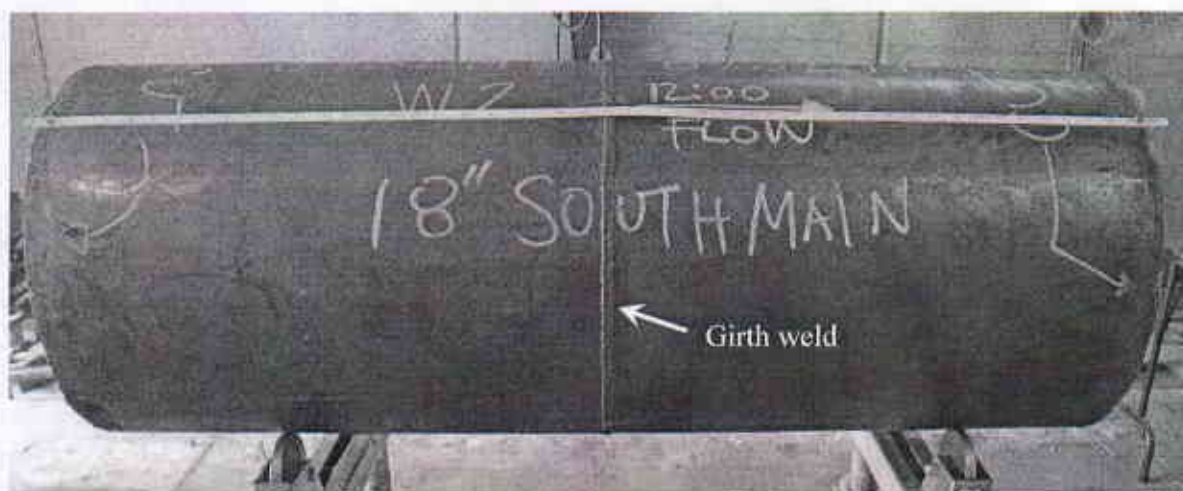
Sample 2 (Figure 2) was next examined closely for overall condition and for any irregularities. A flash butt weld typical of A.O. Smith pipe was observed running the length of both pipe segments. The outer surface of the pipe was covered with a black primer, and there were no signs of corrosion or mechanical damage on the OD of the pipe.

Figure 2. Photograph of pipe Sample 2 as received. Scale shown is in inches.

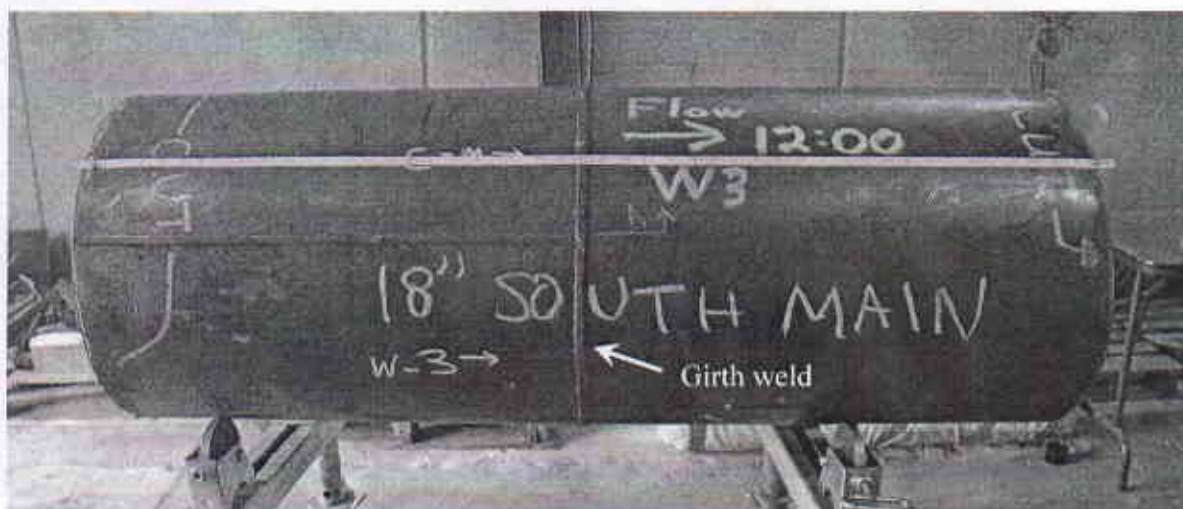
The outer surface of Sample 3 (Figure 3) was also examined closely for overall condition and any irregularities. As in the other samples, the long seam was an A.O. Smith flash butt weld. The OD surface of the pipe was also covered with a black primer, and there were no signs of corrosion or mechanical damage.

Figure 3. Photograph of pipe Sample 3 as received. Scale shown is in inches.

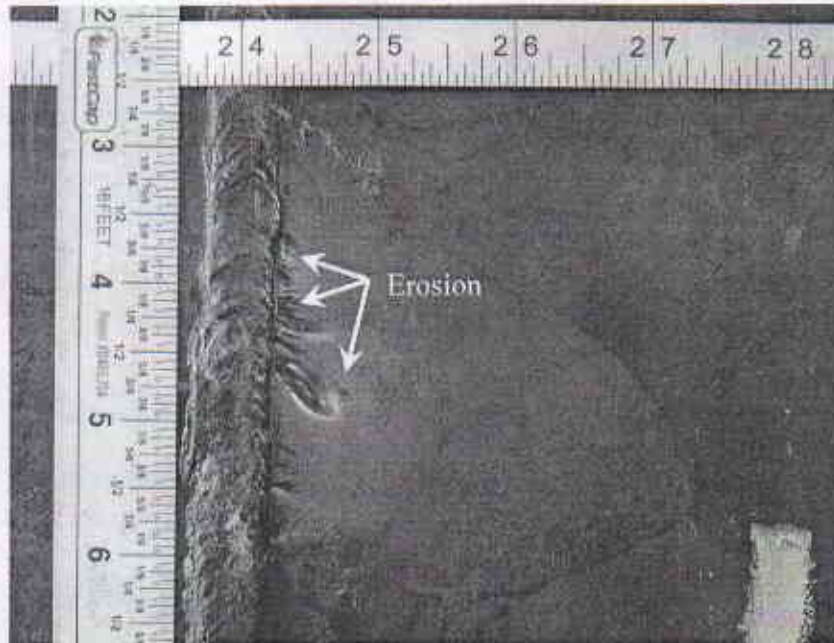
It is not possible to determine exactly when each phase of the cracking occurred. The erosion of the pipe adjacent to the cap is unusual and suggests that a leak had been present for some time. Hydrostatic testing before placing a pipeline in service is effective in finding leaks resulting from construction. The gas test used in this case would not be as effective and is not effective at finding small leaks. There is also a narrow band of what appears to be recent crack extension. This crack extension allowed additional gas to leak, apparently allowing sufficient gas to migrate to the surface to be detectable. This most recent crack extension occurred following record drought for several months followed by a short period of heavy rain which was reported in the region. Changes in moisture content in the soil are known to increase stresses on pipelines, and may have caused the recent crack extension.

Figure 4. Photograph of area that appears to be eroded adjacent to the girth weld. Scale shown is in inches.

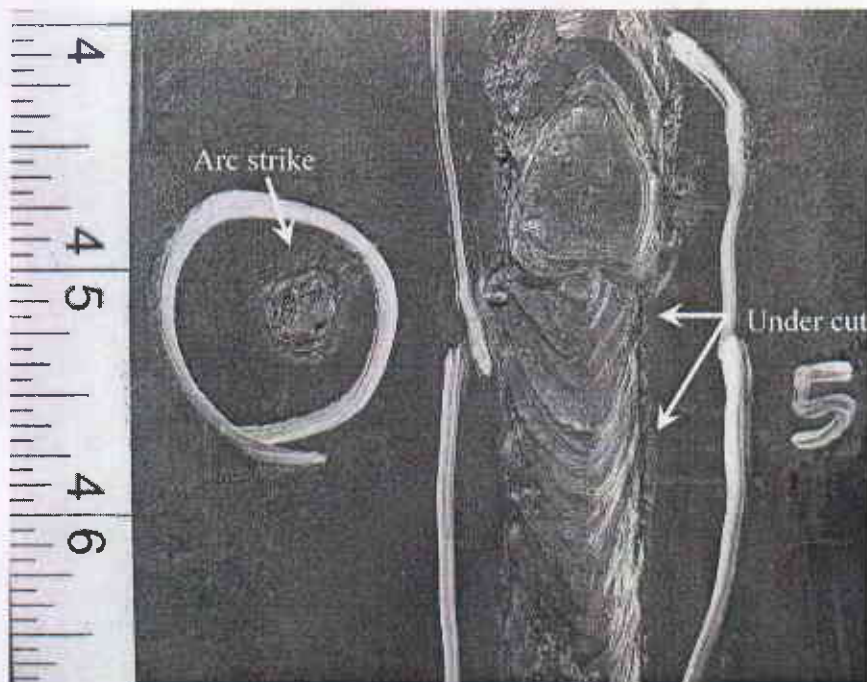
- Arc-strike (arc-burn)
- Undercut
- Misalignment of the pipe ends (1/16 inch maximum)

Figure 5. Photograph of Sample 1 showing workmanship imperfections (under-cut and arc-strike of weld). Scale shown is in inches.

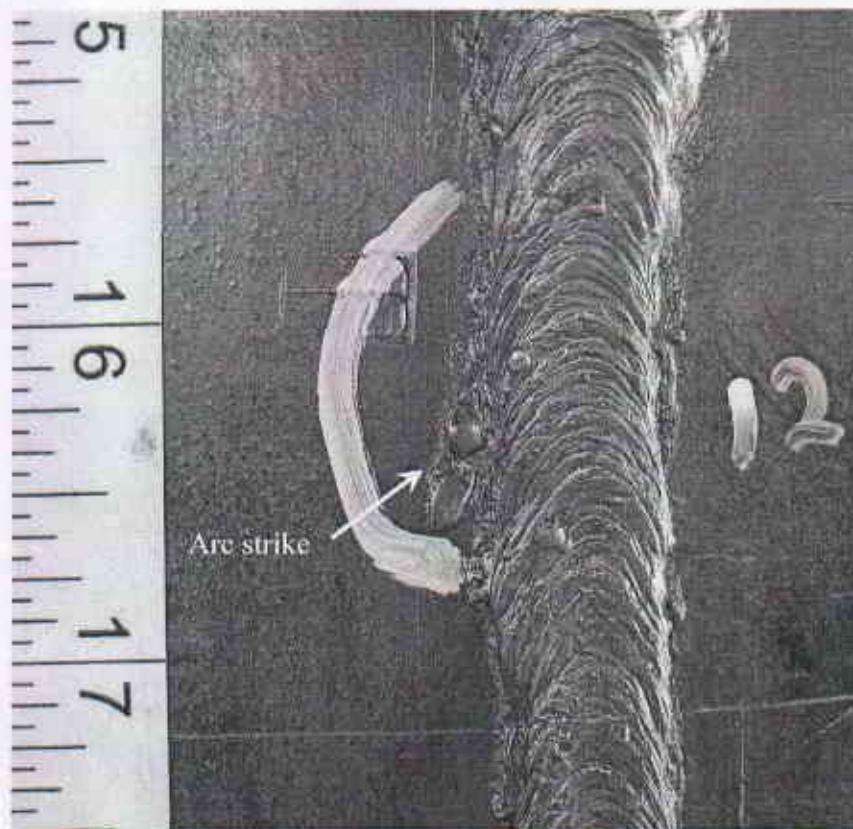
Figure 6. Photograph of Sample 1 showing workmanship imperfection (arc-strike of weld). Scale shown is in inches.

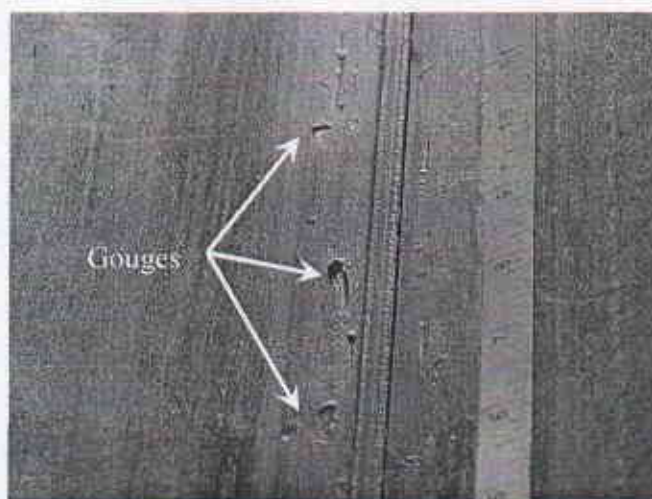
During examination of the ID of the pipe before it was cut, SES found the pipe to be free of corrosion and coated with a thin layer of what appeared to be condensate or engine oil. It was also noted that there was a line of small gouges parallel to the long seam (Figure 7).

Figure 7. Photograph of Sample 1 imperfections in pipe adjacent to long seam weld. Scale shown is in inches.

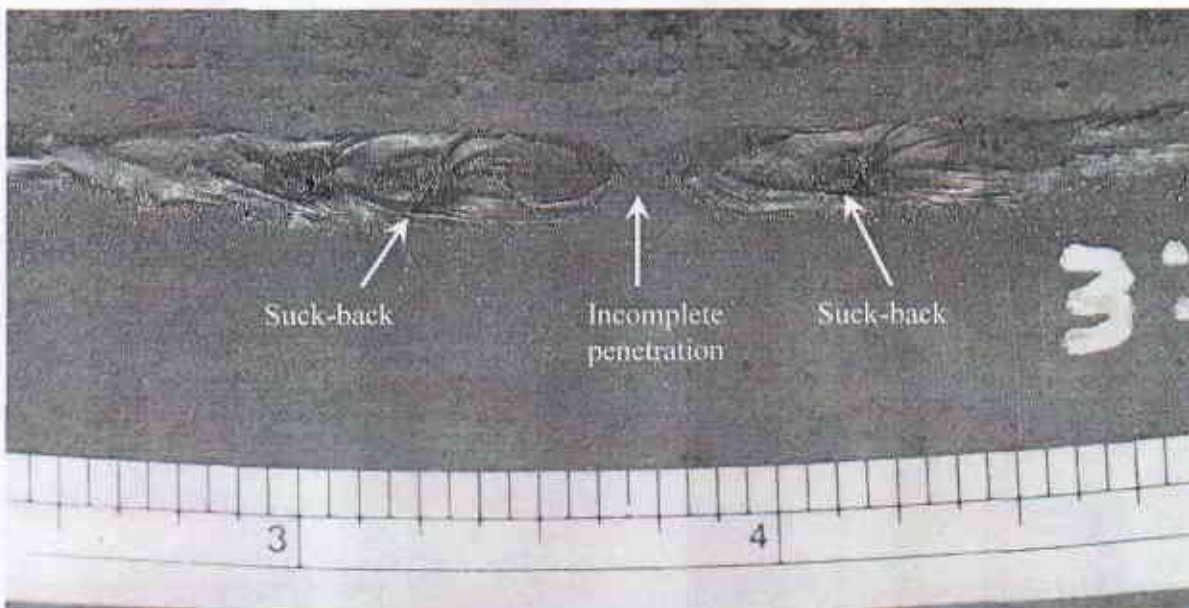
- Cracking was visible on the ID of the pipe near the root of the weld
- Unrepaired burn-through
- Lack of penetration
- "Suck-back"

Visual examination of the girth weld clearly showed that the root pass has several imperfections. The most significant was the unrepaired burn-through. The short segments of lack of fusion were also significant. However, only the lack of penetration was associated with the crack and it is unlikely this imperfection alone would have resulted in a through-wall failure.

Figure 8. Photograph of root of girth weld in Sample 1. Lack of penetration is clearly visible. Scale divisions are 1/16th inch.

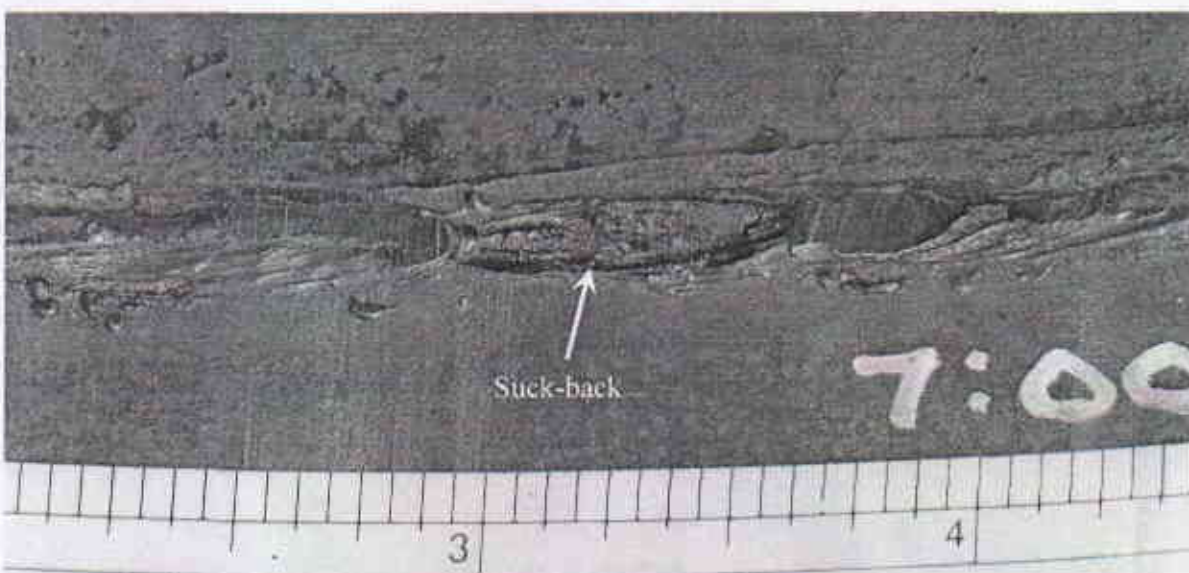
Figure 9. Photograph of root of girth weld in Sample 1. "Suck-back" is clearly visible. Scale divisions are 1/16th inch.

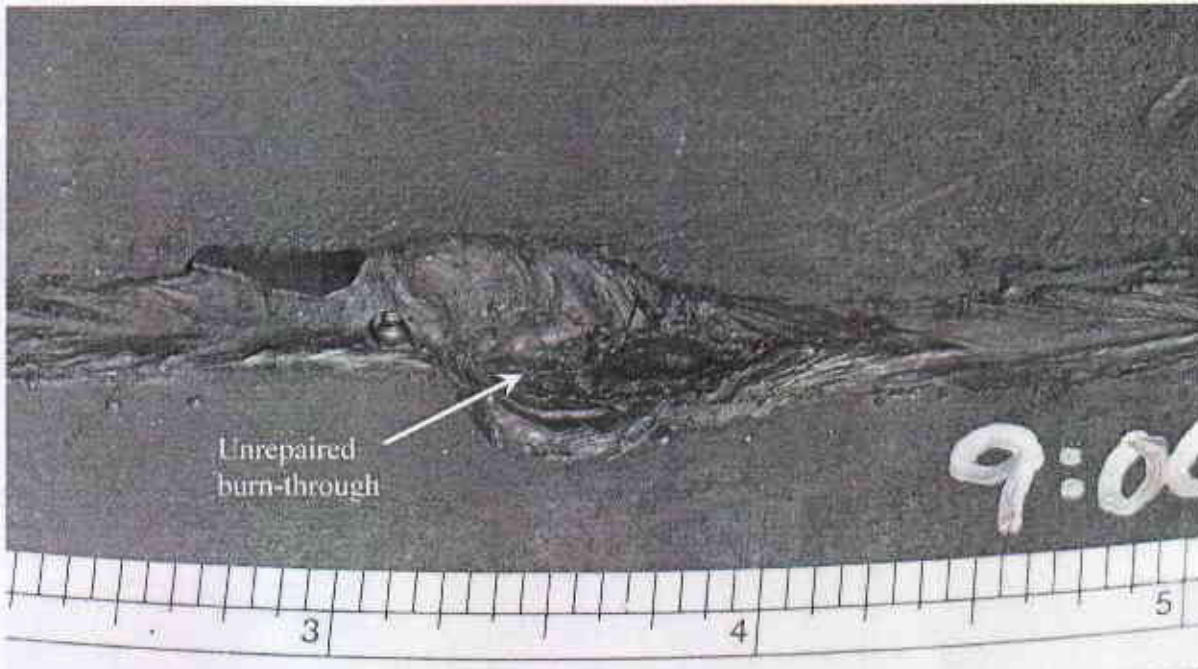
Figure 10. Photograph of root of girth weld in Sample 1. Unrepaired burn-through is clearly visible. Scale divisions are 1/16th inch.

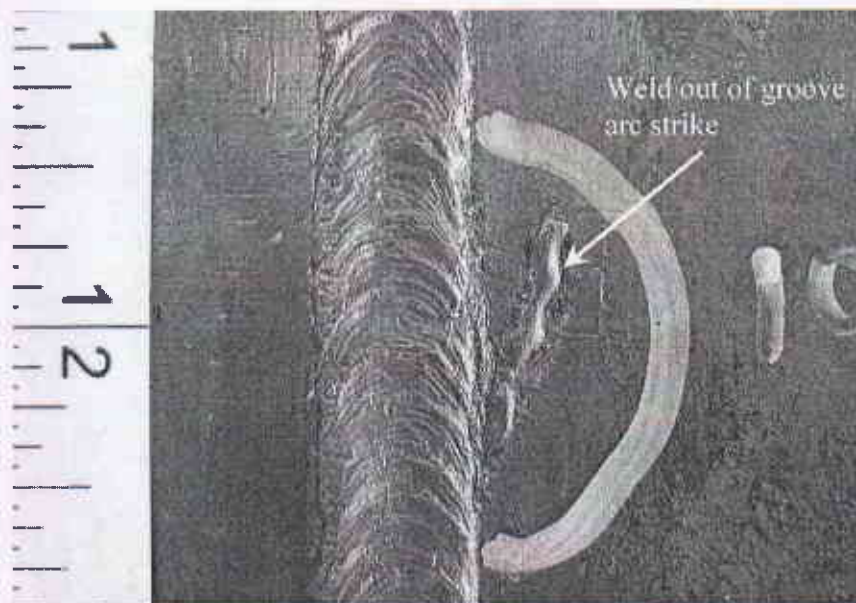
- Arc-strike (arc-burn)
- Undercut
- Hammer strike marks
- Misalignment of the pipe ends (1/16 inch maximum)

Figure 11. Photograph of root of girth weld in Sample 2. Arc-strike or out of groove weld is clearly visible. Scale divisions are 1/16th inch.

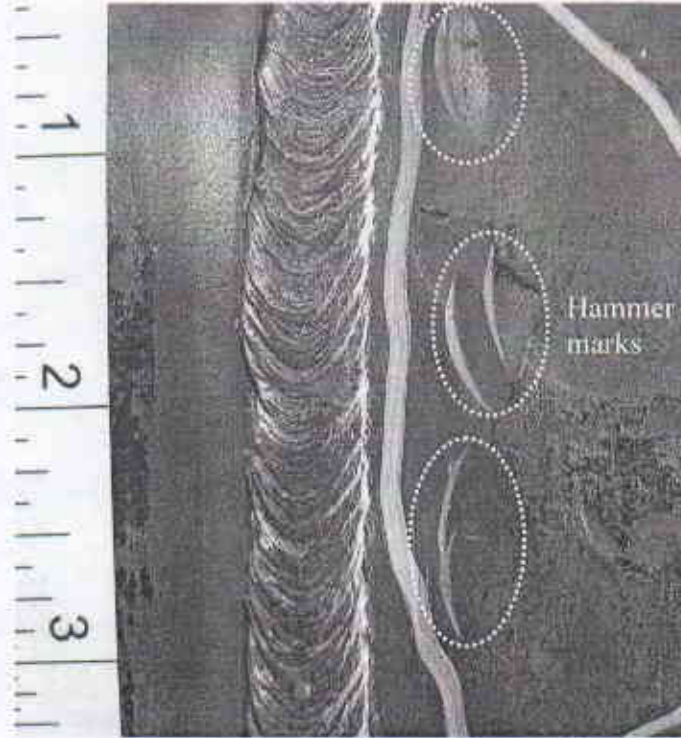
Figure 12. Photograph of root of girth weld in Sample 2. Hammer marks are clearly visible. Scale divisions are 1/16th inch.

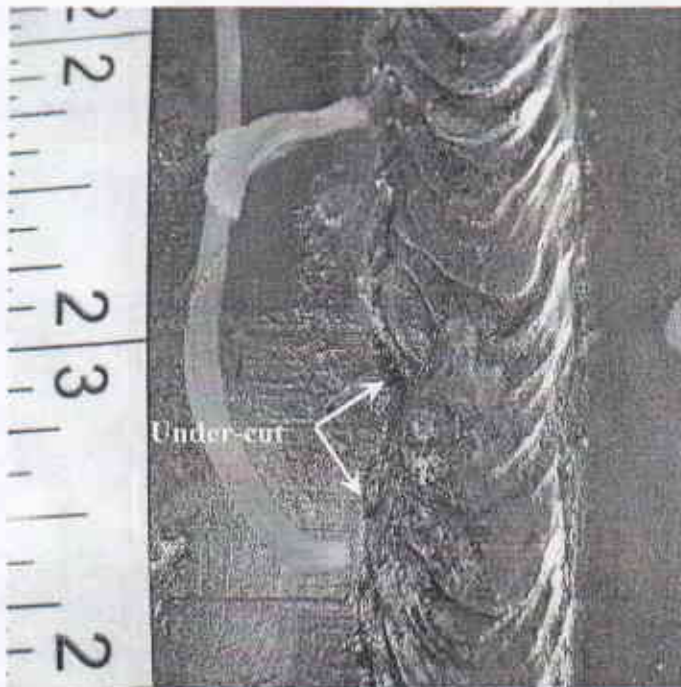
Figure 13. Photograph of root of girth weld in Sample 2. Under-cut is clearly visible. Scale divisions are 1/16th inch.

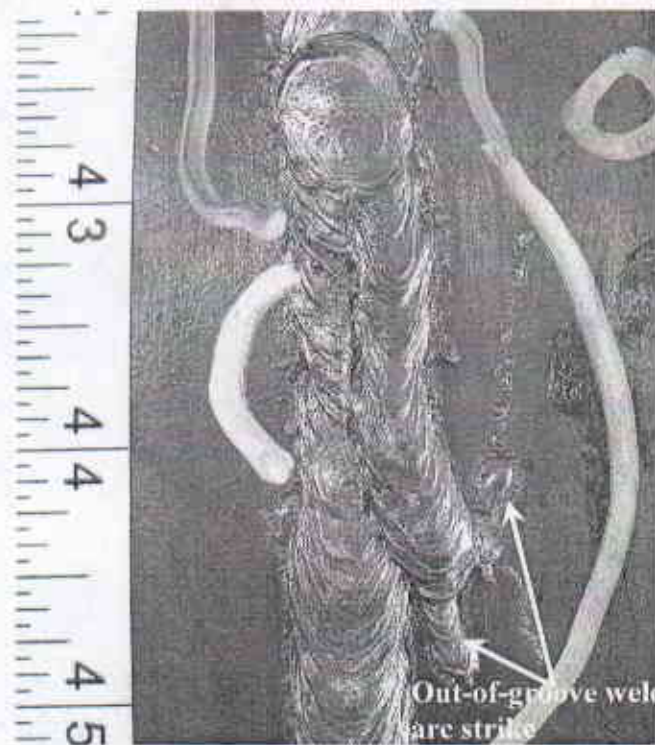
- Arc-strike (arc-burn)
- Undercut
- Misalignment of the pipe ends (1/16 inch maximum)

Figure 14. Photograph of root of girth weld in Sample 3. Arc strike and out-of-groove weld are clearly visible. Scale divisions are 1/16th inch.

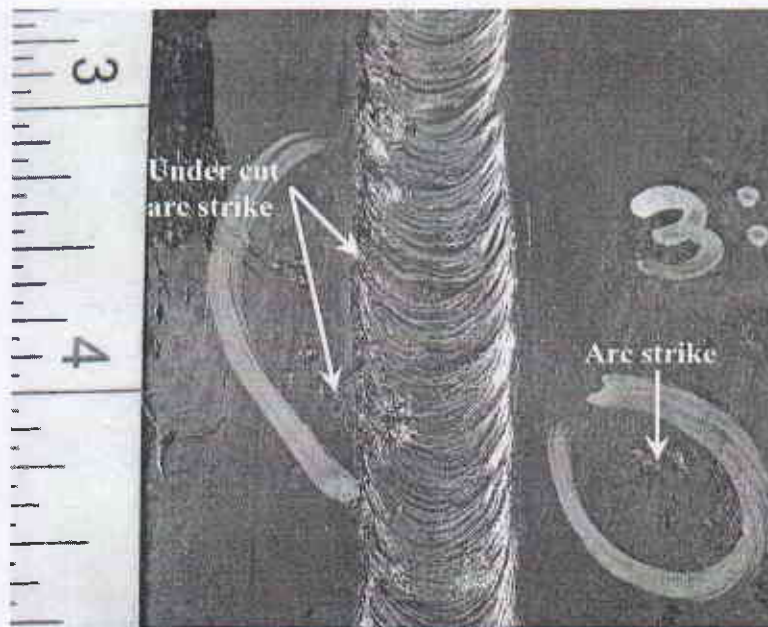
Figure 15. Photograph of root of girth weld in Sample 3. Arc strike and under-cut are clearly visible. Scale divisions are 1/16th inch.

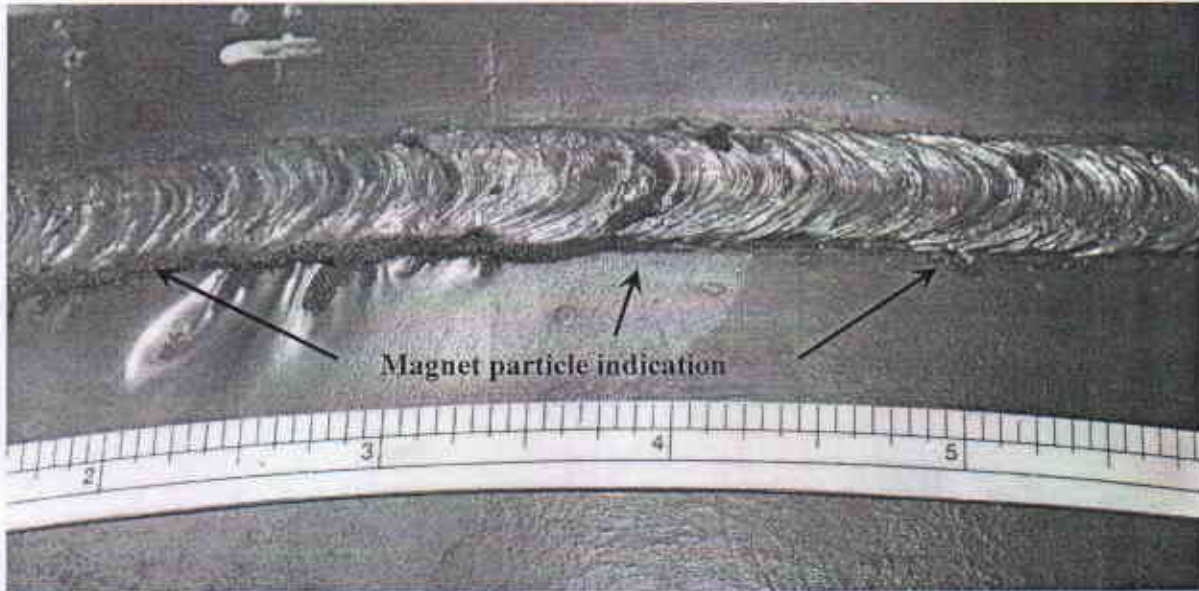
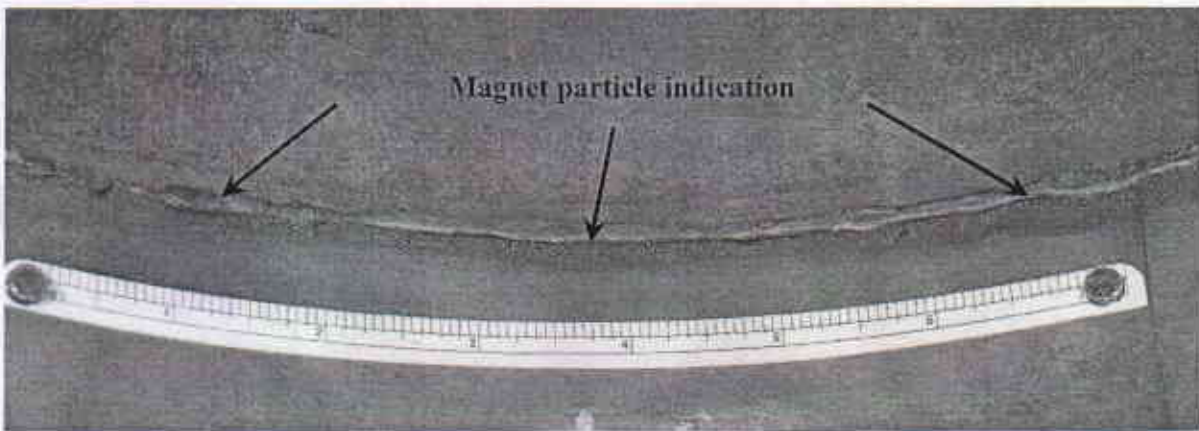
The girth weld in the ring cut from Sample 1 was inspected via magnetic-particle inspection (MPI) for indications of imperfections (Figures 16 and 17). MPI revealed a crack-like indication on the OD and ID at the same circumferential location as the erosion on the OD. The shape and angle of the cap pass with respect to the pipe made it difficult to discern indications of cracking from the tight corner created by the weld cap and OD of the pipe. Similarly, the root shape at some locations made it difficult to define the length of the crack. It was clear that indications of

cracking were present both on the ID and OD of the weld, but the precise extent was difficult to discern.

Figure 16. Photograph showing magnetic particle indication of crack-like indication on OD of Sample 1. Scale divisions are 1/16th inch.

Figure 17. Photograph showing magnetic particle indication of crack-like indication on ID of Sample 1. Scale divisions are 1/16th inch.

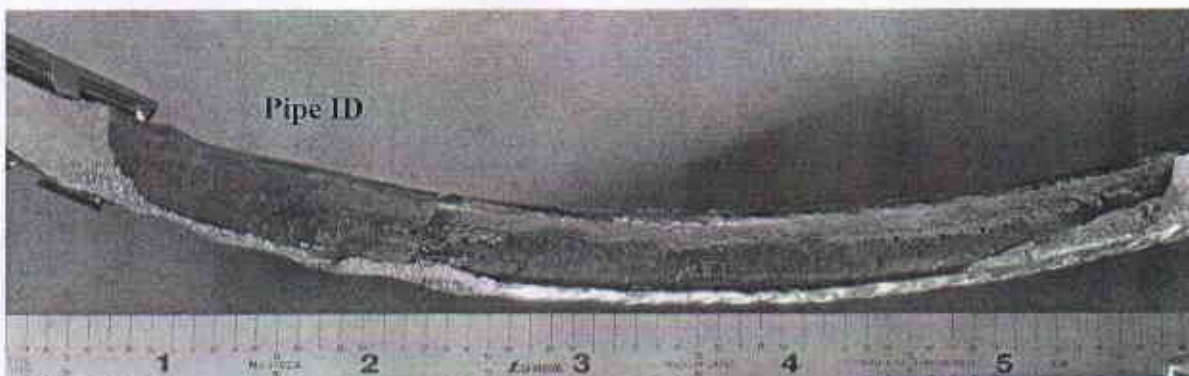
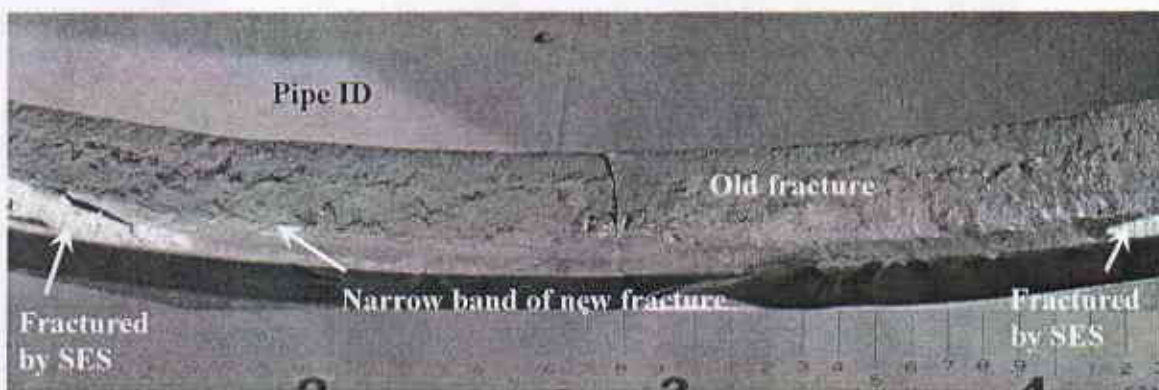
SES examined the fracture first with low-power magnification (less than 5X) using a stereoscope (Figures 18 and 19). Much of the fracture surface was smooth with very few fracture features.

Figure 18. Photomicrograph showing fracture after crack was broken open. Scale divisions are 1/10th inch.

Figure 19. Photomicrograph showing fracture after crack was broken open. Scale divisions are 1/10th inch.

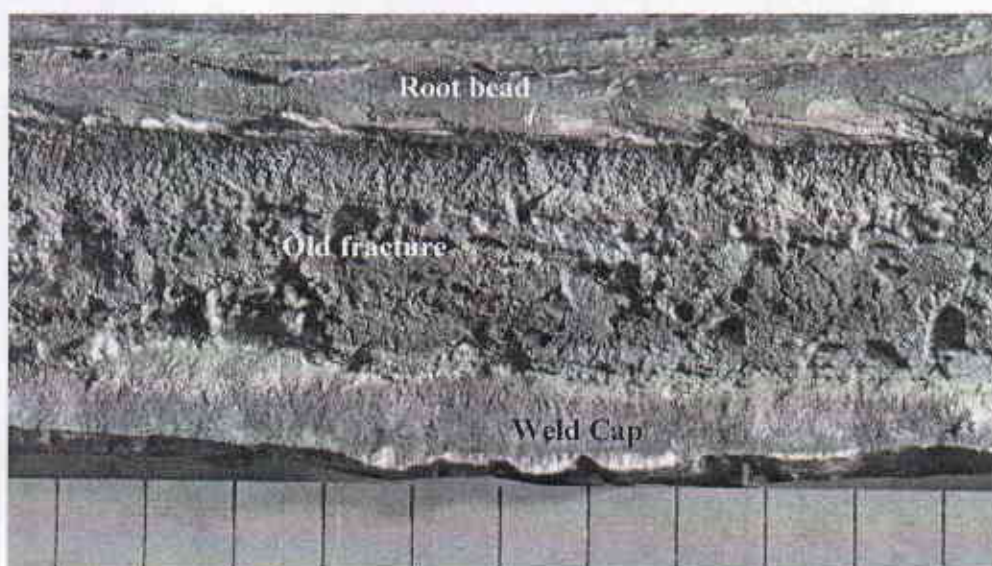
Fracture features that were present suggested that the weld contained slag and gas pockets before the fracture occurred (Figures 20 and 21).

Figure 20. Photomicrograph showing fracture after crack was broken open and before cleaning. Scale divisions are 1/10th inch.
