Kaneb Pipe Line Operating Partnership, L.P., a Valero L.P. company
7340 West 21st St. N., Suite 200 • Wichita, Kansas 67205
Telephone (316) 773-9000

RE: CPF NO. 3-2007-5002 – Response to NOPV

EXHIBIT A

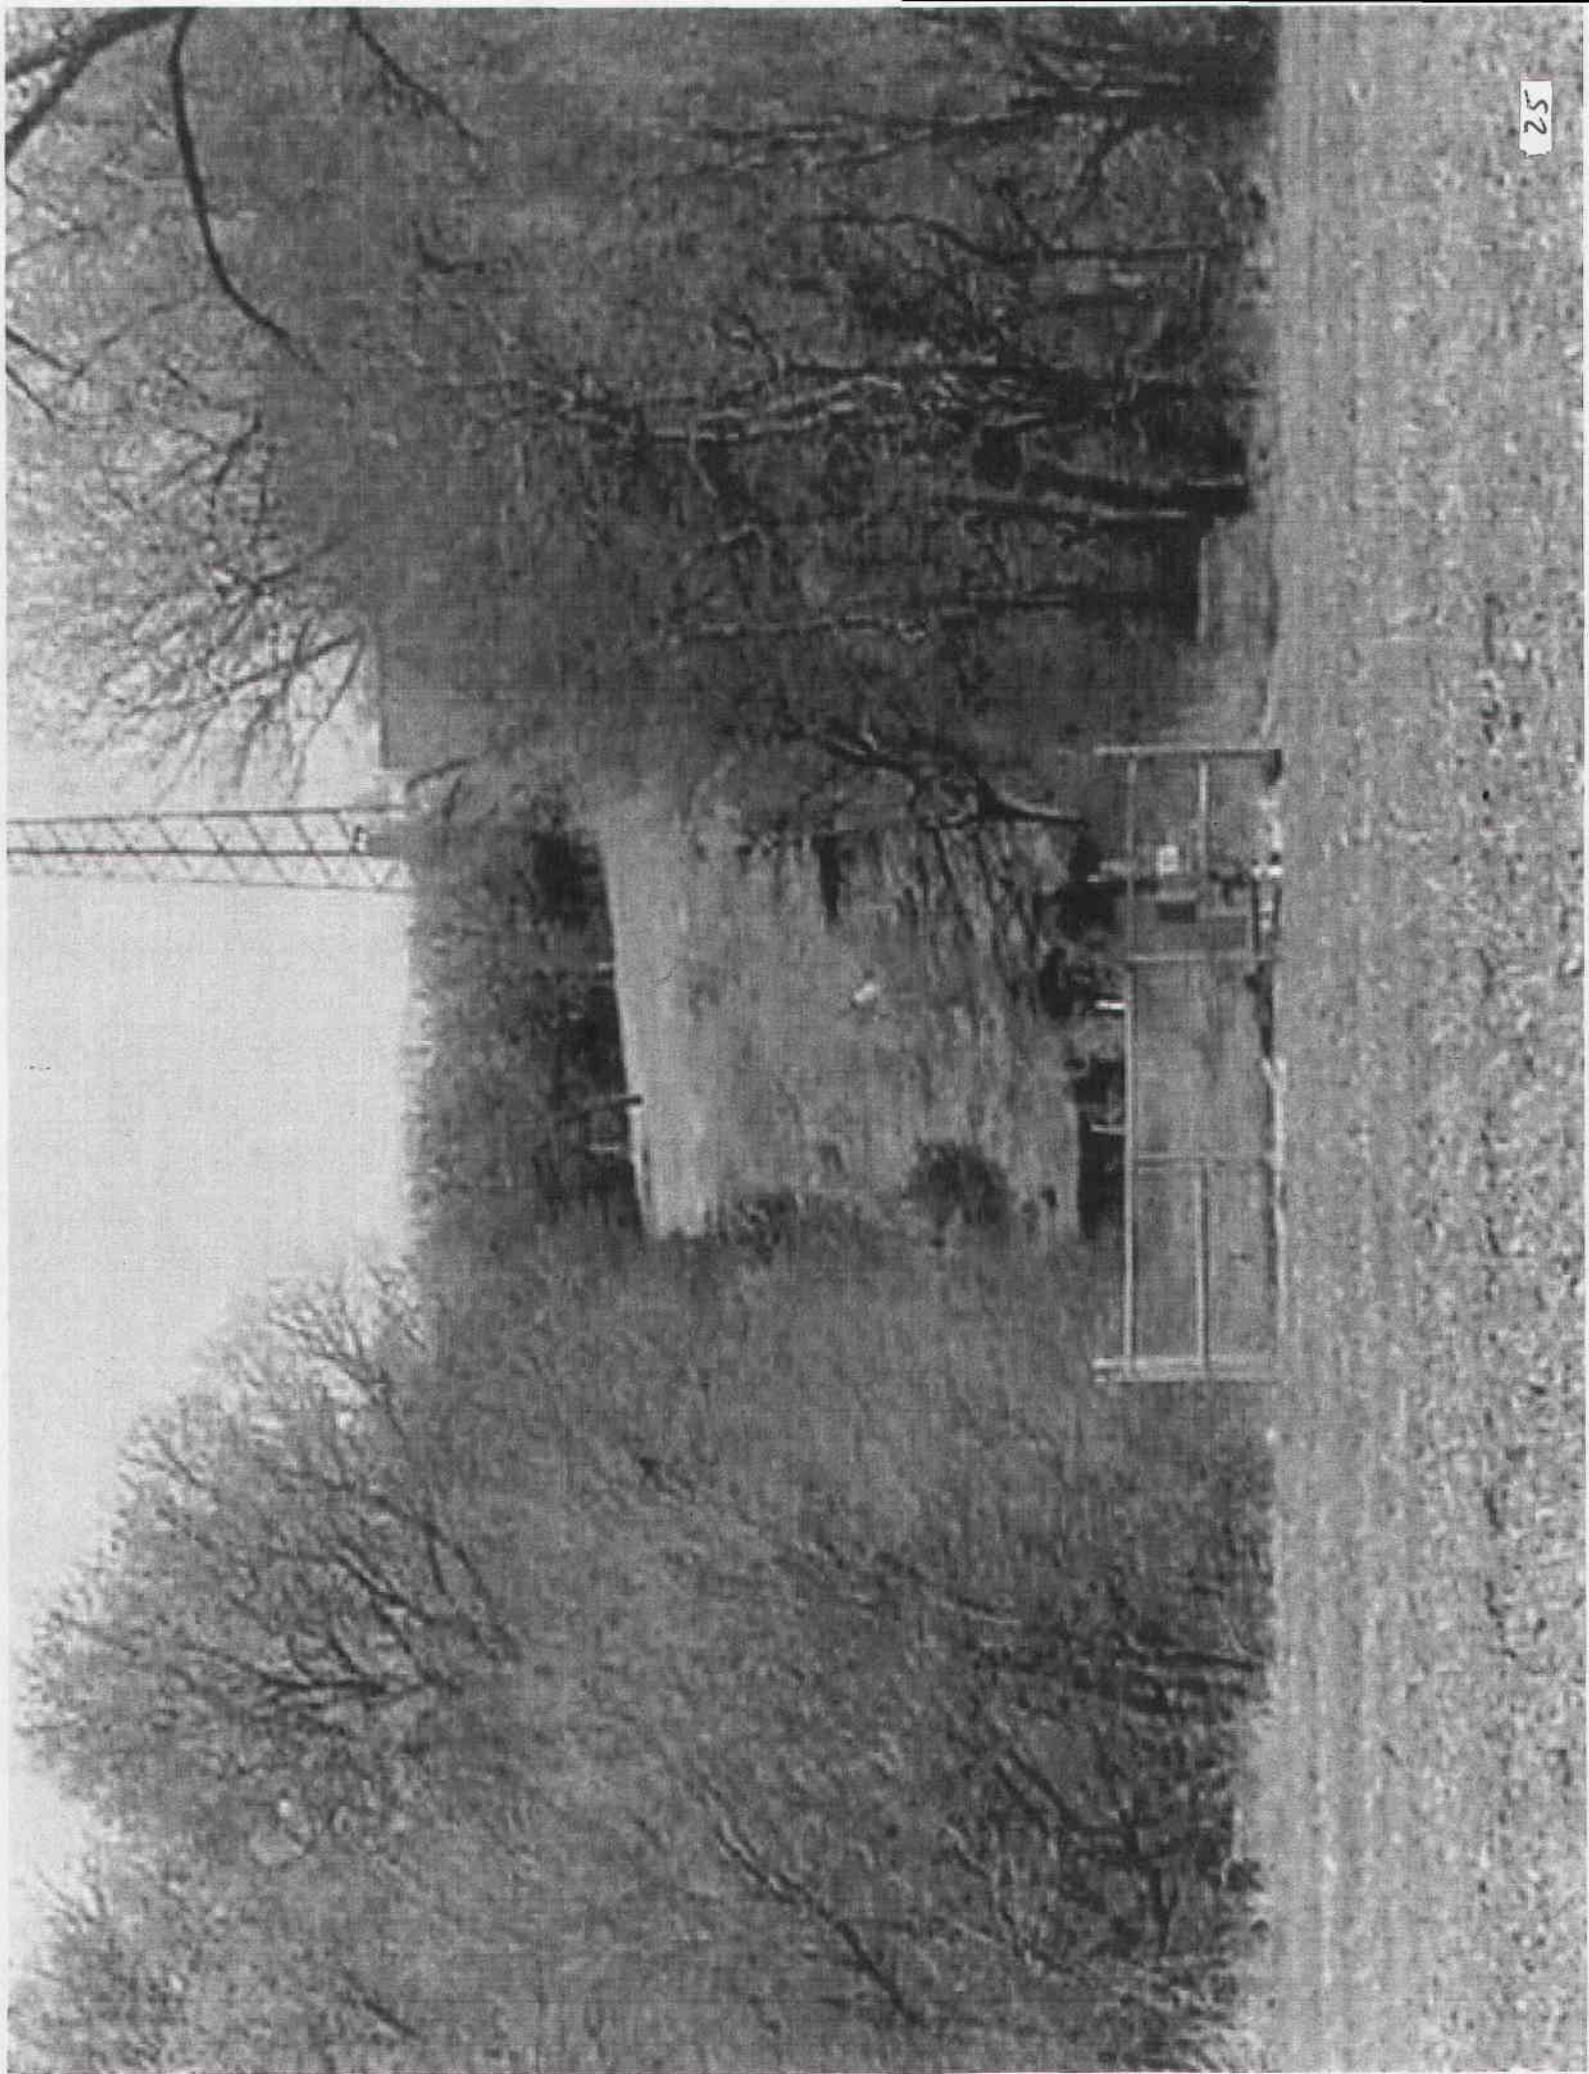
- 4) In an approximate 200 foot section of small woods on the west side of the Elkhorn River crossing at MP33.0 near Arlington, Nebraska
 - Picture 24: Before
 - Picture 25: After
 - Picture 26 & 27: Aerial After
