Tesoro High Plains Pipeline Company LLC
19100 Ridgewood Parkway
San Antonio, Texas 78259

RE: CPF 3-2012-5028

EXHIBIT A
KIEFNER & ASSOCIATES, INC.
TESORO'S SPAN EVALUATION REPORT
EXCERPT FROM APPENDIX A (PAGE 1 OF 14)

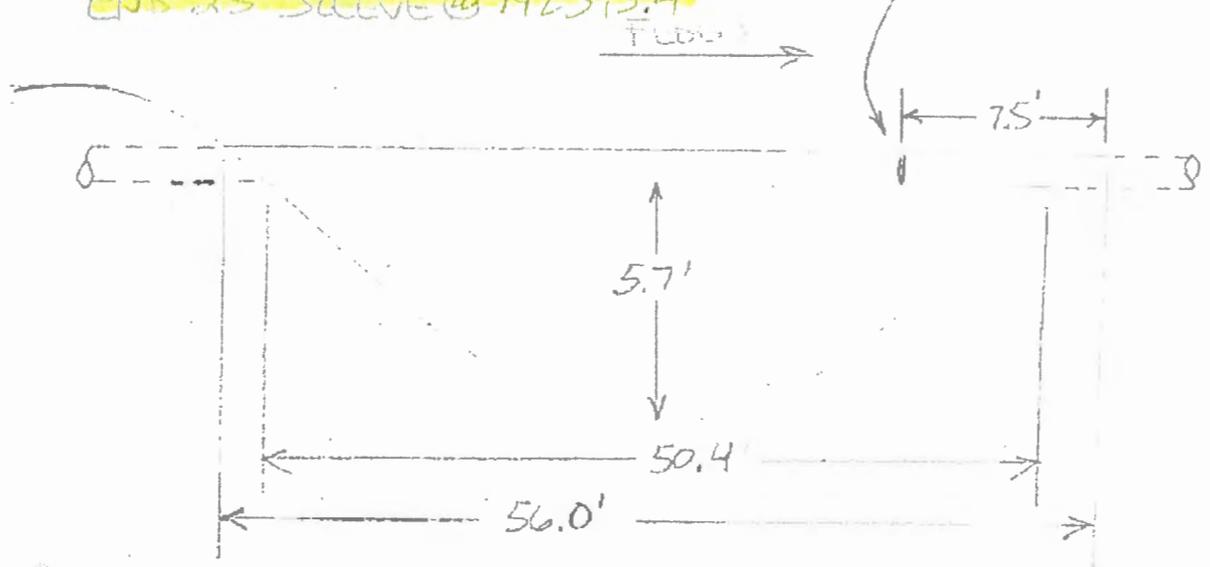
Span 1

As demonstrated in the attached documentation (See Exhibit A), the repair sleeve was not installed in response to this anomaly, but rather was installed in the 1970's, prior to the first ILI run on this pipeline. Specifically, the excerpt from the referenced Kiefner report shows the location of the anomaly to be at 142366.5' and the location of the beginning and end of the repair sleeve to be at 142370.3' and 142395.4', respectively. Thus, the anomaly was located approximately 4 feet outside of the repair sleeve. Additionally, the size and severity of the internal anomaly did not meet established criteria for being repaired; rather, Tesoro has chosen to monitor this anomaly.

- WELD @ 142353.5'
- ANOMALY @ 142366.5' (INTERNAL W/L 27° TO DEPTH, 1.2" L x 2.0" WIDE AT 6:35)
- START 25' SLEEVE @ 142370.3'
- WELD @ 142377.5'
- END 25' SLEEVE @ 142395.4'

FIELD IDENTIFIED WELD

- ONLY FIELD IDENTIFIED WELD IS PROBABLY THE D/S WELD ON THE 25' SLEEVE
- EVIDENCE OF HIGH WATER FLOW UNDER THE SPAN
