PIPELINE QUALIFICATION RECORD

1. Pipeline
Line Number 38 MNT05-1 Orig. Appro. # _____
Line Name Norteno #5
Description of Location El Paso Delivery Point near Anthony, Texas in El Paso County, Texas to end of line in Dona Ana County, New Mexico.

REPORT OF PIPELINE PRESSURE TEST

Pipeline Condition Report

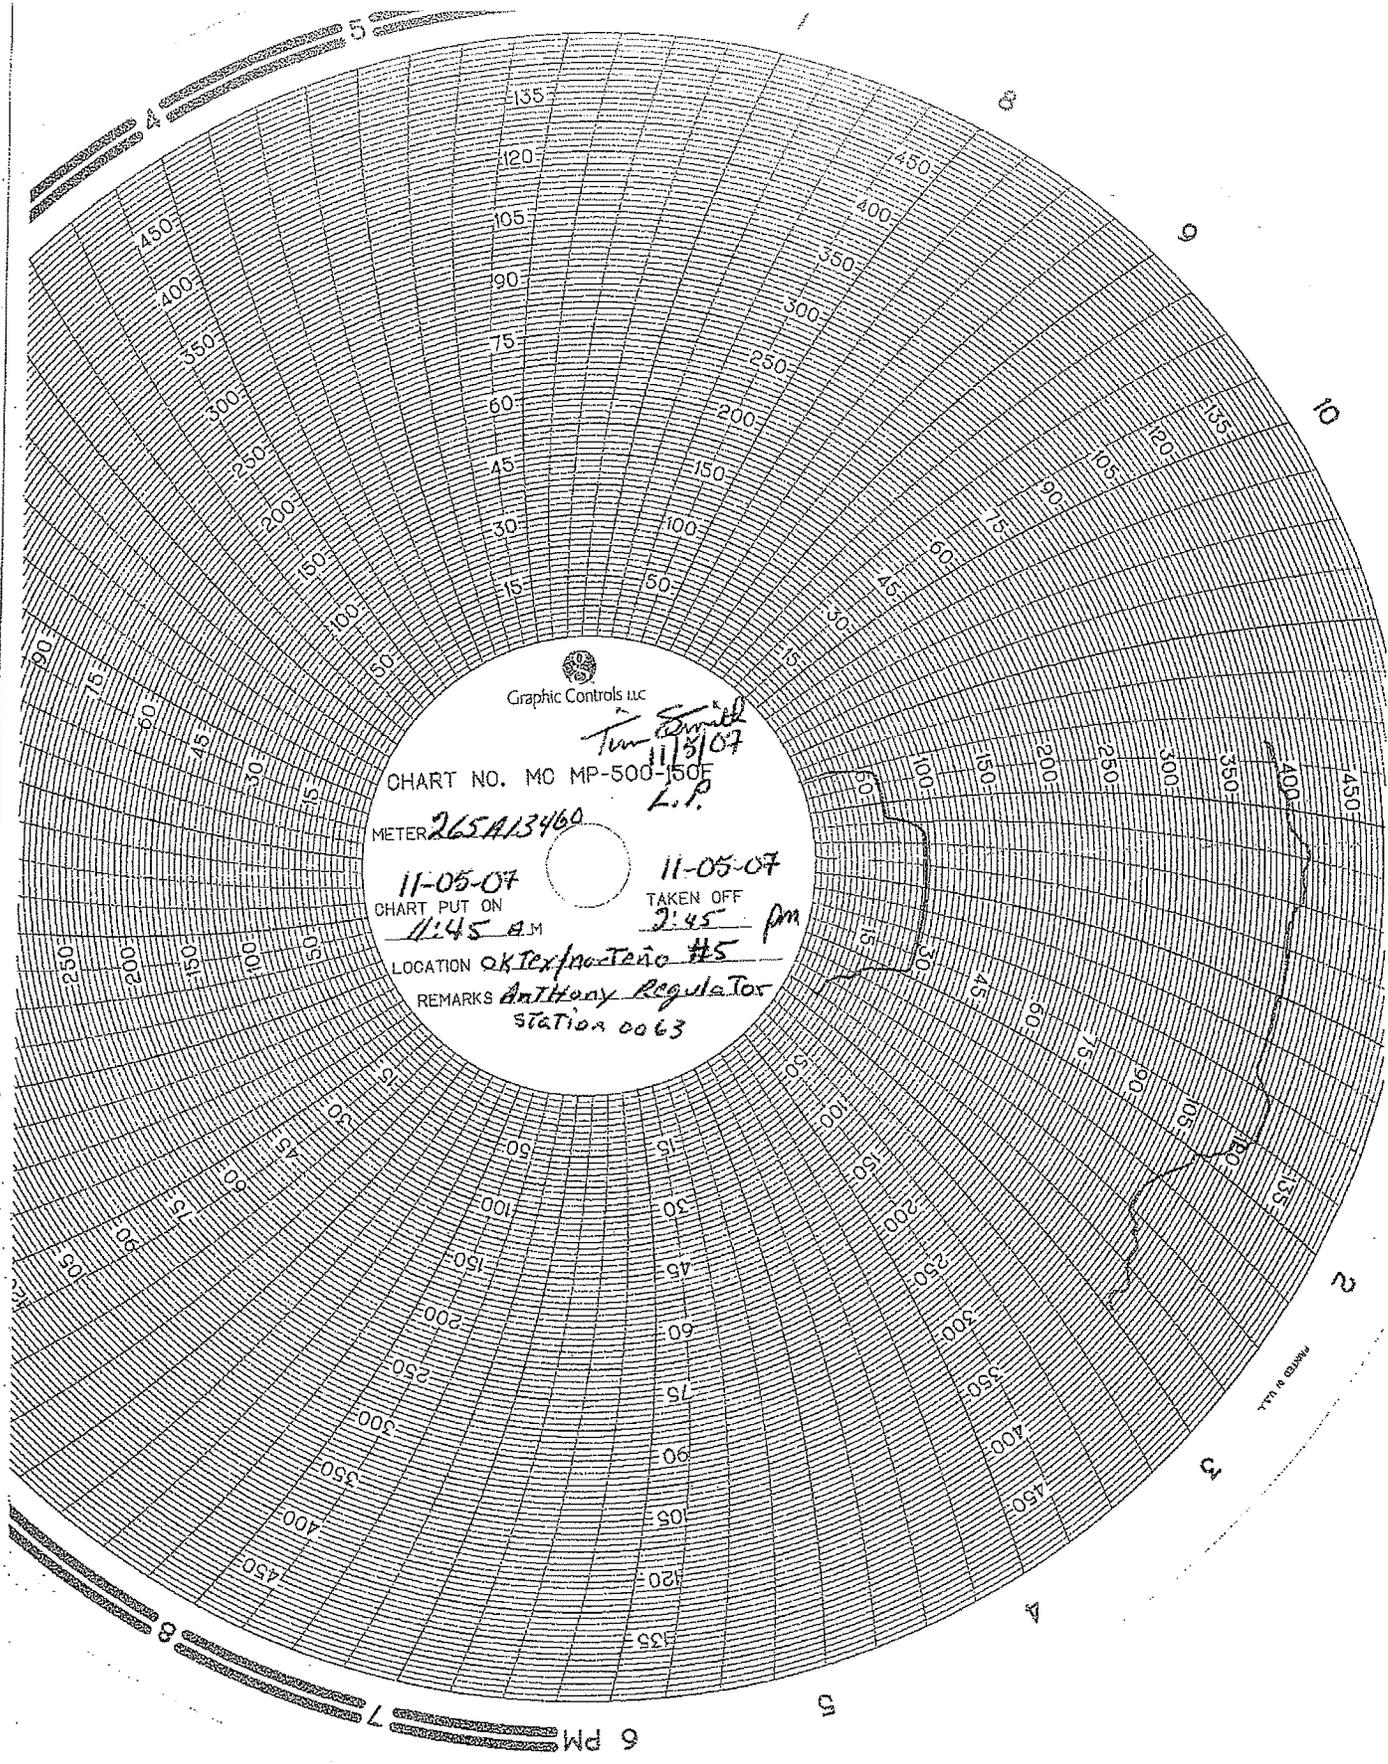
CHART NO. MC MP-500-150F
METER 265A13460
Tom Smith
11/3/07
L.P.

11-05-07
CHART PUT ON 11:45 AM
TAKEN OFF 2:45 PM

LOCATION *OKTepnoTeHc #5*
REMARKS *Anthony Regulator*
Station 0063

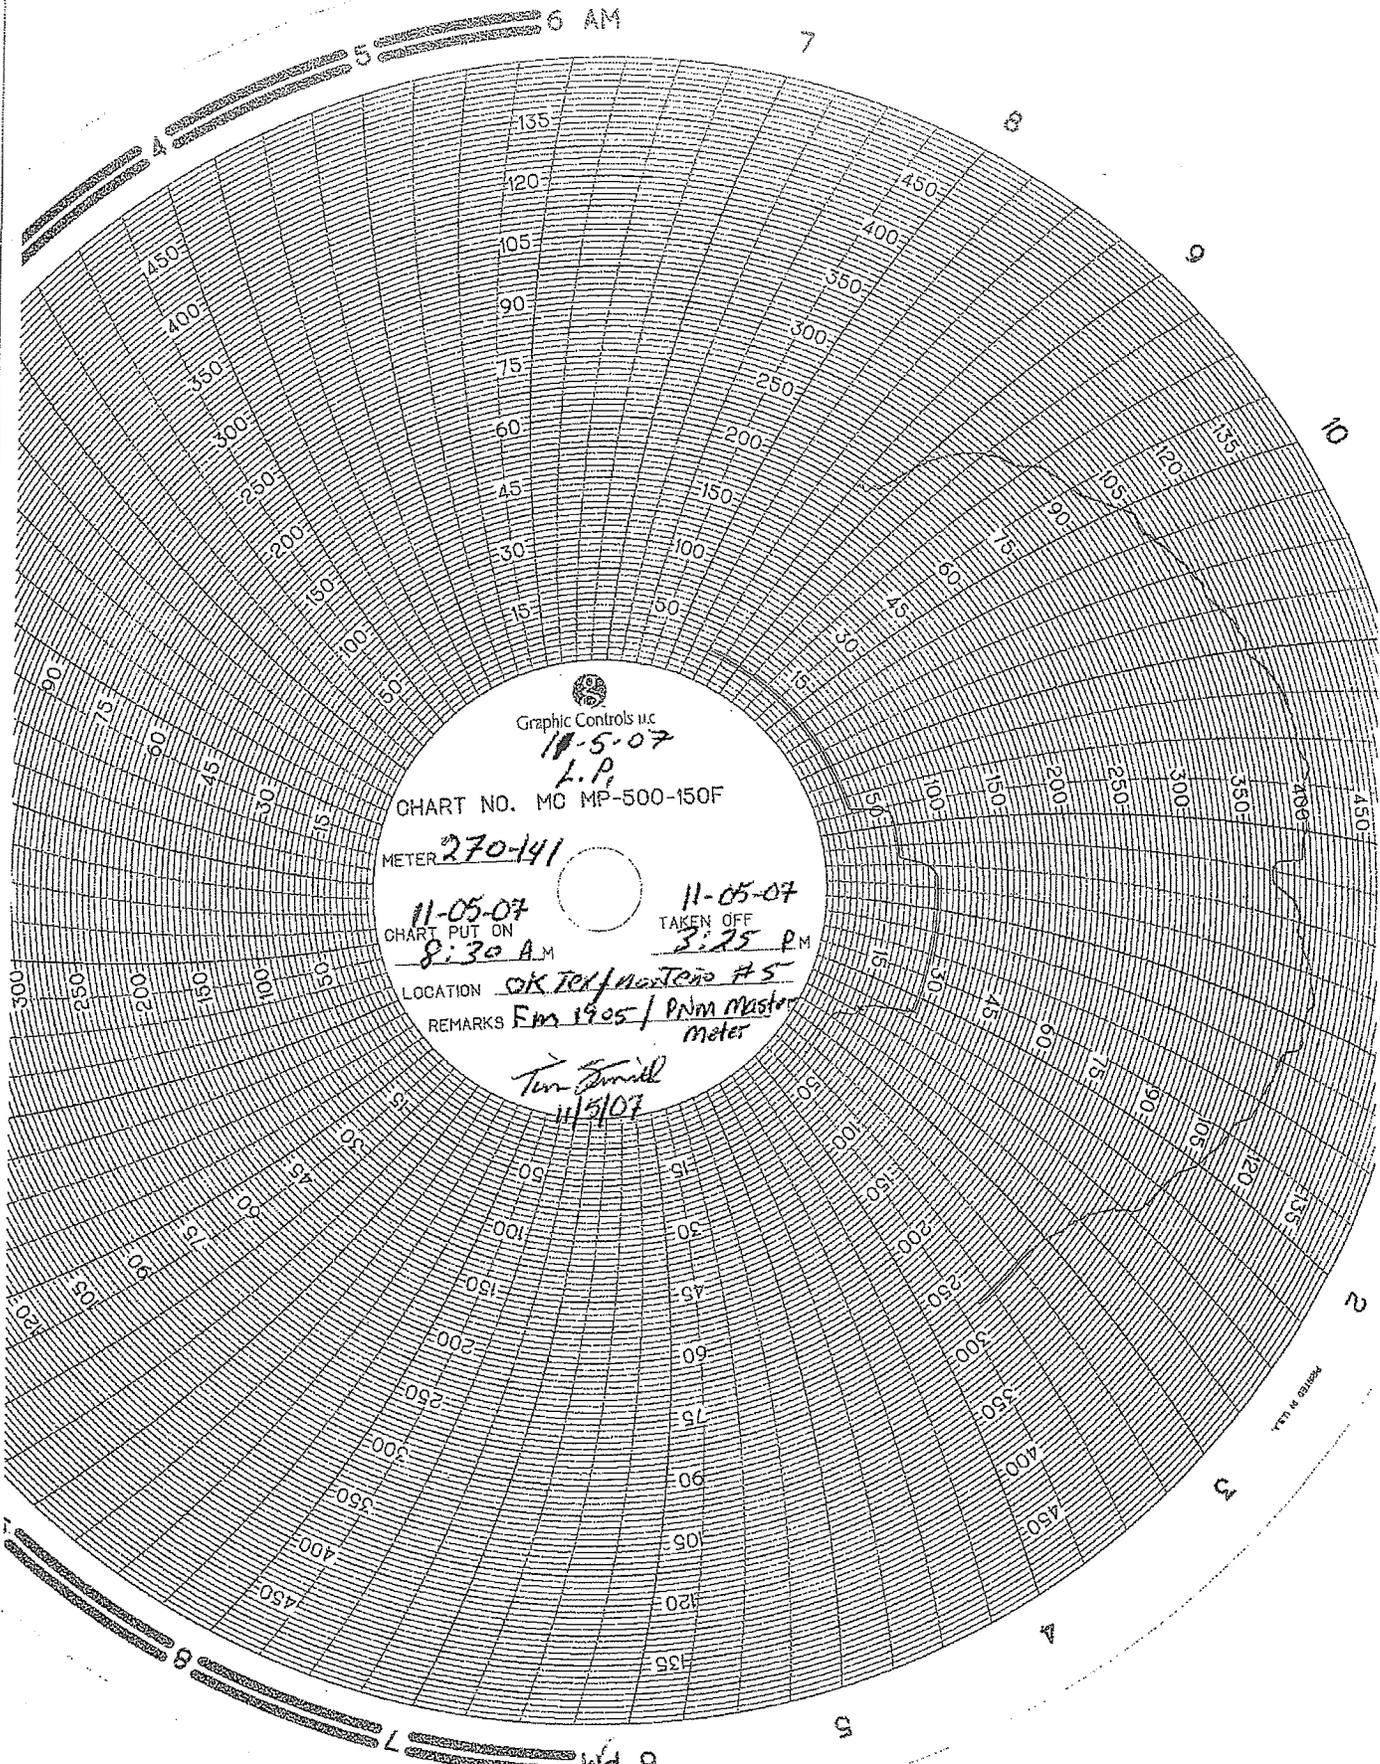
METER 270-41

11-05-07
CHART PUT ON
8:30 A.M.

11-05-07
TAKEN OFF
3:25 P.M.

LOCATION OK Tex / Martins #5

REMARKS Fm 1905 / PNM Master
meter

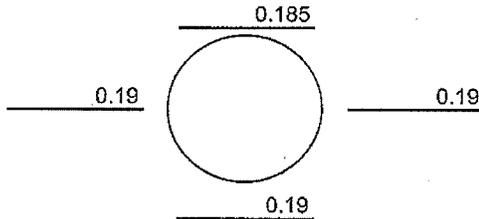
UT Readings:

Carrier Pipe Size: 4" Grade: X-42 Wall Thickness: 0.188 Pipe Mfg: _____
 Instrument: Make CYGNUS Model 4 Serial Number 748

Dug each side of casing out at FM 1905 and Main St on SW Corner. On the west side casing was very deep. Used shoring equip. Blowed down line cut line with cold cutters. Inserted new 4" pipe that was pressured tested to 98 psi for 4 hours above ground. Jeeped coating repaired jeeps with Tape Coat M50RC with Primer. Installed plastic casing spacers 5 feet apart on 4" pipe. (PAGE 2)

Coat M50 RC with Primer. Tied-In on east side and west side of RR Tracks. Had B&H Welder tie-in on east side and TGS Welder Paul tie-in on west side due to close quarters. After tying in new pipe to old pipe. I checked for shorted casing. All was clear. The line was purged and pressured back up to specs. The field welds were soaped to check for leaks in welds. The field welds were taped with Tape Coat M50 RC with Primer. The area was backfilled and wacker packed on the east and west sides to TXDots standards. We poured 2 sack concrete in the asphalt area. Asphalt will be repaired by Seal Rite in the following weeks. The area to 2 sack and asphalt is 2' x 13' x 1' deep. All paper work and pictures have been filed.
