Re: CPF No. 4-2008-1008

We are in receipt of your Notice of Probable Violation ("NOPV"), Proposed Civil Penalty and Proposed Compliance Order, dated May 19, 2008, in which the Southwest Region of the Pipeline and Hazardous Materials Safety Administration ("PHMSA") asserts that Tennessee Gas Pipeline Company ("TGP") may have violated the Pipeline Safety Regulations, Title 49, Code of Federal Regulations. TGP received the NOPV May 27, 2008. This letter and its exhibits comprise our response to the captioned NOPV. This response is formatted to correspond with the items in that NOPV. Text inserted from the NOPV document are shown within quotation marks.

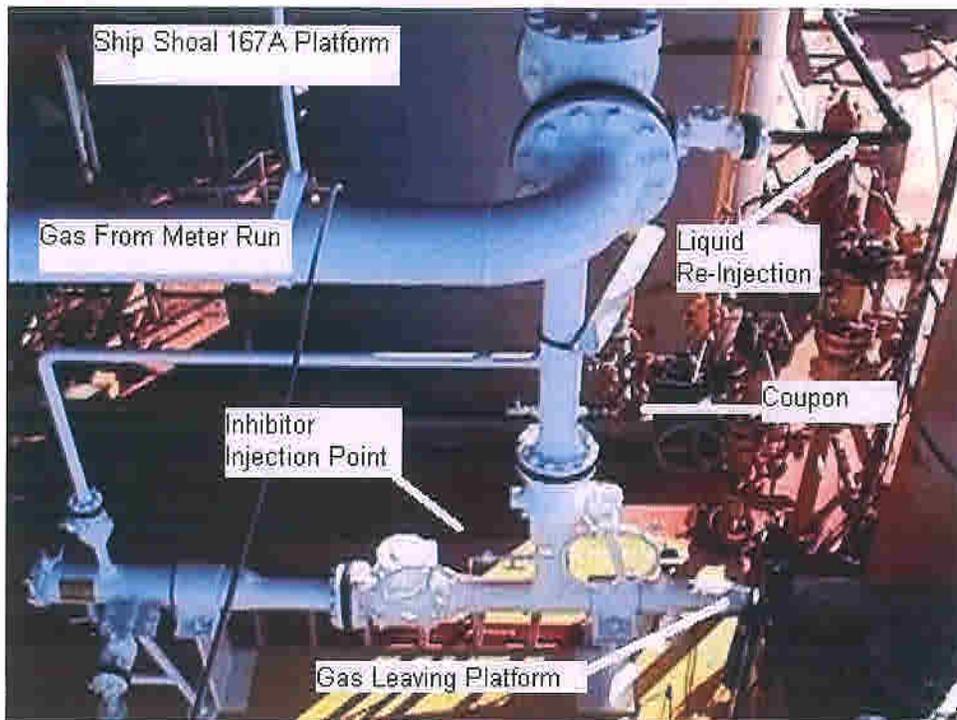
“During the inspection it was observed that TGP’s coupons used to investigate internal corrosion are not always placed in effective locations. It is unlikely that installations such as can be found on platform Ship Shoal 167A (where the coupon is held off to the side of a vertical riser) will be able to provide meaningful results. The coupons should be placed such that they are near the area where corrosive constituents accumulate most (bottom of the pipe).”

- At Ship Shoal 167A platform, see Figure 1 below, TGP has a common offshore configuration where gas and hydrocarbon liquids (free water is removed from the hydrocarbon distillate) are separated on a production platform, measured, and recombined to bring the product to onshore separation facilities.

- The coupon in this instance is located upstream of chemical injection to evaluate the corrosivity of the gas/hydrocarbon mixture. This coupon location being a *detection* location is evaluating the corrosivity of the product (gas and hydrocarbons) coming into the system at this platform.

- The coupon has been placed in a worst case scenario for monitoring corrosion by installing the coupon in a sample chamber to collect liquids. If water is in the hydrocarbon phase, the stagnant conditions in this chamber will allow the water to separate at the coupon.

- This is the most opportune location on the platform to measure the corrosion potential of the commingled liquid prior to chemical injection and pigging operations. These conditions exist over only 4 ½ feet of piping which is all in the vertical position. For a two-phase pipeline this location with the liquid product flowing downward provides useful information on the corrosivity of the gas-liquid stream.
