Black Marlin Pipeline Company
2800 Post Oak Blvd
Houston, TX 77056
(405) 626-1785

November 29, 2018

Re: CPF 4-2018-2002

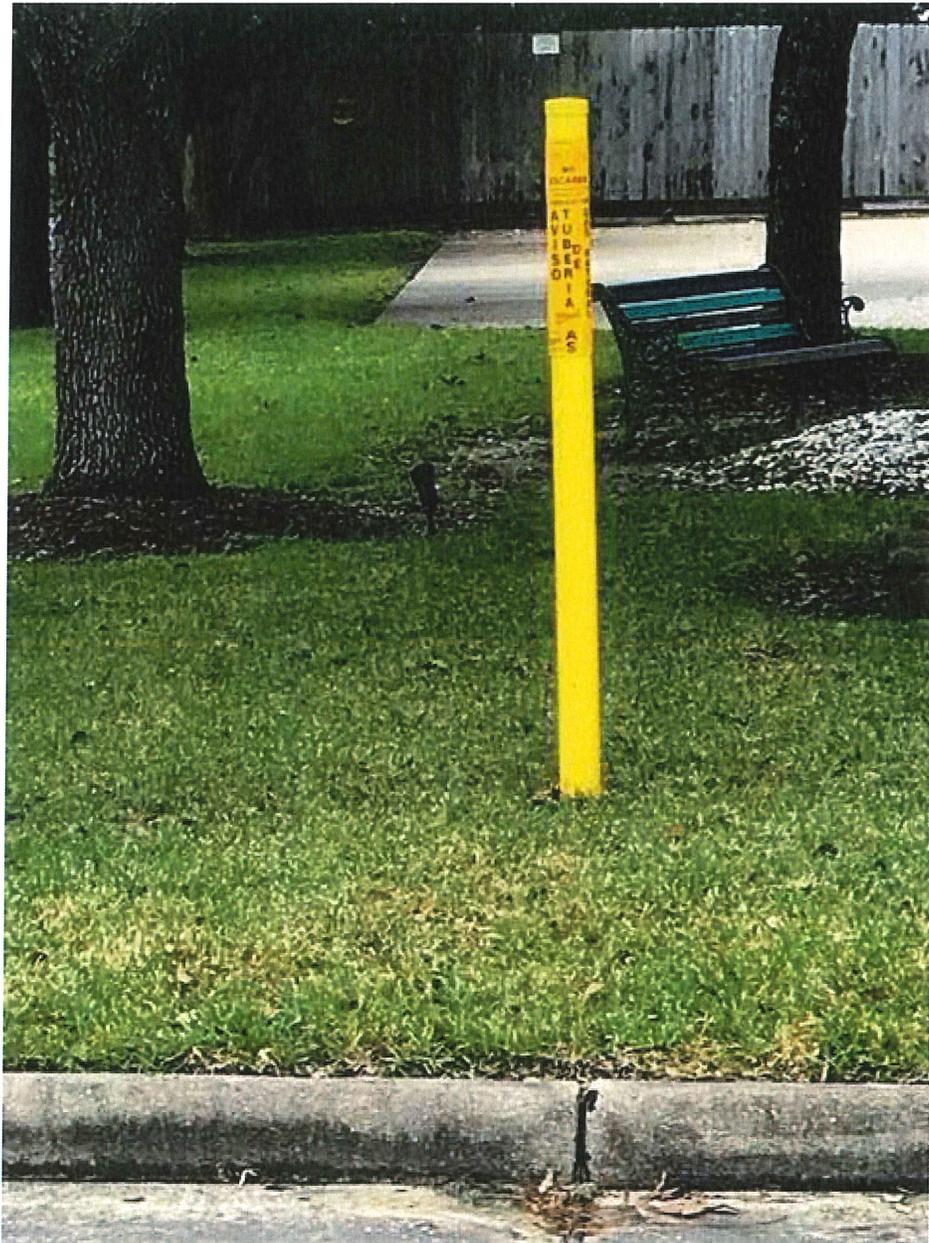
Pelican Harbour Subdivision Line Marker Photograph.

PHMSA alleges that Black Marlin failed to place and maintain line markers that meet the requirements of §192.707(d), specifically there was no line marker at the entrance to the Pelican Harbour Subdivision but the marker was placed on the fences of the residents on the corner. The line markers for the Black Marlin Pipeline were not visible to the public.

Proposed Compliance Order: Black Marlin should place and maintain adequate line markers in the referenced area.

Black Marlin has installed line markers in the area as referenced by the enclosed photographs.
