TRANSMONTAIGNE OPERATING COMPANY LP

RE: CPF 4-2019-5024

Incorrect Classification of Anomaly as 180-day Dig:

The anomaly in question is on the 8" Diamondback Line. It was reported by the Enduro in-line inspection (ILI) run of April 21, 2011 as a 43% external metal loss anomaly. The report is available upon request.

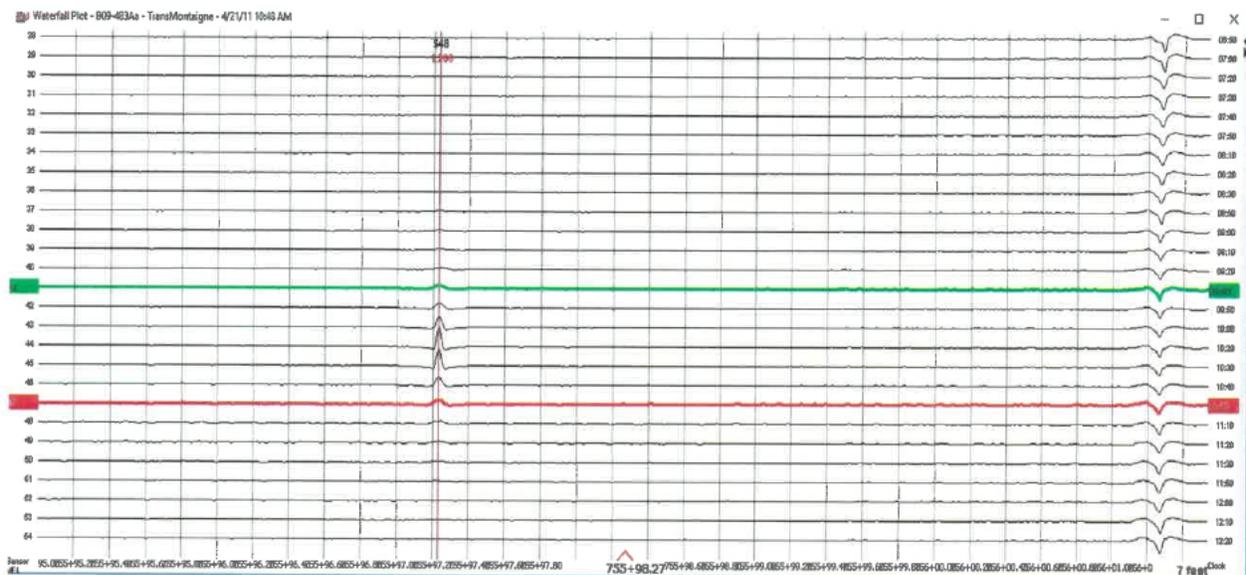
TransMontaigne requested that Rosen and Enduro each generate a “magnetogram” (as part of the analytical and grading process) of this anomaly and the girth weld downstream of it. The “magnetograms” prepared by each were a match illustrating that the location, shape and dimensions had basically not changed, allowing TransMontaigne to reach the conclusion that this was the same anomaly and that it had not grown in size. The same anomaly was graded, and graded conservatively, by the ILI service providers. This was further validated by Rosen communicating that the sharp, well-defined edges of this anomaly caused the pointed amplitude on the “magnetogram”, which can subsequently result in conservative grading of the depth of the anomaly. Since it had been properly repaired in 2011 the evidence illustrates it did not continue to grow. Accordingly, TransMontaigne concluded that it was not necessary to investigate this anomaly again as part of its’ 2016 8” Dig Program. The “magnetograms” are provided below as Figures 1 (Enduro) and Figure 2 (Rosen).

Figure 1: Enduro 2011 ILI Magnetogram

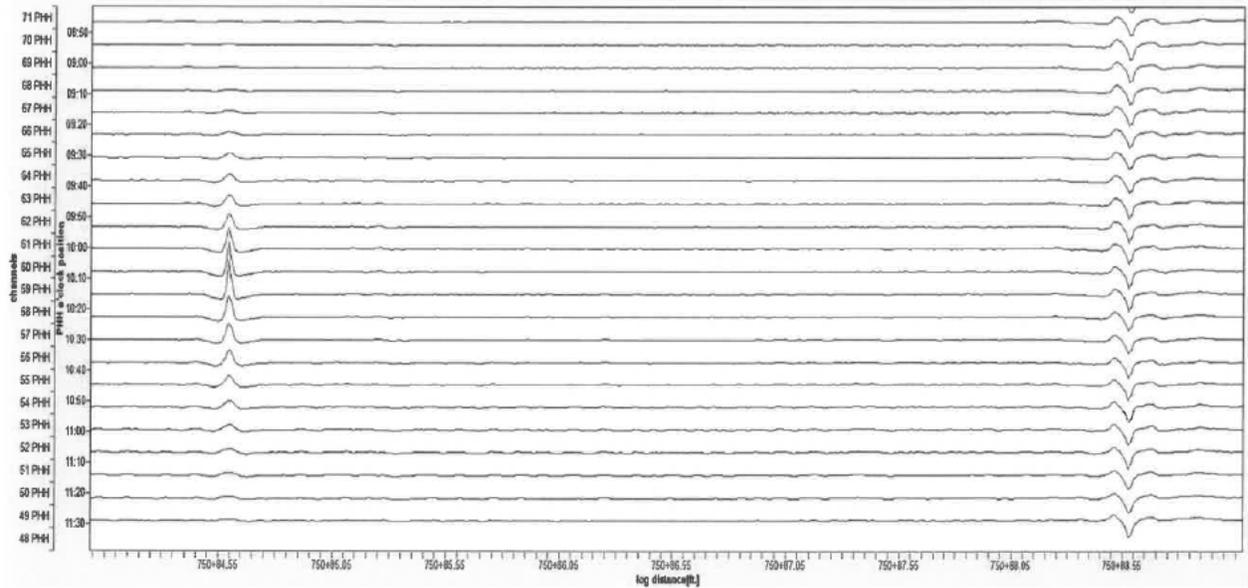
A Rosen ILI run of April 26, 2016 identified this same anomaly as a 59% external metal loss anomaly. The anomaly was initially mischaracterized as a 180-day condition.

Figure 2: Rosen ILI Run 2106 Magnetogram

The anomaly in question was initially reported by the Rosen 2016 ILI as a 59% wall loss anomaly. The anomaly was initially mischaracterized by Integrity Solutions as a 180-day condition. After additional analysis by both Rosen and Enduro, TransMontaigne was able to determine it was not a 180-day condition, but was an **isolated corrosion pit**. It should be noted that because it was **NOT** generalized corrosion as TransMontaigne's May 4, 2011 investigative dig previously confirmed, but rather an isolated corrosion pit, the anomaly was not, by definition, classified in the DOT 195 regulations as a 180-day condition, and therefore not required to be investigated. The actual definition of a 180-day condition from DOT 195.452 is as follows:

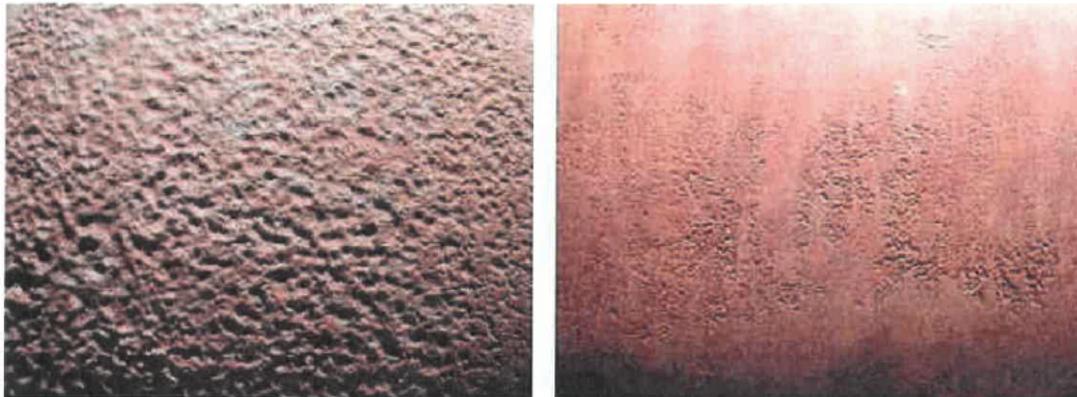
Uniform attack corrosion accounts for the greatest amount of metal destruction by corrosion, but is considered as a “safe” form of corrosion, due to the fact that it is predictable, manageable and often preventable. Examples of uniform (or Generalized) attack corrosion are depicted below:

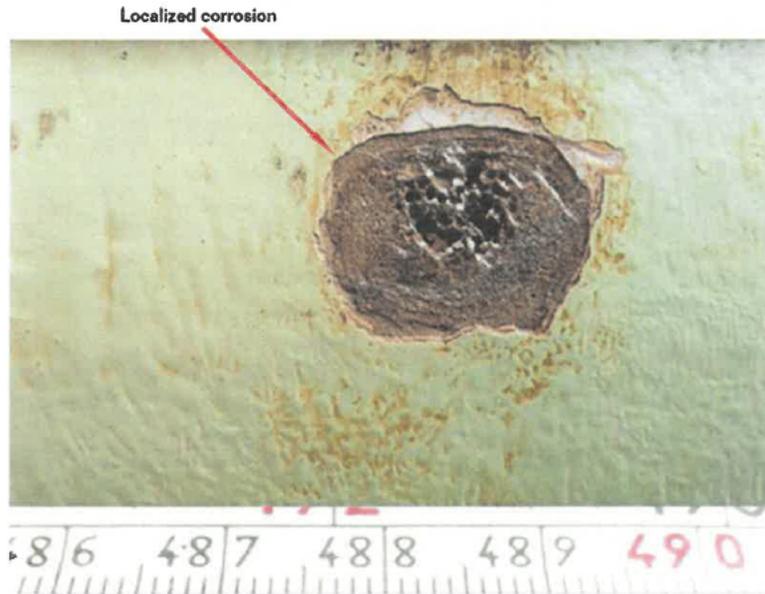
Based on accepted industry definition, we believe the identified anomaly to be an instance of an **isolated corrosion pit** as opposed to **generalized corrosion**.

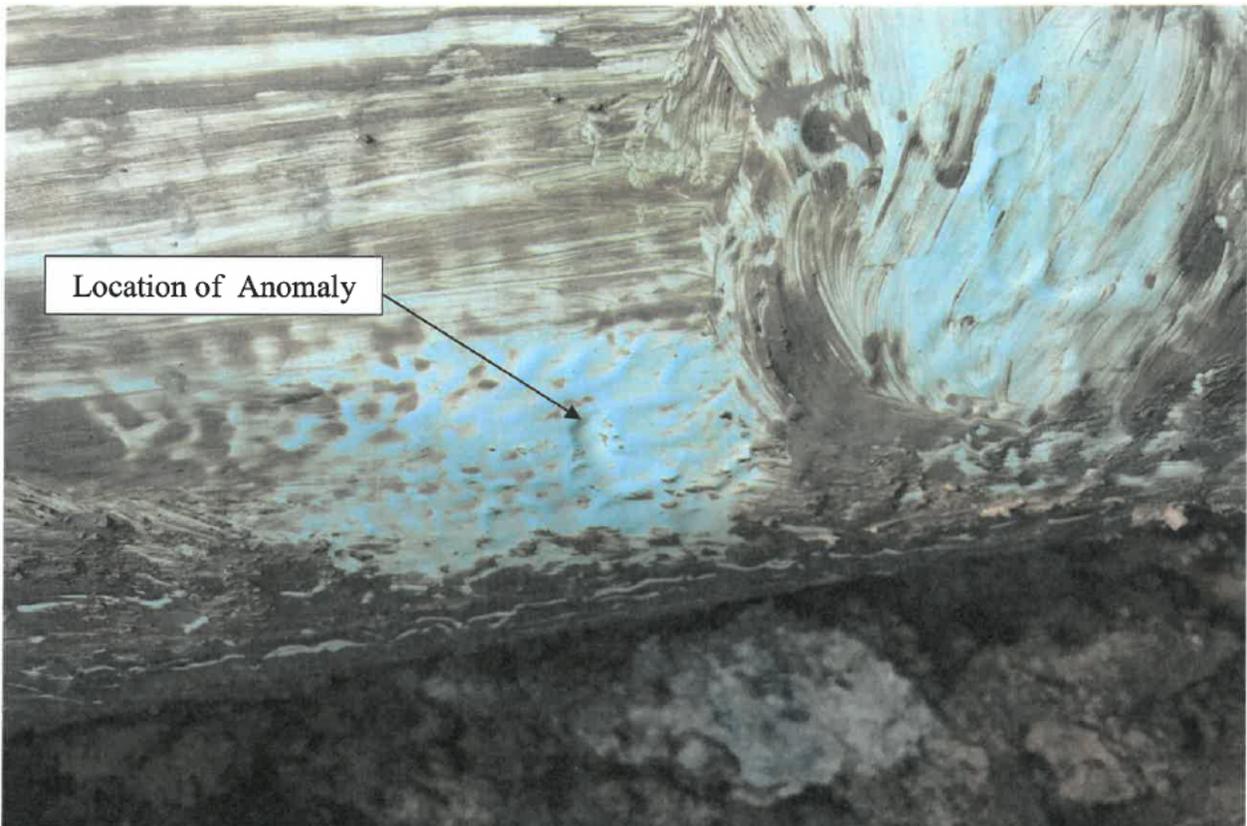
1. The coating applied in 2011 was intact and in excellent condition.
2. There was no evidence of any corrosion having taken place at the location of the anomaly.
3. The depth of the anomaly was measured as 29% wall loss.

Photograph 1: Anomaly Following 2019 Excavation and Initial Exposure with 2011 Coating Intact

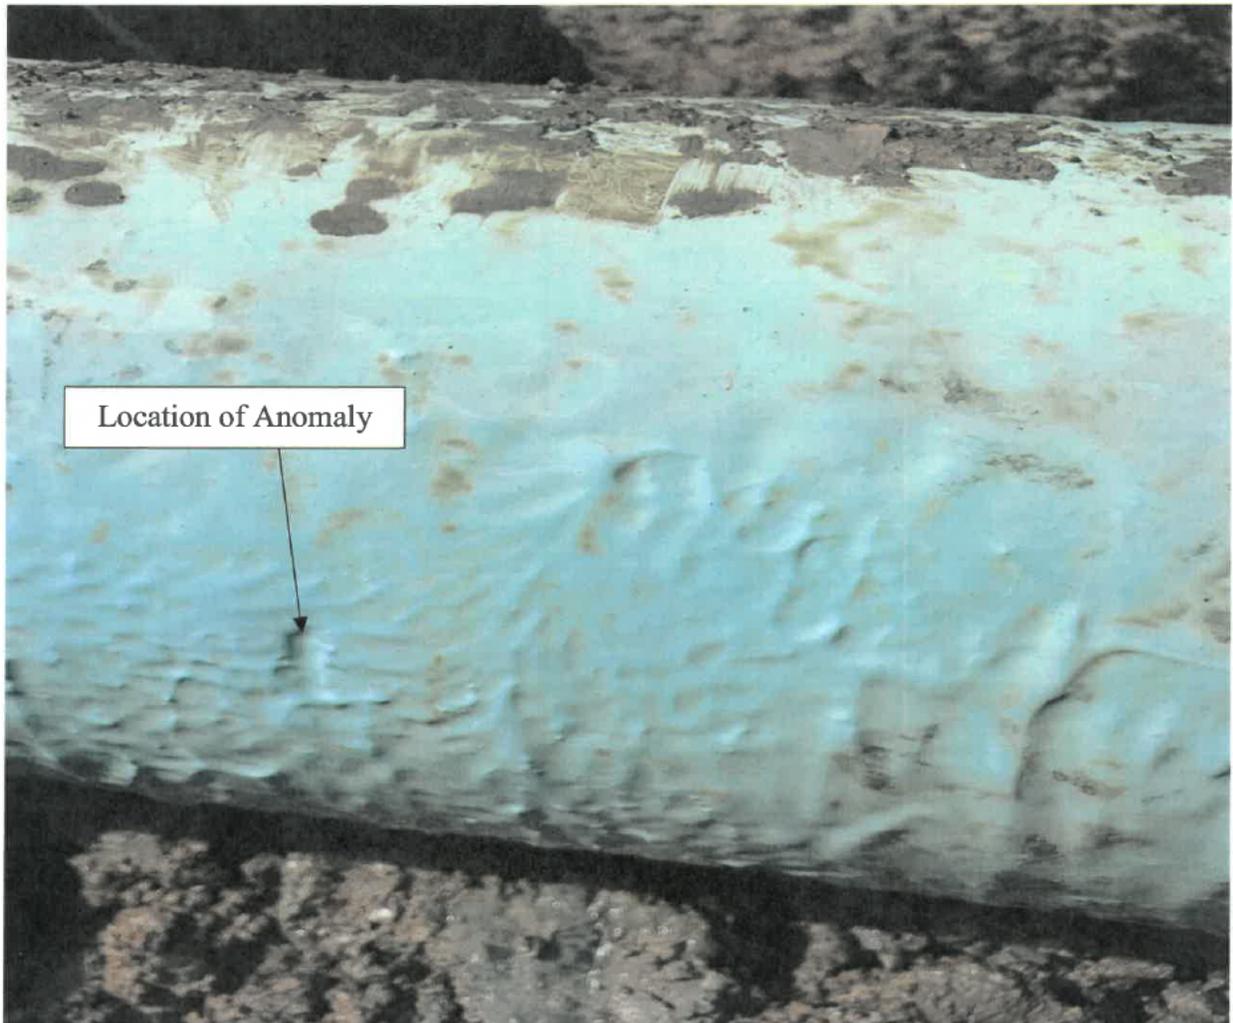
Photograph 2: Anomaly Following 2019 Excavation and Initial Exposure with 2011 Coating Intact

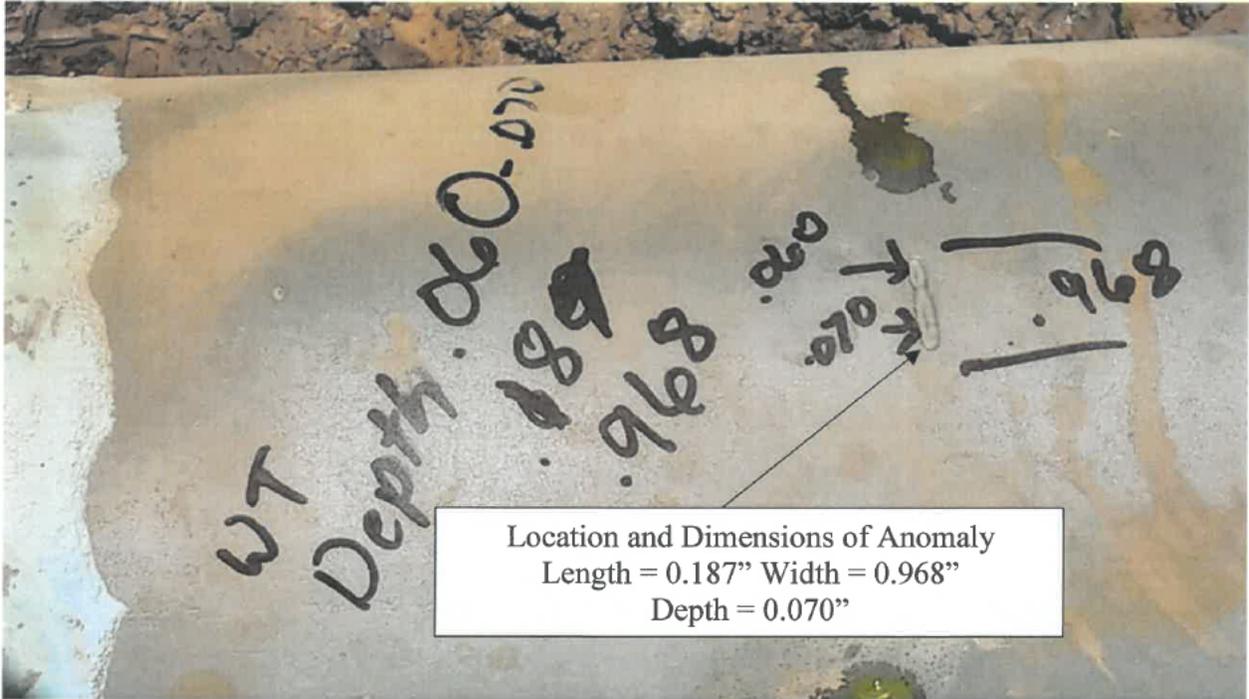
Photograph 3: Anomaly 2019 with Existing 2011 Coating Removed and Labeled

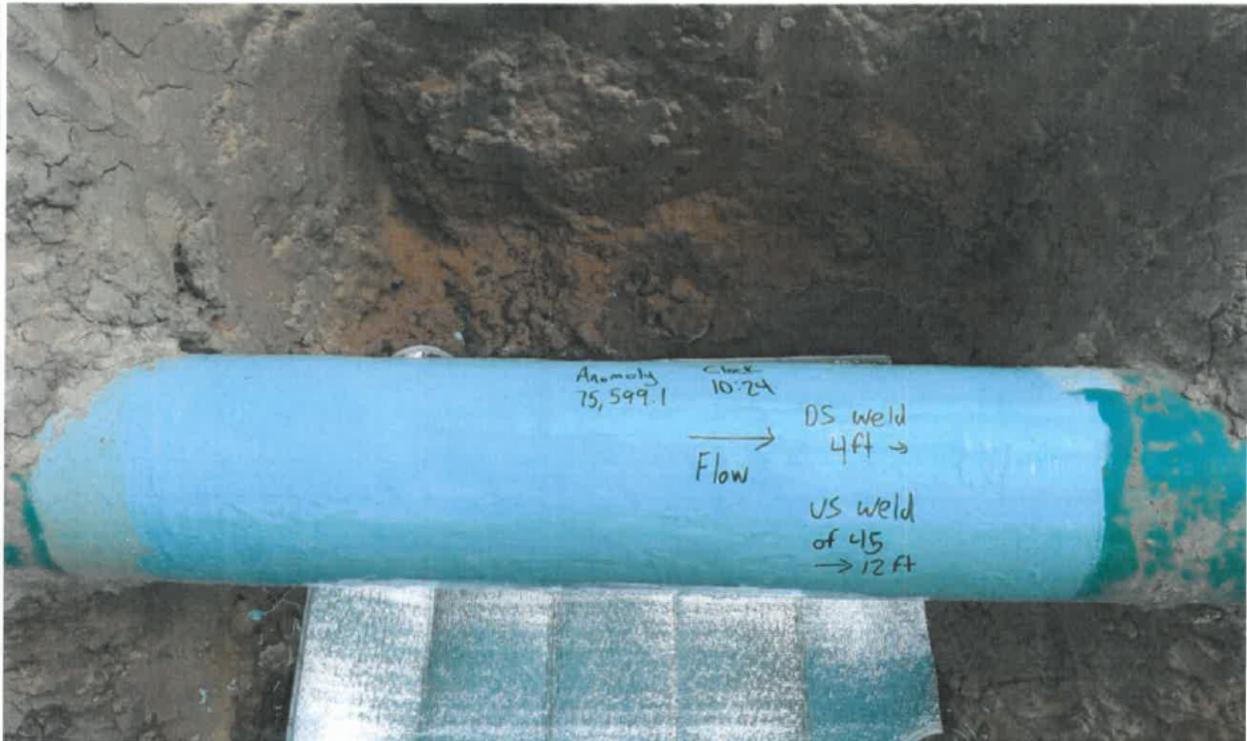
Photograph 4: Anomaly 2019 Repaired with Reference Measurements and Other Labeling

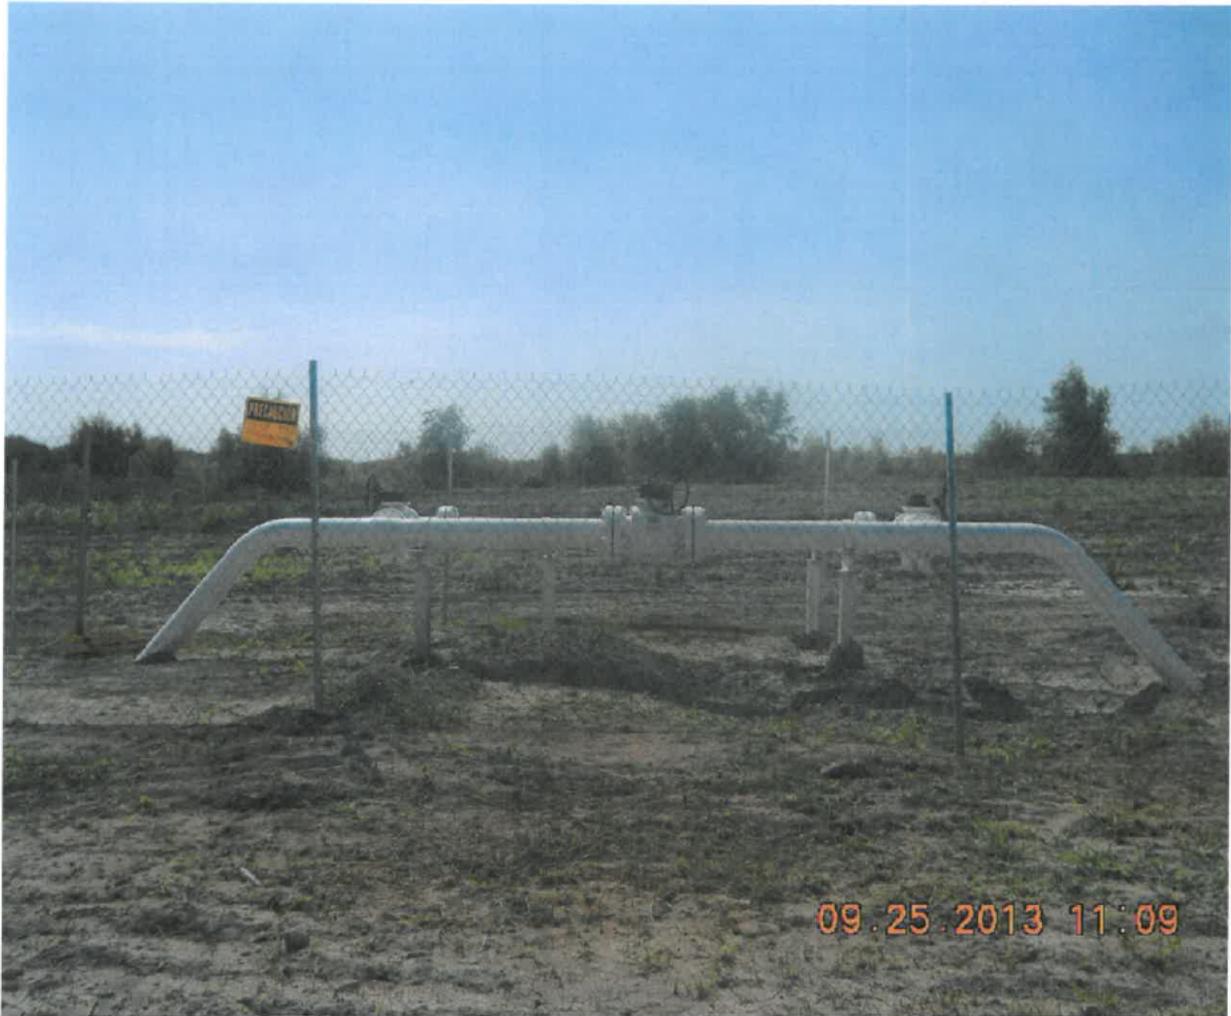
Photograph 5: Completed 2013 Additional Block Valve Installation on the 8" Line

During 2013, TransMontaigne implemented the installation of one (1) each mainline block valve on the Mexico-side of the Rio Grande River. Each valve included a piping configuration providing for metering to be installed. While not supported by an actual EFRD Study, this action represents a logical, prudent, and proactive step by TransMontaigne to improve the leak detection and mitigation capability of the pipeline.
