April 27, 2017

**RE: Notice of Probable Violation and Proposed Compliance Order – CPF 5-2017-7001
Platform Gilda, Gina and Mandalay Onshore Separation Facility (MOSF)**

Platform Gilda, Gina and Mandalay Onshore Separation Facility (MOSF)

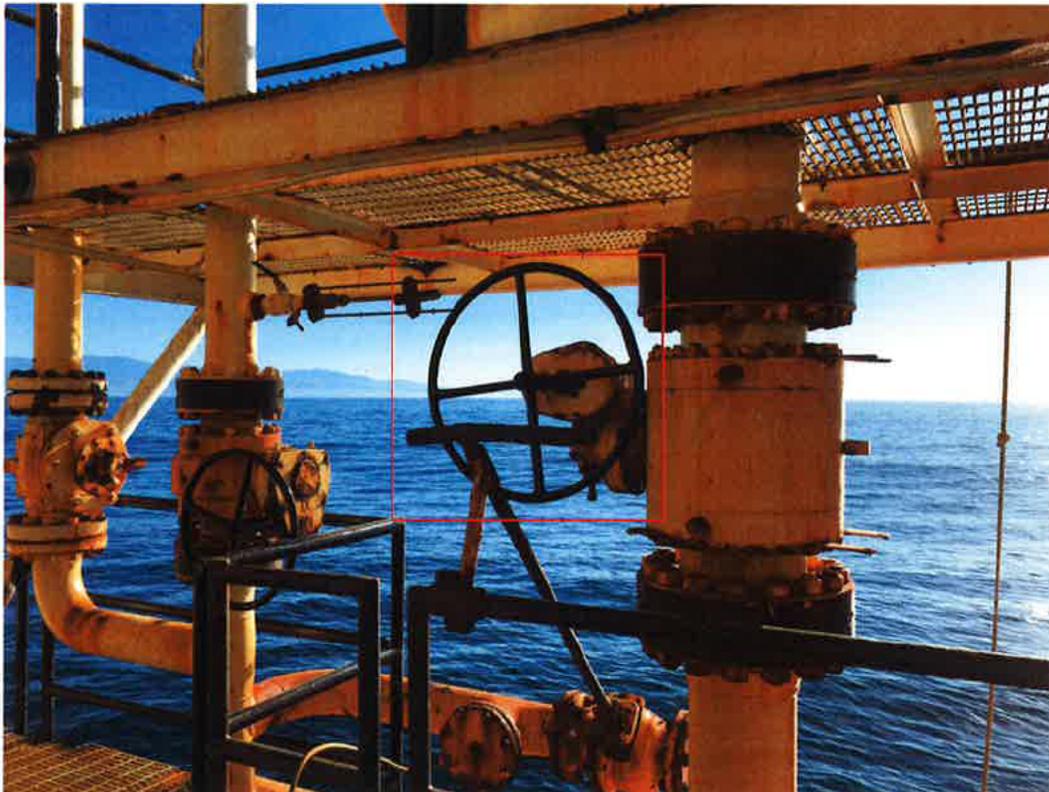
To clarify, the valve and riser in question is located on Platform Gilda's gas line, not oil line, as initially stated by the PHMSA letter.

Platform Gina – New Valve Wheel on Gas Riser

The valve handle wheel on Platform Gina's gas line was immediately replaced on January 2017. Although not a critical valve, the valve was exercised on March 29, 2017 (see **Attachment 6**) and a follow-up atmospheric corrosion inspection showed atmospheric corrosion on the valve body with no evidence of metal loss.

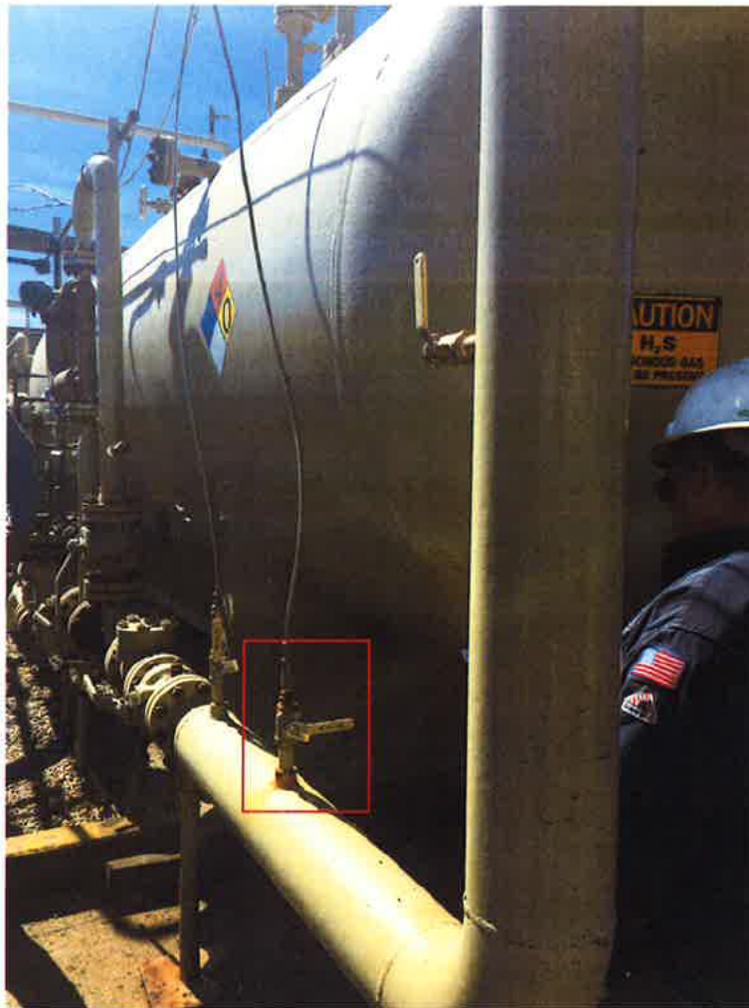
- (c) Re-evaluate the design location of the corrosion inhibitors' test point to make sure it is not in contact with the soil. Follow Procedure HL6.01 'Atmospheric Corrosion' and correct the deficiencies found;
- (d) Evaluate the integrity and inspect for corrosion activity on the flange's surface where it had metallic contact with the metal support. Follow Procedure H6.01 'Atmospheric Corrosion' and correct the deficiencies found.

Platform Gina Oil at MOSF – New Corrosion Inhibitor Location

Baker Hughes will install a new coupon on the Gina oil piping to the MOSF Gross Separator F2 by the end of July 2017 during its semi-annual inspection. The new location is downstream of the DOT shutdown valve.

The previous coupon will be removed along with the tape wrap of the Gina oil piping by June 2017.
