NORTH SLOPE BOROUGH

Re: Response to Notice of Probable Violation Proposed Civil Penalty and Compliance Order (CPF 5-2020-0010)

On November 18, 2020 the Borough Office of the Mayor received Warning Letter **CPF 5-2020-0010** from the Pipeline Hazardous Materials and Safety Administration (PHMSA) re; the Barrow natural gas pipeline and Nuiqsut natural gas pipeline. The warning letter, points to PHMSA inspections completed with date references of December 9 through 13, 2019 and March 10, 2020. PHMSA writes it is alleged the Borough committed "probable violations" and cites the following under the Code of Federal Regulations, and in which the Borough issues the following replies:

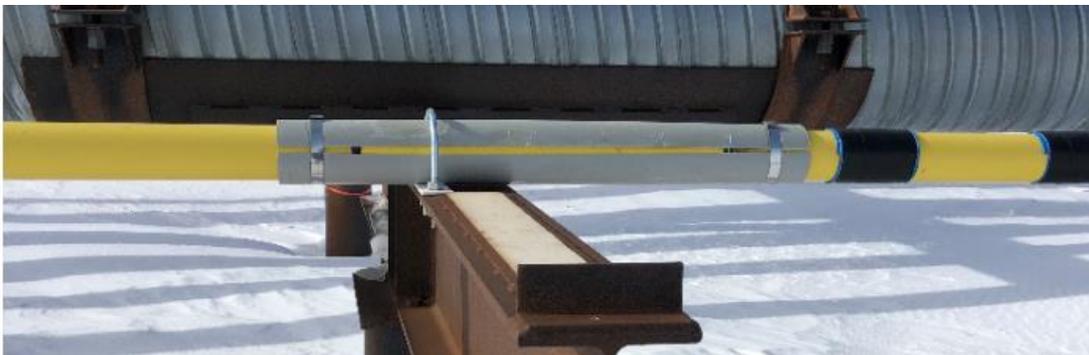
Response: The North Slope Borough repaired coating damage on the entire above-grade section of the pipeline with the exception of a short section near the HDD above-to-below grade transition. The repair methodologies at all of the other VSN & HSMs consisted of repairing any coating damage and encapsulating the pipe in a fiber reinforced polymer (FRP) wear guard to protect the coatings from future damage (see photo below).

The wear guard materials installed in 2018 are non-conducting and provide mechanical and electrical isolation between the pipe and support components (horizontal members and U-bolts).

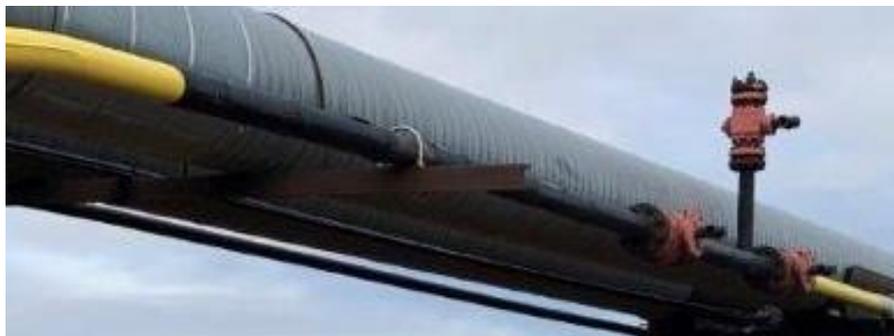
The only support not addressed in this manner is the last HSM immediately adjacent to the soil/air transition at HDD. (below).

This coating repair, inspection and mechanical protection procedures used in 2018, will be utilized to address the lack of isolation at the HSM near the HDD Site. This will be completed within 180-days. The Borough will provide records to the Director within 30-days of construction completion.

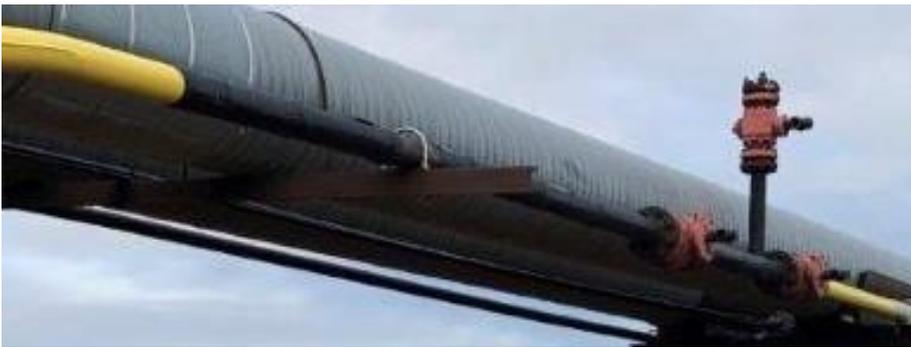
Response: With the exception of a short section of piping adjacent to the HDD aboveground to belowground transition (shown below), the North Slope Borough repaired all damaged coatings on all piping in the aboveground section of the Nuiqsut Pipeline in 2018.

This area adjacent to HDD, is the same area mentioned in Item # 4 (above). As stated in Item # 4, that area will be stripped, cleaned, inspected, documented and recoated with 180-days (in the winter of 2020-21).
