## BUCKEYE PARTNERS, L.P.

### REFERENCE: CPF No. 1-2009-5002

Having conducted a full review of your concerns and our applicable records, this letter is provided as Buckeye's response to the NOPV & PCO.

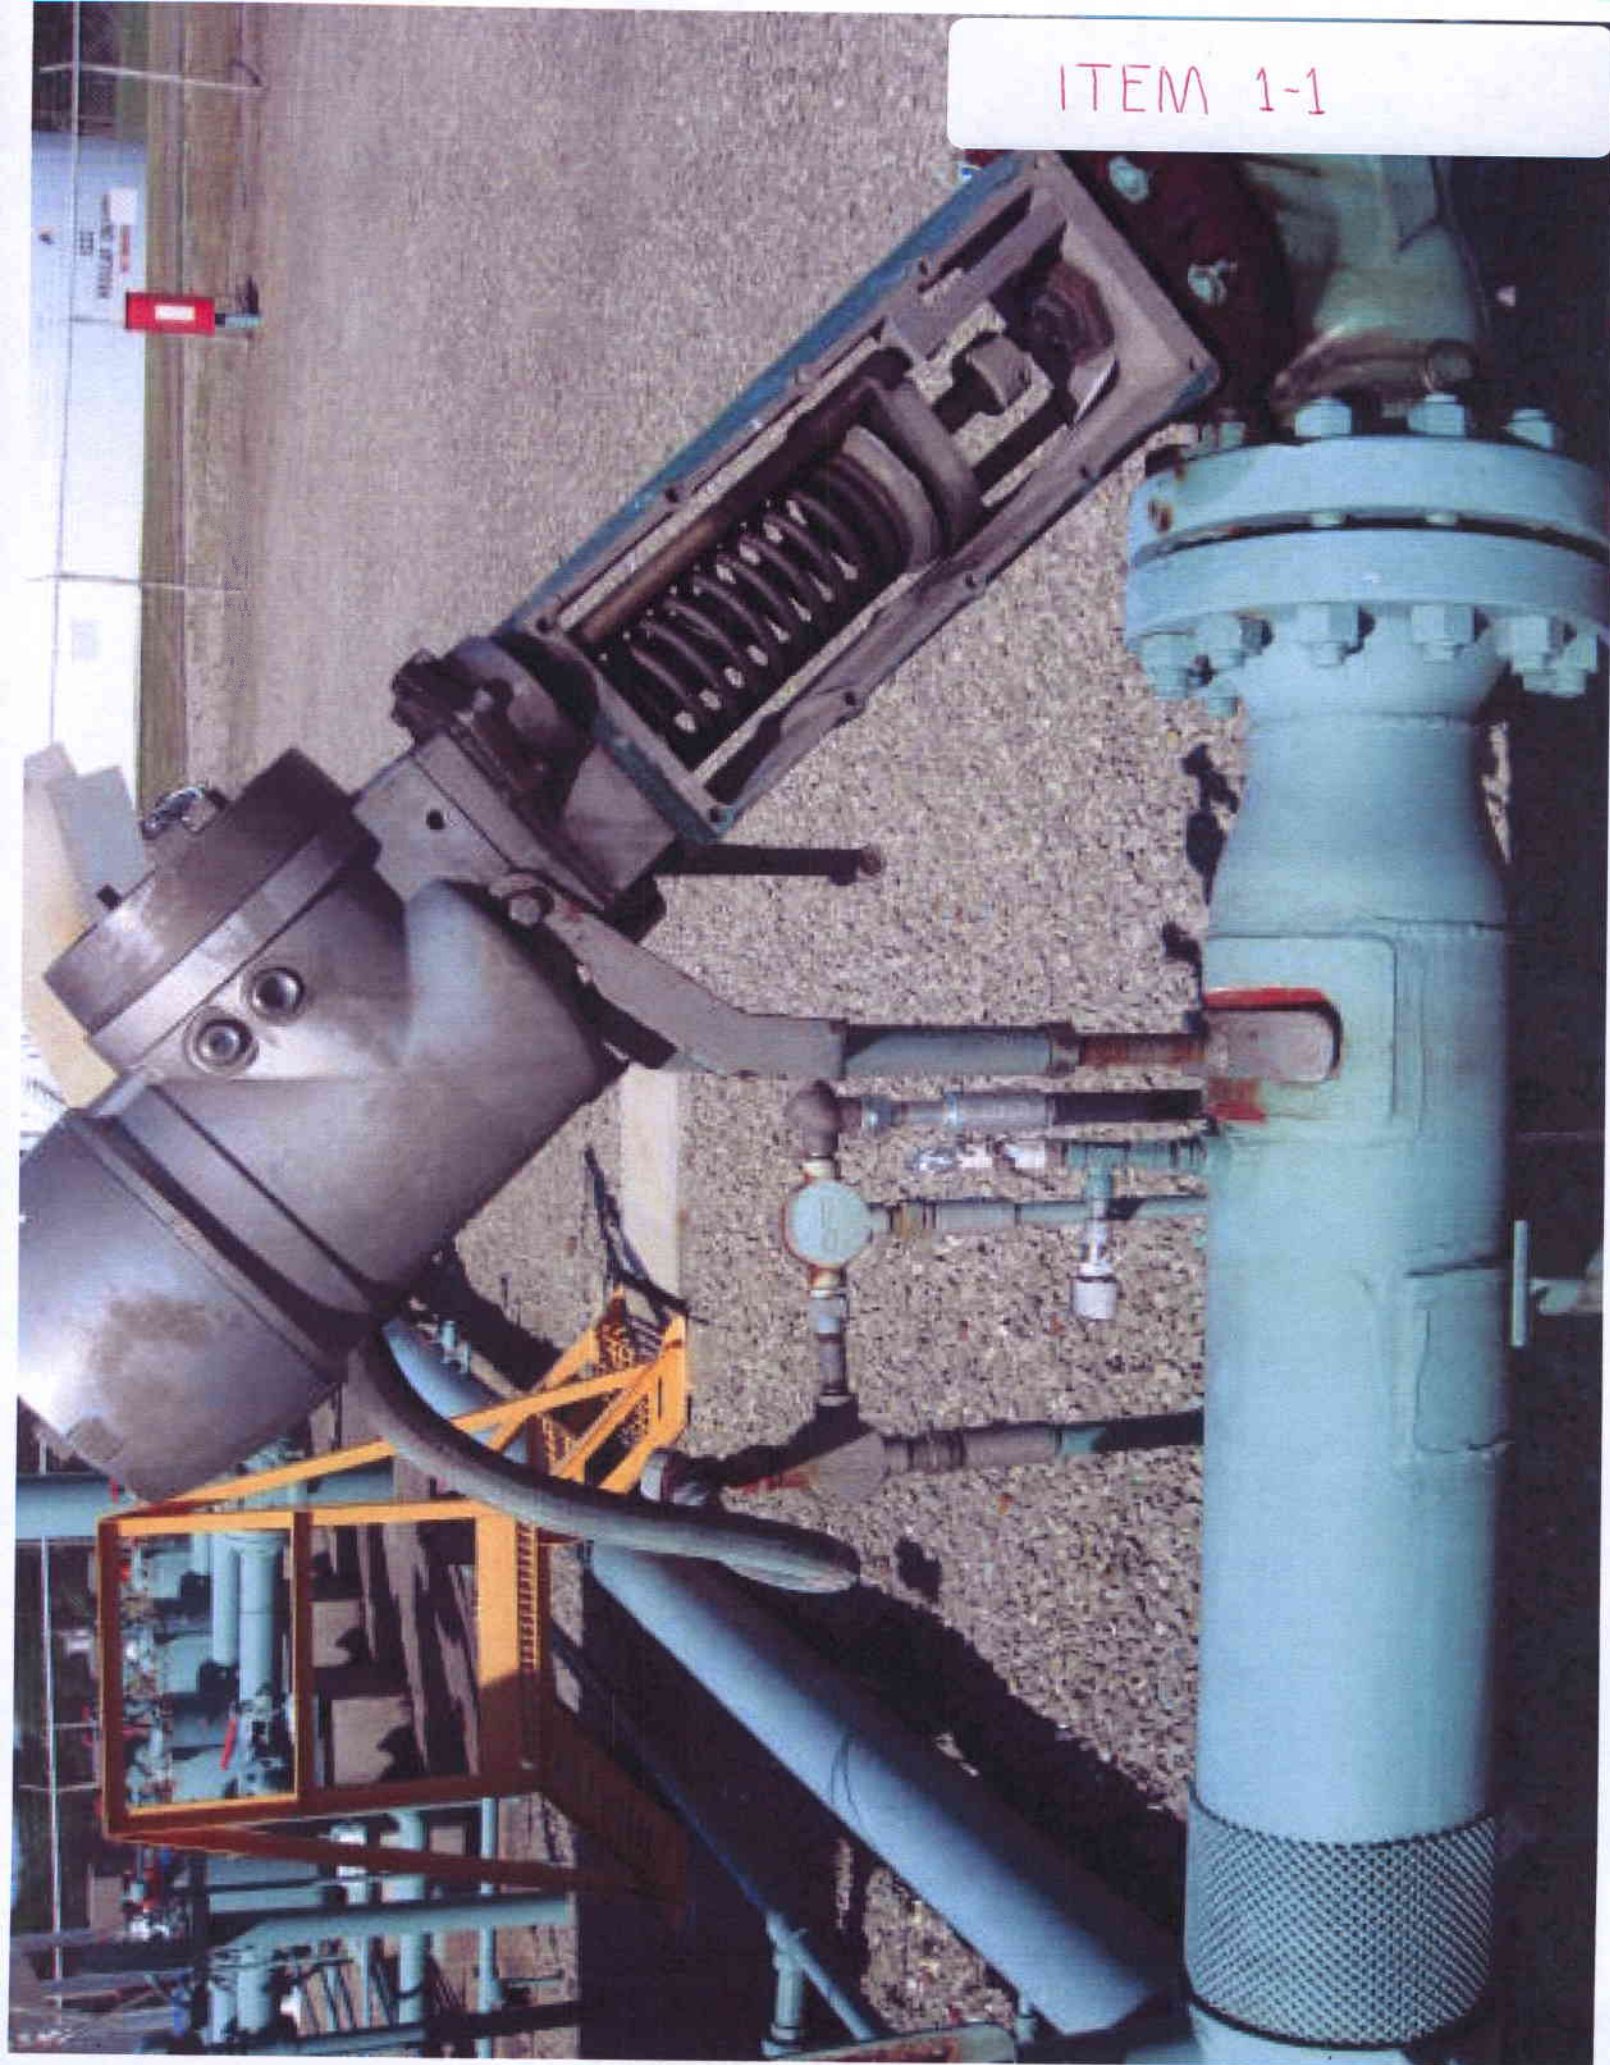
ITEM 1-1

*The inspection team discovered that 1) a block of wood was being used as support for a control valve in the Greensburg Station; 2) a support device at a tank farm in Toledo, Ohio was installed on the 16-inch manifold where pipe modifications had been made, but no associated concrete foundation was present under the pipe support; 3) at the Malvern Station, the pipeline was found to be in contact with a cutoff section of pipe near a line tank; and 4) at the Greensburg Station, the pipeline was found to be in non-intentional contact with a concrete block at the pig receiver. Buckeye failed to correct these adverse conditions within a reasonable time, as required by the regulation*

**Buckeye's Response:** Proper supports have been installed at Greensburg Station and Toledo Tank Farm. The pipe that was in contact with a cutoff piece of pipe at Malvern Station has been corrected. At Greensburg Station, the concrete block was cut back to provide several inches of clearance. When the block was cut away, it was determined that the concrete was not in direct contact with the pipe. All of the above items have been addressed and corrected (photos enclosed).

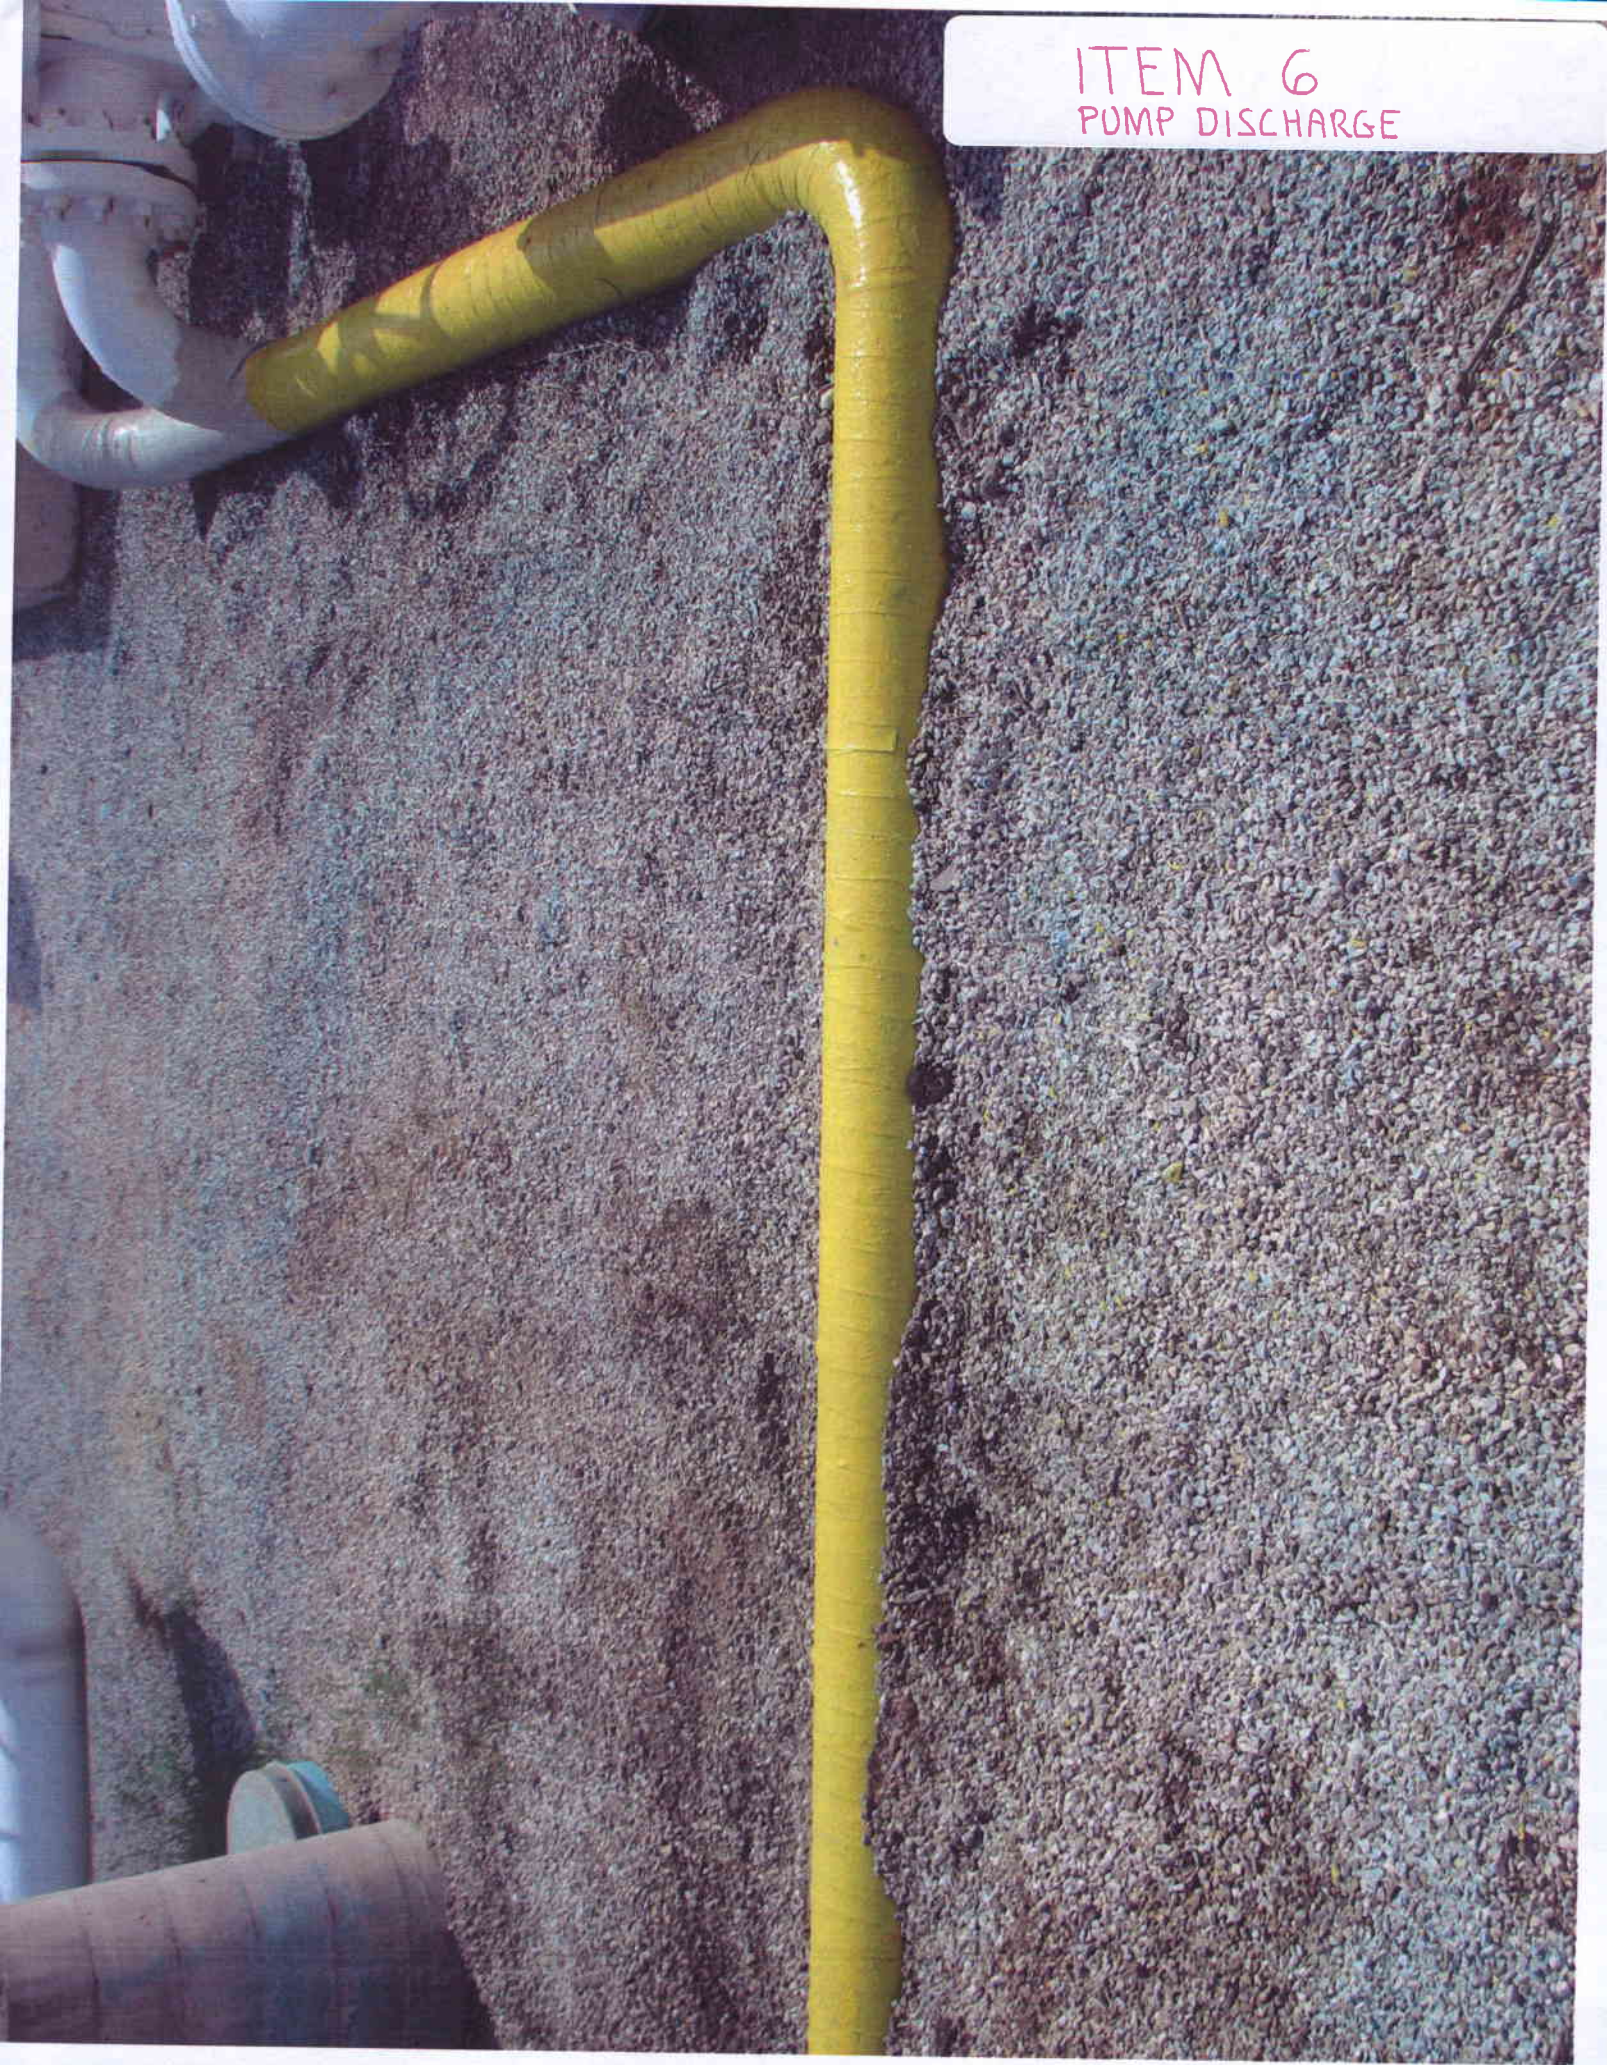
ITEM 6  
PUMP DISCHARGE

*At the time of the inspection, soil-to-air interface on the 301 Line pump discharge pipe and two sample lines at the Toledo Station in Ohio were not coated as required by the regulations.*

**Buckeye's Response:** Buckeye had identified these locations for remediation as part of the Facility Assessment program, which included a prioritized repair schedule. These locations had not been repaired prior to the Integrated Inspection but were corrected as part of the planned work in 2009 (photos enclosed).
