Columbia Gas Transmission LLC

**RE: Response to Notice of Probable Violation and Compliance Order CPF 3-2015-1007**

This letter is provided on behalf of Columbia Gas Transmission LLC (Columbia Gas) in response to Notice of Probable Violation, CPF 3-2015-1007 ("NOPV"), dated May 28, 2015 and received by Columbia Gas on June 8, 2015. The NOPV was issued following inspections conducted by the Ohio Public Utilities Commission between January and August of 2014 of Columbia Gas facilities in Ohio. The NOPV alleges violations of certain provisions of the natural gas pipeline safety regulations and proposes a compliance order.

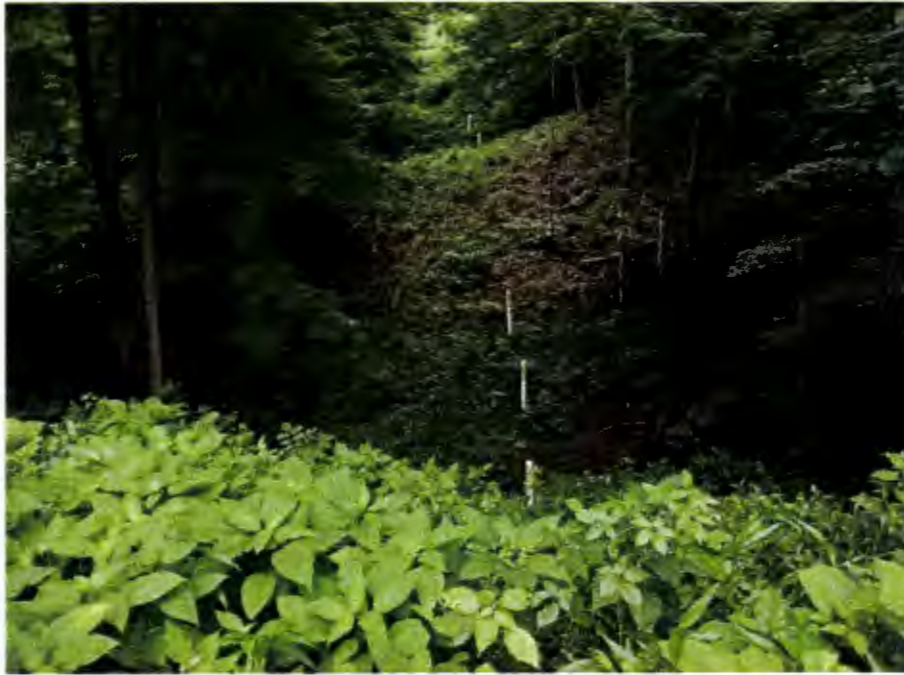
During the field review of Line V-138, two aboveground exposures were observed. The exposures are not located in a restricted area and are accessible by the public. Neither of the exposures had any line markers near them. The exposures noted are as follows:

Line V-138 Exposure - Asset 1369681- Photo Showing Line Markers

Columbia Gas confirmed that line markers were installed at both exposure locations listed above following the 2014 inspection. Photographs confirming installation of line markers at these locations are included in Attachment B.

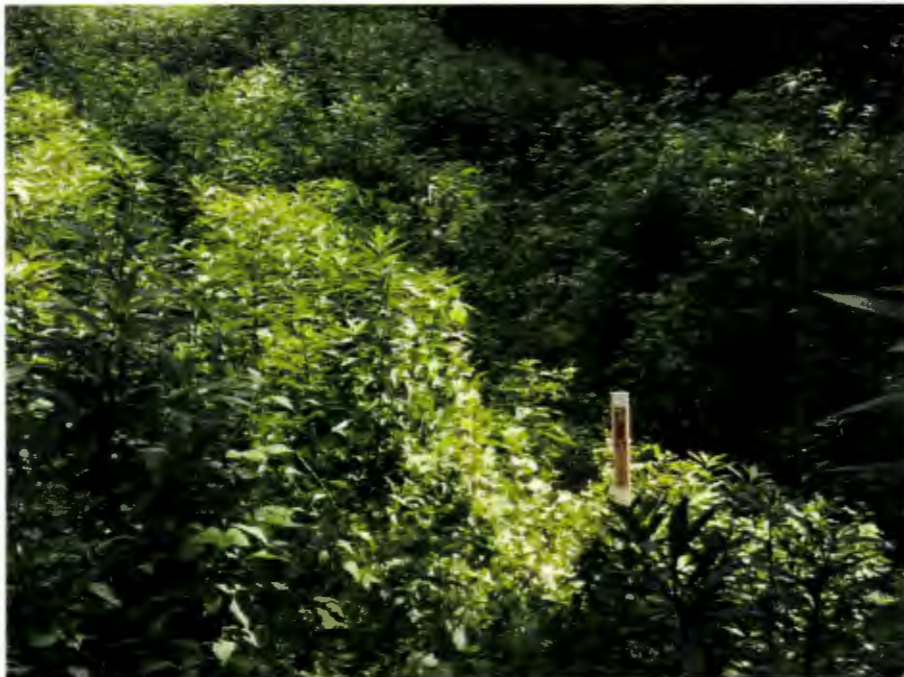
Line V-138 Exposure - Asset 1370688 - Photo Showing Line Markers
