March 11, 2021

**Re: CPF 3-2021-5002**

In response to the above-referenced Notice of Probable Violation, Proposed Civil Penalty and Proposed Compliance Order (NOPV) dated February 10, 2021, The operators, Enbridge Storage (Cushing), LLC; Enbridge Storage (Patoka), LLC; CCPS Transportation, LLC; and Illinois Extension Pipeline Company (collectively "Enbridge") attached the following documents:

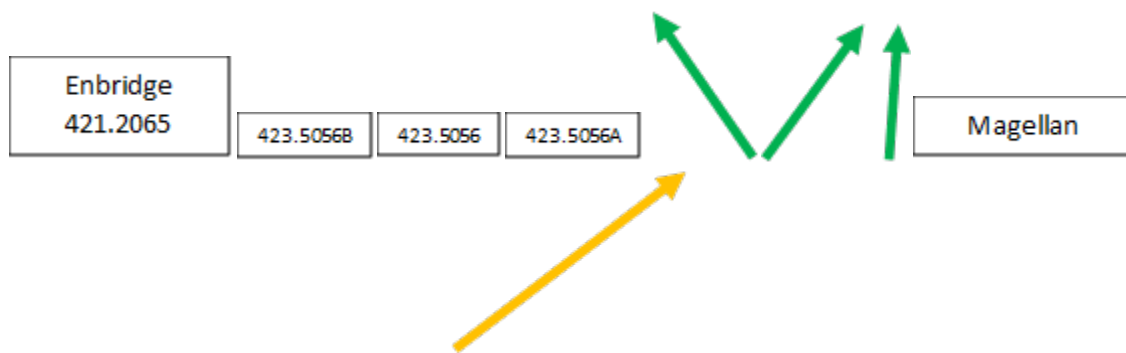
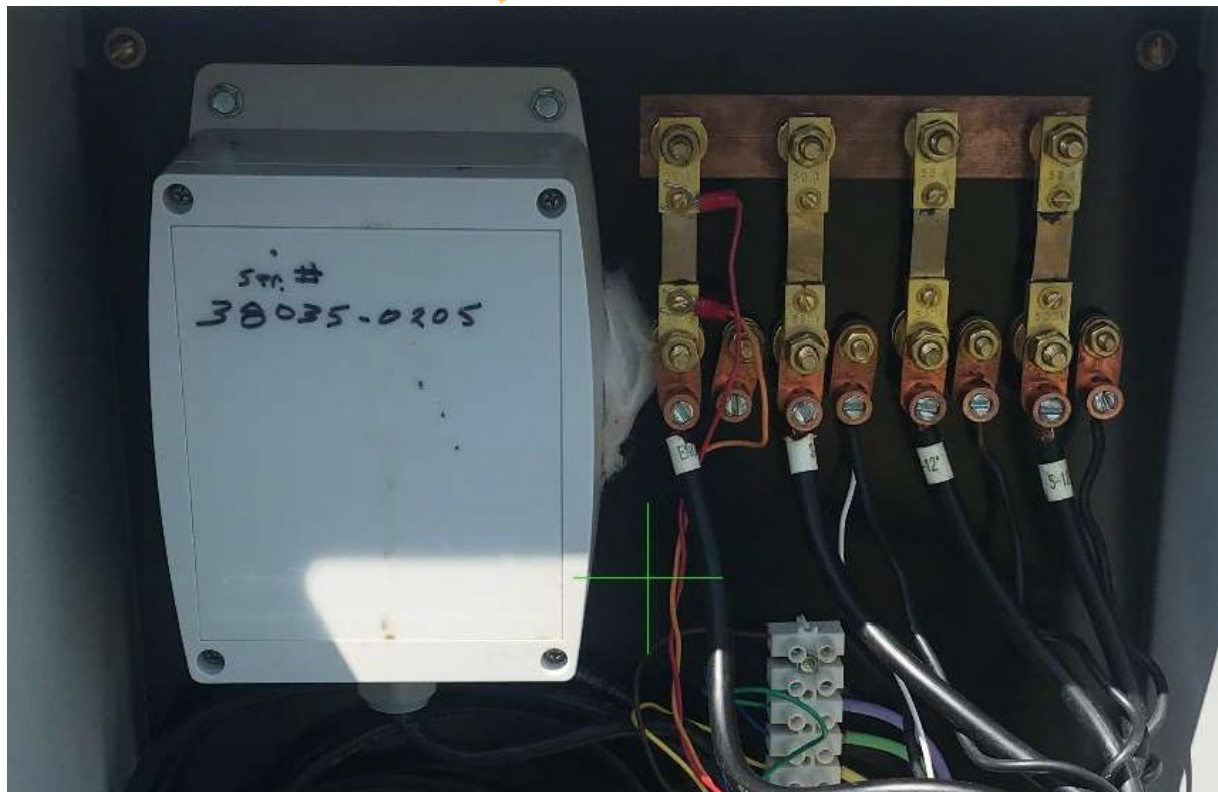
Figure 1 Enbridge Bond with Magellan MP 421.2065

*Bond current measurements at MP 423.5056, MP 423.5056A and 423.5056B were incorrectly identified as “Critical” bonds in the PCS database where Enbridge records cathodic protection data. These three locations should have been identified as “Informational” bonds as they are not interference bonds between Enbridge and Magellan, but are bonds tied into a common bus bar with Magellan. These three locations are current measurements between the three Magellan structures and read for informational purposes only.*

*There is one single bond tied into a common bus bar with the Magellan Lines 3, 4 and 5 at milepost 421.2065 that is currently identified as “Critical” and measurements recorded on at least on a bi-monthly basis. The bond is pictured below:*

*This bond is equipped with a remote monitoring unit that automatically records bond measurements on a scheduled basis. This bond was considered “critical” between 2017 and 2018 and bond measurements were recorded bi-monthly. Prior to 2017 the bond was not considered “critical” and only monitored at least annually.*
