FINAL REPORTGTI PROJECT NUMBER 20385

Plastic Pipe Failure, Risk, and Threat Analysis

DOT Project# 194

Contract Number: DTPH56-06-T-0004

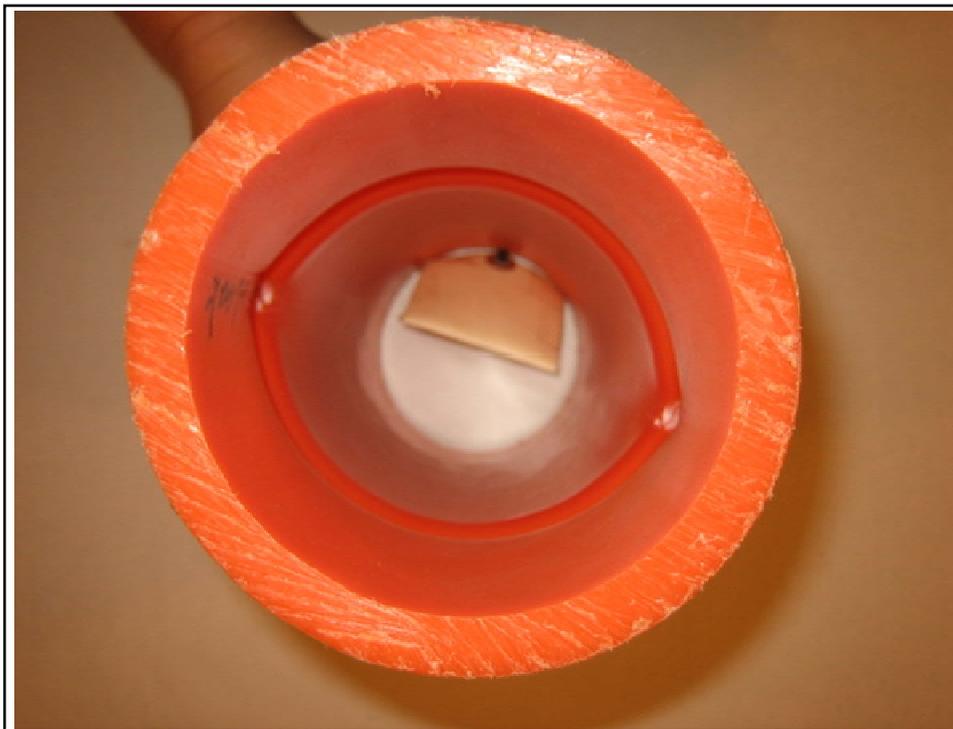
Figure 34. MDPE Pipe that Failed in Field Service Due to a Squeeze-Off

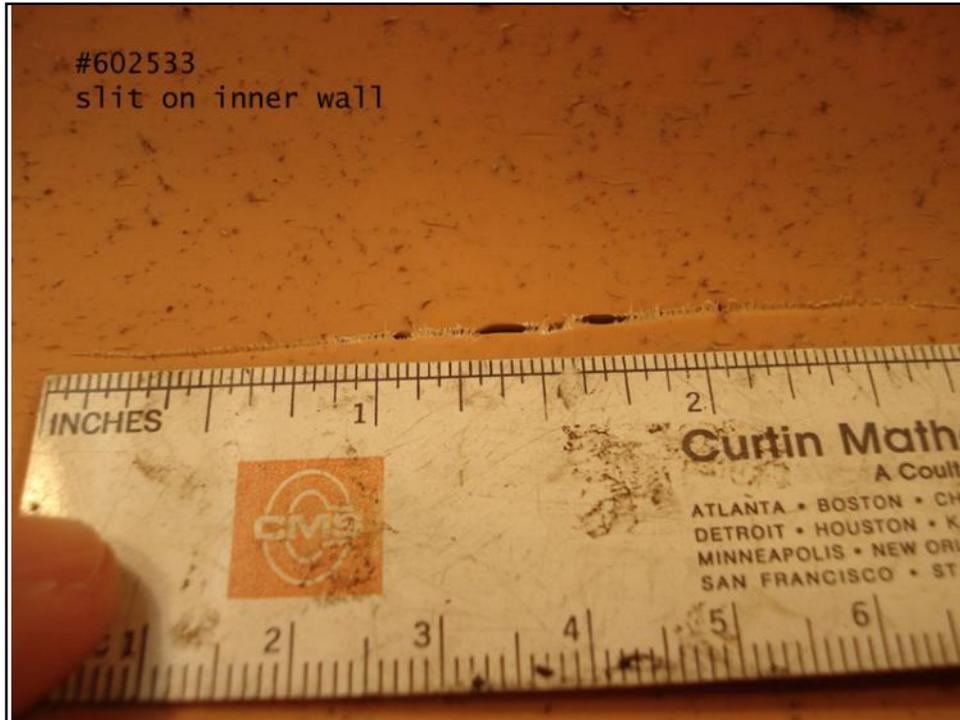
Figure 62. Slit Failure Growing Away From Impingement Point

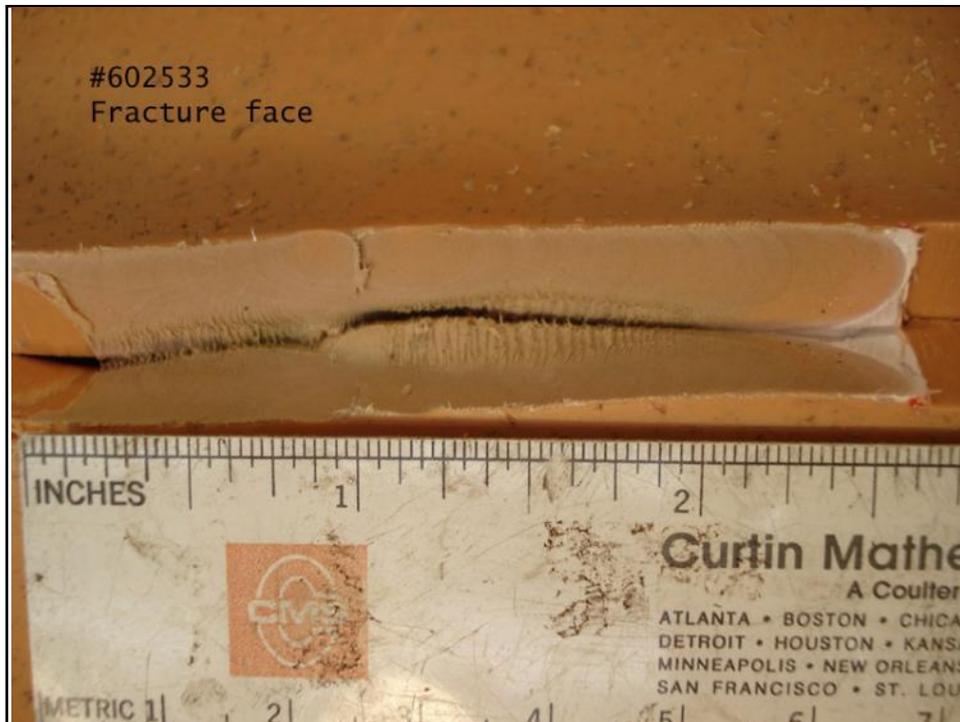
Figure 65. Close Up View of the Fracture Faces

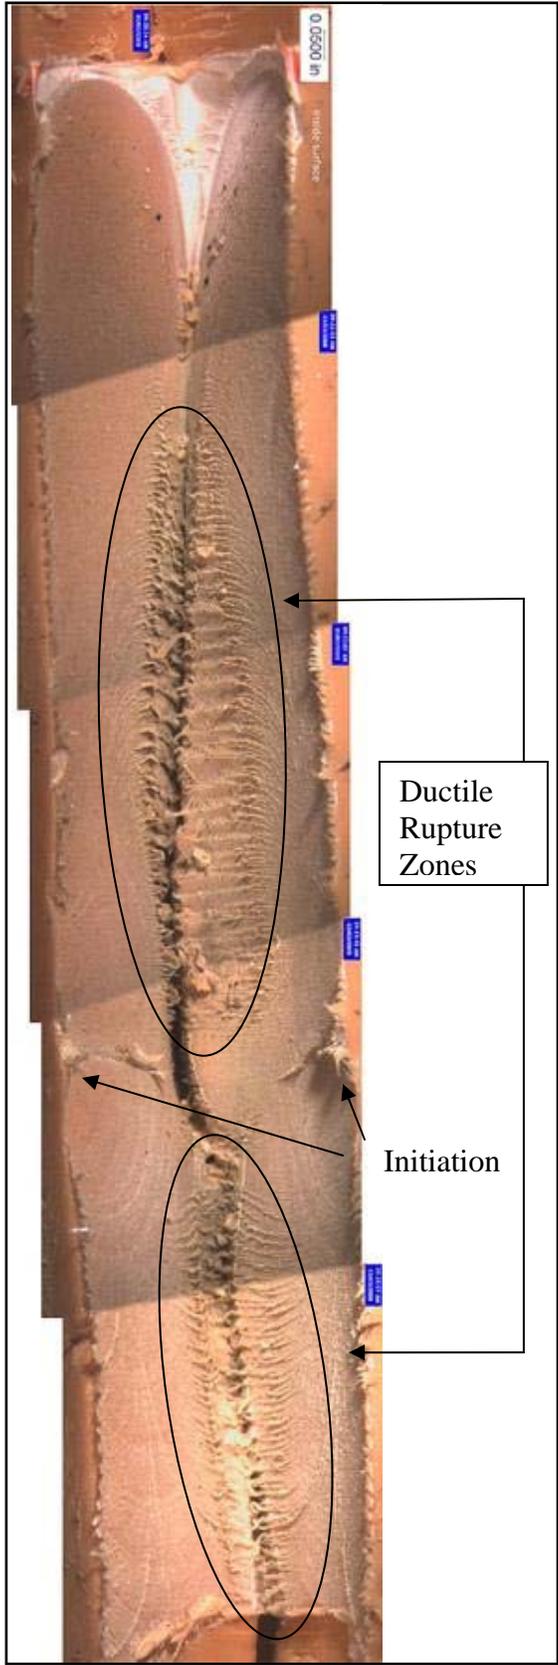
Figure 66. Microscopy

Using high powered optical microscopy, the fracture faces were examined. The photographs taken with the stereo optical microscope were stitched together and are shown in Figure 66. The initiation point is noted on the photograph and was found to be on the inner wall directly opposite of the indentation on the outer wall. The crack left visible striations as it grew step-wise from the initiation point on the inner wall to the outer wall. Two ductile rupture zones are also visible.

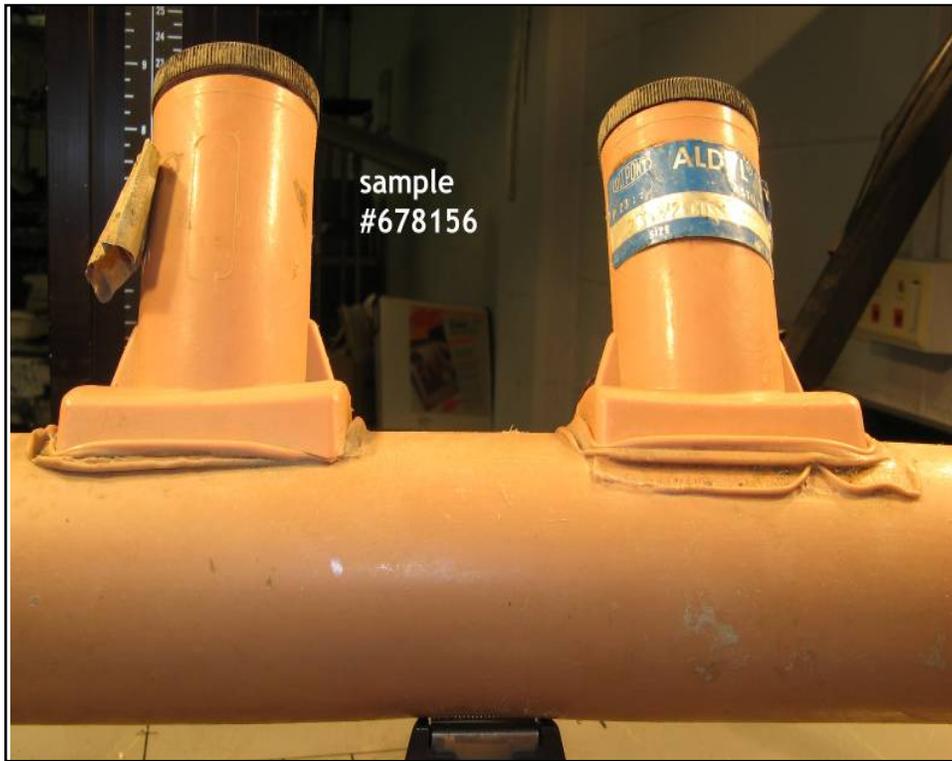
Figure 72. As Received Sample with Two Tees. Leak Occurred At Untapped Tee, Left

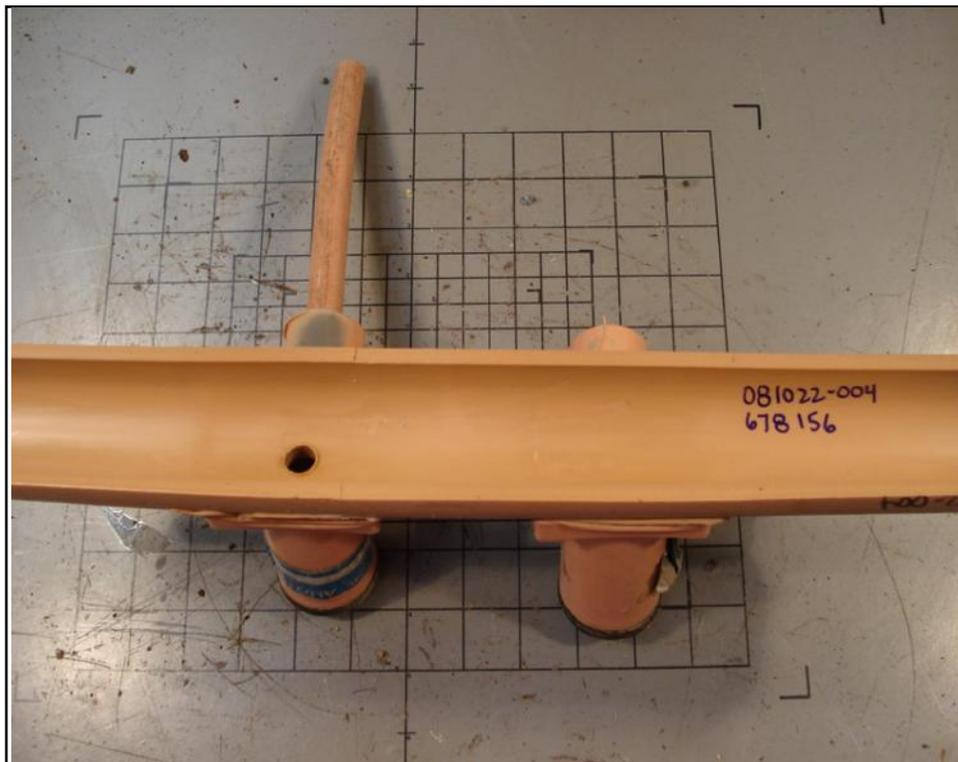
Figure 75. Sample Was Cut to Show Inner Pipe Wall

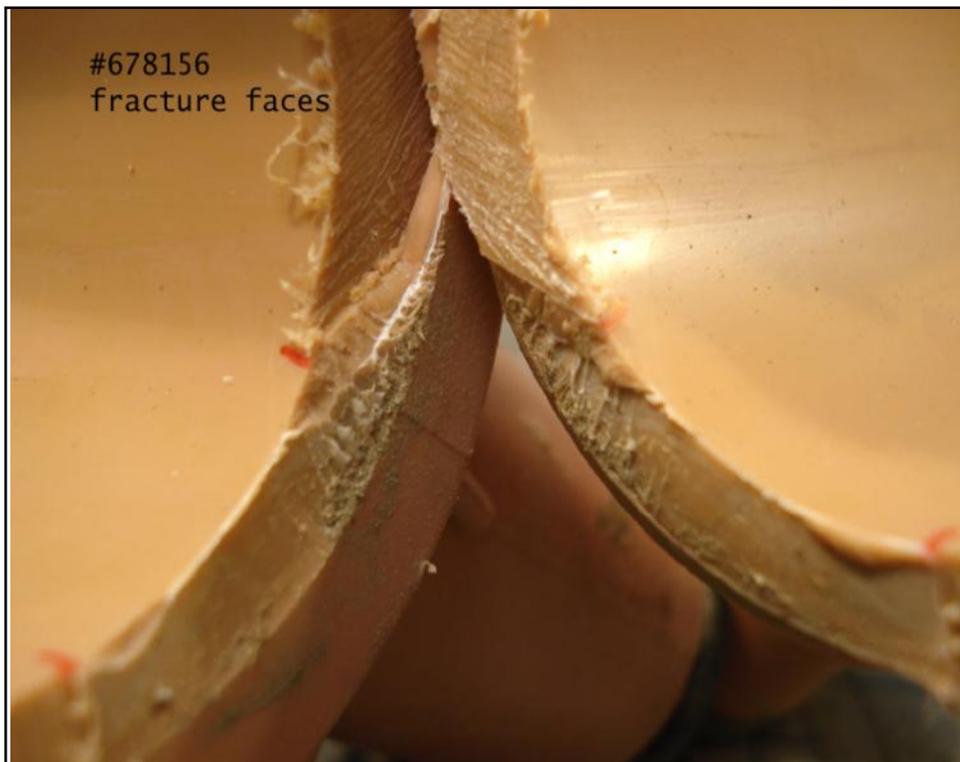
Figure 77. Length of Fracture Faces Identified with Red Marker

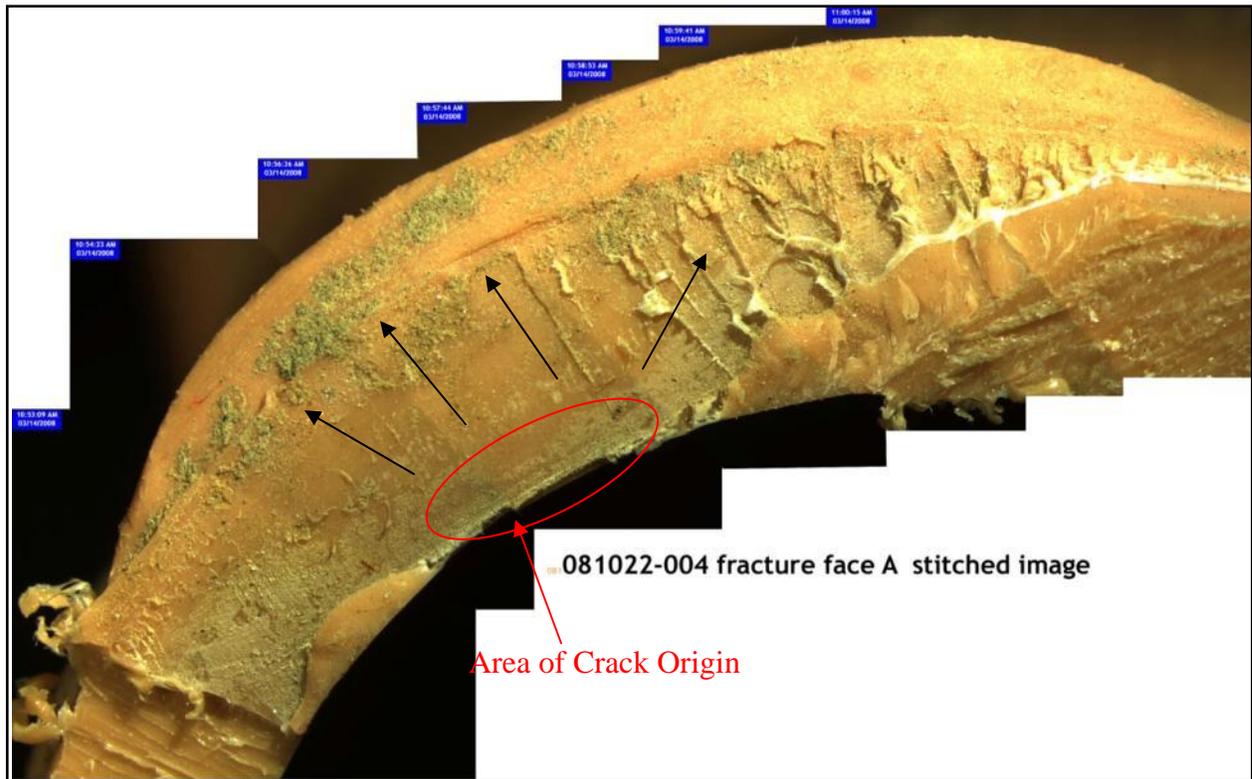
The surfaces were examined with a stereo optical microscope and revealed that the SCG fracture originated from the inner wall of the pipe and proceeded outward as shown in Figure 80. Another area exhibited a secondary SCG fracture origin originating near the outer surface of the pipe then proceeding inward, suggesting a change or compound loading of the area. The secondary origin is identified in Figure 81.

Figure 80. Microscopy of the Fracture Face Away From the Tee

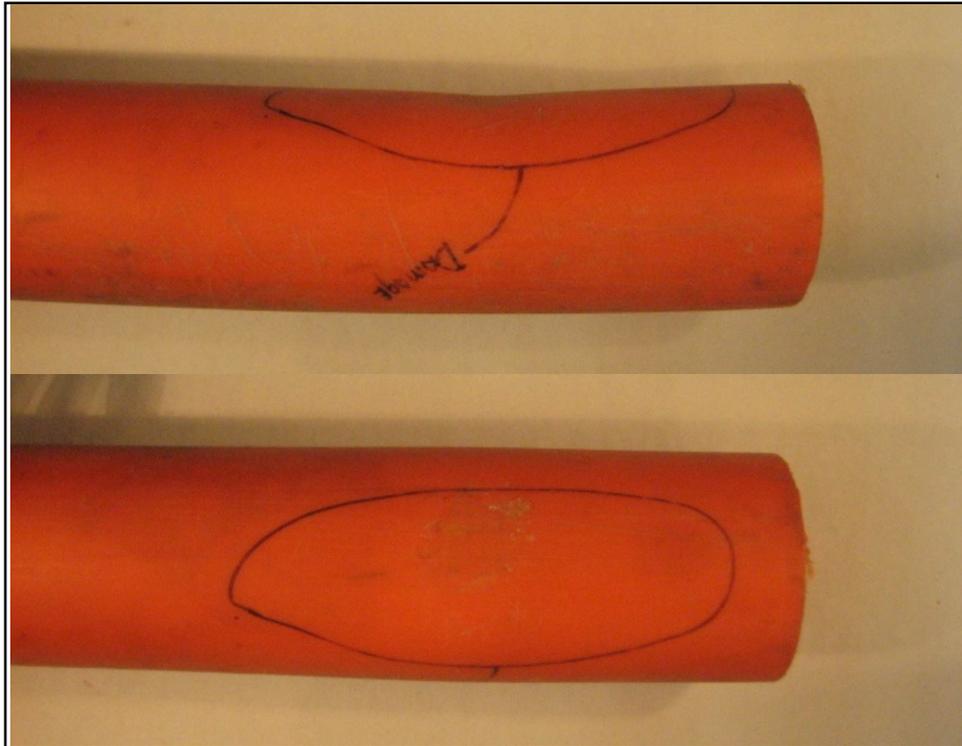
According to background information provided by the submitting company, the pipe was found resting on a 4-inch steel main. This resulted in a localized shell bending load and deformation of the plastic pipe. An axial slit-wise crack was observed centered on the inner wall at the load point. The slit on the inner wall was measured at approximately 4" long. The crack exhibited full wall penetration resulting in a 1" slit on the outer wall.

Figure 97. Side and Bottom View of Sample

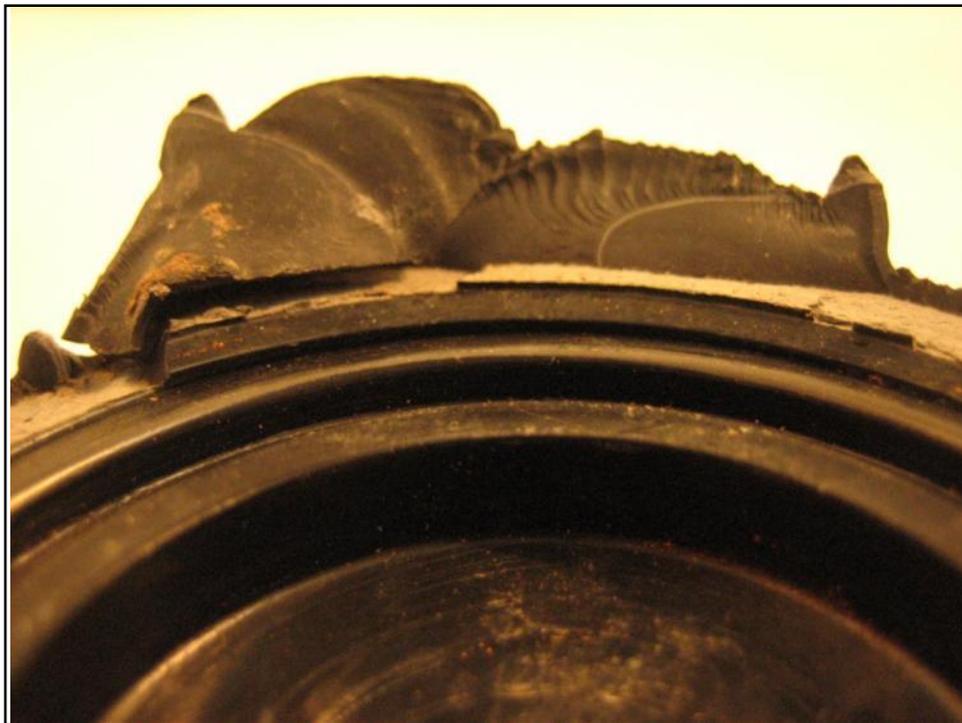
Figure 121. Fracture Surface of the Top of the Cap

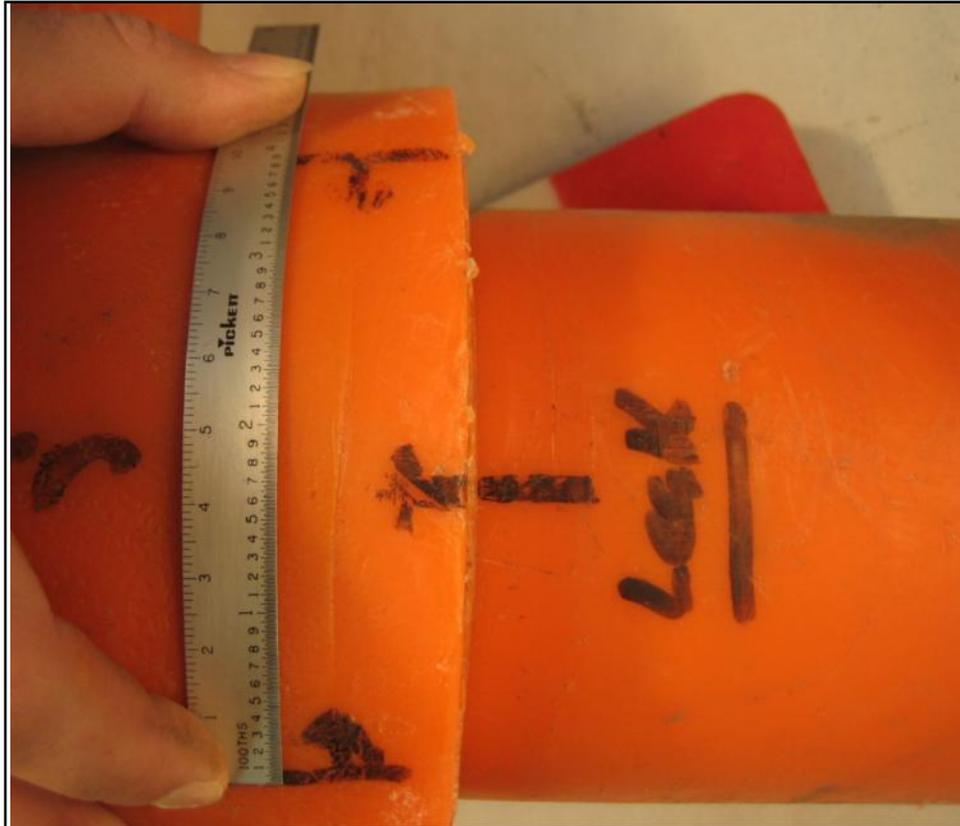
A thru wall circumferential slit on the socket was observed. The 4" slit appeared to line up with the end of the pipe. Also of note, the socket displayed some radial distortion. Interference between the pipe and the socket could be responsible for elevating stresses at the pipe edge/socket interface.

Figure 141. Circumferential Slit in Fitting

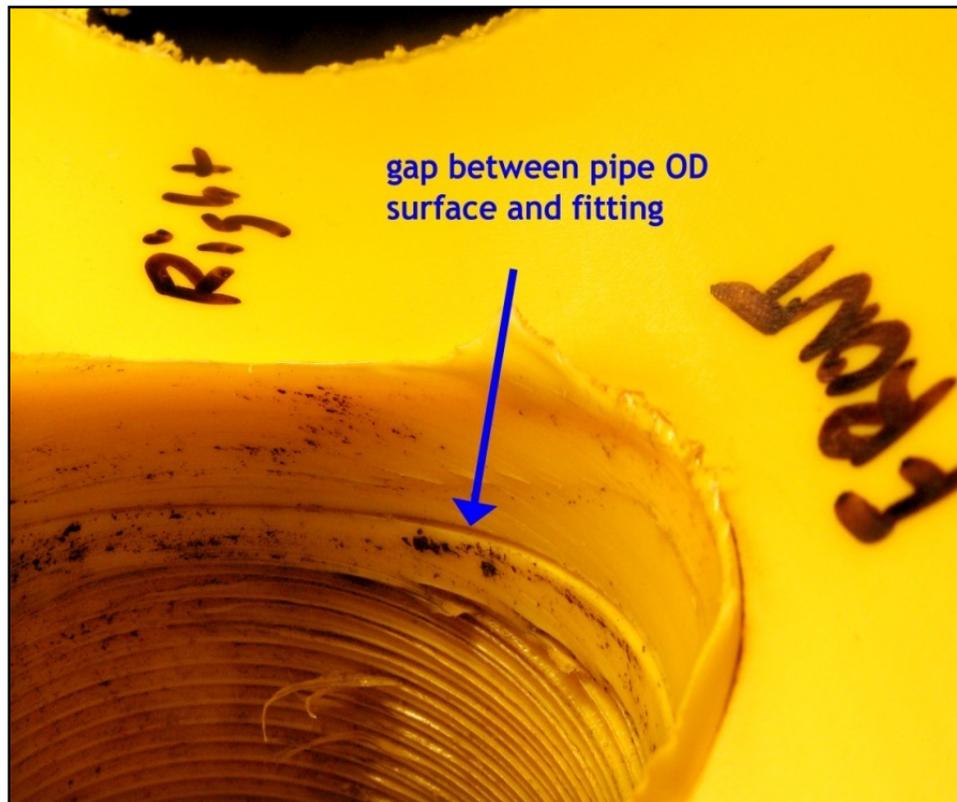
Figure 150. Close-up of Gap between Pipe Surface and Fitting

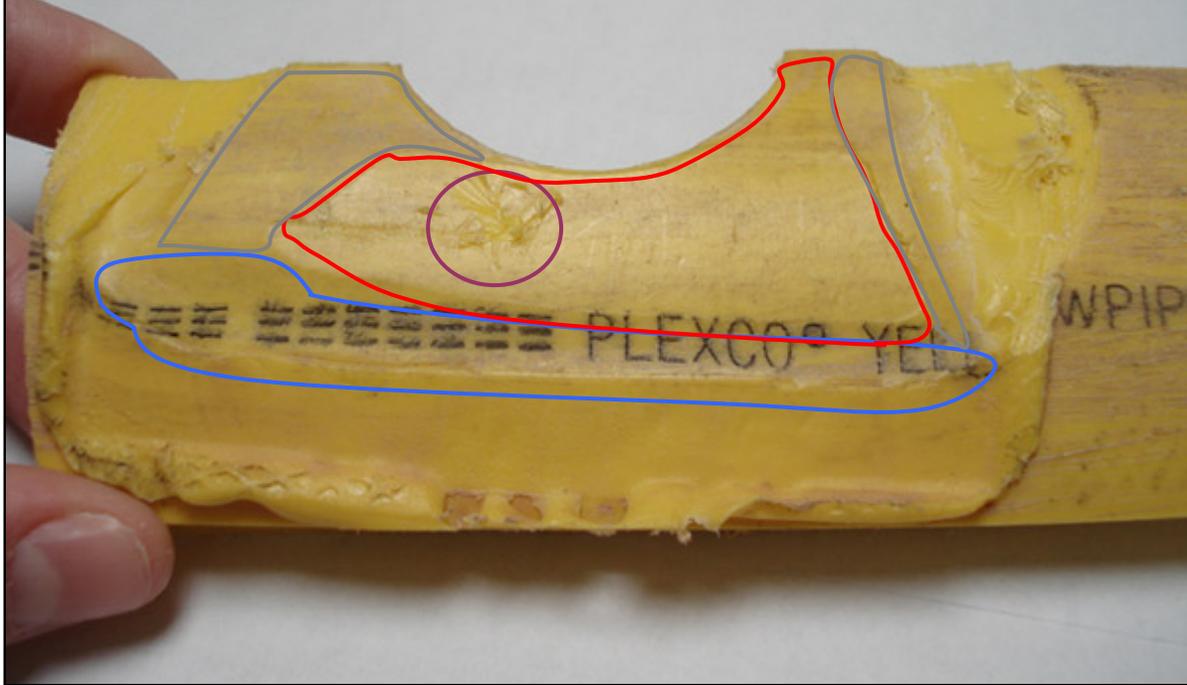
Scraped by GTI
Shiny, smooth, depressed area
Rough, grey colored area
Depressed area

Figure 152. Pipe Segment Surface from Under the Tee on the Side Containing the Leak

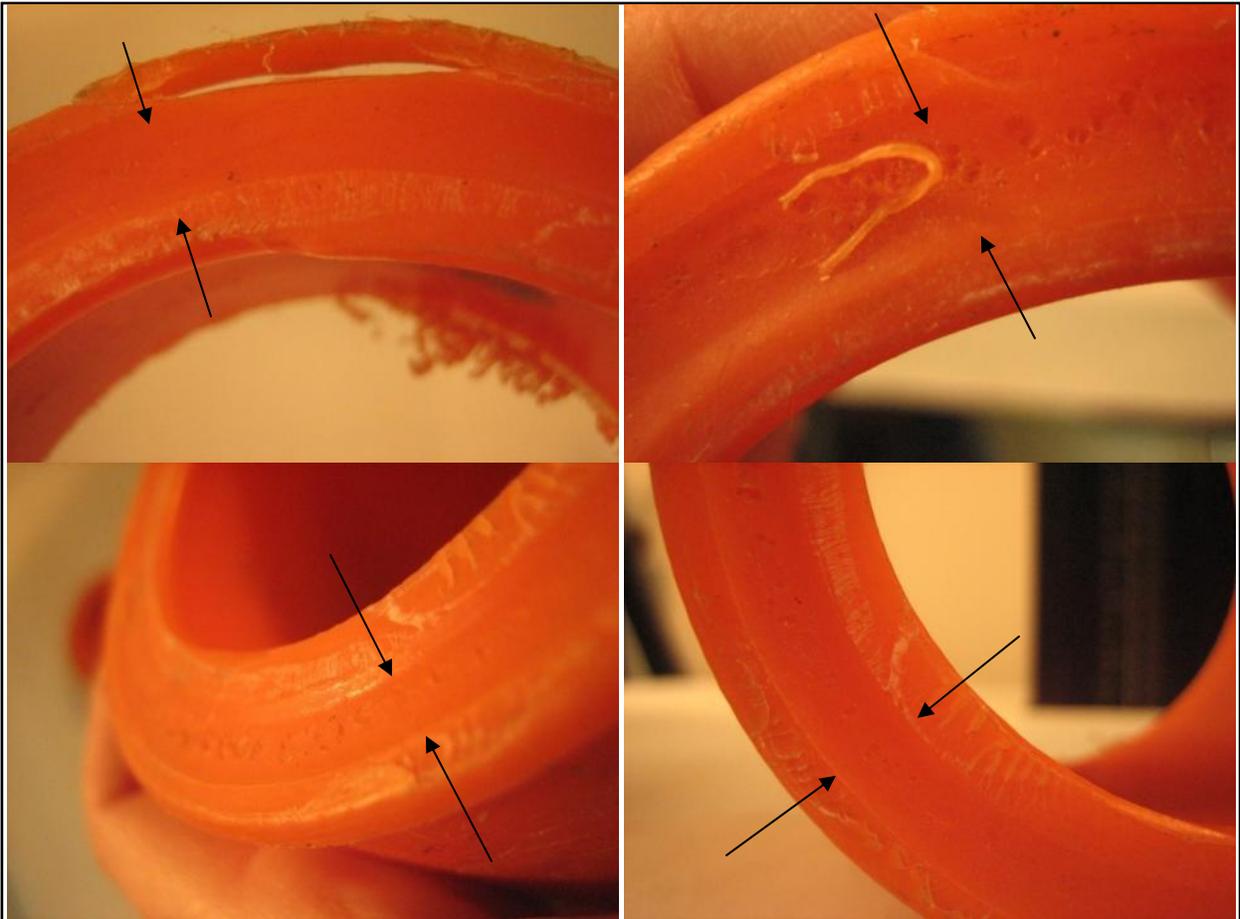
A 360° cold bond was observed on the mid-wall of both faces of the butt fusion. This depressed area is outlined with arrows in Figure 169. The weak to non-existent interface bond between the mid-walls was a result of improper heat/pressure/time variables in the joining procedure. Fusion occurred only in the melt bead and resulted in approximately 30 years of service before final separation.

Figure 169. Fusion Faces Showing Cold Fusion Area

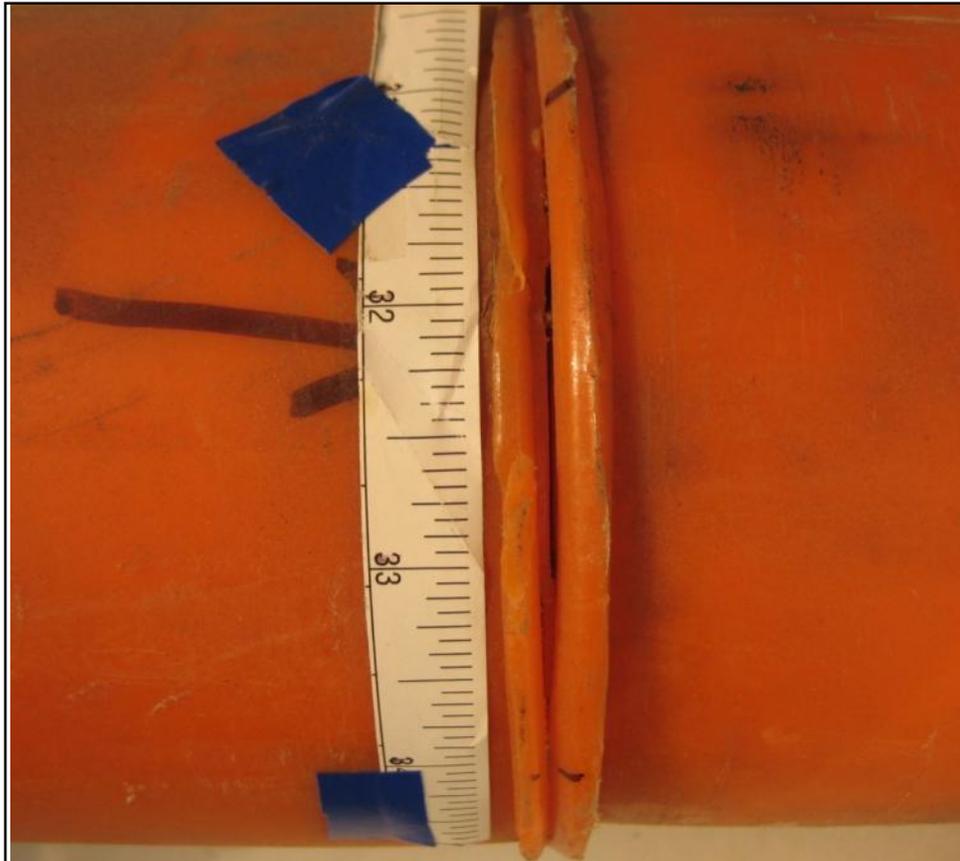
This fusion joint displayed axial misalignment of the pipe ends (Figure 180) and a visible separation within the joint (Figure 181). Bead rolover was also inadequate and nonsymmetrical as seen in Figure 182.

Figure 181. Weld Separation along ~3" Arc Length

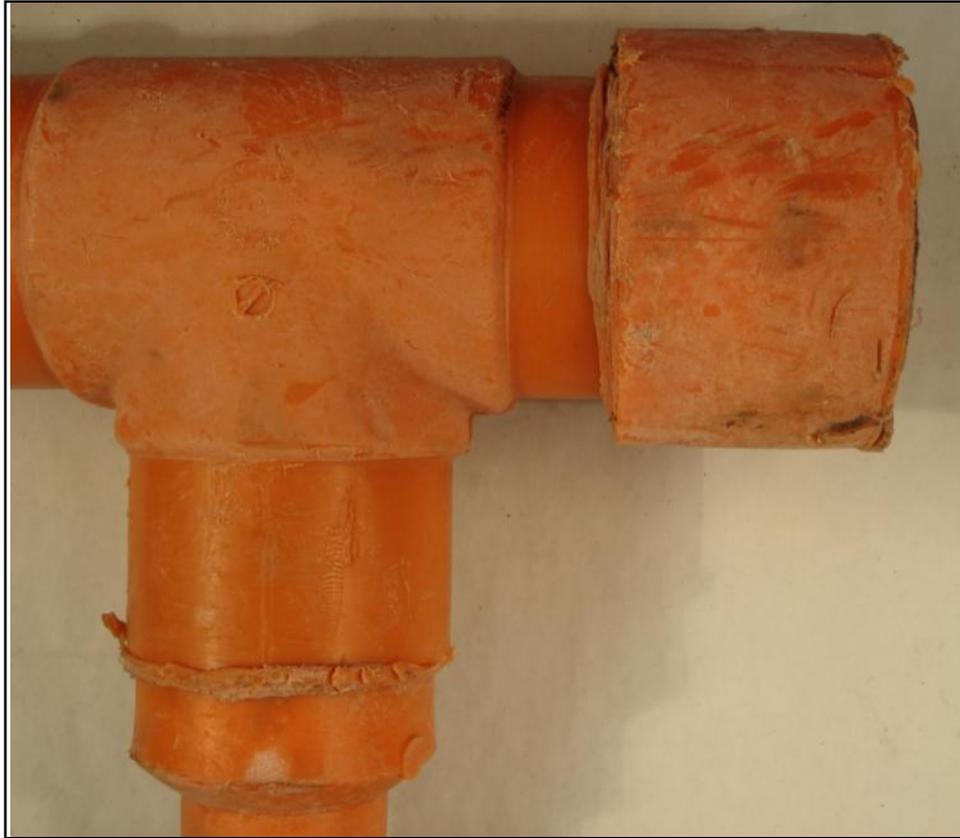
This sample would require pressure testing to determine the leak location and sectioning to determine the cause. The entire sample consisted of sloppy workmanship. Poor bead rollover, parallel misalignment, and burn marks were all visible on the specimen.

Figure 189. Close Up View of Specimen

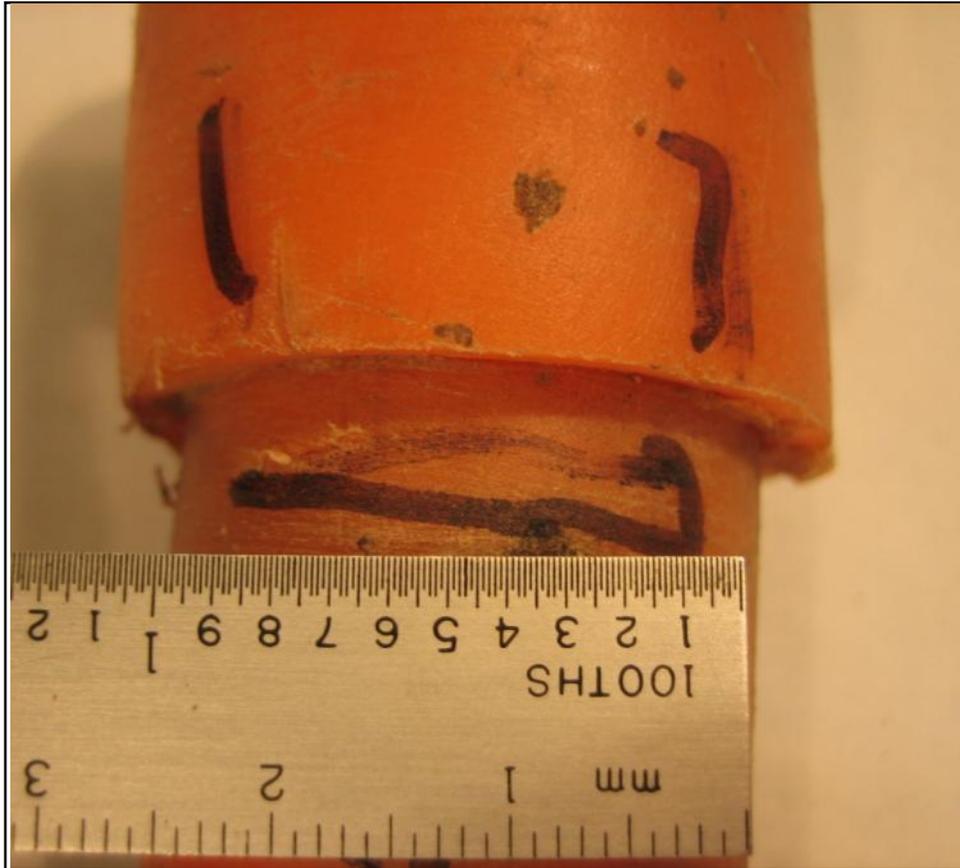
The leak location was marked by the field crew during removal of the section. The marking was approximately 1" around the circumference of the pipe as seen in Figure 193. The coupling and pipe were in parallel misalignment to each other. Due to the nature of this sample, the root cause cannot be determined without sectioning.

Figure 193. Leak Location

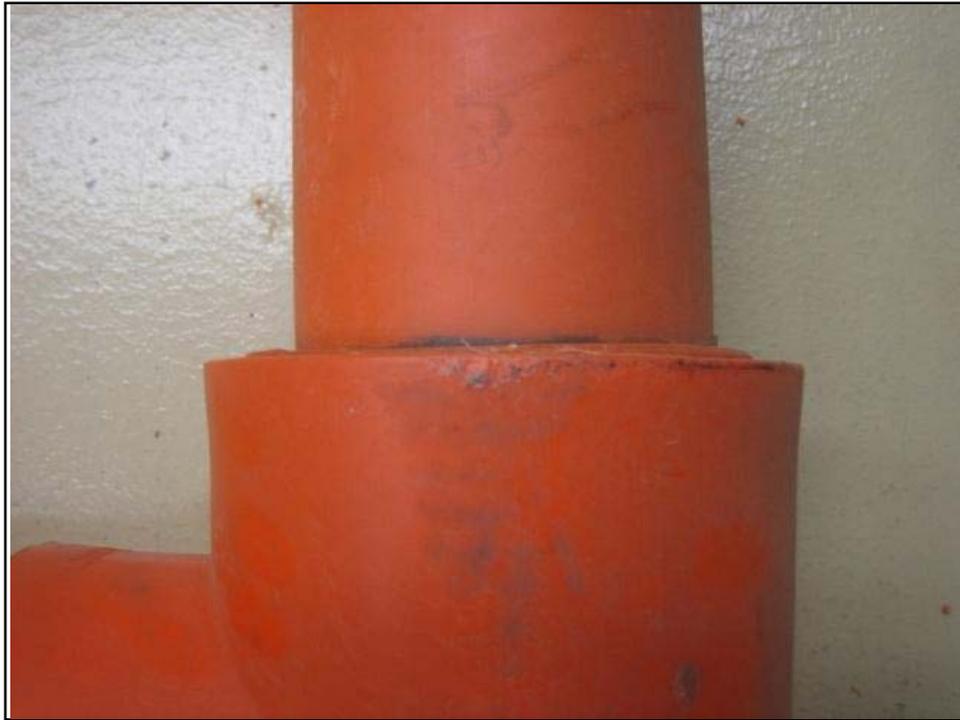
Radial distortion as seen in Figure 201 was observed in the sockets. Misalignment of the pipes into the sockets was also apparent. This sample was submitted without any indication of the leak location. A pressure test was performed and determined that gas leaked out of the joint at the pipe/socket interface. As shown in Figure 202, the leak occurred over 3” of the circumference in the fusion joint. A close up of this area is shown in Figure 203.

Figure 201. Radial Distortion

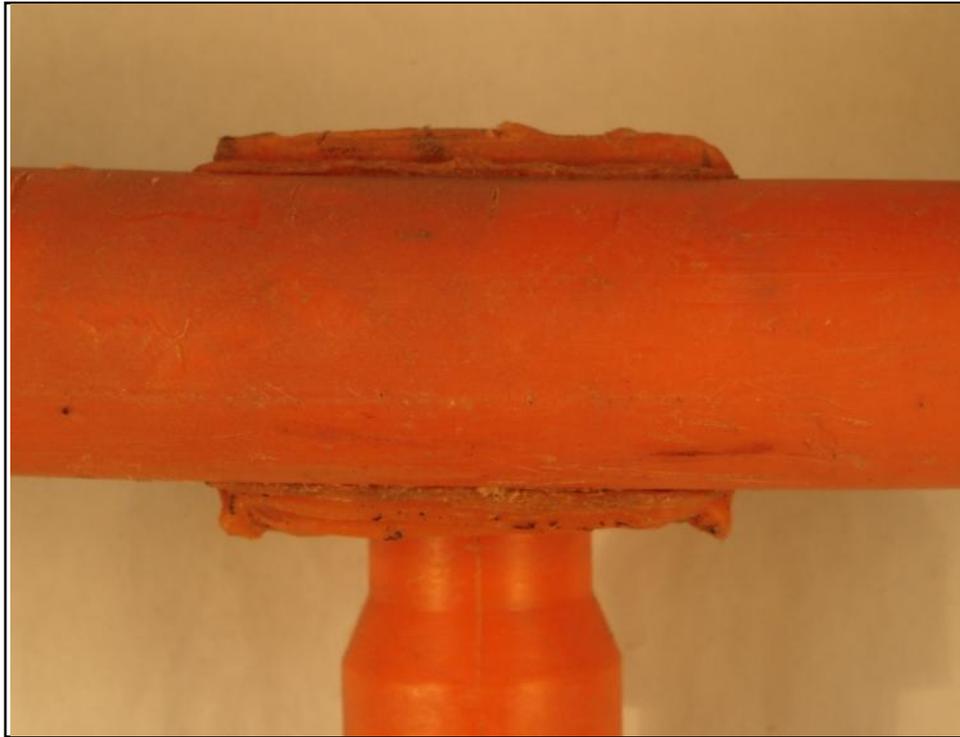
This fusion exhibited a very asymmetric and poorly formed bead. The marked location of the leak was at a location with a high stress concentration between the pad and the pipe. During the visual examination no crack or void was seen so a leak test would need to be performed to verify the leak path. The likely cause for failure is poor workmanship.

Figure 214. Underside of the Pipe and Saddle

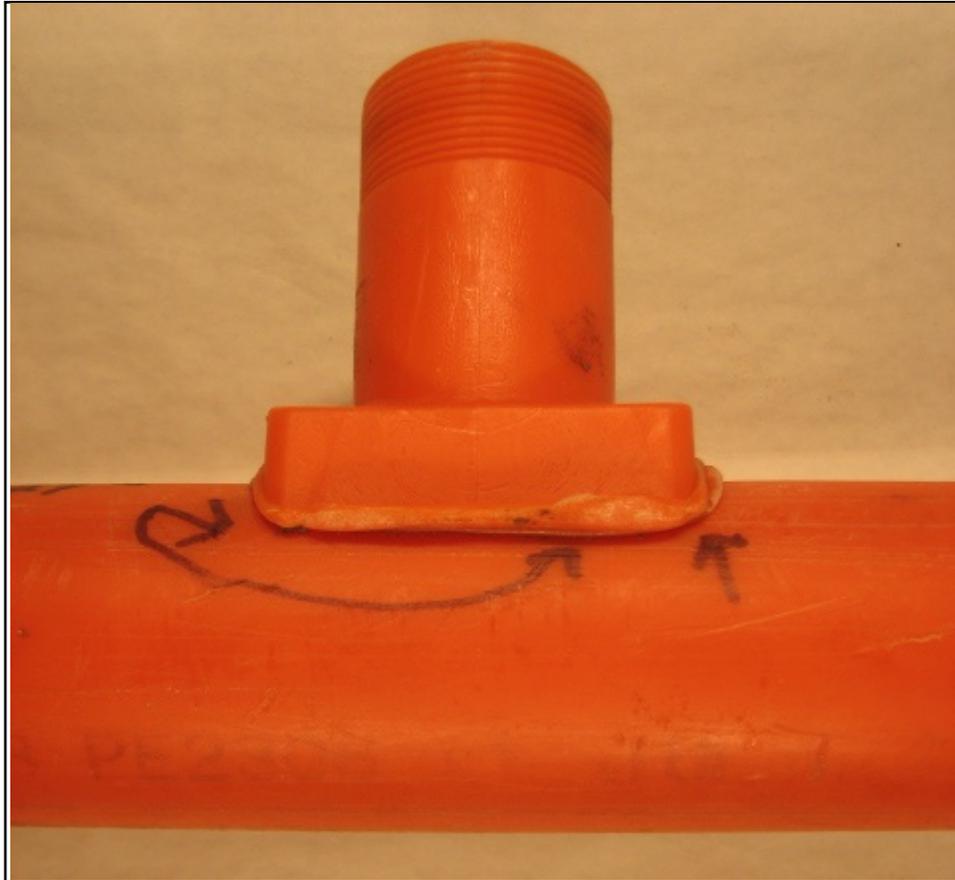
The sample had inadequate melt and roll over on the backside of the saddle tee where the leak locations are marked. This sample would require sectioning for further comment.

Figure 218. Backside of Saddle Tee

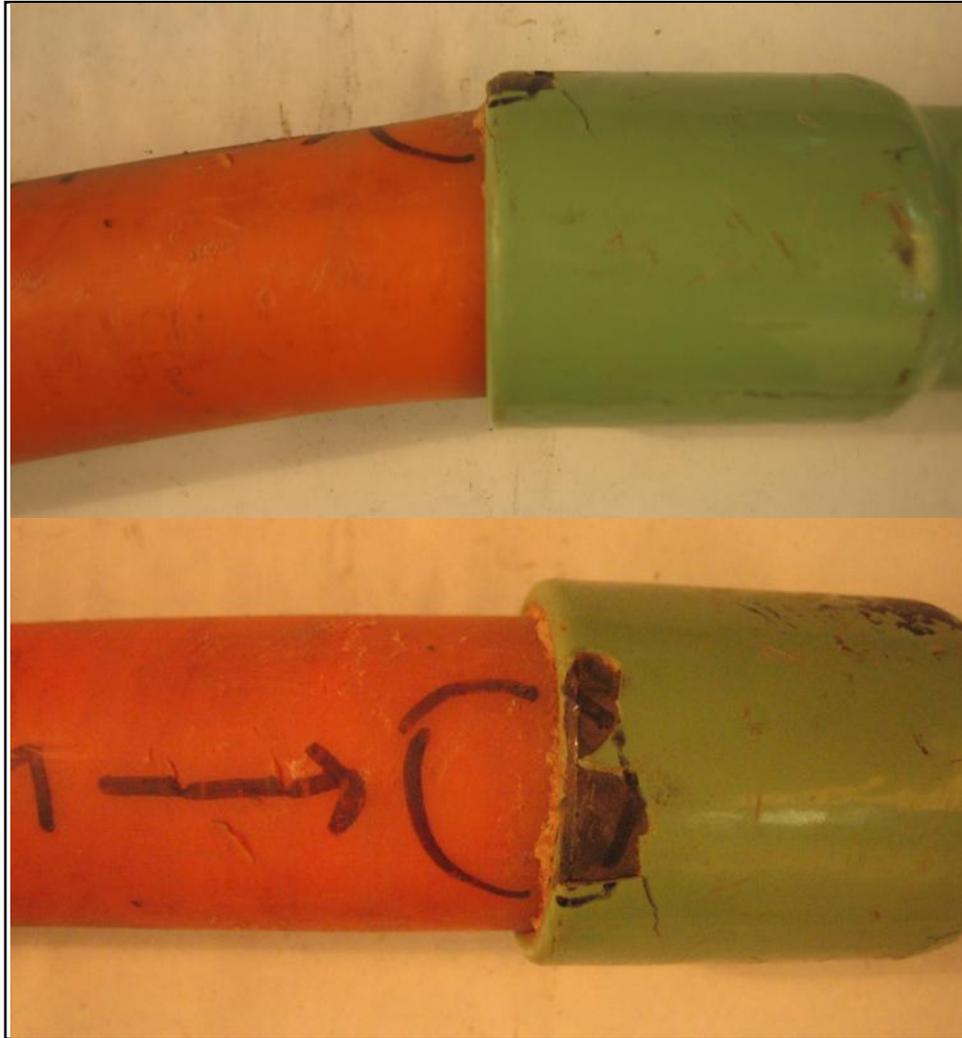
The sample suffered excessive bending between the pipe and the stab fitting likely due to improper support on the underside of the pipe based on the field report.

Figure 230. Side and Bottom View of Transition

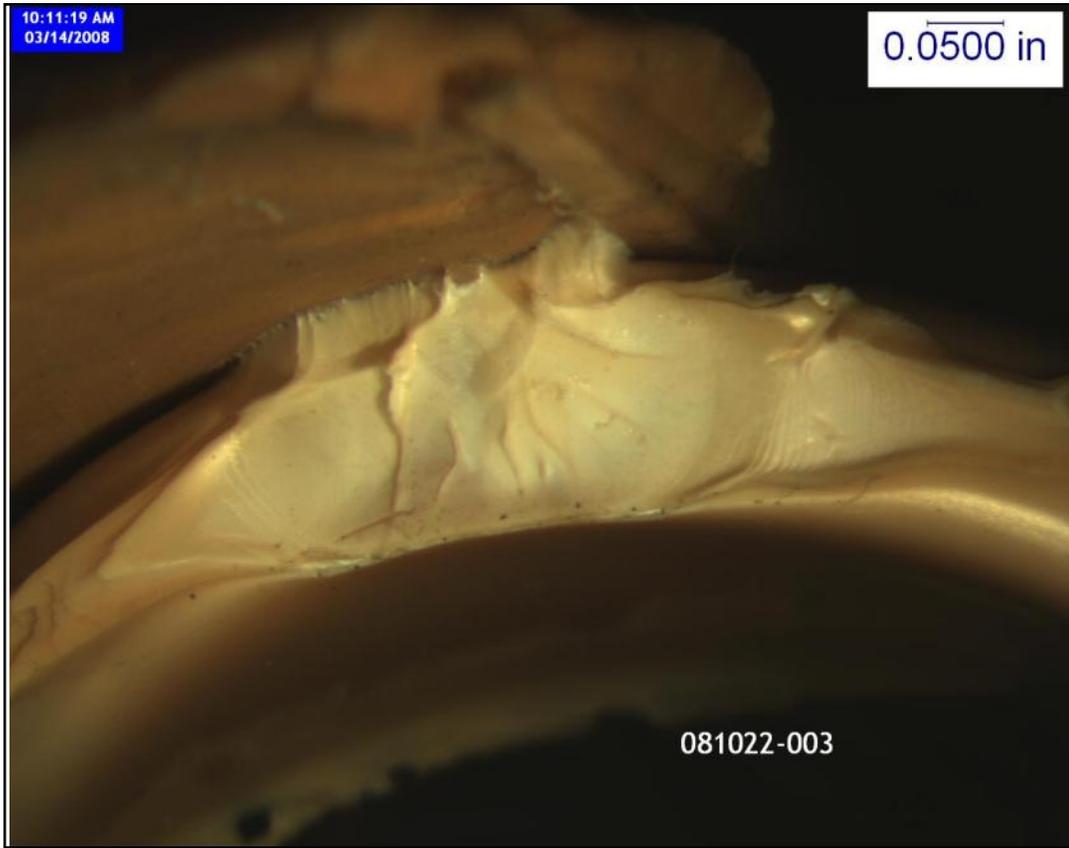
Figure 278. Fracture Face Microscopy on the Pipe No Longer Attached to the Tee

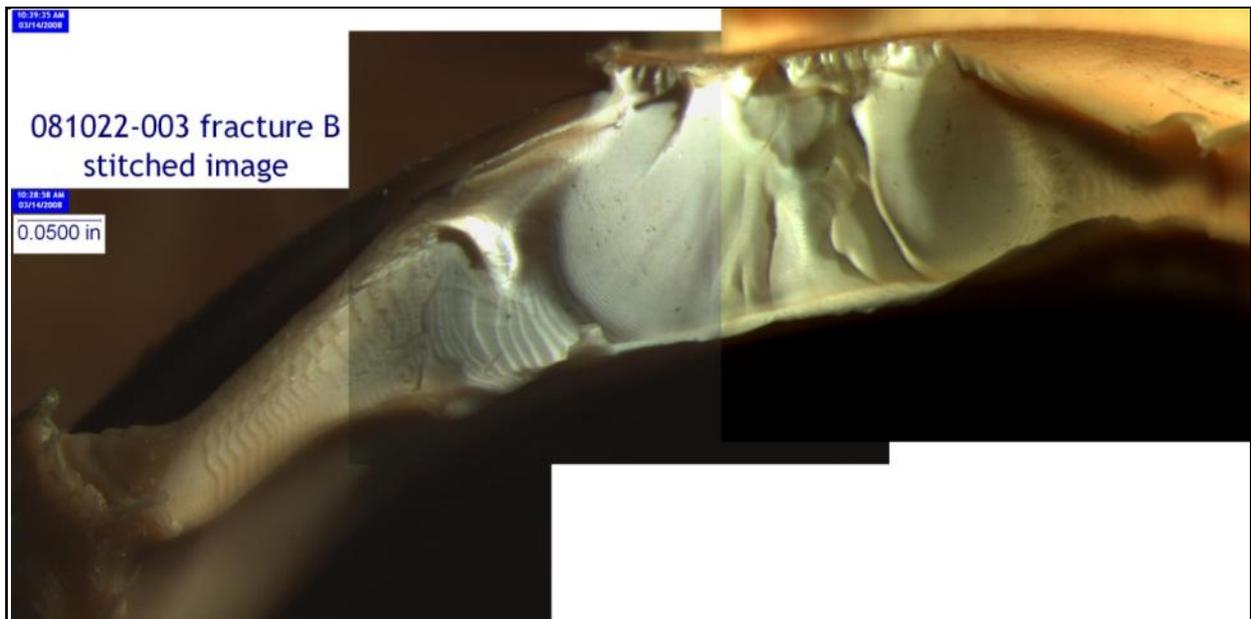
Figure 279. Opposing Fracture Face Microscopy
