TECHNICAL REPORT - OPS 89-1

**ELECTRIC RESISTANCE WELD PIPE FAILURES
ON HAZARDOUS LIQUID AND GAS TRANSMISSION PIPELINES**

AUGUST 1989

**Office of Pipeline Safety
Research and Special Programs Administration
U.S. Department of Transportation**

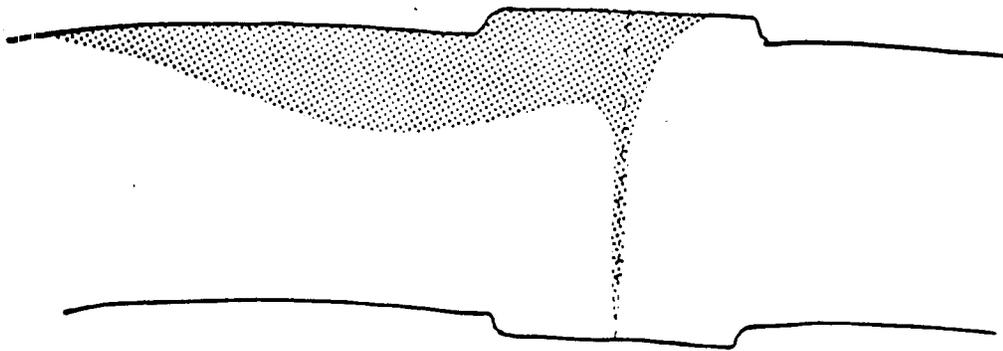
Figure B-4

Sketch based on evidence indicated by Figures B-1, B-2, and B-3 illustrating how localized corrosion (corroded areas shown by dots) along the flash weld extended across the wall and developed a deep narrow groove that had the effect of a crack with sufficient depth and length to initiate the failure.

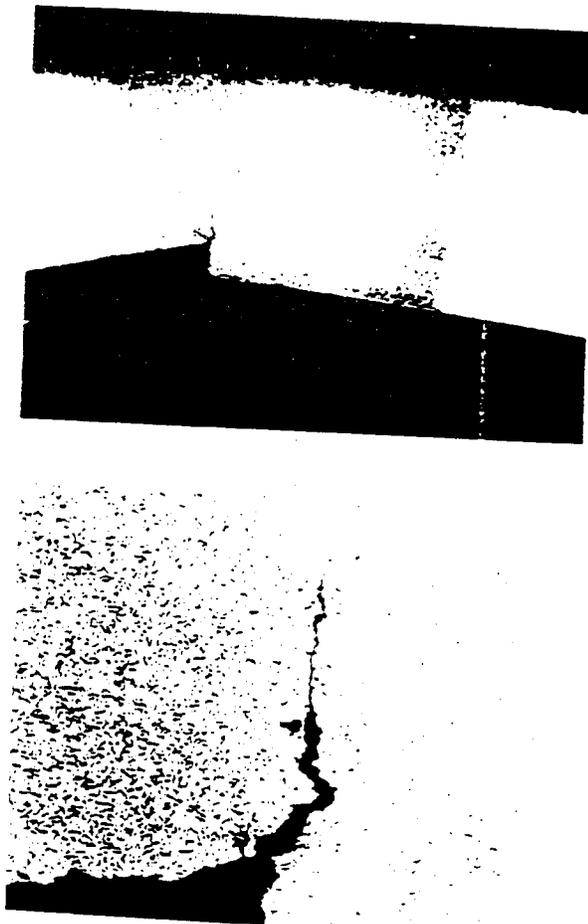
Figure C-5 **Misalignment**

- (a) **Misalignment on Inside Diameter (outside ground flush)**
- (b) **Fatigue Crack Initiating From Toe of Misalignment (magnified view of (a))**

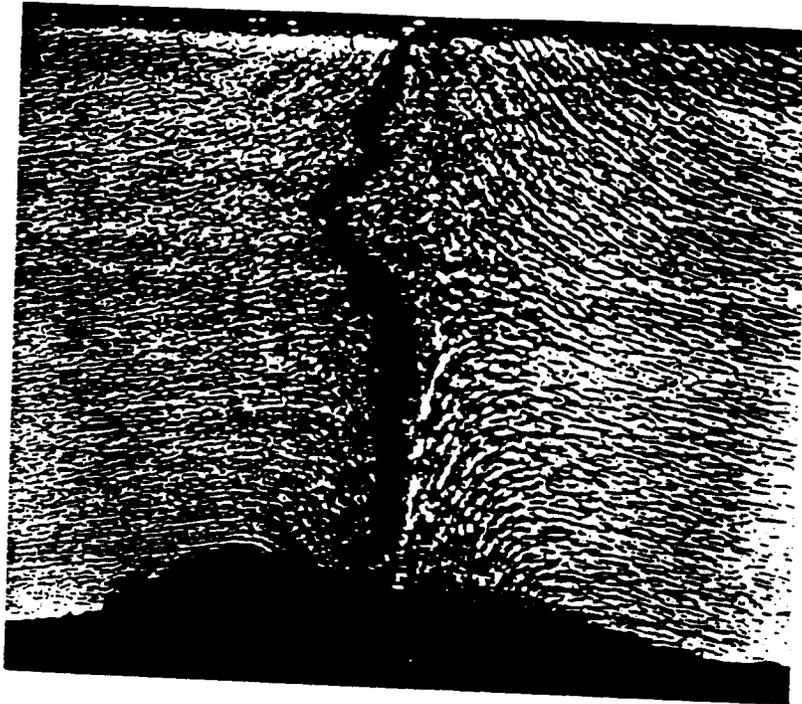
Figure C-6 Excessive Trim on the Inside Diameter

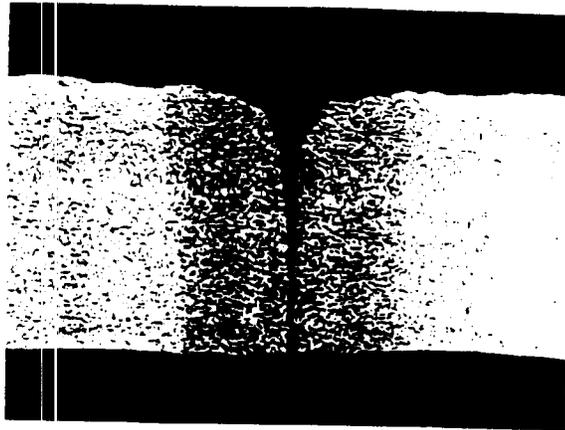
(a) Section From Station 71.5
WPL, Mounds View

Figure C-7 Selective Corrosion
