Final Report

ERW and Flash Weld Seam Failures

J.F. Kiefner and K.M. Kolovich

September 24, 2012

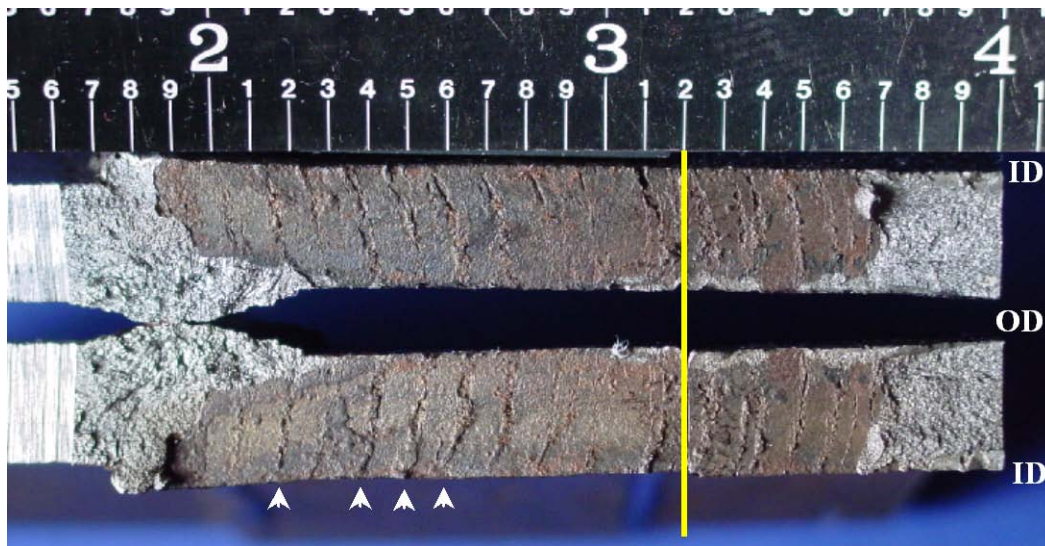
Figure 8. Through-wall Cold Weld on a Fracture Surface of Leak in a LF-ERW Pipe that was Broken Open after Being Chilled in Liquid Nitrogen (repetitive pattern is “stitching”)

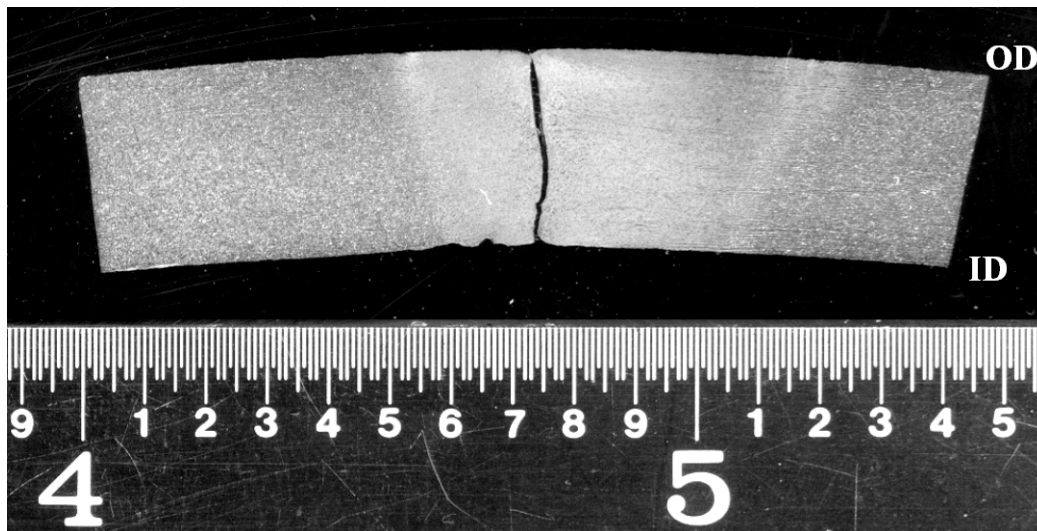
Figure 9. Appearance of the Cold Weld on a Metallographic Section across the Weld shown in Figure 8 (taken at the location of the yellow line in Figure 8)

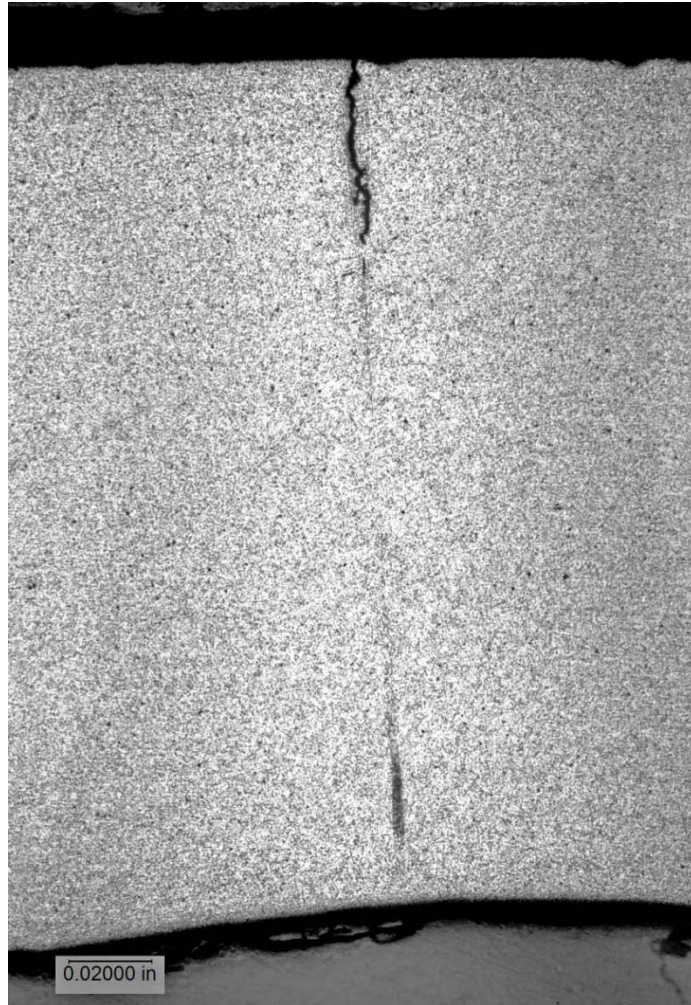
Figure 13. Part-Through Cold Weld in LF-ERW Pipe

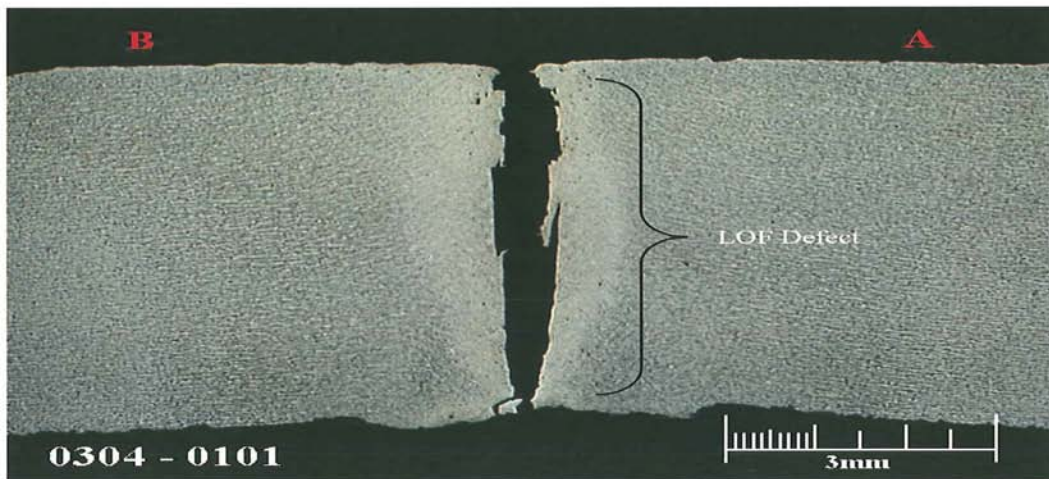
Figure 16. Cross Section of the Cold Weld Shown in Figure 15 Showing Evidence of Strain Possibly Produced by a Hydrostatic Test to a Stress Level of 96.6% of SMYS

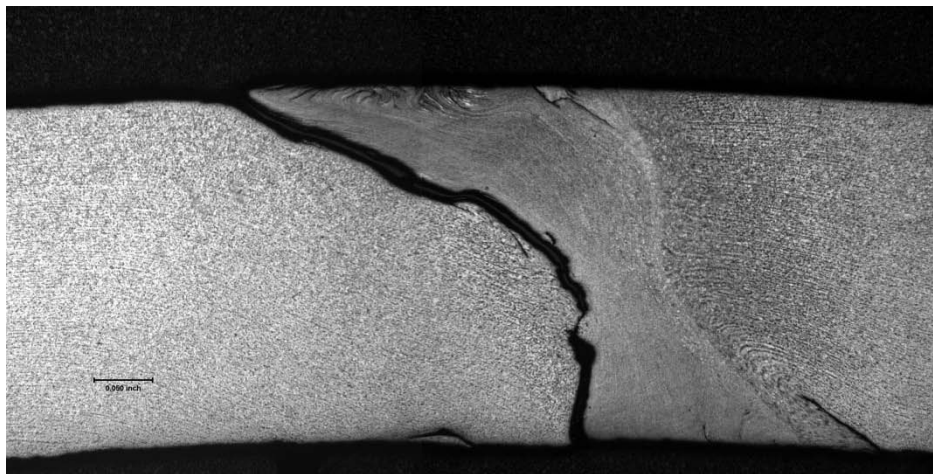
Figure 17. Cold Weld in LF-ERW Pipe Containing Melted Material

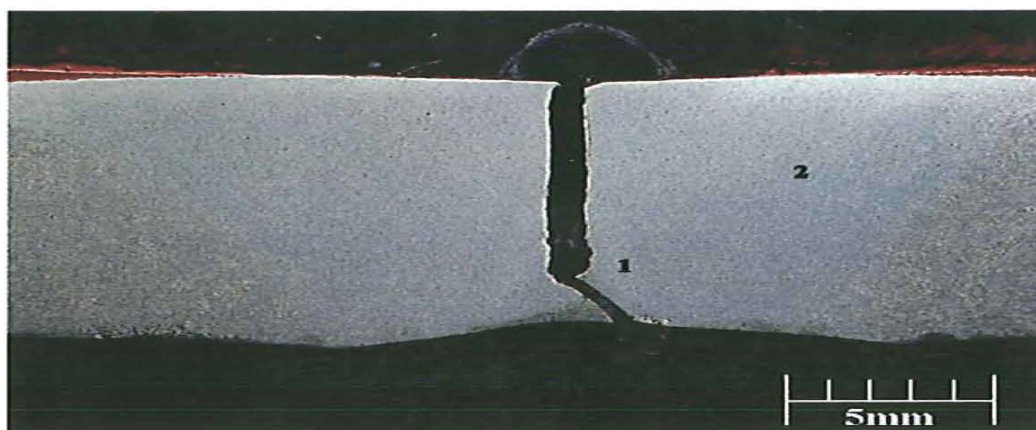
Figure 19. Cross Section of the Cold Weld Shown in Figure 18

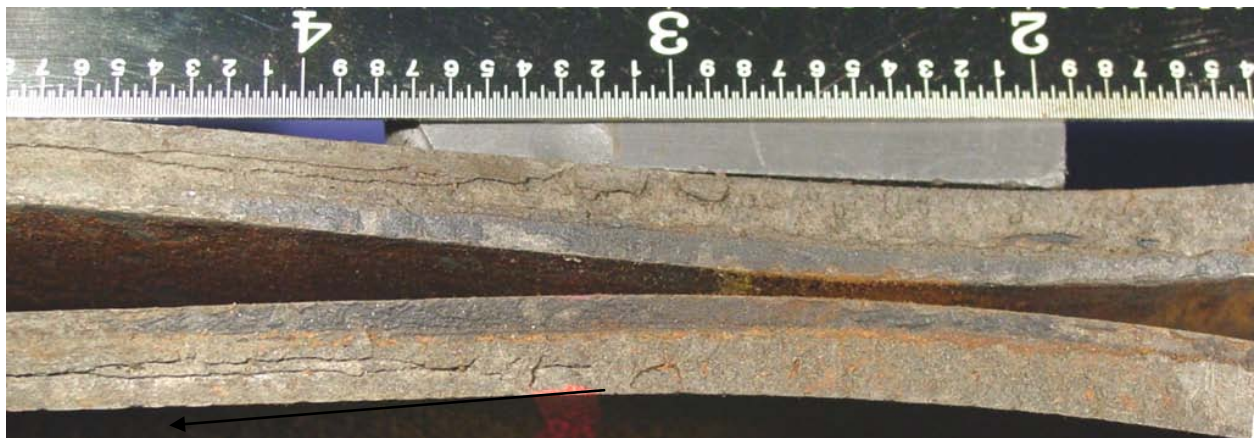
Figure 26. Hook Crack Seen on a Fracture Surface

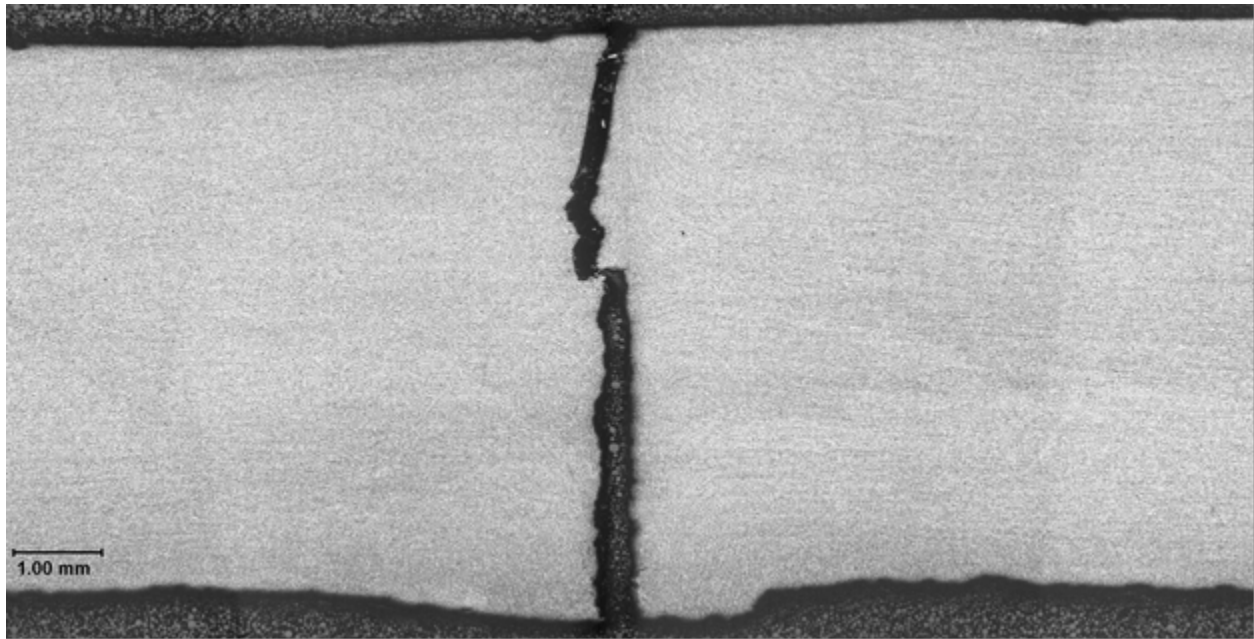
Figure 27. Cross Section of Hook Crack Shown in Figure 26 (Note that the end of the hook crack was close to the bondline and that the fracture jumped into the bondline.)

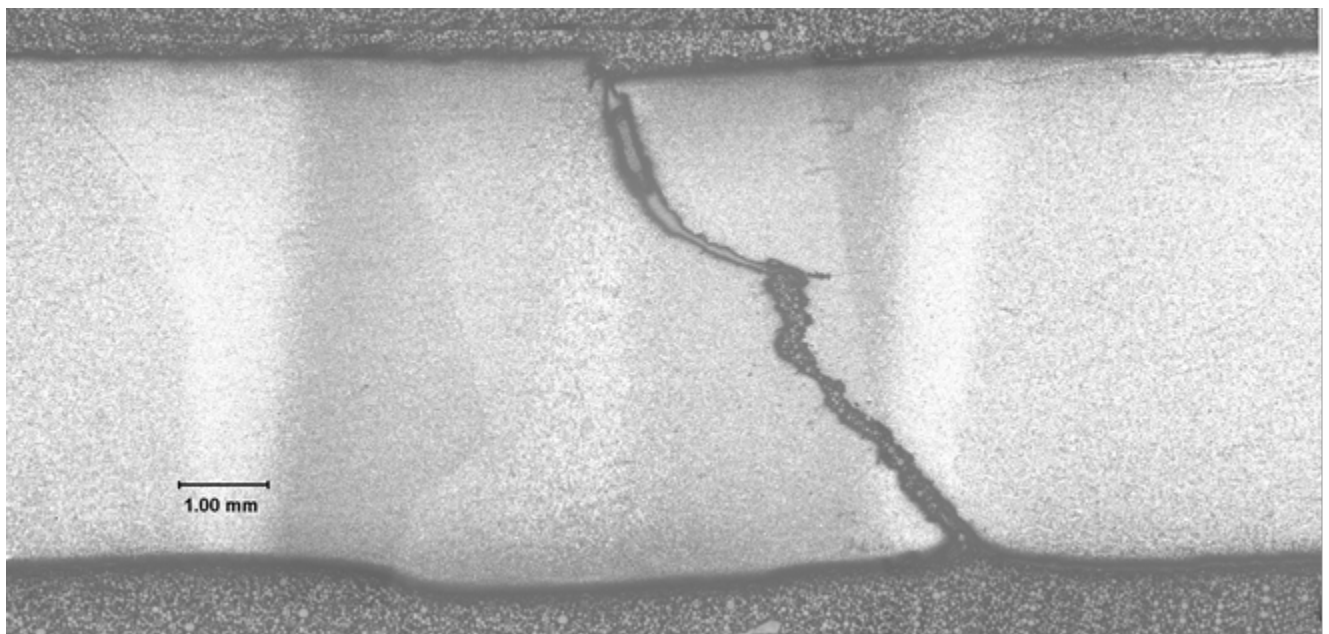
Figure 28. Cross Section of Hook Crack Where End of Hook Crack Was Not Close to the Bondline (Note that the fracture propagated in the heat-affected zone of the base metal.)

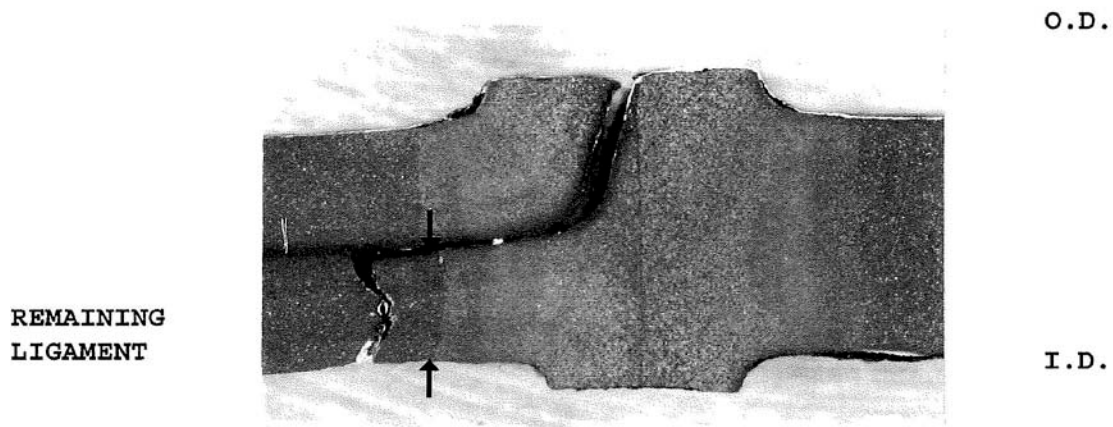
Figure 29. Cross Section of a Flash-Welded Seam Where the Hook Crack Extended Far From the Bondline (Failure is in the base metal.)

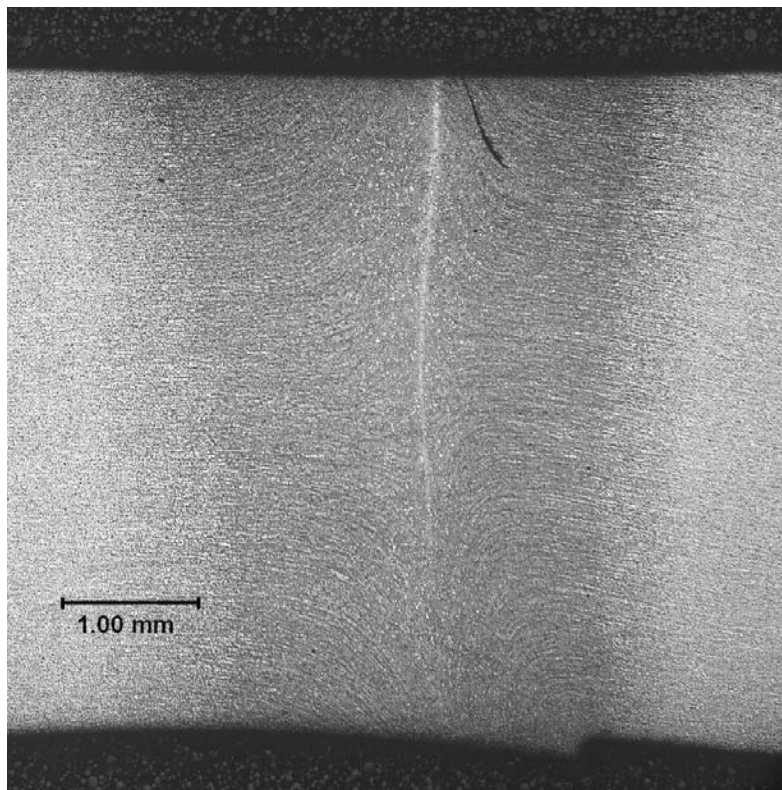
Figure 30. Cross Section of a Small Hook Crack near a Low-Frequency-Welded Seam

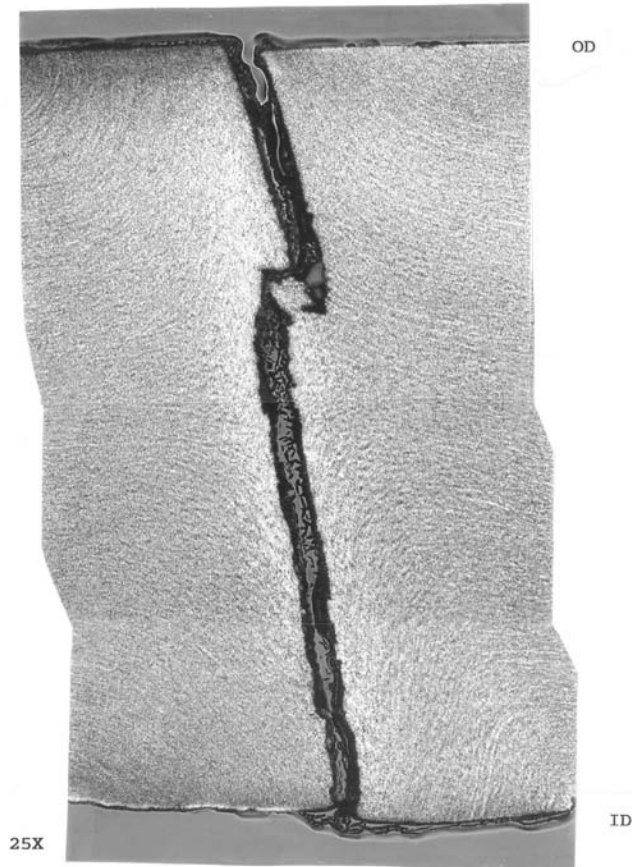
Figure 31. Cross Section across HC Case Number 2 Defect

A photograph of a metallographic section across this anomaly is shown in Figure 31 where the almost-detached piece of material and the transition from a hook crack to a bondline failure can be seen.

The end of the crack is close to the bondline in the manner shown in Figure 27. Moreover, the appearance of the fracture shown in Figure 31 is similar to the appearance of the metallographic section of the likely origin of the Carmichael service failure (see Figure 32). Both appeared to have been extended by some amount of ductile crack extension followed by an abrupt transition step from the hook crack to a bondline failure. Both had survived previous tests to stress levels considerably above the observed failure stress of the anomaly. The anomaly in HC Case Number 2 failed at a hoop stress level of about 80 percent of the hoop stress level in the manufacturer's hydrostatic test conducted 32 years earlier. The anomaly that likely initiated the Carmichael failure, failed at a hoop stress level of about 80 percent of the hoop stress level in a previous hydrostatic test conducted 23 years earlier. The implication is that something changed in both situations over the period between the tests and the subsequent failures at much lower stress levels. Growth of the defects either by ductile tearing or pressure-cycle-induced fatigue is assumed to have occurred, and that growth may have facilitated the abrupt failure of the bondline in a brittle manner in both cases.

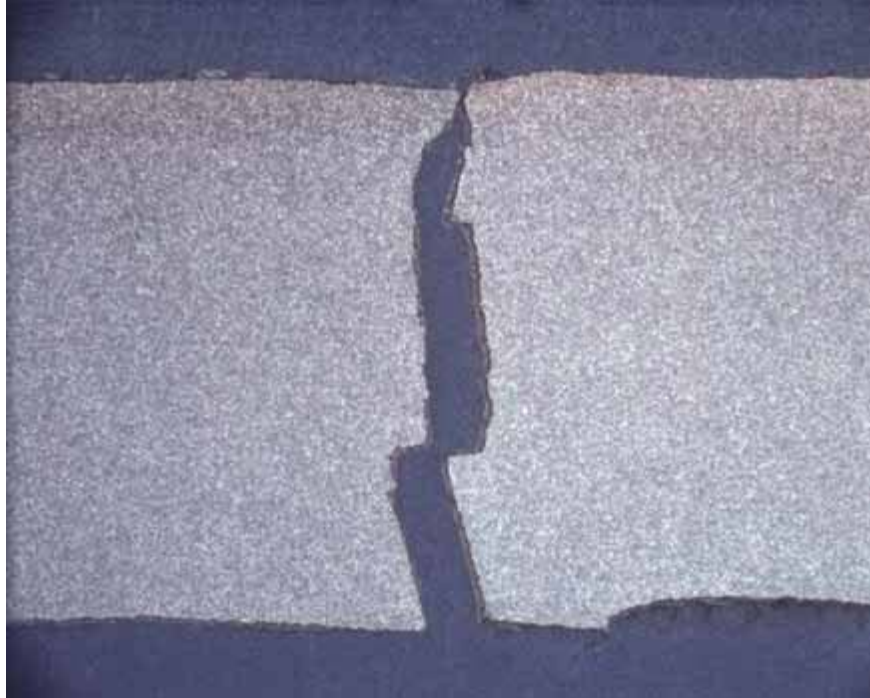
Figure 32. Metallographic Section across Likely Origin of the Carmichael failure.

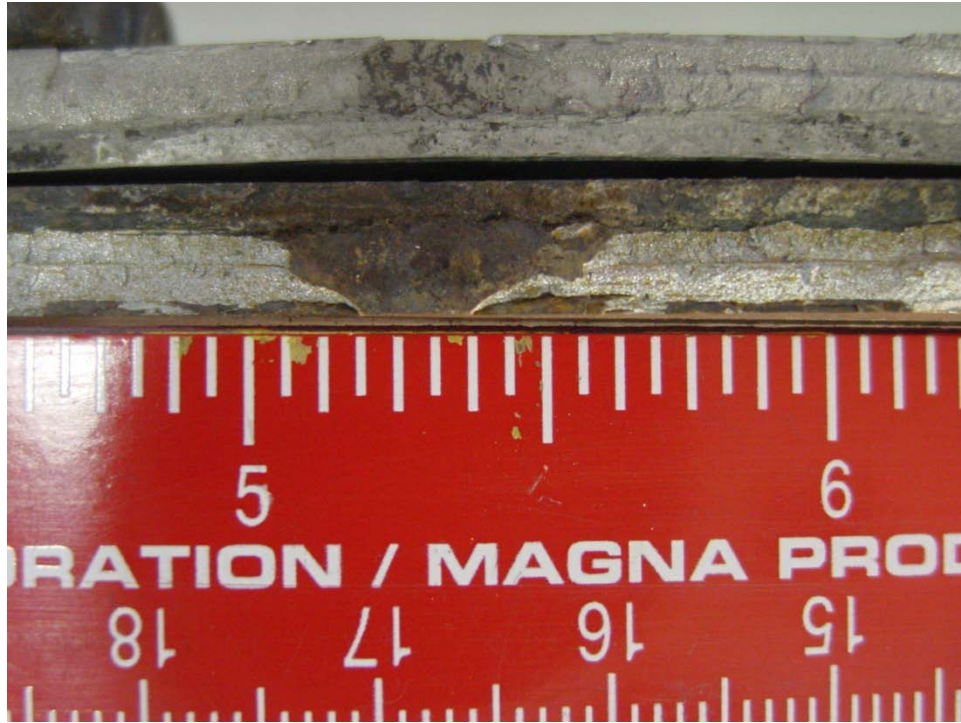
The nature of the combined cold weld and hook crack is shown in Figure 36 and Figure 37. The cold weld in this case was less than ½ inch long, and it was ID-surface connected and extended about 60 percent through the wall. Opposite the cold weld at the OD surface was a long hook crack that had a depth of about 30 percent of the wall thickness. It appears that the leak was caused by tearing of the remaining ligament between the cold weld and the hook crack. Perhaps this tearing was caused by the hydrostatic test 11 years prior to the discovery of the leak.

Figure 36. Leak Associated with an OD-connected Hook Crack and ID-connected Cold Weld

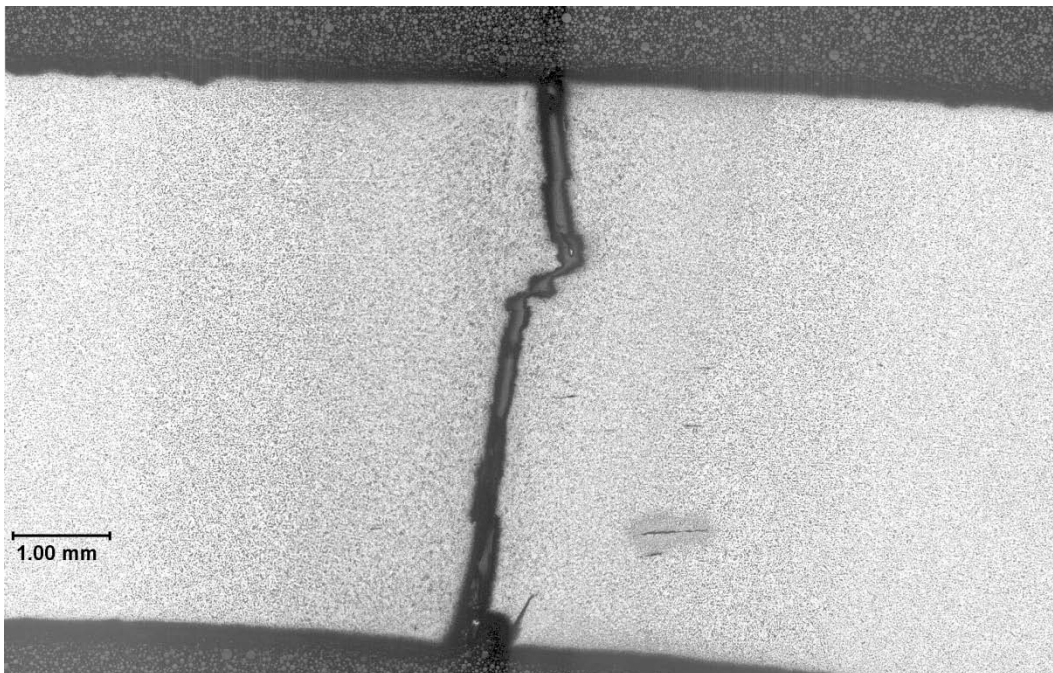
Figure 37. Metallographic Section across Leak Associated with a Cold Weld and a Hook Crack Showing that the Leak Path was the Result of Ductile Tearing Between the Two Anomalies

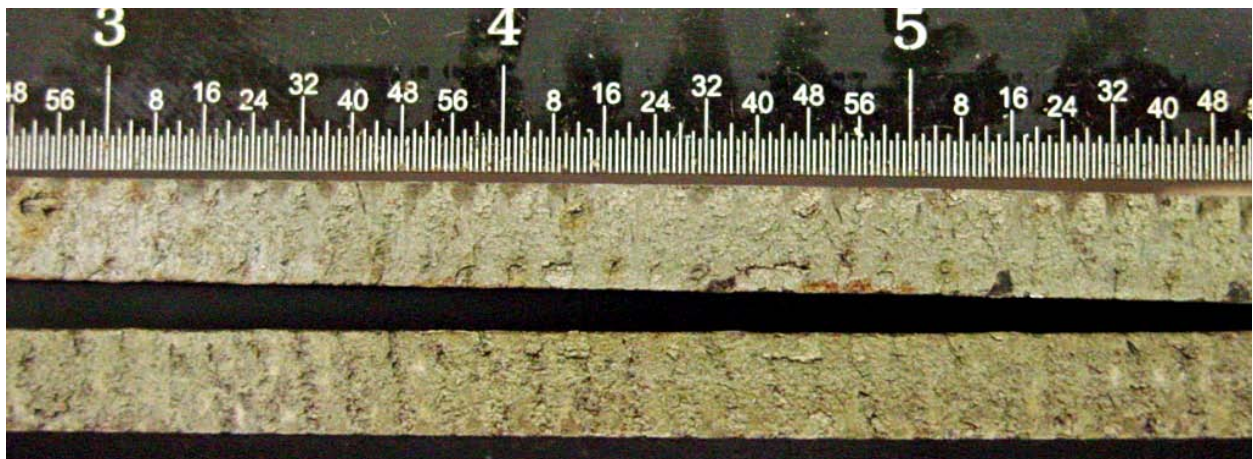
Figure 38. Stitch Pattern on a Fracture of the Bondline of a LF- ERW Seam

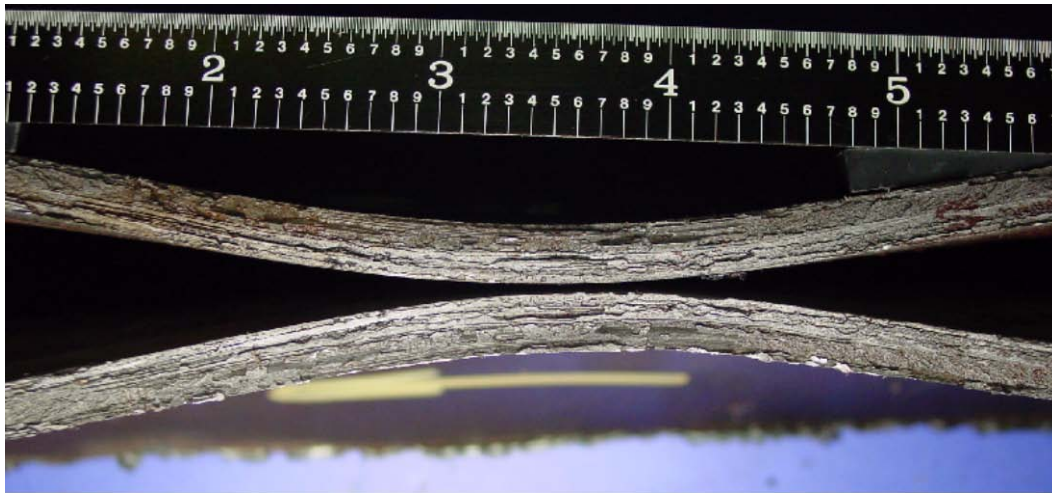
Figure 39. Fracture Surface of a Woody Fracture – Case Number W2

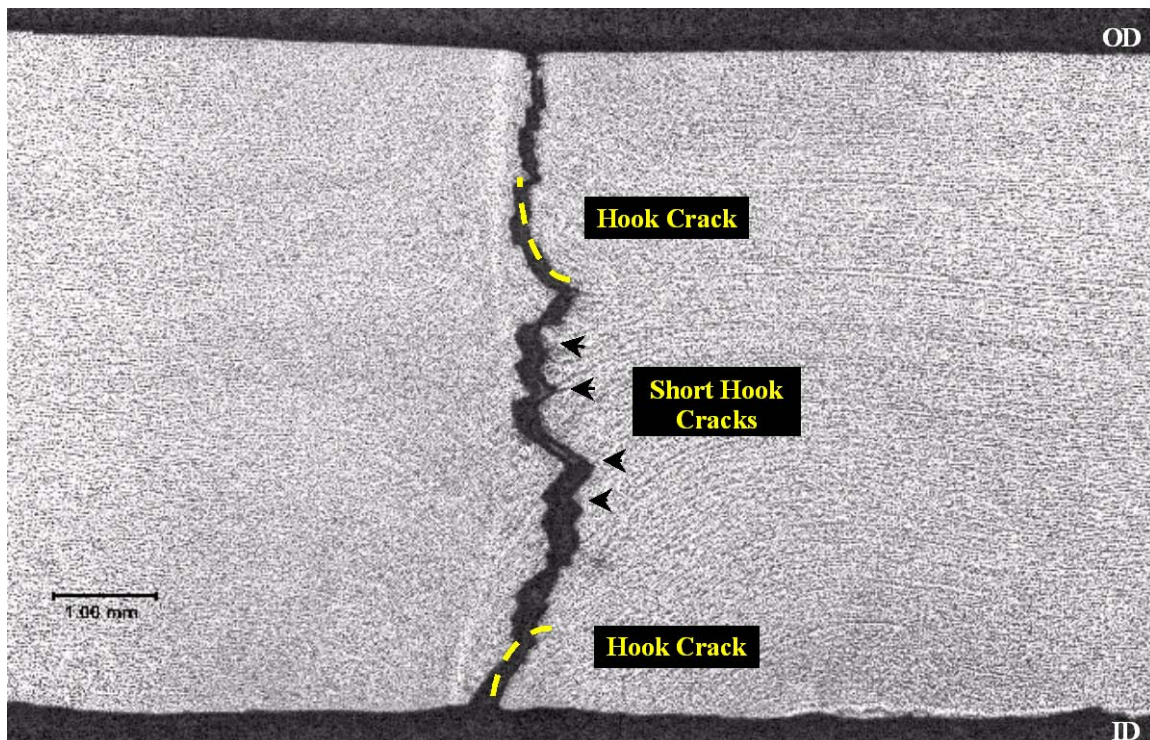
Figure 40. Metallographic Section across Woody Fracture – Case Number W2

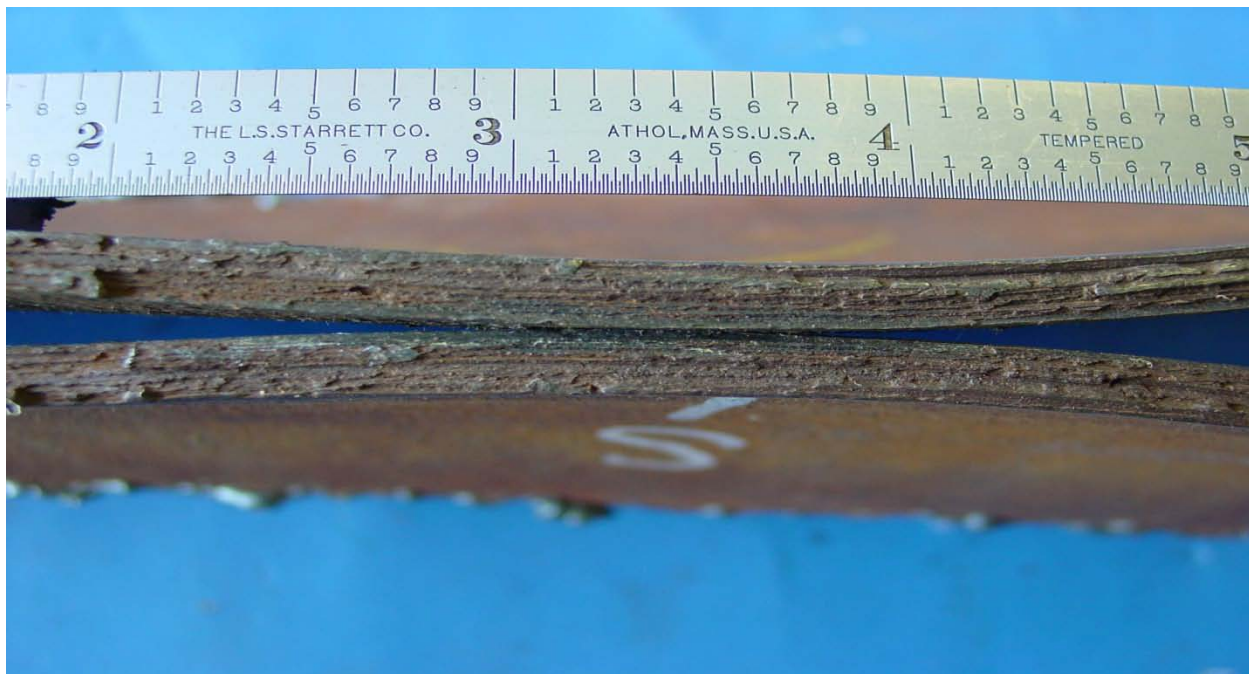
Figure 41. Fracture Surface of a Woody Fracture – Case Number W3

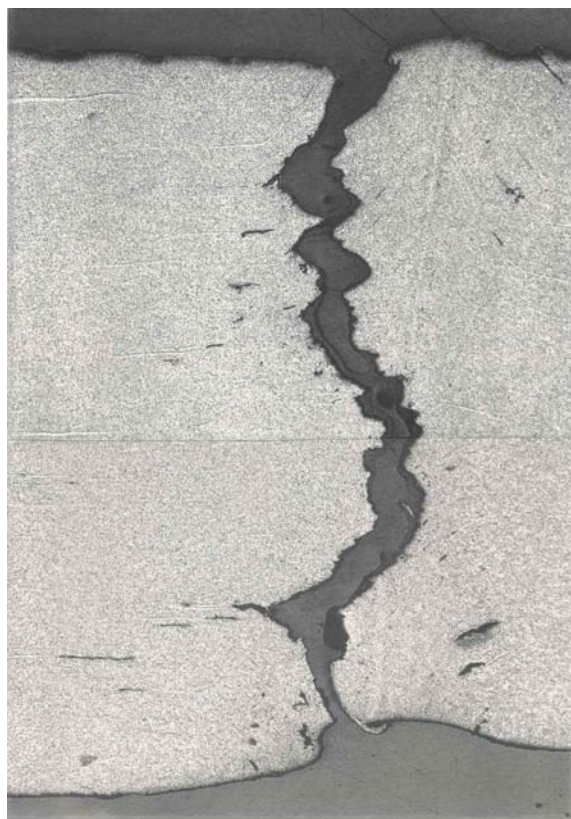
Figure 42. Metallographic Section across Woody Fracture – Case Number W3

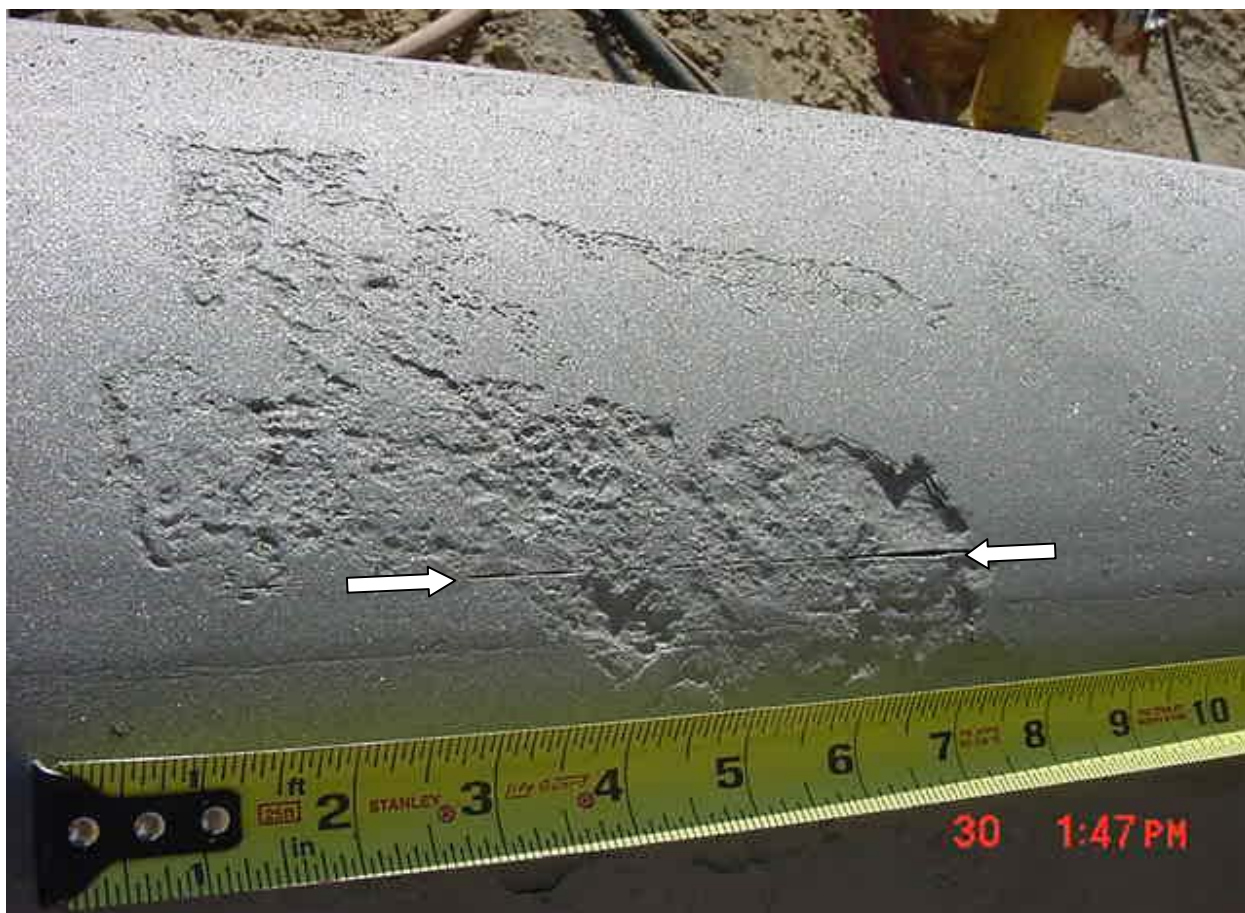
Selective seam weld corrosion as it appears at the surface of a pipeline is illustrated in Figure 43. It tends to appear as a straight groove within an area of corrosion-caused metal loss.

Figure 43. Selective Seam Weld Corrosion

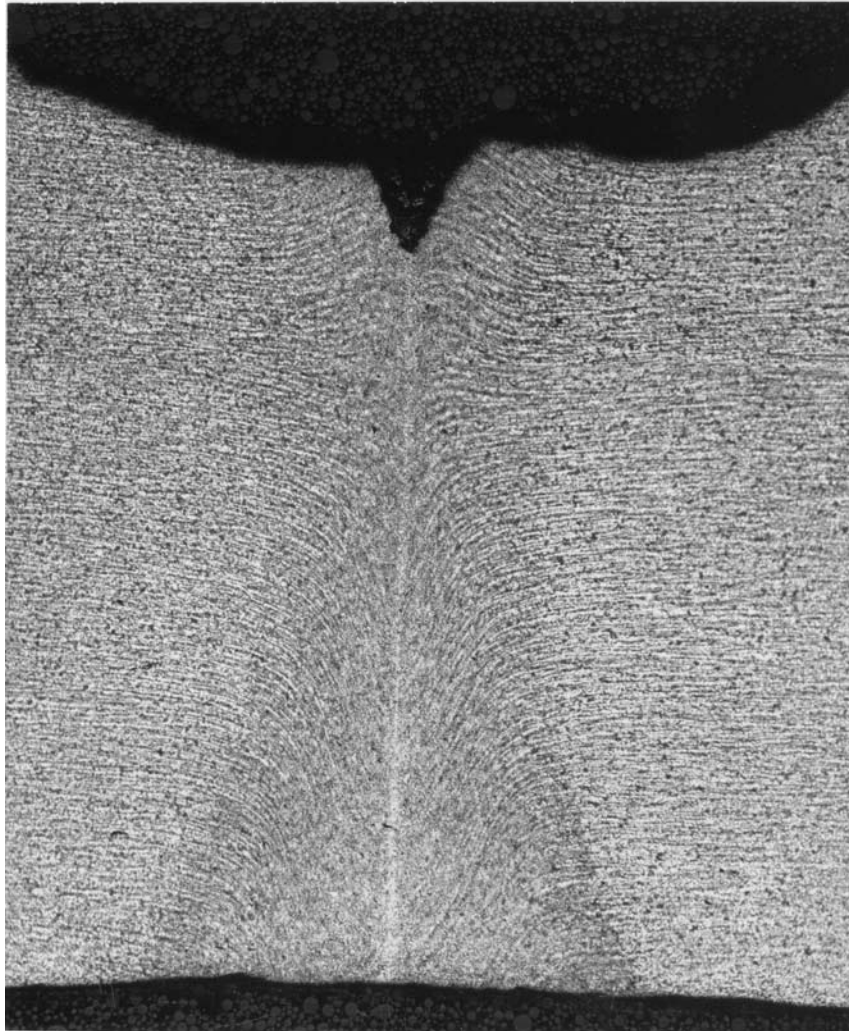
Selective seam weld corrosion typically advances at a rate of 2 to 4 times that of the corrosion in the surrounding base metal. Consequently, selective seam weld corrosion will tend to appear as a deeper groove at the bondline within the adjacent, shallower pipe body metal loss. The ratio of depth of corrosion at the bondline to the depth of corrosion in the adjacent pipe body is sometimes referred to as the “grooving” ratio. An example of the grooving is shown in a cross-section of the wall thickness in Figure 44.

Figure 44. Selective Seam Corrosion with a Grooving Ratio of About 2 in a High-Frequency-Welded Seam

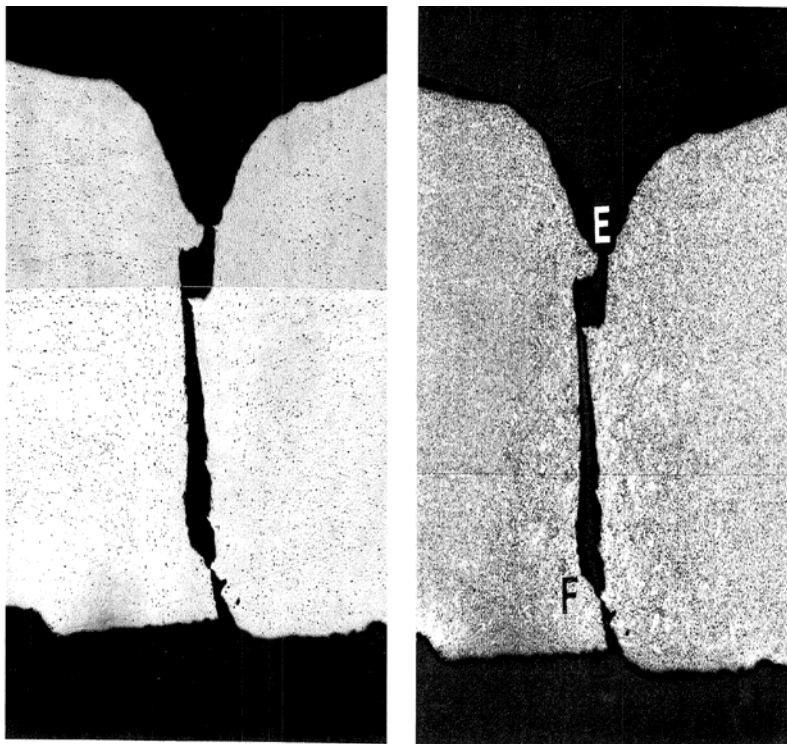
Figure 50. Close-up of the Selective Seam Corrosion in Case Number 1 Showing that it Was Not Centered on the Bondline

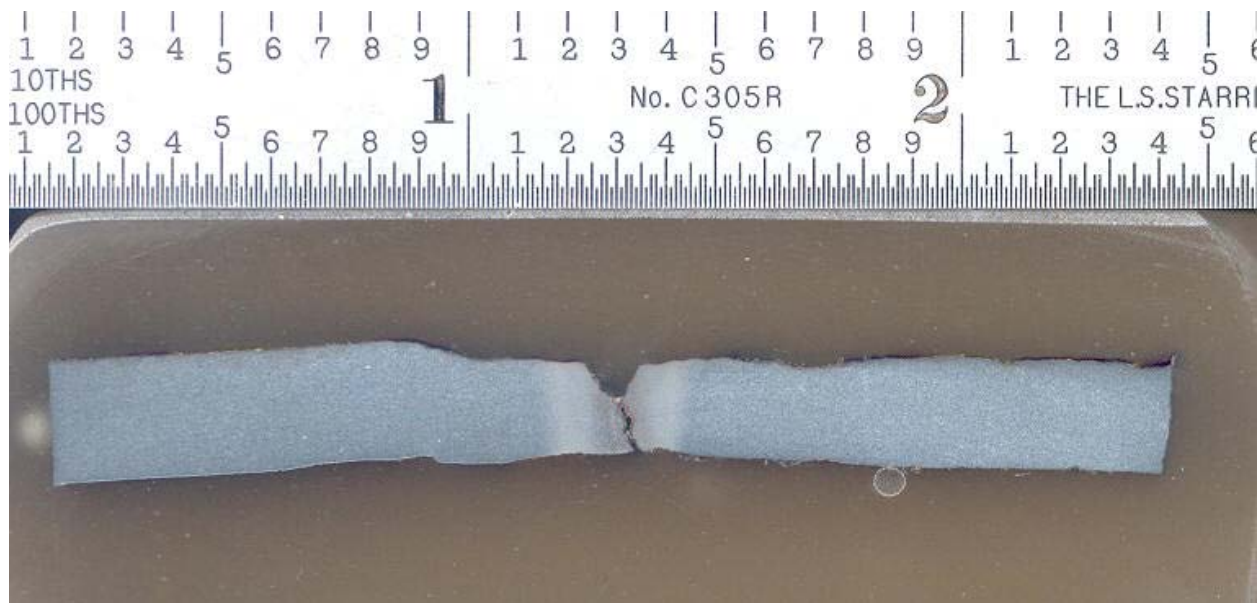
In this case the 12.75-inch-OD, 0.250-inch-wall, X52, low-frequency-welded pipe ruptured in service at a stress level of 61.6 percent of SMYS 20 years after a test to a stress level of 91.7 percent of SMYS. The test-pressure-to-failure-pressure-ratio was 1.49. A metallographic section across the rupture is shown in Figure 51. Although the seam area is selectively corroded, the tip of the corrosion is relatively blunt.

Figure 51. Selective Seam Weld Corrosion in Case Number 2 showing a Relatively Blunt Corrosion Tip

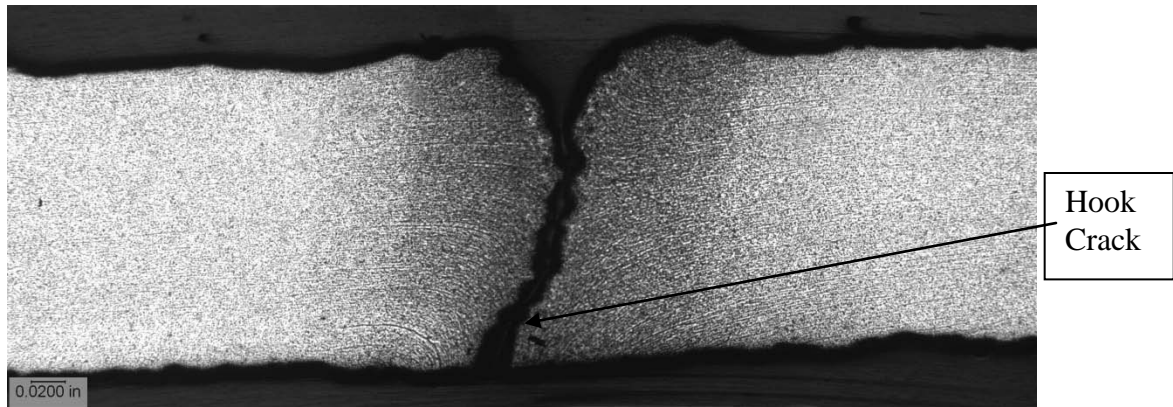
Figure 57. Cross Section of SSWC Case Number 14 Anomaly

In this case the pipe was a 12.75-inch-OD, 0.250-inch-wall, X46 material with a low-frequency-welded seam. The pipe ruptured in a hydrostatic test at a stress level of 86.9 percent of SMYS three years after a test to a stress level of 95.9 percent of SMYS. The test-pressure-to-prior-test-pressure-ratio was 1.10. The selective seam corrosion anomaly that initiated the failure was 2 inches long and had penetrated 24 percent of the wall thickness. A cross section of the anomaly is shown in Figure 57. A small ID-surface-connected hook crack may have contributed to this failure.

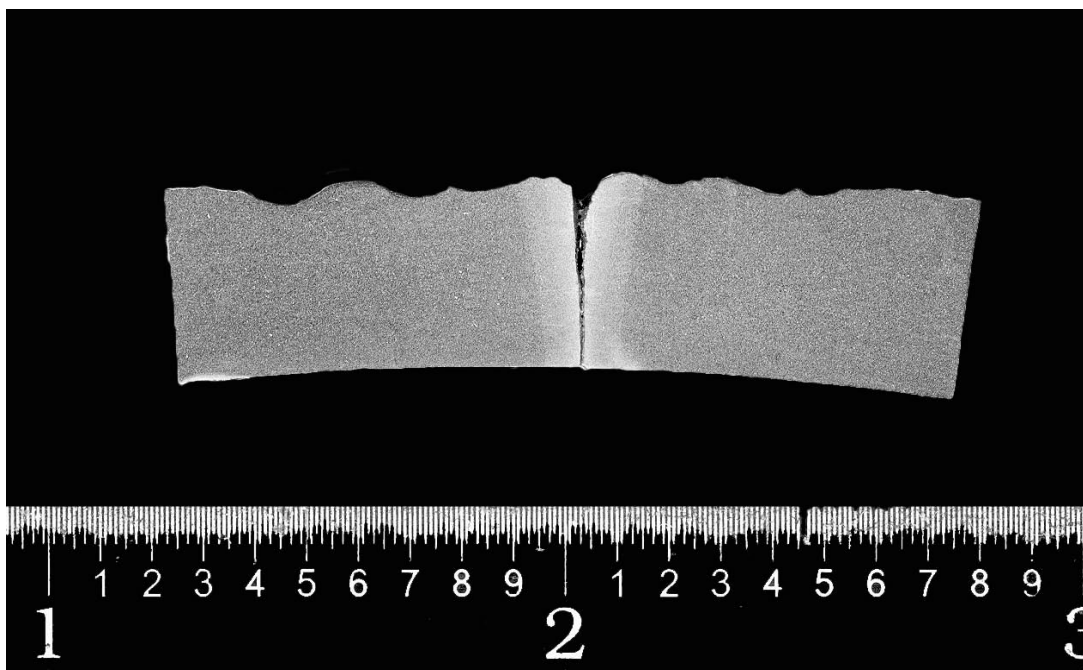
Figure 58. Cross Section of SSWC Case Number 15 Anomaly

In this case the pipe was a 16-inch-OD, 0.375-inch-wall, Grade B material with a low-frequency-welded seam. The pipe ruptured in-service at a stress level of 7.3 percent of SMYS. No prior hydrostatic test had been conducted as this pipe was part of a natural gas distribution system with an MAOP of less than 20 percent of SMYS. The selective seam weld corrosion was narrow and deep with a grooving ratio in excess of 4. The cross section of the corrosion is shown in Figure 58.

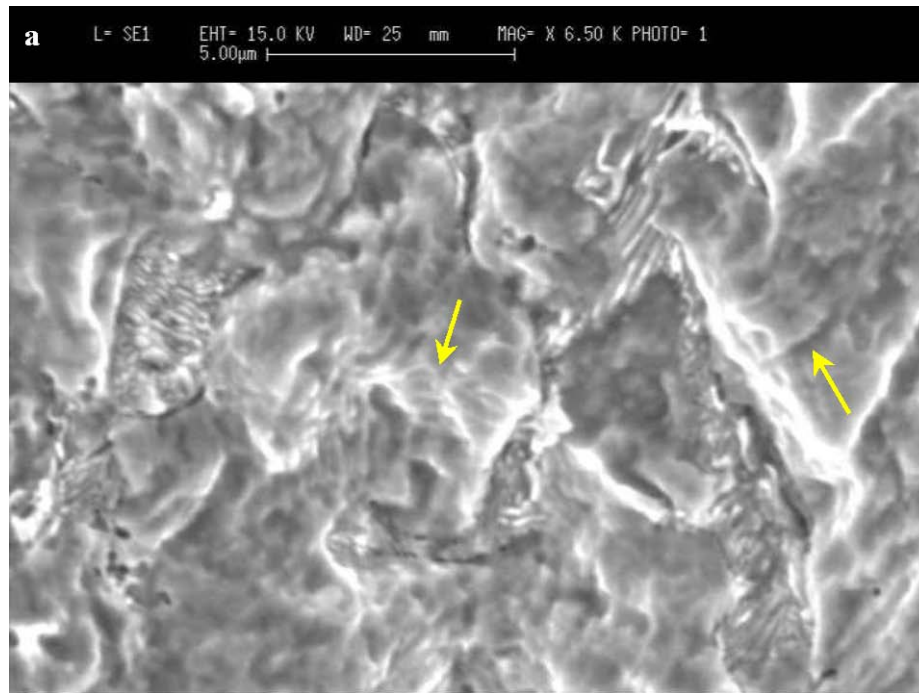
Figure 70. SEM Image of Possible Fatigue Crack Area, 6500X

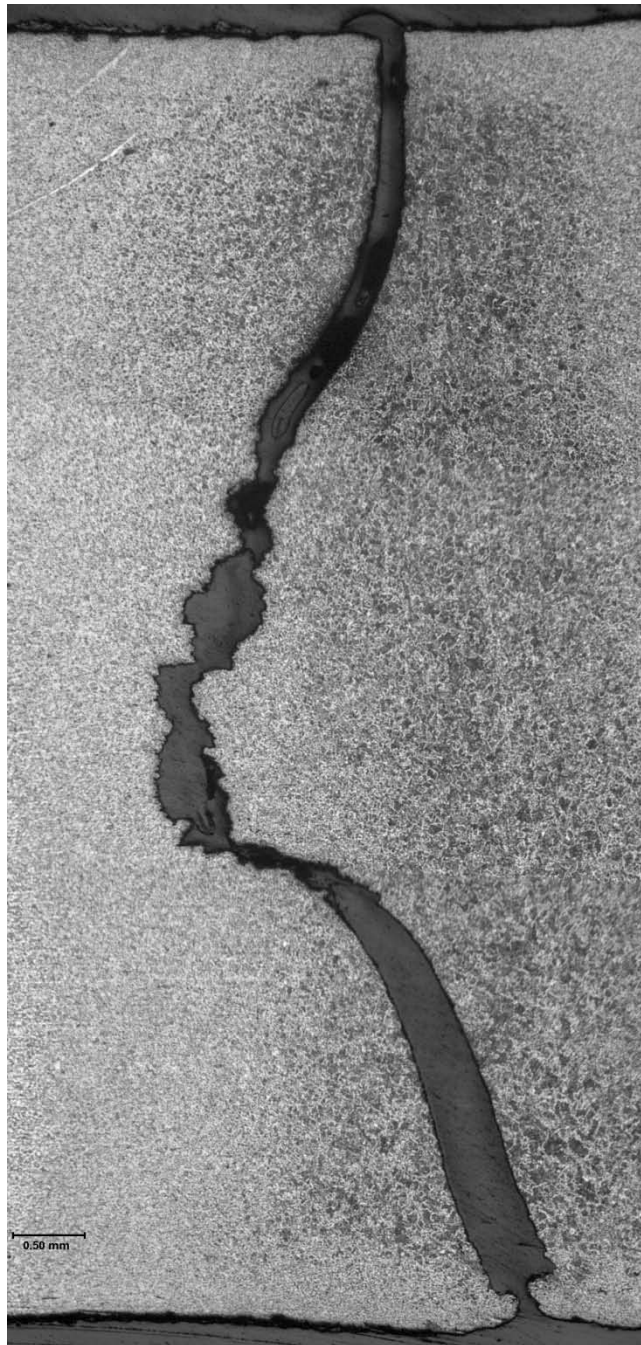
Figure 86. Cross Section of Fatigue Case Number 18 Anomaly

predicted failure stress level of 119 percent of SMYS, a level well above the actual failure stress level of 85.9 percent of SMYS.

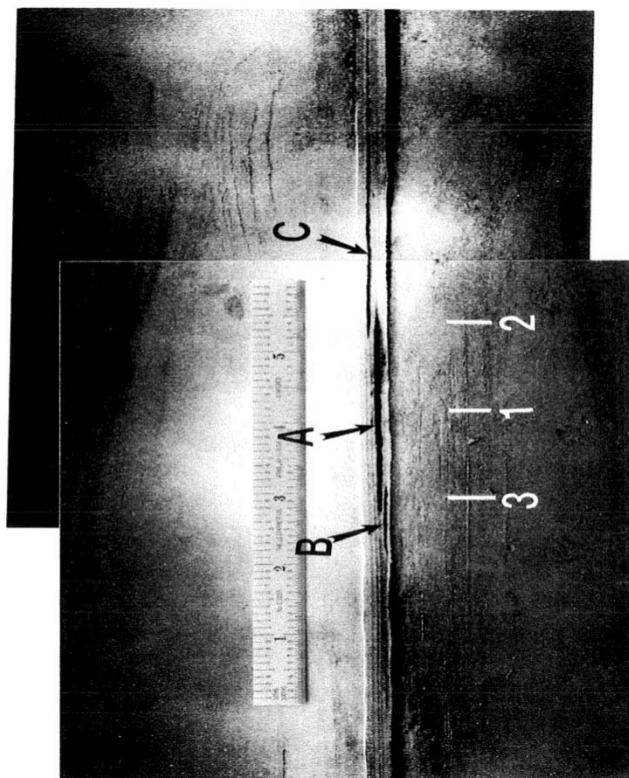
Figure 92. Pipe Surface Showing Anomalies in the Flash-Welded Seam of the Pipe in Fatigue Case Number 24

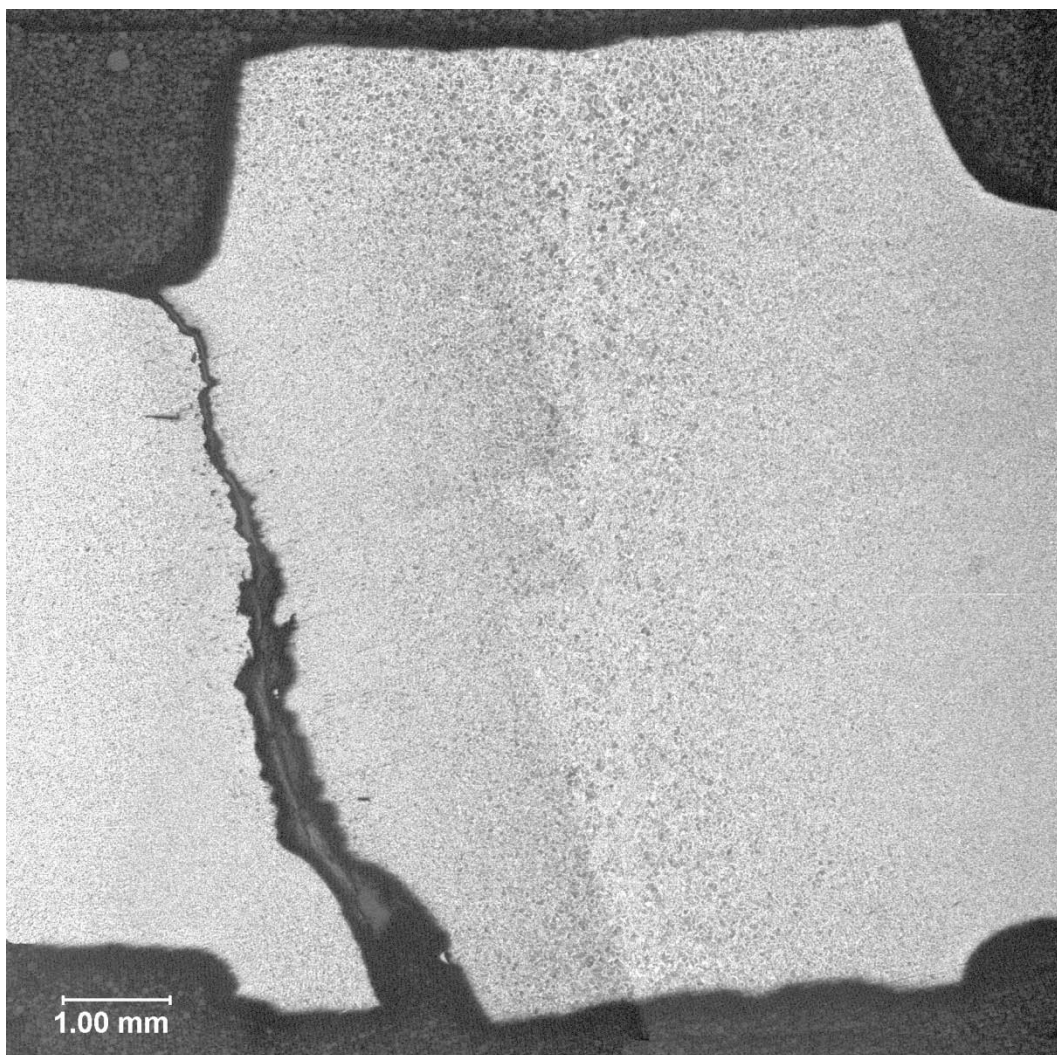
Figure 98. Metallographic section across the weld showing the various stages of cracking

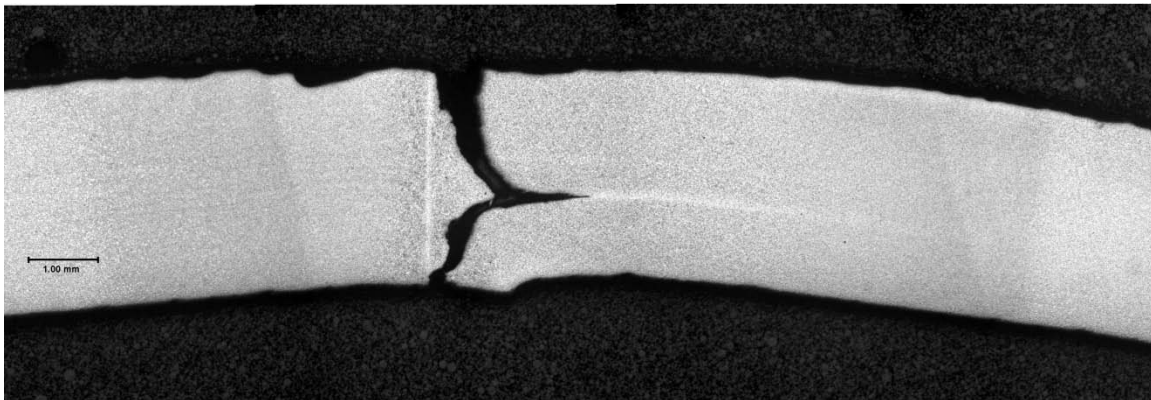
Figure 99. Combination of SCC and Hook Crack the Caused a Hydrostatic Test Rupture

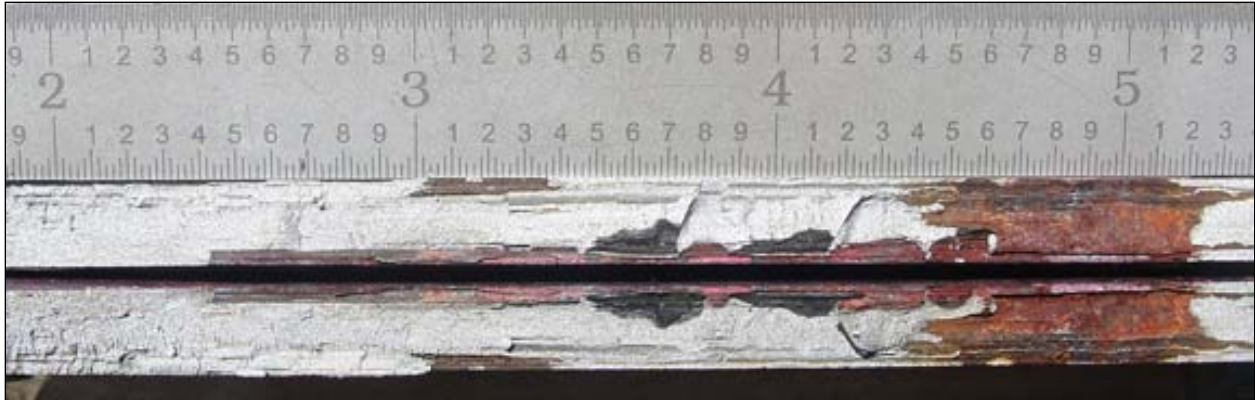
Figure 100. Fracture Surface Showing SCC on the Same Plane as Hook Cracks
