# **Development of Dual Field Magnetic Flux Leakage (MFL) Inspection Technology to Detect Mechanical Damage**

Contract No. DTPH56-06-T-000016 (Project #203)

March 2013

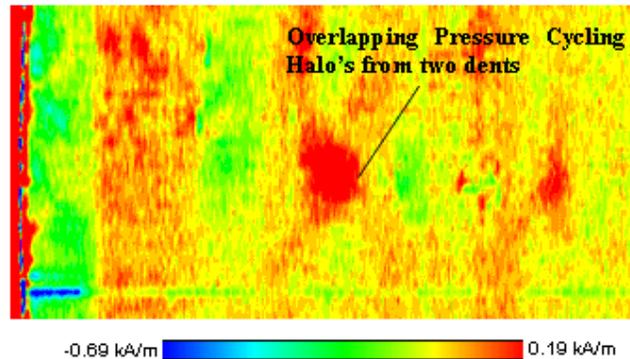
Dent 2 was made with two dents side by side, which have the same geometries and depths as dents 5 and 7, to see what effect this will have on the decoupled signal. In Figure 18, the signal pattern is unclear, but it does look like the decoupled signal patterns from two individual dents placed next to one another with partial overlap. For example, there appear to be three areas that are positive with respect to background, that are likely composed of the individual pressure cycling signals. The area in the middle of the signal where one would expect overlap between the individual pressure cycling signals does in fact have an average amplitude approximately 50% greater than the individual pressure cycling signal from Dent 9.

**Figure 18. Decoupled pull test results with background subtraction corresponding to Dent 2 in Figure 4 and table 1. Applied high and low fields are 170 Oe and 73 Oe (13.5 kA/m and 5.8 kA/m) respectively. The area where two pressure cycling halos from neighboring dents overlap is identified.**

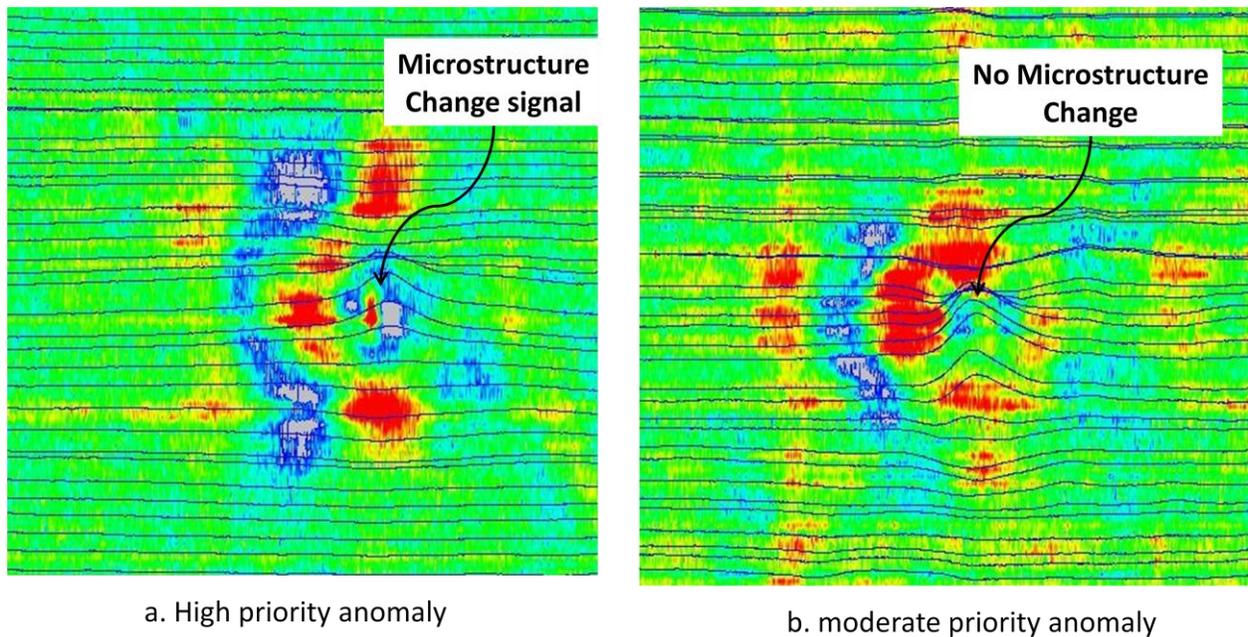
Analysis of the data showed a clear difference in the decoupled signals for dents with nominally the same dent geometry. Figure 20 shows the decoupled data in color and caliper data with lines for a moderate and a high priority anomaly as determined by the dual field methodology. Comparing the caliper data for both anomalies, the image on the right shows a slightly deeper, wider and more abrupt dent. This anomaly was rated as a moderate priority because the dual field magnetization technique did not detect any microstructural change or gouging at the deepest part of the dent. The image on the left shows a distinct signal at the deepest part of the dent that usually correlates with cold working of the steel; this signal caused the anomaly to be rated as a high priority. Both images show the stress signal at the shoulder of the dent (larger red areas), and a re-round signal away from the dent (large blue and grey area). The image on the right is very similar to some of the more severe anomalies created in test samples used for the development of the dual magnetization technology.

**Figure 20. Decoupled MFL data in color and caliper data in lines for two dents on 30-inch liquid pipeline.**

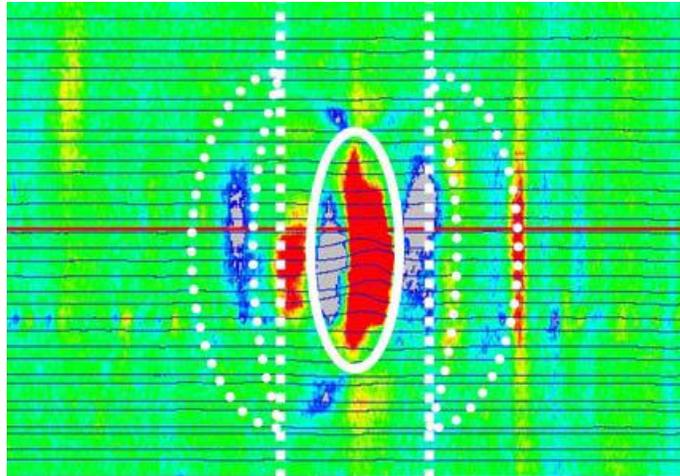
**a.) high priority anomaly**

Figure 21 shows the two ID anomalies (dents) with a high priority and low priority ranking. Decoupled signal data is shown with the color image and caliper data are overlaid in line view. The outline of the dent is shown with the solid white line. The original dent length before rerounding is indicated by the dashed vertical lines in both images, and the reround halo is only seen in the high priority anomaly. Dent depths were similar for the two dents, however, the dent strain as seen in the disturbance in line data is higher for anomaly identified as high priority in by the dual field analysis. In-the-ditch measurement methods will assist in further identifying possible micro-structural changes.

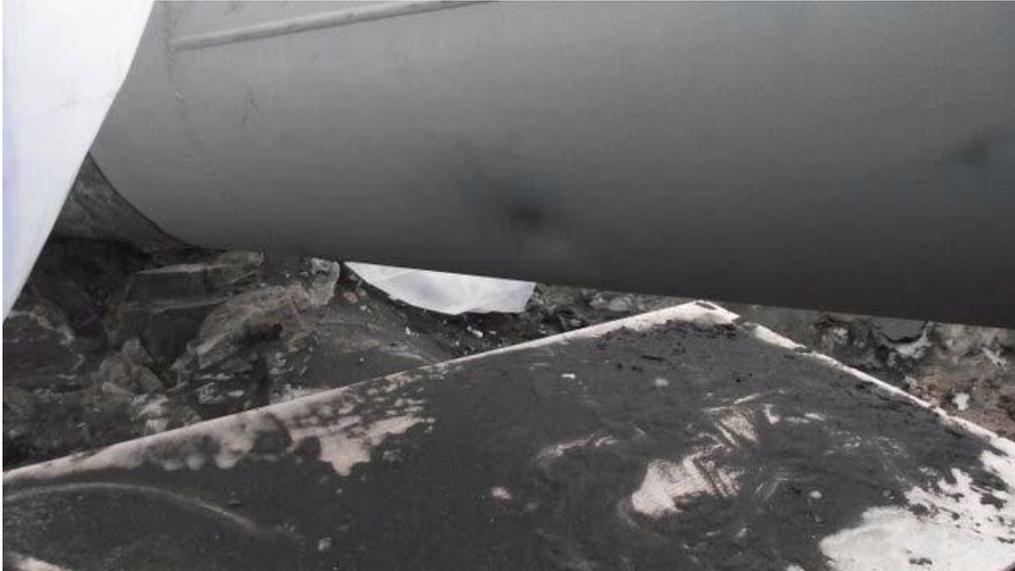
Dent 1, shown in Figure 22, is a bottom side dent with a plow/gouge signal and re-rounding halos from the ILI tool run data. The dent was marginally above 2% in depth and showed residual strains of greater than 6%. Dent 2, shown in Figure 23, was a top side dent with an adjacent hard spot and pressure cycling halos. The three dimensional (3-D) laser scan representation of dent 1 and dent 2 are shown in Figures 24 and 25 respectively. The VWA001 MWM-array scans of dent 1 and dent 2 are shown in Figures 26 and 27 respectively. The FA24 MWM-array scan was performed for dent 2 only and is shown in Figure 28.

**Figure 22. Photograph of Dent 1. This is a bottom side dent at 07:20.**

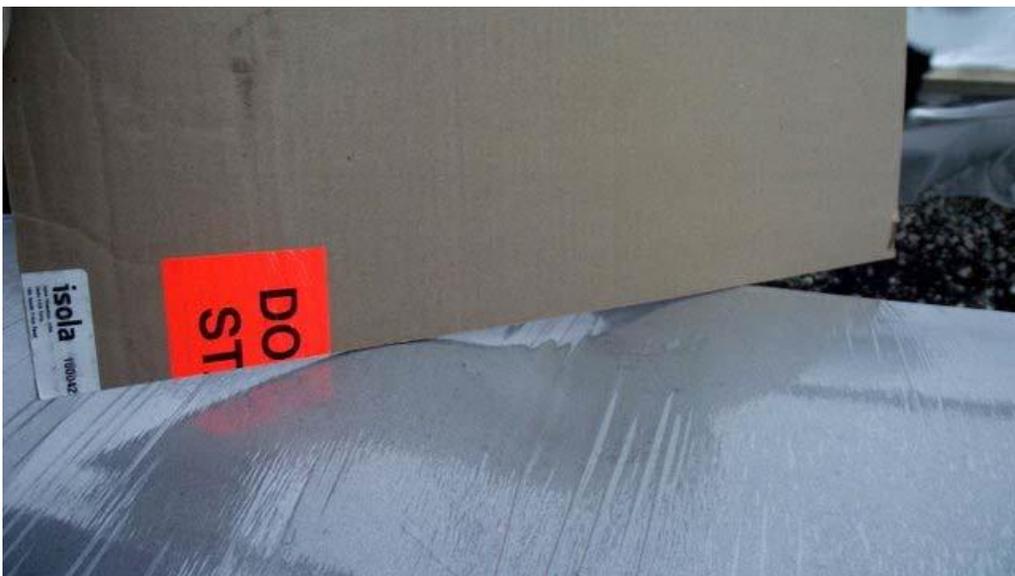
**Figure 23. Photograph of Dent 2. This is a top side dent 12:20. The pipe is wrapped in plastic.**

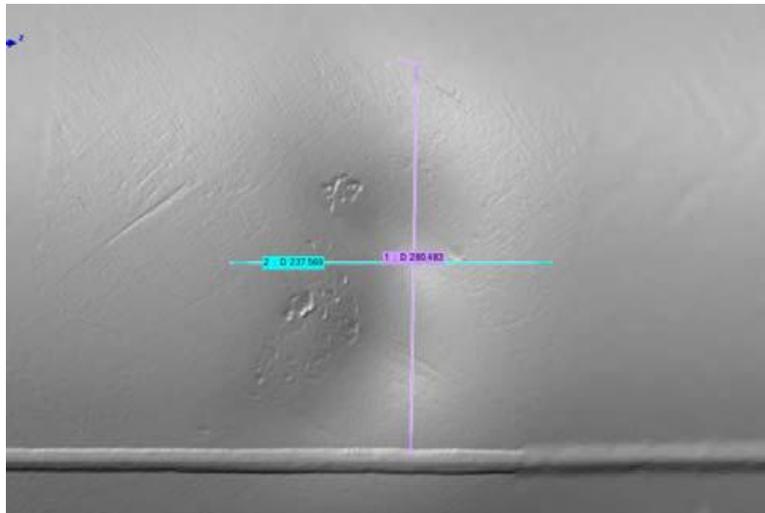
**Figure 25 Three dimensional (3-D) laser scan representation of Dent 2.**

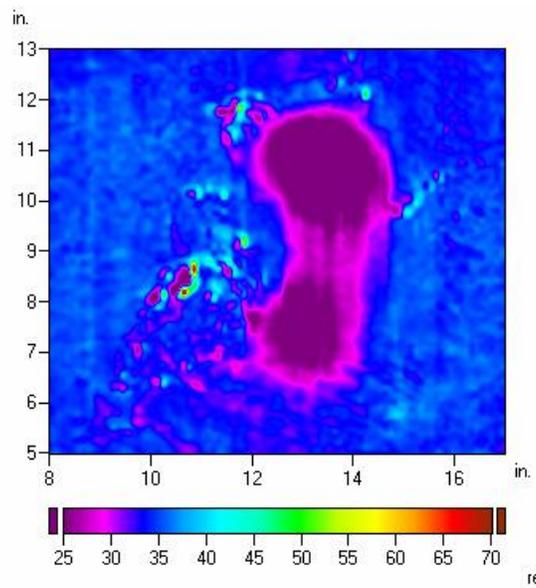
Figure 28. FA24 scan taken circumferentially in and surrounding the dent. Variations in permeability can be indicators of stresses, material changes (hard spots), and cracks.

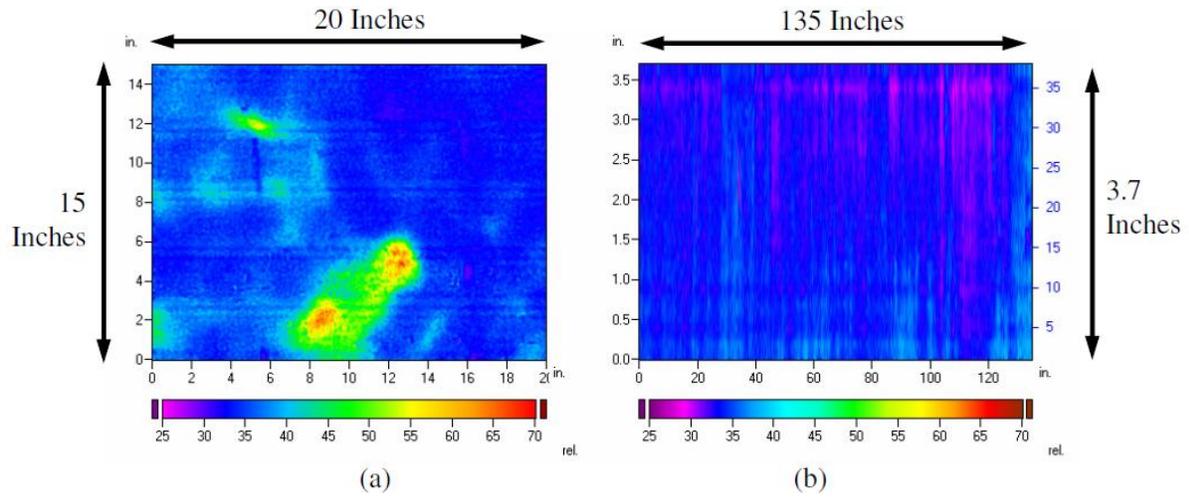
Figure 14: FA24 scans. (a) Permeability measurements in the area of the reported “hard spot”. (b) Permeability measurements taken over a 135 inch by 3.7 inch section of pipe. The axes on this image are not on the same scale

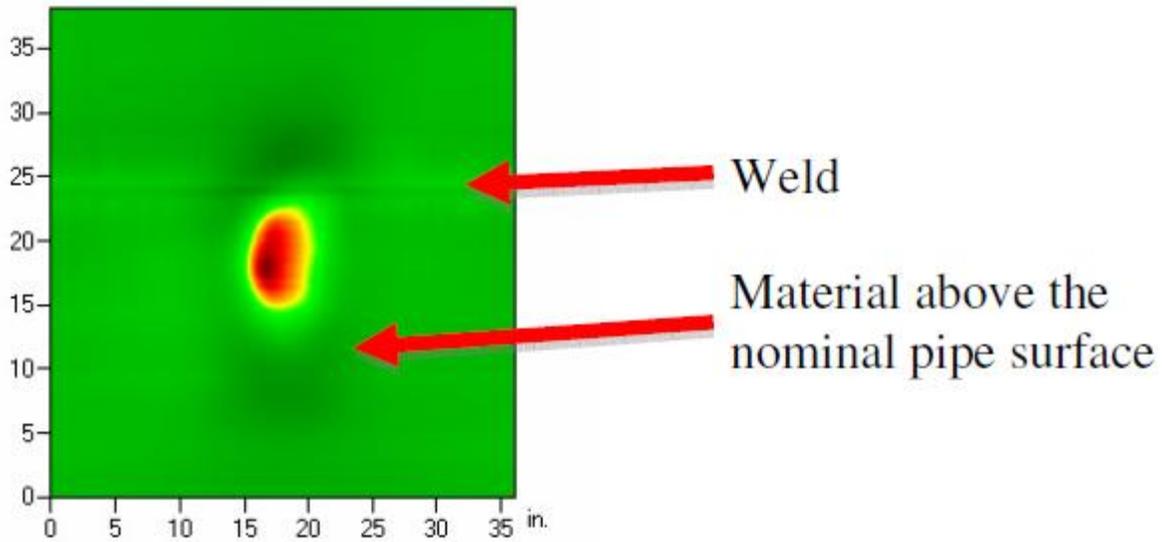
Figure 23: Composite scan image of the dent using the GridStation software. Color represents the depth of the dent relative to the nominal pipe surface. Note the area around the dent where the material protrudes above the nominal pipe surface (darker green).
