U.S. Department of Transportation
Pipeline and Hazardous Materials
Safety Administration
1200 New Jersey Ave., SE
Washington DC 20590
RE: Contract DTPH56-11-T-000003
Comprehensive Study to Understand Longitudinal ERW Seam Failures

Final Interim Report – Task 2.6

Characterizing Failure in ERW Line Pipe

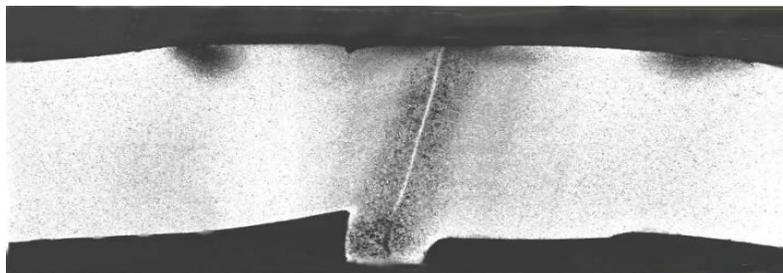
Figure 2. Section through a misaligned 1940s YS&T seam: $t = 0.312$ ”

It is evident from this view that misalignment coupled with a close scarf on the OD can lead to cases where the wall thickness is much reduced when compared to nominal, even considering typical production tolerances. While not apparent in this case, misalignment such as this opens to the formation of a lip that can roll from one side of the seam over the flash onto the other side of the seam, which creates an ID stress raiser that could serve as a site that nucleates axial cracking. It follows that serious misalignment opens to a number of potential integrity threats. While the microstructure is poorly characterized in the copy of report that this image was captured from, the skelp was not indicated to be a concern. The white band that tracks along the bondline is ferrite, and is commonly observed in such seams (in varying thicknesses) as it reflects steel that has been heated and decarburized prior to upsetting, but not ejected from the bondline. The darker fields that appear on the OD about a wall-thickness to either side of the

seam are contact marks, where the wheel electrode rode along the pipe wall. While not an issue for this weld, these areas can contain untempered martensite, and develop cracks if the process control is upset.

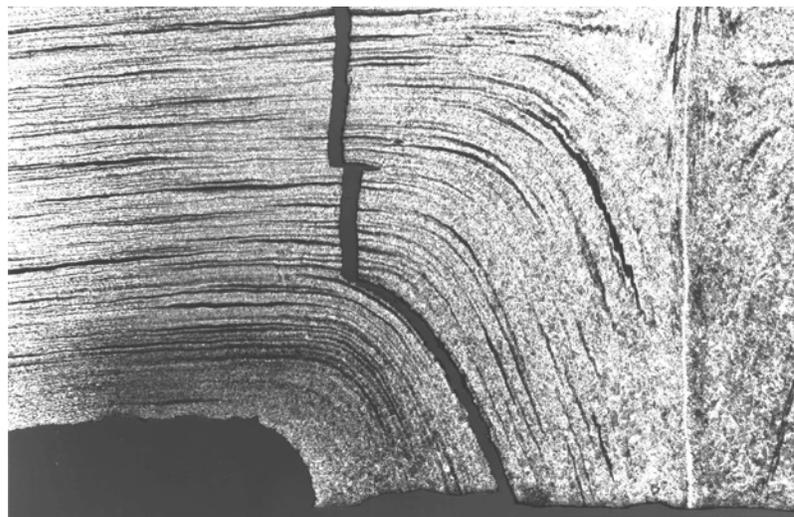
Figure 3. Section through 1950's FW seam showing about one-half of the wall thickness

The crack shown in the cross-section in Figure 3 is characteristic of hook cracks that form along 'out-bent fibers', whose shape reflects the macro-flow that occurs during the upset developed in the ERW seam process. This type of cracking is not driven by a process upset nor does it require misalignment. Rather, it occurs simply because the dirty steel contains concentrations of impurities that are strung-out and flattened during rolling of the skelp. The dirtier the steel, the more widespread are such features – which in very dirty steels lead to rather thick films and/or bands of pancaked inclusion stringers. Because the interfaces between the bands of impurities are weakly bonded to the adjacent pancaked steel grains, this layered structure is anisotropic and provides little strength or ductility in response to loading across such interfaces.

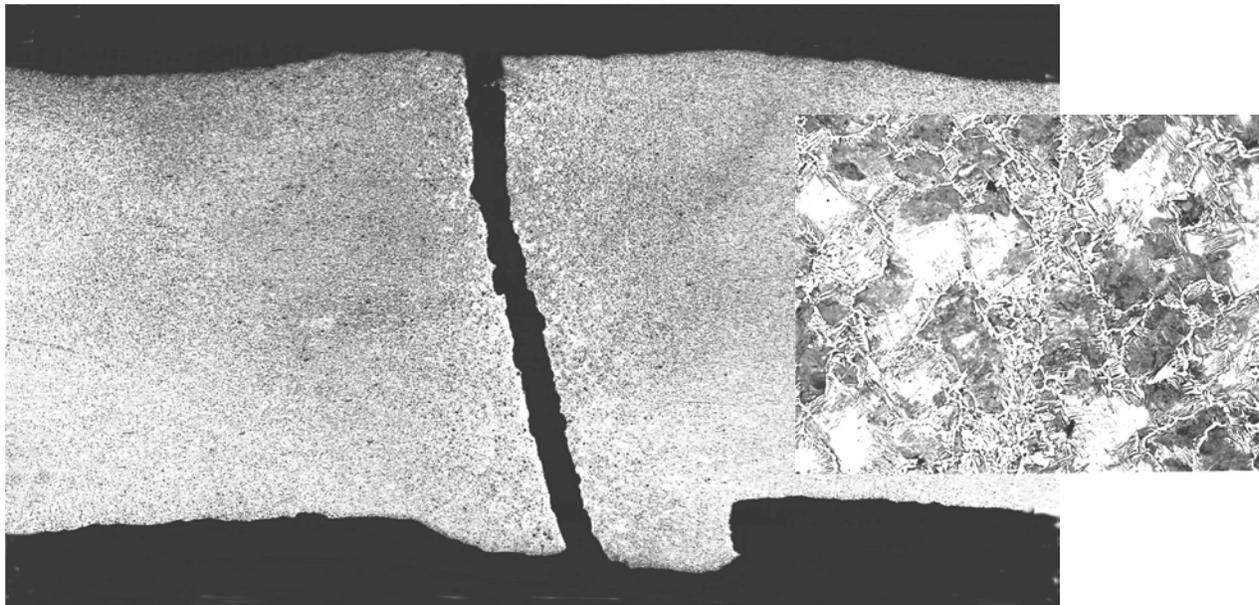
Figure 4. Cracking along a path with scattered areas of untempered martensite: $t = 0.250''$

The primary image in Figure 4 characterizes an overview of the seam and the crack path, which shows patches of coarse ferrite along the bondline. The inset image was initially captured at 500 times magnification in the usual 4x5-inch film format, which can be used to infer the scale of the microstructural features evident in the inset. The light grey fields are untempered martensite, the white fields are ferritic, while the dark grey fields are bainitic. As might be expected, cracking through patches of untempered martensite shows little evidence of ductility, and experiences limited resistance to its continued advance.

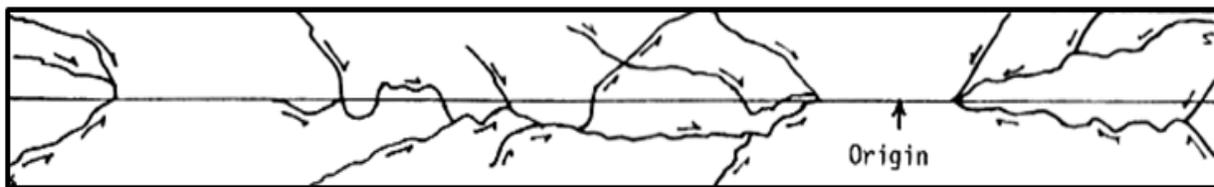
Figure 11 shows the fracture map for an ERW seam failure, for which the extent of the axial cracking was contained by the girth welds at either end of the joint that failed. It is usual to present the pipe with the longitudinal seam (if present) or some clock position noted central to the surface of the pipe as if the pipe were unrolled. Thus, the line placed at mid-height in this figure shows the location of the ERW seam, with the path of the cracks located on the unrolled pipe, with one-half the circumference shown either side of the seam. The arrows placed along the crack paths indicate the direction of the cracking determined in this case by the presence of chevrons on the fracture surfaces. Once the segment containing the origin as indicated in the mapping was identified, the investigation shifted into the laboratory wherein the details along the seam led to identification of the origin as a cold weld.

Figure 11. Fracture mapping for an early vintage ERW seam

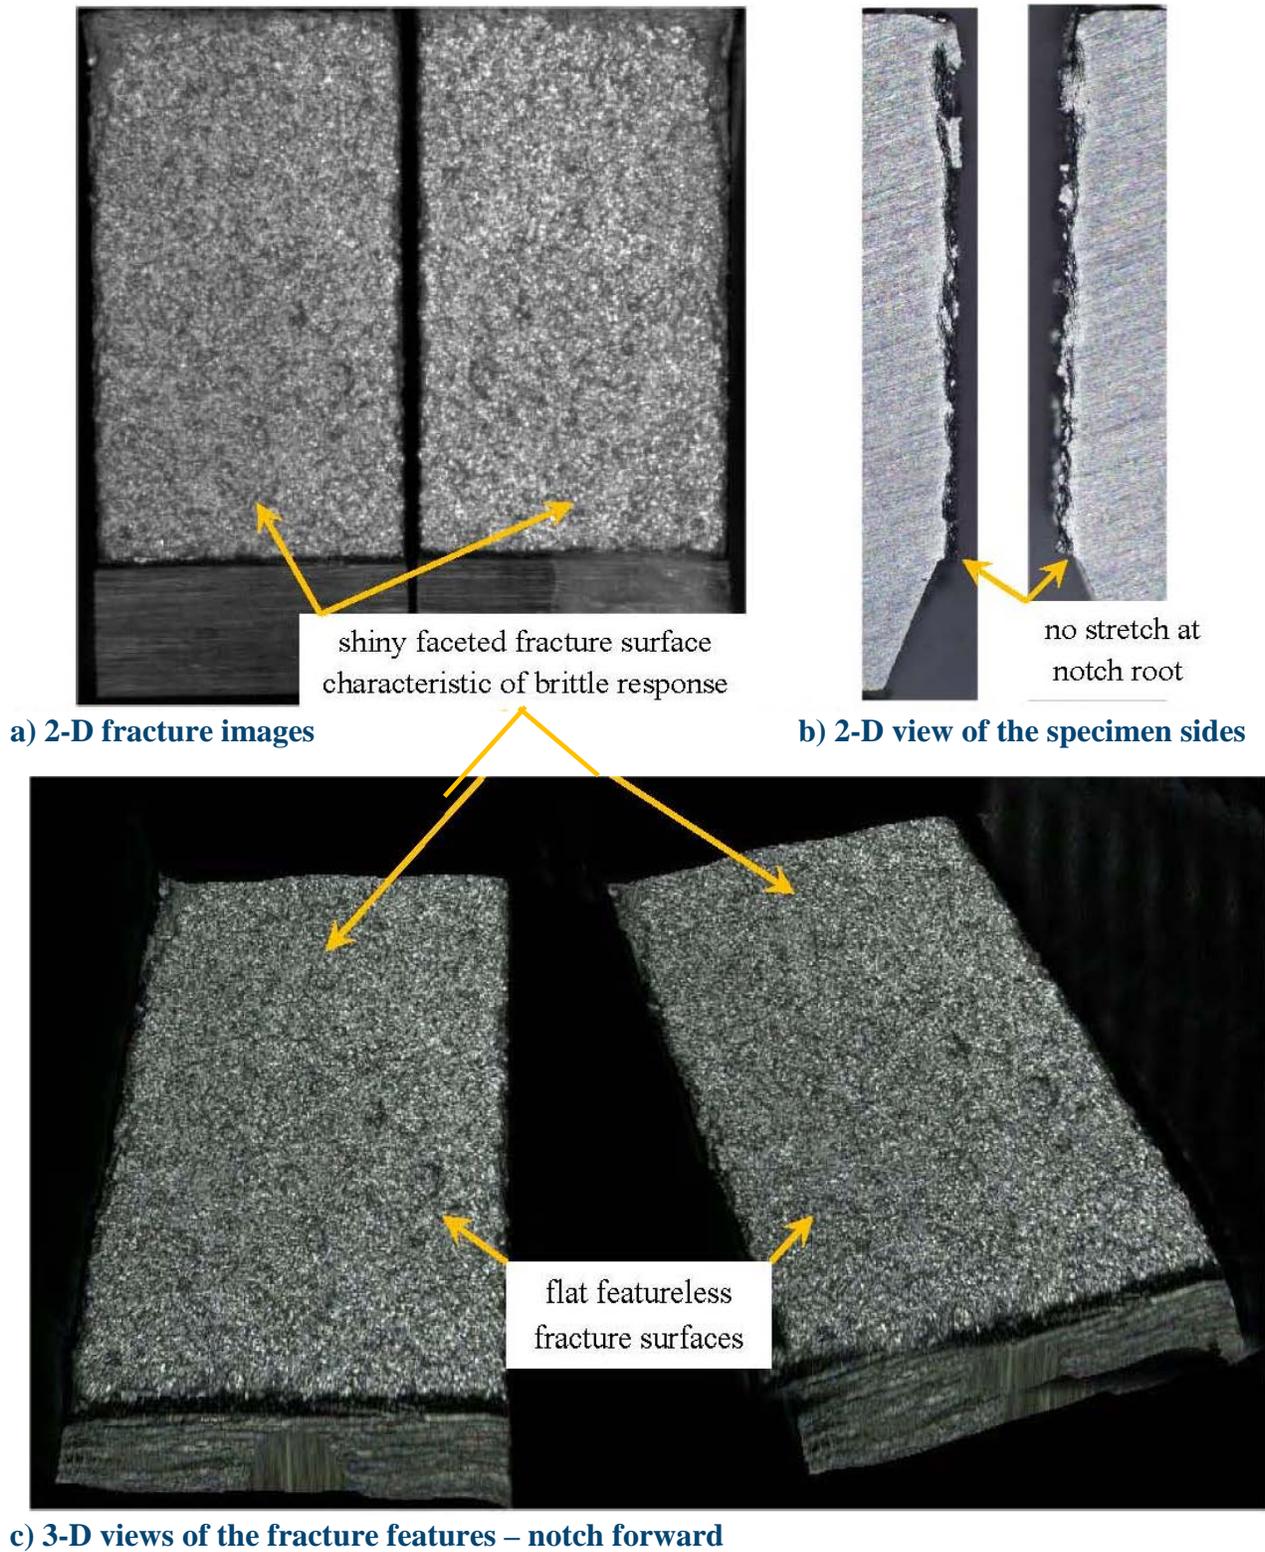
Figure 14. Half-size CVN specimen # 7-1 in the bondline: 4.5 ft-lb (FSE) & 3% SA

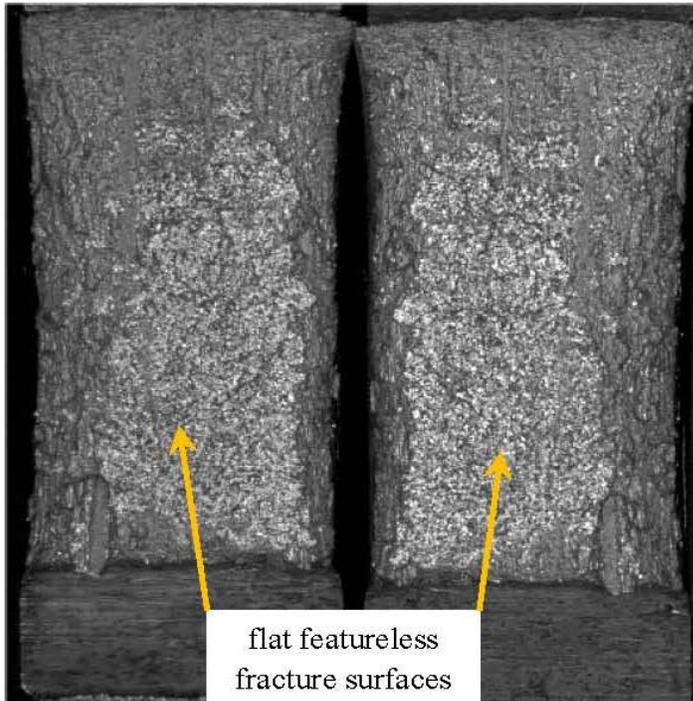
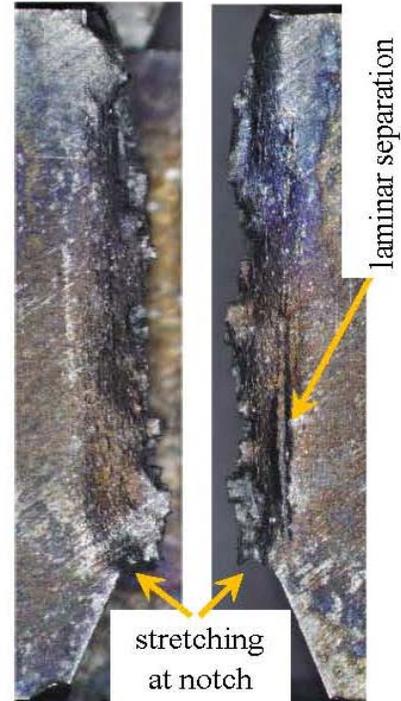
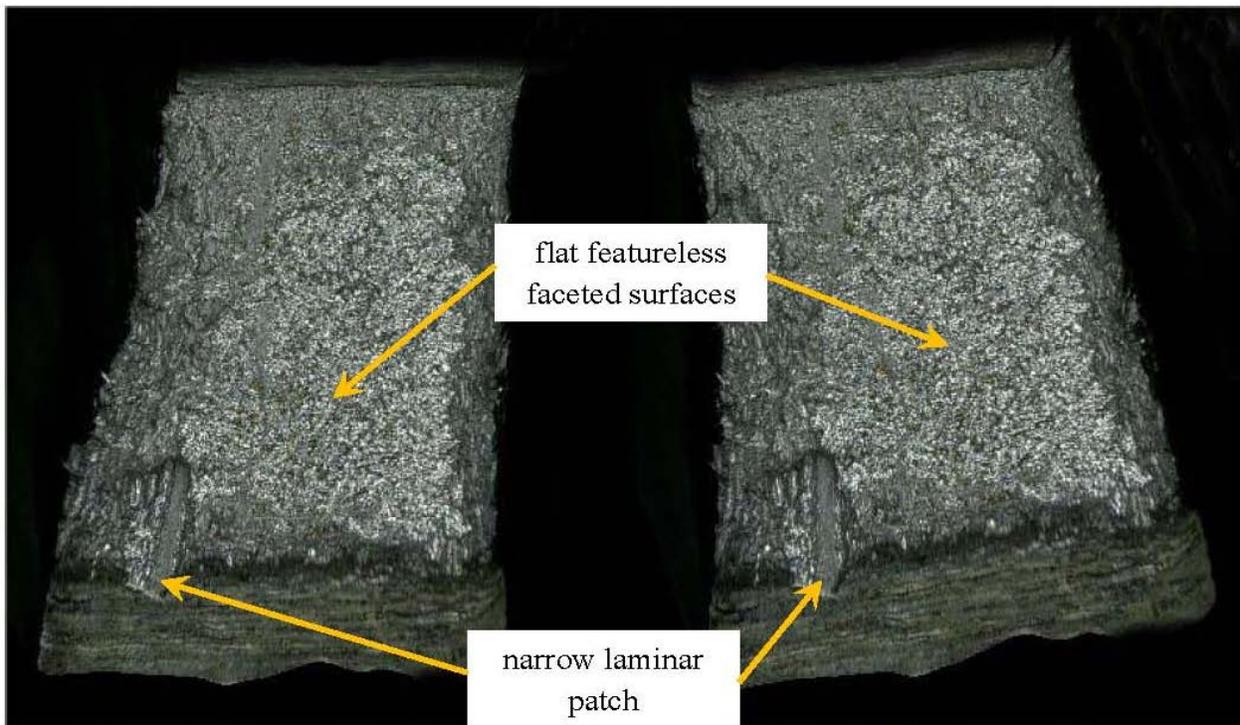
c) 3-D views of the fracture features – notch forward: about half in the still brittle bondline

Figure 15. Half-size CVN specimen # 7-5 through the seam: 11.1 ft-lb (FSE) & 47% SA

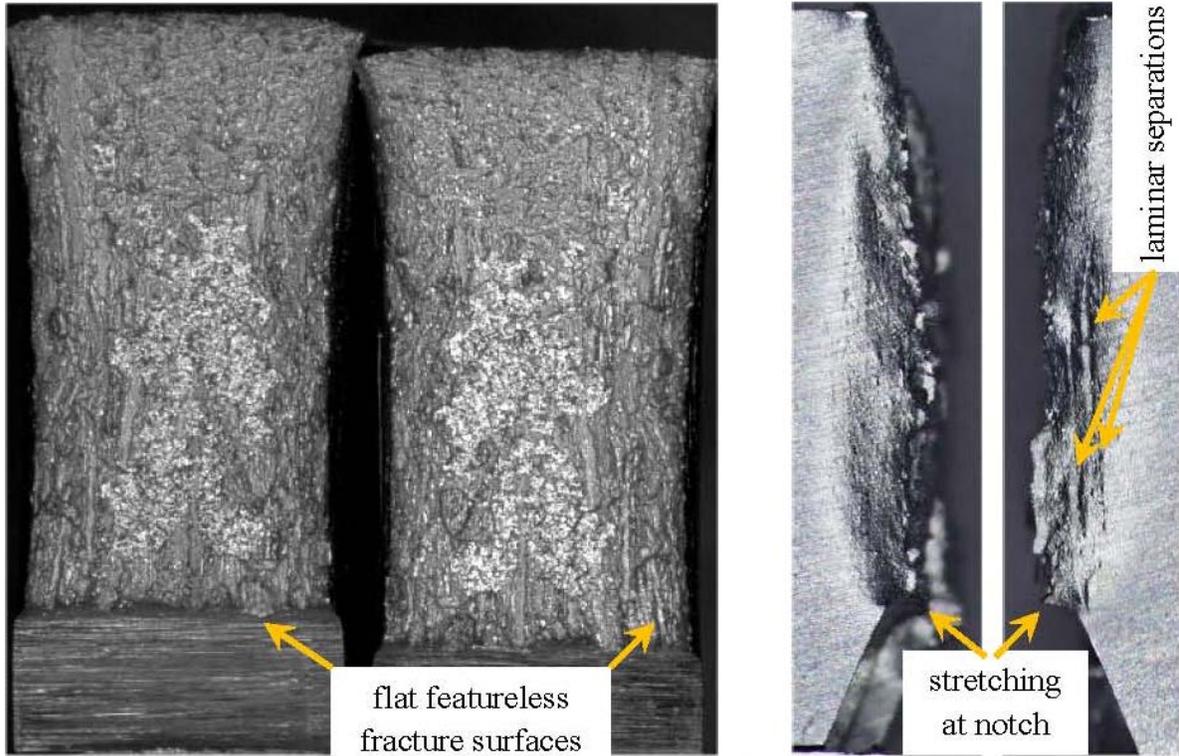
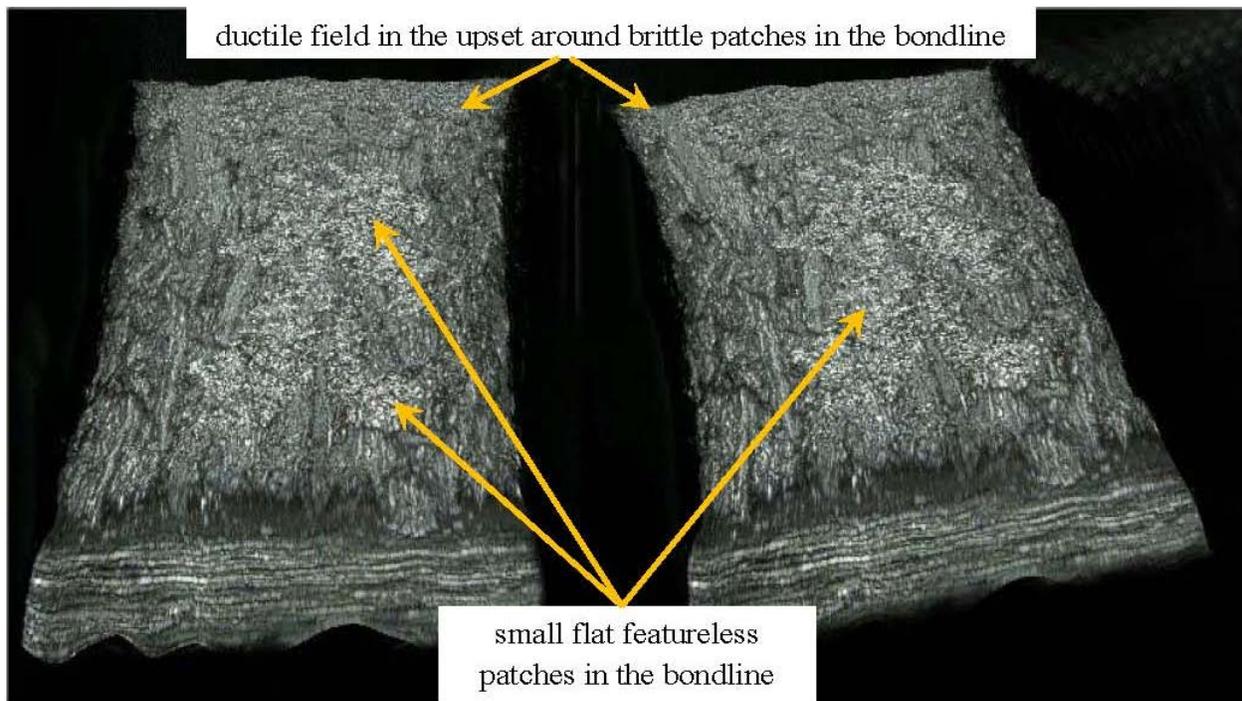
c) 3-D views of the fracture features – notch forward: mostly off the still brittle bondline

Figure 16. Half-size CVN specimen # 7-13 in the seam: 18 ft-lb (FSE) & 72% SA

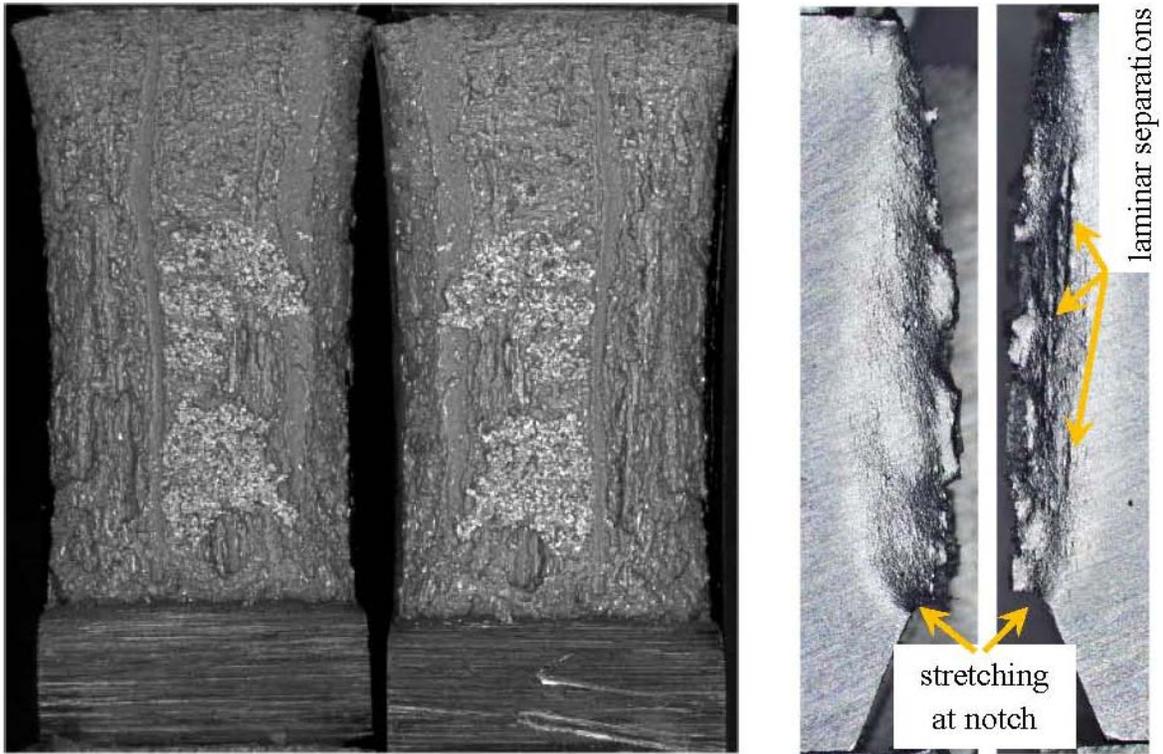
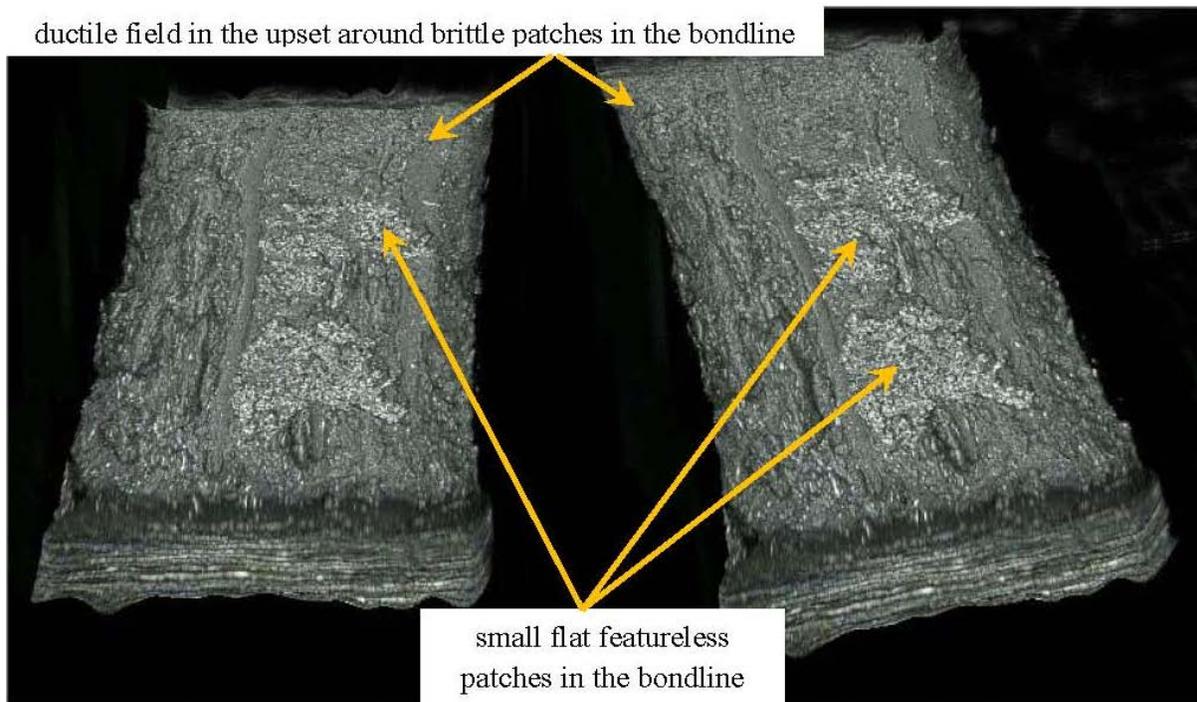
c) 3-D views of the fracture features – notch forward: mostly off the brittle bondline

Figure 17. Half-size CVN specimen # 7-7 in the seam: 17.8 ft-lb (FSE) & 75% SA

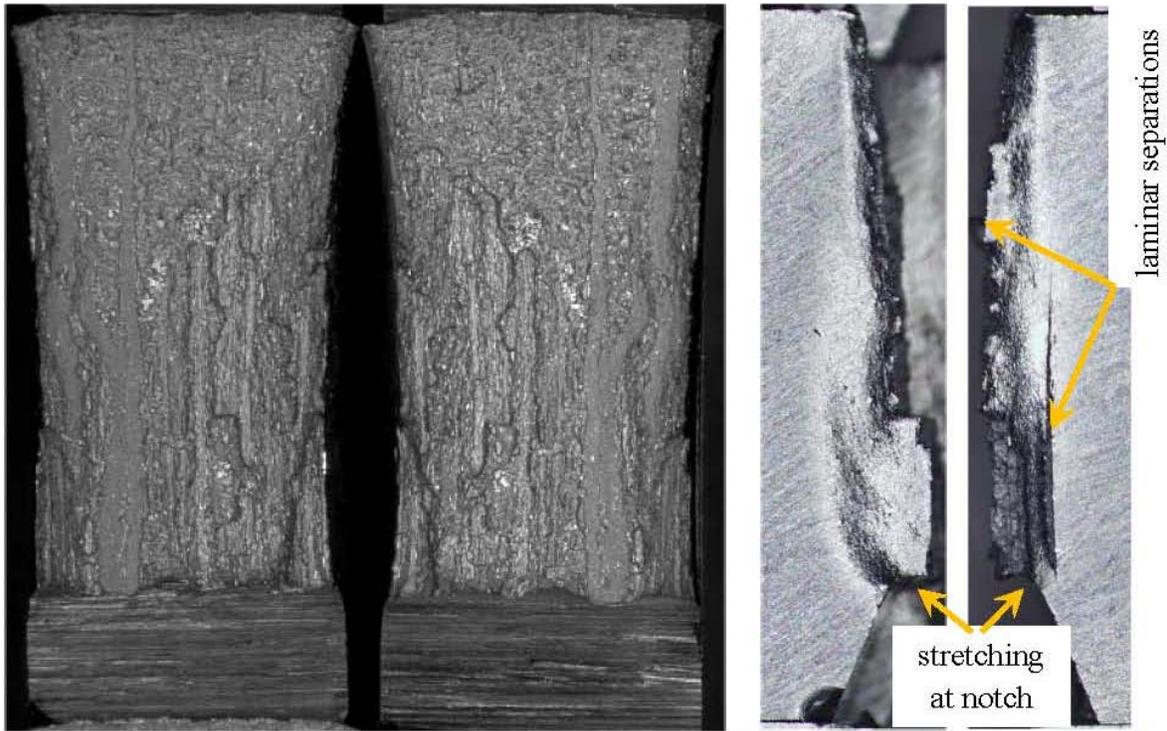
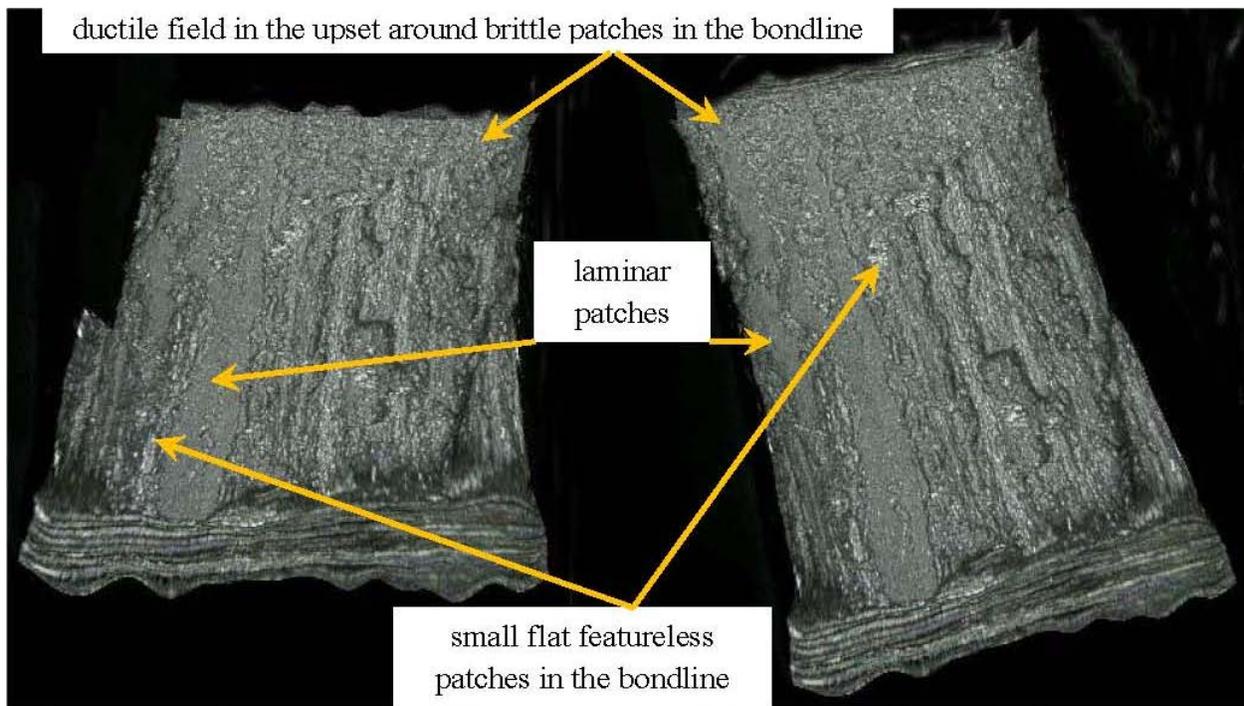
c) 3-D views of the fracture features – notch forward; primarily off the still brittle bondline

Figure 18. Half-size CVN specimen # 7-8 in the seam: 18 ft-lb (FSE) & 98% SA

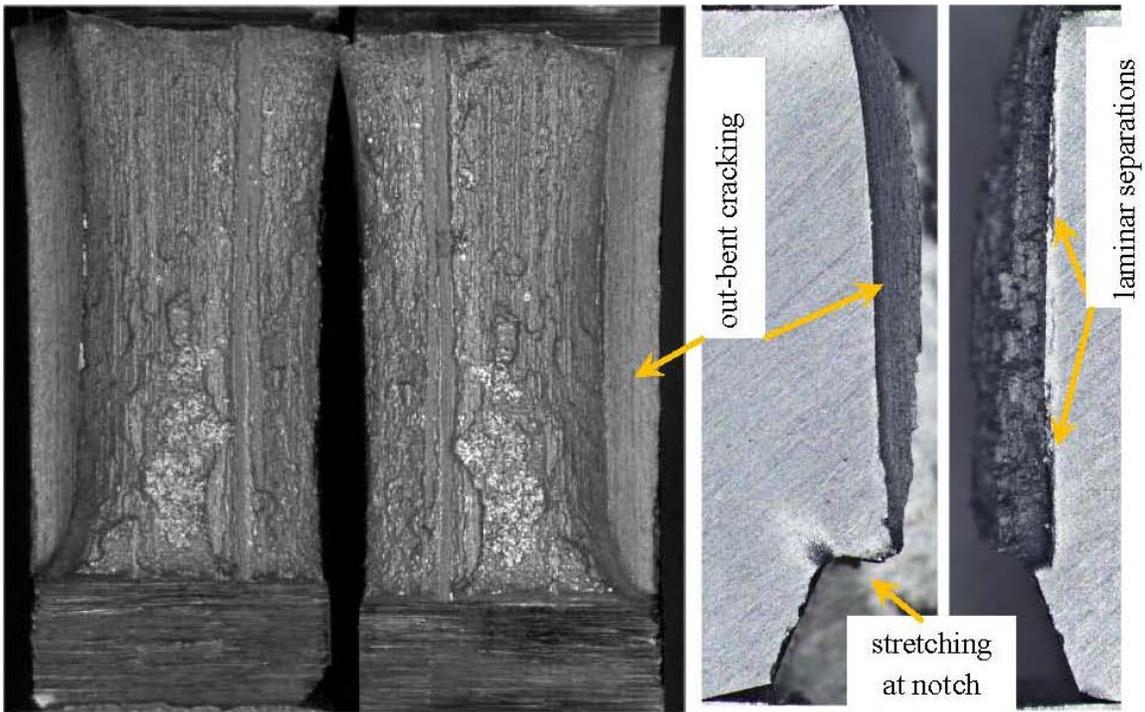
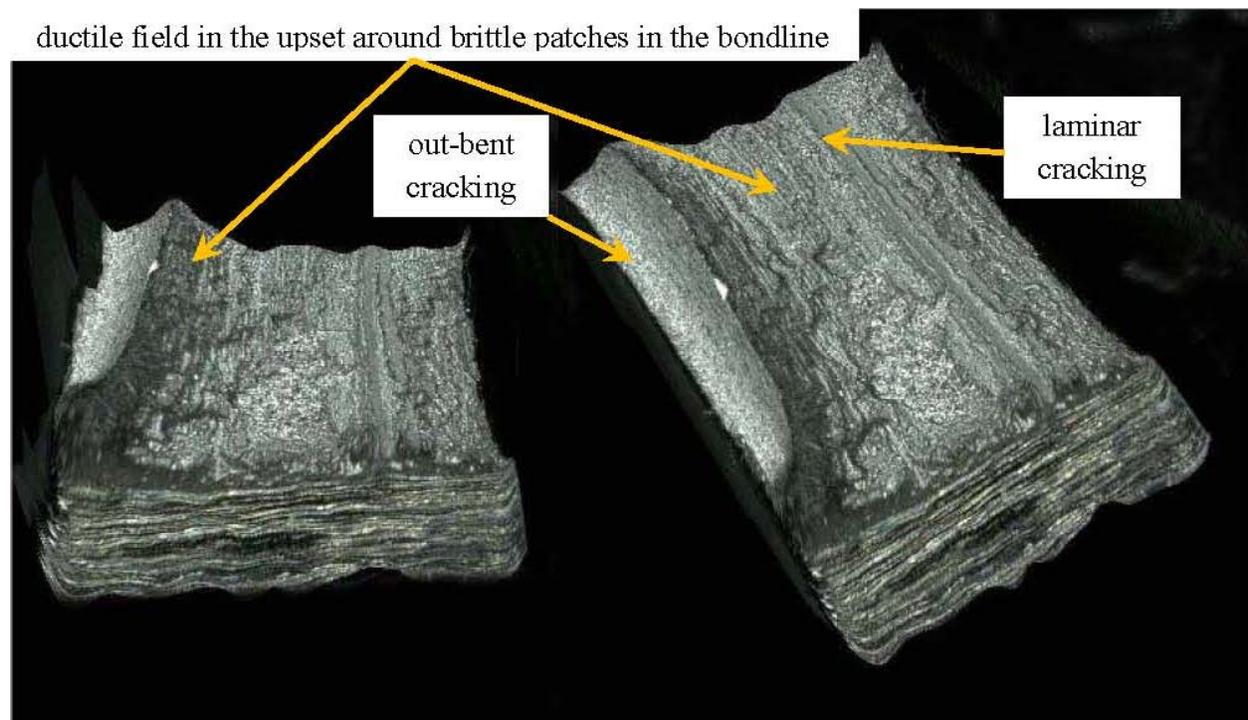
c) 3-D views of the fracture features – notch forward; largely off the still brittle bondline

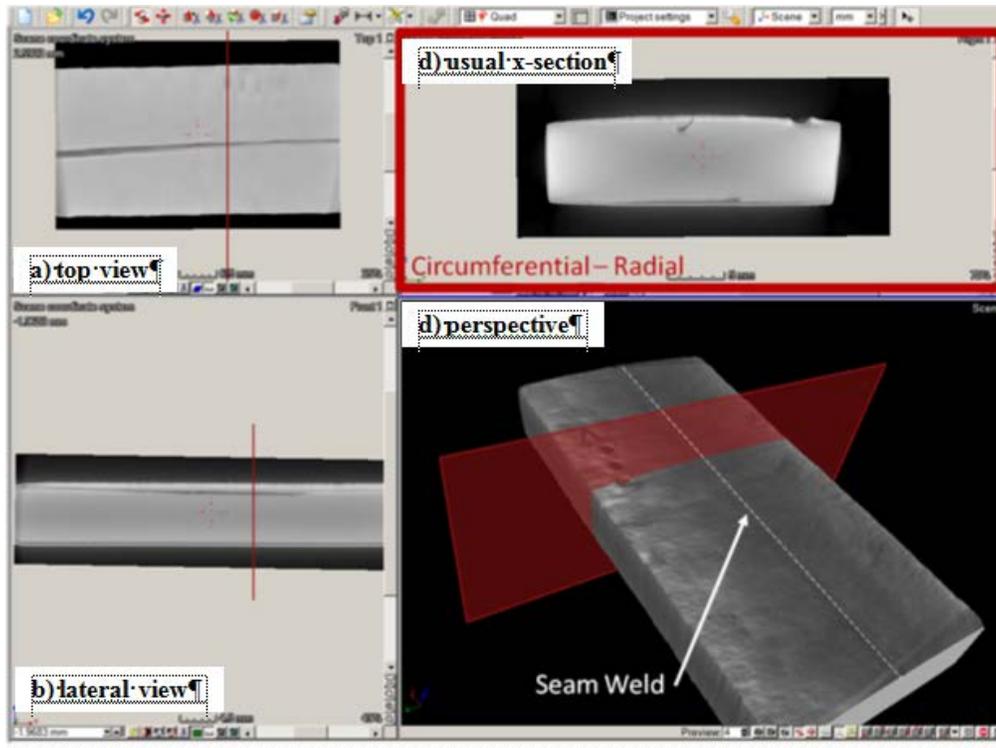
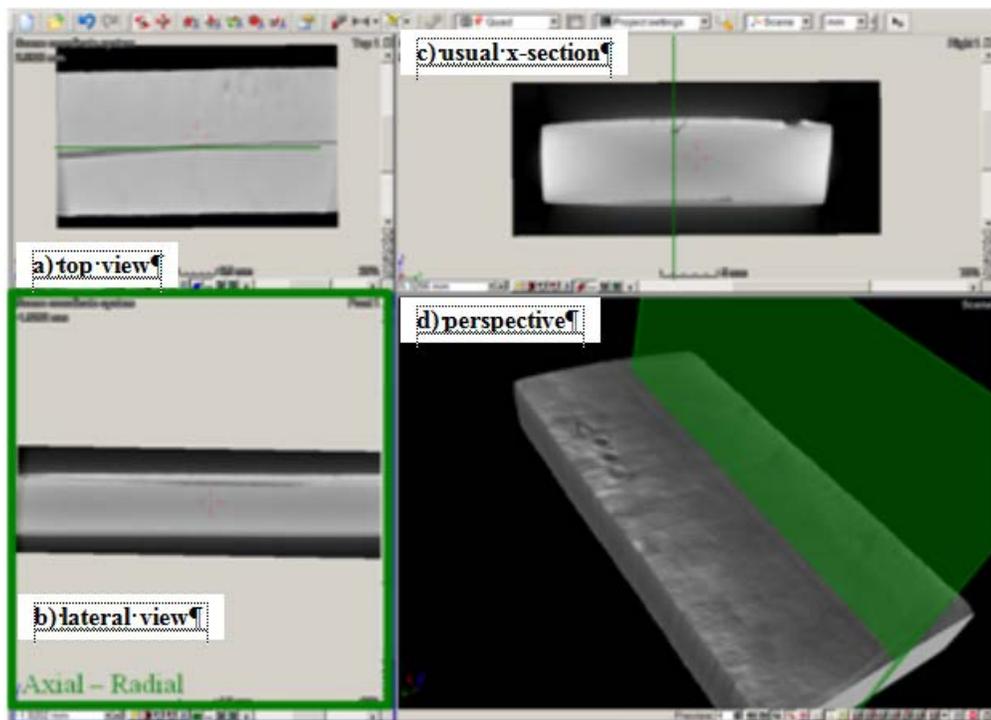
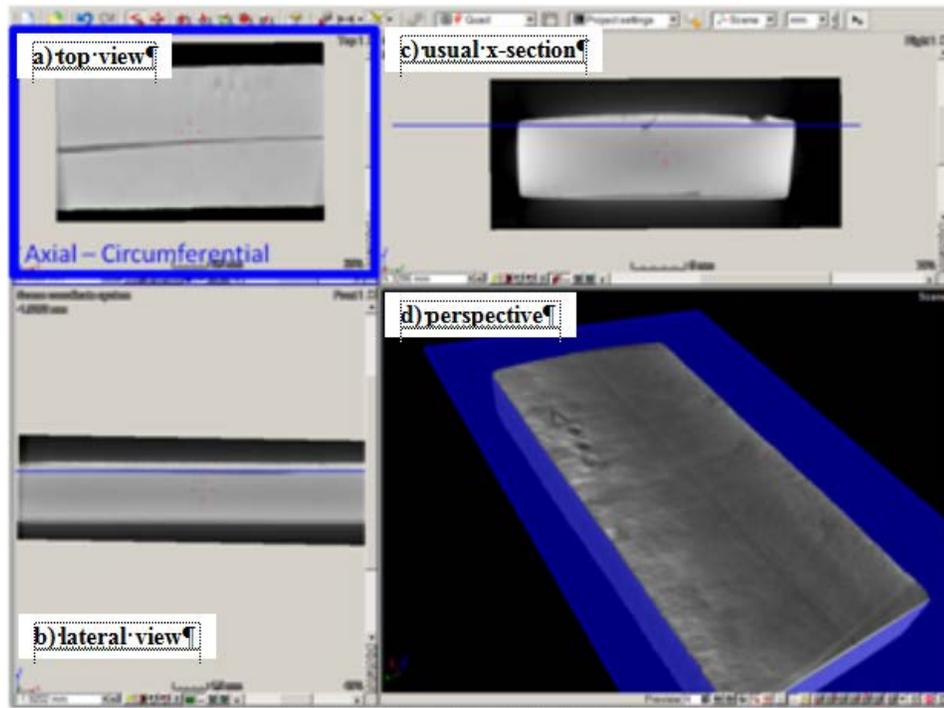
The slicing planes that were illustrated in Figures 23 to 25 were images from sample 1, pipe ID 22-11. The hook crack seen in these figures was relatively consistent in depth and shape along

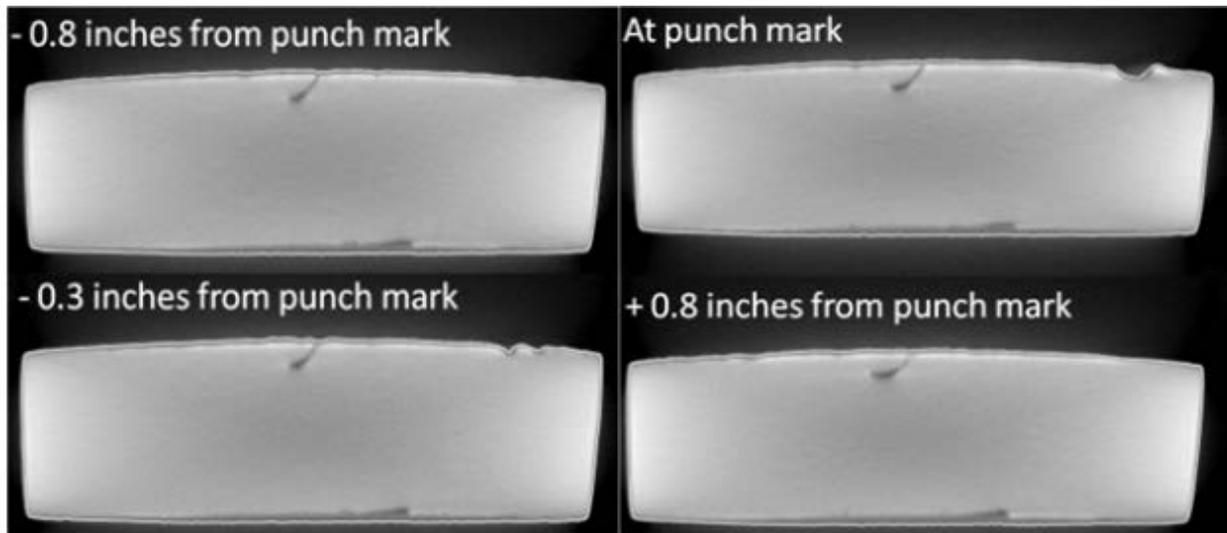
Figure 26. Views of the hook crack from serial CT sections in specimen 22-11

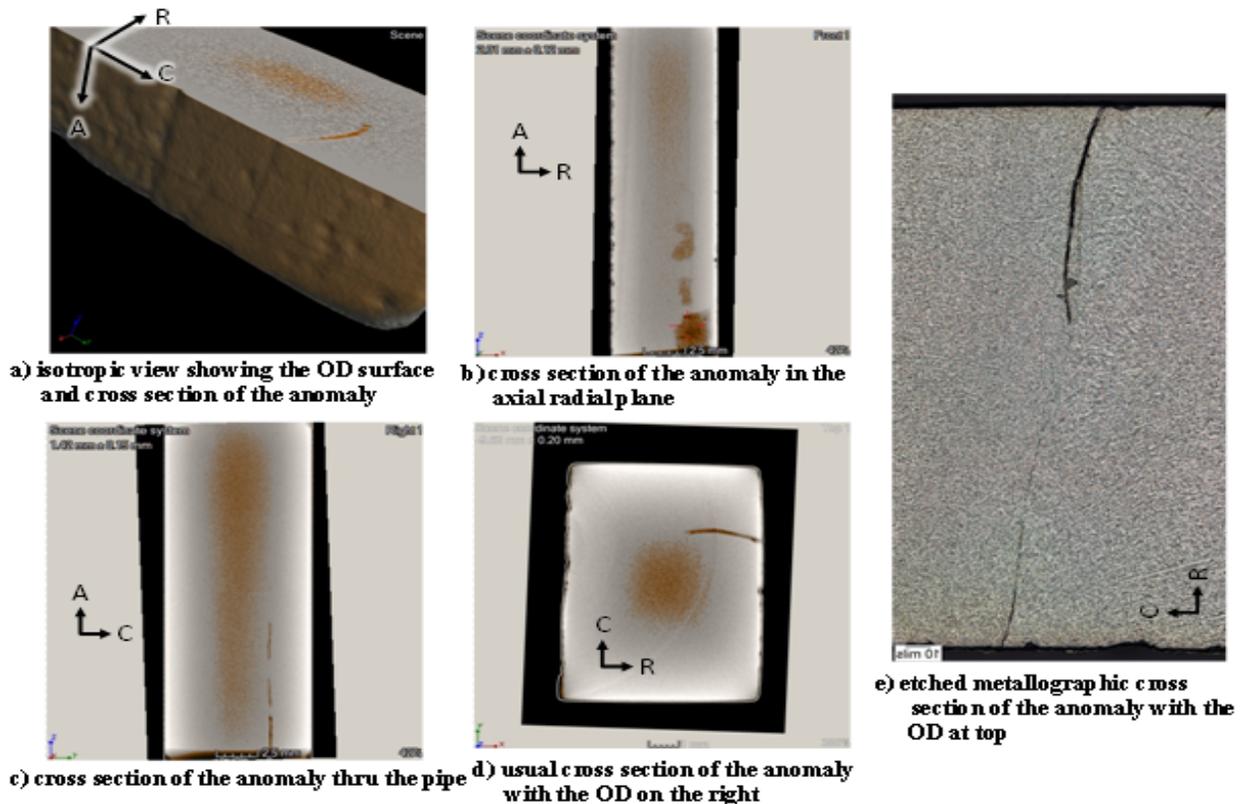
Figure 27. Tomography and metallography of a seam anomaly in pipe 16-16

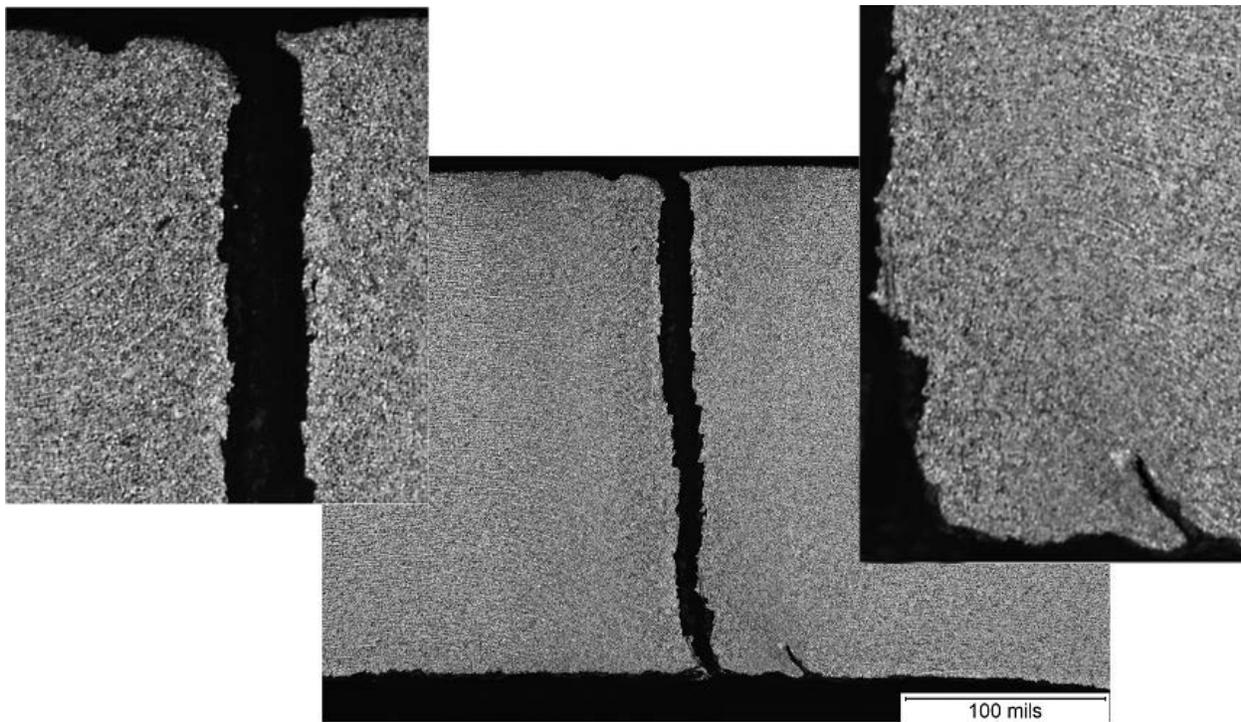
The montage in Figure A2 shows a typical metallographic cross-section view through a LF ERW seam in pipe produced in 1956 by Lonestar. From a metallographic perspective the seam is narrow and relatively fine-grained, in skelp that shows some evidence of banding and upset MnS stringers. Both the ID and the OD of the seam are neatly scarf'd back even with the pipe body. The inset to the left shows the upper-third of the seam, which makes clear that failure occurred along the bondline as indicated in the full-thickness view. The inset to the right shows the lower-third of the seam, and from the swirl evident in the upset indicates that this side of the skelp was a little mismatched through the thickness, with the fold at the bottom evidence that the mismatch was accommodated by the upset. The small steps evident to either side of the seam suggest that while the failure occurred within the bondline there is microstructural weakness to either side of the bondline that contributed to this failure – as cold cracking tends to be feature free (planar).

Figure A2 Metallographic section through a bondline failure, $t = 0.250''$ (nominal)

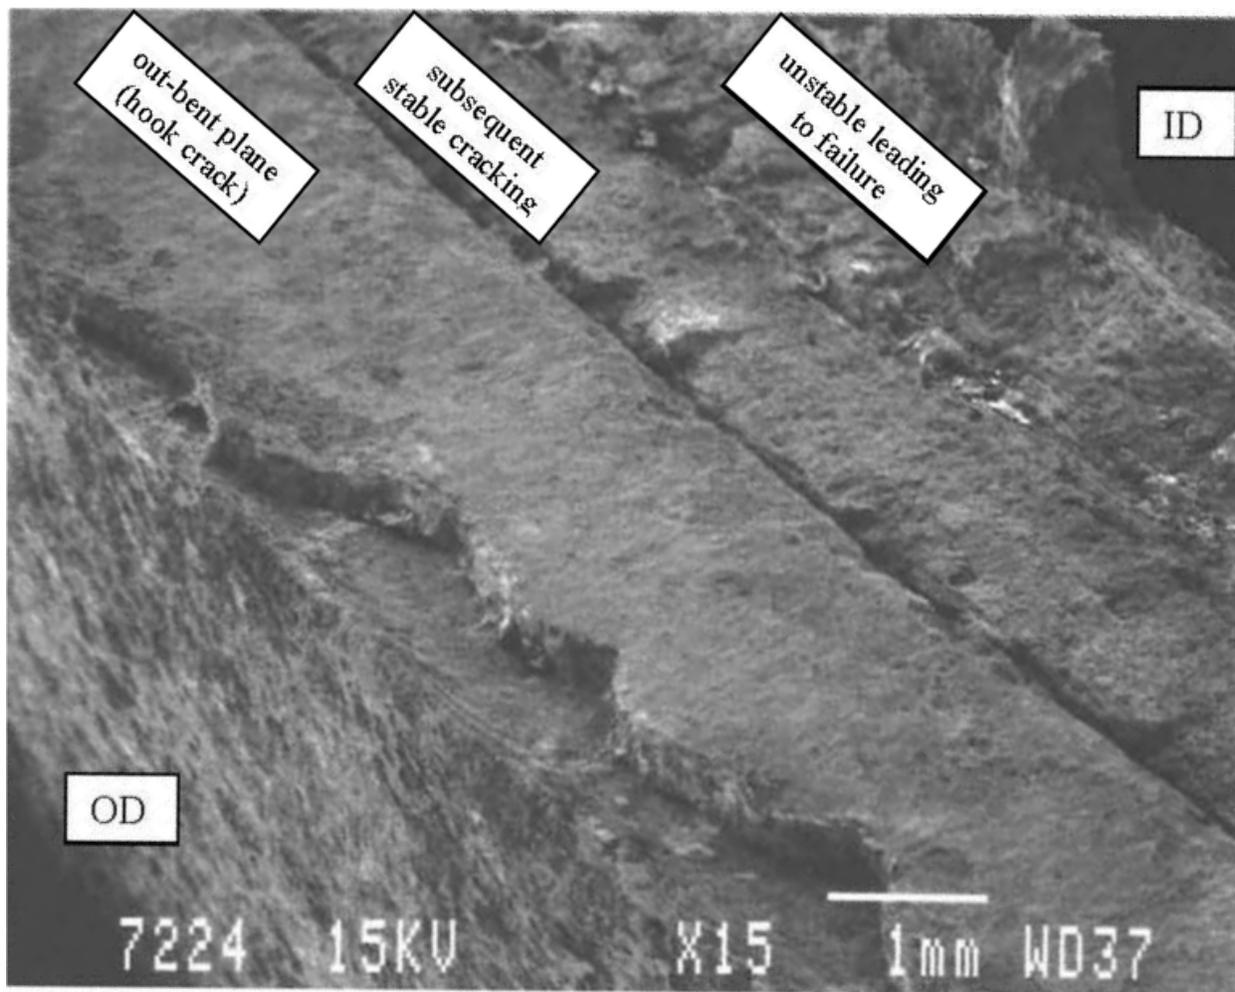
Figure A6. Detail in the boxed area of Figure A3

Five regions labeled in Figure A6, which from the left side are: 1) the OD surface of the pipe; 2) the hook crack; 3) the cracking below the initial defect (hook crack); 4) the unstable growth that breached the wall and led to rupture; and 5) the ID of the pipe. Given the twisted perspective used in Figure A6, these five regions are most easily visualized in reference to the cross-section shown in Figure A7. This section was cut immediately adjacent to the origin, where as apparent from this figure the final fracture plane below the defect had turned to shear.

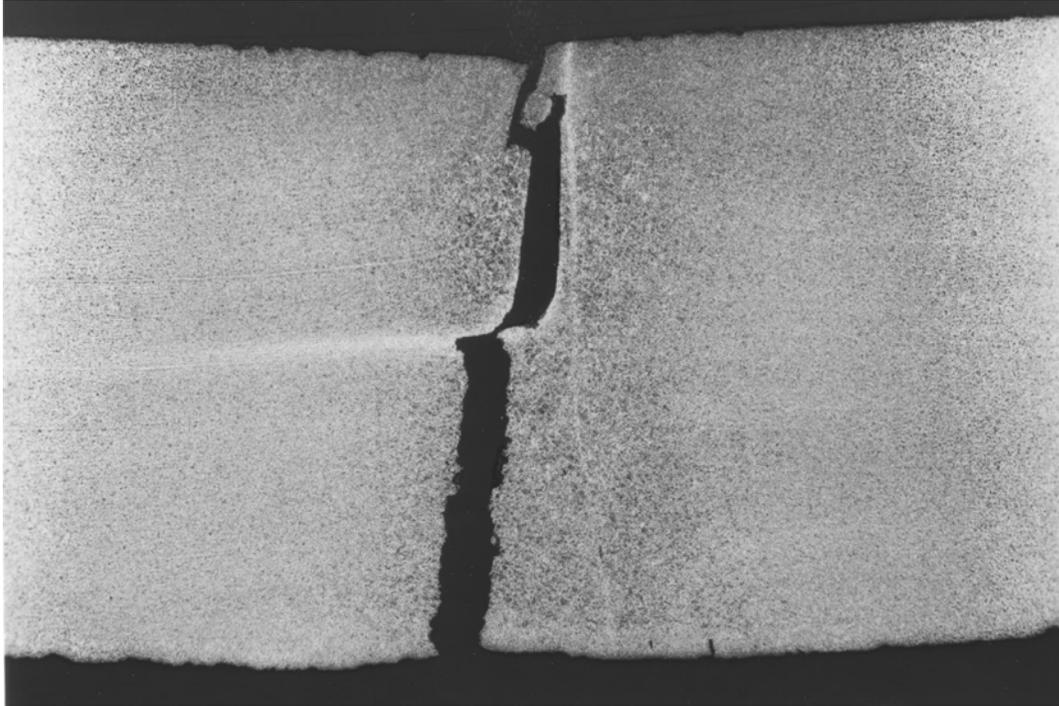
Figure A7 Metallographic section through the hook-crack origin, $t = 0.250''$ (nominal)

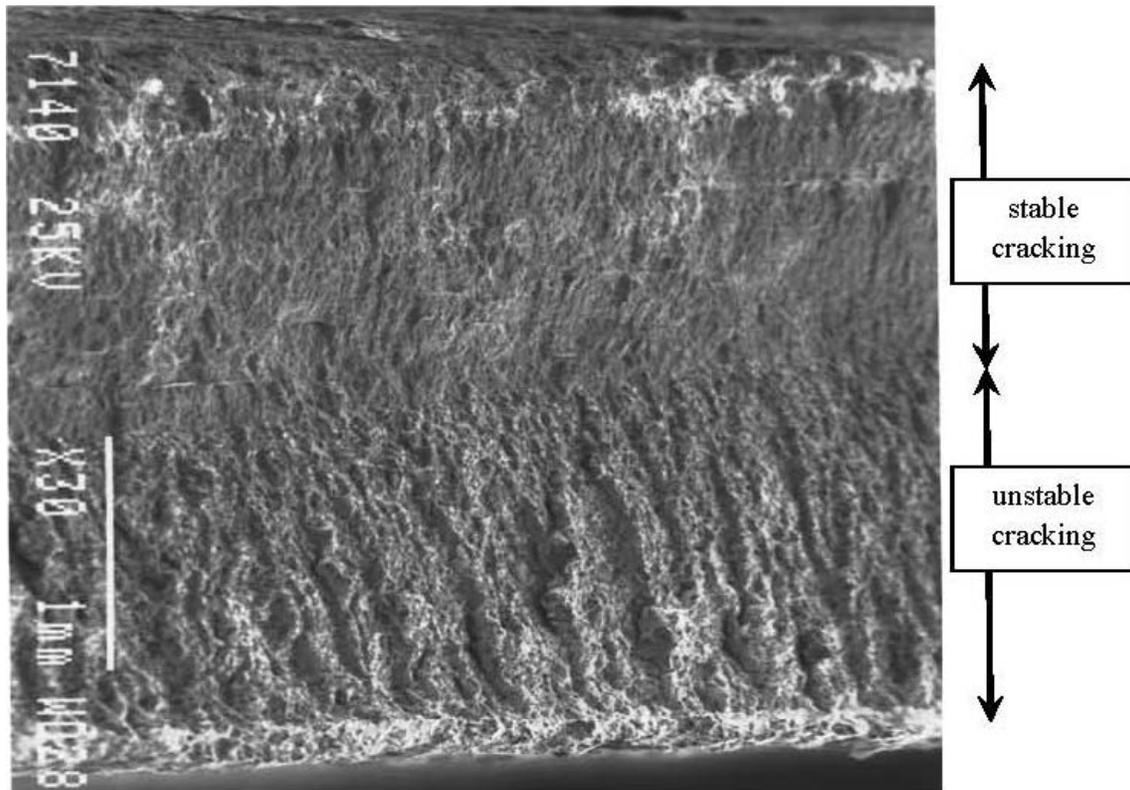
Figure A8 shows a low-power SEM view of the fracture surface spanning the lower half of the cross-section shown in Figure A7, on the right side of the fracture. The upper-half of this image is the cracking below the hook crack while the lower-half is the unstable tearing that breached the wall and led to the rupture.

Figure A8. Fracture details below the hook crack

The surface shown in Figure A8 was scanned for evidence of both stable tearing and fatigue. The zone immediately below the hook crack down through about one-third of wall thickness noted as stable cracking was relatively flat and exhibited coarse, blocky features typical of transgranular, stable tearing, the mechanism of ductile crack growth. This is the mechanism by which crack growth during a hydrotests causes pressure reversals. This zone appears to have been damaged by corrosion after that portion of the crack had formed. Below this zone is another axially oriented band that was characterized by somewhat axially oriented arrest fronts and woody appearance at lower magnification. Such macro-features often are observed on fracture surfaces of carbon steel where FCP has occurred, however well-defined striations were not observed at higher magnifications over this portion of the fracture surface. Below that zone lies an area bounded below by the onset of unstable fracture. This area contained axially aligned regions that showed features typical of stable tearing as can occur during a hydrotests, as well as evidence of crack extension due to cyclic loading in patches of ill-formed striations oriented consistent with through-wall growth. The view in Figure A9 illustrates such features, where the axial continuity persists across microstructural changes over a distance the order of three or four grain diameters.

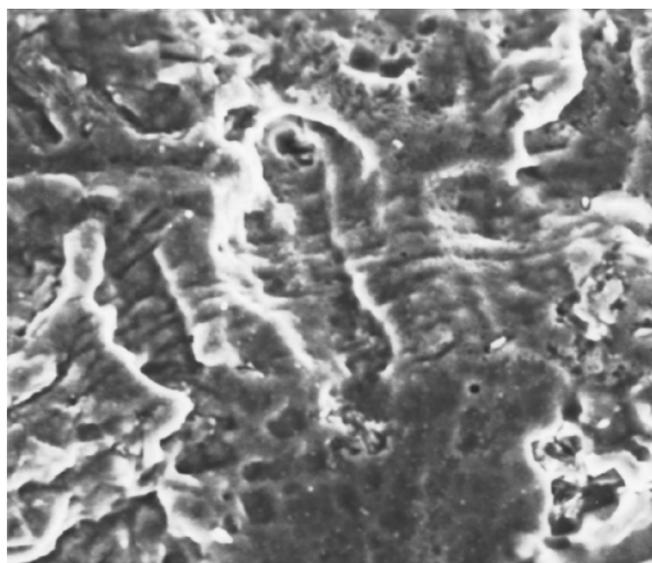
Figure A9. Small patch of ill-formed axially oriented striations
