U.S. Department of Transportation
Pipeline and Hazardous Materials
Safety Administration
1200 New Jersey Ave., SE
Washington DC 20590
RE: Contract DTPH56-11-T-000003
Comprehensive Study to Understand Longitudinal ERW Seam Failures

Final Interim Report – Task 2.6

Characterizing Failure in ERW Line Pipe

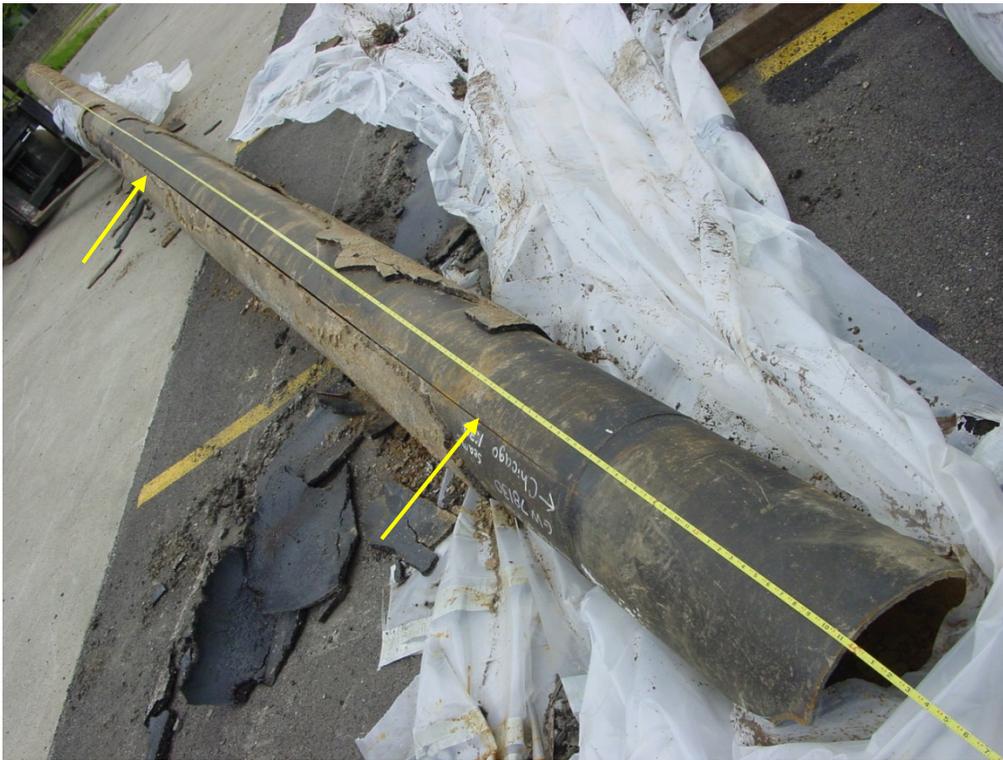
Figure 6. LF-ERW pipe that ruptured along the seam during a hydrostatic test

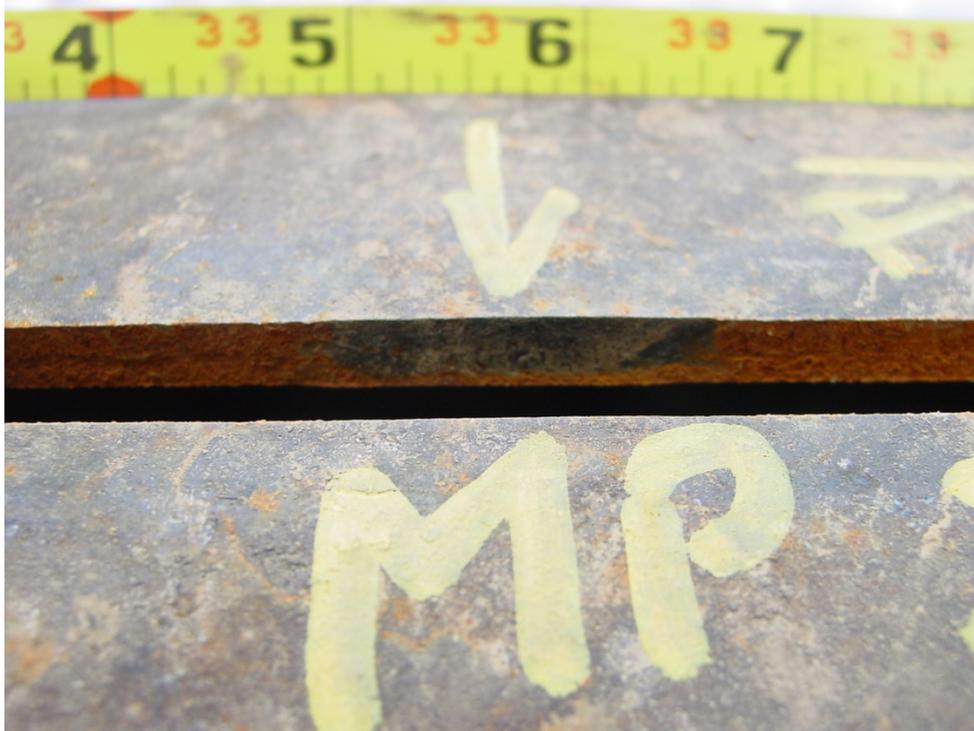
Figure 7. Anomaly A on the fracture surface of Sample 1 at 1.1X

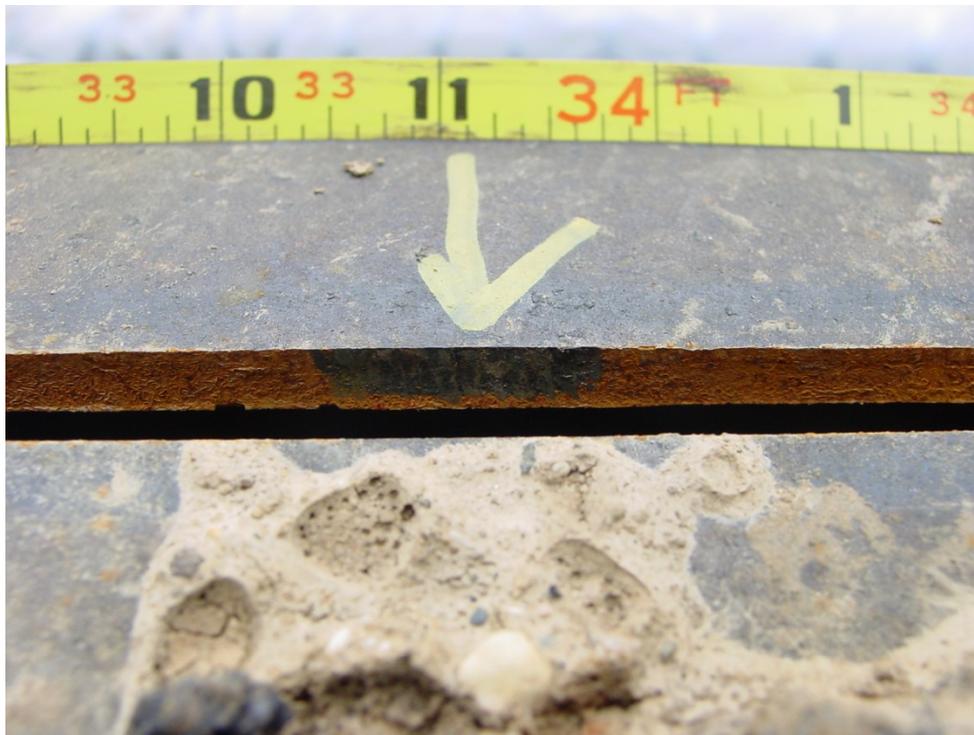
Figure 8. Anomaly B on the fracture surface of Sample 1 at 1X

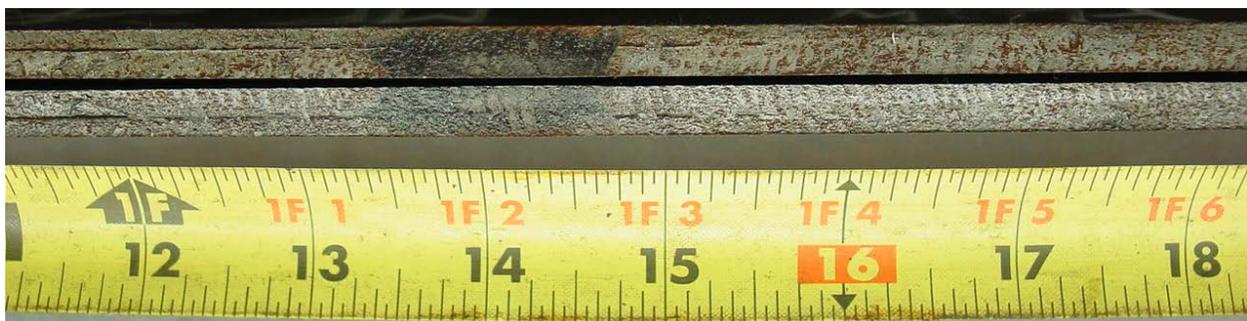
Figure 9. Fracture surface at Anomaly A (OD surfaces back-to-back) at 7/8X

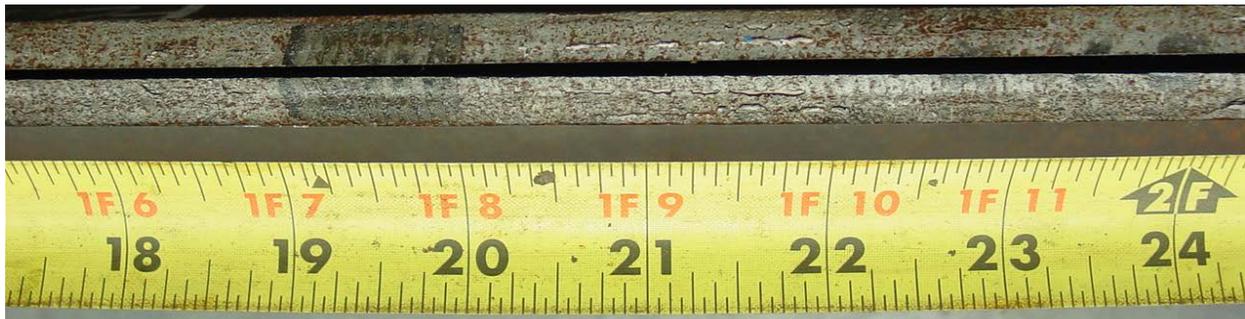
Figure 10. Fracture surfaces at Anomaly B (OD surfaces back-to-back) at 7/8X

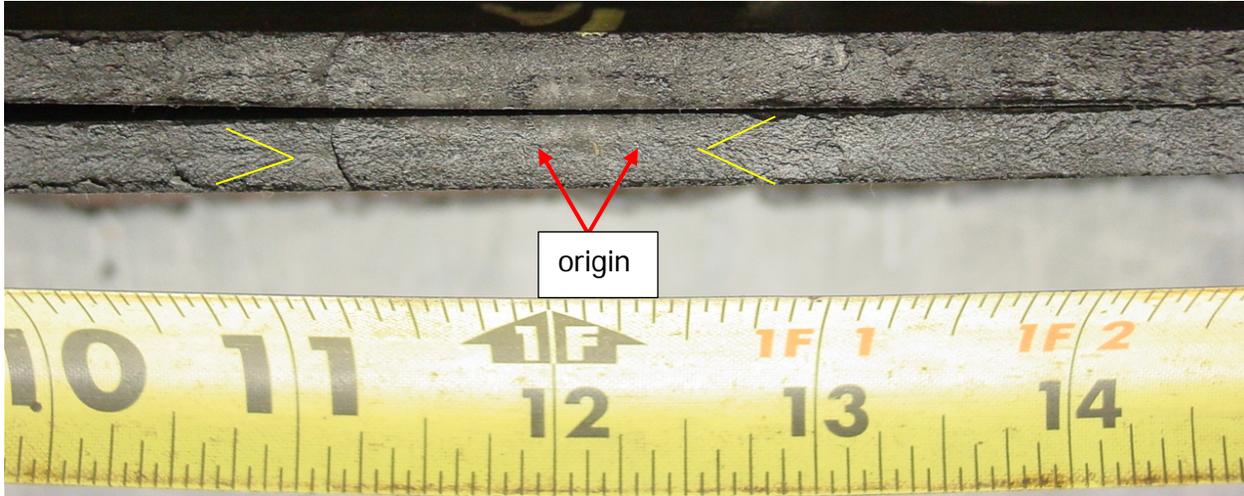
Figure 11. An example of a seam failure where brittle fracture “chevrons” point toward the origin of the failure (OD surfaces back-to-back) at 1.25X

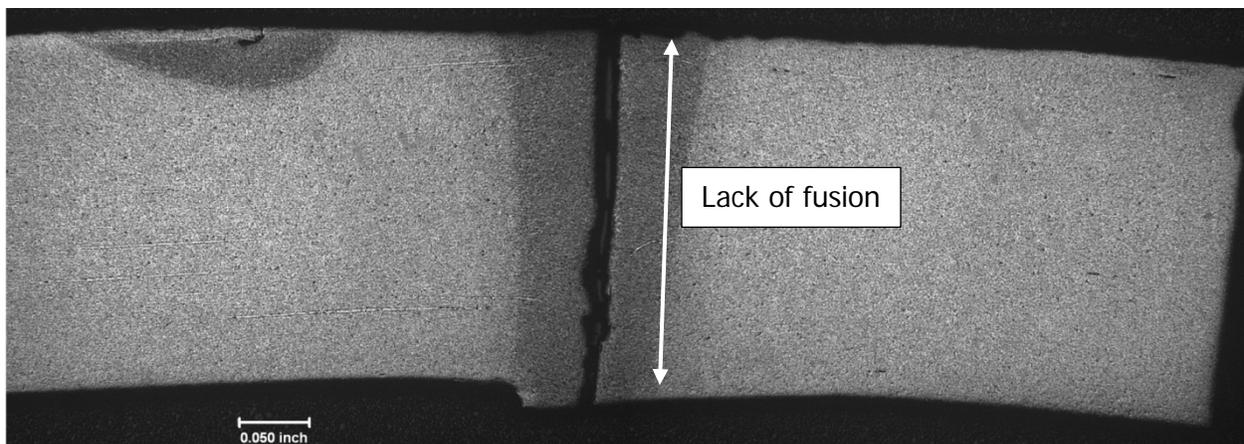
Figure 12. Metallographic section across Anomaly A at 8X

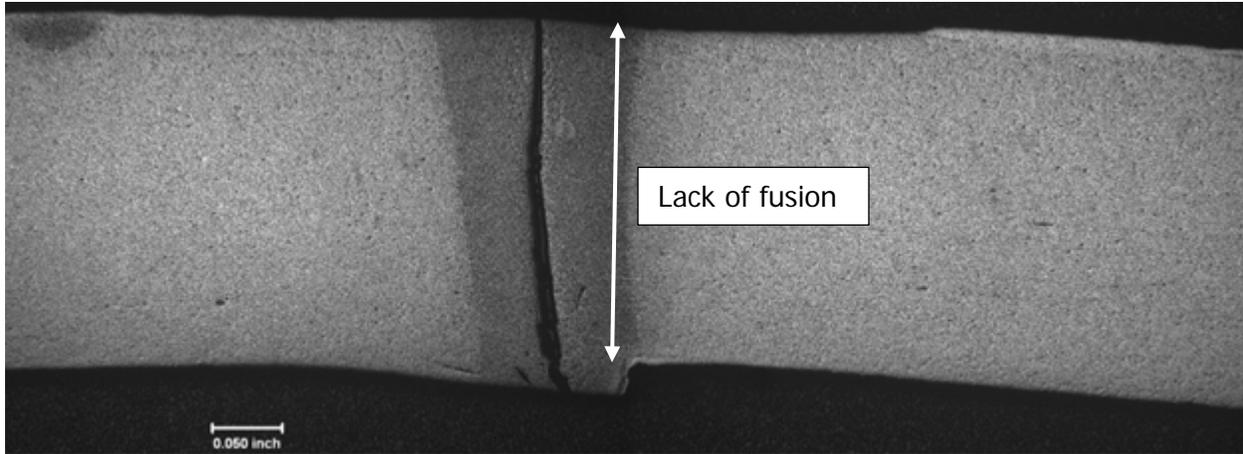
Figure 13. Metallographic section across Anomaly B at 8X

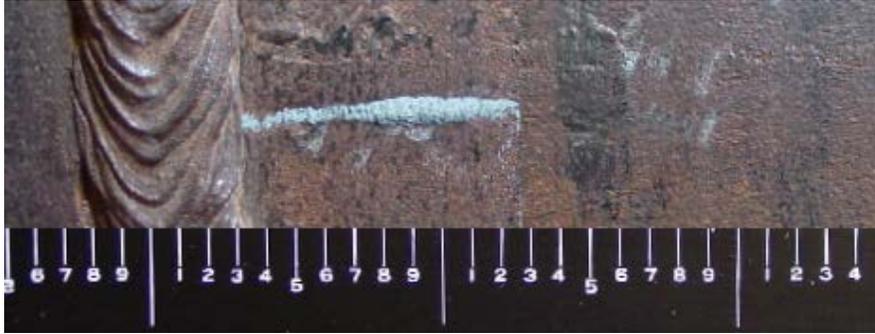
Figure 15. View of the leak at the OD surface (highlighted by magnetic particles)

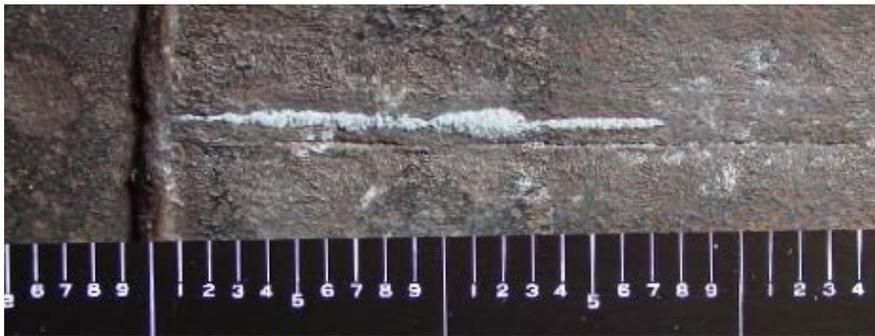
Figure 16. View of the leak at the ID surface (highlighted by magnetic particles)

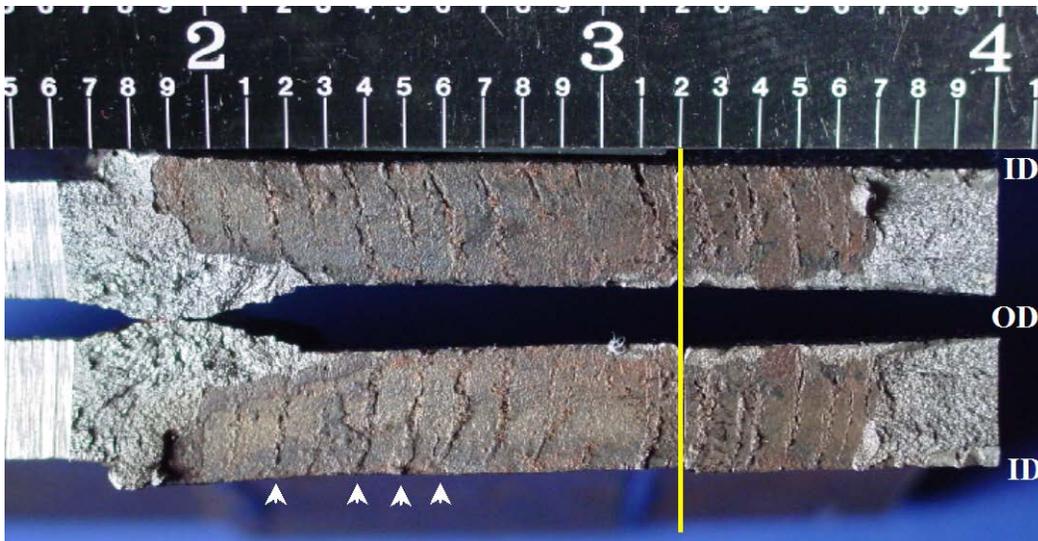
Figure 17. Exposed surfaces of the leak at 2X

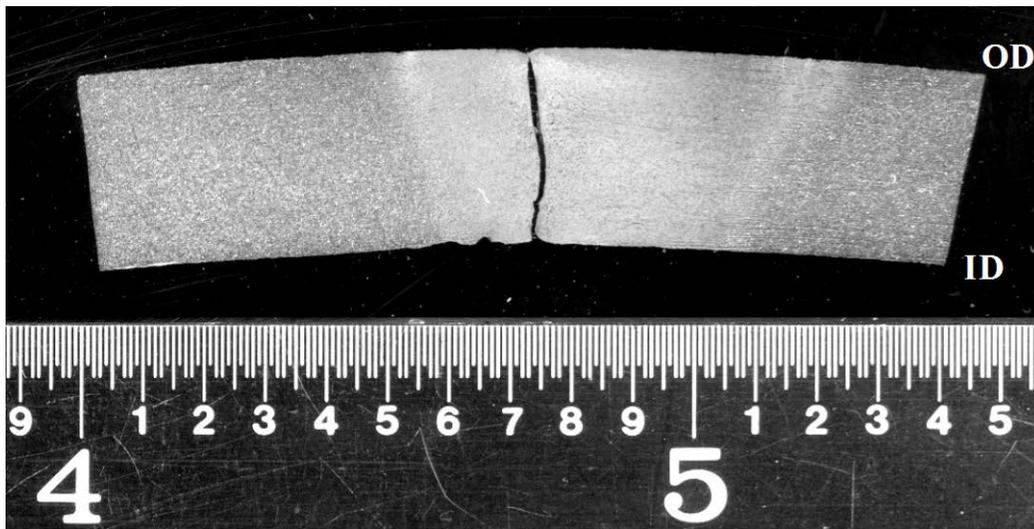
Figure 18. Metallographic section across a cold weld at 3X

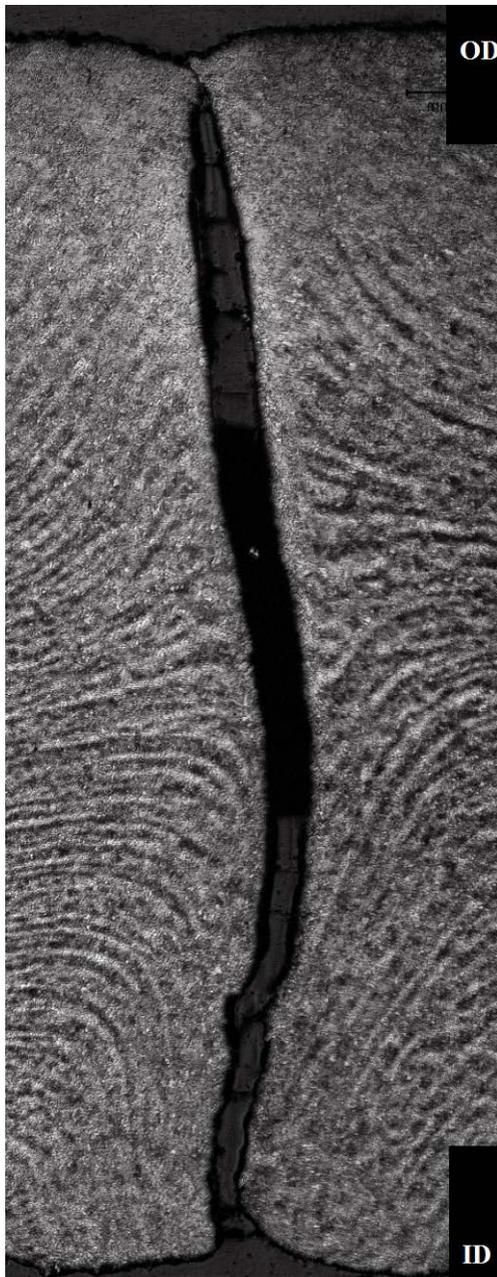
Figure 19. Metallographic section across cold weld at 20X

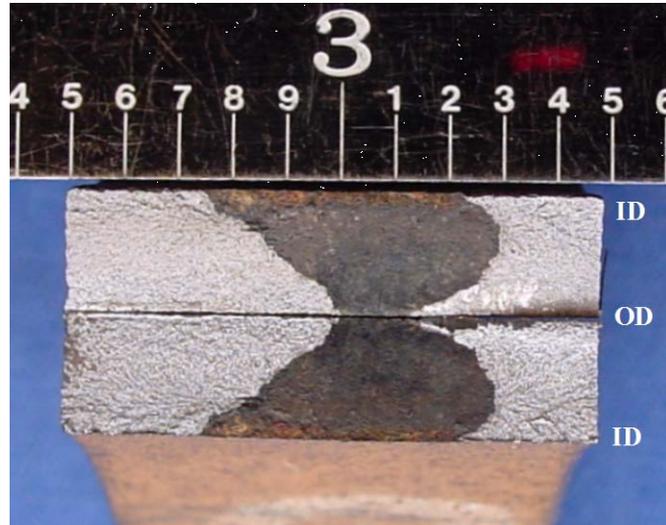
Figure 20. Penetrator as seen after the sample was chilled in liquid nitrogen and broken open at 2.5X

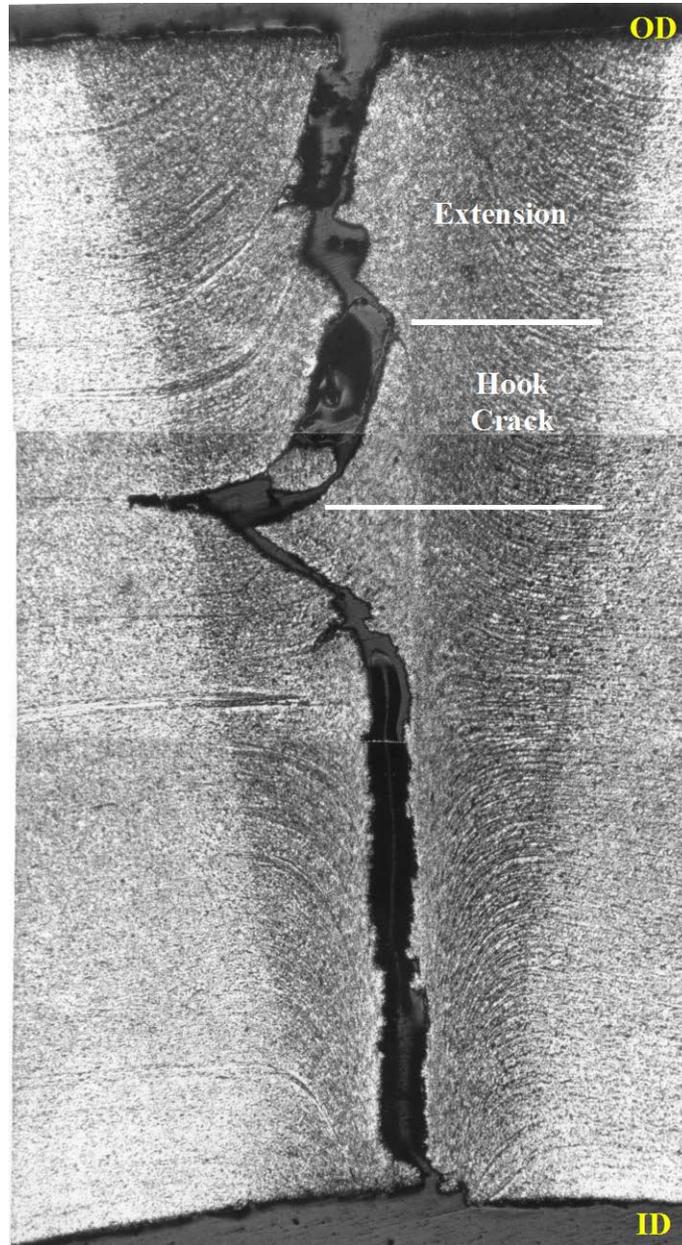
Figure 21. Metallographic section across an HF-ERW seam showing an embedded hook crack at 20X

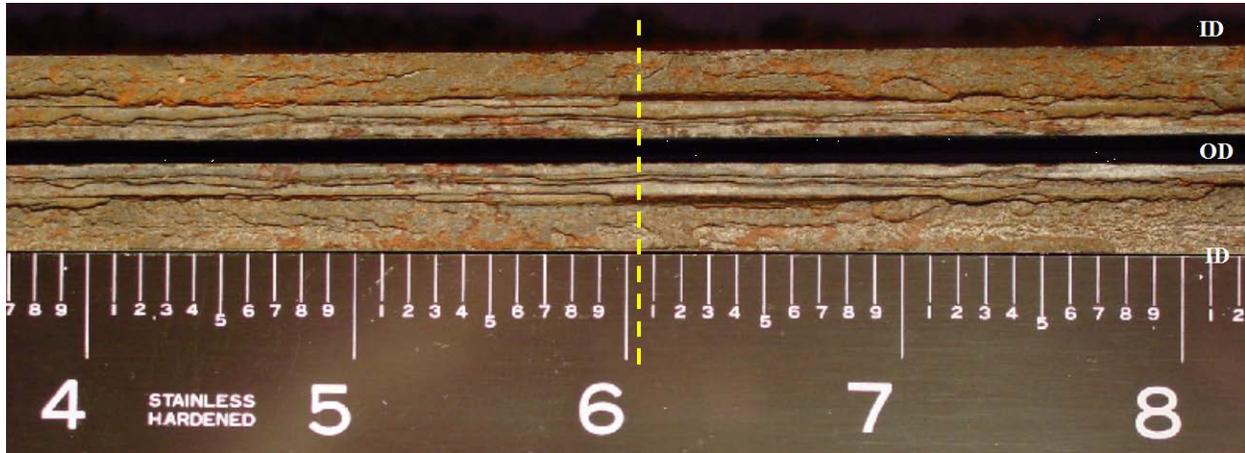
Figure 22. Fracture surfaces containing the anomaly shown in Figure 21 (the metallographic section in Figure 21 was taken at the location of the dashed line) at 1.4X

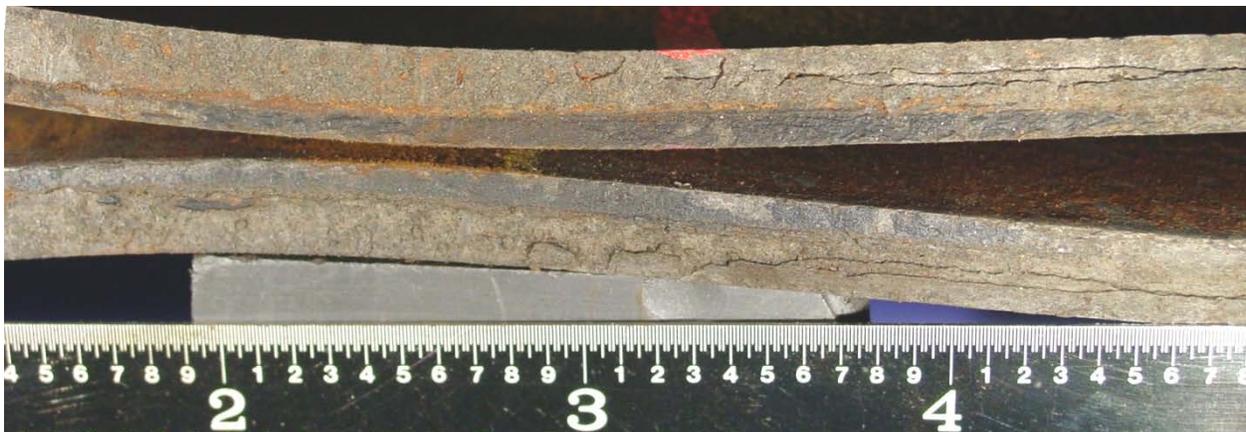
Figure 23. Fracture surfaces showing a long, mill-scale-coated hook crack at 1.75X

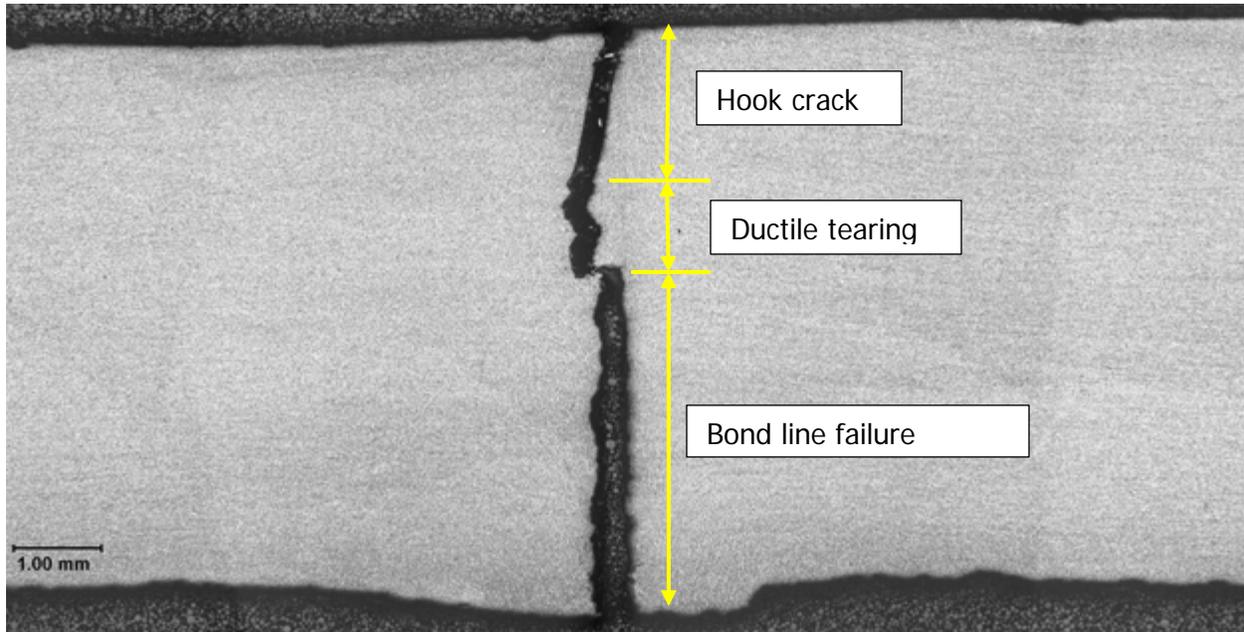
Figure 24. Metallographic section across a failure that originated at an OD-surface-connected hook crack at 10X

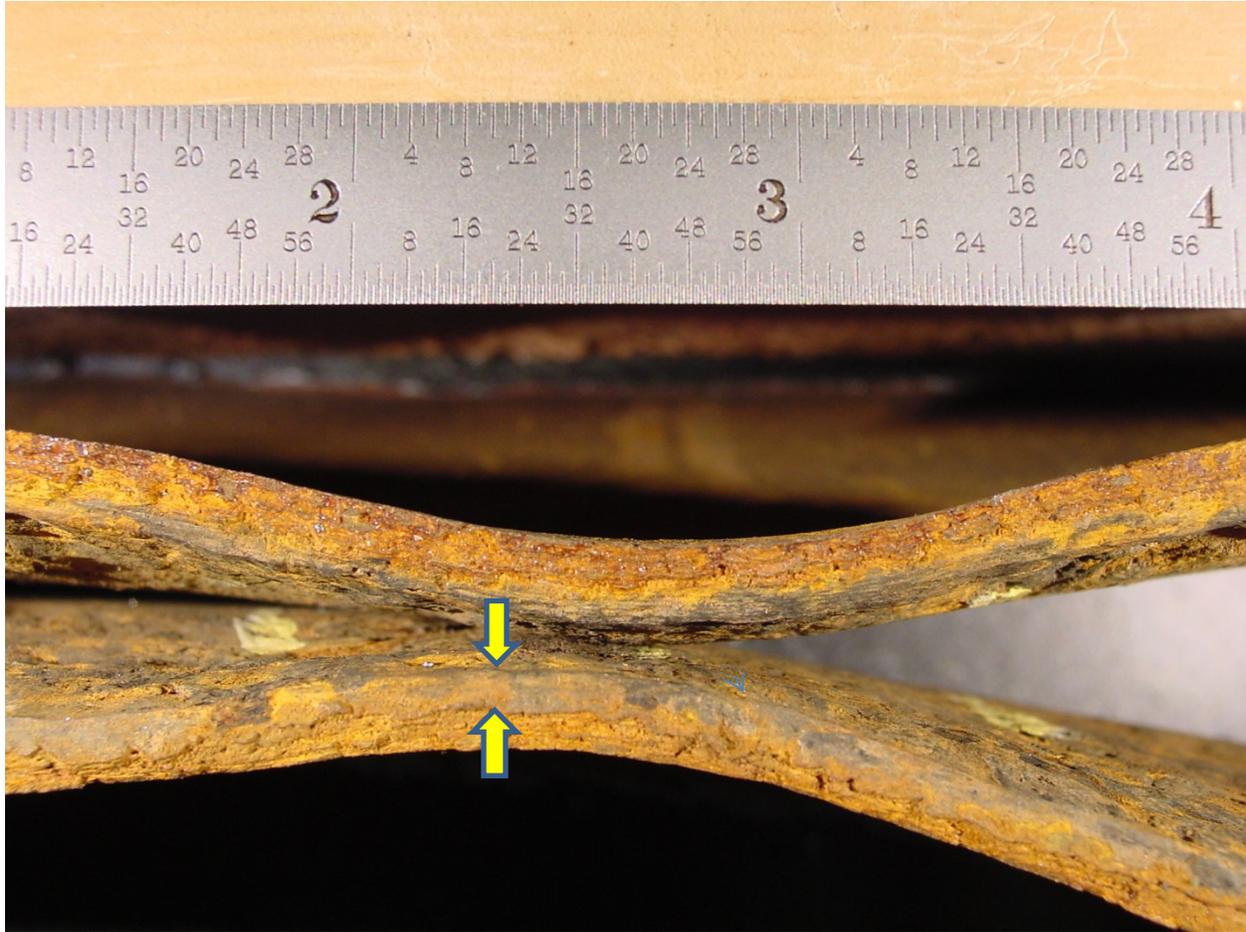
Figure 25. Fracture surfaces of a failure caused by selective seam weld corrosion. Arrows denote missing metal; remainder of the surface is fracture at 2X

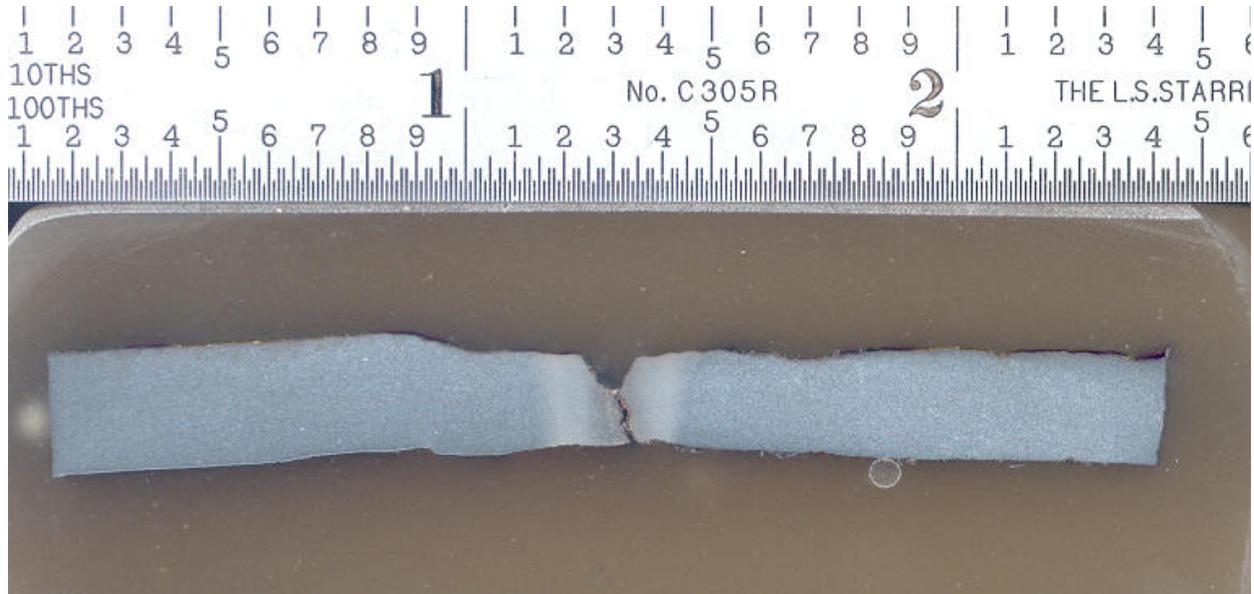
Figure 26. Metallographic section across a failure caused by selective seam weld corrosion at 2.5X

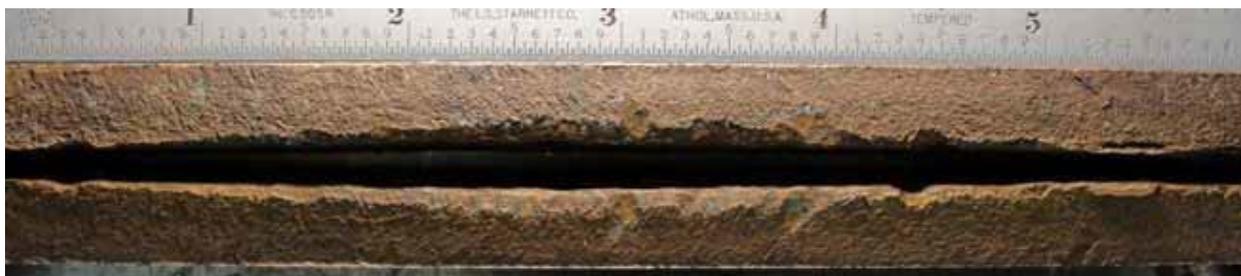
Figure 27. Fracture surfaces of another failure caused by selective seam weld corrosion at 1X

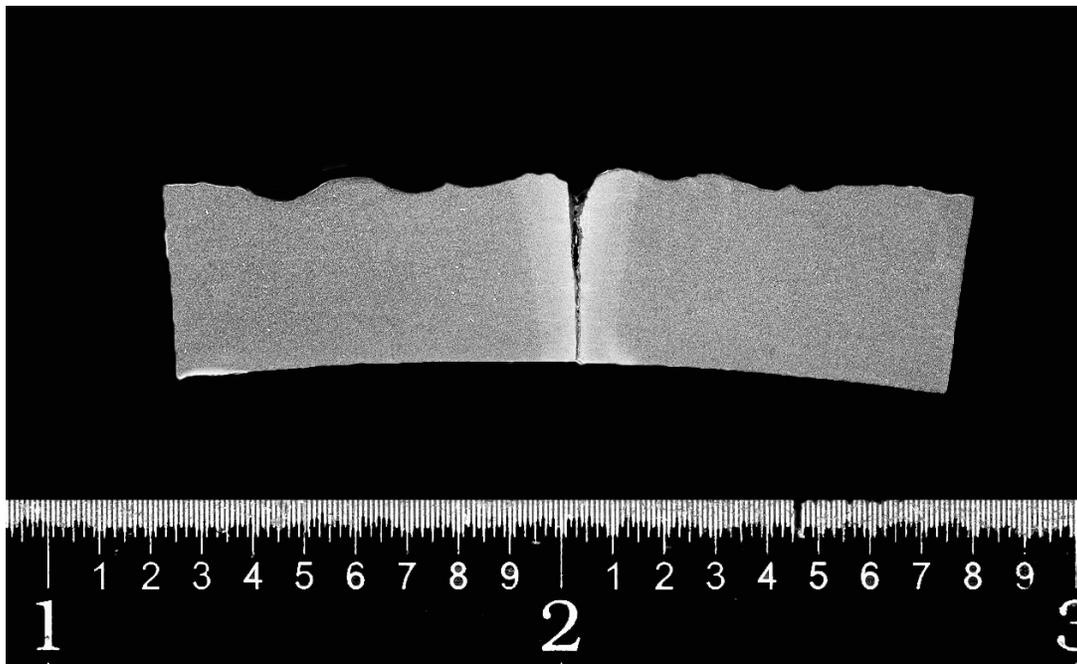
Figure 28. Metallographic section across another failure caused by selective seam weld corrosion at 2.5X

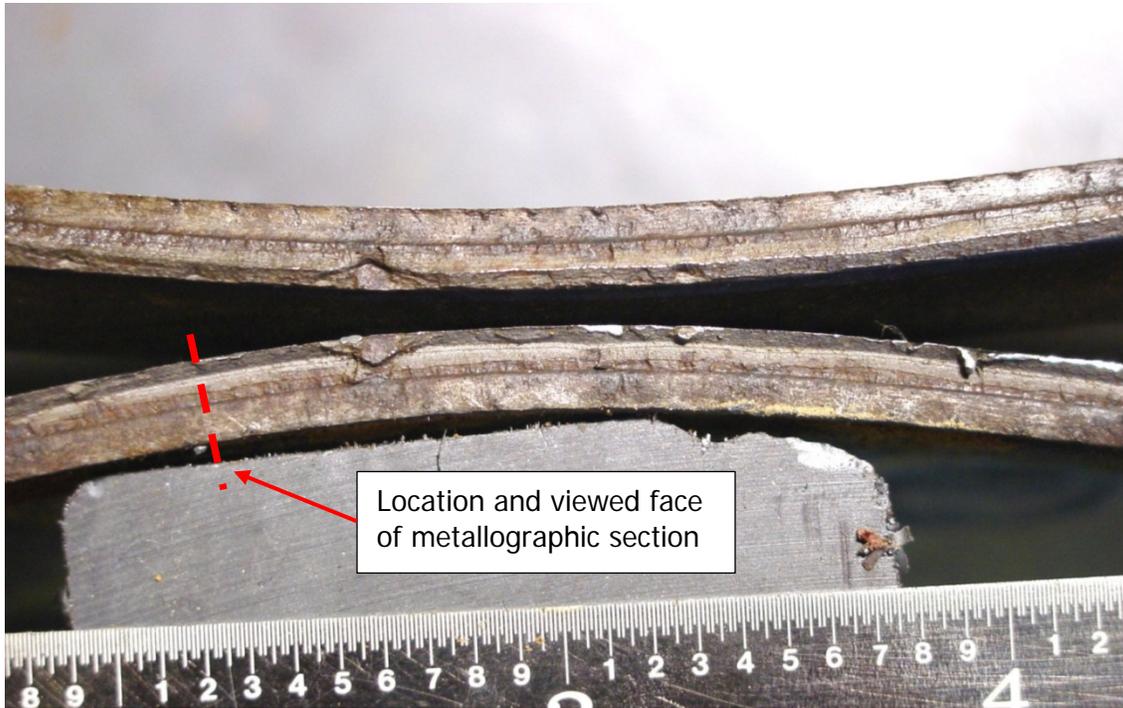
Figure 29. Fracture surfaces of a failure caused by fatigue crack growth from an OD-surface-connected hook crack at 2X

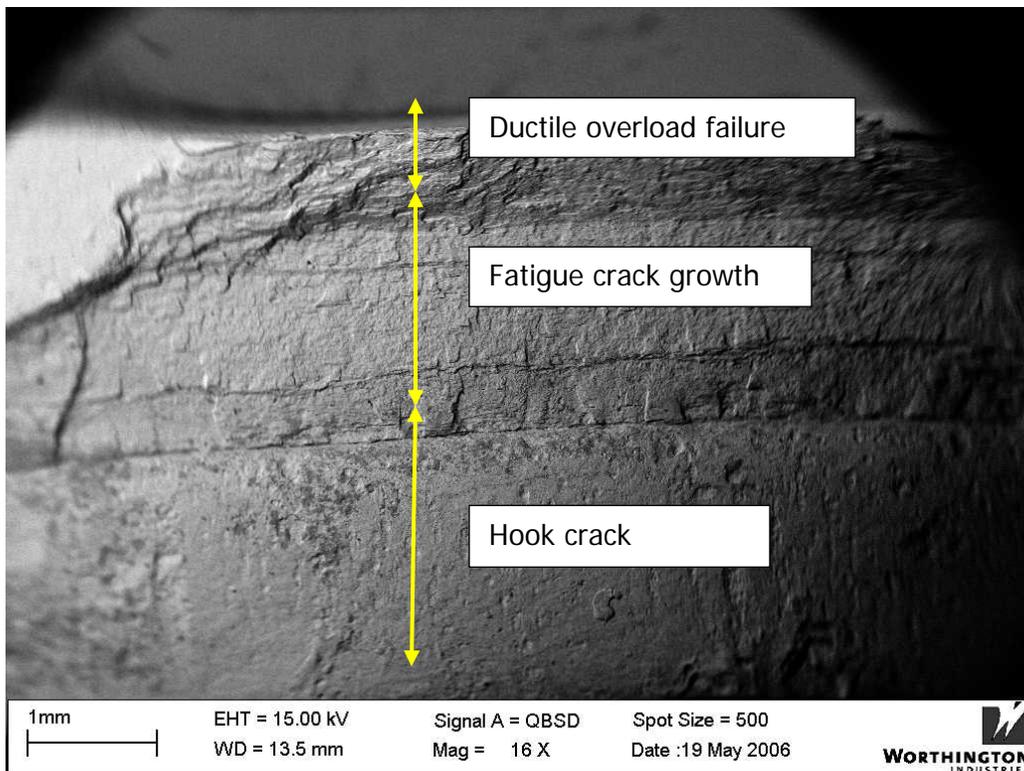
Figure 30. Electron microscope picture of part of the fracture surface of a fatigue failure from a hook crack at 16X

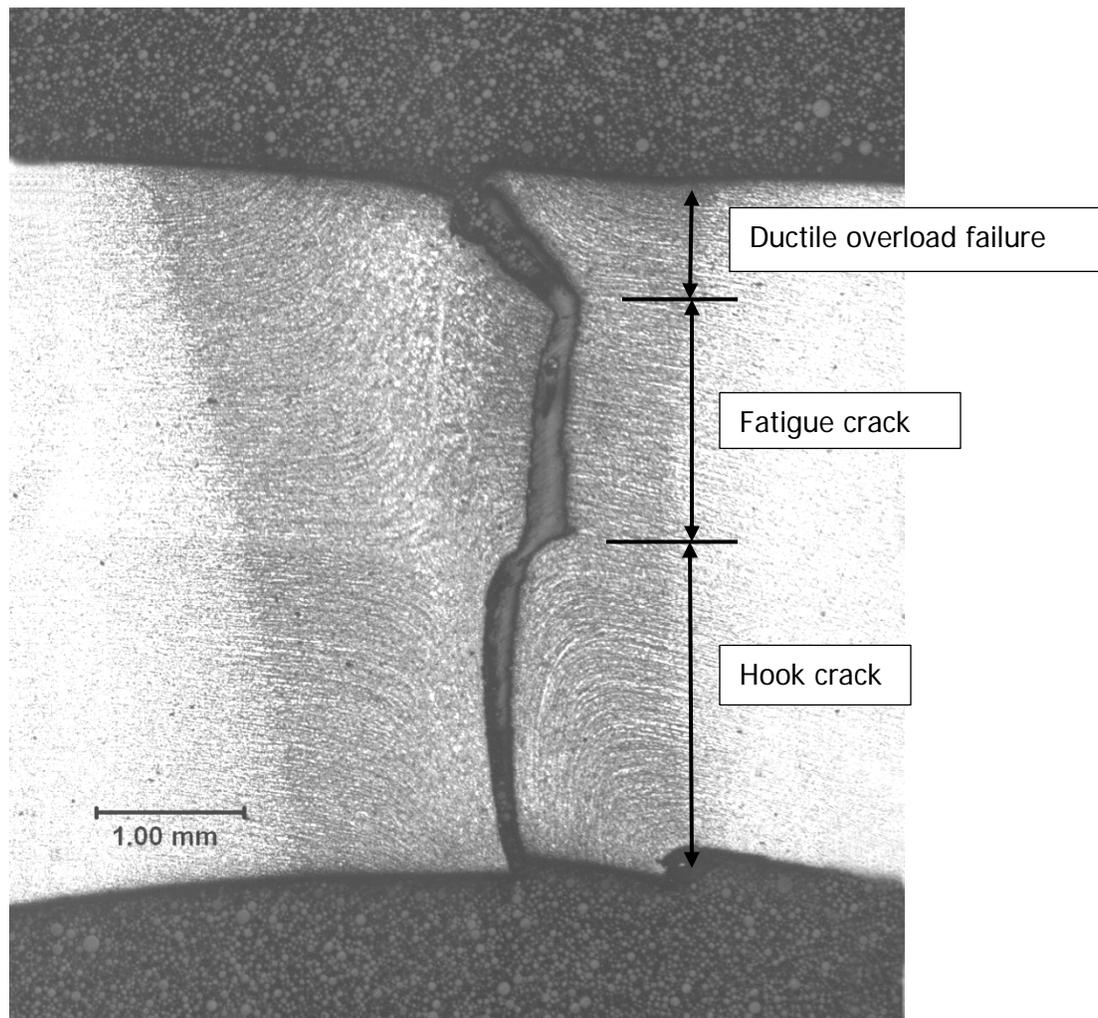
Figure 31. Metallographic section across the fatigue failure at 20X

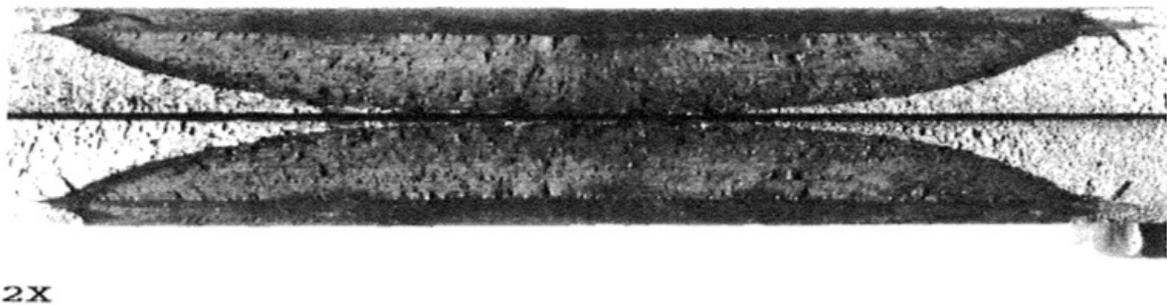
Figure 32. Fracture surfaces of a fatigue-induced leak at 2X

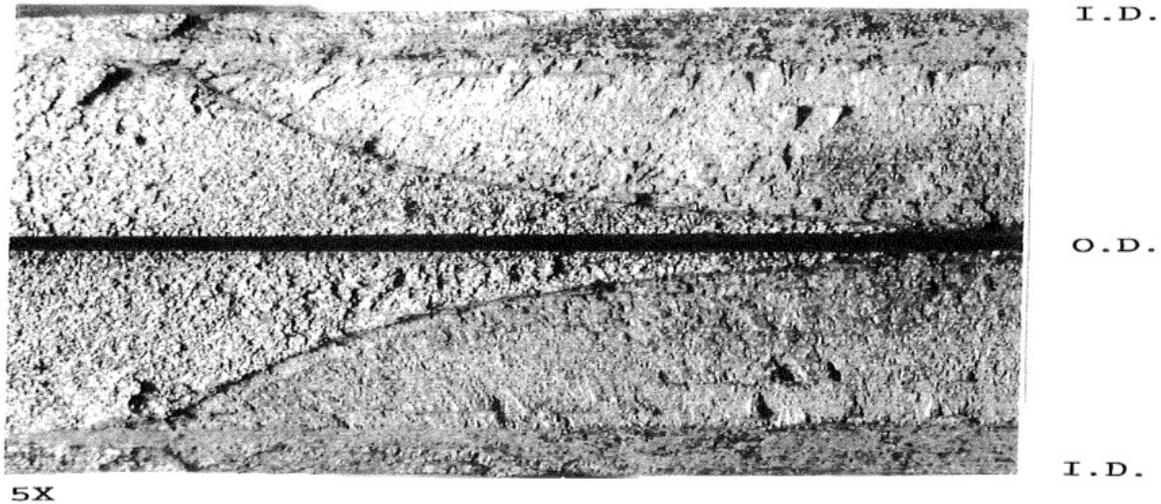
Figure 33 . Fracture surfaces of a fatigue-induced leak at 5X

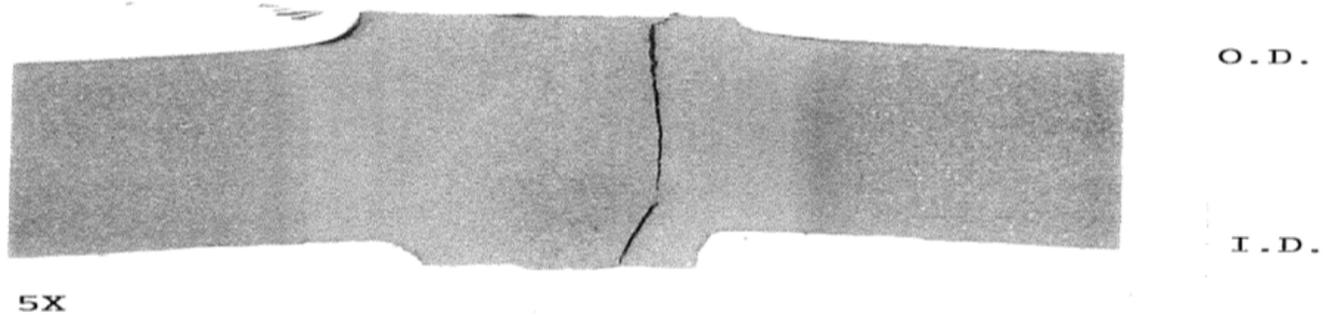
Figure 34. Metallographic section across leak at 5X
