Final Interim Report – Task 4.1

**Compare - Contrast Analysis of Inspection Data and Failure  
Predictions versus Burst-Test Outcomes for ERW-Seam Defects**

B. N. Leis  
B N Leis, Consultant, Inc  
517 Poe Avenue  
Worthington, OH, 43085

Contract No. DTPH56-11-T-000003  
Battelle Project No. G006084

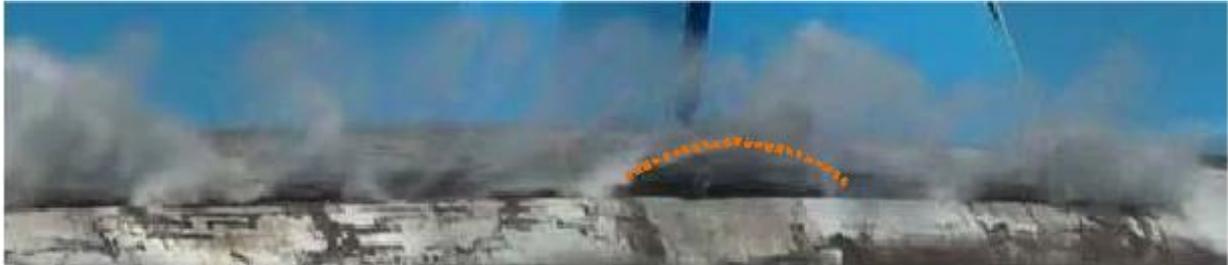
**Figure 1 First frame of the video for Pipe 16-16**

almost the full length of the split. This figure indicates that a wispy mist formed as tiny droplets of water were released through the still tight axial split runs the full length of the split. On that basis, this ~8-foot long split developed within the interval between images, indicating that the speed of this fracture was at least  $480 \text{ ft-sec}^{-1}$ . This speed is within the range typically observed for dynamic fracture in high-pressure pipelines.

Because there was no evidence of bulging and the seam split formed within the time interval between images, which of the three features intersected by the split was the origin could not be simply identify from the video, or the presence of a local bulge. In more homogeneous materials it is reasonable to assume the speed of the split was uniform over its length, so the origin lies at its mid-length. However, because the ERW seam properties can be quite variable, this approach is not reliable.

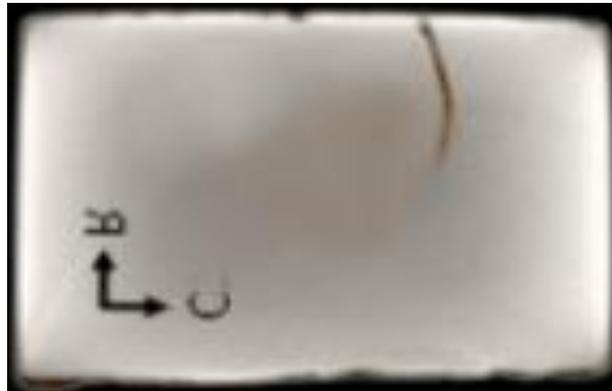
**Figure 2 Transverse cross-sections that characterize the stable anomaly in Pipe 16-16**

The metallographic section indicates that in some places this anomaly involved cracking from both the outside as well as the inside diameter (ID) of the pipe, and that the cracking lay largely in or immediately adjacent to the bondline.<sup>(5)</sup> It should be noted that the fine cracking at the ID could have developed during the test, and so not have been apparent in the pre-test inspections. Both cross-sections show that the OD crack faces were separated slightly, which makes this feature a better reflector for the PAUT. The depth of the OD feature measured on the metallographic cross-section was 40% of the wall thickness, which is much larger than the maximum depth called by PAUT at 24%. This tomographic slice shows it to be slightly shallower than the actual measured depth, by which process it measures at ~36%. While such differences can embed some measurement uncertainty, the differences for the present appear to be driven more so by differences in actual crack depth. This is because the actual depth of the feature varies depending on the specific section where the measurement is made along its length.

**a) metallographic section (Nital etch)**      **b) tomographic section**

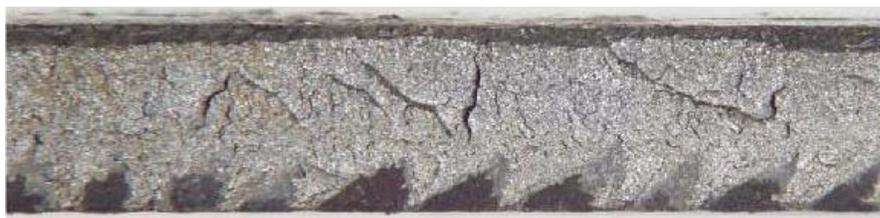
**Figure 3 Discontinuous ID cracking along the stable anomaly in Pipe 16-16: t = 0.252 inch**

Such variations in depth were indicated by the full tomographic characterization<sup>(5)</sup>, which showed the cracking to be discontinuous along its length. Discontinuous cracking could be identified by making serial metallographic sections through use of sequential grind – photograph cycles, but this is tedious. In contrast, discontinuous is more easily evaluated via fractography – if the cracking is deep enough to easily open the fracture in the laboratory, or if the fracture surfaces are exposed by the pressure test. Figure 3 illustrates the nature of the discontinuous cracking from the ID that was apparent over long segments of the split. The dark band along the upper edge of the portion of the split shown here is a shadow created by a shallow shear-lip, and so in this area is not indicative of a black oxide layer or other form or pre-existing anomaly.

It is apparent from Figure 3 that the discontinuous nature of this cracking shows axial spacing that is not too different from that for some stitched welds. But while similar in some ways to stitching, this oxide is present only part-through-wall. Each segment of this ID cracking contains a black high-temperature oxide, indicating this cracking formed as the seam was being made – as occurs for stitched welds. The remainder of the fracture surface shows areas of small reflective facets, which are indicative of localized zones of cleavage, and lower fracture resistance, which could give rise to a locally higher high fracture speed. Because this ID cracking is discontinuous, it is less likely to initiate cracking and serve as an origin as compared to a continuous anomaly.

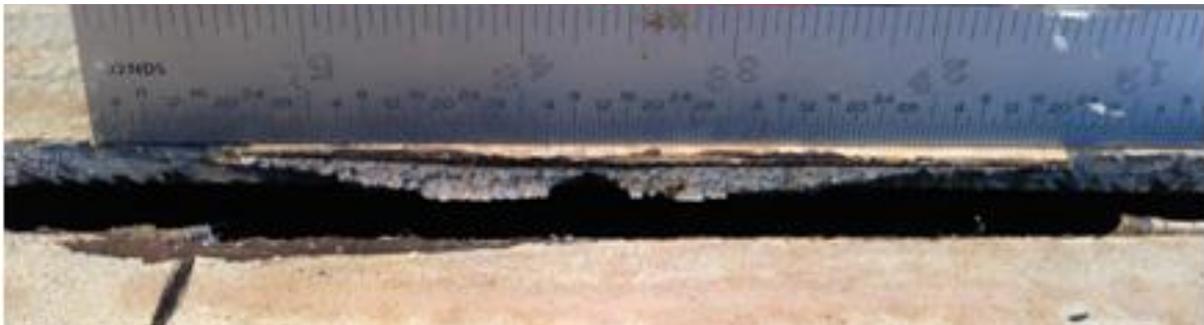
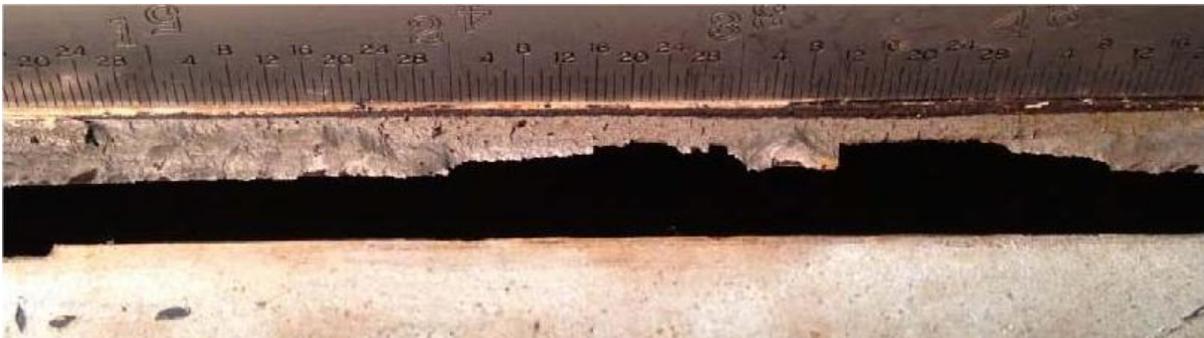
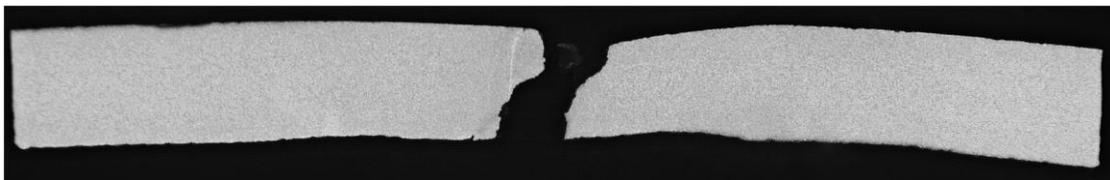
**Figure 4 Views of the fracture surface at the failure origin for Pipe 16-16:  $t = 0.252$ ”**

Figure 4 shows images of the likely fracture origin taken just after the burst test that have been taken from either side of the pipe to show each side of the fracture. In contrast to Figure 3, the darker band that runs along the upper edge of the view of the fracture surface shown in Figure 4a is not a shadow created by a shear-lip. Rather this is a discolored band that runs along the OD of the pipe, whose coloration is strong contrast to the fresh fracture below it, which occurred in the burst test.

In contrast to Figure 3, the black oxide layer on this pre-existing feature appears less intense. Figure 4c indicates this origin lies within the upset of the seam rather than in the bondline, although at this location as the cracking grew into the wall it shifts back toward and then runs parallel to the bondline. Etched higher magnification views indicate that the full-wall evident on the left side of the seam was formed by upset flow from the offset edge, which falls well below the OD profile of the pipe. Figure 4c indicates that the OD scarf trimmed the upset more or less even with the OD profile of the pipe, with a slight over scarf at the ID, which while not unusually large acts to further reduce the net wall thickness. The preexisting feature apparent in Figures 4a and 4b develops in this net wall, at the point where the wall is its thinnest. What is not clear without further study of the oxide layer is when this defect was formed.

The dark thumbnail feature evident along the ID in Figure 4a is a shadow, which forms due to pullout of metal that contained a small surface anomaly that creates a step along the opposite face of the fracture, as is evident in Figure 4b. Figure 5 illustrates the area of the pullout in more detail, with the overall shape of the thumbnail-shaped step on the fracture surface highlighted. Within the highlighted field lies a small thumbnail that is covered by black oxide, which also has been highlighted to help identify it. This thumbnail shaped area of black oxide and the surrounding material on this pullout-step lies in the bondline for this ERW seam. The presence of this small pre-existing defect on the ID evidently is responsible for the step in the ID crack path from the seam into the bondline – but as this is a small step that is due to a trivial bondline defect, this apparent origin for the failure forms due to the much larger OD mill mismatch and related pre-existing defect, which fall within the upset.

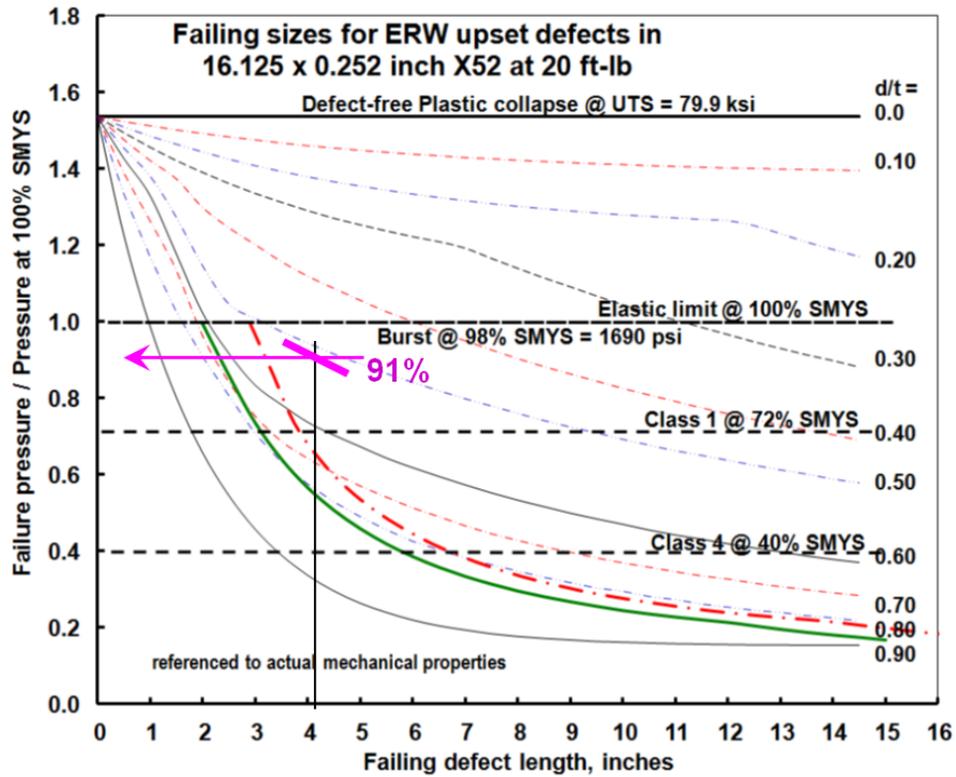
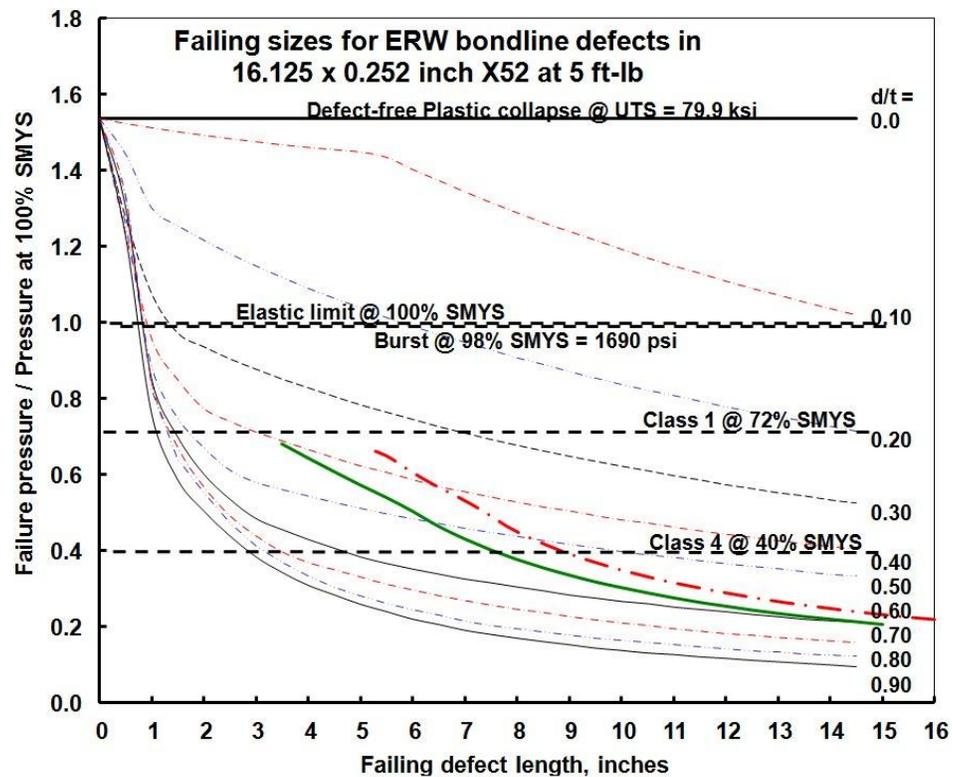
Figure 6 Predicted failure boundaries for Pipe 16-16

Predictions of the failing defect sizes for Pipe 16-16 are presented in Figure 6 based on Release 5 of PAFFC (Pipeline Axial Flaw Failure Criterion)<sup>(10)</sup>, which was developed at Battelle under funding from the PRCI. These predicted failure boundaries are based on the actual pipe size and its properties, which are presented in Annex B. Note that Figure 6a presents results at 20 ft-lbs as representative of failure in the upset of the seam, while Figure 6b presents results at 5 ft-lbs as representative of failure in the bondline. These full-size equivalent (FSE) Charpy v-notch

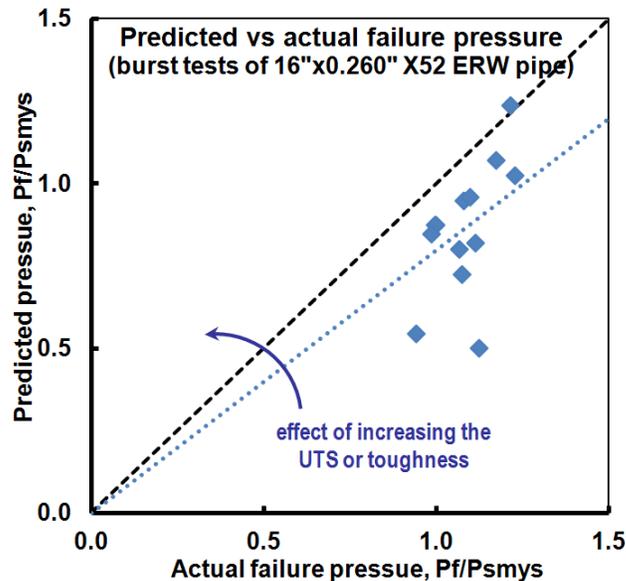
**Figure 7 Failure pressure predictions for field testing of 16” x 0.260” X52 ERW pipe**

Figure 7 presents the results of such predictions. The x-axis in this figure is the actual failure pressure normalized by SMYS, while the y-axis is the predicted failure pressure normalized in the same way. It is apparent from these results that the predictions tend to be conservative, and that there is significant scatter. Two factors drive scatter in predictions – uncertainty in the properties and uncertainty in the defect size and its position within the seam. In reference to Figure 6 it is clear that uncertainty in each of these aspects can cause very large swings in failure pressure, particularly when dealing with defects less than a few inches in length, which becomes extreme when they are in the bondline. For example, the same 3-inch-long 30% deep feature in the upset fails at 134% of SMYS while in the bondline it fails at just 88% of SMYS, for an error of over 50% relative to failure in the bondline. Variations in toughness or the UTS can have a similar impact for failure controlled, respectively by fracture versus NSC. Small errors in length can affect significant errors – particularly for shorter features a few inches long, as the failure boundaries vary strongly with defect length for such cases. But if a feature that that comprises

two or more thumbnail segments is miscalled or misrepresented as a single feature, the error in failure pressure can become very large. Overlaid on this variability is the uncertainty in toughness that can trace to variations in the burst test (or hydrotests) temperature. In regard to the toughness trends shown in Figure A3 in Annex A, it is apparent that the ductile-to-brittle FATT for the seam tends to lie within the range of typical field-supplied water. An uncertain or varying burst/hydro test temperature thus can cause significant variation in predicted failure pressure when as in the above predictions a constant temperature is adopted for all predictions. It follows that disparities in predicted versus actual pressure the order of 10% are not surprising.

In regard to Figure 7, the results would be improved through consideration of a slightly higher resistance in contrast to that for Pipe 16-16. Variability in the predictions enters as well in that the temperature in for the field testing was not always recorded. The sensitivity of the predictions to toughness noted above in regard to Figure 6 underscores the need to better quantify this parameter in order to more effectively validate predictive models. While such uncertainty could be addressed by embedding conservatism in predicted failure pressure, the effect of that conservatism causes non-conservative predictions of the related defect size, which confounds analysis of re-inspection intervals. It follows that models that predict failure pressure as a function of anomaly size must be accurate and embed minimal conservatism. And given the difference between bondline versus upset properties, it also follows that inspection tools must not only better size seam anomalies, but also must better locate them relative to the bondline versus the upset.

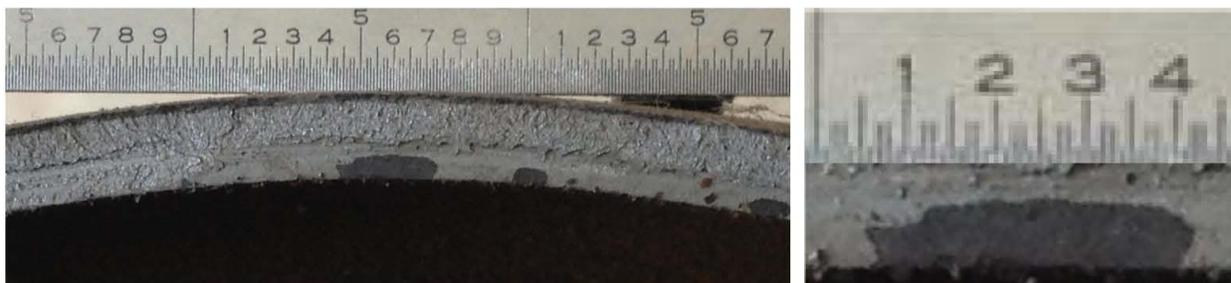
Figure 8 shows a portion of the fracture surface that contains the only candidate origin. As shown there, this origin involved a few patches of black oxide connected to the ID surface. In addition, there are a few shadowed areas that are not oxide covered. Based on this and other observations the failure originated in the bondline. These oxide covered patches (cold welds) are contained within a largely featureless fracture surface that runs to about half-through-wall at its maximum depth, and over a length of ~2.5 inches. The largest of the patches contained within this featureless fracture surface has a surface-breaking length of ~0.355-inch, and a maximum depth of ~0.094-inch, or 42% of the wall thickness. Examination of the surrounding fracture features indicates that this black oxide patch was the triggering defect – which is logical given that it is clearly the largest of these oxide patches.

**a) overview of the origin**

**b) oxide covered defect**

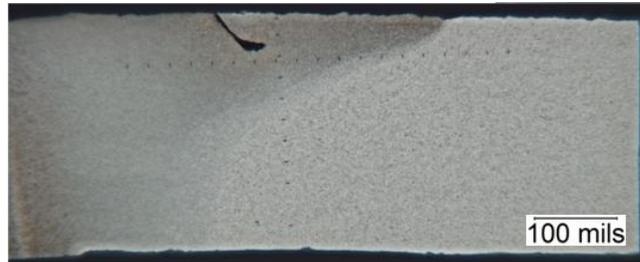
**Figure 10 Metallographic section through the seam in Pipe 22-11:  $t = 0.290$ "**

Figure 10 captures the details evident in a metallographic section, for which the bondline is just visible at the left margin of the image. This figure confirms the presence of a surface-breaking feature whose appearance at the OD surface is crack-like. While the feature appears crack-like from the OD of the pipe, the cross-section indicates that it lies at about 45° to the pipe's surface, and that terminates in a very blunt tip. High-power optical microscopy did not show evidence of microcracking within this feature, and while not oxide-filled it does show their presence. The shape of this feature is not inconsistent with what Battelle's archives have termed arc burns, while in other cases such features also have been referred to as folds or laps (apparently due to skelp production). While past cases of similar features termed arc burns were present on sides of the seam, this feature occurred only on one side.

Hardness traverses were run, as evident in their tracks in Figure 10, to better assess the significance of the microstructural variations evident of in this figure. Figure 10 indicates that the heat-affected zone (HAZ) of the seam is modified and shows traits that could be due to seam normalization. This is consistent with both the vintage and supplier of the pipe involved, which involves mid-50s construction and production by Youngstown Sheet and Tube (YS&T).

Based on Figure 10, this long possibly discontinuous axial feature lies well outside the upset zone in the base metal, and has a maximum depth into the thickness of about 16% of the local wall. If continuous, its total length was ~83 inches.

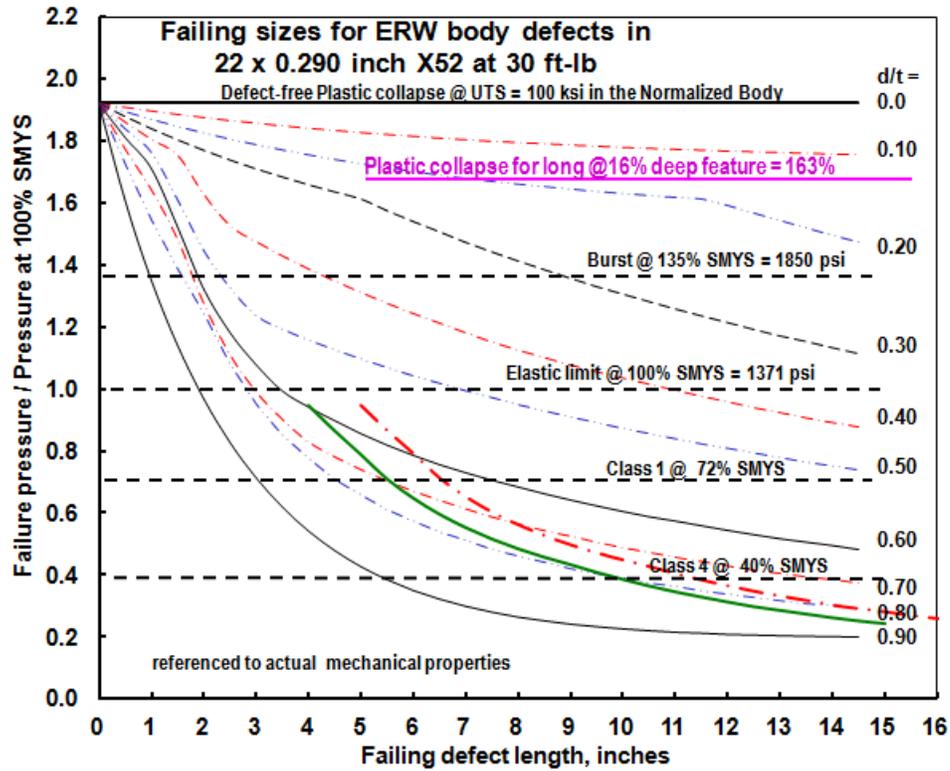
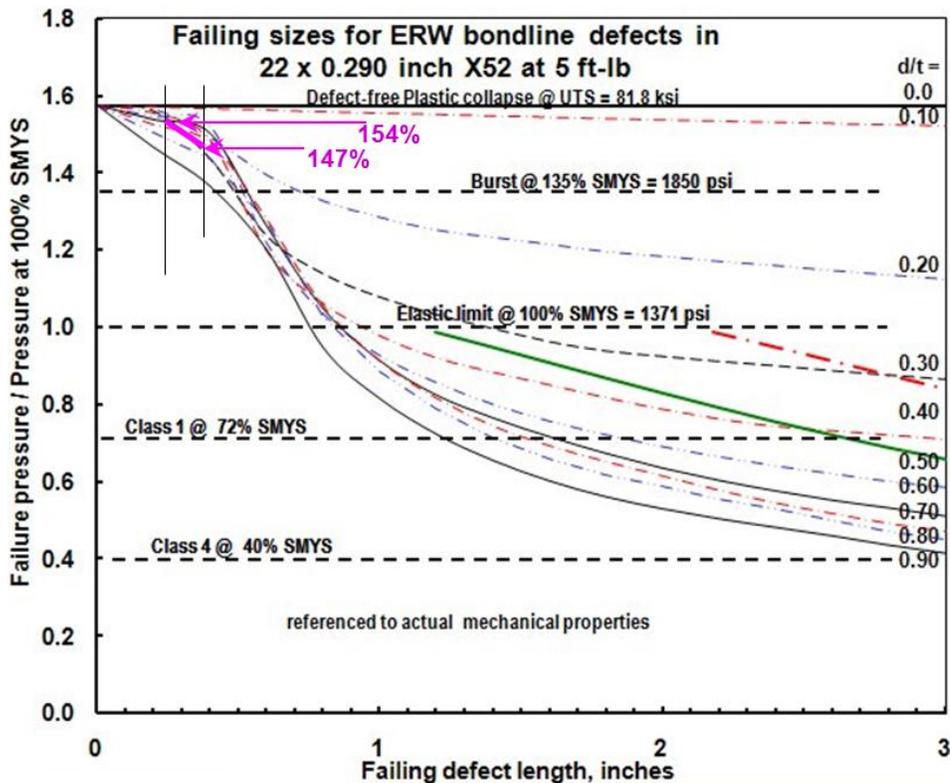
Figure 12 Predicted failure boundaries for Pipe 22-11: t = 0.290"

As for the other test pipes, predictions have been made of the failure pressure based on the results of PAFFC, which are presented in Figure 12 based on the toughness data presented in Annex A. As above the format of Figure 6 that presents the combined results for both plastic collapse and fracture is adopted. Thus, the same general statements made in regard to the trends shown initially for Pipe 16-16 and considered for Pipe 10-7 in regard to Figure 9 apply equally here.

It is apparent from Figure 12 that as for the prior discussion the results for Pipe 22-11 show a very strong effect of toughness on failure pressure and the potential for rupture in lieu of a leak. In contrast to the prior discussion that contrasted the response of defects in the bondline versus those in the upset, the possibly continuous 83-inch-long stable feature was not in the upset. Rather, it lay in the pipe body, within a microstructure that was marginally harder than the base metal. As such, the present discussion contrasts the response of defects pipe body with those in the bondline. In that context, Figure 12a presents the response of anomalies in the pipe body in comparison to those in the bondline that are shown in Figure 12b. Note that the UTS for the prediction of the pipe body feature reflect its presence in a locally harder microstructure, with correspondingly higher UTS. Thus the y-axis scales differ between Figures 12a and 12b.

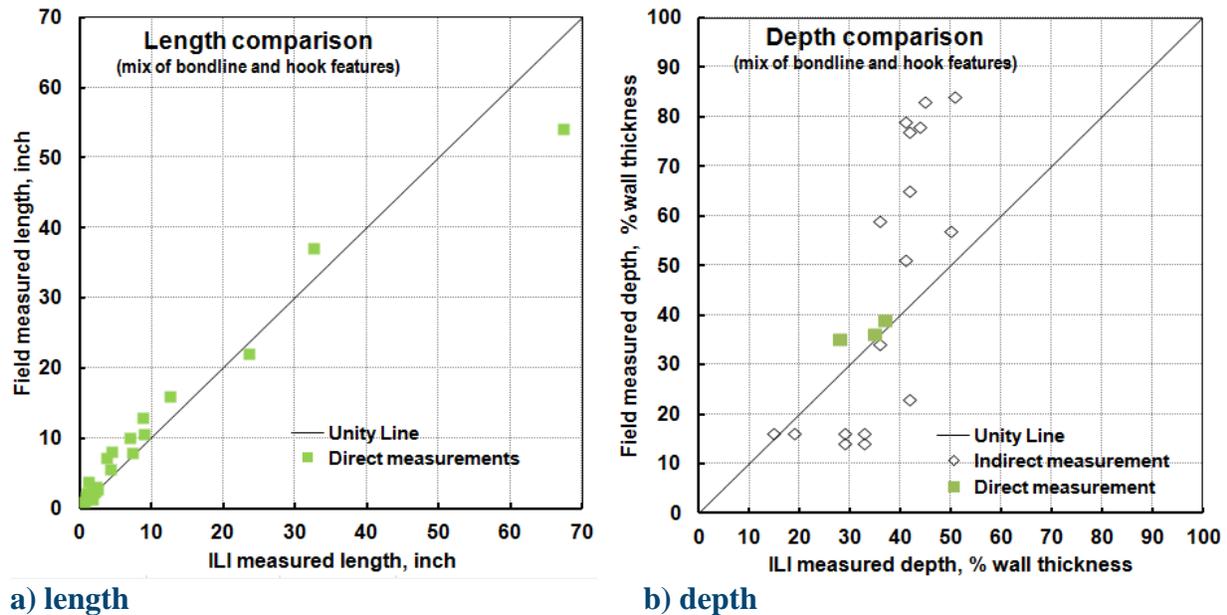
**Figure 13 Comparison of the SMFL measurement with reference data**

provide a benchmark for the viability of the ILI results. However, as was noted above in regard to the data discussed in Reference 3, if the results developed in a field dig are based on other indirect measurements, such as those made using PAUT, they can be less reliable. Nevertheless, because PAUT remains the best ITD technology for such purposes, and also is convenient for use in such digs, this technology underlies the majority of the measurements reported on the y-axis in Figure 13. For this reason it is not a surprise that for the one case where use of PAUT was replicated, the independently measured depths reported by two UT crews were quite different. One crew reported the depth at 68% of wall, while the second crew reported it at 85% of wall. These very different depths are reported in Figure 13 as the average of these values, which is 76.5%.

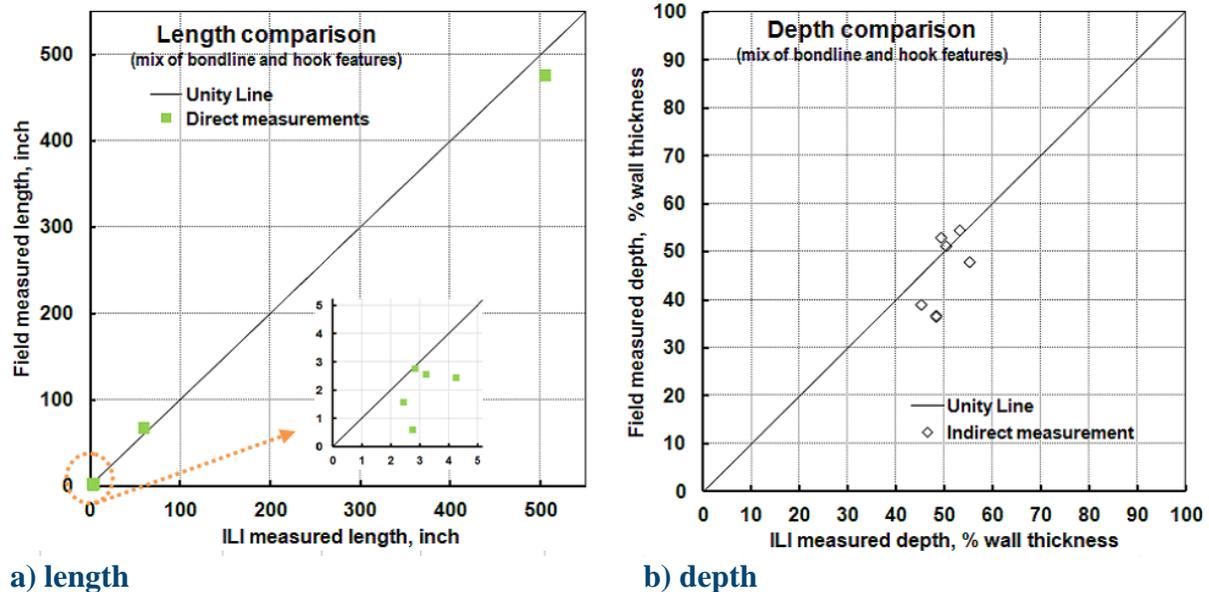
**Figure 14 Comparison of the EMAT measurement with reference data**

With this background, the results of this collaborative study are presented in Figure 14, wherein the x-axis is the dimension called by the ILI, the y-axis in the corresponding field measurement. It is evident that all results shown in Figure 13a involve benchmarked lengths, whereas for these data all depth measurements are indirect. Figure 14a presents the measured length, while

Figure 14b presents measured depth. These figures show the results developed to date for the 7 anomalies reported by the EMAT ILI<sup>(17)</sup>. Because the available data are limited, this comparison is limited to consideration of a unity plot.

**Results and Discussion.** It is apparent from Figure 14a that the EMAT technology provides quite accurate sizing in regard to the direct length for longer features and PAUT depths for these cold welds. Because of the wide range of lengths measured, five of the seven results lie clustered together for the shorter features, which show that the ILI tool over estimates the lengths for shorter features (for results captured from photographs). Such results cover lengths from well under an inch to approaching the length of the seam in a typical double-random joint.
