Appendix B – Task 2
Catalog of Seam Weld Defect Types

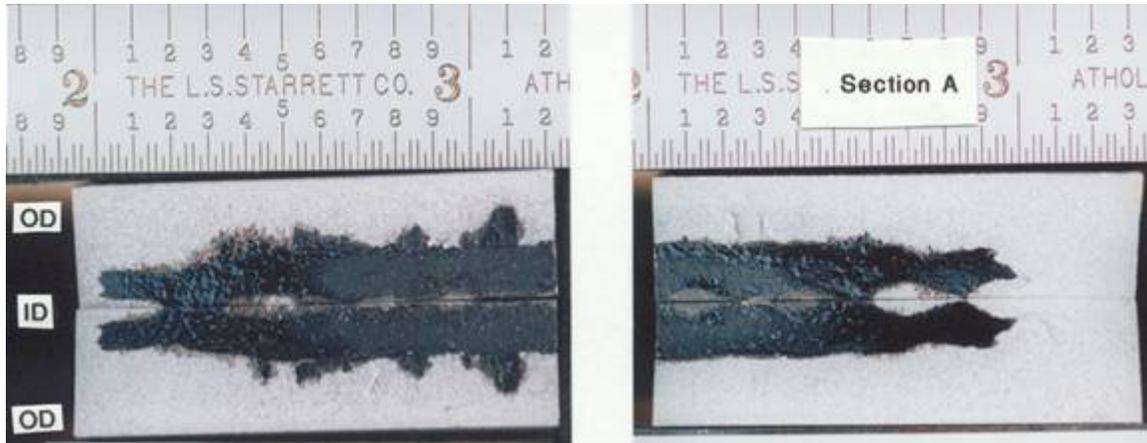
Catalog #: 30
 Report #: 3
 Defect #: 13

Photograph of Fracture Surfaces.

NDE technique(s): UT
 NDE result(s): 60%, 3.5 inch
 (89 mm) ID crack
 Visual: ID Hook Crack
 L
 depth/ t_{weld} : 2.21 inch (56.1 mm)
 71%
 depth: 0.240 inch (6.10 mm)
 t_{weld} : 0.340 inch (8.64 mm)

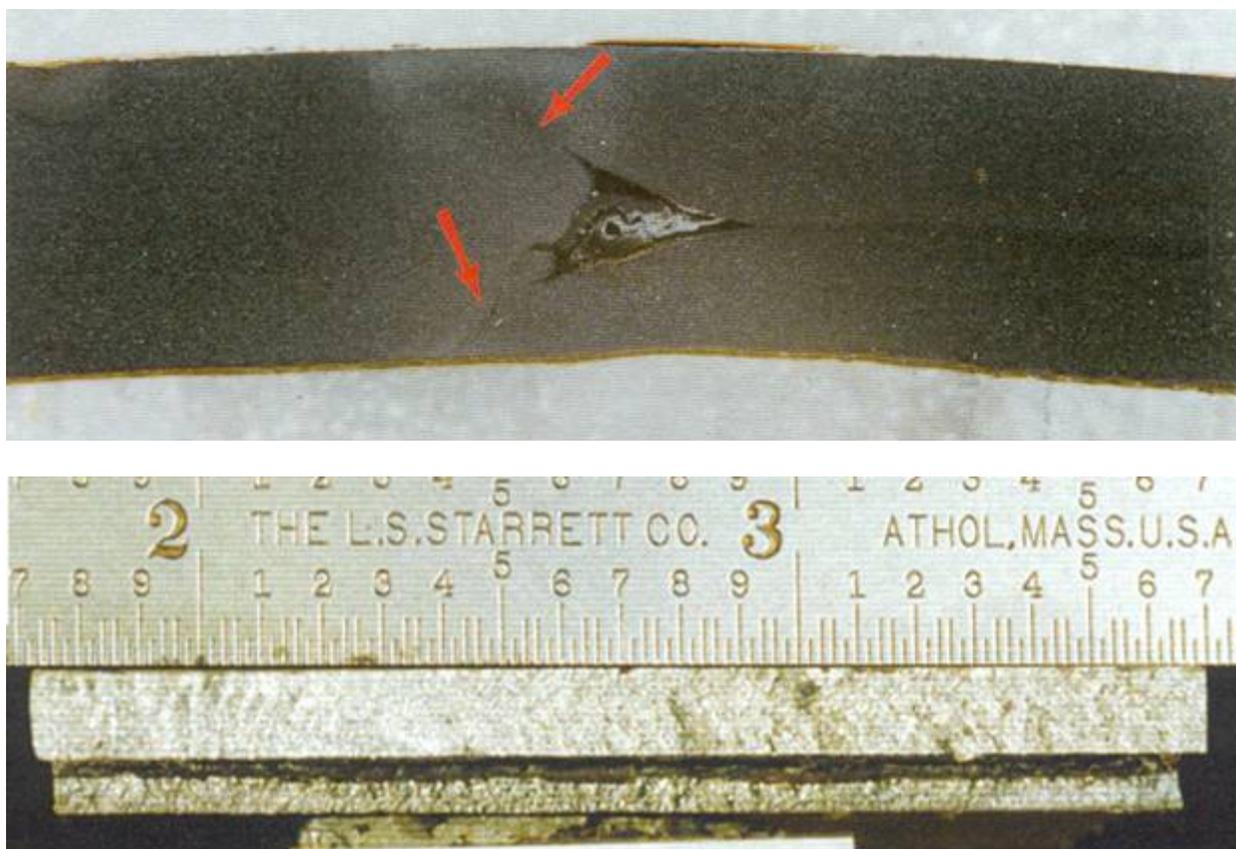
Catalog #: 135
 Report #: 12
 Defect #: 71A

Photographs of Metallographic Section and Fracture Surface.

NDE technique(s): Fast UT, MPI
 NDE result(s): 60%, 8.5 inch
 (216 mm) ID & Mid-wall Non-Fusion
 Mid-wall Void + Laminations + ID
 Hook Crack
 Visual: > 2 inch (51 mm)
 (ID Hook Crack)
 depth/ t_{weld} 48% (ID Hook Crack)
 depth: 0.122 inch (3.10 mm)
 t_{weld} 0.251 inch (6.38 mm)

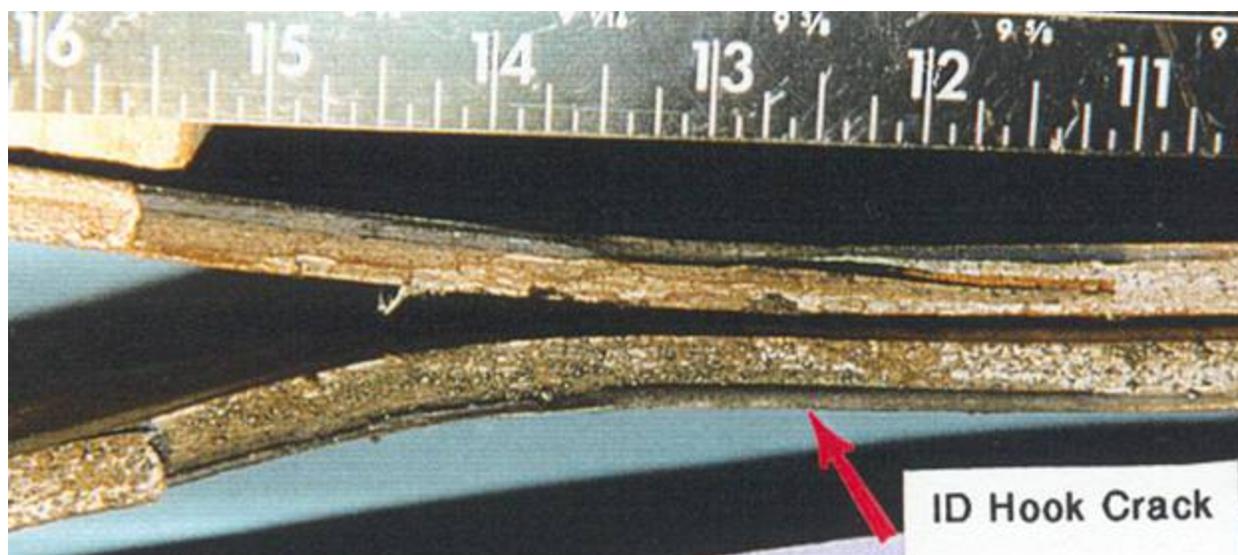
Catalog #: 22
 Report #: 2
 Defect #: 421

Photograph of Fracture Surfaces.

Seam Type: ERW
 Grade: X52
 D_{nominal} : 20 inch (508 mm)
 t_{nominal} : 0.312 inch (7.92 mm)
 t_{pipe} : 0.326 inch (8.28 mm)
 Failure: Burst test rupture at
 2,200 psig (15.17
 MPa) (136% of SMYS)

NDE technique(s): UT
 NDE result(s): 50%, 7 inch (178 mm)
 crack like
 Visual: ID Hook crack
 L 5.5 inch (140 mm)
 depth/ t_{weld} : 43%
 depth: 0.150 inch (3.81 mm)
 t_{weld} : 0.344 inch (8.74 mm)

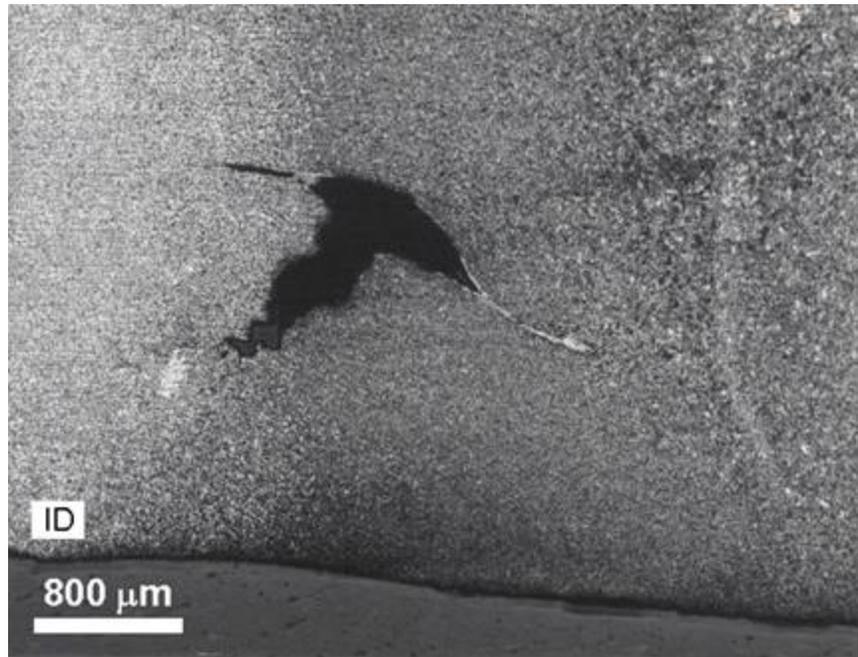
Photograph and Photomicrograph of Metallographic Section.

Catalog #:	104		
Report #:	11		
Defect #:	3B		
<u>Pipe</u>		<u>Defect</u>	
Vintage:	1953	NDE technique(s):	Fast UT
Manufacturer:	Unknown	NDE result(s):	40%, 3 inch (76 mm) ID Crack ID Hook Crack Mid-wall Void
Seam Type:	LF-ERW	Visual:	Not Determined
Grade:	API 5L X42	L	39.6% (ID Hook Crack)
D _{nominal}	12.75 inch (324 mm)	depth/t _{weld}	Not Determined
t _{nominal}	0.250 inch (6.35 mm)	depth:	Not Determined
t _{pipe}	Not Determined	t _{weld}	Not Determined
Failure:	N/A

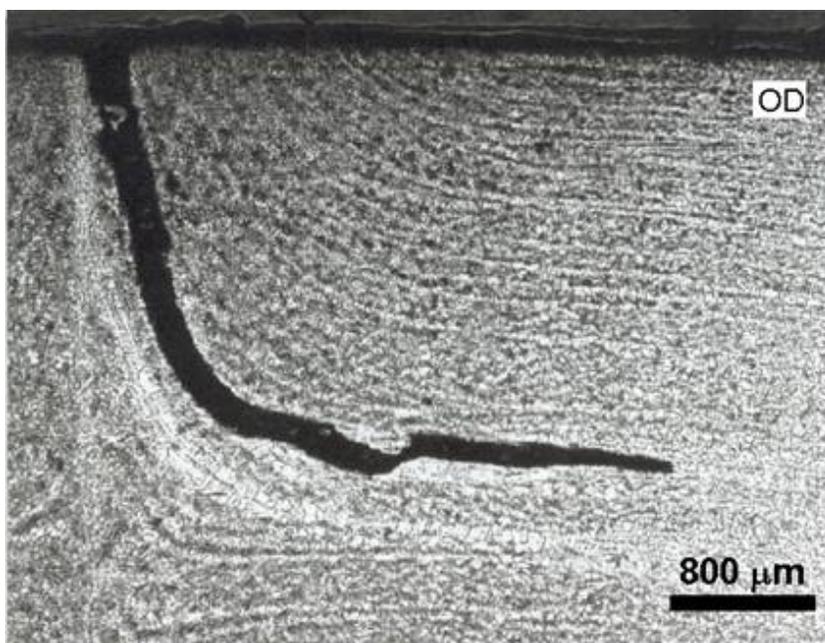
Catalog #: 140
 Report #: 12
 Defect #: 73D

Photograph and Photomicrograph of Metallographic Section.

Visual: OD Hook Crack
 L: Not Determined
 depth/ t_{weld} : 38%
 depth: 0.090 inch (2.29 mm)
 t_{weld} : 0.236 inch (5.99 mm)

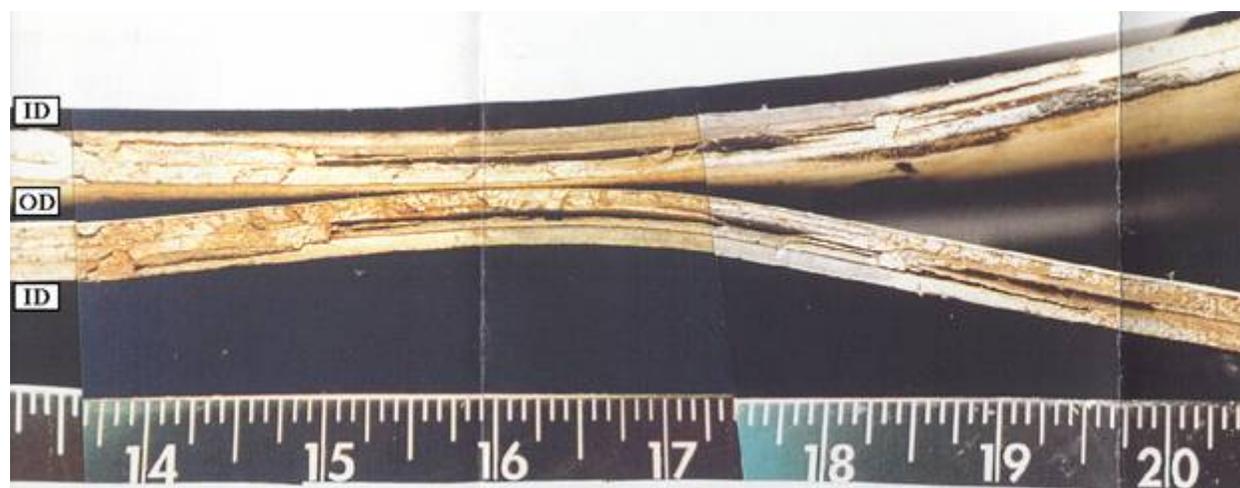
Catalog #: 24
 Report #: 2
 Defect #: 551-39.6.b

Photographs of Fracture Surfaces.

Seam Type: ERW
 Grade: X52
 D_{nominal} : 20 inch (508 mm)
 t_{nominal} : 0.312 inch (7.92 mm)
 t_{pipe} : 0.332 inch (8.43 mm)
 Failure: Burst test rupture(*) at
 2,200 psig (15.17 MPa)
 (116% of SMYS)

NDE technique(s): UT
 NDE result(s): 80%, 5.5 inch (140 mm)
 ID crack like
 Visual: ID Hook crack
 L: 7.0 inch (178 mm)
 $\text{depth}/t_{\text{weld}}$: 35%
 depth: 0.120 inch (3.05 mm)
 t_{weld} : 0.346 inch (8.79 mm)

(*) Burst test failed two adjacent hook cracks at one pressure.

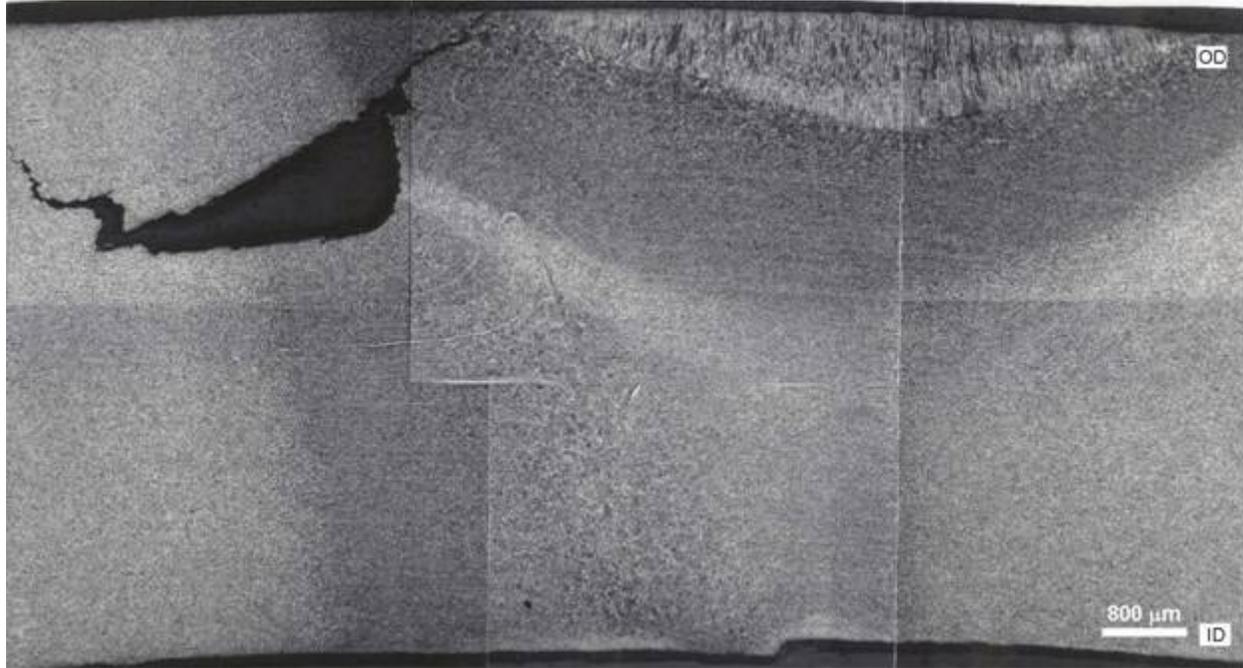
Photograph and Photomicrograph of Metallographic Section.

Catalog #:	108		
Report #:	11		
Defect #:	4A		
<u>Pipe</u>		<u>Defect</u>	
Vintage:	1953	NDE technique(s):	Fast UT
Manufacturer:	Unknown	NDE result(s):	40%, 3.5 inch (89 mm) OD Crack
Seam Type:	LF-ERW	Visual:	OD Hook Crack + Mid-Wall Void + OD Weld Repair
Grade:	API 5L X42	L	Not Determined
D _{nominal}	12.75 inch (324 mm)	depth/t _{weld}	33.5% (OD Hook Crack)
t _{nominal}	0.250 inch (6.35 mm)	depth:	Not Determined
t _{pipe}	Not Determined	t _{weld}	Not Determined
Failure:	N/A

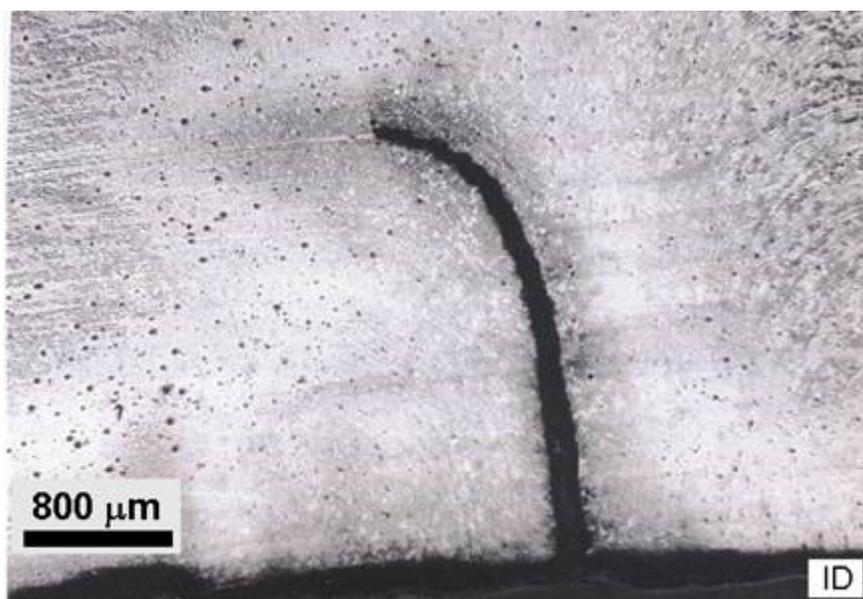
Photograph and Photomicrograph of Metallographic Section.

Catalog #:	7		
Report #:	1		
Defect #:	415		
Pipe		Defect	
Vintage:	1950s	NDE technique(s):	UT
Manufacturer:	Youngstown	NDE result(s):	<10% x 2.4 inch (61 mm) grind area on seam
Seam Type:	ERW	Visual:	ID hook crack
Grade:	X52	L	N/A
D _{nominal}	20 inch (508 mm)	depth/t _{weld}	27.9%
t _{nominal}	0.312 inch (7.92 mm)	depth:	0.092 inch (2.34 mm)
t _{pipe}	0.330 inch (8.38 mm)	t _{weld}	0.330 inch (8.38 mm)
Failure:	Yielding at 2,100 psig (14.48 MPa) (129% of SMYS)

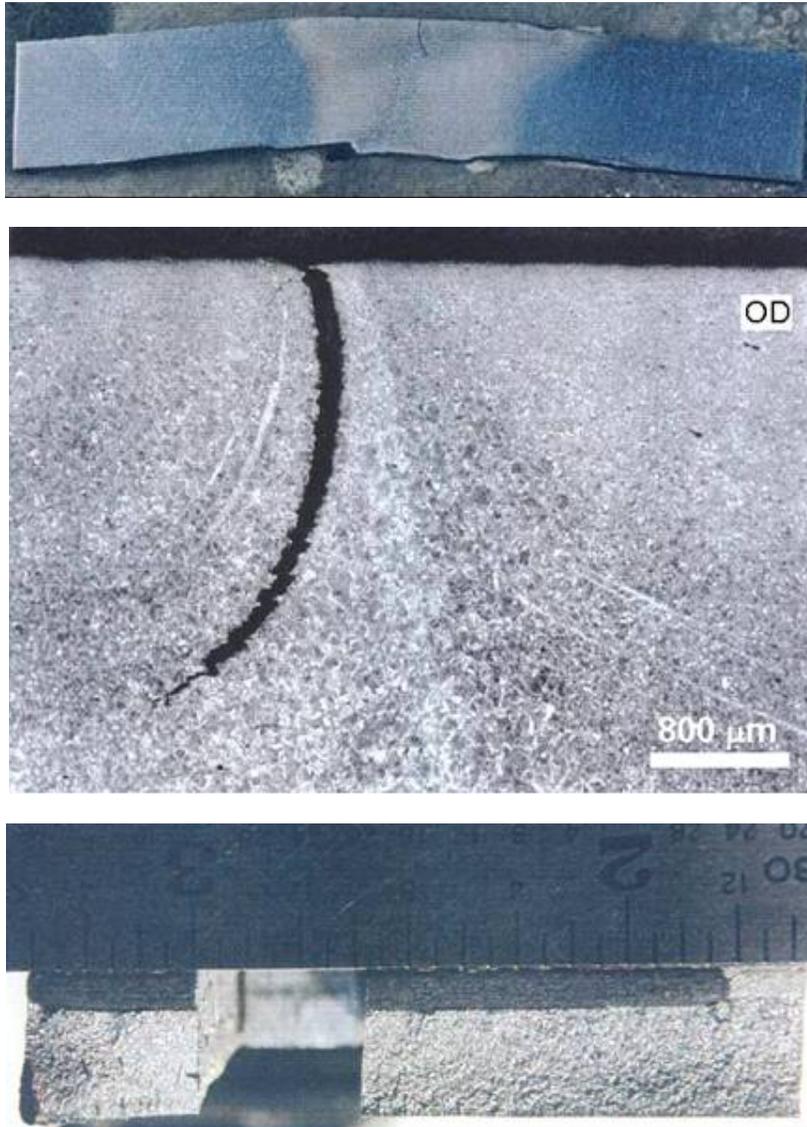
Catalog #: 98
 Report #: 10
 Defect #: CY-7

Photographs and Photomicrograph of Metallographic Section and Fracture Surface.

NDE technique(s): N/A
 NDE result(s): N/A
 Visual: OD Hook Crack
 L: 1.6 inch (41 mm)
 depth/ t_{weld} : 27.5 %
 depth: 0.100 inch (2.54 mm)
 t_{weld} : 0.363 inch (9.22 mm)

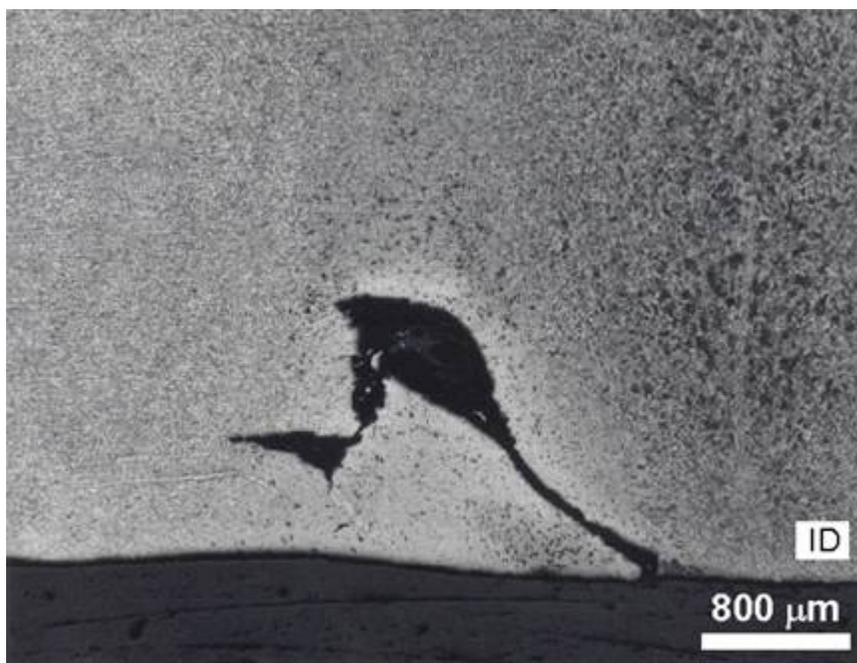
Catalog #: 106
 Report #: 11
 Defect #: 3D

Photograph and Photomicrograph of Metallographic Section.

NDE technique(s): Fast UT
 NDE result(s): 30%, 2.5 inch (63 mm) ID Crack
 ID Hook Crack Mid-wall Void
 Visual: Not Determined
 depth/ t_{weld} : 24.2% (ID Hook Crack)
 depth: Not Determined
 t_{weld} : Not Determined

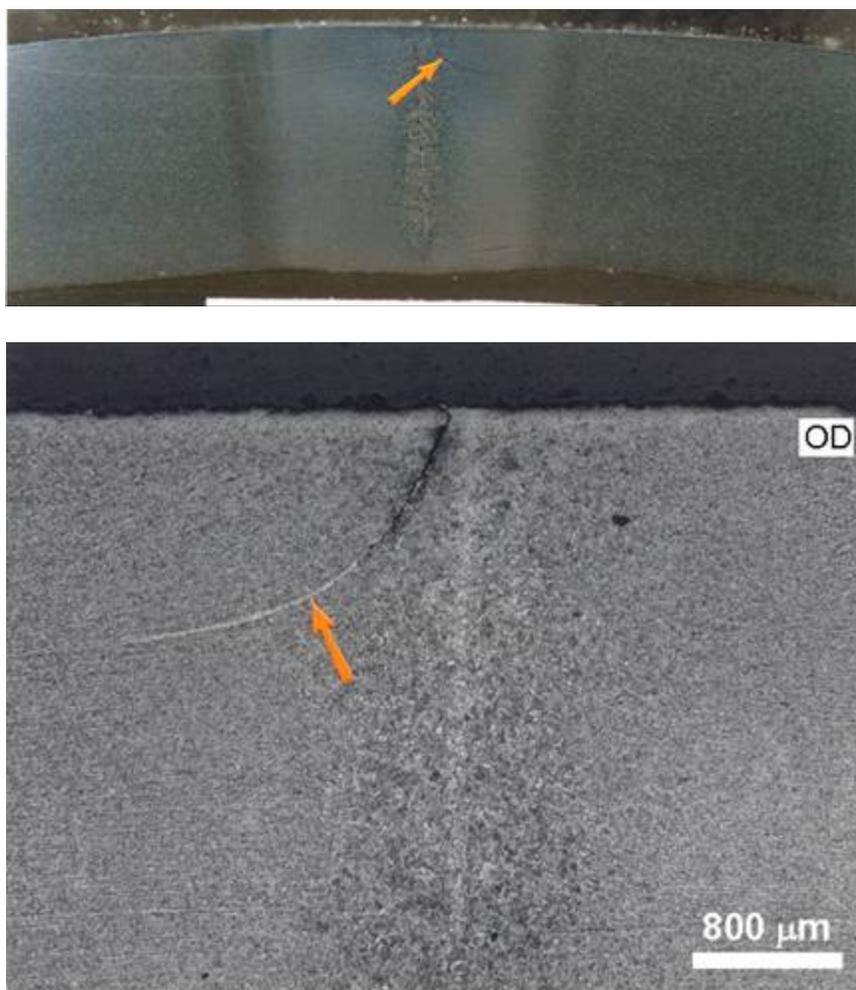
Catalog #: 105
 Report #: 11
 Defect #: 3C

Photograph and Photomicrograph of Metallographic Section.

NDE technique(s): Fast UT
 NDE result(s): 15%, 2 inch (51 mm)
 OD Crack
 Visual: OD Hook Crack
 L
 2 inch (51 mm)
 depth/ t_{weld} : 16.5%
 depth: Not Determined
 t_{weld} : Not Determined

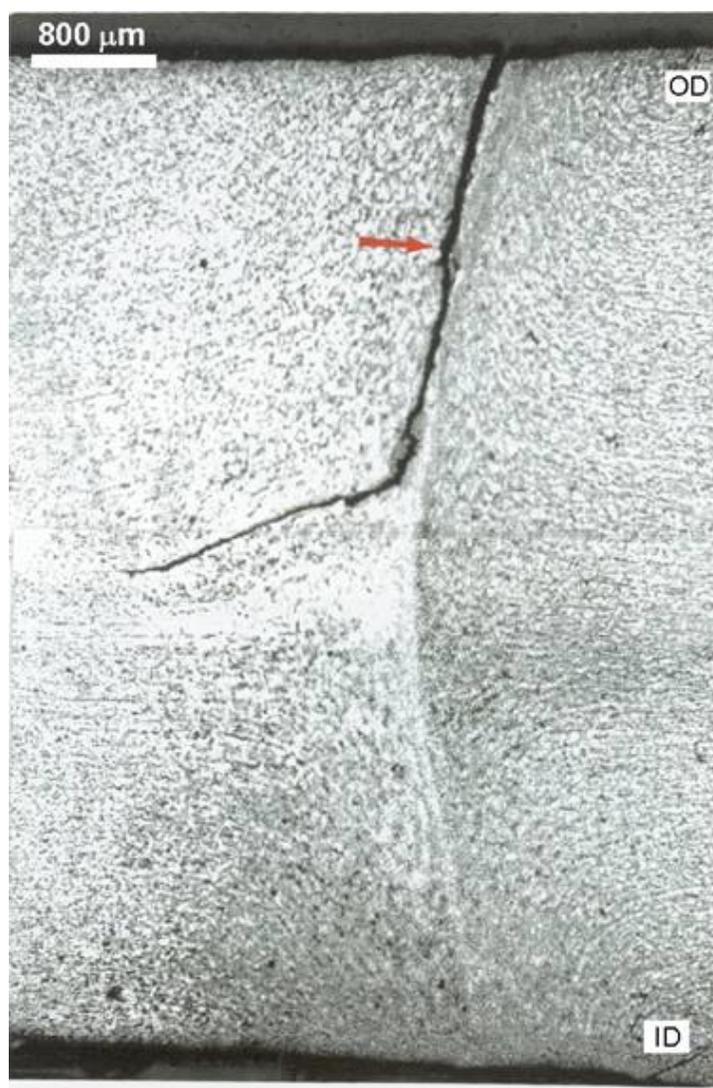
Catalog #: 114
 Report #: 12
 Defect #: 46B-D

Photograph and Photomicrograph of Metallographic Section.

Visual: Hook Crack
 L: Not Determined
 $\text{depth}/t_{\text{weld}}$: Not Determined
 depth: Not Determined
 t_{weld} : Not Determined

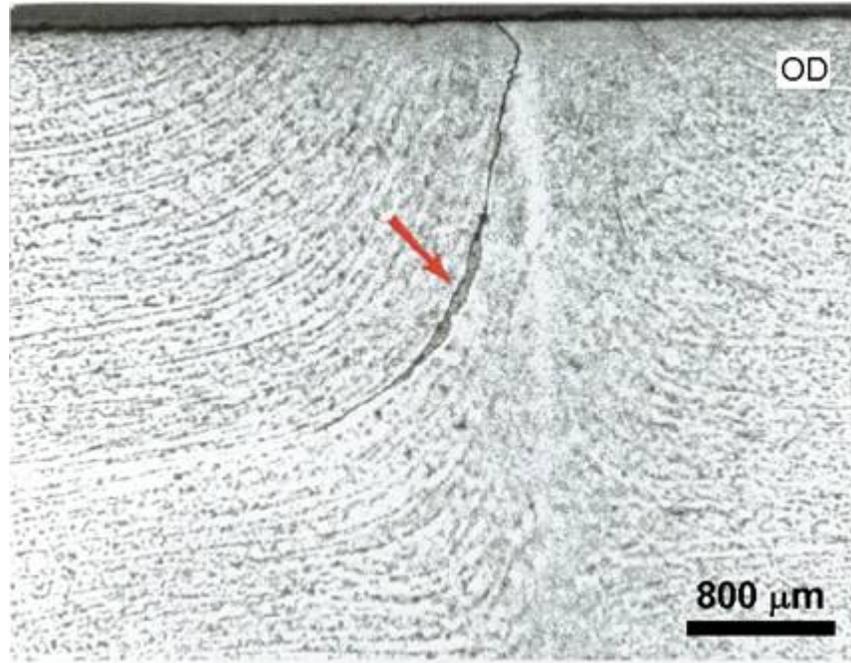
Catalog #: 143
 Report #: 12
 Defect #: 79B

Photograph and Photomicrograph of Metallographic Section.

NDE technique(s): TOFD, MPI
 NDE result(s): N/A
 Visual: Hook Crack + Alloy Segregation

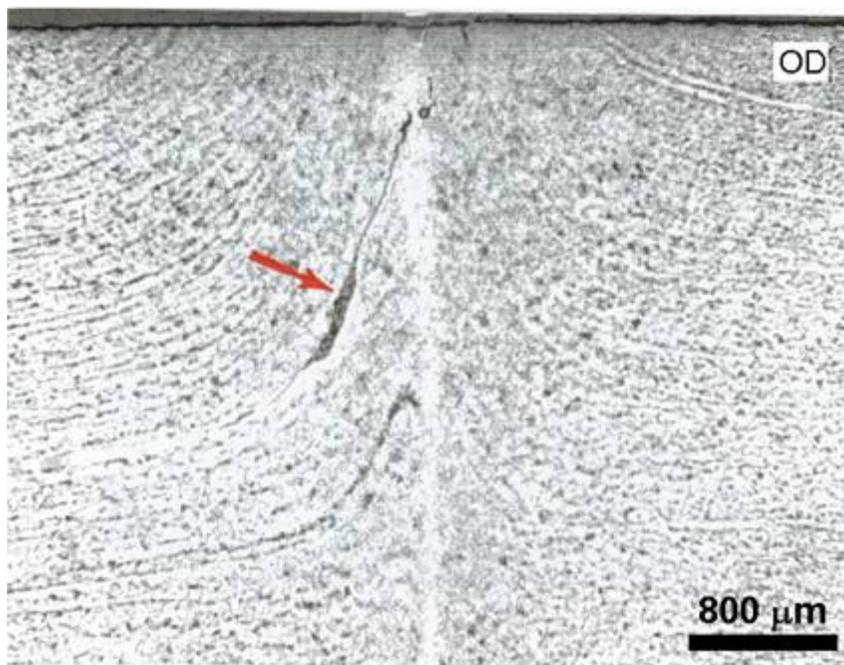
Catalog #: 144
 Report #: 12
 Defect #: 79C

Photograph and Photomicrograph of Metallographic Section.

Visual: OD Non-Fusion
 Hook Crack + Alloy Segregation

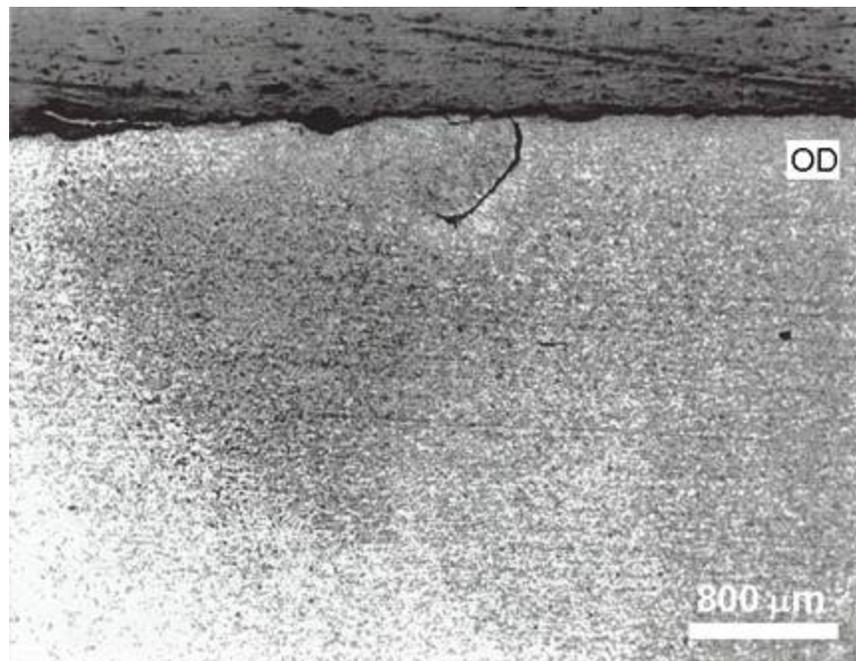
Catalog #: 100
 Report #: 10
 Defect #: CY-9

Photograph and Photomicrograph of Metallographic Section.

NDE technique(s): N/A
 NDE result(s): N/A
 Visual: OD Crack at Contact Mark + ID Under-trim
 Not Determined
 L
 $\text{depth}/t_{\text{weld}}$: < 7.0% (OD Crack)
 depth: < 0.024 inch (0.61 mm)
 t_{weld} : 0.344 inch (8.74 mm)

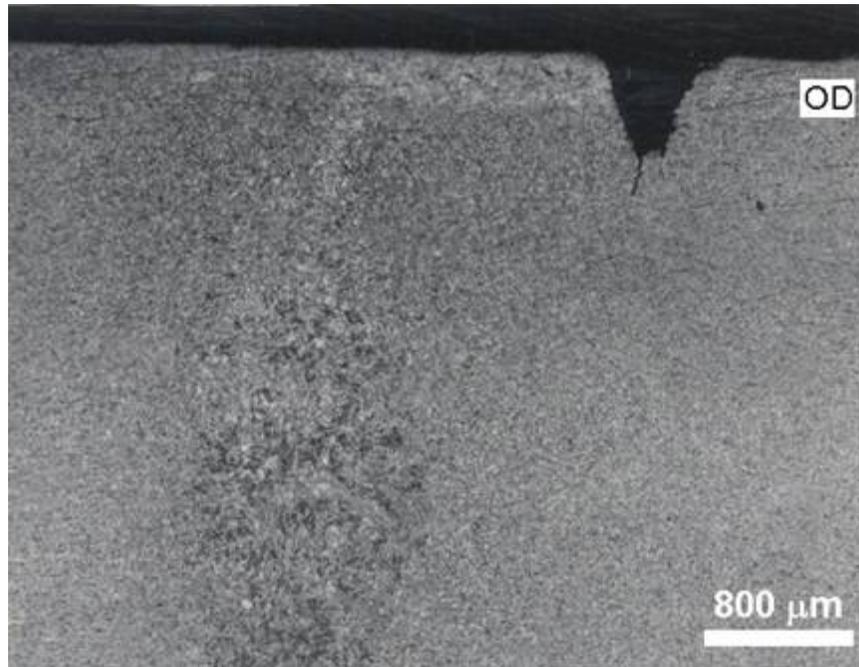
Catalog #: 107
 Report #: 11
 Defect #: 3E

Photograph and Photomicrograph of Metallographic Section.

NDE technique(s): Fast UT
 NDE result(s): 50%, 5 inch (127 mm)
 OD Crack
 Visual: OD Crack
 L: 5 inch (127 mm)
 depth/ t_{weld} : 9.2%
 depth: Not Determined
 t_{weld} : Not Determined

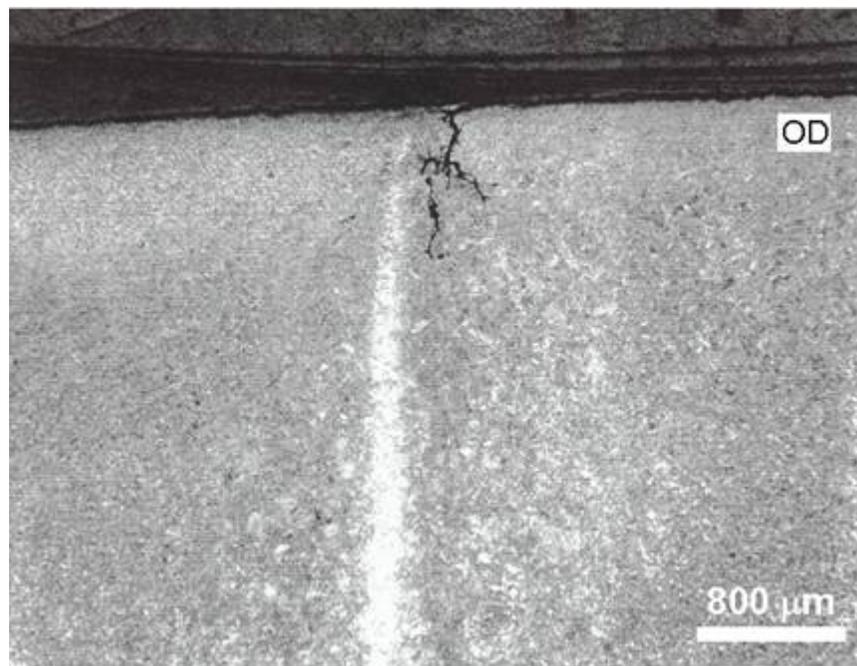
Catalog #: 93
 Report #: 10
 Defect #: CY-2

Photograph and Photomicrograph of Metallographic Section.

NDE technique(s): N/A
 NDE result(s): N/A
 Visual: OD Crack
 L: Not Determined
 $\text{depth}/t_{\text{weld}}$: 8.8%
 depth: 0.031 inch (0.79 mm)
 t_{weld} : 0.353 inch (8.97 mm)

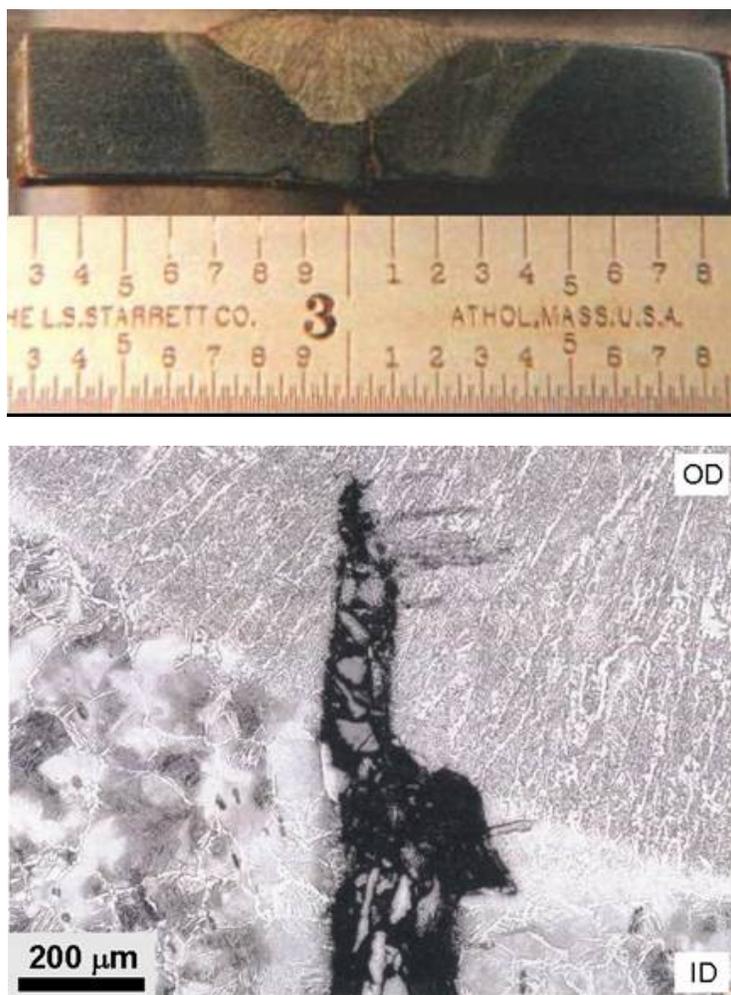
Catalog #: 13
 Report #: 1
 Defect #: 574

Photograph and Photomicrograph of Metallographic Section.

L: N/A
 $\text{depth}/t_{\text{weld}}$: 42%
 depth: 0.200 inch (5.08 mm)
 t_{weld} : 0.427 inch (10.9 mm)

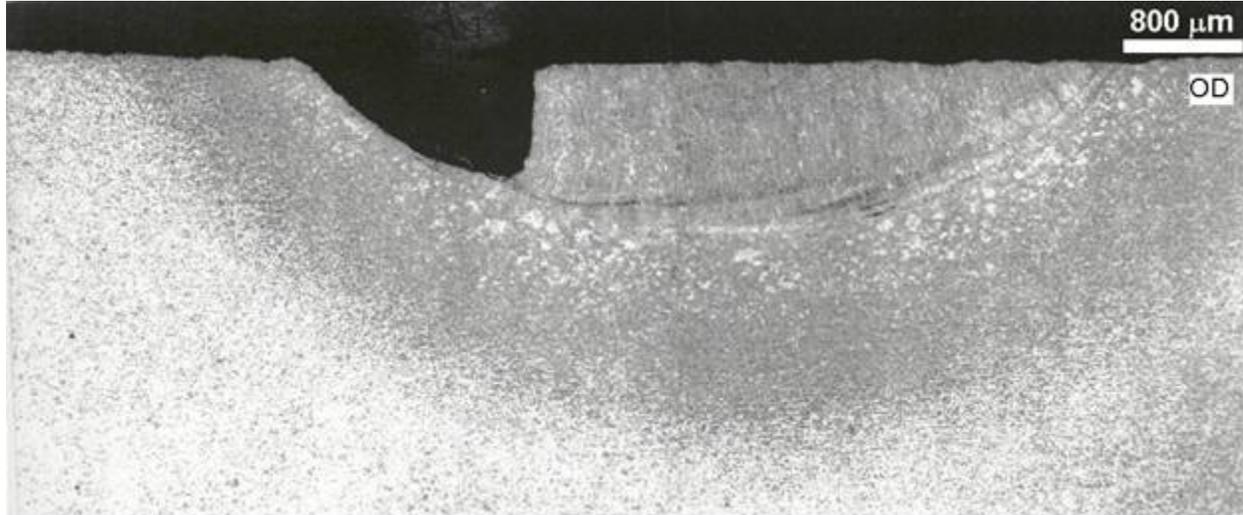
Photograph and Photomicrograph of Metallographic Section.

Catalog #:	96		
Report #:	10		
Defect #:	CY-5		
Pipe		Defect	
Vintage:	circa 1950	NDE technique(s):	N/A
Manufacturer:	Youngstown	NDE result(s):	N/A
Seam Type:	ERW	Visual:	Offset Plate Edges + OD Notch
Grade:	X52	L	Not Determined
D_{nominal}	20 inch (508 mm)	depth/ t_{weld}	Not Determined
t_{nominal}	0.312 inch (7.92 mm)	depth:	Not Determined
t_{pipe}	0.260 inch (6.60 mm) (at offset)	t_{weld}	Not Determined
Failure:	N/A

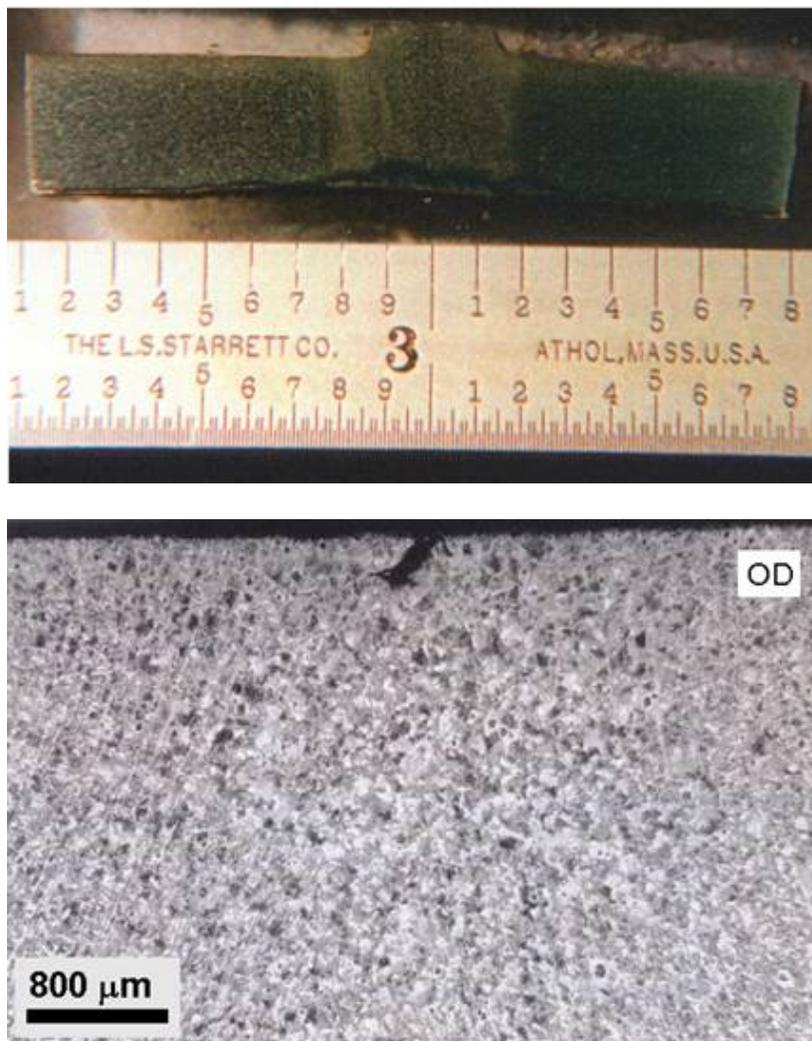
Photograph and Photomicrograph of Metallographic Section.

Catalog #:	15		
Report #:	1		
Defect #:	624		
Pipe		Defect	
Vintage:	1950s	NDE technique(s):	UT
Manufacturer:	AO Smith	NDE result(s):	<10% x 5.5 inch (140 mm) crack
Seam Type:	FW	Visual:	OD crack
Grade:	X52	L	N/A
D_{nominal}	20 inch (508 mm)	depth/ t_{weld}	3.1%
t_{nominal}	0.312 inch (7.92 mm)	depth:	0.012 inch (0.31 mm)
t_{pipe}	0.303 inch (7.7 mm)	t_{weld}	0.385 inch (9.78 mm)
Failure:	None at 2,300 psig (15.86 MPa) (142% of SMYS)
