In-Ditch Validation Methodology for Determination of Defect Sizing

Peter den Boer, Harvey Haines, Lars Hörchens,
Pushpendra Tomar, and Jeff Vinyard
August 23, 2016

Final Report

PHMSA

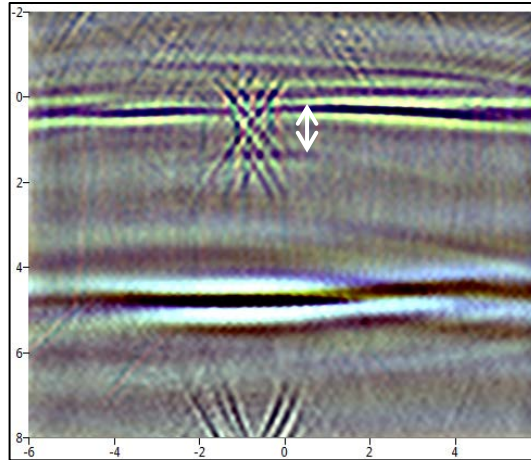
Figure 18. IWEX image of a 20% top notch, vertical extent indicated by the arrow. Indications are present in several modes, which are superimposed on each other. A mirror image of the defect is visible below the inner pipe interface.

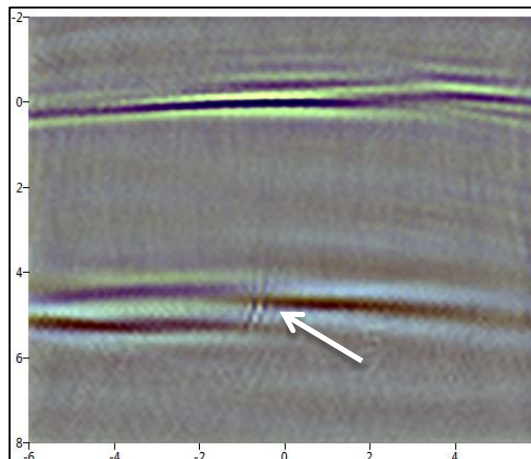
These effects can be caused by changes in the pipe wall thickness, too. Figure 19 presents an example of this case. The actual wall thickness deviates from the geometrical model, leading to double indications of the inner pipe wall in the left half of the image. The bluish IWEX-0 mode shows that the pipe is actually thicker to the left side of the weld. The greenish IWEX-2 mode is a mirrored version of the same indication, based on the assumed nominal position of the inner pipe wall as a mirroring plane.

Figure 19. IWEX image with an example of poor trim. The difference in wall thickness between the left and right side is indicated by the arrow. The bluish IWEX-0 image shows the actual wall thickness. Another indication mirrored at the nominal position of the inner interface is visible in the greenish IWEX-2 mode just above the inner interface on the left side.

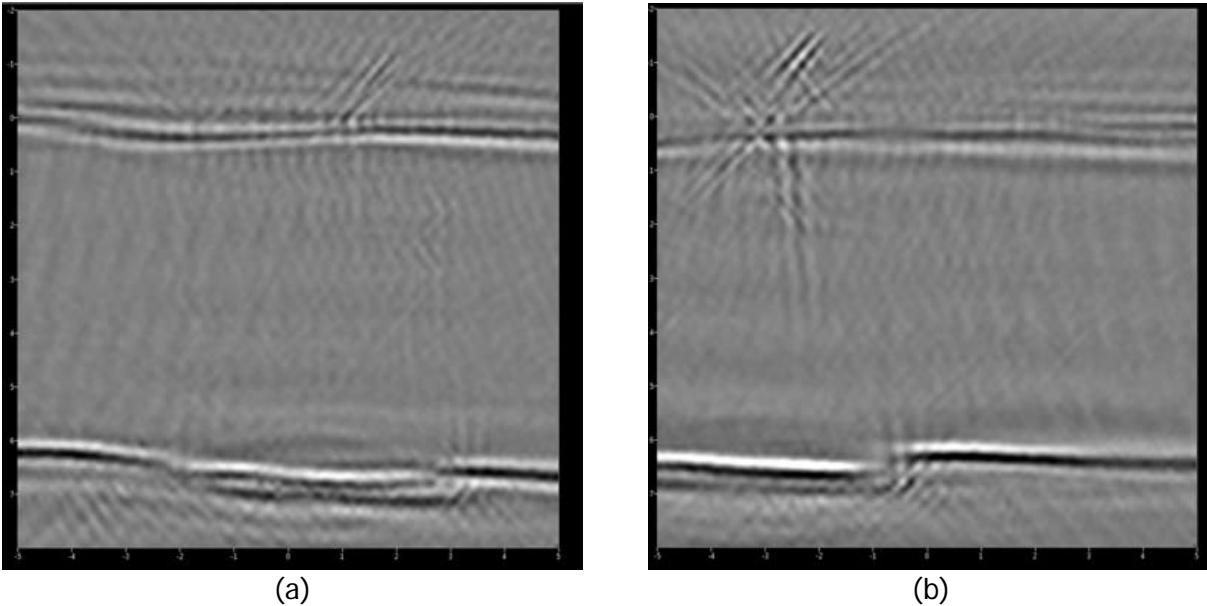
Below are images obtained from the Houston AC testing. The image on the left shows a seam weld with no defect although there is some trim variability, whereas the image on the right shows a lack of fusion (cold weld) anomaly in the seam. The right image also shows poor trim on the ID with an offset in the ID surface. The cross pattern on the OD is an artifact of a corner reflection at the base of the lack of fusion. In this case the IWEX-2 modes from the left and right produce 45-degree lines where the vertical crack-like anomaly meets the surface. These corner reflections are similar to what PA produces from the corner when identifying surface breaking cracks-like anomalies, only PA will not image the vertical flaw itself and must be inferred. IWEX images the vertical anomaly with a tandem mode such as IWEX-1 or IWEX-3 which requires an odd number of skips off the OD and ID surfaces.

Figure 20. 16-inch ERW samples inspected at Houston AC (a) no seam weld defect with trim variability, (b) lack of fusion anomaly

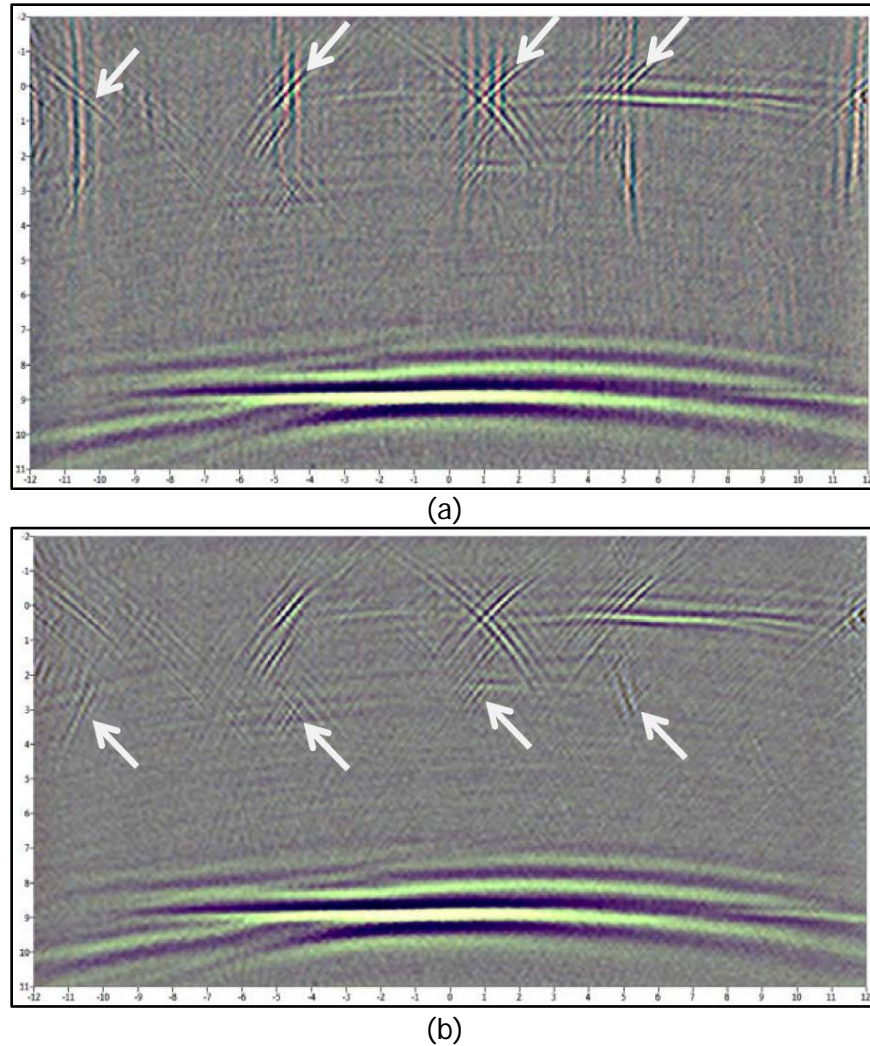
At the lower end of the cracks, tip diffractions are picked up by the IWEX-2 (skip) mode. The presence of these weaker indications is seen better when the IWEX-3 mode is switched off as shown in Figure 38(b). The height of the cracks can be determined roughly by the extent of the red IWEX-3 indications, but more accurately using the lower tip diffractions picked up by the IWEX-2 skip mode.

Figure 38. IWEX image of several cracks; Aside from the vertical indications, corner effects indicated by arrows occur (a). The height of the cracks can be determined accurately using tip diffraction, indicated by arrows (b); in this image, the red IWEX-3 made has been removed (all dimensions in millimeters).

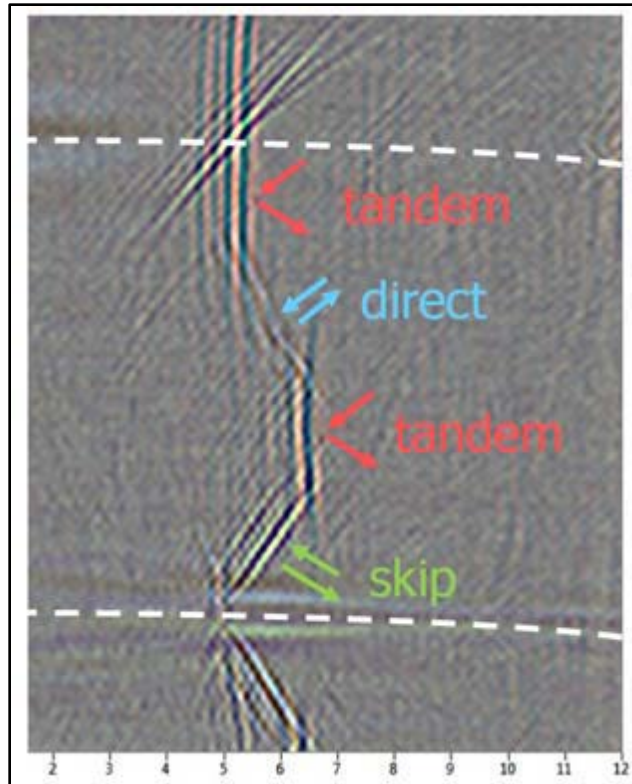
An example of a through-wall crack is shown in Figure 39. In this particular case, the different IWEX modes represented by different colors contribute to different parts of the crack in the image. Only the combination of all modes shows the entire crack. If a through-wall crack is present, the inner and outer pipe surface disappear from the image altogether because no cross mode from one array probe to the other can no longer be measured. Obviously, if there are several through-wall cracks present at the same scan position, the region in between cannot be reached acoustically and, therefore, cannot be inspected.

Figure 39. IWEX image of a through-wall crack. Note that the different modes image different parts of the crack dependent on the orientation. The modes contributing to the different parts are labeled (all dimensions in millimeter).

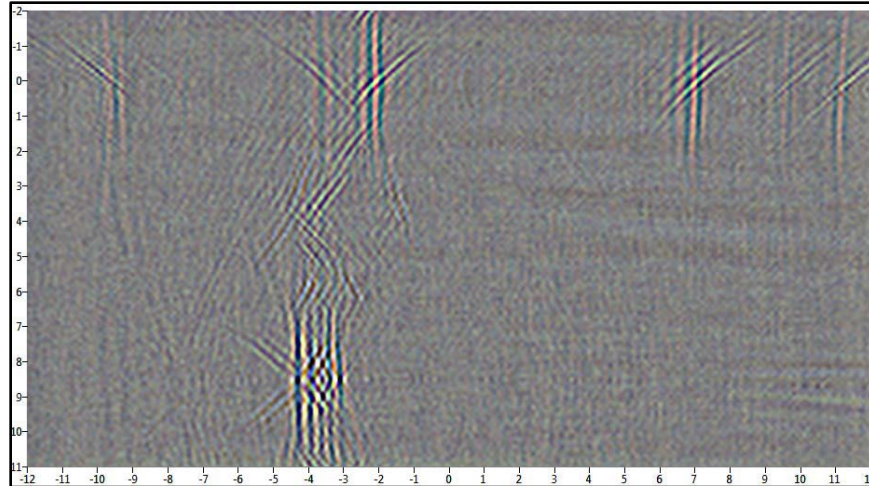
Figure 40. IWEX image of a crack exhibiting different branches. Note that the different modes image different parts of the crack dependent on the orientation (all dimensions in millimeters).

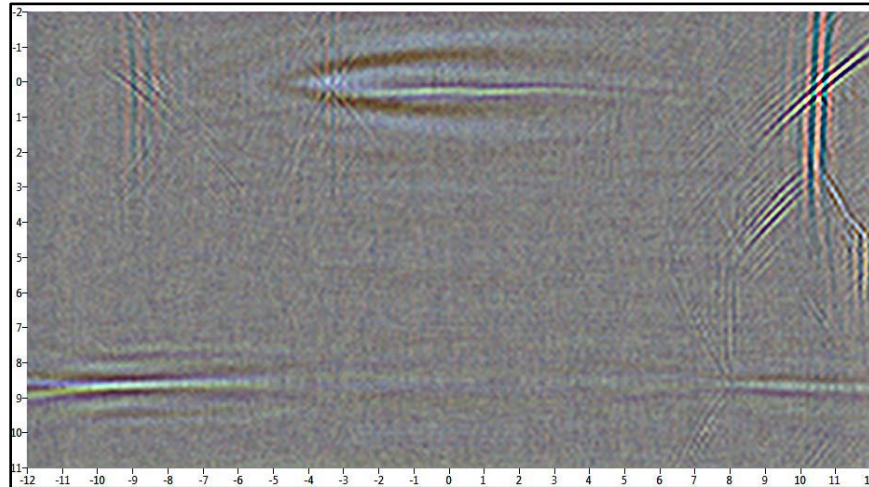
Figure 41. IWEX image of a crack exhibiting different branches. Note that the different modes image different parts of the crack dependent on the orientation (all dimensions in millimeters).

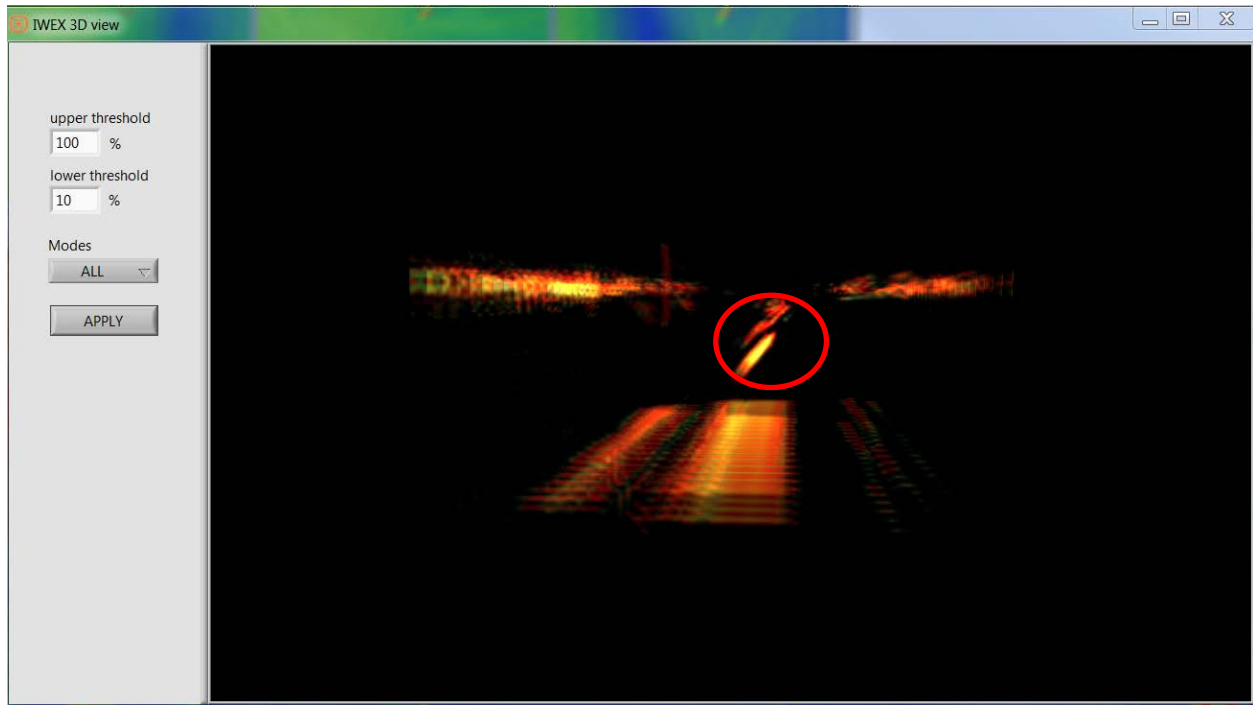
**Figure 47. Part 116050, 1096 + 9 mm, D1.2- 2.7, H 1.5mm, DS 90° Side with flow
Sub surface LOF**

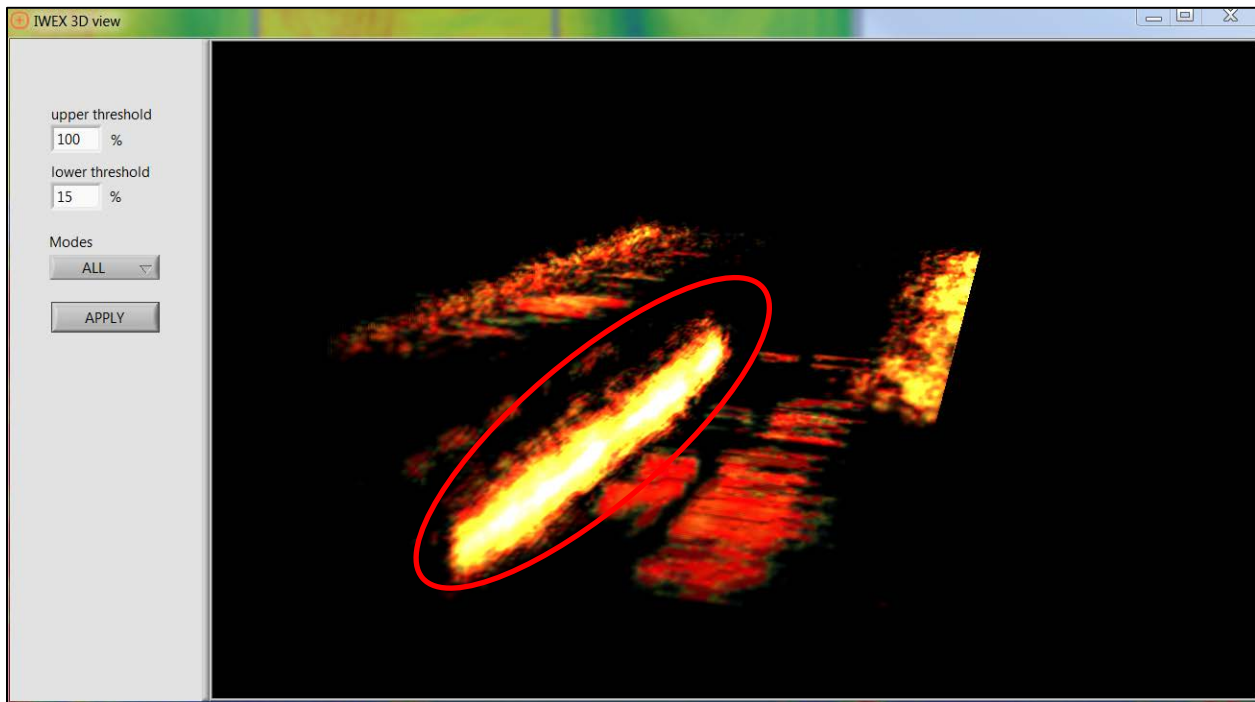
Figure 54. Pipe sample 149890, 1846 + 157mm, D5.7 – 7.1, H 1.4, US 270 side LOF ID surface

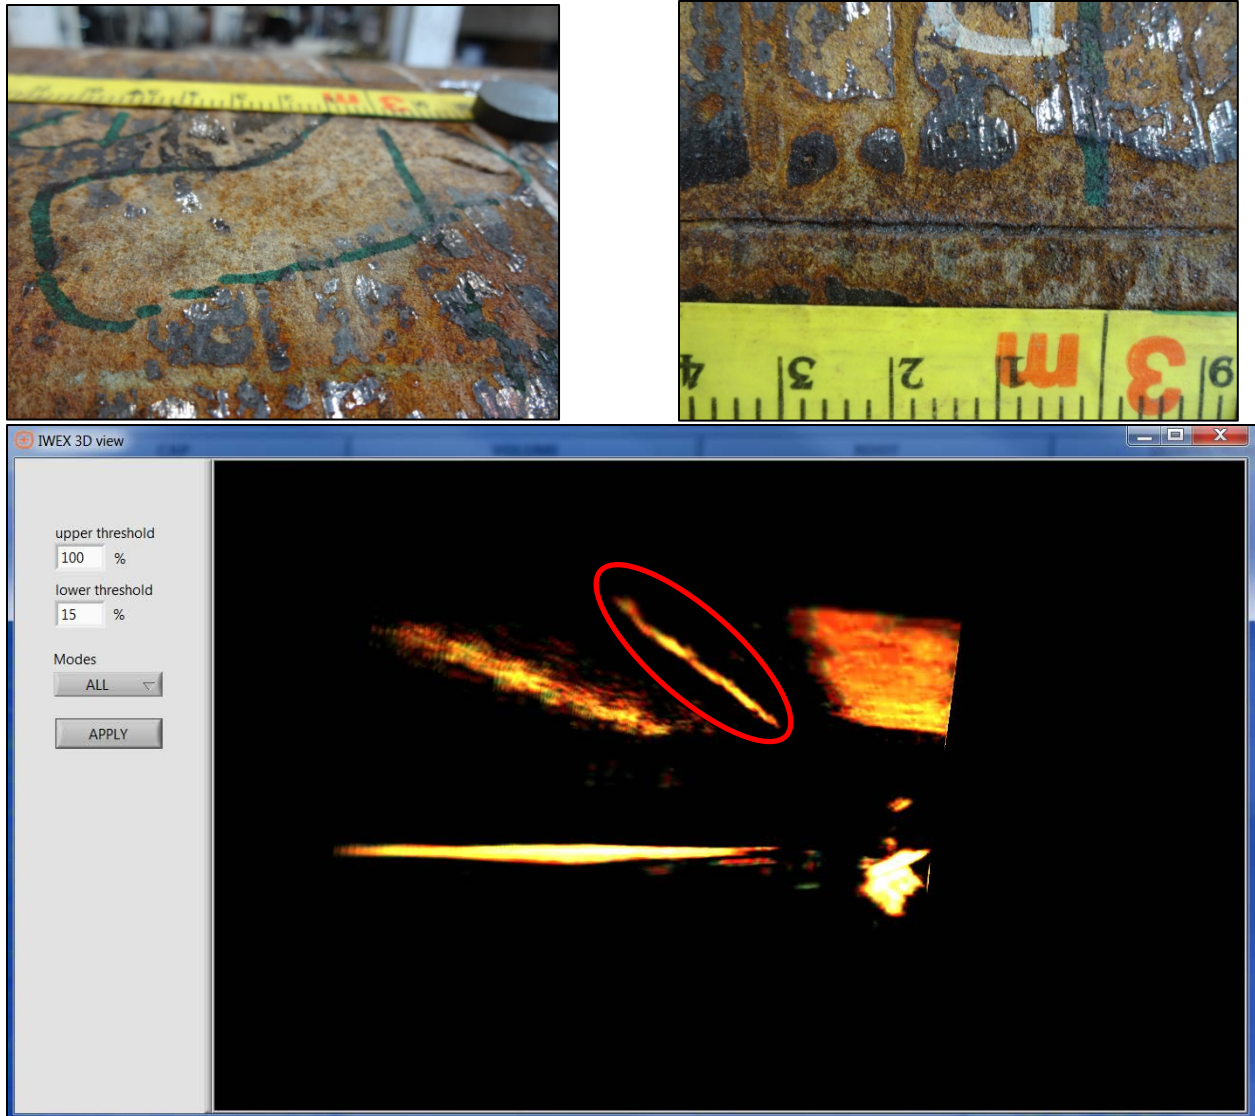
Figure 60. Pipe Sample 159070, 2989 + 51mm, D 0.0 – 1.3mm, H 1.3mm, DS 90 side with Flow LOF - Due to surface conditions only one probe could image this flaw.

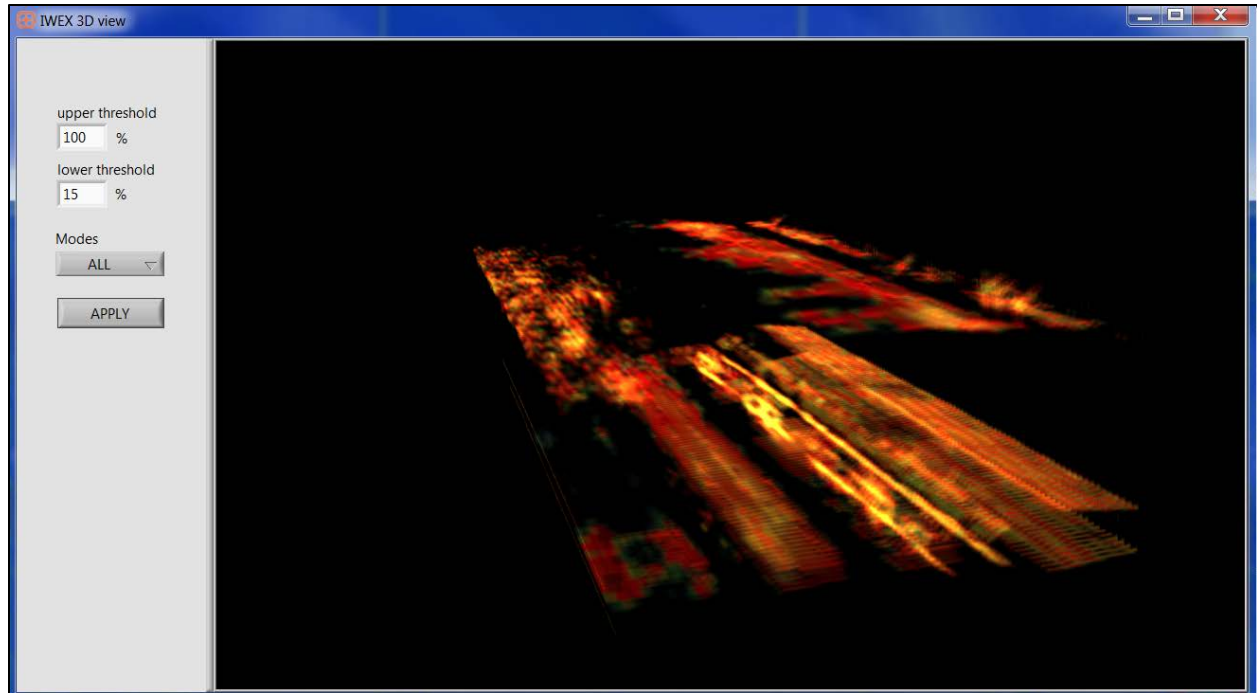
Figure 61. Pipe Sample 159070, 4337 + 45.0mm, D 6.3 – 7.3mm, H 1.0mm, Center Edge

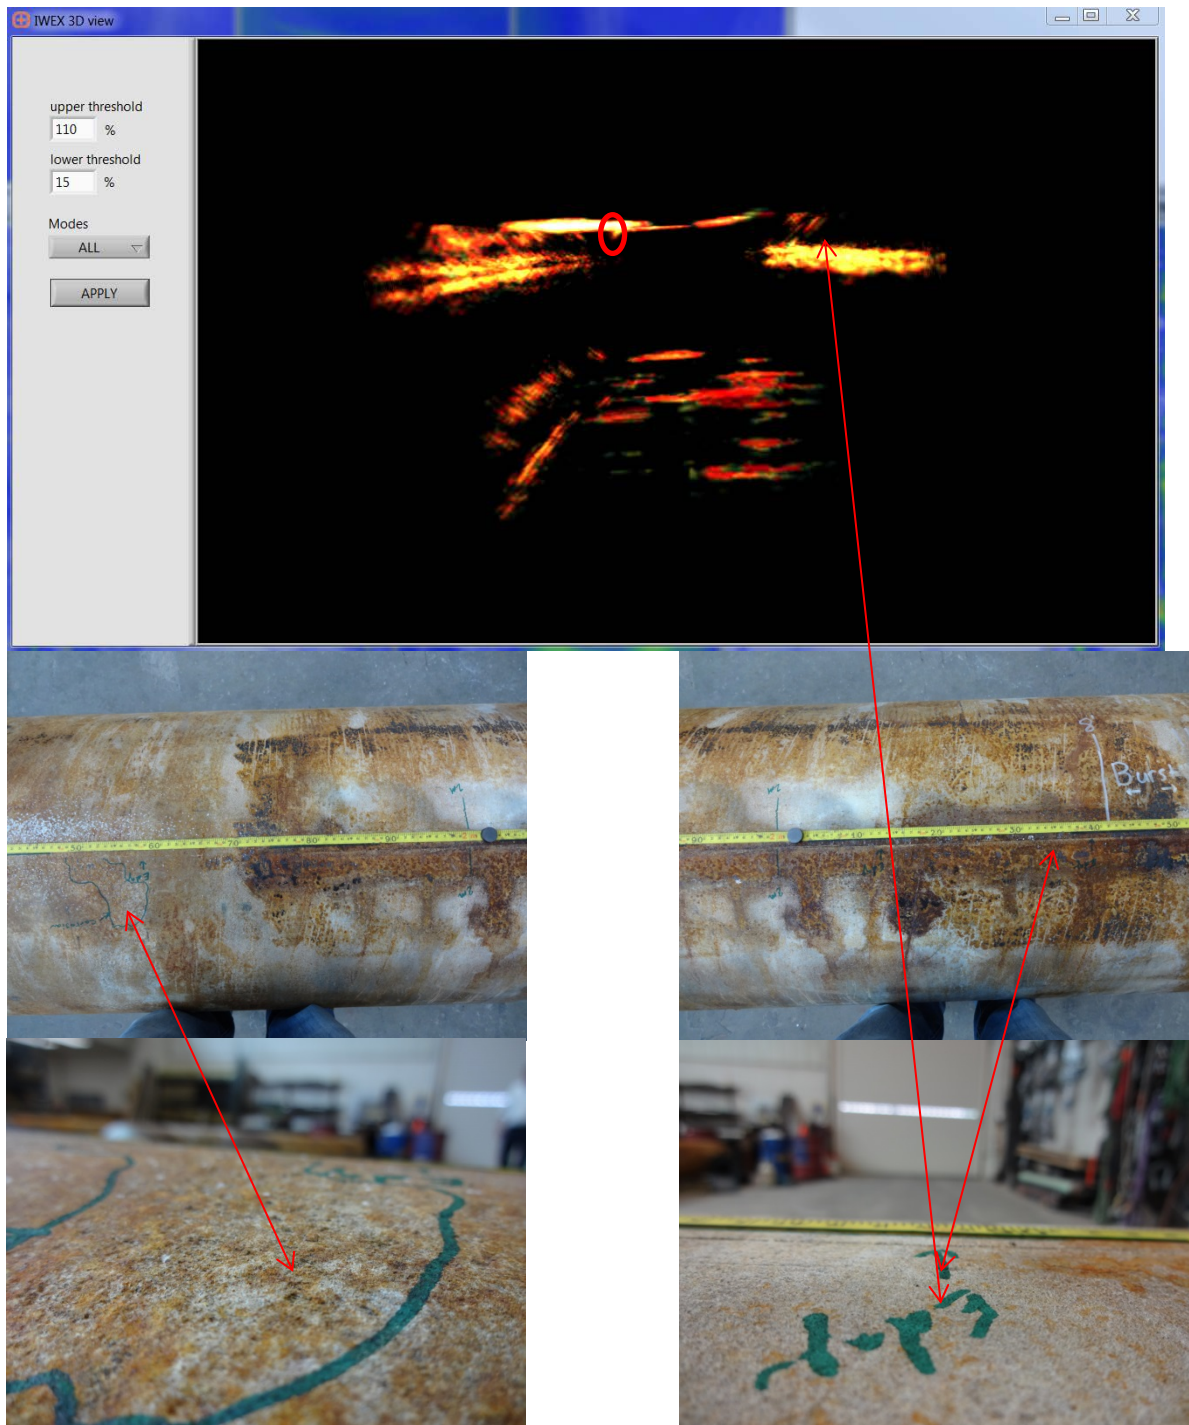
Figure 64. Pipe Sample 115310, 3335 +6, D O – 1.8mm, H 1.8mm, US 270 side with flow LOF OD Surface

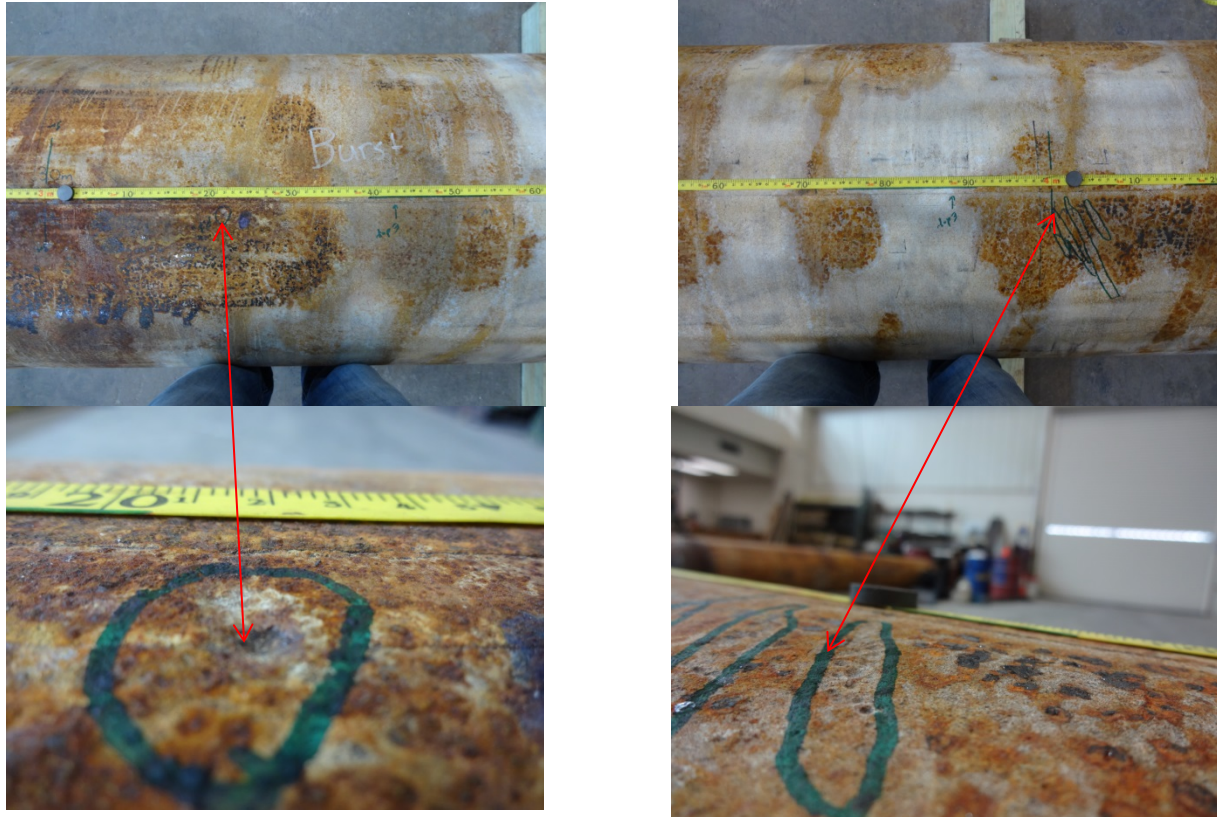
Figure 65. The images above show some of the surface conditions that made it difficult to get good images with UT

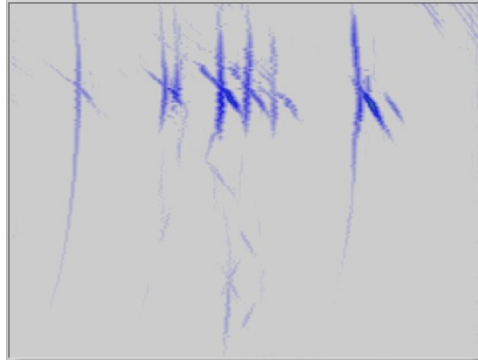
Figure 84. Cross-sectional IWEX image of cracks in the pipe body linked to the OD surface

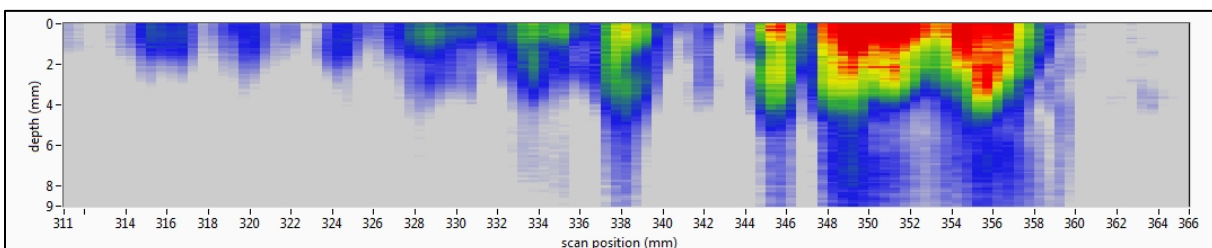
Figure 85. D-scan (side view) image of a toe crack at the OD, showing the extent into the pipe

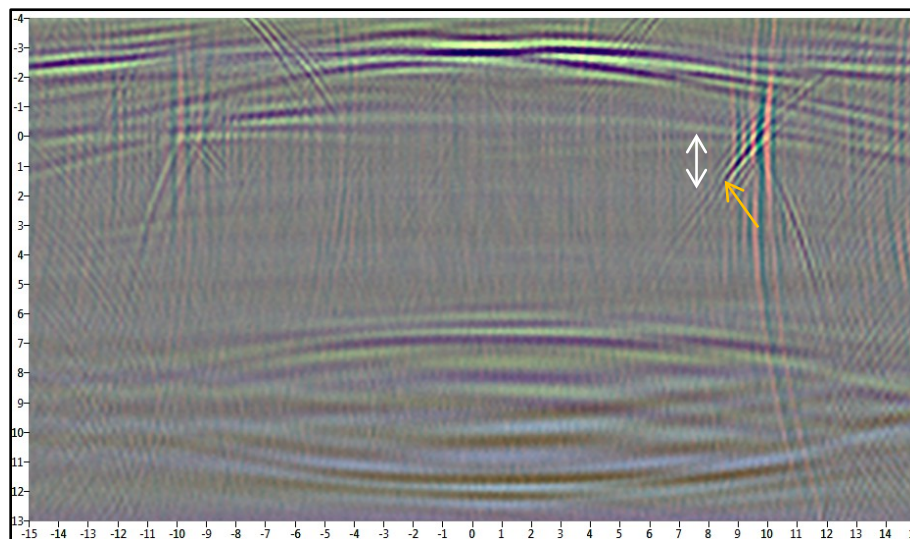
Figure 99. IWEX image showing a toe crack at the OD surface to the right of the weld with a height of 1.1 mm (white arrow indicates vertical extent; yellow arrow indicates lower tip diffraction)

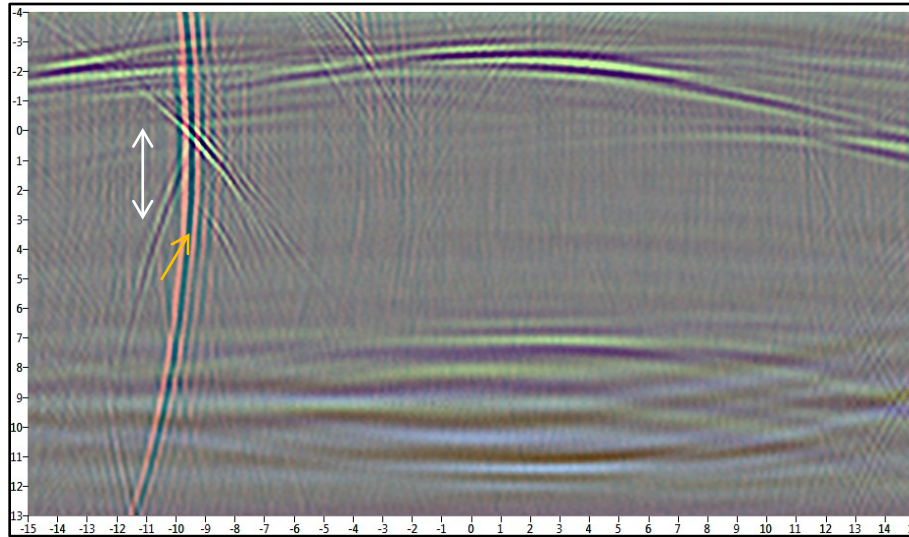
Figure 100. IWEX image showing a toe crack at the OD surface to the left of the weld with a height of 3.0 mm (white arrow indicates vertical extent; yellow arrow indicates lower tip diffraction).

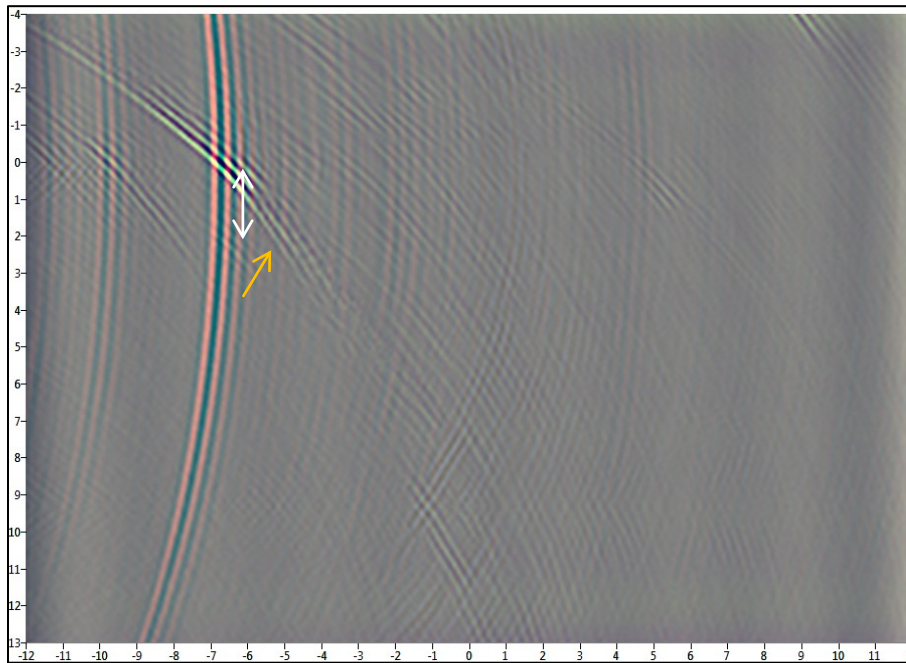
Figure 102. IWEX image obtained with one array showing a crack at the OD surface in the pipe body with a height of 2.3 mm (white arrow indicates vertical extent; yellow arrow indicates lower tip diffraction).

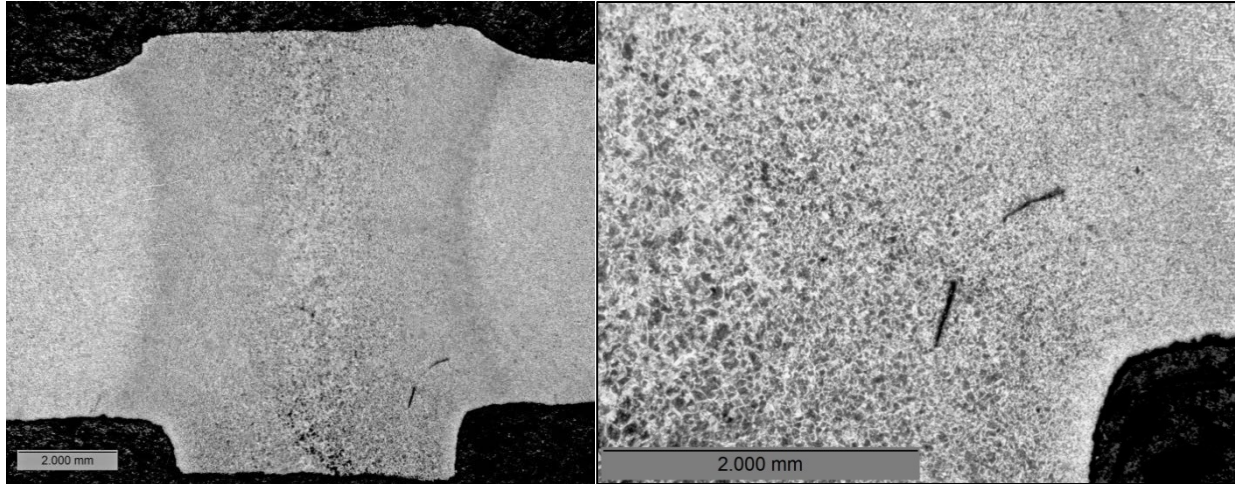
Figure 111. A section of Defect #1. The defect did not break in the desired plane, so the defect was sectioned circumferentially perpendicular to the plane of the defect. The defect height appears to be about 1.0 mm and 0.35 mm from the flash weld trim on the IDs

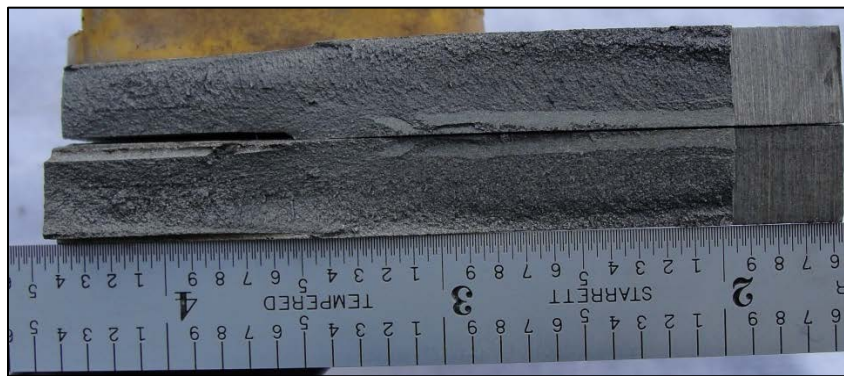
Figure 112. Fracture surface of Defect #2, the fracture broke in the intended plane for about half the fracture surface.

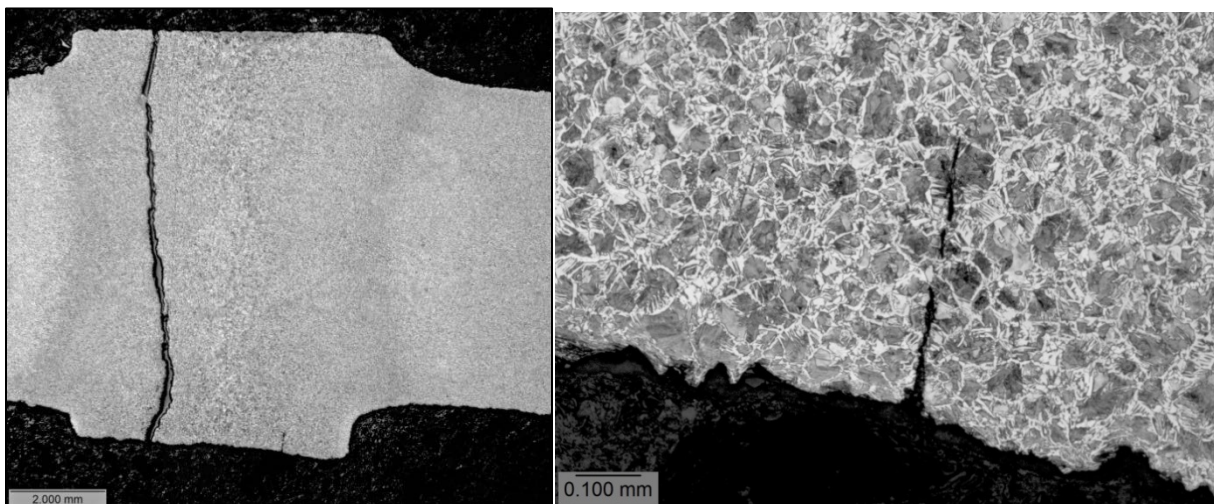
Figure 113. Section of Defect #2, showing a defect depth of 0.4 mm from the ID

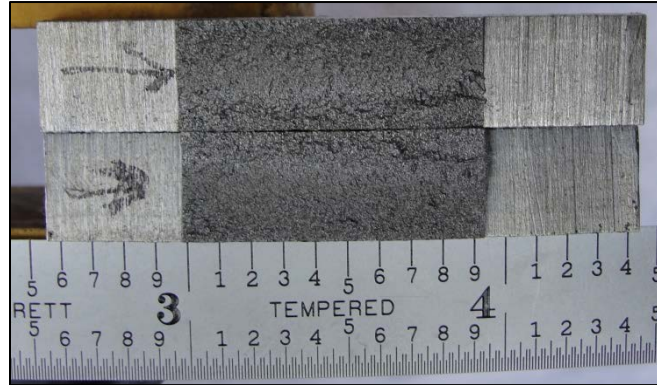
Figure 114. Fracture surface of Defect #3. The defect appears to be 0.1-in (2.5 mm) deep from the ID surface

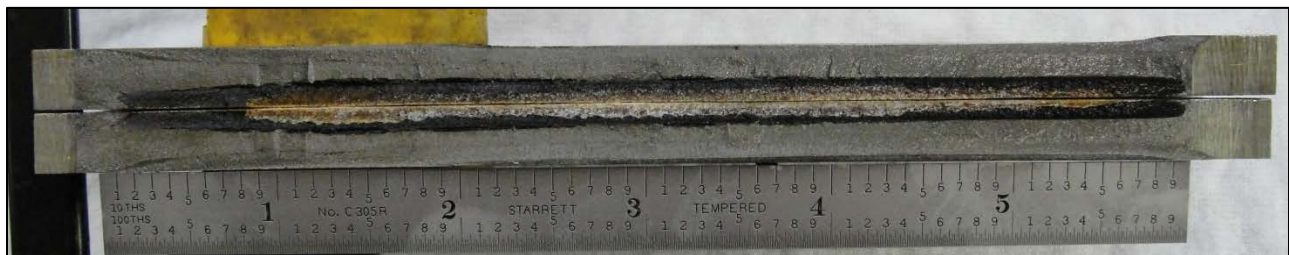
Figure 115. Fracture surface of Defect #4, the largest defect with the internal surface breaking defect. The defect appears to be about 0.15-in (3.8 mm) deep from the ID surface.
