Interim Report for Phase II – Task 2 of the Comprehensive Study to Understand Longitudinal ERW Seam Failures

“Pipe Inventory, Inspection by In-The-Ditch Methods and In-Line
Inspection, and Hydrostatic Tests - a Continuation of Phase 1,
Task 2”

Phase II, Tasks 2.1-2.11

Inspection by In-The-Ditch Methods and
In-Line Inspection, and Hydrostatic Tests
DTPH56-11-T-000003

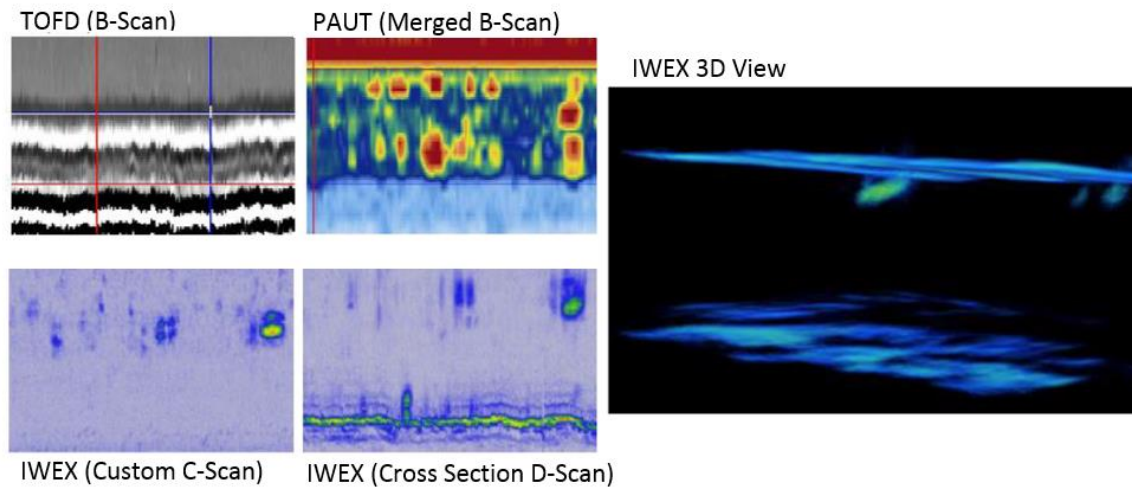
ITDM inspection included commercial magnetic particle inspection (MPI), phased array ultrasonics (PAUT), and time-of-flight diffraction (TOFD), provided by ApplusRTD. ApplusRTD's developing IWEX was also ran to provide additional crack geometry and sizing insight. Differences in PAUT, TOFD, and IWEX signals are pictorially displayed in Figure 1 for a sample location on joint 14-03. When sizing the features, TOFD offers length and depth to the bottom of the indication only. PAUT and IWEX offers length, depth, and height insight. However, discrepancies can arise in the final crack type call. For example, PAUT in Figure 1 suggests the crack is a cold weld while the IWEX signal shows an angled indication, a capability beyond PAUT and

TOFD, which suggests the flaw is a hook crack. As such, IWEX calls were used to differentiate crack geometry throughout Phase II as well as general detection and sizing.

Figure 1: Pictorial Comparison of ITDM Signals Taken from Joint 14-03 [3]

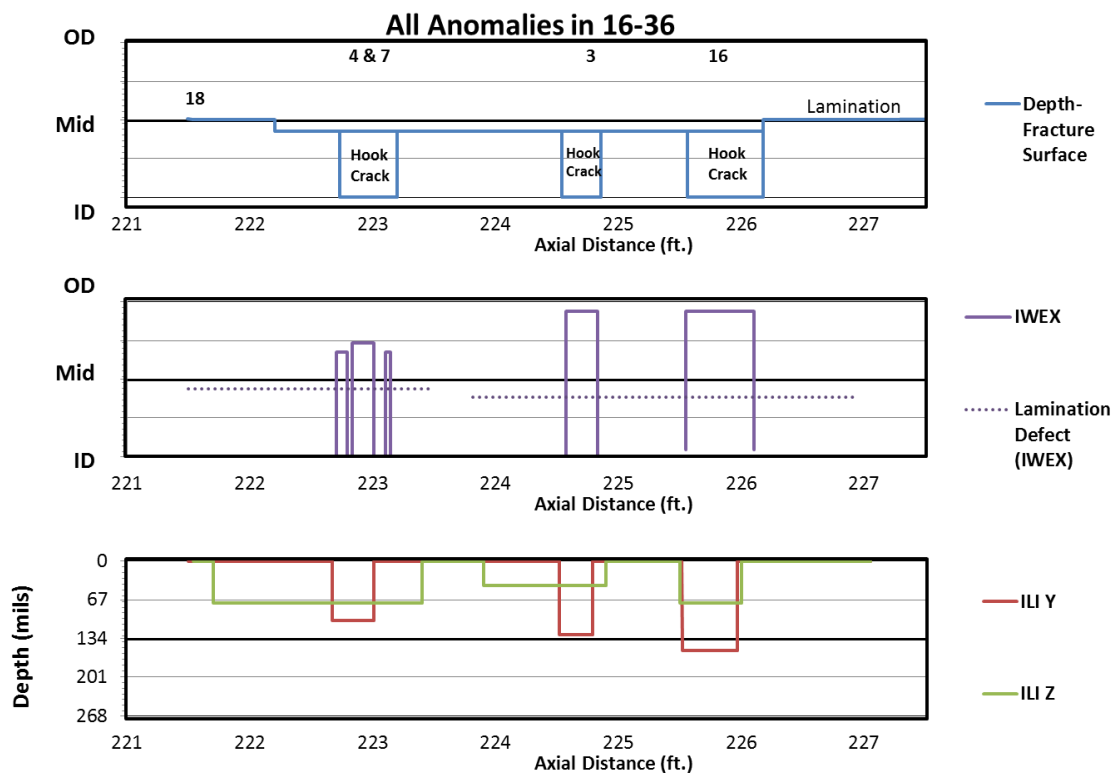
Figure 8: Depth Profile and Inspection Results of Complex Anomalies in Joint 16-36, Including Anomaly #3 Shown in Previous Image

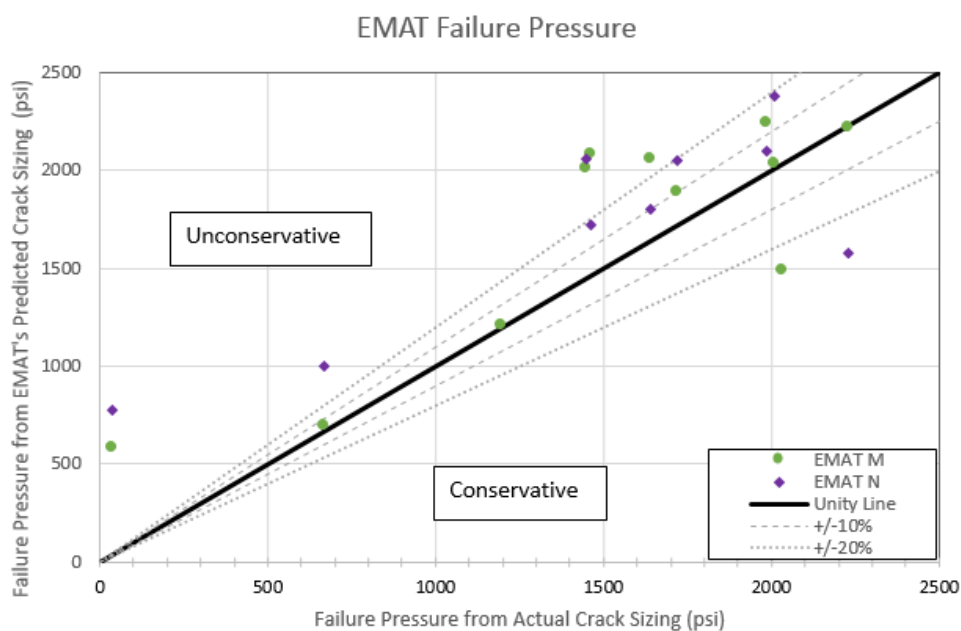
The impact of EMAT's crack sizing on failure pressure predictions is illustrated in Figure 11. The majority of the predictions were slightly unconservative (i.e. predicted failure pressure was higher than what would be anticipated in reality). This is driven by the EMAT depth calls. While the crack lengths were reported longer than reality and the depths slightly shorter, the combination of length and depth generally resulted in an unconservative burst pressure. This is because the failure pressure is more dependent on crack depth than length, although both certainly play a role.

Figure 11: Battelle's PipeAssess PI™ (Version 1.03) Failure Predictions When Using EMAT Crack Sizes Versus Actual Fracture Crack Sizes

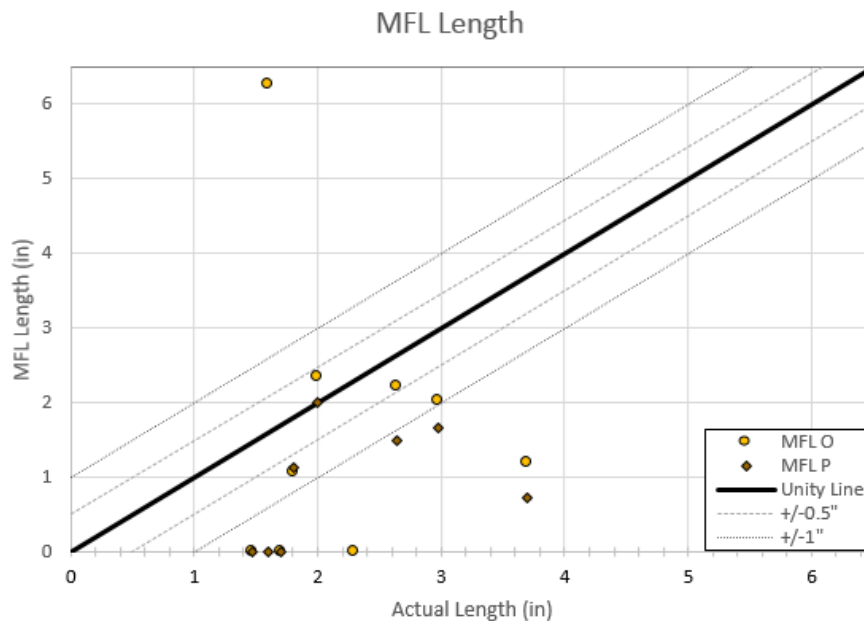
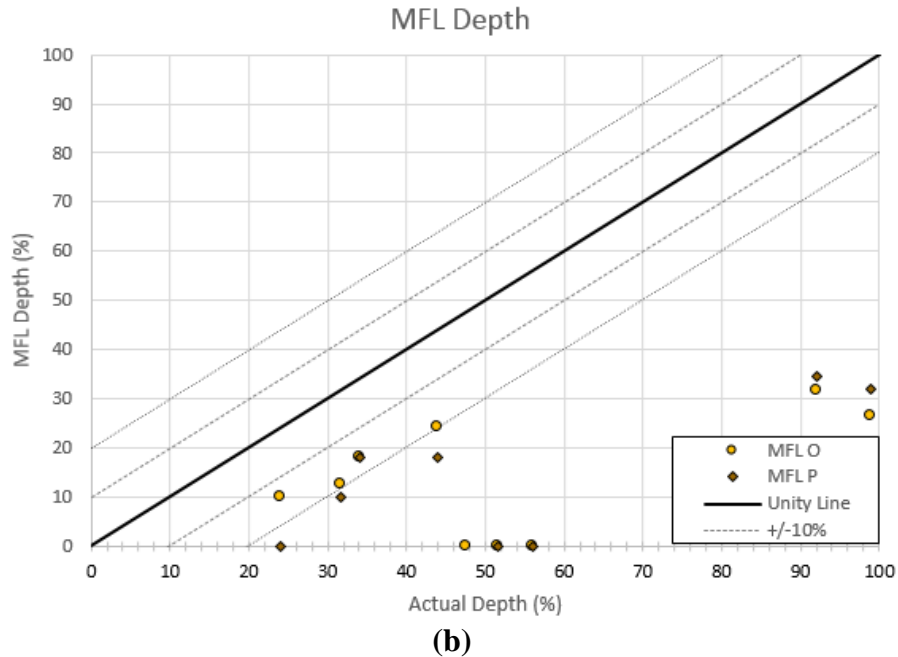
In general, MFL undersized the long-seam anomalies in this study. In the case of near-through wall cracks, MFL severely undersized them, reporting 30% NWT depths when in reality they exist at 90%+. Therefore, additional conservatism may be required for dig criteria and fatigue analysis when using this method.

Figure 12: Unity Plots of MFL versus Actual Fracture Surface Crack Sizing Length-to-Length (a) and Depth-to-Depth (b)

The crack-like anomalies in this study were generally undersized by MFL, most likely due to minimal crack opening (width), which is critical for proper MFL performance. Although secondary, another contributing factor is the depth which ILI first detects a crack length. The physical principles naturally limit ILI to a minimum measurement threshold. If an anomaly extends out to the surface beyond perpendicular, the length beyond the measurement threshold is not detected. Therefore, the ILI measured length is typically shorter than actual, as shown in Figure 13.

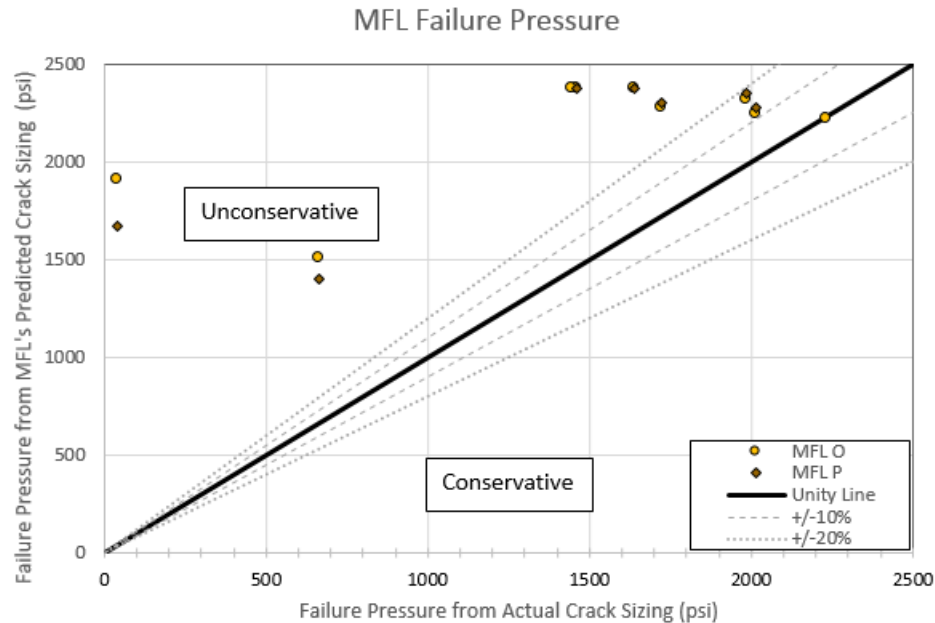
The impact of MFL's crack sizing on failure pressure predictions is illustrated in Figure 14. No new conclusions are drawn. As previously stated, it is generally accepted that MFL technology is not well suited for detection and sizing of all seam anomaly crack types. This comparison is simply included for report completeness.

Figure 14: Battelle's PipeAssess PI™ (Version 1.03) Failure Predictions When Using MFL Crack Sizes Versus Actual Fracture Crack Sizes

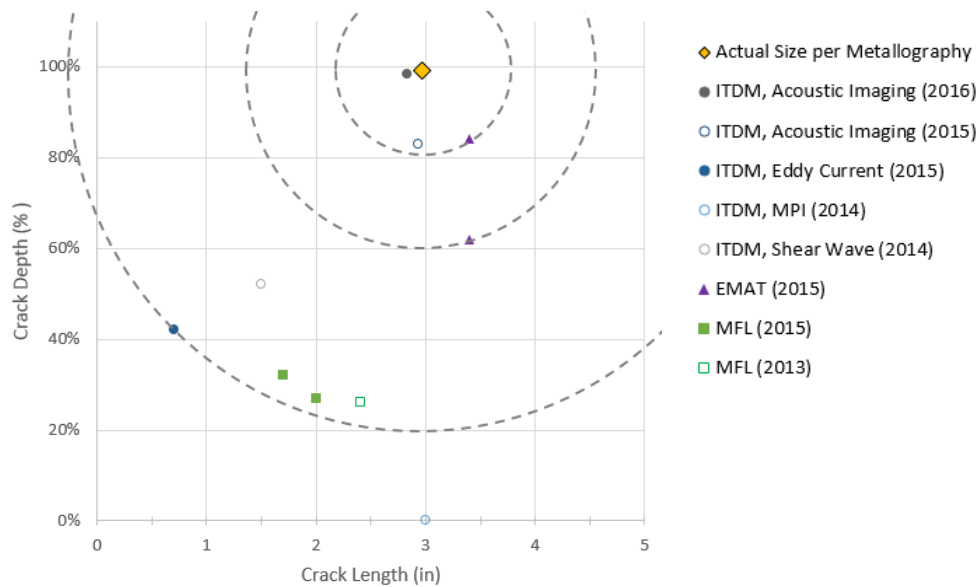
Figure 22: Various NDE Sizing of Feature #1 over the Years

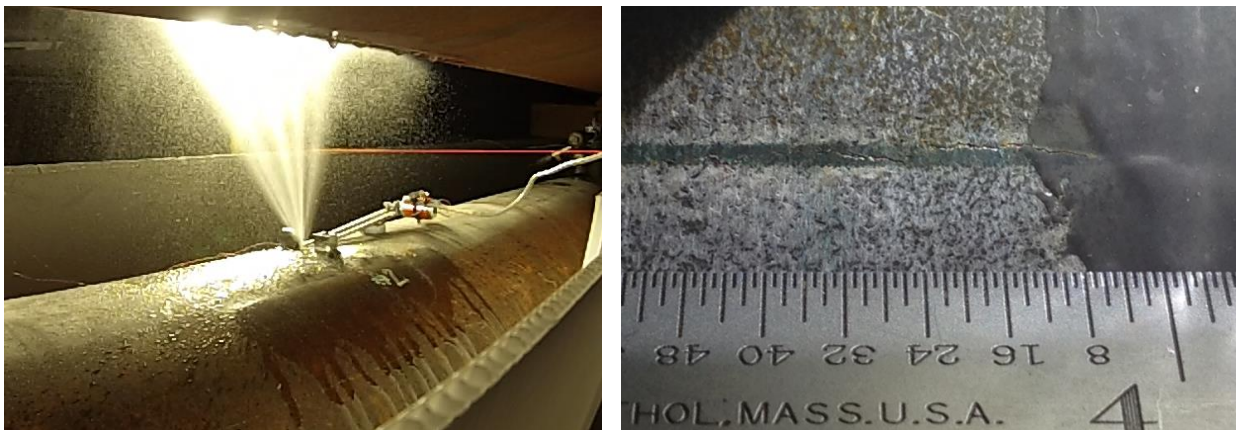
This joint began to leak at 125% SMYS. After the leak, initiated the pressure was slowly increased to 133% SMYS before it was de-pressurized. Reviewing video and pressure vessel measurements revealed the crack resealed at approximately 390 psi. Figure 23 shows the resealed crack and moments earlier when it was at maximum test pressure. Pressure-volume plots suggest the joint began yielding shortly before the leak initiated.

Figure 23: Feature #2 Leaking While Pipe at Approximately 1500 psi (left) and Then Shown after De-pressurized (right)

Per the latest ITDM this flaw was characterized as a 1.2" long, 81% deep OD cold weld before burst testing. Post testing the specimen underwent metallography to determine actual size of the initial crack. Freeze and break methods revealed a cold weld 2.00" long, 92% deep as shown in Figure 24 and Figure 25. Similar to Anomaly #1, a repair weld with no post weld heat treatment was observed. Again, one EMAT service provider also noted a permeability change co-incident with this anomaly.

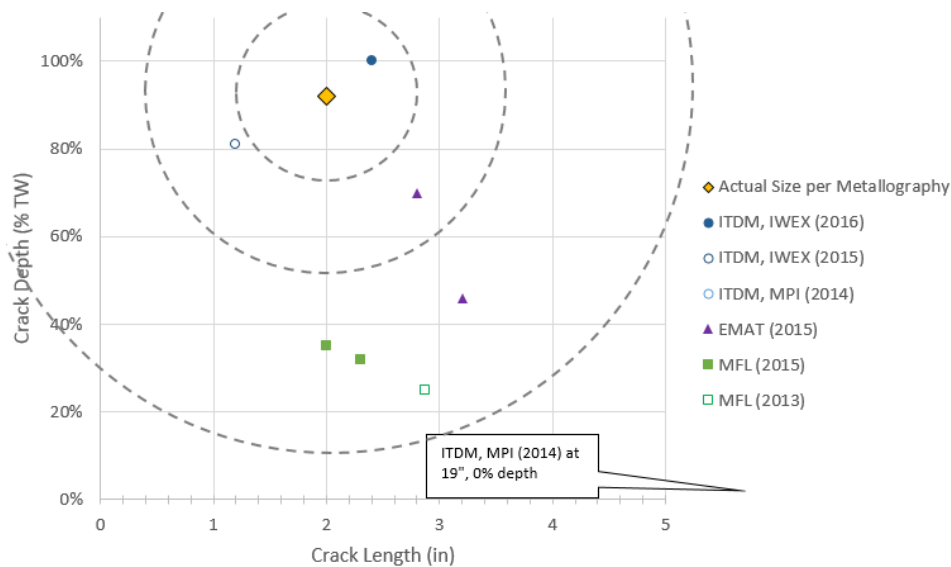
Figure 26: Various NDE Sizing of Feature #2 over the Years

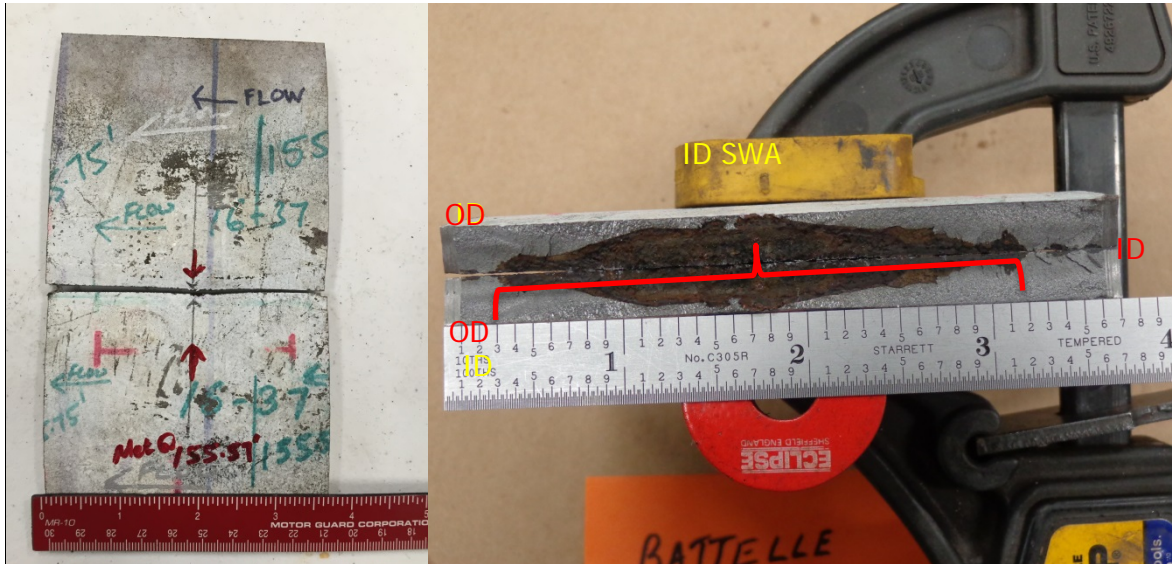
Figure 4. SWA #1, Break location and fracture surface

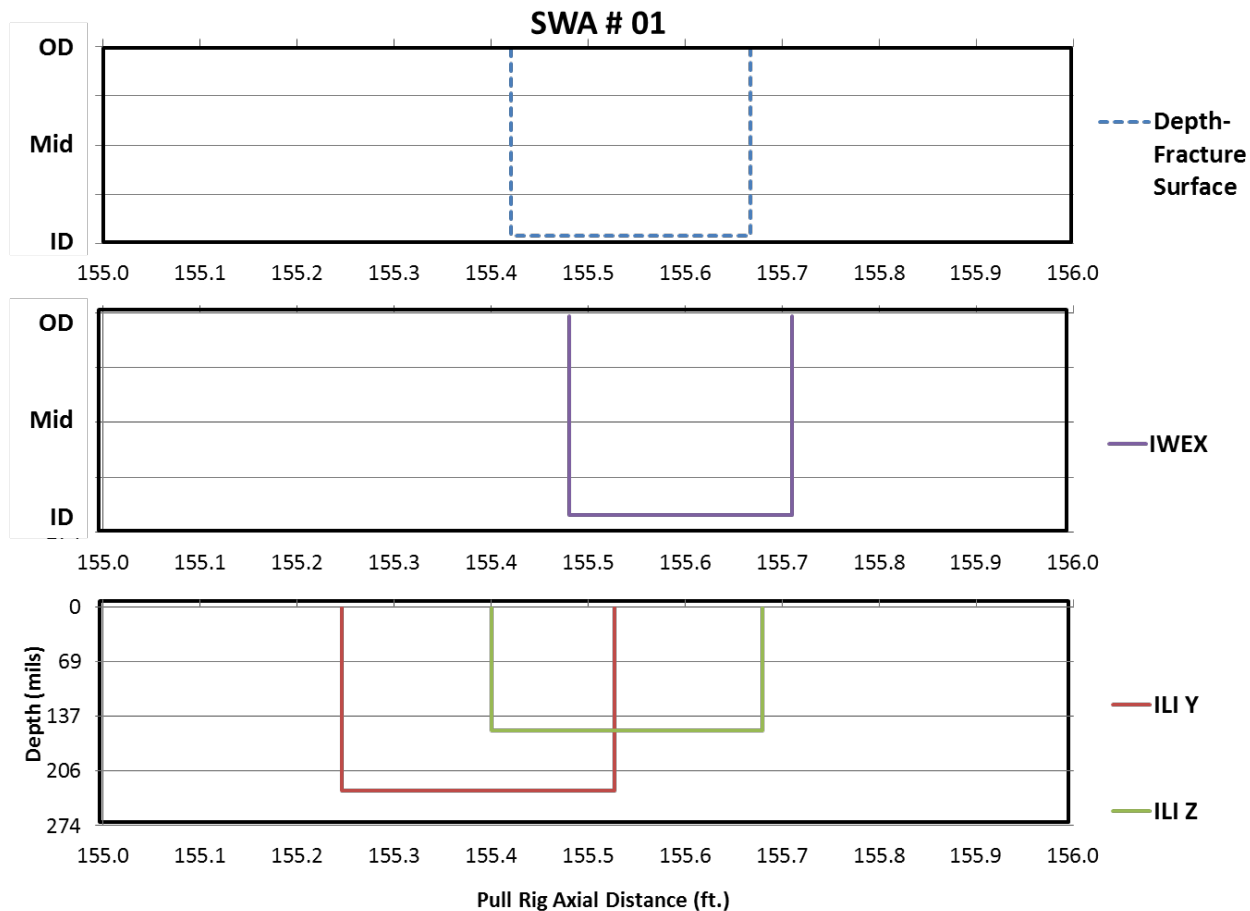
Figure 7. Depth profile and inspection results of SWA #1

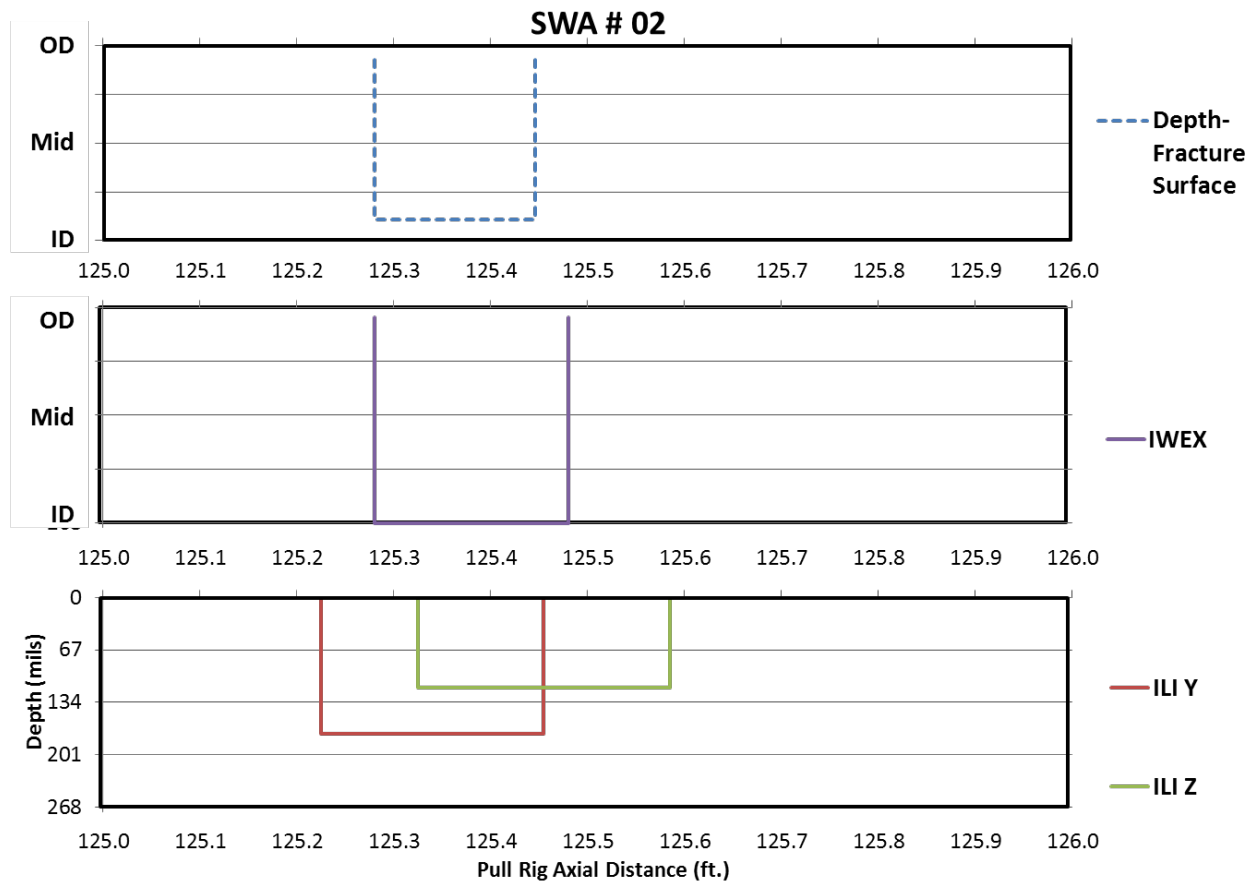
SWA #2: SWA #2 was located on Pipe #16-33. Metallographic examination revealed this SWA to be a cold weld. Metallographic cross sections also revealed the presence of a repair weld (possibly a mill repair) in the seam weld area. Figure 8 shows the pipe marked in preparation for the fractography specimens. Figure 9 through Figure 11 show the metallographic, metallurgical, and fractographic results. An ID SWA can be seen in the picture on the right in Figure 9. The anomaly location details along with details of ILI and IWEX reported anomalies are presented in Figure 12.

Figure 12. Depth profile and inspection results of SWA #2

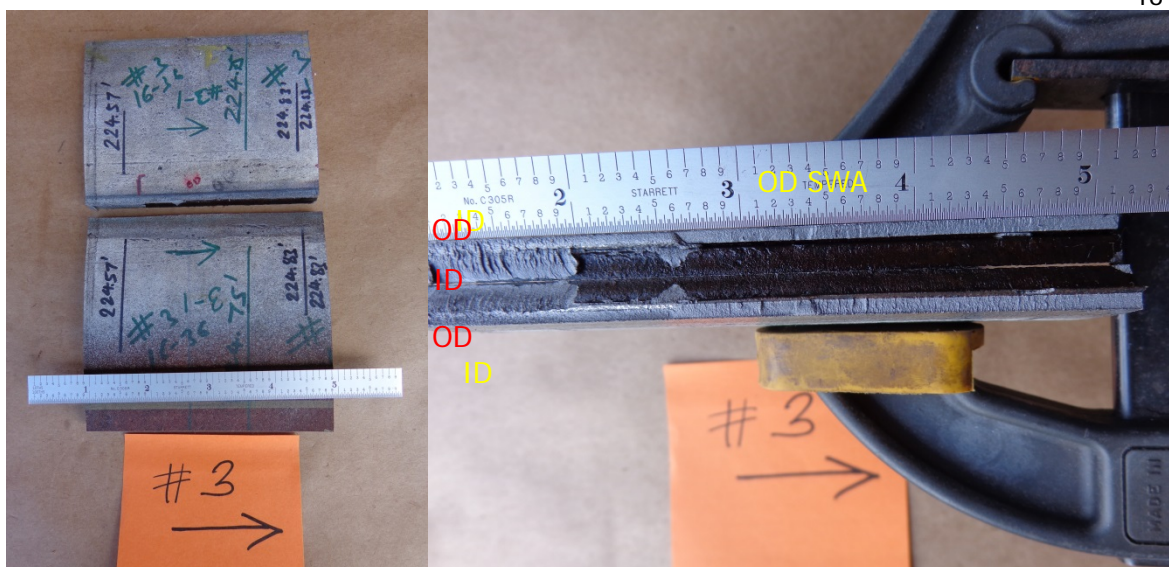
SWA #3: SWA #3 was located on Pipe #16-36. Metallographic examination revealed this SWA to be a hook crack. A metallographic cross section also revealed the presence of a near mid-wall lamination feature in SWA #3. The presence of a lamination feature connected to the hook crack suggests that this hook crack was formed due to the lamination feature disturbing the seam in the electric resistance weld (ERW) process. Figure 13 shows the pipe marked in preparation for the fractography specimens. Figure 14 through Figure 16 show the metallographic, metallurgical, and fractographic results. The anomaly location details along with details of ILI and IWEX reported anomalies are presented as the feature in Pipe 16-36.

Figure 14. SWA #3, break location and fracture surface

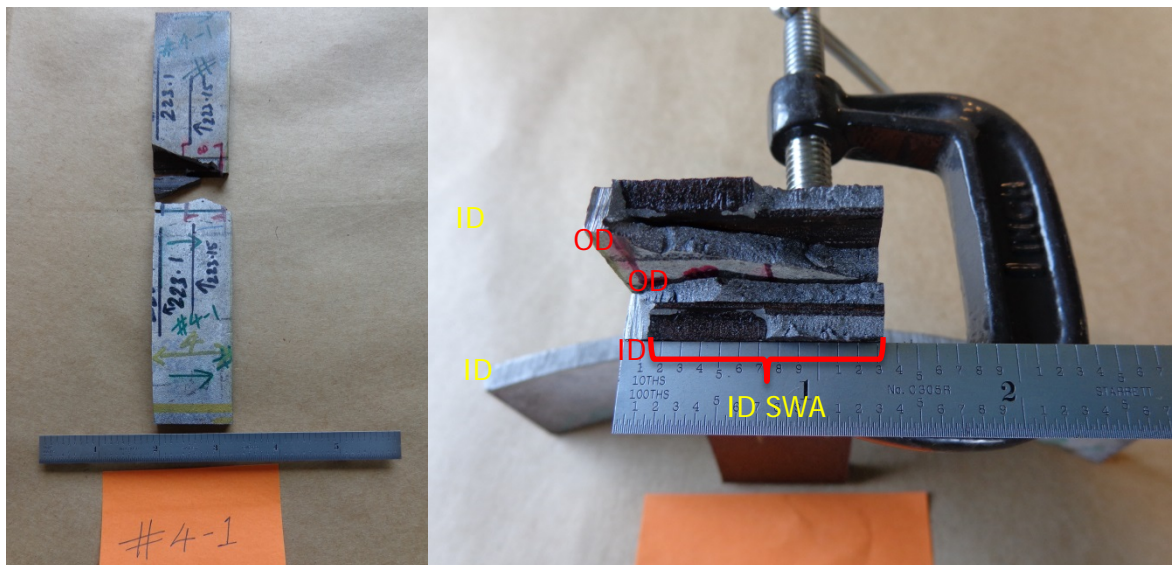
Figure 18. SWA #4, Break location and fracture surface

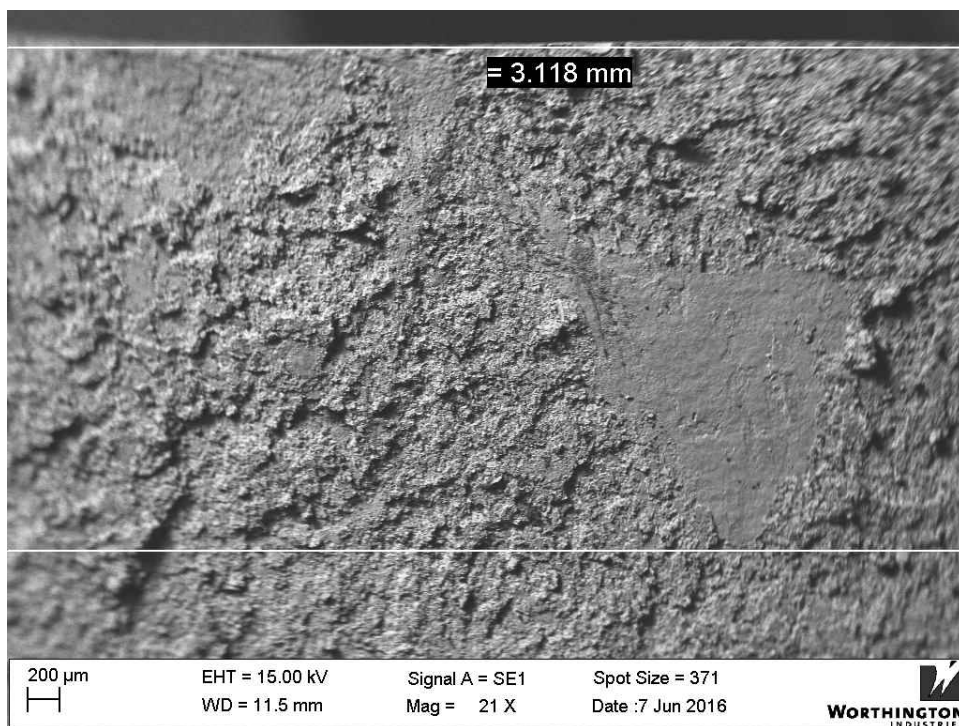
Figure 23. SEM image of non-surface breaking part of cold weld feature; SWA #5-3

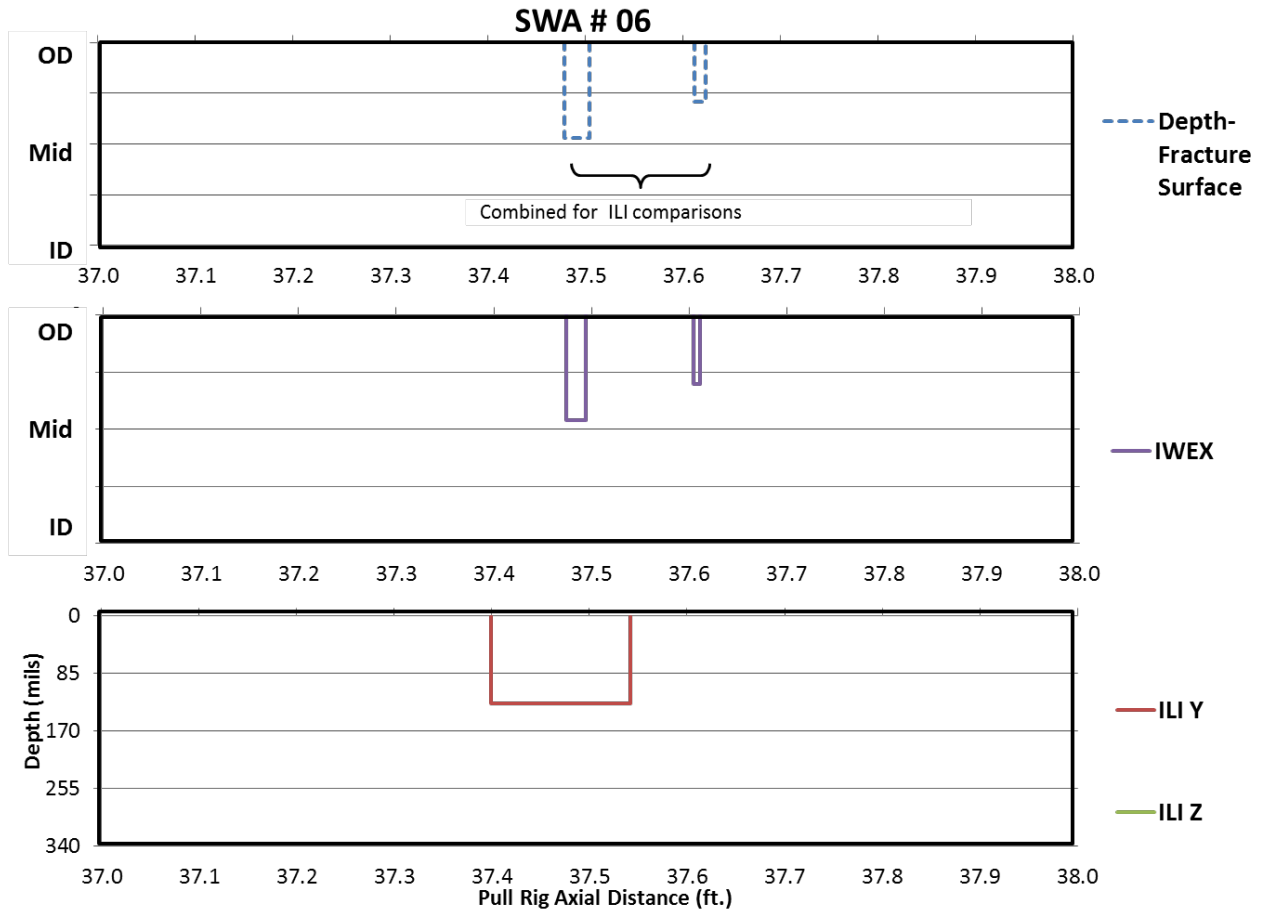
Figure 34. Depth profile and inspection results of SWA #6

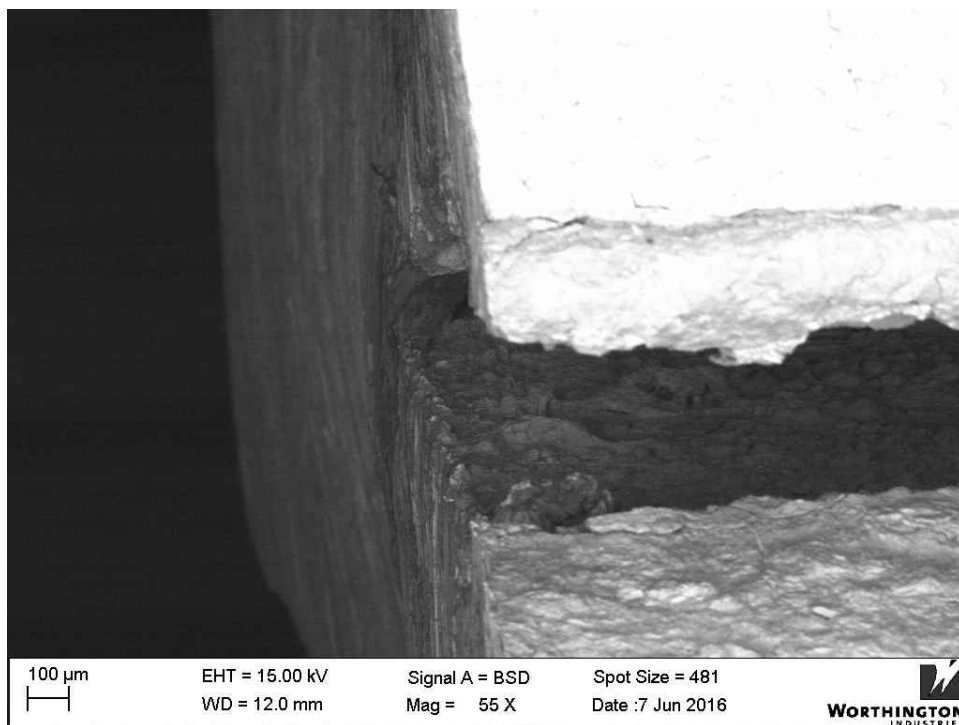
SWA #7: SWA #7 was located on Pipe #16-36. Metallographic examination revealed this SWA to be a hook crack. A metallographic cross section also revealed the presence of a near mid-wall lamination feature in SWA #7. The presence of a lamination feature connected to the hook crack suggests that this hook crack was formed due to the lamination feature disturbing the seam in the ERW process. A metallographic section for SWA #7 was cut before performing fractography to obtain an intact seam metallographic cross section. SWA #7 was divided into three break sections to achieve a full anomaly profile. Figure 35 shows the pipe marked in preparation for the fractography specimens and Figure 36 through Figure 38 show the fractographic results. An ID SWA can be seen in the pictures on the right side.

Figure 39. SEM image of fracture surface of lamination feature SWA #7-3

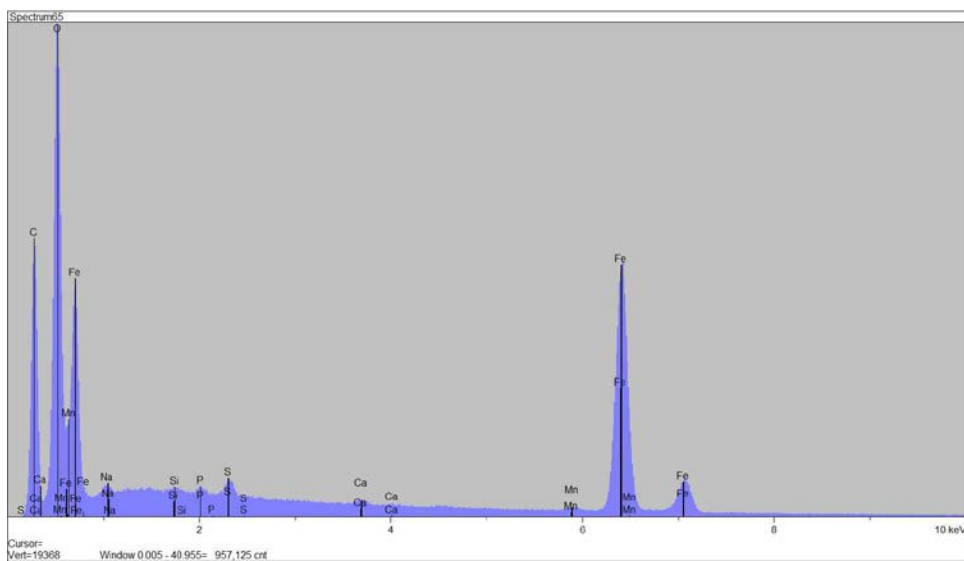
Figure 40. EDS of material in fracture surface of lamination feature, SWA #7-3

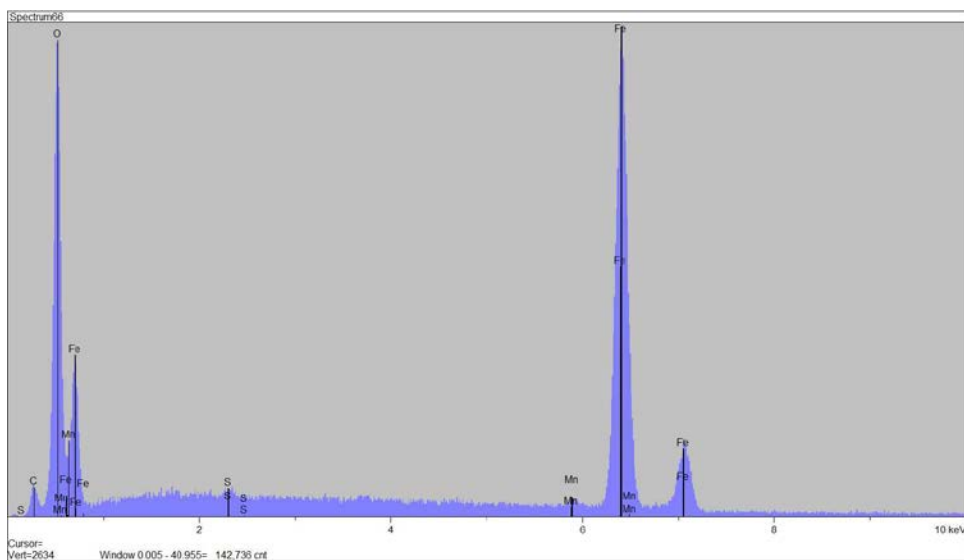
Figure 41. EDS of material in fracture surface of hook crack, SWA #7-3

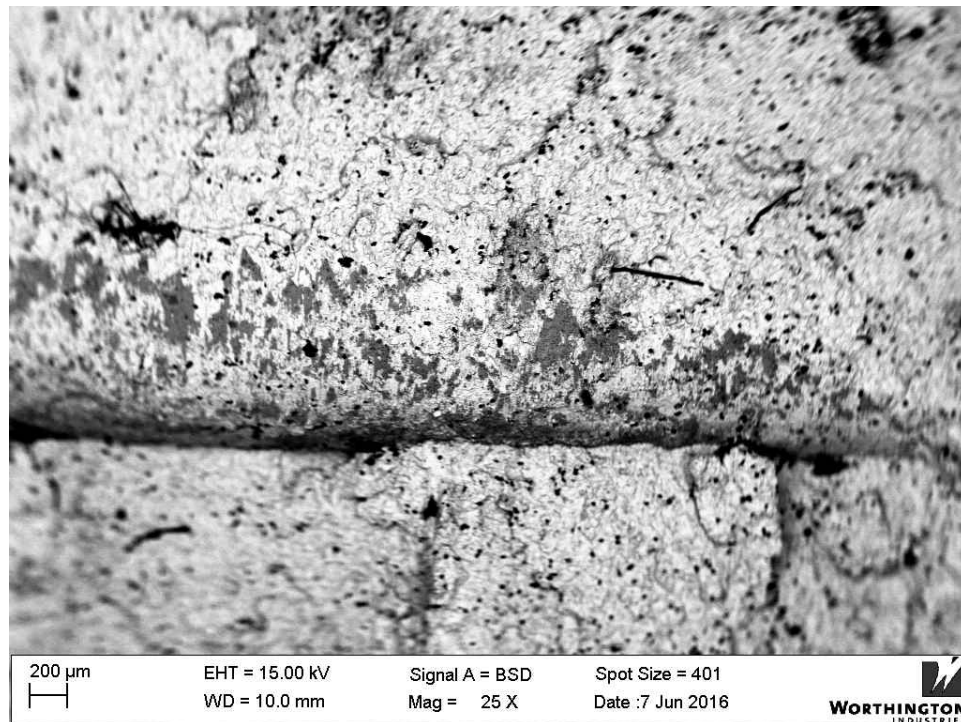
Figure 47. SEM image (25X) of mid-wall feature on SWA #8-1

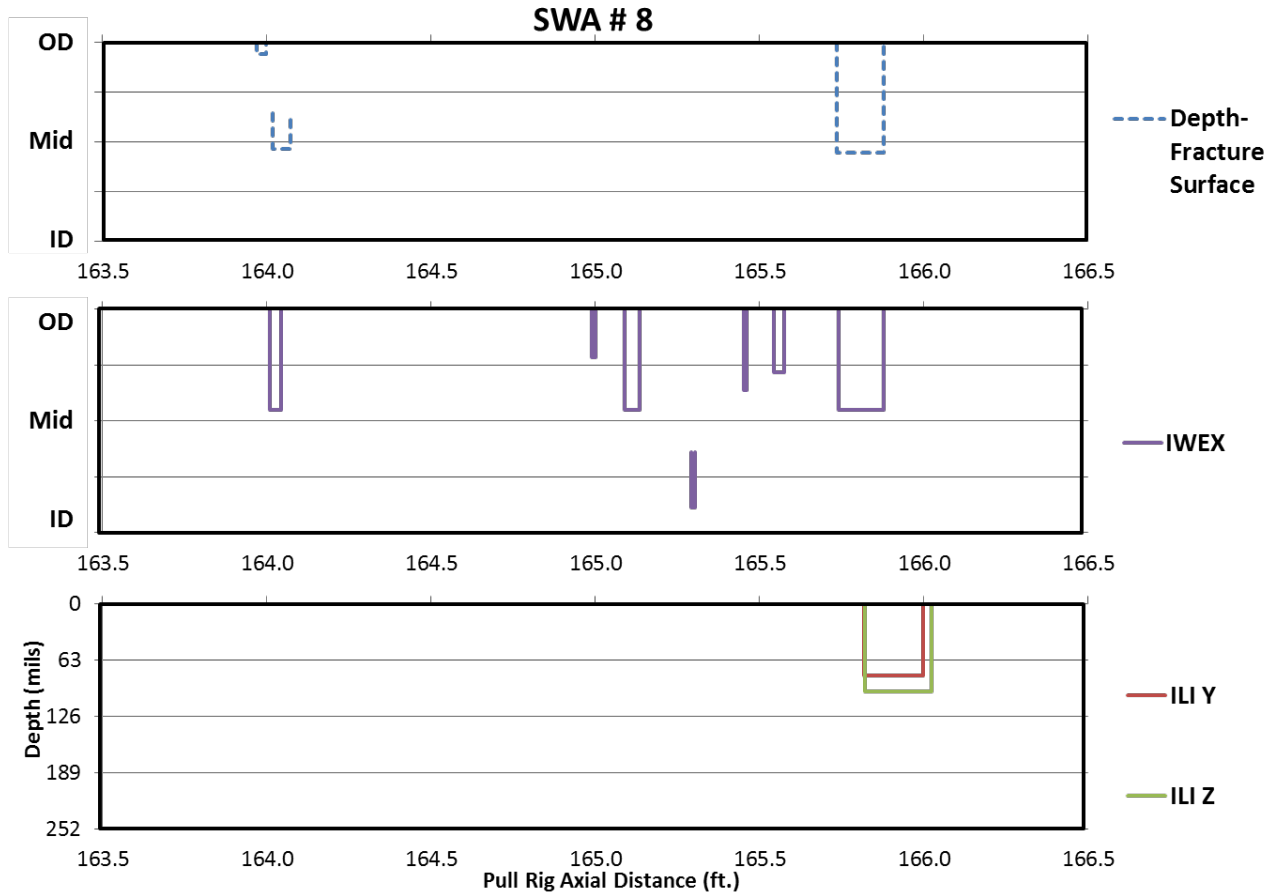
Figure 52. Depth profile and inspection results of SWA #8

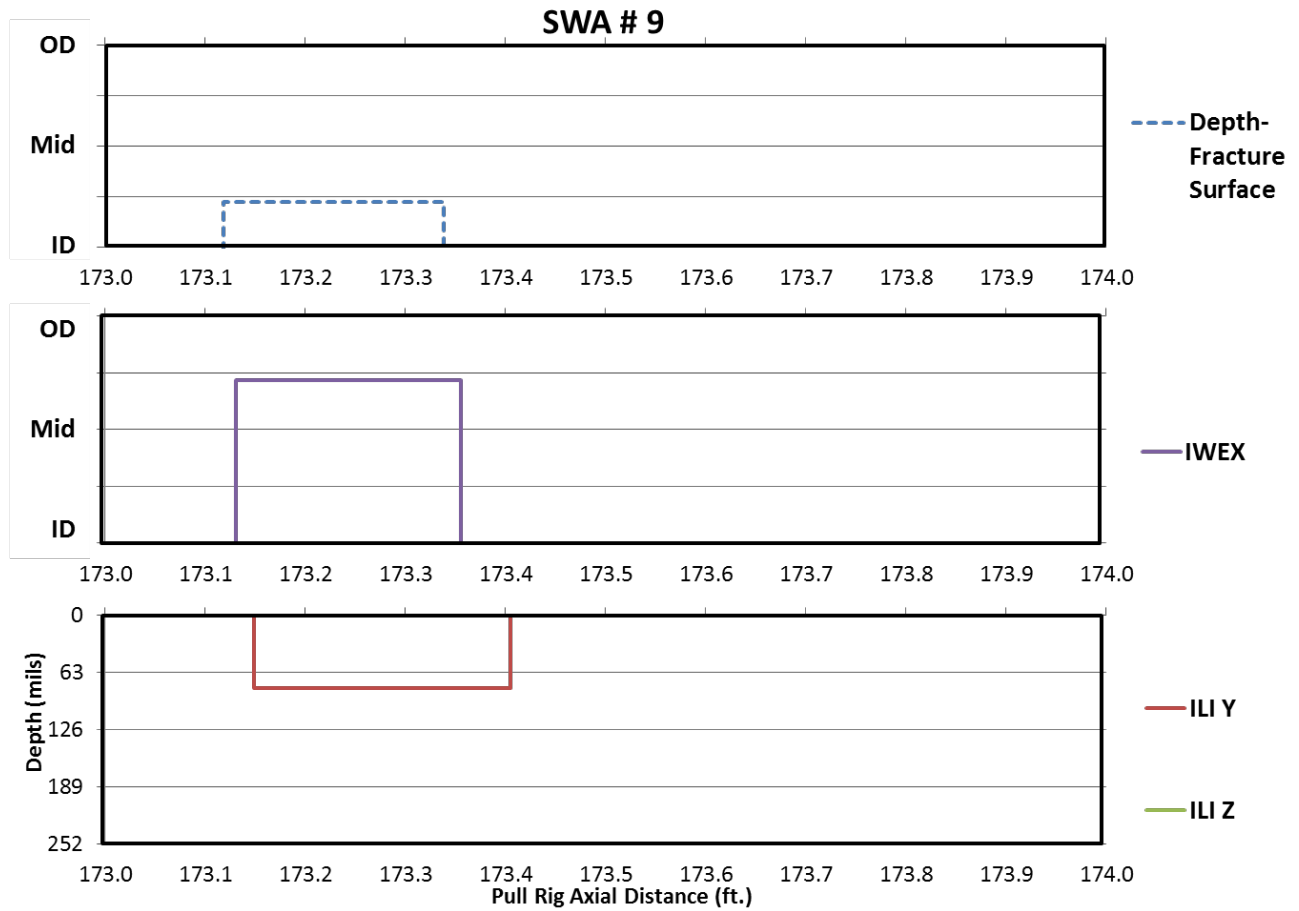
Figure 57. Depth profile and inspection results of SWA #9

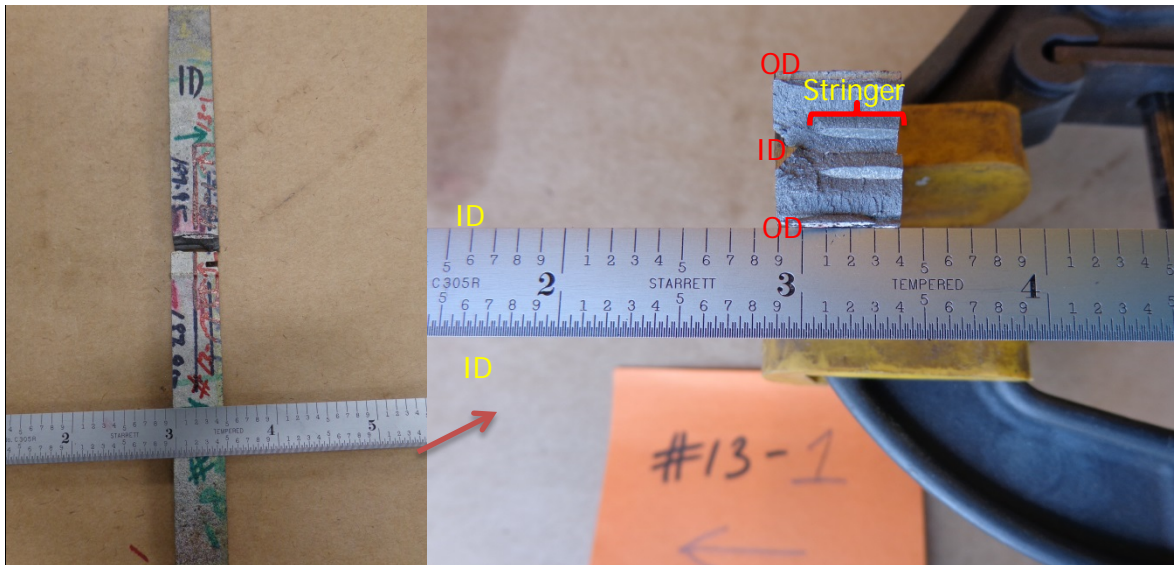
Figure 66. SWA #13, break location and fracture surface

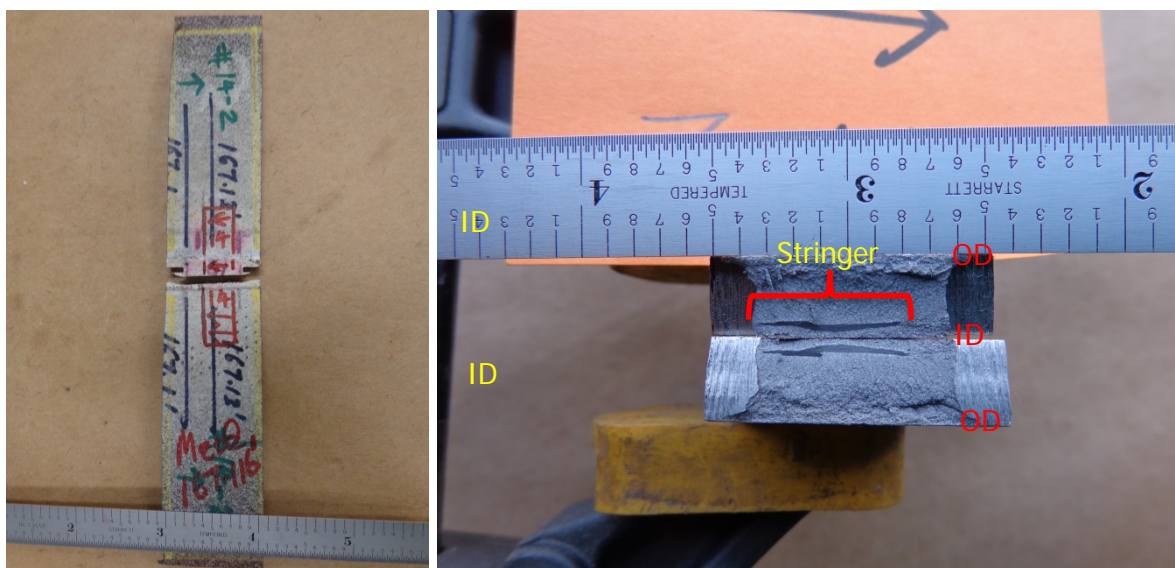
Figure 70. SWA #14, break location and fracture surface

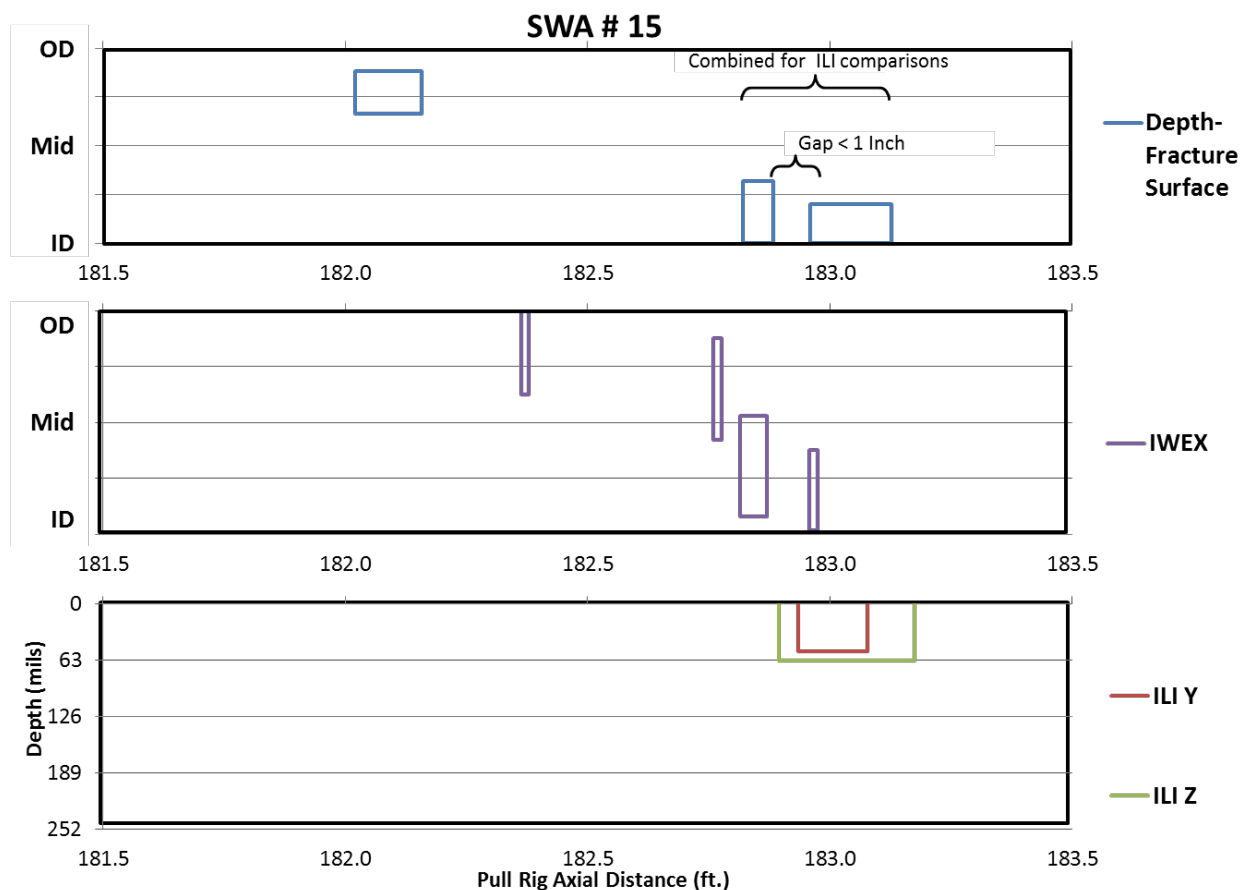
Figure 78. Depth profile and inspection results of SWA 15

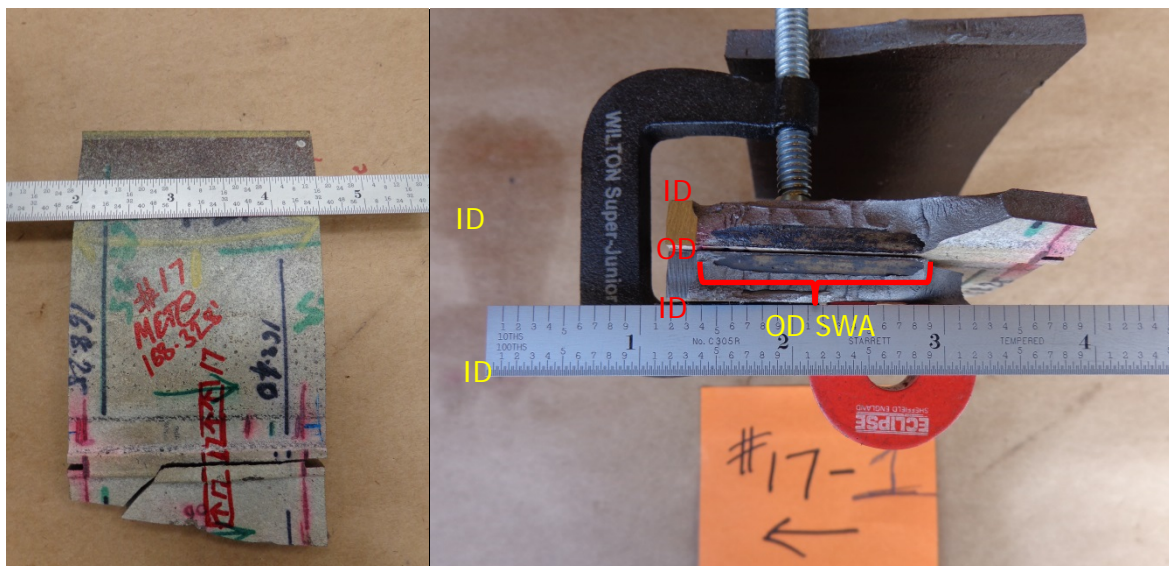
Figure 87. SWA #17, break location and fracture surface

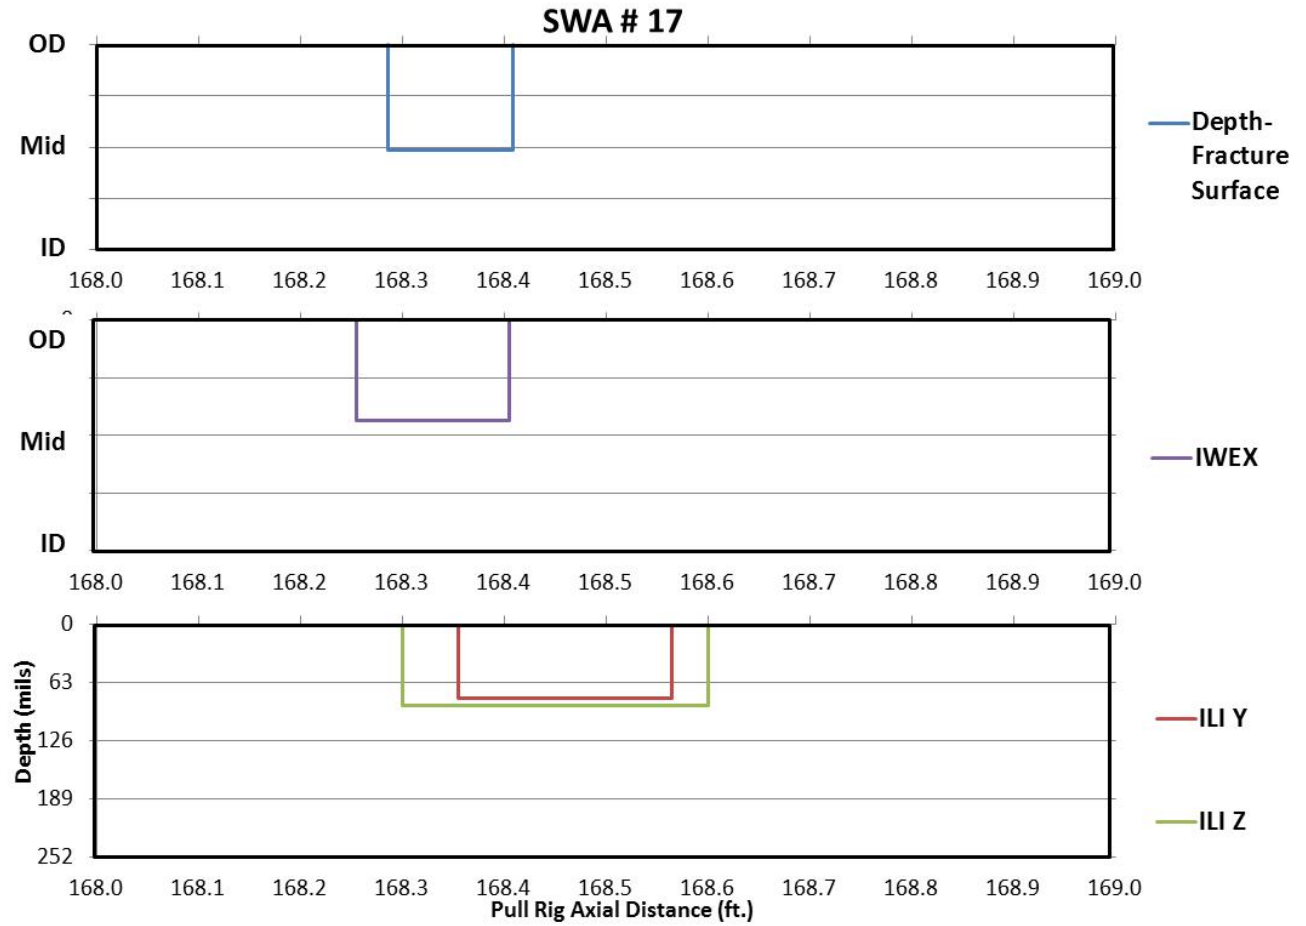
Figure 88. Depth profile and inspection results of SWA #17
