Interim Report for Phase II – Task 2 of the Comprehensive Study to Understand Longitudinal ERW Seam Failures

“Pipe Inventory, Inspection by In-The-Ditch Methods and In-Line
Inspection, and Hydrostatic Tests - a Continuation of Phase 1,
Task 2”

Phase II, Tasks 2.1-2.11

Inspection by In-The-Ditch Methods and
In-Line Inspection, and Hydrostatic Tests
DTPH56-11-T-000003

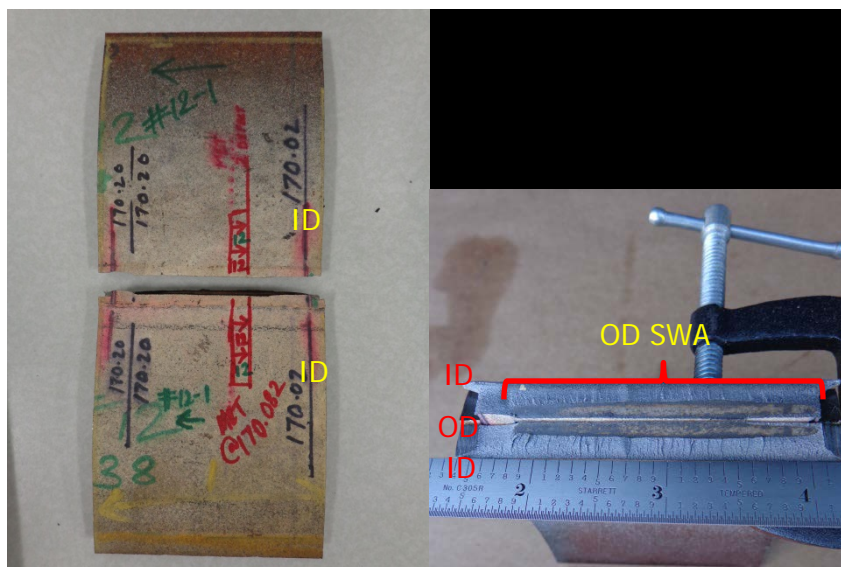
Figure 93. SWA #19, break location and fracture surface

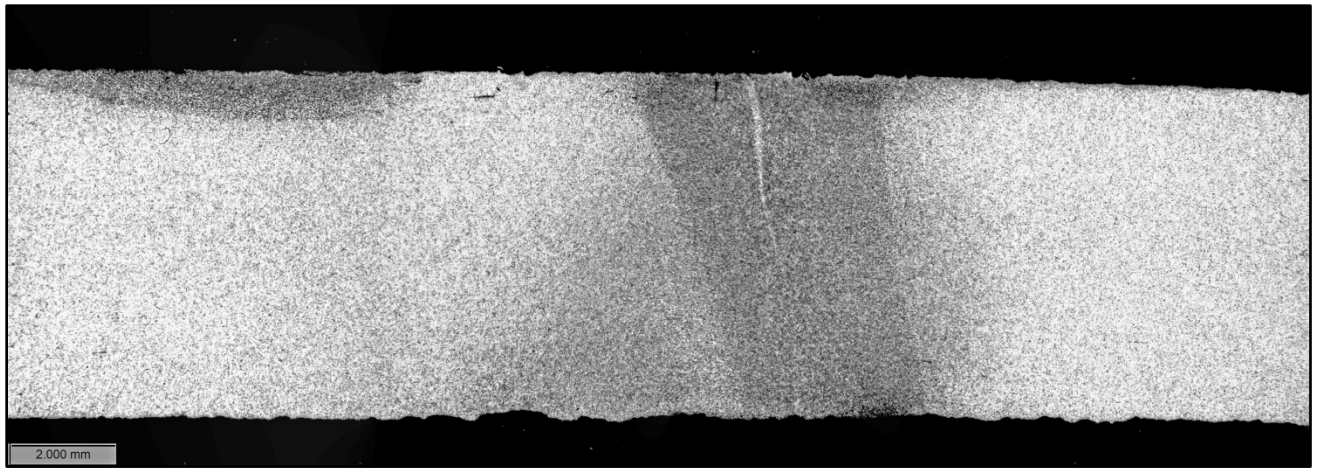
Figure 3. Sample 16-33 longitudinal seam weld metallographic cross section
