# Eddy Current Verification of Macros

## Semi-Automated and Manual EC

**Evgueni Todorov, PH.D.**  
**Senior NDE Engineer**  
**614-688-5268**  
**[evgueni\\_todorov@ewi.org](mailto:evgueni_todorov@ewi.org)**

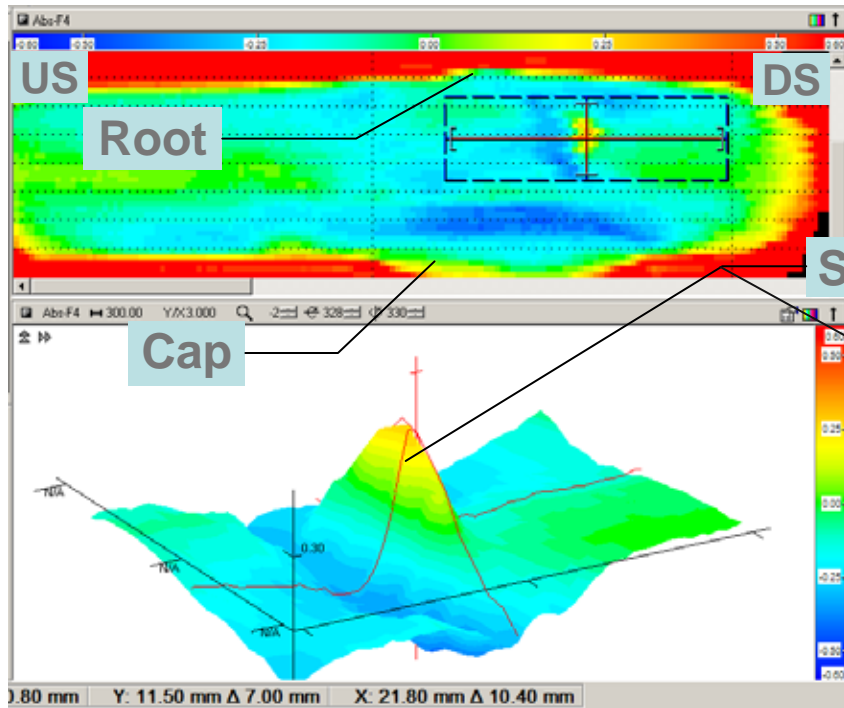
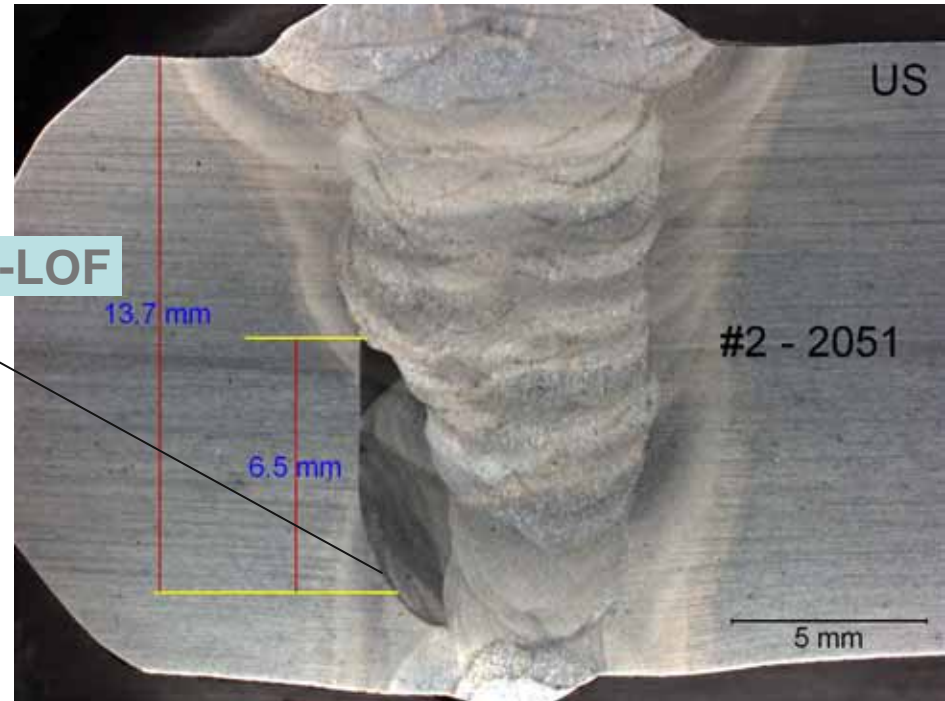
# Section W2-2051

- Shorter (3-mm height) side wall lack of fusion (SW-LOF) confirmed
- All-feature height 7 mm
- SW-LOF top and bottom sections might be fused

- Flaw 6.5 mm missed by fingerprinting and all 5 AUT vendors

- ◆ Suggested that flaw with the largest height 6.5 mm (see slide ...W2-2051) missed by fingerprinting and all 5 AUT vendors be removed from the sample. EC indicated partial fusion or extreme tightness
- ◆ More flaws with height larger than 1 mm might be removed from the sample to improve POD if the discrepancy (7 larger flaws) between the EC and fingerprinting is resolved and EC is improved
- ◆ EC performance for detection of surface and slightly subsurface (smeared opening due to cutting and polishing) discontinuities must be improved especially for flaws with height larger than 1 mm

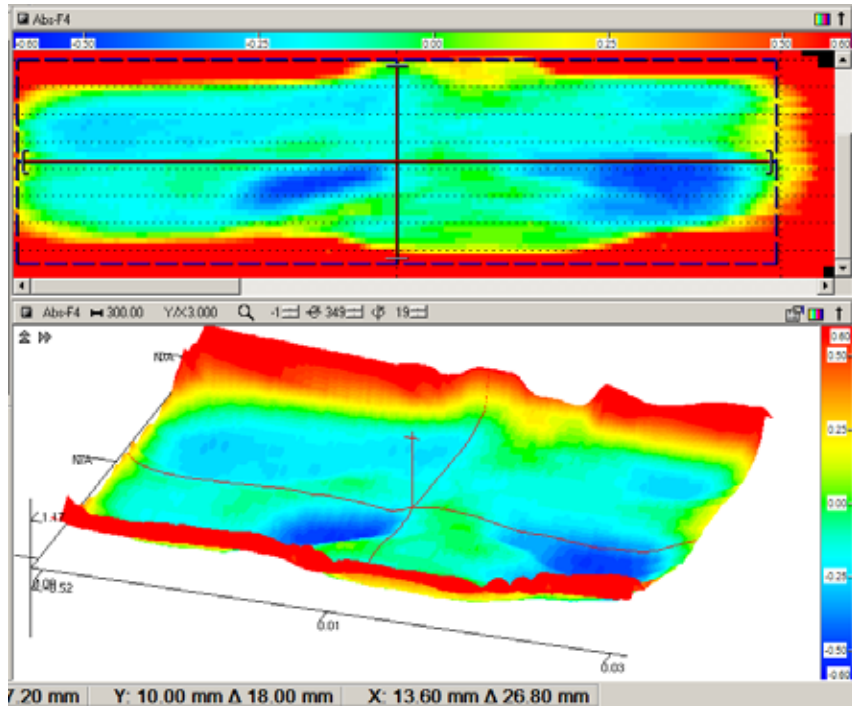
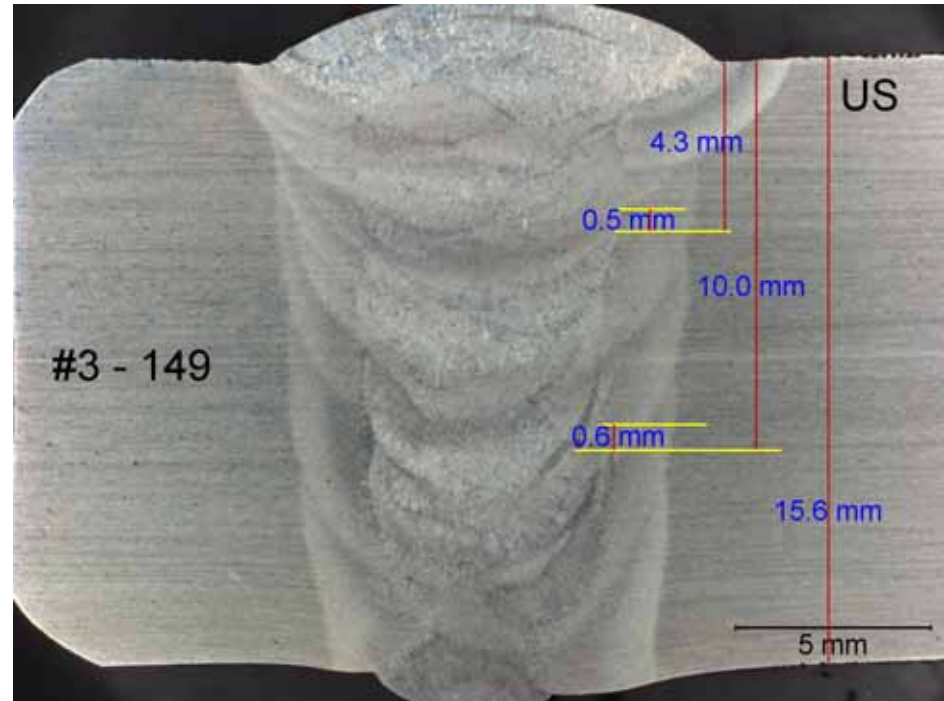
# Section W3-149

- No confirmation of small flaws

- Flaws 0.5 and 0.6 mm missed by fingerprinting and all 4 AUT vendors

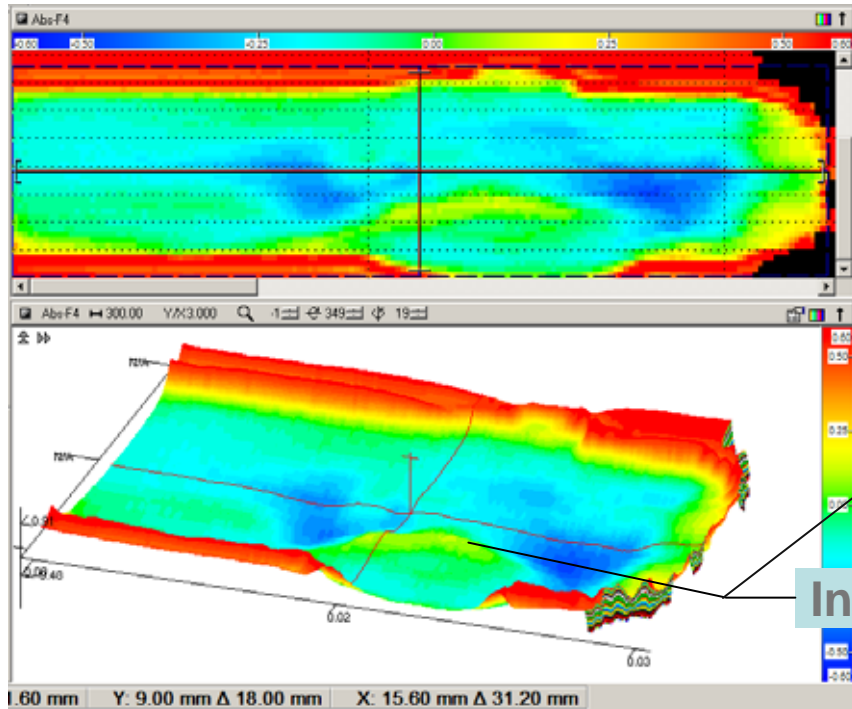
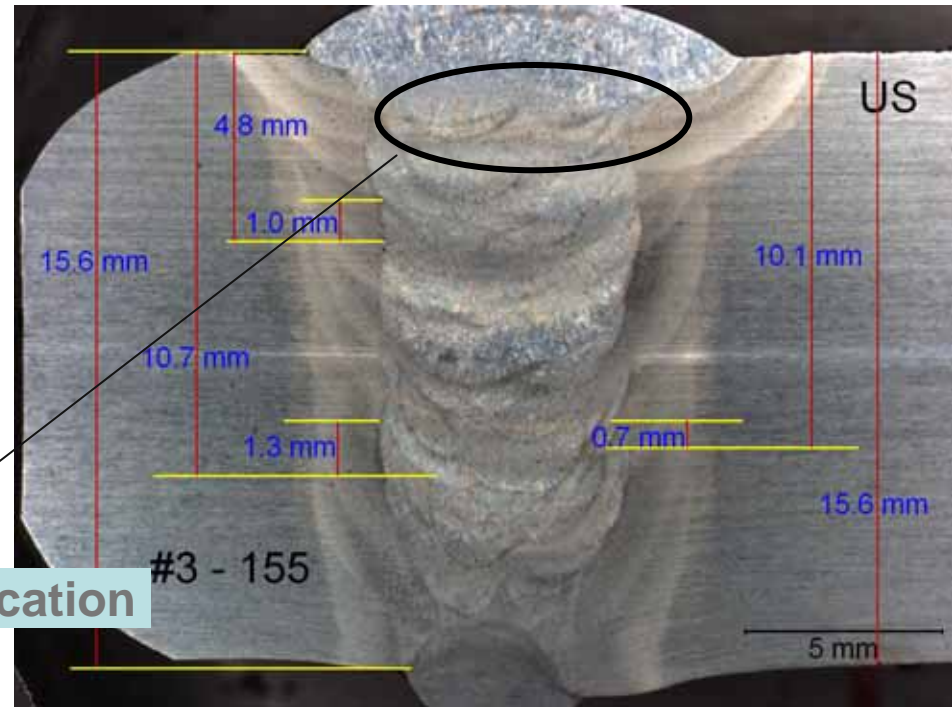
# Section W3-155

- No confirmation of any flaw
- Pronounced inter-bead transition

- Flaw 1 mm part of flaw 1.1 mm on W3-158 (see slide ...W3-158)
- Flaw 1.3 mm detected by fingerprinting but missed by all 4 AUT vendors
- Flaw 0.7 mm missed by fingerprinting and all 4 AUT vendors

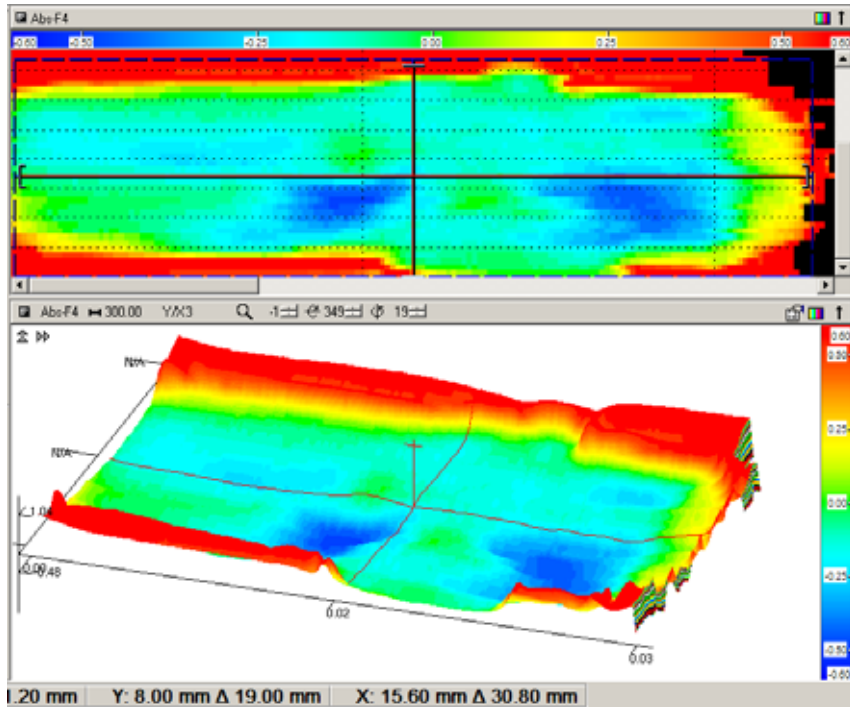
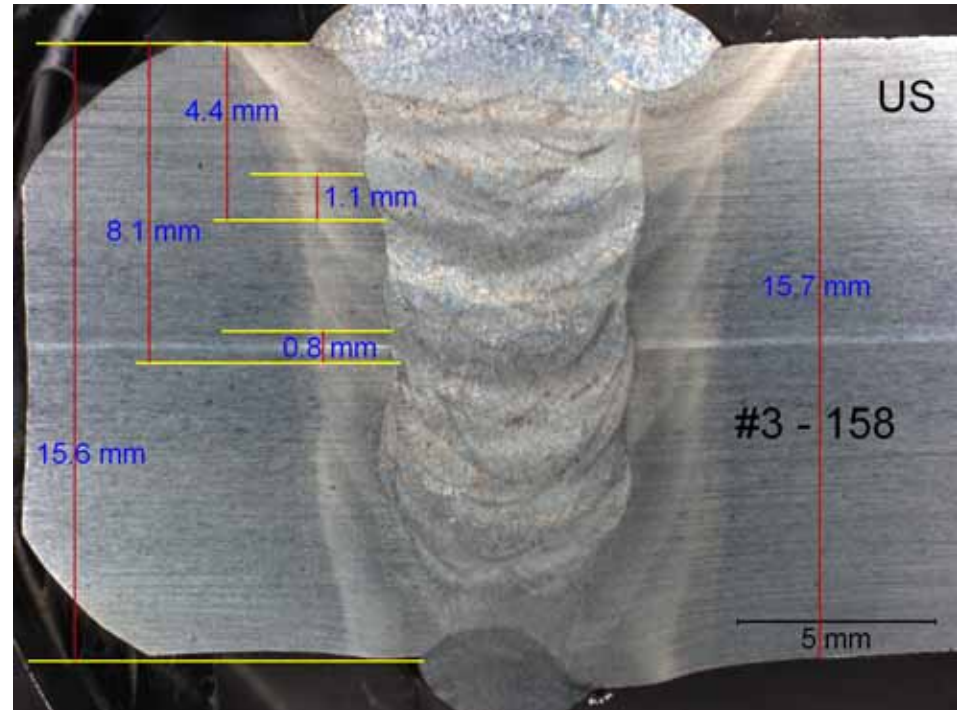
# Section W3-158

- No confirmation of any flaw

- Flaw 1.1 mm detected by fingerprinting but missed by all 4 AUT vendors
- Flaw 0.8 mm missed by fingerprinting and all 4 AUT vendors

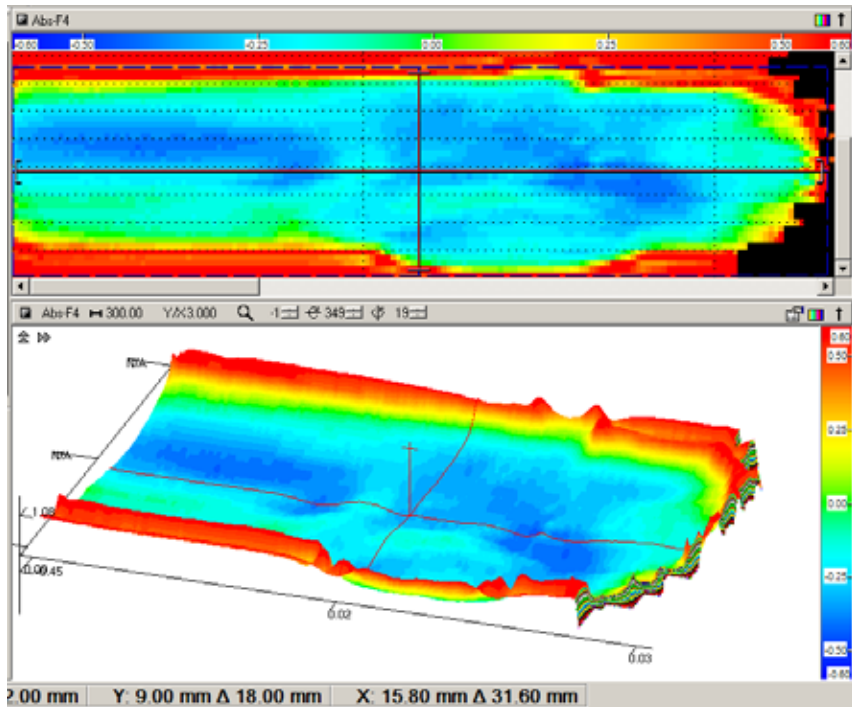
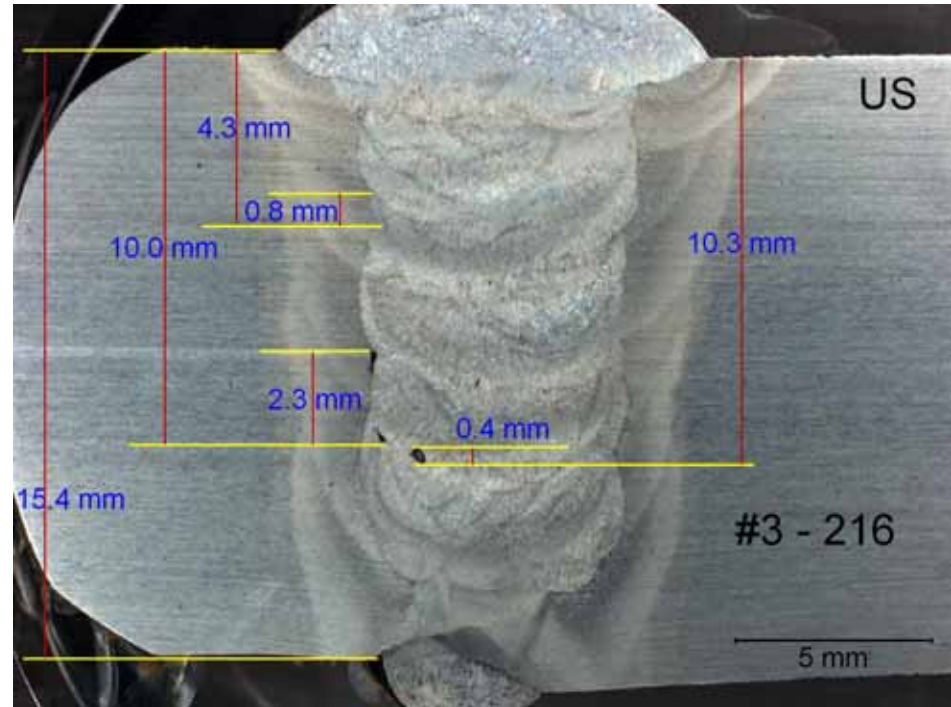
# Section W3-216

- No confirmation of any flaw on C-scan
- Only pores part of 2.3 mm (no 2.3-mm link) and 0.4 mm confirmed by manual EC

- Flaw 2.3 mm detected by fingerprinting but missed by all 4 AUT vendors
- Flaws 0.8 and 0.4 mm missed by fingerprinting and all 4 AUT vendors

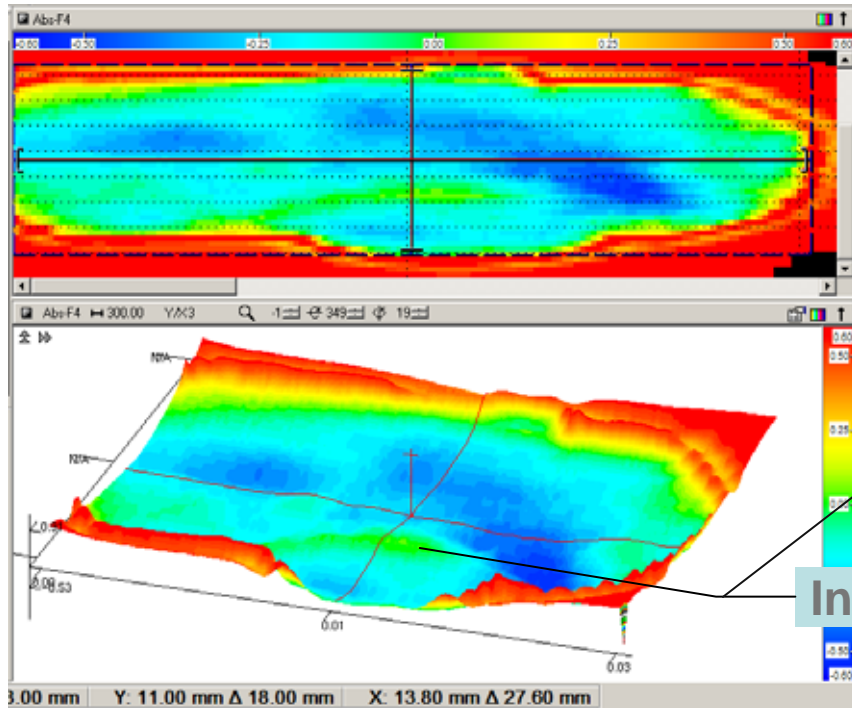
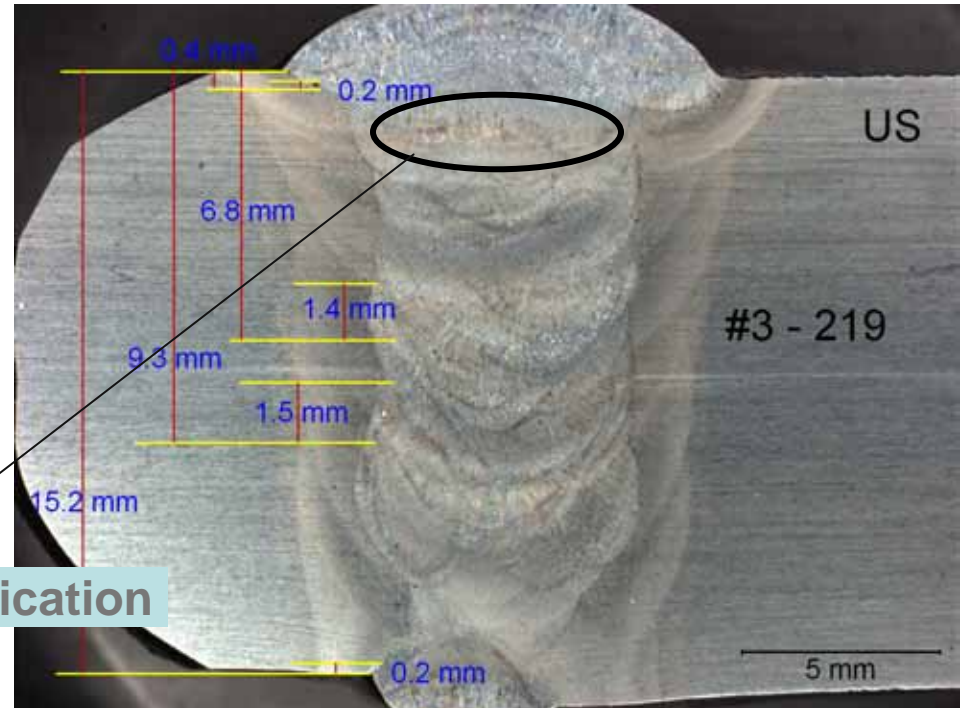
# Section W3-219

- No confirmation of any flaw
- Pronounced inter-bead transition

- Flaw 1.5 mm part of 2.3 mm flaw on W3-216 (see slide ...W3-216)
- Flaws 1.4 and two 0.2 mm missed by fingerprinting and all 4 AUT vendors

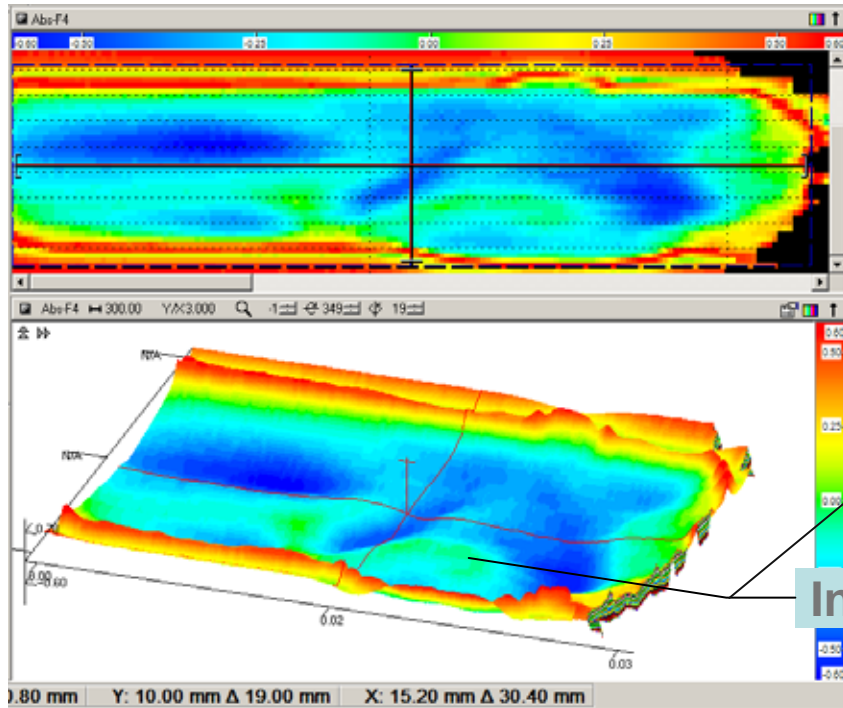
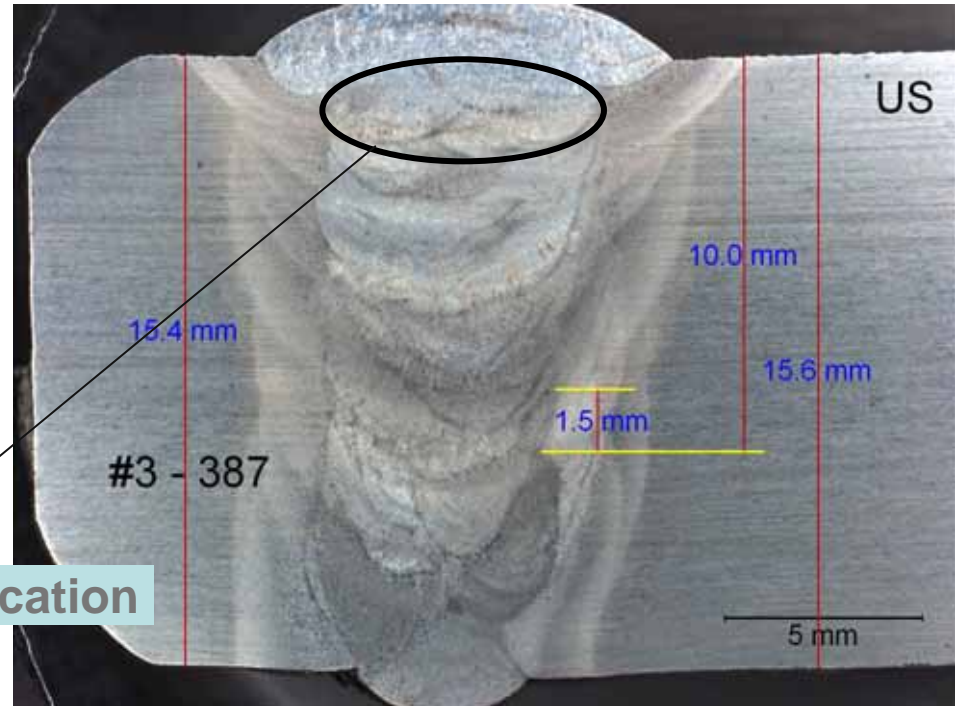
# Section W3-387

- No confirmation of any flaw
- Pronounced inter-bead transition

- Flaw 1.5-mm part of 1.8-mm flaw on W3-390. Flaw 1.8 mm detected by fingerprinting and AUT V4 but missed by other 3 AUT vendors

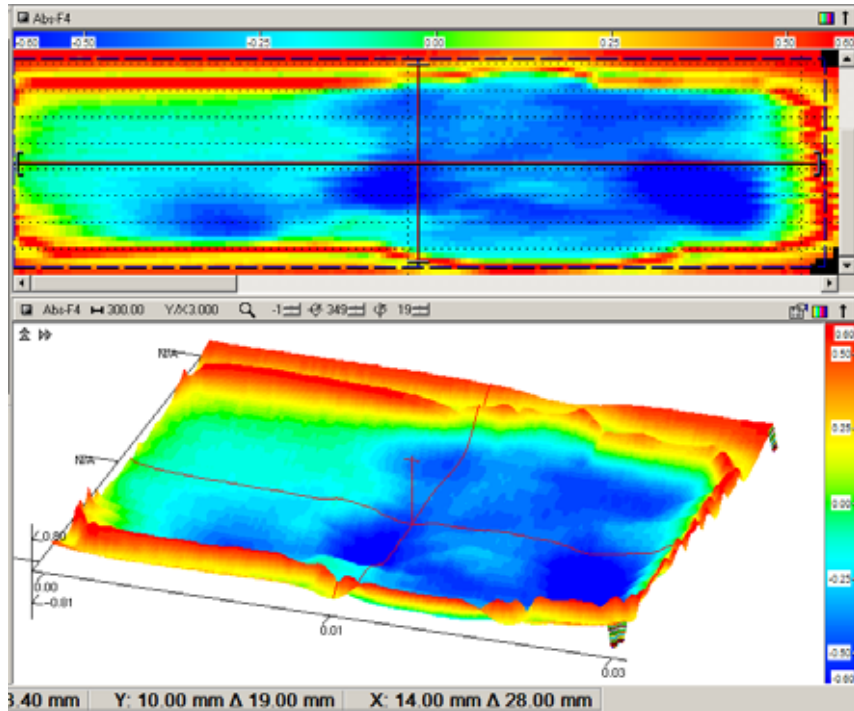
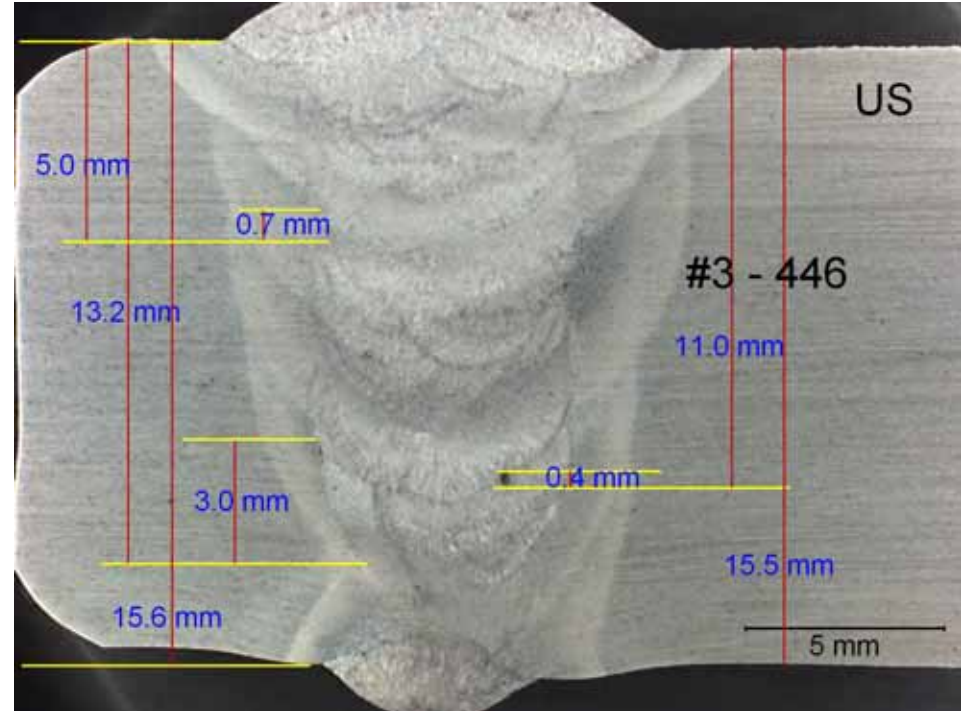
# Section W3-446

- No confirmation of any flaw on C-scan
- Only 0.4 mm pore confirmed by manual EC

- Flaws 0.4 and 0.7 mm missed by fingerprinting and all 4 AUT vendors
- Flaw 3.0-mm part of 3.6 mm on W3-449. Flaw 3.6 mm detected by fingerprinting and AUT V1 but missed by other 3 AUT vendors

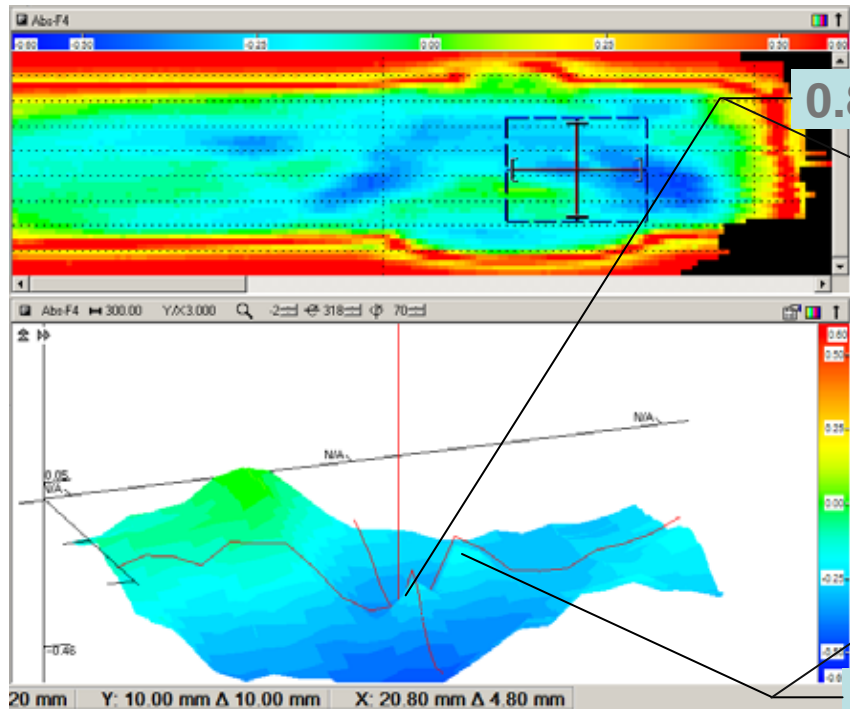
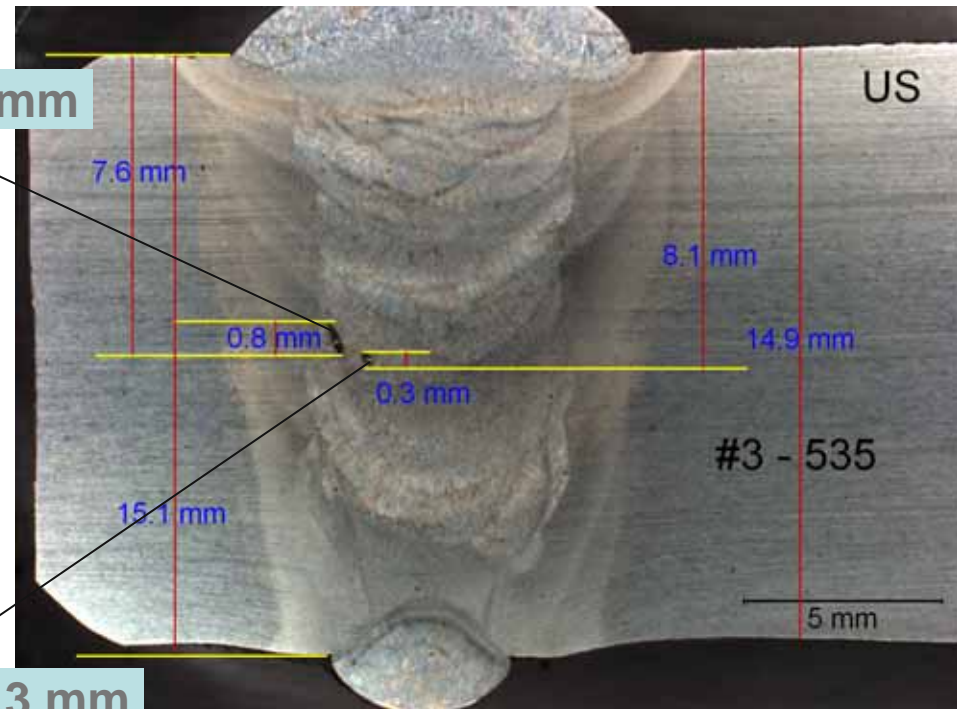
# Section W3-535

- All flaws confirmed on C-scan and manual EC

- Flaws 0.8 and 0.3 mm missed by fingerprinting and all 4 AUT vendors

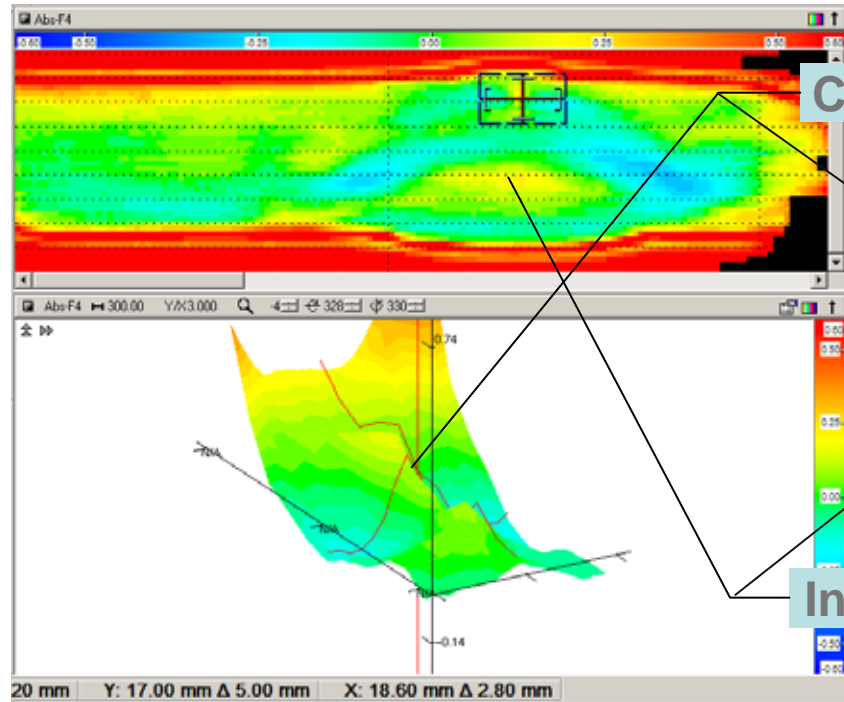
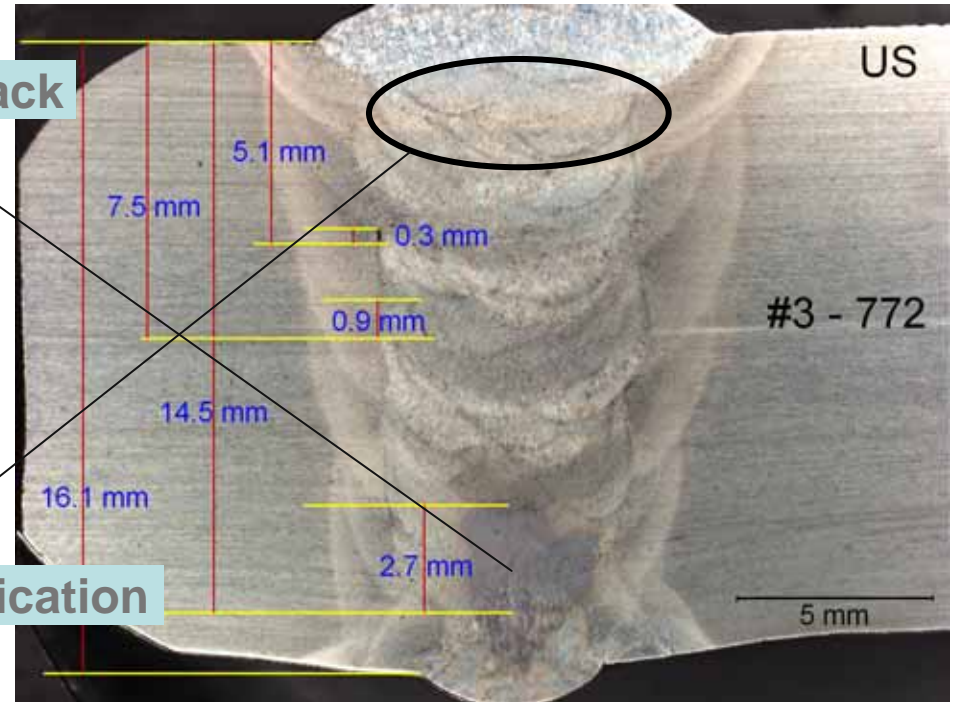
# Section W3-772

- ◆ **EC**
  - Crack 2.7 mm confirmed on C-scan. Difficult to detect. Might be tight or partially fused.
  - Pore 0.3 mm confirmed with manual EC
  - Flaw 0.9 mm was not confirmed
  - Pronounced inter-bead transition
- ◆ **AUT**
  - Flaw 2.7 mm detected by fingerprinting and AUT V1 but missed by other 3 AUT vendors
  - Flaws 0.9 and 0.3 mm missed by fingerprinting and all 4 AUT vendors

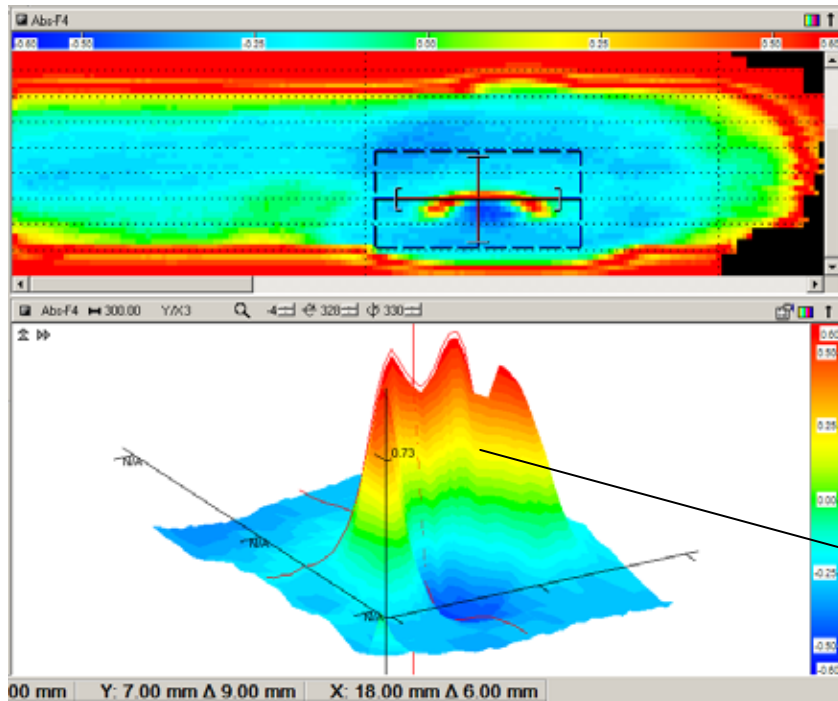
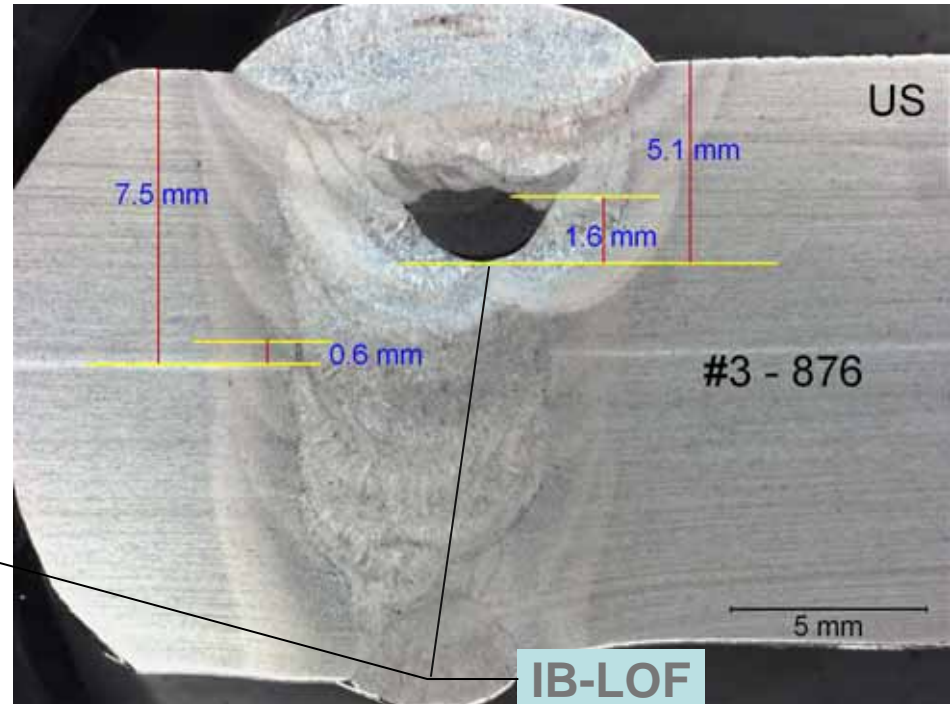
# Section W3-876

- Inter-bead lack of fusion (IB-LOF) easily confirmed on C-scan
- Flaw 0.6 mm confirmed with manual EC

- Flaw 1.6 mm part of 1.7 mm on W3-870. Flaw 1.7 mm detected by fingerprinting and all 4 AUT vendors
- Flaw 0.6 mm part of 0.7 mm flaw on W3-870. Flaw 0.7 mm detected by fingerprinting but missed by all 4 AUT vendors.

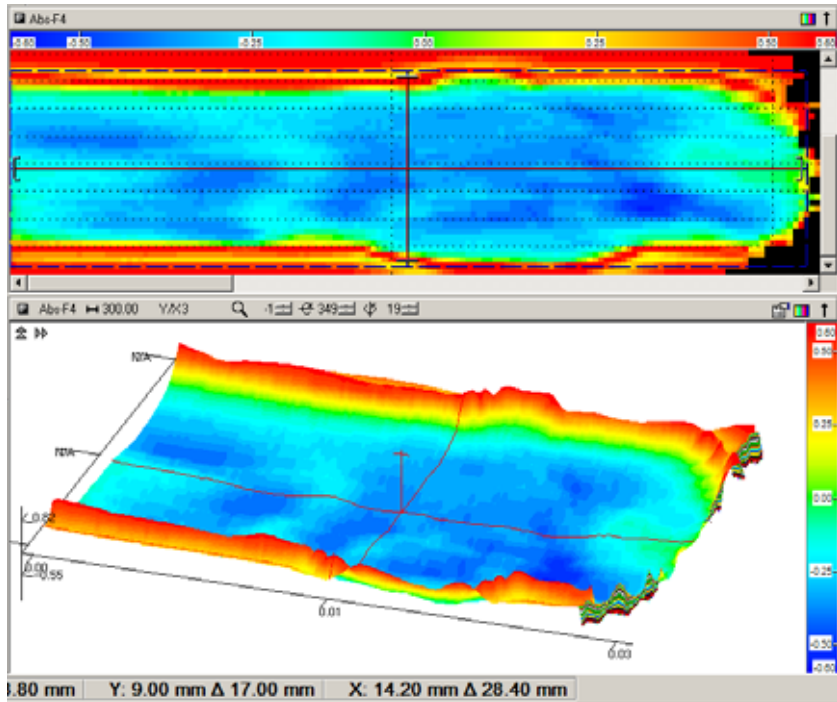
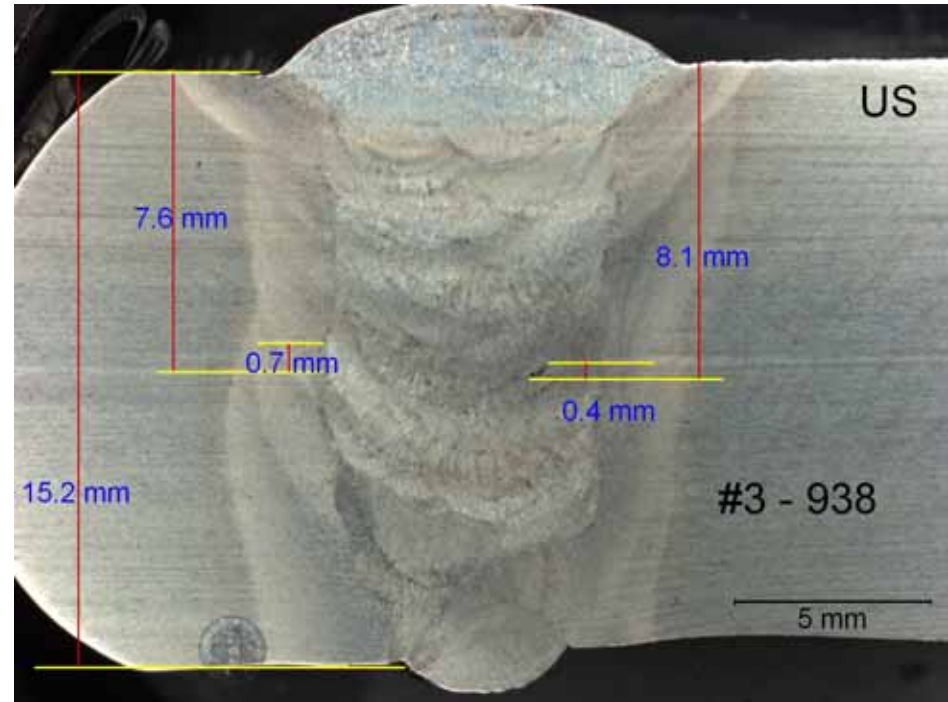
# Section W3-938

- No confirmation of 0.7 mm flaw
- Flaw 0.4 mm confirmed with manual EC

- Flaws missed by fingerprinting and all 4 AUT vendors

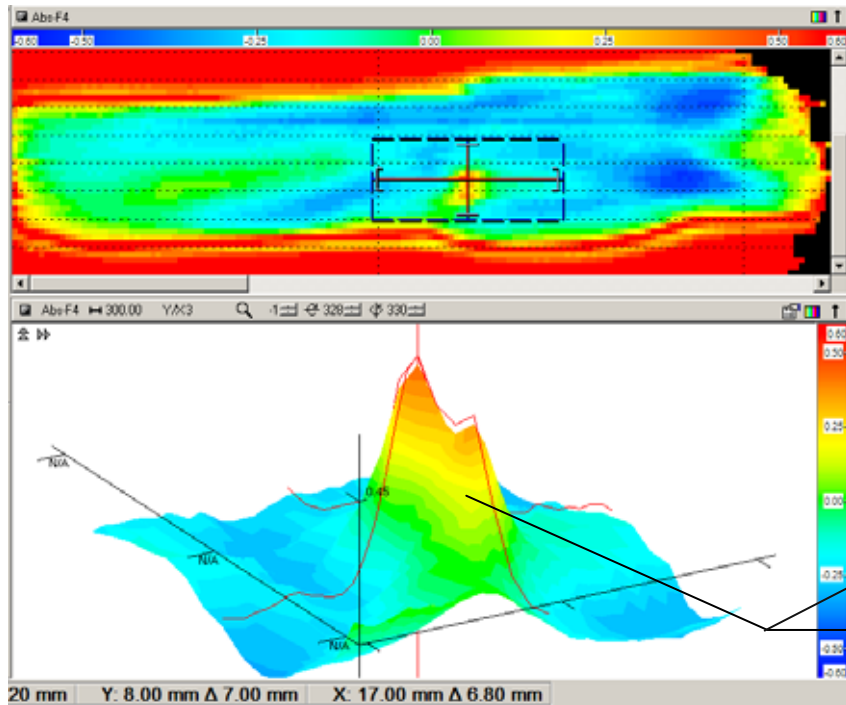
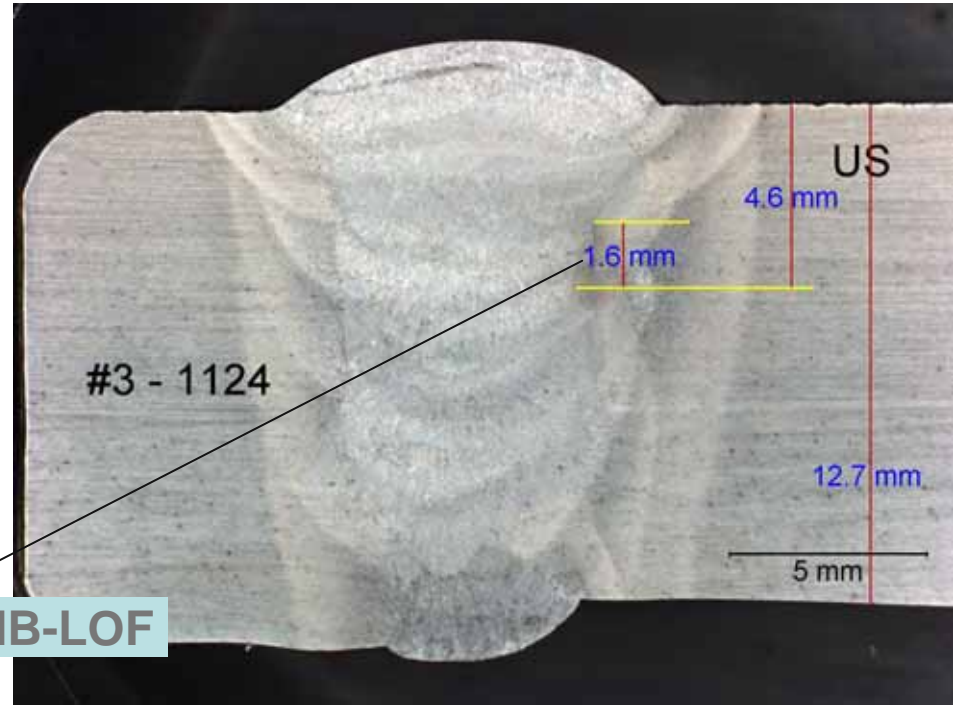
# Section W3-1124

- IB-LOF easily confirmed on C-scan

- Flaw 1.6 mm is possibly part of 2.8 mm on W3-1132 (implanted from 1129 to 1144). Flaw 2.8 mm detected by fingerprinting and AUT V1 but missed by other 3 AUT vendors

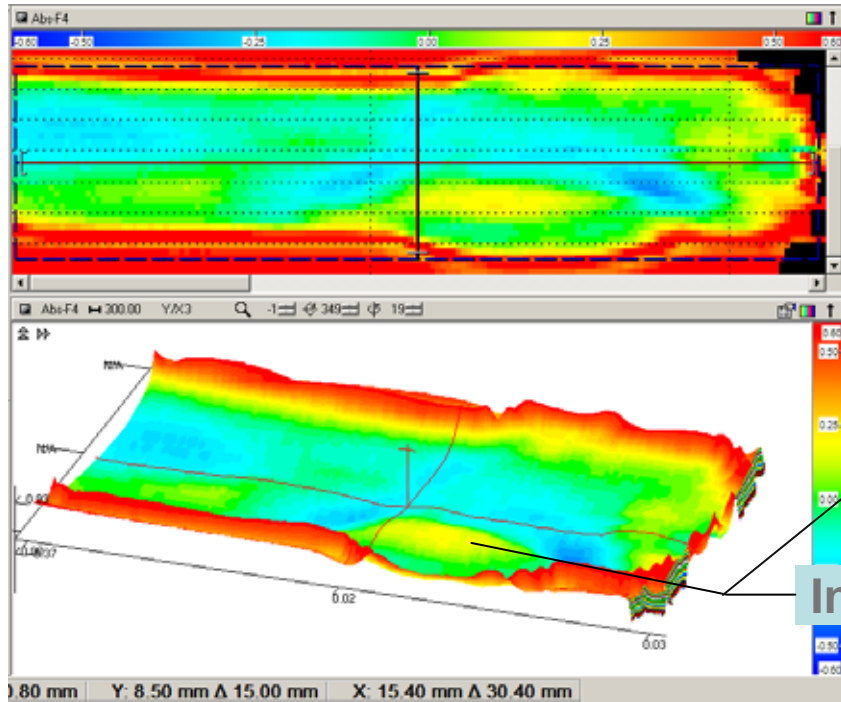
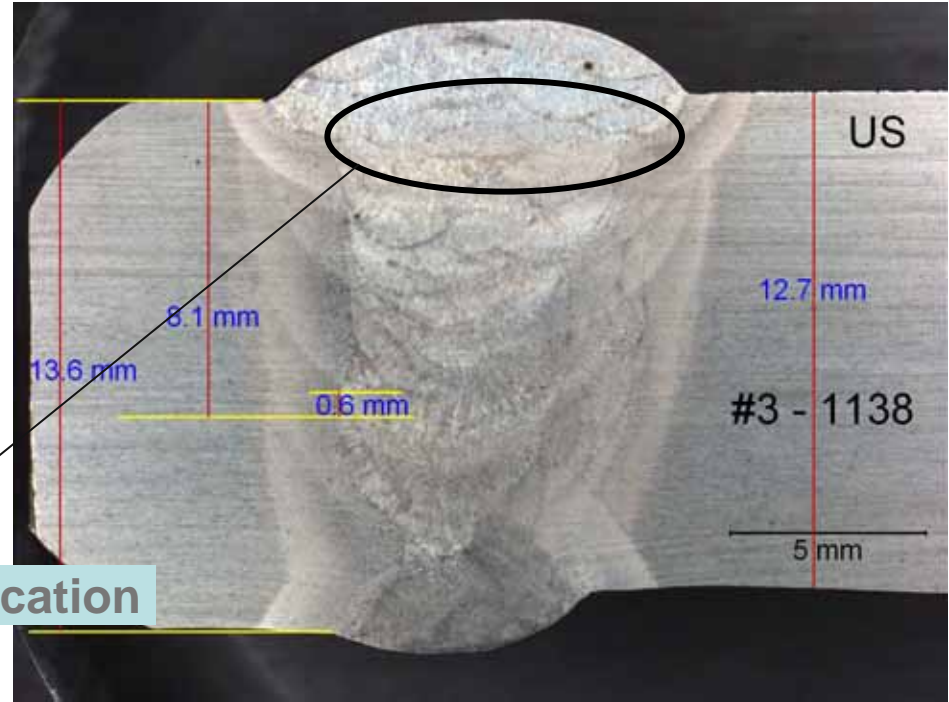
# Section W3-1138

- No confirmation of 0.6 mm flaw
- Pronounced inter-bead transition

- Flaw 0.6 mm missed by fingerprinting and all 4 AUT vendors

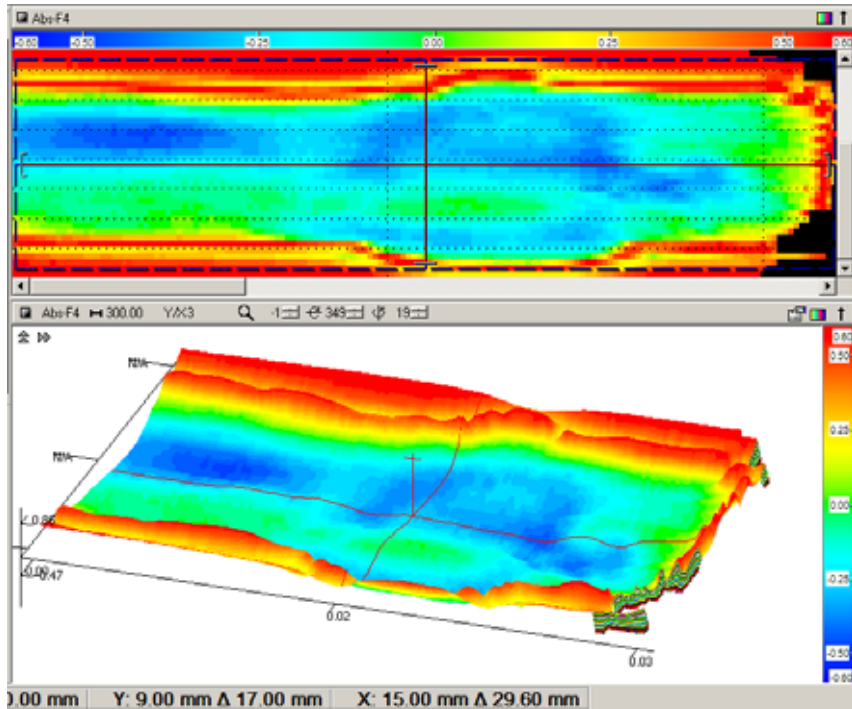
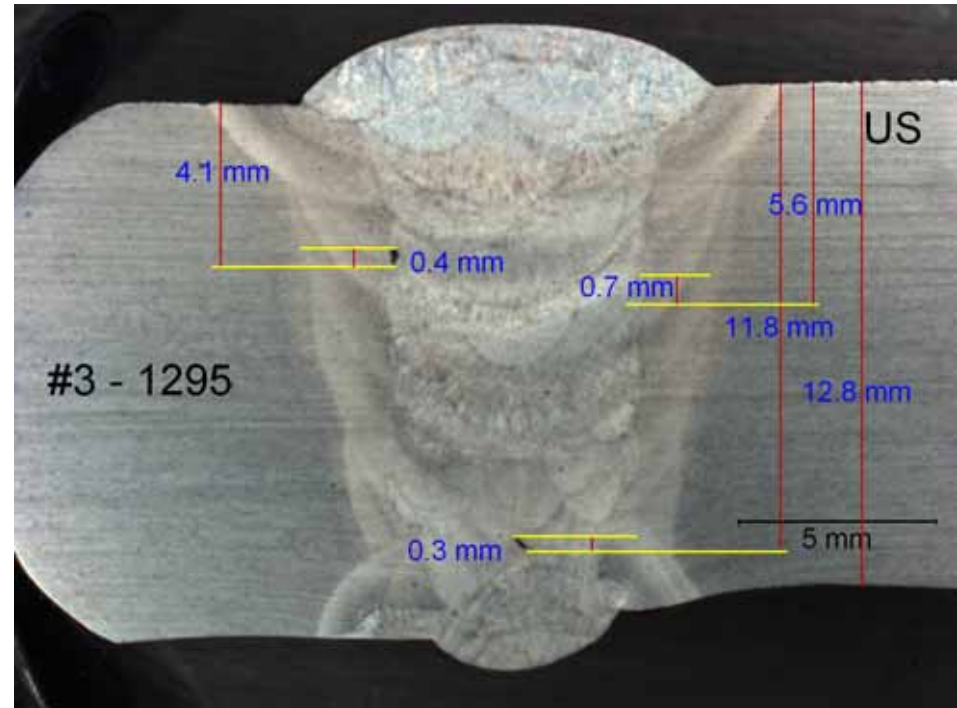
# Section W3-1295

- No confirmation of any flaw

- Flaws missed by fingerprinting and all 4 AUT vendors

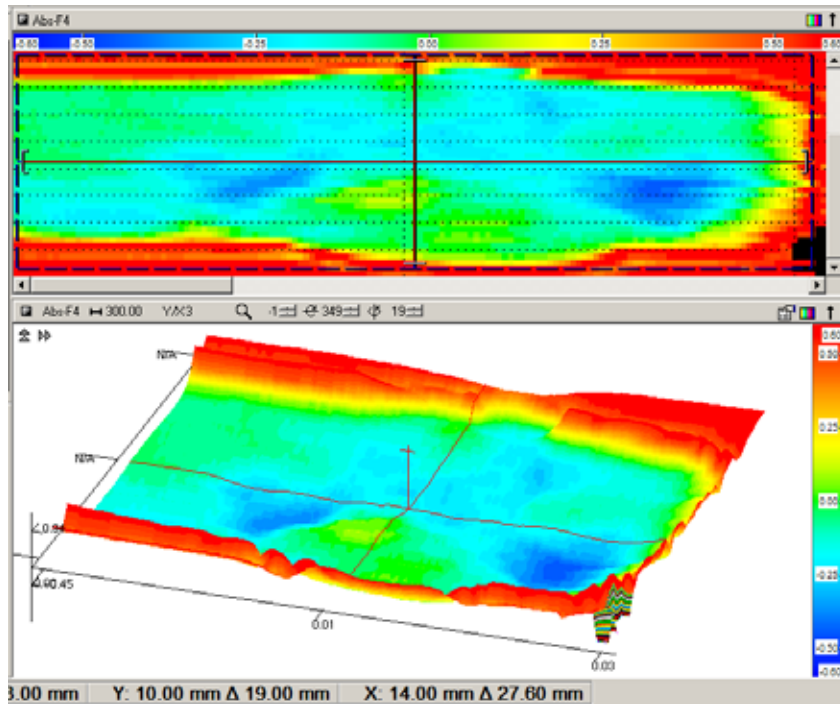
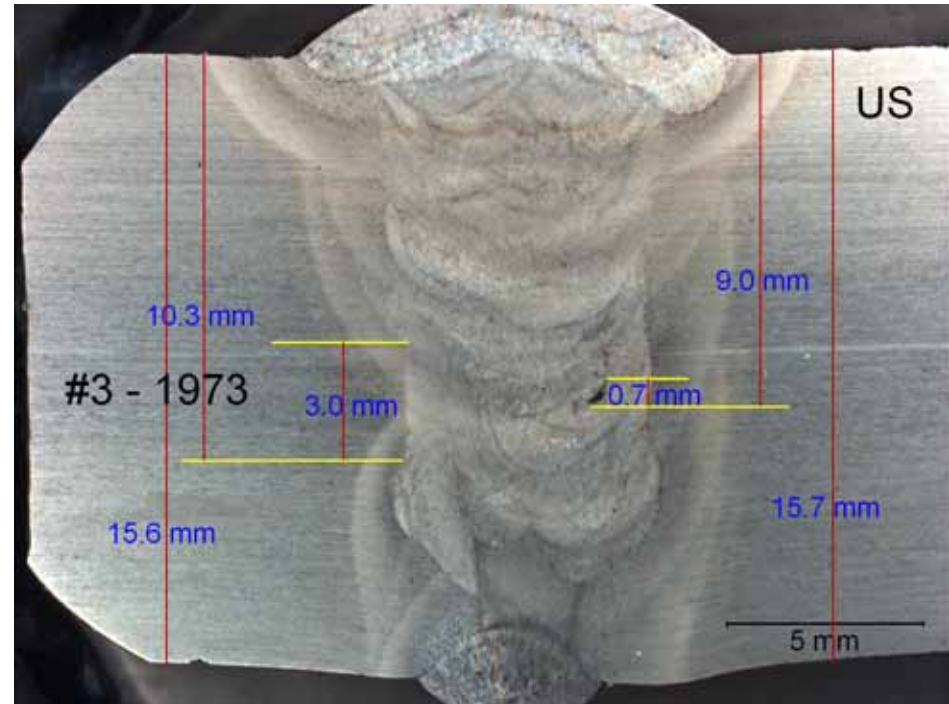
# Section W3-1973

- Side-wall lack of fusion 3 mm was not confirmed on C-scan. Might be tight or fused.
- Flaw 0.7 mm confirmed with manual EC

- Flaw 3.0 mm detected by fingerprinting and AUT V4 (high sizing error) but missed by other 3 AUT vendors
- Flaw 0.7 mm missed by fingerprinting and all 4 AUT vendors

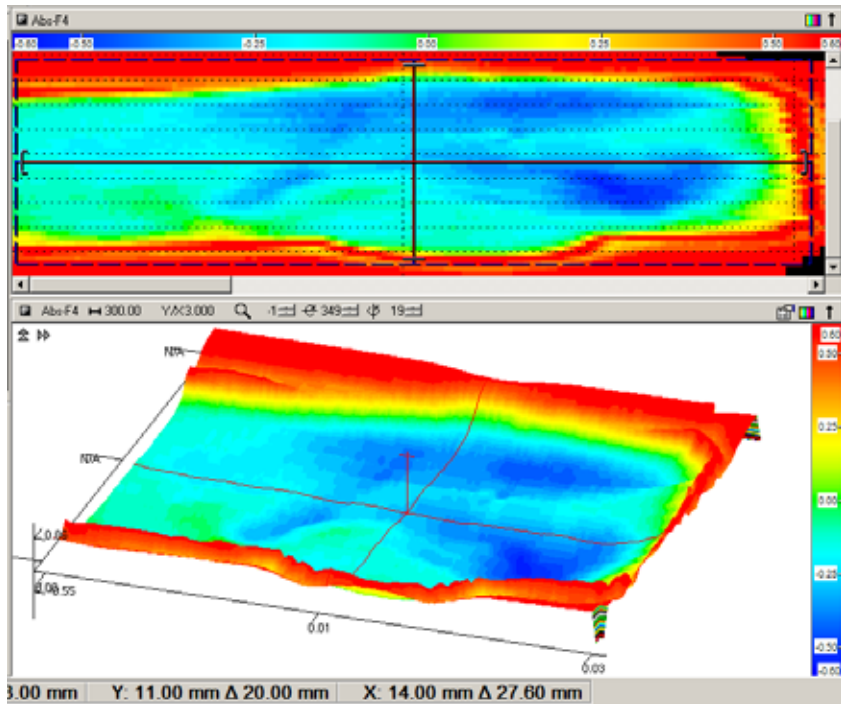
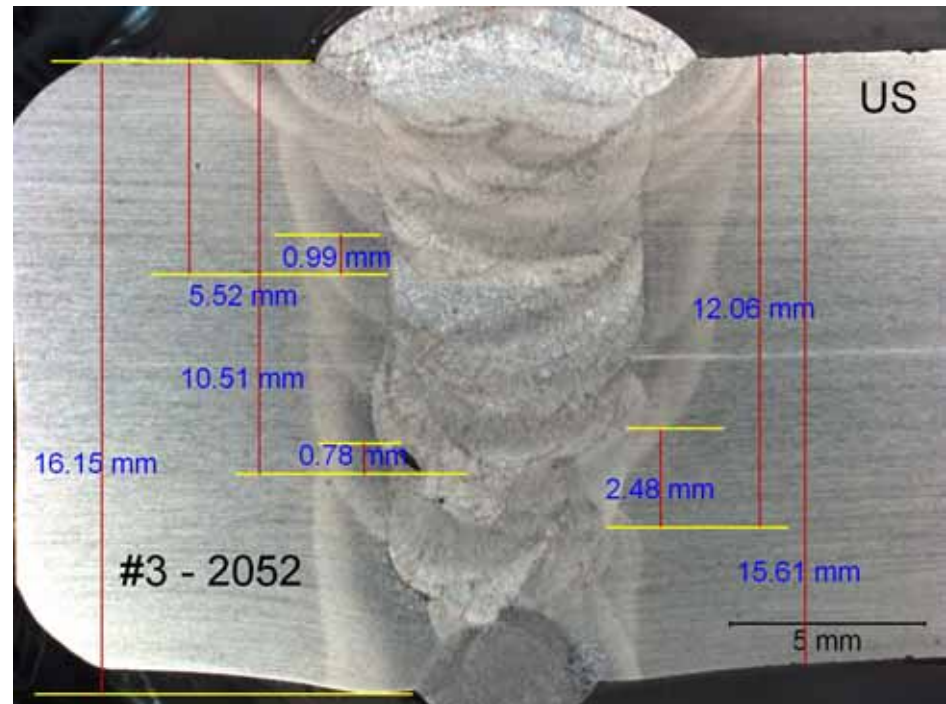
# Section W3-2052

- ◆ **EC**
  - Flaw 0.99 mm was not confirmed on C-scan
  - Flaw 2.48 mm was not confirmed on C-scan either. Might be tight or fused.
  - Flaw 0.78 mm confirmed with manual EC
- ◆ **AUT**
  - Flaw 0.99 mm detected by AUT V4 but missed by fingerprinting and 3 AUT vendors
  - Flaw 2.48-mm part of 2.51 mm on W3-2055. Flaw 2.51 mm detected by fingerprinting and AUT V4 (high sizing error) but missed by other 3 AUT vendors
  - Flaw 0.78 mm detected by fingerprinting but missed by all 4 AUT vendors
