# Eddy Current Verification of Macros

## Semi-Automated and Manual EC

**Evgueni Todorov, PH.D.**  
**Senior NDE Engineer**  
**614-688-5268**  
**[evgueni\\_todorov@ewi.org](mailto:evgueni_todorov@ewi.org)**

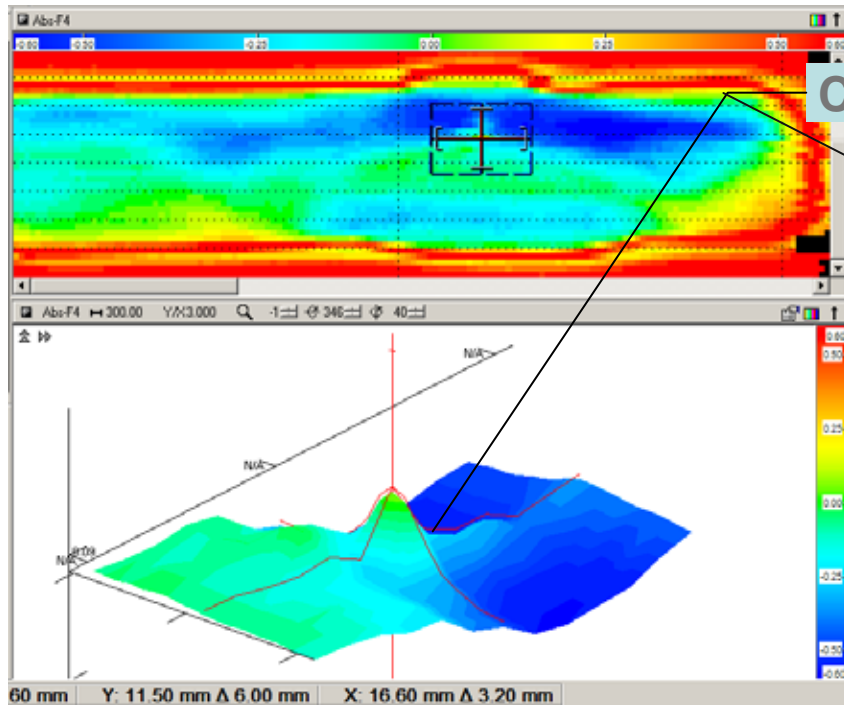
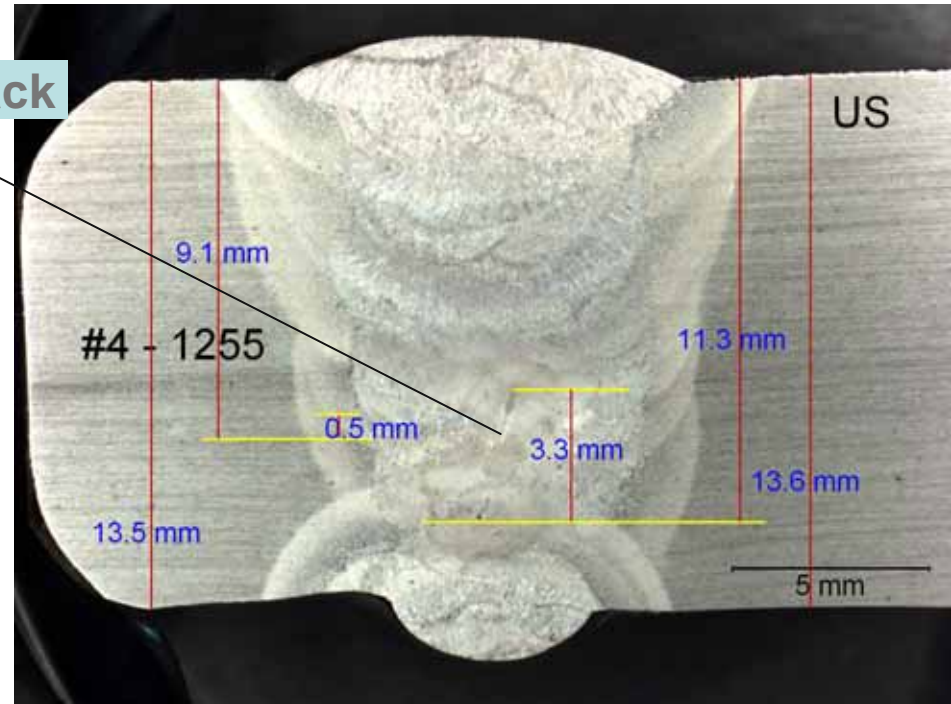
# Section W4-1255

- Crack 3.3 mm confirmed on C-scan. Difficult to detect. Might be tight or partially fused.
- Flaw 0.5 mm not confirmed

- Crack 3.3 mm is part of 3.8 mm crack on W4-1252. Crack 3.8 mm detected by all with exception of AUT V3
- Flaw 0.5 mm missed by fingerprinting and all 5 AUT vendors

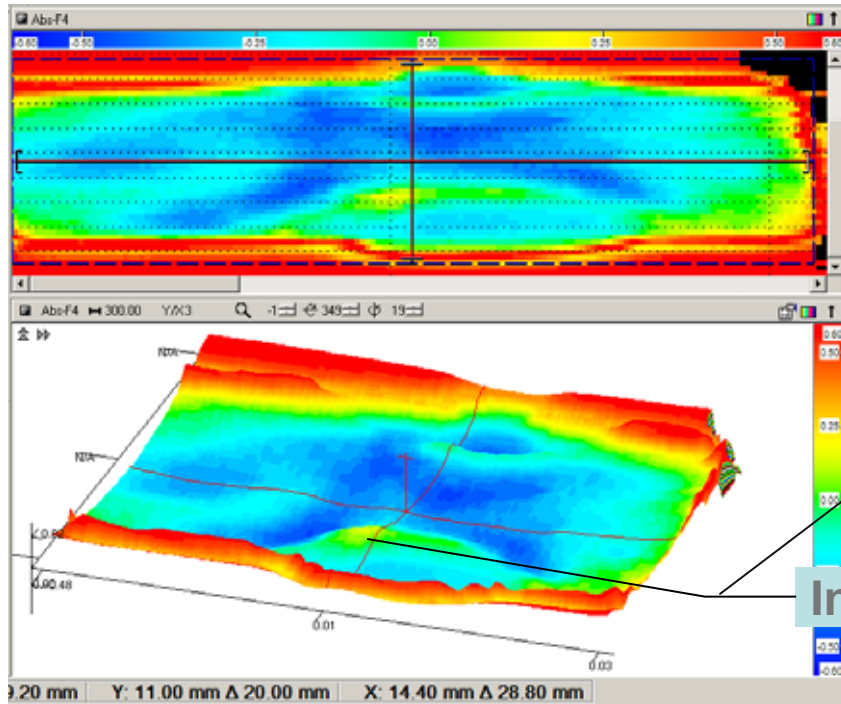
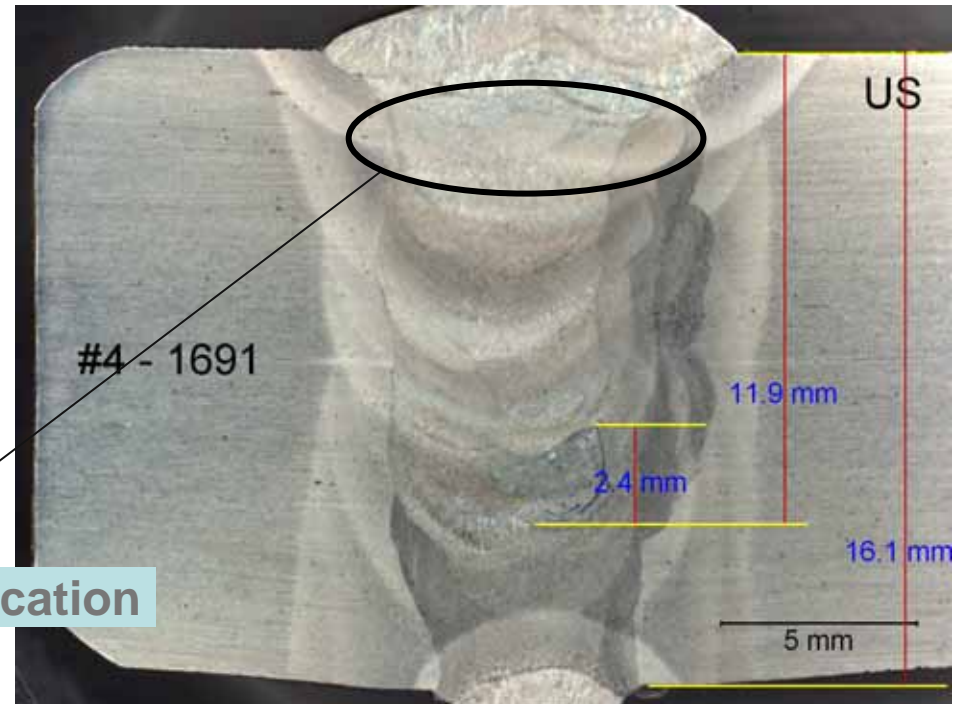
# Section W4-1691

- IB-LOF 2.4 mm not confirmed
- Pronounced inter-bead transition

- Flaw 2.4 mm missed by fingerprinting and all 5 AUT vendors

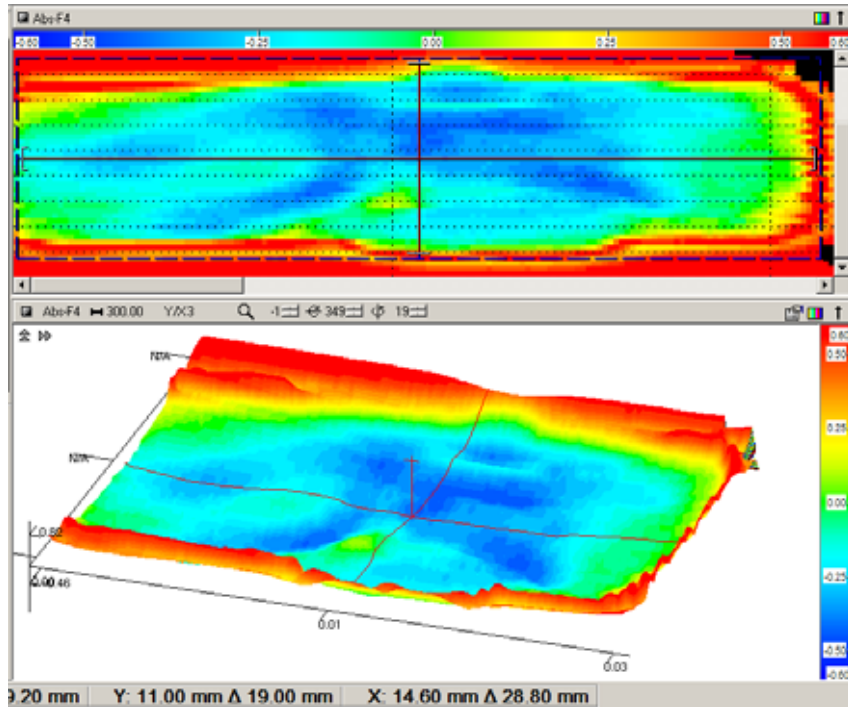
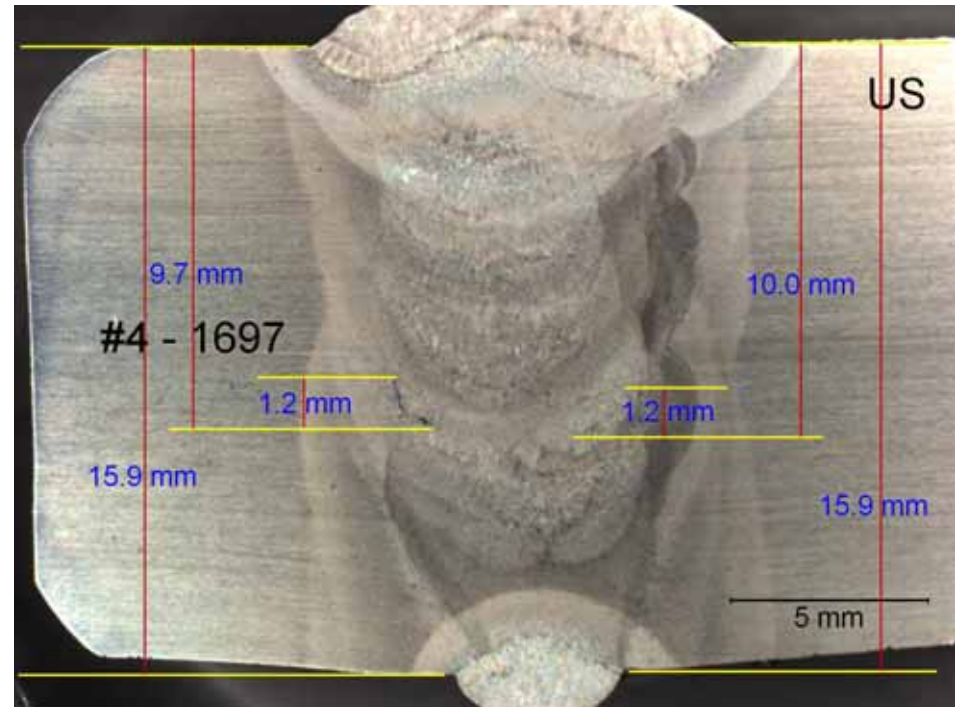
# Section W4-1697

- No confirmation of any flaw

- Flaw 1.2-mm DS detected by fingerprinting but missed by all 5 AUT vendors
- Flaw 1.2-mm US missed by fingerprinting and all 5 AUT vendors

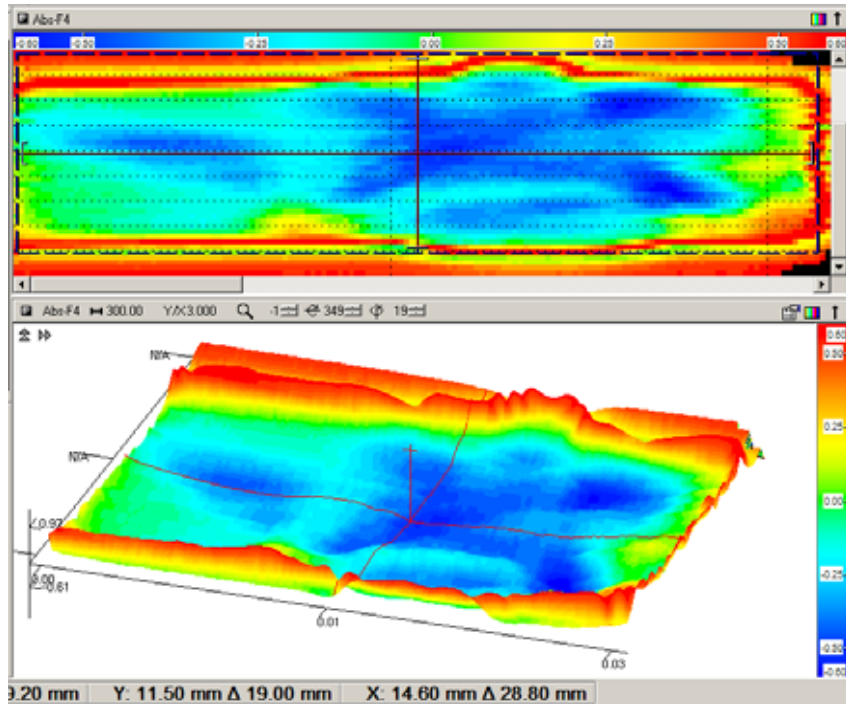
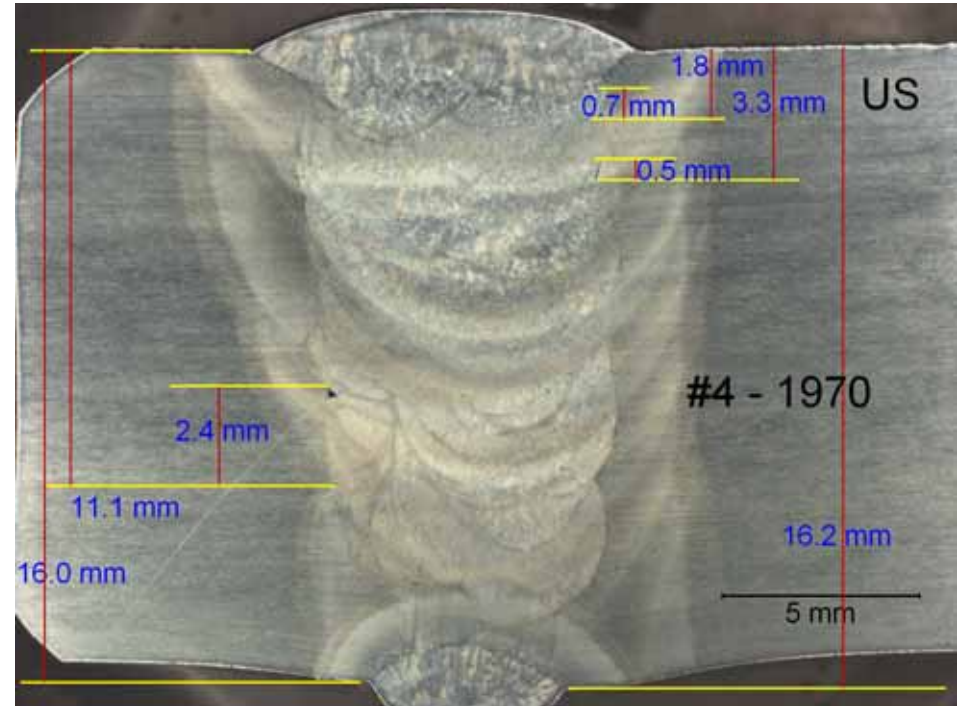
# Section W4-1970

- No confirmation of 0.5 or 0.7 mm flaws
- Flaw 2.4 mm was not confirmed either. Might be tight or fused.

- Flaws 0.5 or 0.7 mm missed by fingerprinting and all 5 AUT vendors
- Flaw 2.4 mm is part of 3.5 mm crack on W4-1976 (see slide ...W4-1976)

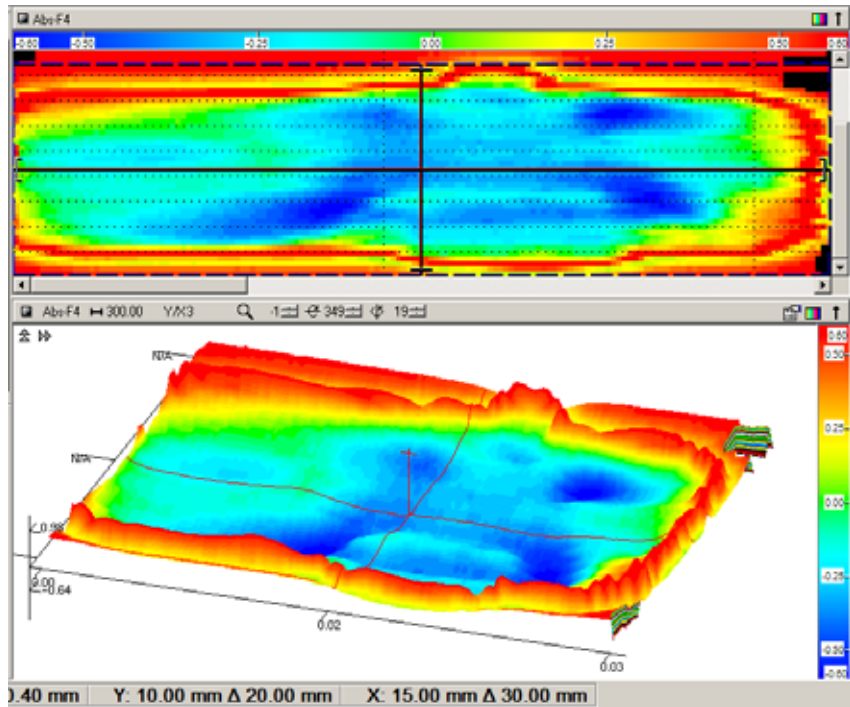
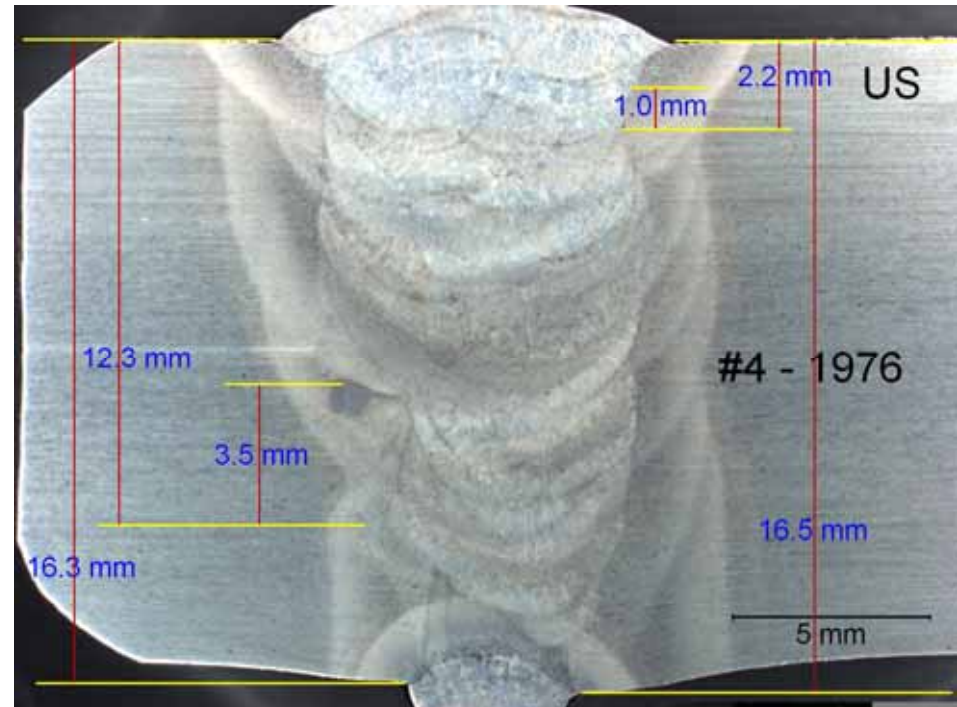
# Section W4-1976

- No confirmation of 1 mm flaw
- Flaw 3.5 mm was not confirmed either. Might be tight or fused.

- Flaw 1.0 mm missed by fingerprinting and all 5 AUT vendors
- Flaw 3.5 mm detected by all with exception of AUT V3
