## Effectiveness of Hydrostatic Testing for Assessing the Integrity of ERW and Flash-weld Pipe Seams

K. M. Kolovich and J. F. Kiefner  
January 15, 2013

**AS THE DELIVERABLE OF SUBTASK 1.2 ON  
U.S. DEPARTMENT OF TRANSPORTATION  
OTHER TRANSACTION AGREEMENT NO. DTPH56-11-T-000003**

**January 15, 2013**

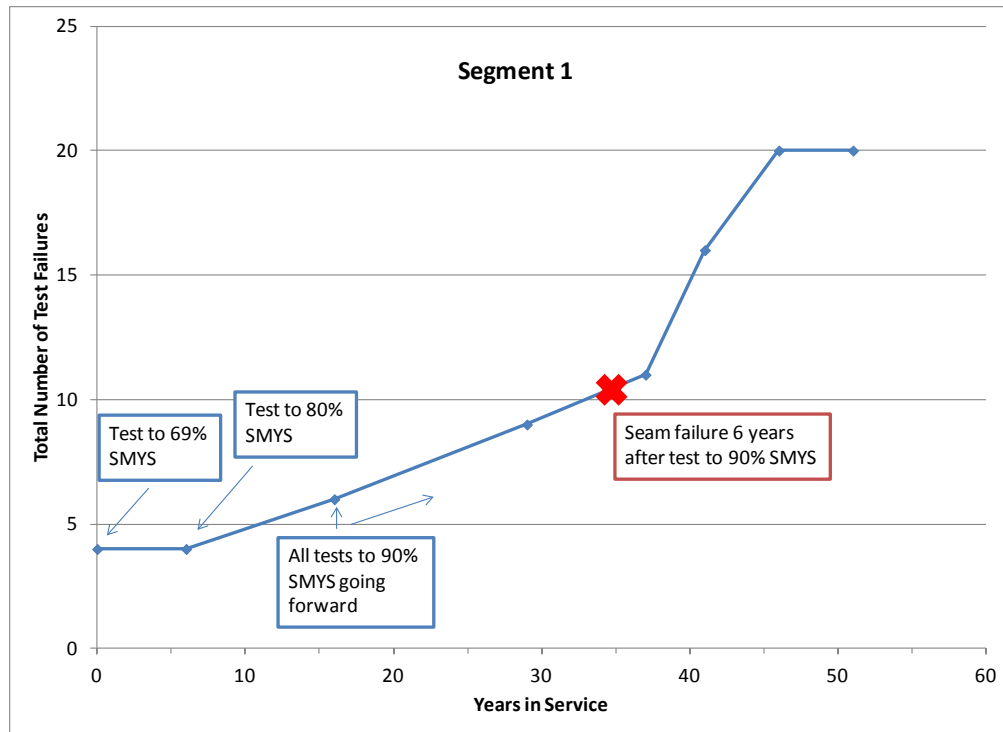
**Figure 1. Case Study 1, Segment 1 Hydrostatic Test and Service Failure Timeline**

Figure 1 through Figure 3 show the cumulative number of seam test failures over time for Segments 1 through 3, respectively. Also shown on the timelines are the occurrences of in-service seam failures with the exception of the three pinhole leaks. As discussed in the Subtask 1.4 report<sup>2</sup>, pinholes (also described as penetrators, the two terms having effectively the same meaning) might not be detected by either hydrostatic testing or in-line inspection and such defects are analogous to pinholes in girth welds in that respect. Both pinholes in seam welds and girth welds may result in small leaks, but none has ever caused an in-service rupture.

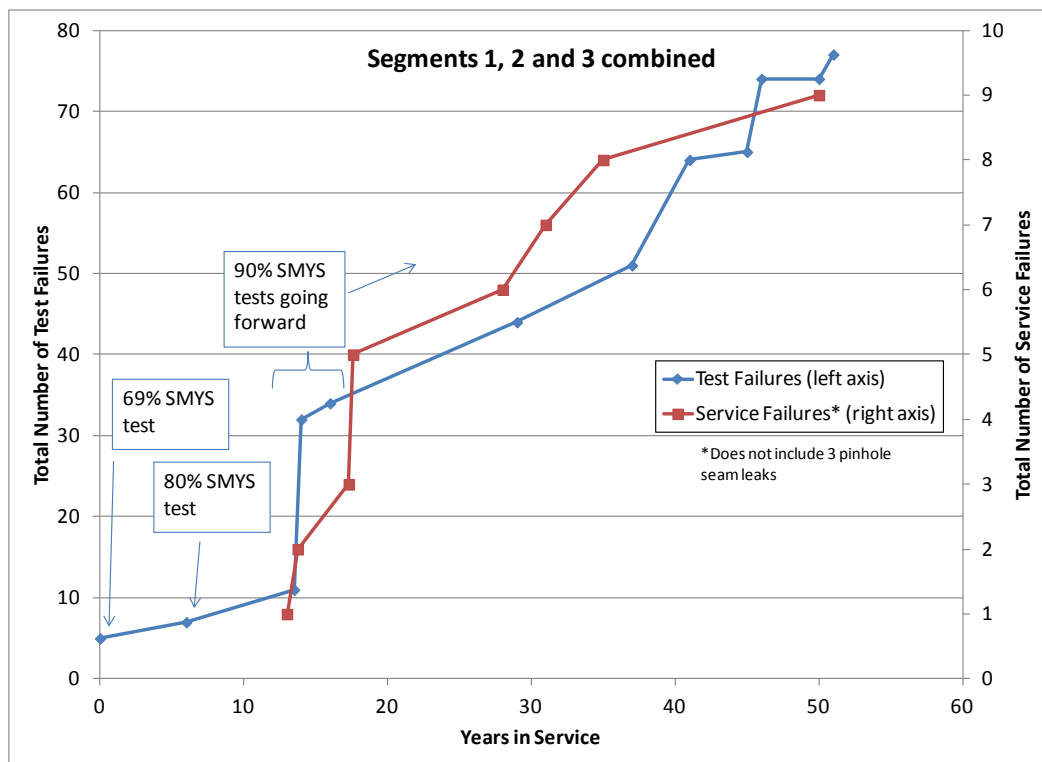
**Figure 4. Case Study 1, Segments 1-3 Hydrostatic Test and Service Failure Timeline**

Figure 4 shows the cumulative failure history for all three segments combined. While the number of test failures over time appears somewhat steady after the pipeline was tested to levels of around 90% SMYS, the number of service failures over time appears to be flattening out.

The number of test failures increased with increasing test pressure levels from 69% to 80% to 90% SMYS, which was expected. The occurrences of service failures shortly after hydrostatic tests (i.e. within 3 years) in the early years are disconcerting. However, without the results of metallurgical investigations one can only speculate as to the scenario that led to the failure. Possible scenarios include (1) that the test itself caused damage to the subcritical flaw, (2) that the strength and toughness of the pipe was sufficient for the flaw to survive the test, but the flaw was so large that the remaining life was very short, (3) that an upset condition (i.e. overpressure event) occurred. One could also speculate that the service failures that occurred 6 to 13 years after a hydrostatic test could have been prevented by a timely hydrostatic test.

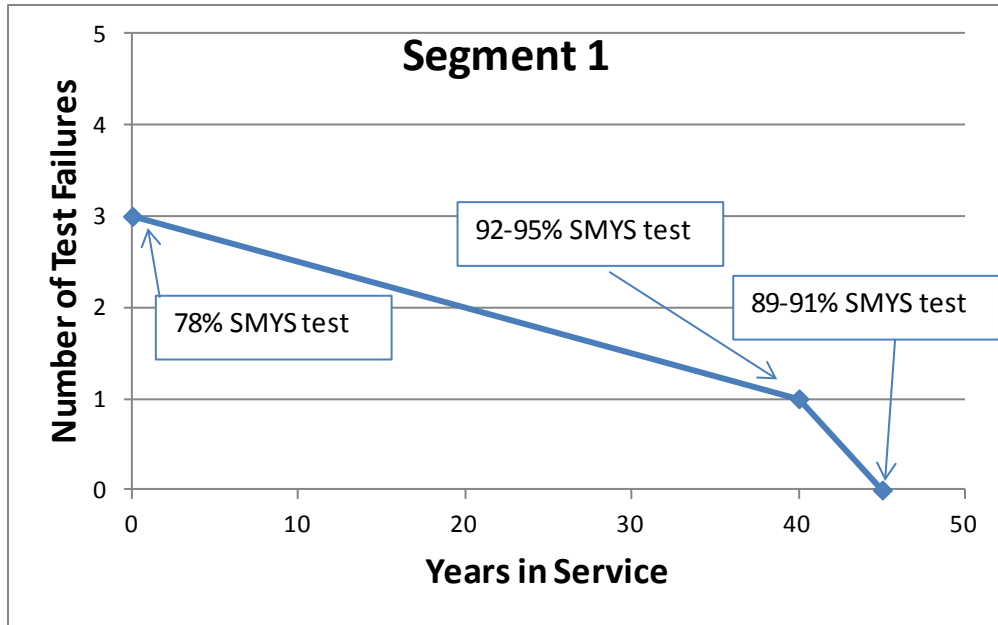
**Figure 5. Case Study 2, Segment 1 Hydrostatic Test and Service Failure Timeline**

Pipeline Segment 1 (out of 4 segments discussed) was hydrostatically tested 40 years after the commissioning test. The test pressure was 92-95% SMYS, which was higher than that of the previous tests. Only one seam failure occurred during the test. The segment was re-tested five years later (Year 45) to 88-91% SMYS and no seam failures occurred.

The number of test failures for Segments 2 and 3 has declined and the test pressure in the last two tests of those segments was similar. Segment 1 has only experienced 1 test failure since the pre-service test while in contrast Segment 4 has experienced 32 over the last three tests.

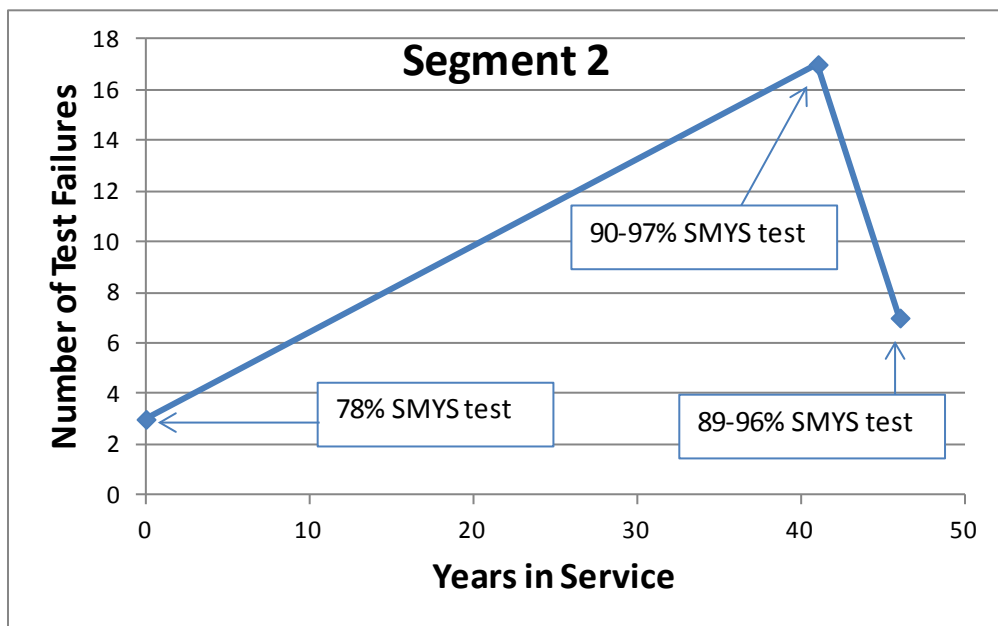
**Figure 6. Case Study 2, Segment 2 Hydrostatic Test and Service Failure Timeline**

Pipeline Segment 2 was hydrostatically tested 41 years after the commissioning test. The test pressure was 90-97% SMYS, which was higher than that of the previous tests. Seventeen seam failures occurred during the test. The segment was re-tested five years later (Year 46) to 89-93% SMYS and seven seam failures occurred.

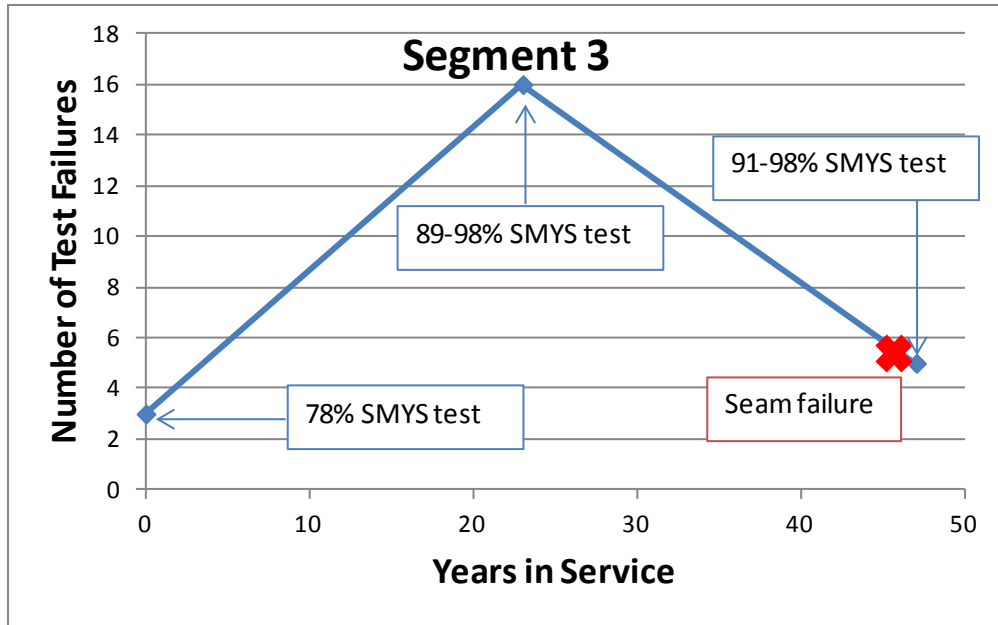
**Figure 7. Case Study 2, Segment 3 Hydrostatic Test and Service Failure Timeline**

Pipeline Segment 3 was hydrostatically tested 23 years after the commissioning test. The test pressure was 86-98% SMYS, which was higher than that of the previous tests. Sixteen seam failures occurred during the test. Twenty-three years after the test (Year 46), an in-service seam failure occurred. The segment was re-tested the year after the service failure (Year 47) to 91-98% SMYS, resulting in five seam failures.

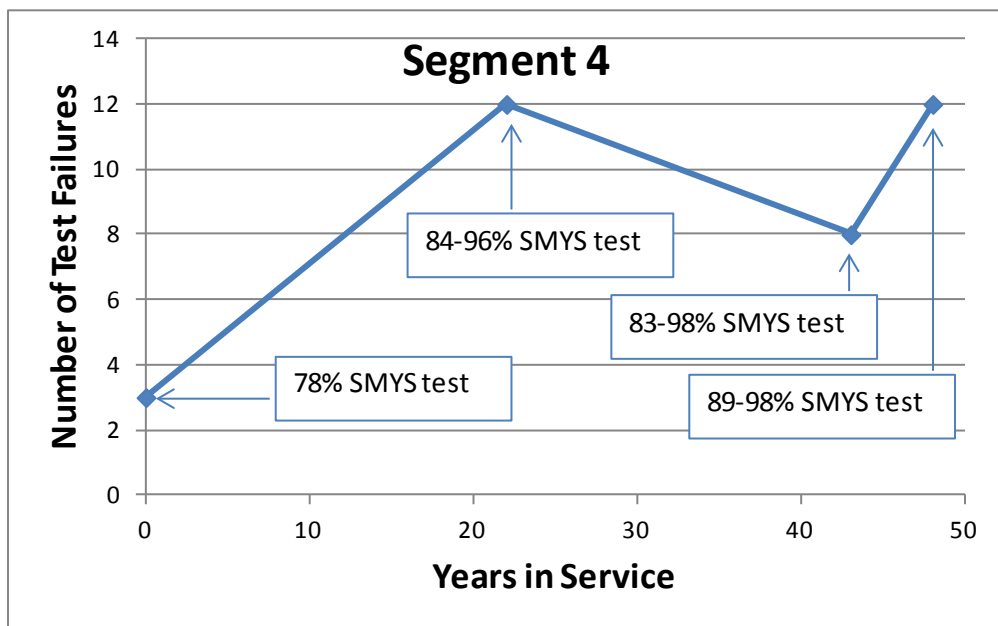
**Figure 8. Case Study 2, Segment 4 Hydrostatic Test and Service Failure Timeline**

Pipeline Segment 4 was hydrostatically tested 22 years after the commissioning test. The test pressure was 84-96% SMYS, which was higher than that of the previous tests. Twelve seam failures occurred during the test. The segment was re-tested 21 years later (Year 43) to 83-98% SMYS and eight seam failures occurred. The segment was tested again five years later (Year 48) to 89-98% SMYS and twelve seam failures occurred.

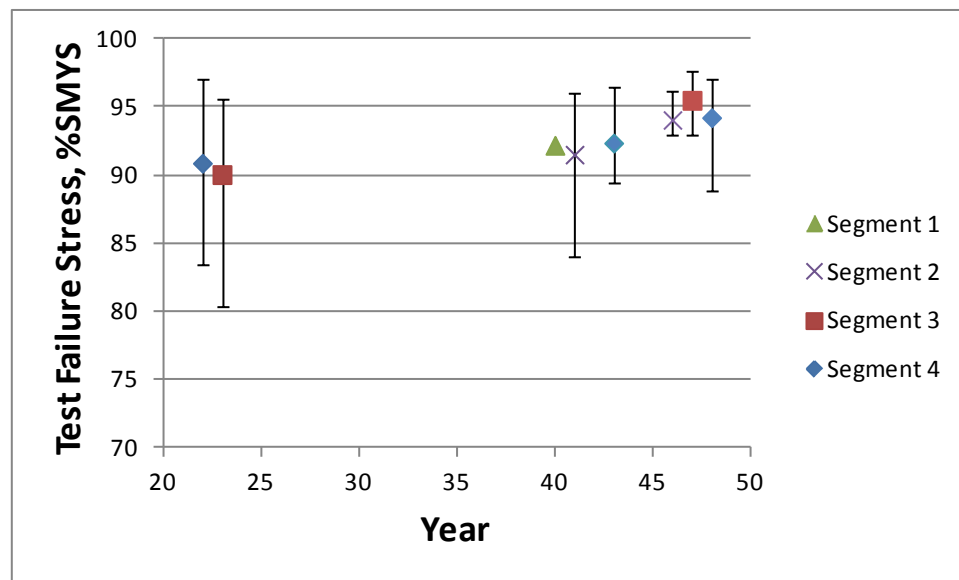
**Figure 9. Case Study 2 Hydrostatic Test Failure Stress Levels**

The failure pressures at the site of each test failure are known for this pipeline. Figure 9 shows the average, minimum, and maximum failure stress level as a percentage of SMYS for each test.

The average is denoted by the symbol, and the extremes are indicated by the error bars. Except for Segment 1 which had only one test failure, the first hydrostatic test to pressures higher than commissioning test or mill test produced a wider range of failure stress levels than subsequent tests, and the first test also resulted in a test failure slightly below the mill test pressure level (85% SMYS). The average failure stress level increased with each test and the range of failure pressures generally decreased.

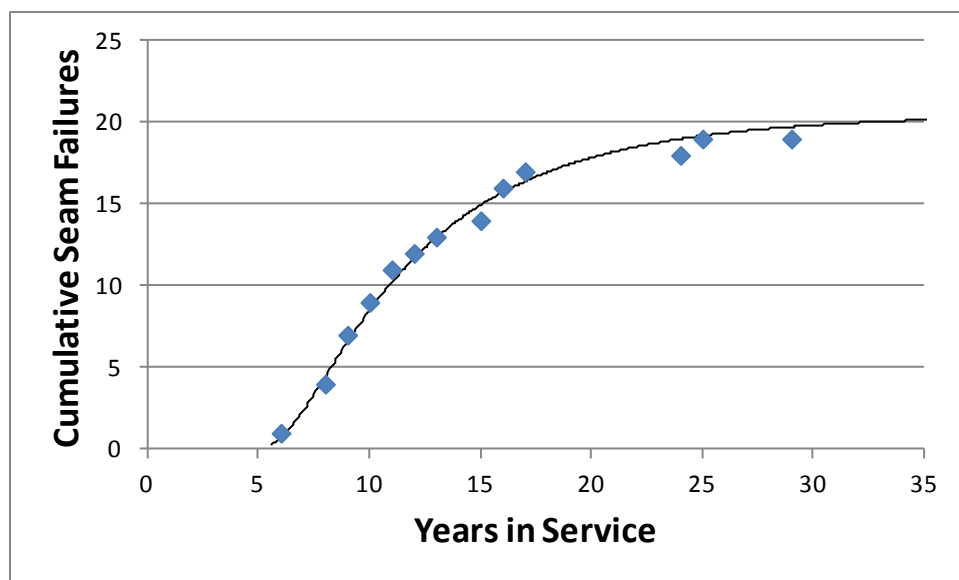
**Figure 10. Case Study 3 Cumulative In-Service and Test Seam Failures Involving Flash-Weld Defects**

This pipeline experienced fourteen in-service seam-weld leaks within the first 30 years of operation. Two in-service seam-weld ruptures occurred as a result of overpressure events. Three seam-weld leaks occurred as a result of hydrostatic re-tests. All 19 of these seam-weld failures were attributed to fatigue, although it is noted that not all were subject to metallurgical examination. The trend of service leaks over time (Figure 10) showed fewer and fewer failures with increasing time intervals between them, suggesting that the population of fatigue-sensitive seam defects is on the decline.

The pipeline was hydrostatically tested as it was constructed to pressure levels corresponding to 85-95% SMYS. Seam leaks began to occur 6 to 11 years after the pre-service tests. The entire pipeline was then retested to about 85% SMYS, producing three seam leaks which were attributed to fatigue. A year after this test a seam leak occurred, followed by another in the following year.
