Direct Assessment Activities by GTI

- > DOT R&D Forum
Houston, TX March 2005

Daniel Ersoy
Gas Technology Institute
daniel.ersoy@gastechnology.org
847.768.0663

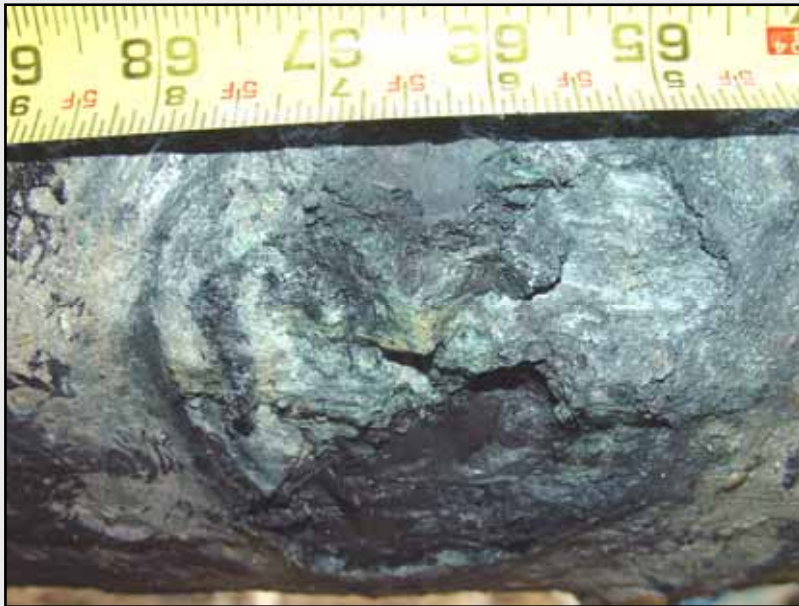
Salt deposit and coating defect

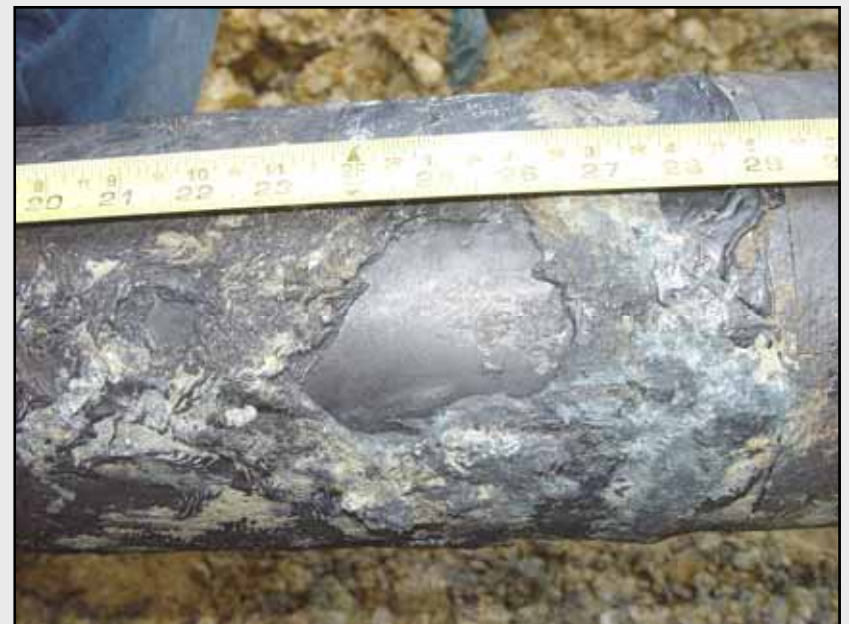
Large coating defect

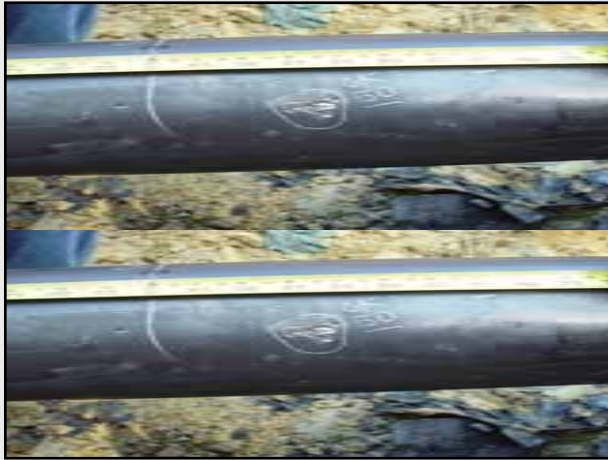
Corrosion defect 50 mils deep.
Potential MIC.

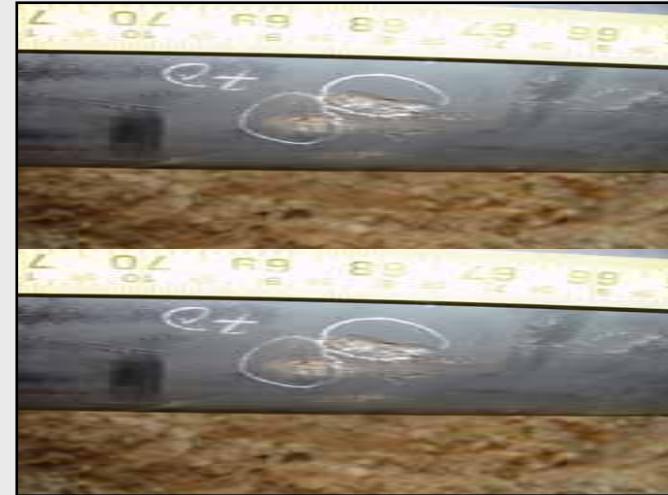
Corrosion defect on bottom
portion of pipe

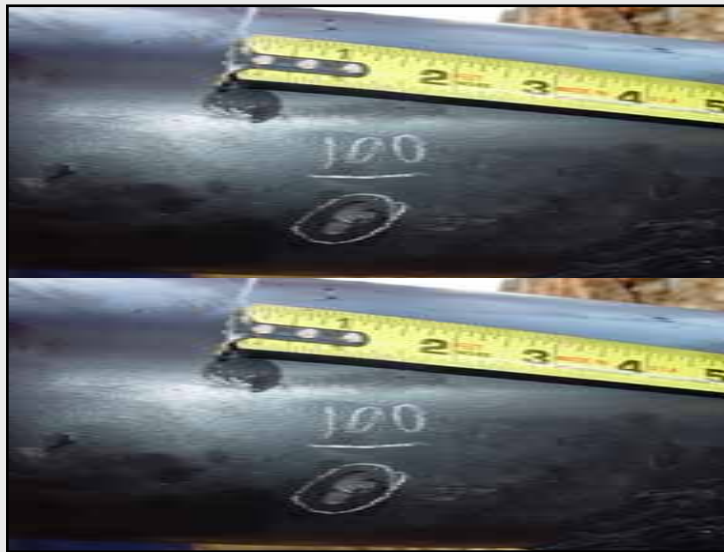
Deepest pit. There was a
smell of sulfur when
corrosion was removed
which is a good indication
of MIC.

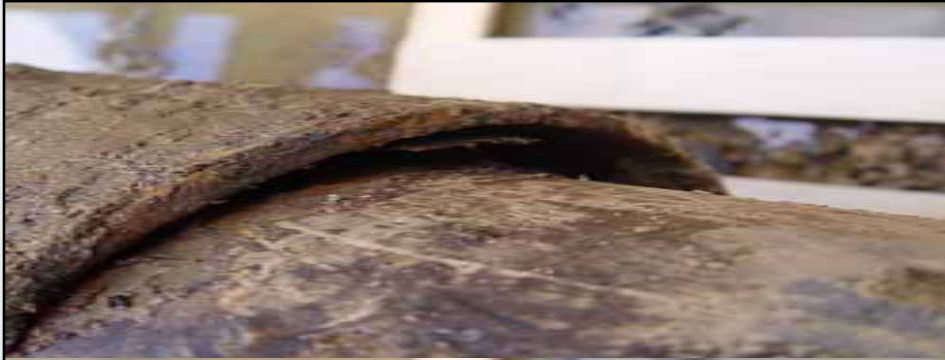
**Bottom of casing, no seal.
Casing filled with water and mud.**

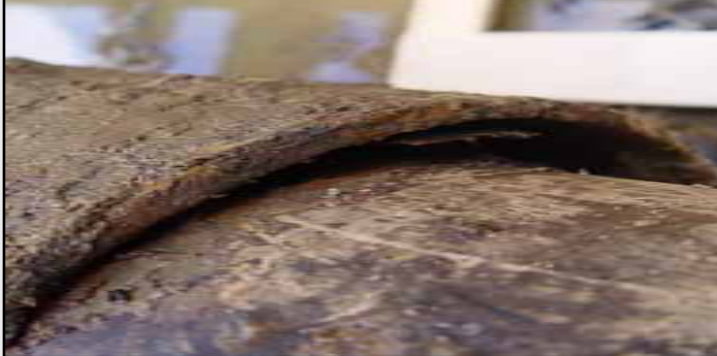
Top of casing, no seal

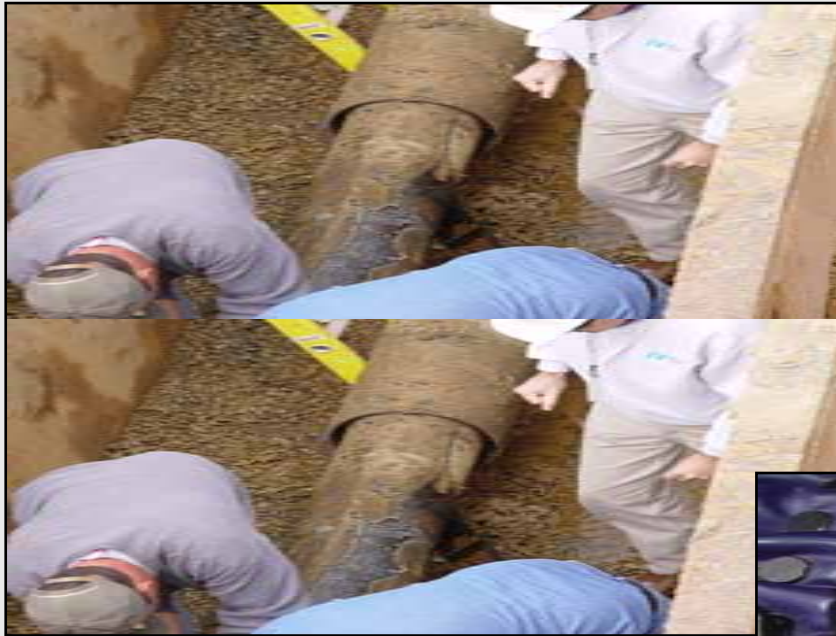
The condition of the exposed pipe (outside of the casing) was very good to excellent. Any areas of corrosion had a depth not measurable or less than 10 mils deep

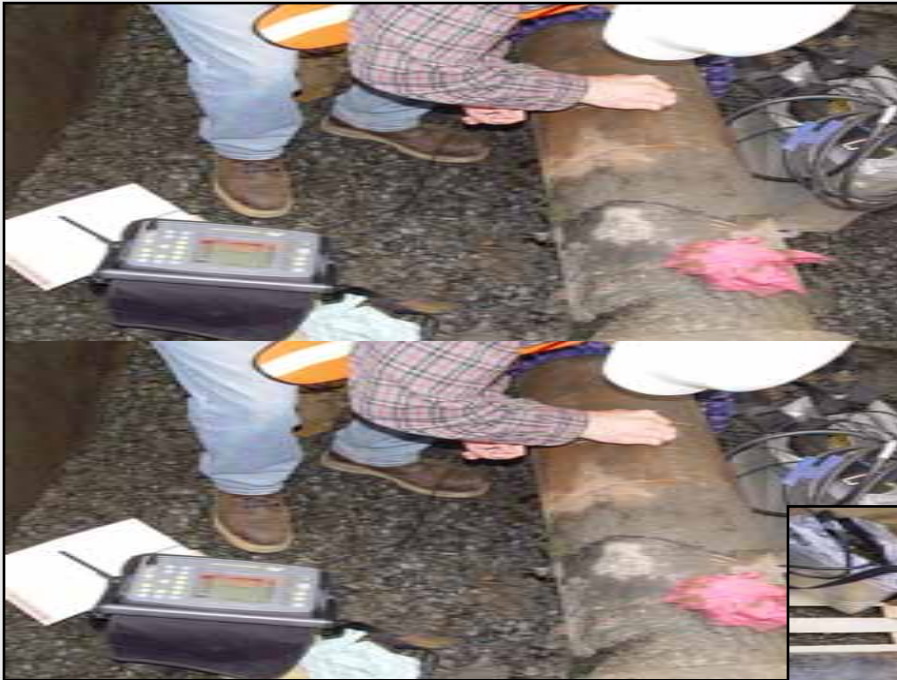
The pipe wall thickness was measured at all clock positions along the exposed length. It varied from 0.270" to 0.300" in the radial direction but was consistent in the axial direction (artifact of forming).

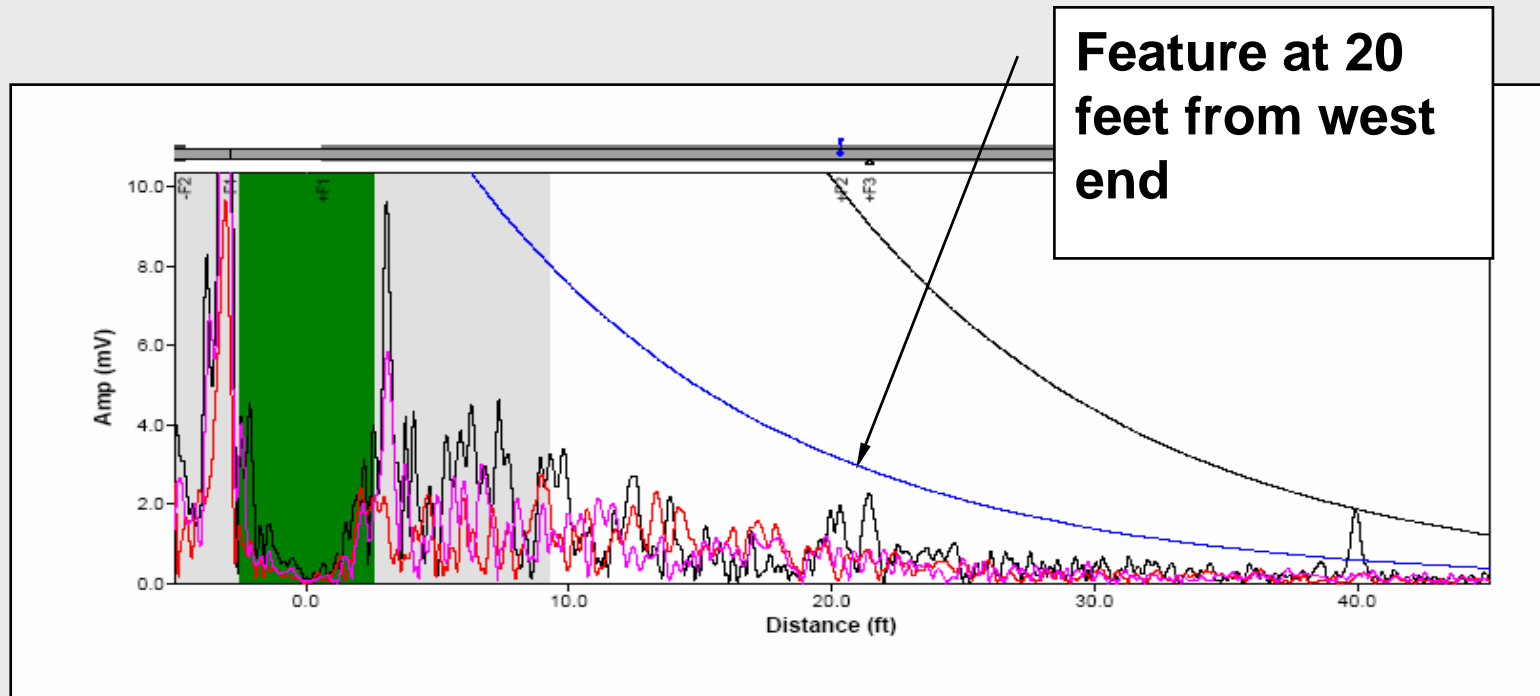
The wax wrap on the pipe attenuated the propagation of the guided waves as they traveled down the pipe axially in both directions. The attenuation rate was about -2.0 dB/meter. To obtain full coverage, the cased pipe was inspected from both ends of the casing. The two welds contained within the casing were easily identified and located. One area of suspect corrosion/wall loss was identified. A single scan is shown above. This scan shows a feature located 20 feet from the west end of the casing

- > This was the only indication/feature along the casing that had a significant signal strength (approaching 10% area cross section change).
- > Based on the collection of scans it was predicted that the wall loss would cover about $\frac{1}{4}$ of the pipe circumference and be between 20-40% of wall loss.
- > The scans also indicated that the feature would be more *top/bottom* located versus on the sides.

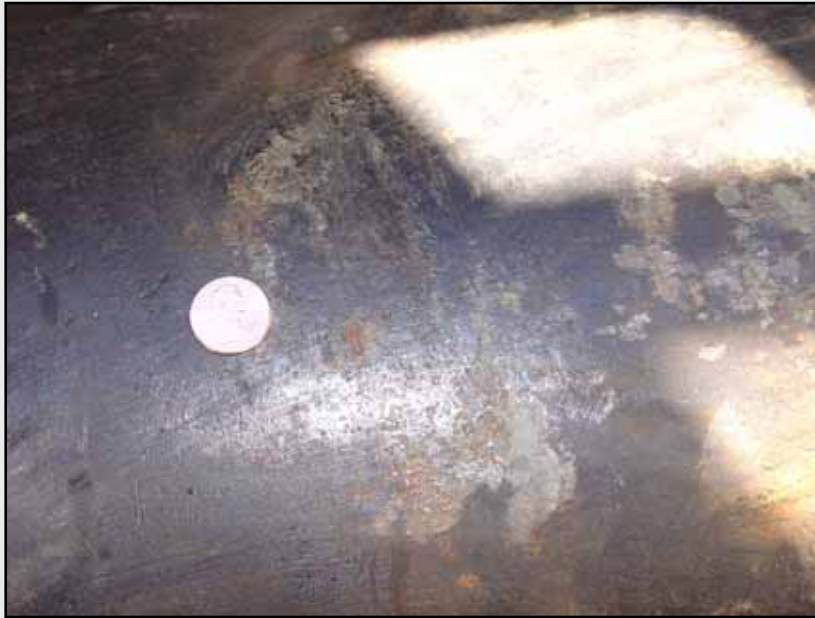
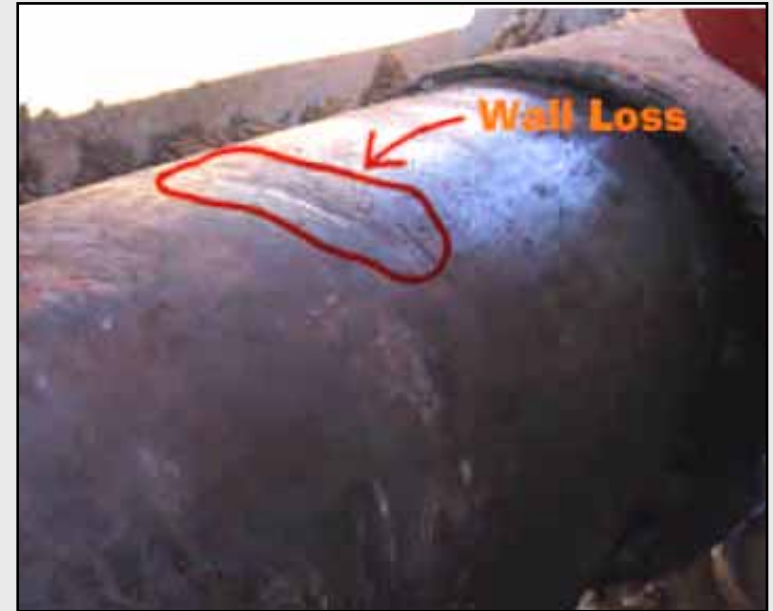
After removal of the casing, a wear patch was discovered centered at the predicted location.

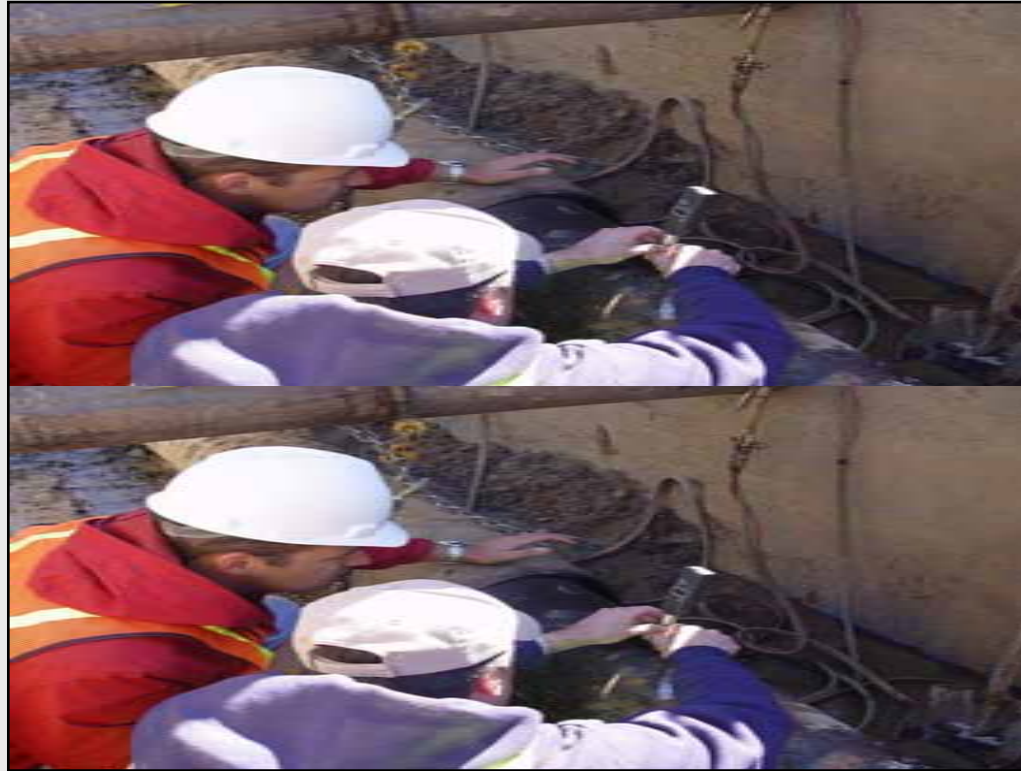
It extended about 2 inches circumferentially and 0.250 inches axially. The maximum depth was 0.043 inches (43 mils) or about 16% of wall thickness.

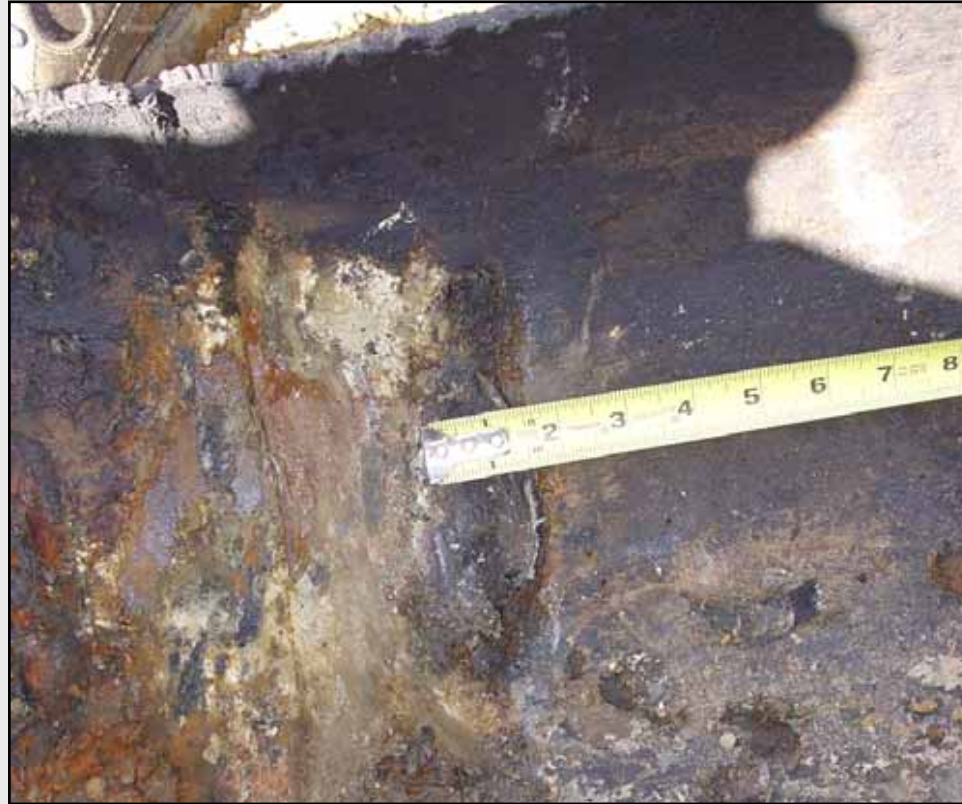
The casing opposite of the defect showed signs of corrosion and wear. There was a girth weld on the casing at this location and it was misaligned, producing an offset ridge that appeared to be resting on the carrier pipe (point of wear contact).

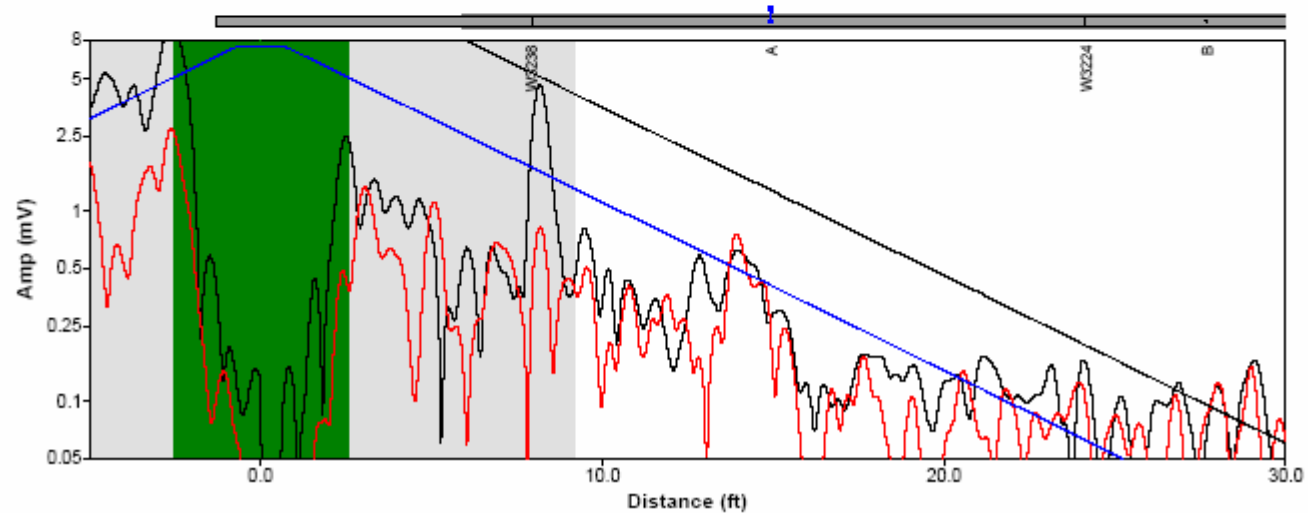
- > About 25' of pipe could be tested from a single location in both directions.
- > Two welds were clearly seen in the diagnostic length of the test and their position has been confirmed with the Pig results.
- > An area indicated as **A** was identified as a possible area of concern. The length of pipe between W3238 and W3224 (including area **A**) was identified as Class 1 by the Pig. Class 1 is assigned by the MFL pig to areas where there could be a defect in the range of 0-25% of wall loss.

Feature	Location	Class	Notes
W3238	8'0"	Weld	Weld between new FBE pipe and original section
A	15'0"	Medium	Suspected 10 percent cross sectional loss at the 6 o'clock position (MFL shows a bit of an increase in losses (from 10%wall to 25%wall))
W3224	24'2"	Weld	Where weld should be based on MFL data
B	27'8"	Minor	Center of an area of concern. However, the confidence is low because the amplitude of the reflections is very small. MFL scan shows about a 20 percent wall loss distributed wall loss
