DNV RESEARCH AND INNOVATION

METHOD FOR QUALIFICATION OF COMPOSITE REPAIRS
FOR PIPELINES: PATCH REPAIRS AND CONSIDERATIONS
FOR CATHODIC PROTECTION

REPORT No 2009-9332

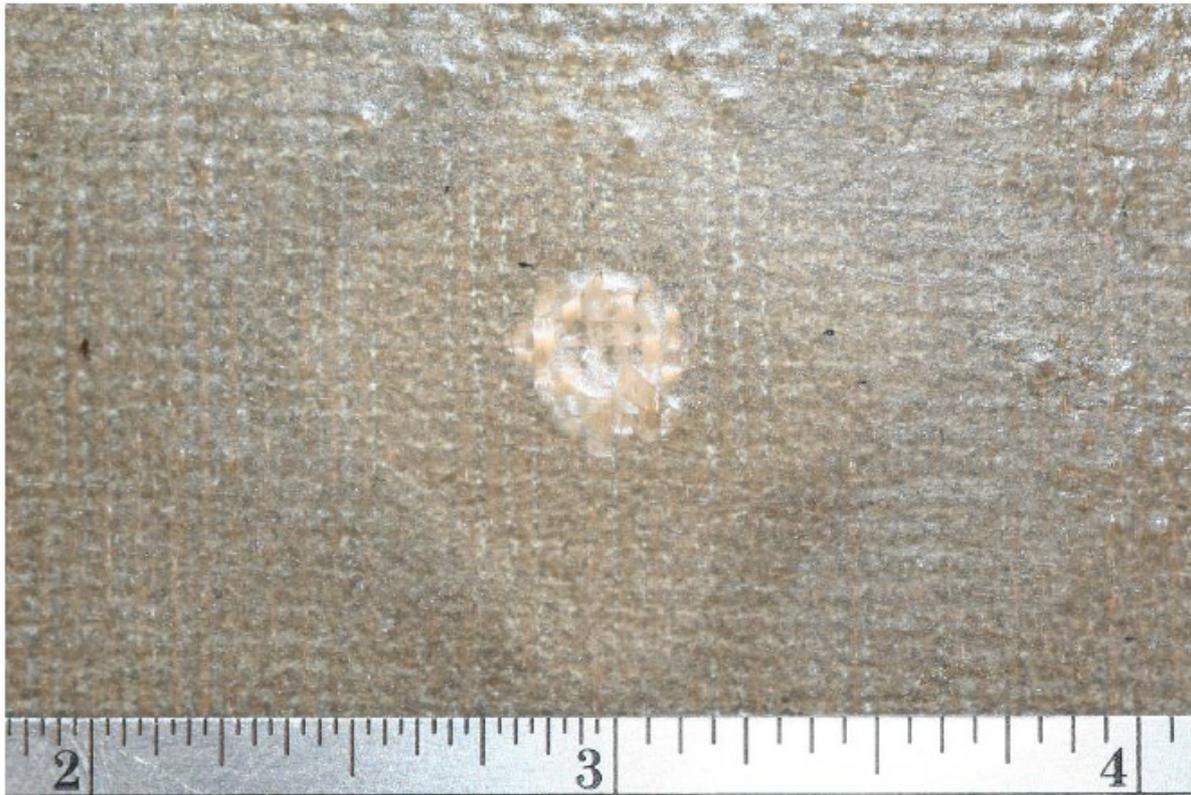
Figure 7 The impact with the glass fiber reinforced polyester caused noticeable deformation around the impact site, as shown in this photograph. Scale is in inches.

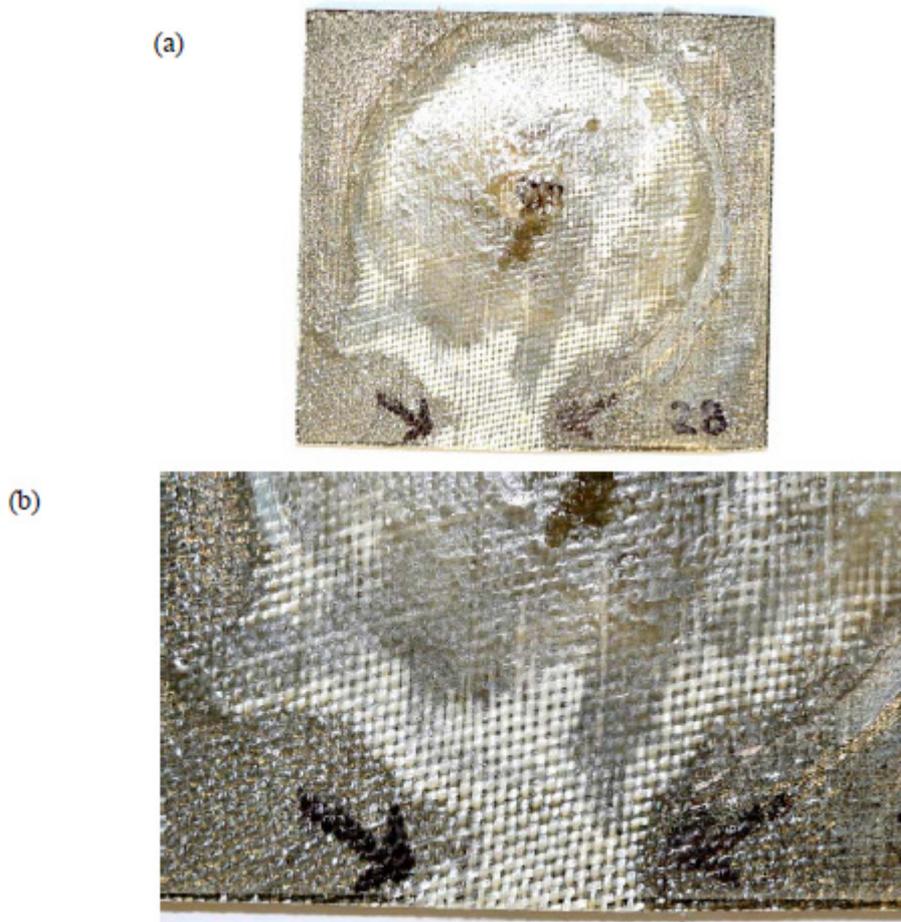
Specimens with one layer of fiberglass began to fail after 30 days of cathodic disbondment testing. Other specimens failed within the testing period with a maximum time of 90 days. If the specimen passed the ASTM G62 holiday detection test, in most cases it would eventually develop full penetration at the impact site. When failures were observed, the failure was first characterized by leaking of the test solution at the composite-steel interface at the edge of the plate. Subsequent evaluation revealed the dissolution of the polyester matrix in the majority of the exposed area and sometimes beyond, as shown in Figure 9. In most cases, total disbondment was achieved with these generic products. These results are not necessarily representative of all commercial products.

Figure 9 Photographic views of generic glass fiber reinforced polyester composites exposed to a cathodic disbondment cell show (a) the entire test area illustrating evidence of dissolution of the polyester matrix with the presence of localized dry fiber areas, and (b) a close-up of the polyester matrix dissolved beyond the cathodic cell.

As shown in the figure, the disbondment process led to adhesion loss at both the steel substrate and between layers. This kind of behaviour was evident for all materials that failed

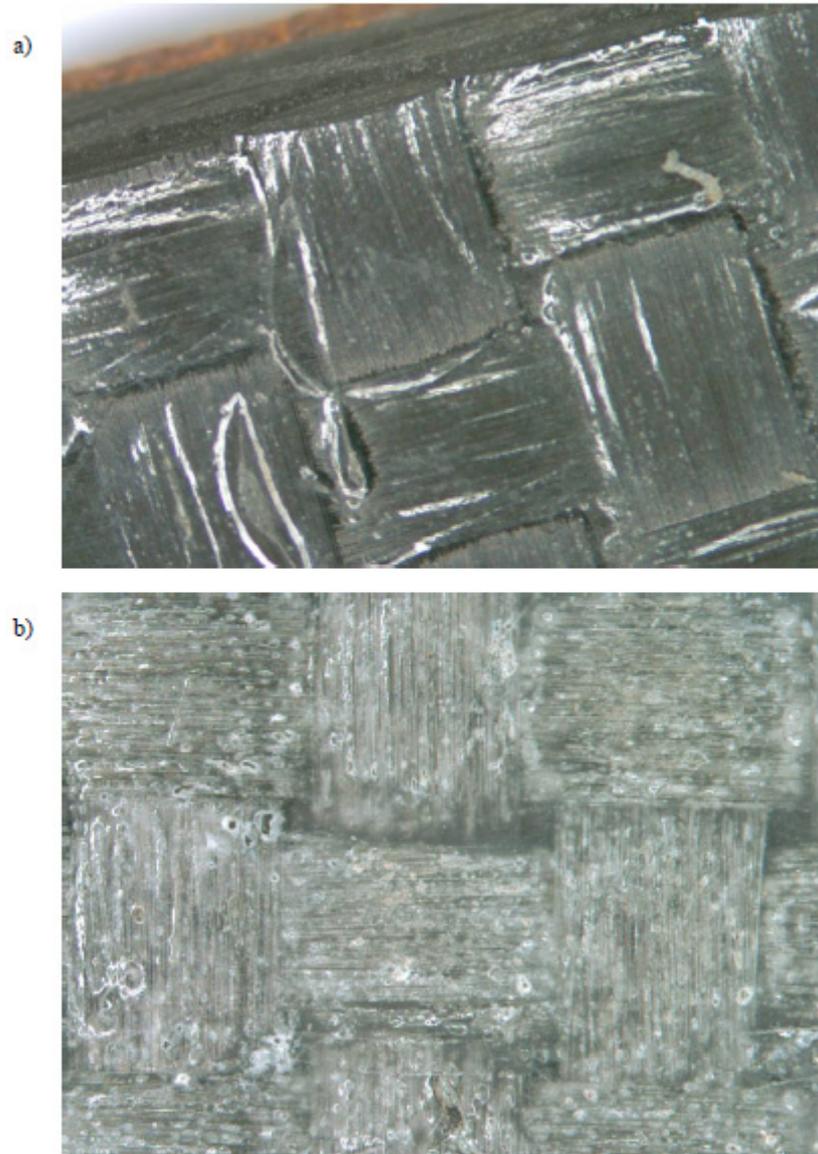
In Figure 11, the degradation of the carbon fiber with product B is shown. The unexposed area (a) exhibits uniform dispersion of the resin matrix and low roughness (as indicated by the high reflectivity of the surface). The exposed area exhibited signs of degradation similar to pitting (b). The surface roughness and opacity increased as time progressed.

Figure 11 Carbon fiber with product B after nearly 30 days of cathodic disbondment shows a) no defects before, and b) pitting after.

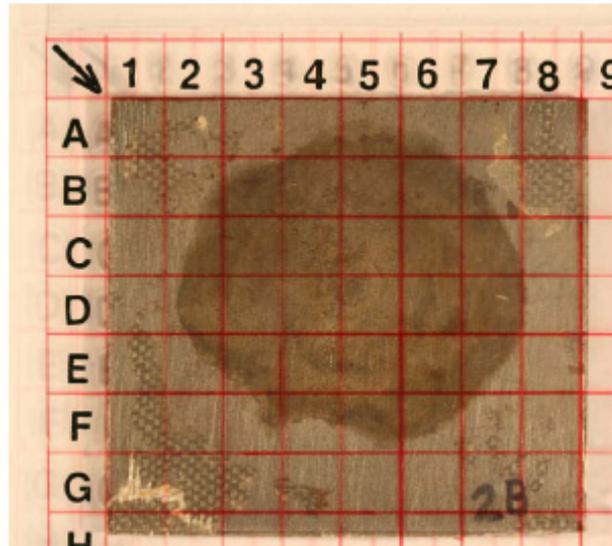
Figure 12 Total disbonded area for 2 layers of fiberglass with polyester matrix.

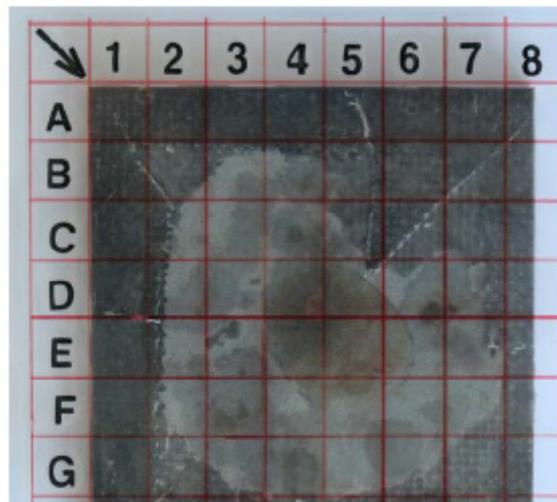
Carbon fiber specimens showed disbondment behavior similar to the polyester/E-glass specimens. The degree of disbondment ranged from partial to total. Typically the disbonded area was lowest for specimens with more than one layer, and greatest for specimens with only a single layer. An inspection of the disbonded area for carbon fiber with product B is shown in Figure 13.

Figure 13 A single layer of carbon fiber in an acrylic matrix after an impact showed near total disbondment.

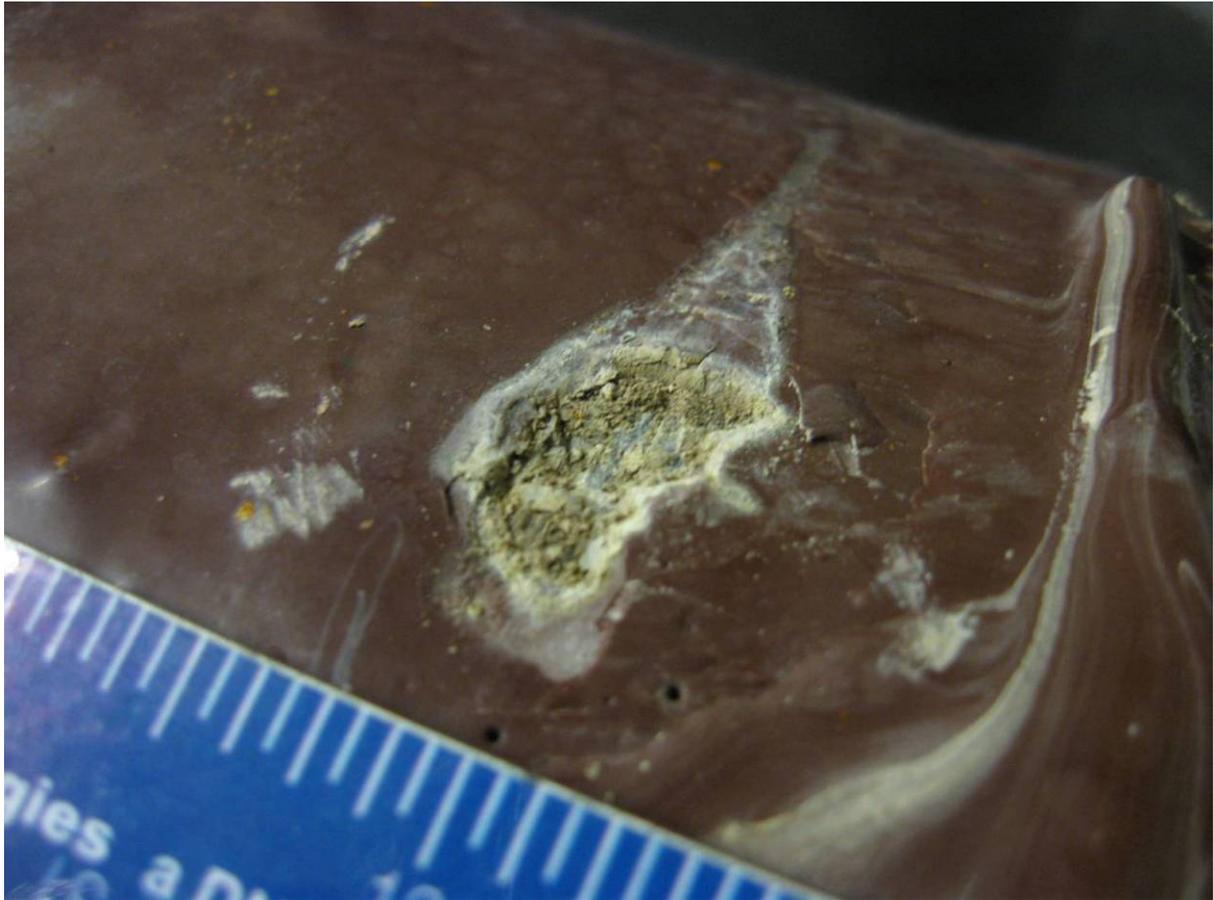
After testing, the specimens were inspected for disbondment. The results were consistent with the benchtop ASTM G95 tests. Product B, which had performed reasonably well with ASTM G95, performed reasonably well during the ASTM G8 + cyclic loading test. The impact area after testing but before inspection is shown in Figure 27. After inspection and removal of coating and composite around the impact area, little disbondment was observed (see Figure 28). Note that Product B is carbon fiber and was not insulated from the pipe steel. The coating appeared to be intact but with minor disbondment from the composite around the impact area.

Figure 27 After testing, the impact area of Product B showed some bare steel, precipitation of NaCl due to drying of the test solution, and minor orange discoloration (scale in 1/16" increments).

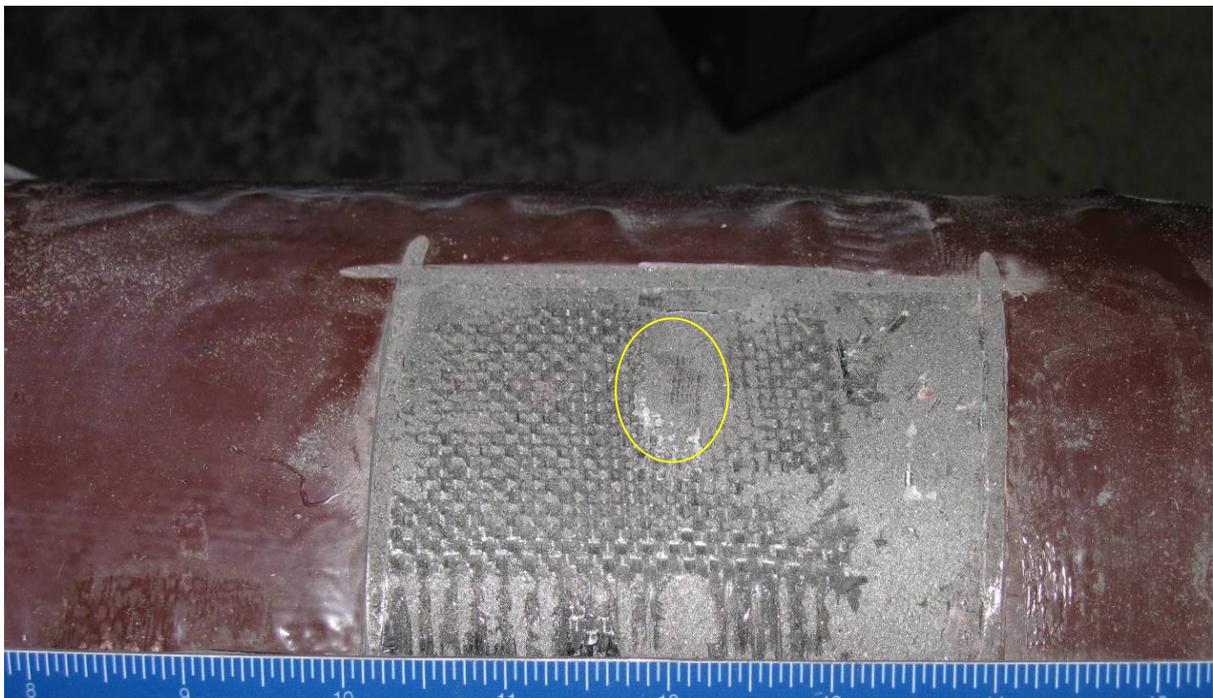
Figure 28 Product B showed minor disbondment after testing (scale is in inches with 1/16" hash marks).

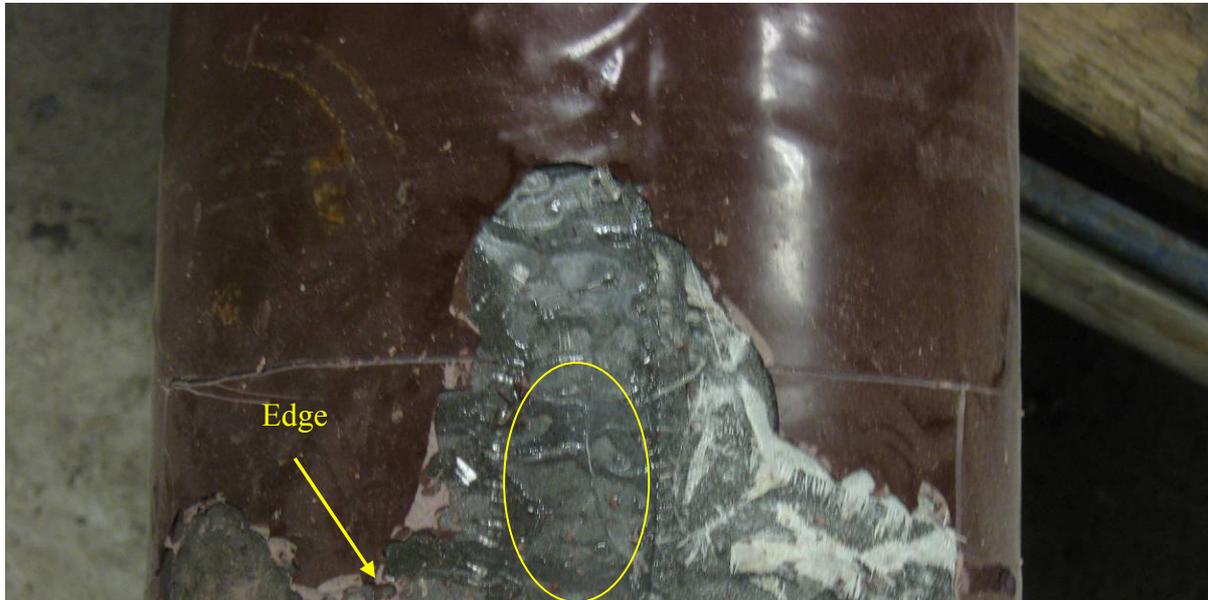
There was interest in detecting disbondment, if any, near the edge of the composite repair. In only one instance was there an indication that this may occur in Product A. One should recall that Product A has exhibited poor adhesion elsewhere in this testing program and is not necessarily a fair representation of all composite repair products. However, it can be noted that the free edge of the composite product is a potential surface for water infiltration. The disbonded region is shown in Figure 29.

Figure 29 Product A showed minor disbondment near the edge of the composite repair after inspection.

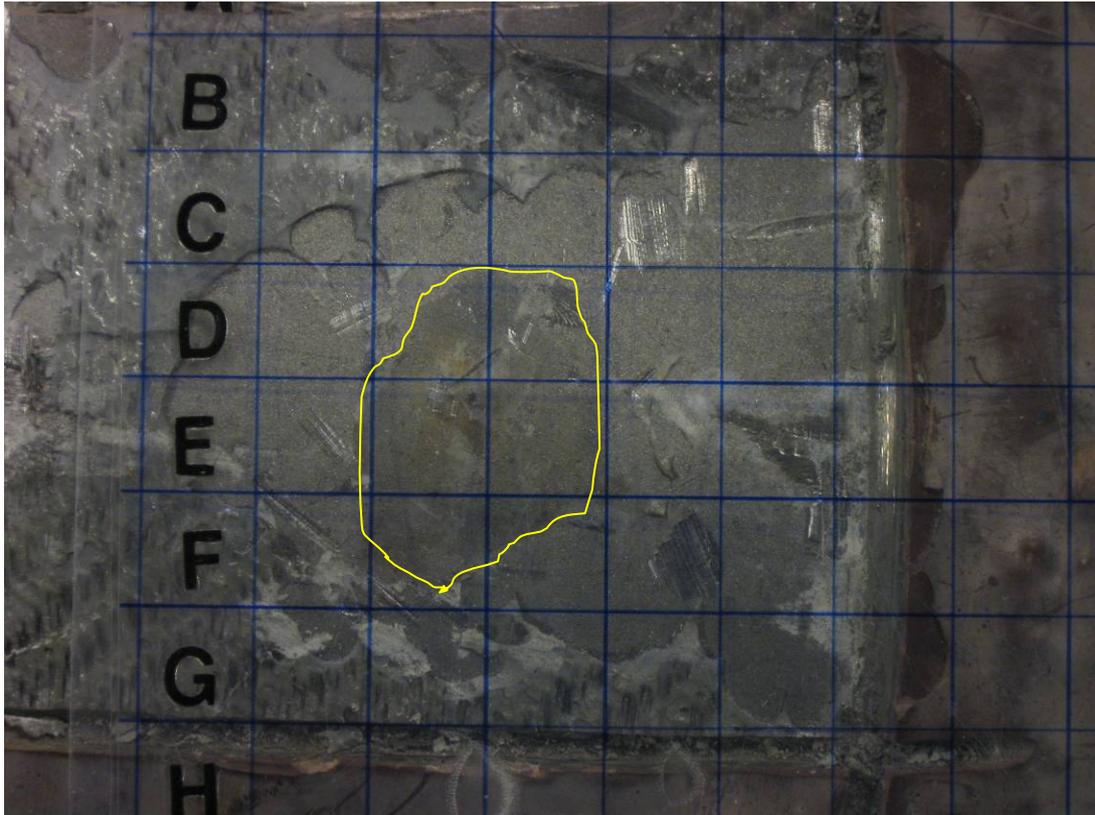
Figure 30 Disbonded area around impact site after cyclic loading test, Product C (grid scale is 1/2").

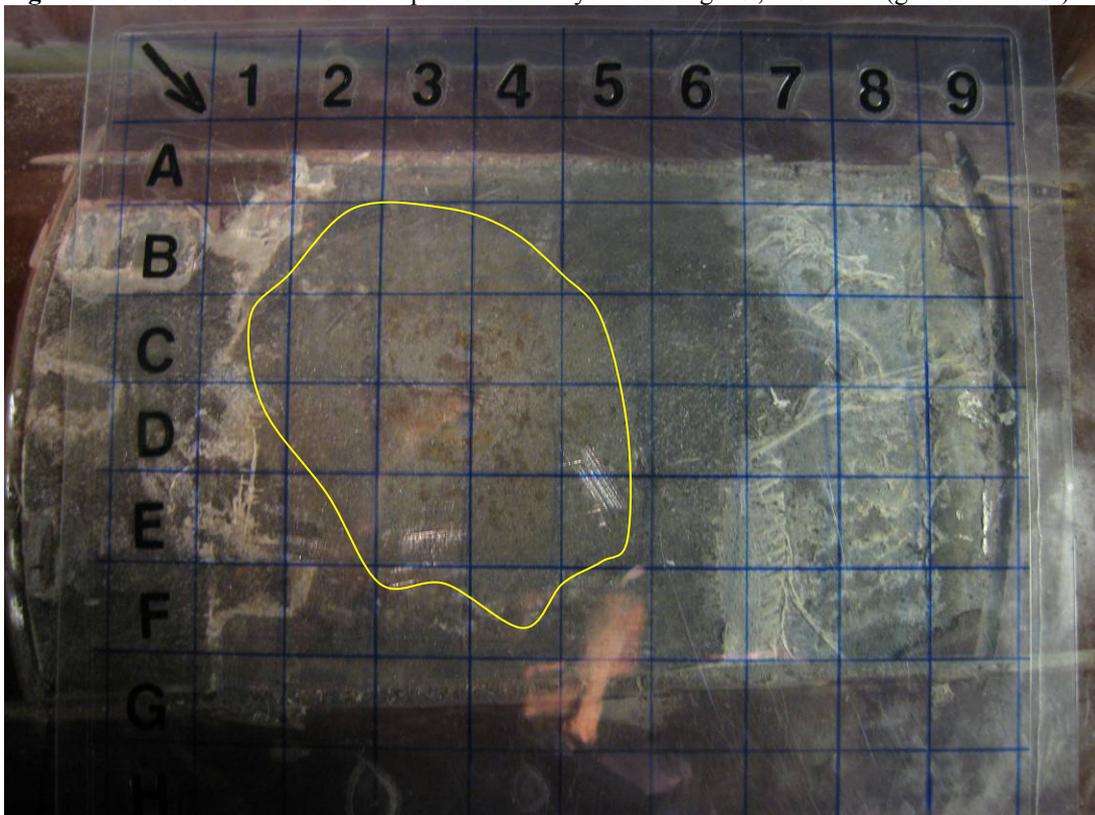
Figure 31 Approximate disbonded area under impact for Product A after cyclic loading (grid scale is 1/2").

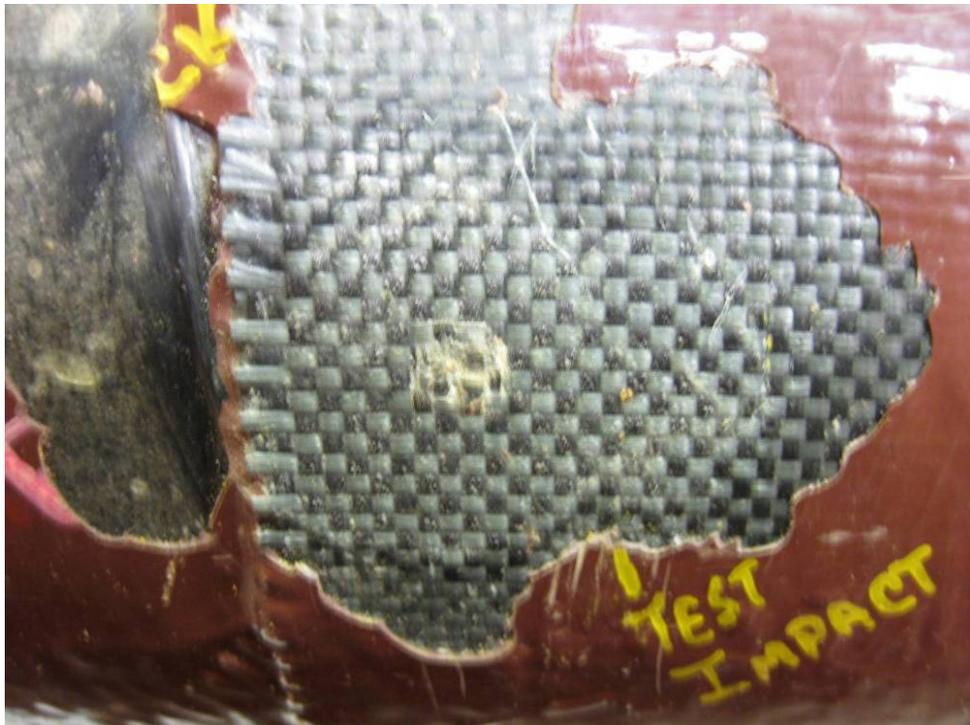
The carbon fiber specimen (product B) is shown after 1 year of exposure in the field environment in Figure 36. In some cases the coating disbonded slightly from the composite repair surface. In general, the soil environment was not aggressive enough to incur any significant disbondment on the coating or composite.

Figure 36 After testing, specimens were inspected for disbondment at the impact site as well as in areas far from the impact site. Product B is shown here.

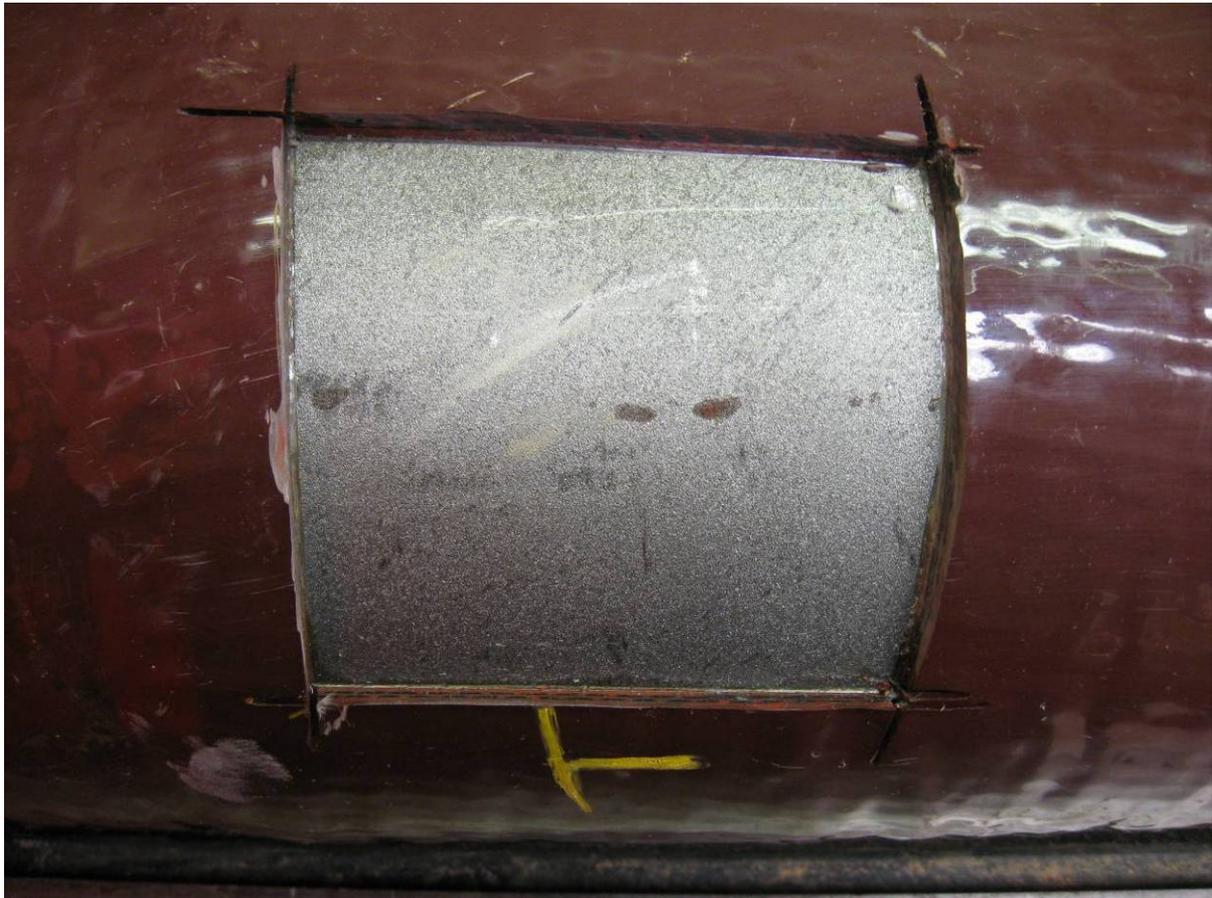
Specimens from the field were inspected as other specimens have been inspected. As shown in Figure 37, there is not a significantly visible disbondment zone. Indications of adhesion were consistent with specimens tested in the lab. The relatively mild environment of the soil and the short exposure time (1 year) appear to have had little effect on most of the specimens. Though the area in which the pipes were buried is fairly wet, the depth of the burial and the slope on which the pipes were buried may have contributed to good water flow away from the burial site. By maintaining a relatively dry area, the environment did not appear particularly corrosive.

Figure 37 Specimens from the field study showed very little evidence of disbondment near the impact area.
