## Challenges with Field Girth Welding

#### Kenneth Y. Lee

Engineering & Research Division Office of Pipeline Safety

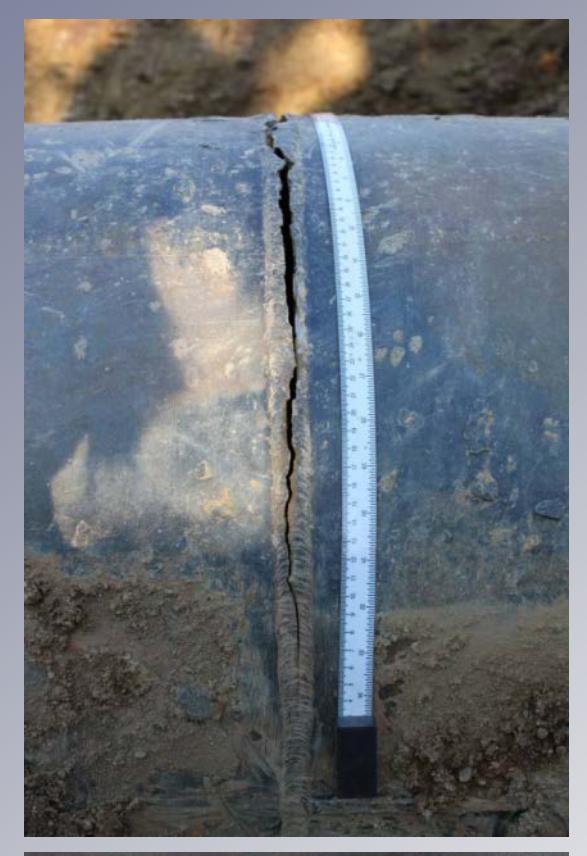
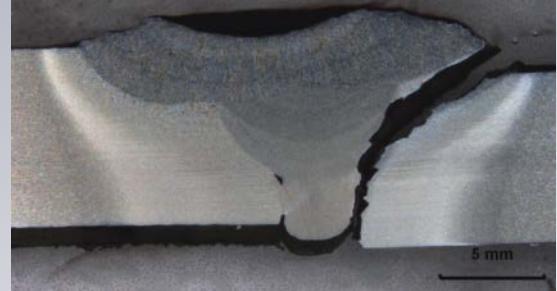
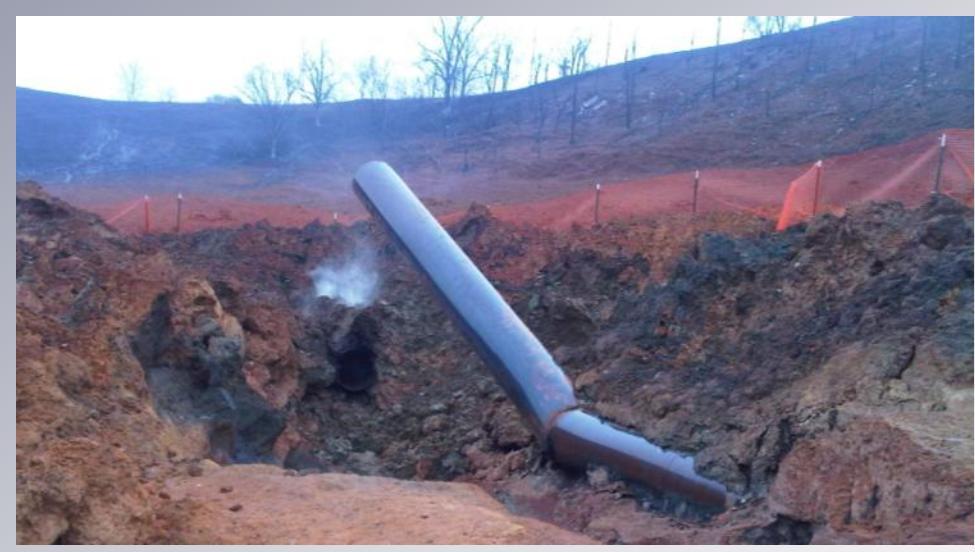
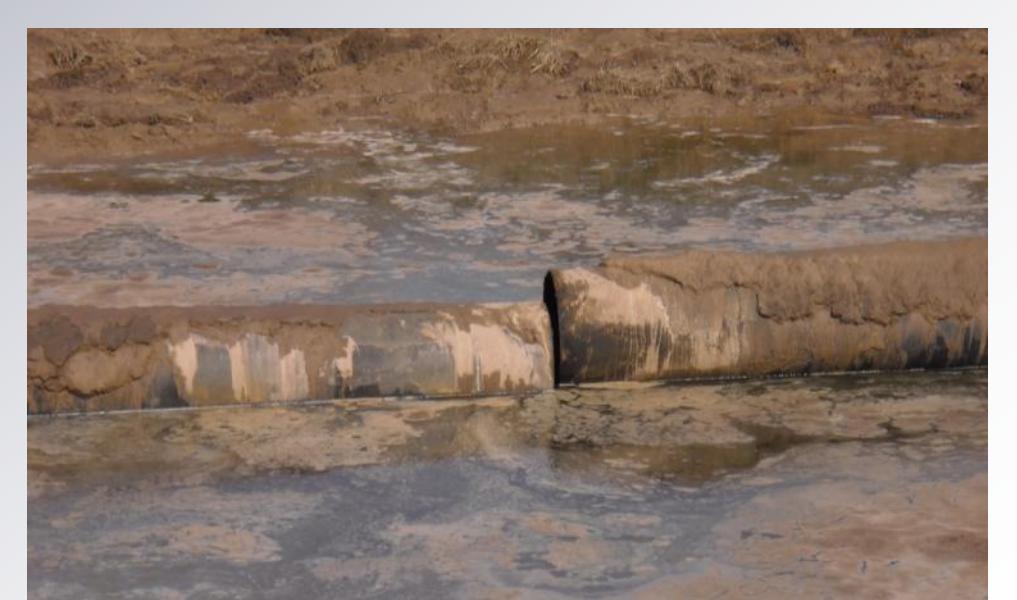
#### **Recent Girth Weld Incidents**

- Recent incidents:
  - High weld misalignment
  - Poor weld quality
  - Pre-existing hydrogen-assisted WM/HAZ cracks
  - Evidence of little or no plastic deformation
- Codes have no requirement for girth weld tensile strain capacity

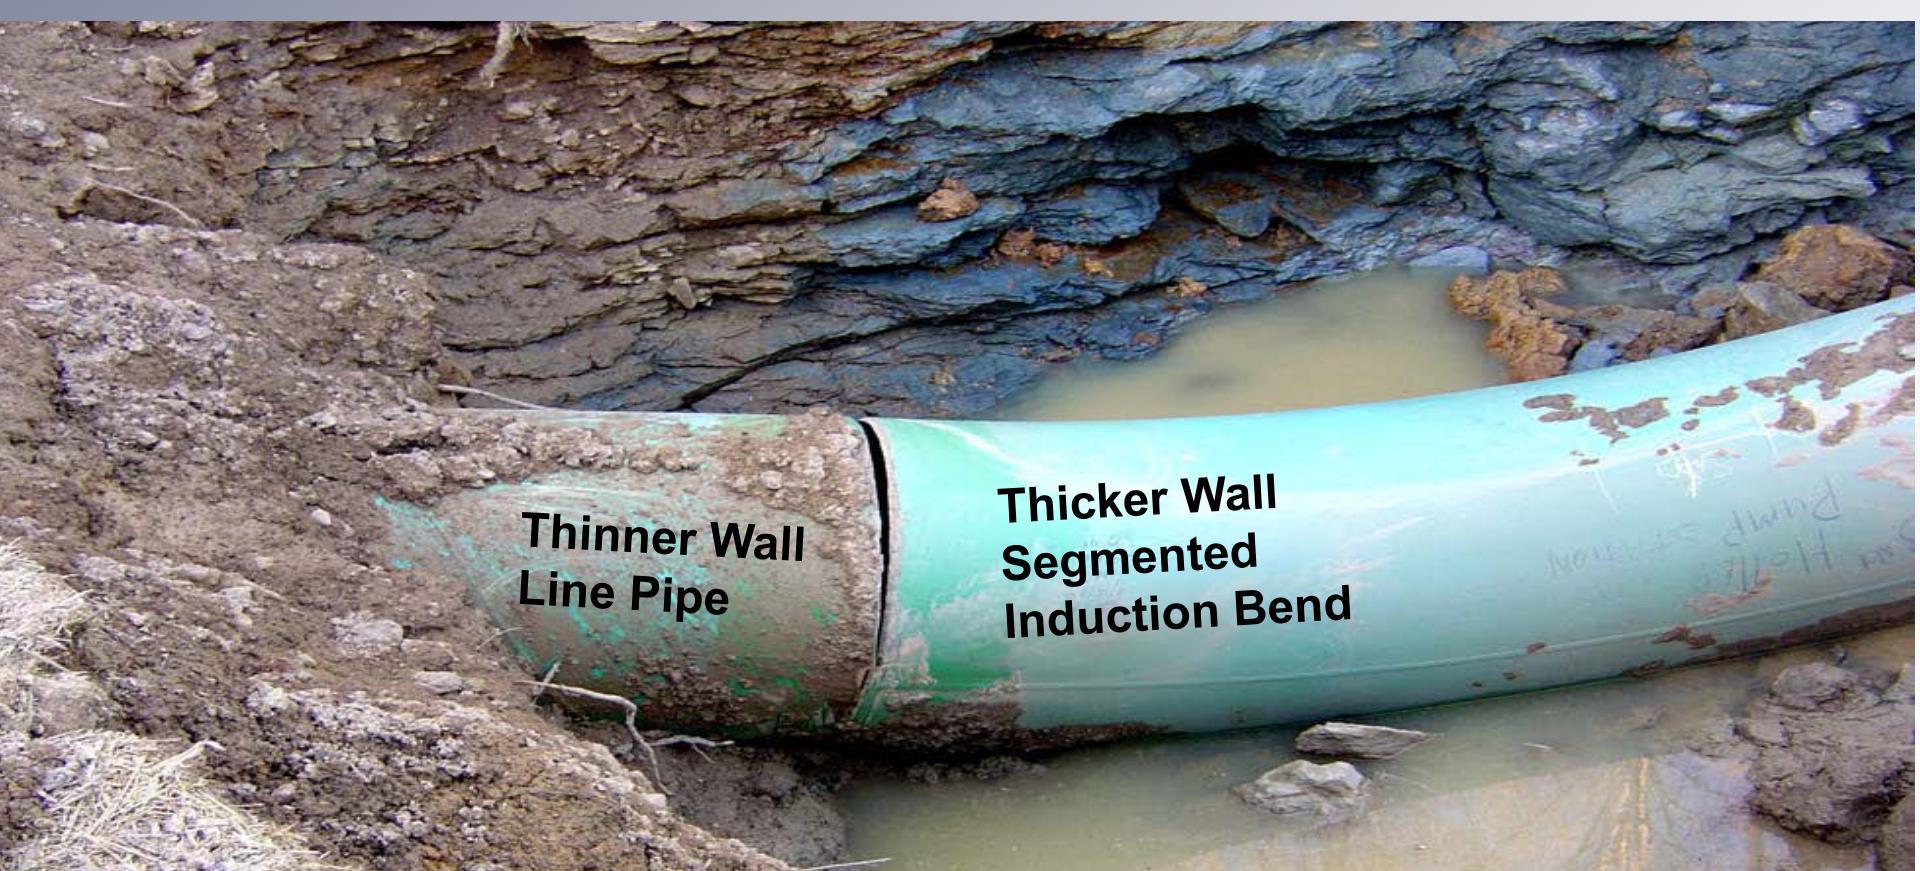
#### **In-service Failure**

• Below in-service failure of 42" X70 gas transmission pipeline at 1200 psi (65% SMYS)
