Date of Report: <November 15, 2015>

Project Title: <Composite Self-Sensing Thermal Sprayed Coatings for Pipeline Corrosion Prevention and Mitigation>

Prepared by: <North Dakota State University>

(b) Draft Final Report

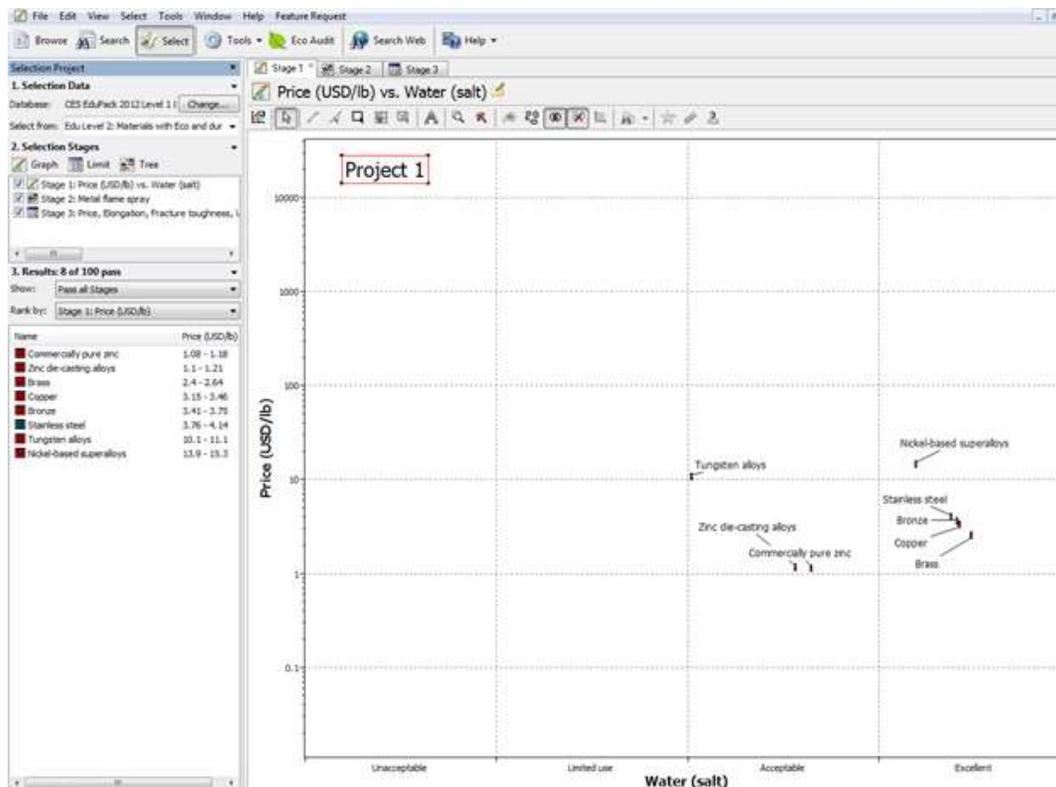
Figure 1 A screen shot from CES program as used for materials selection.

To systemically select the materials for pipeline corrosion mitigation using thermal spraying coating technique, CES software had been used in this study. CES is a commercially available software which is widely used by material scientists for accurate material selection. The material selection using CES has been performed based on some fundamental criteria including: material durability at fresh water, alkali and acidic soil, material processability (ability to be thermal sprayed), cost, flammability, and mechanical properties such as fracture toughness.

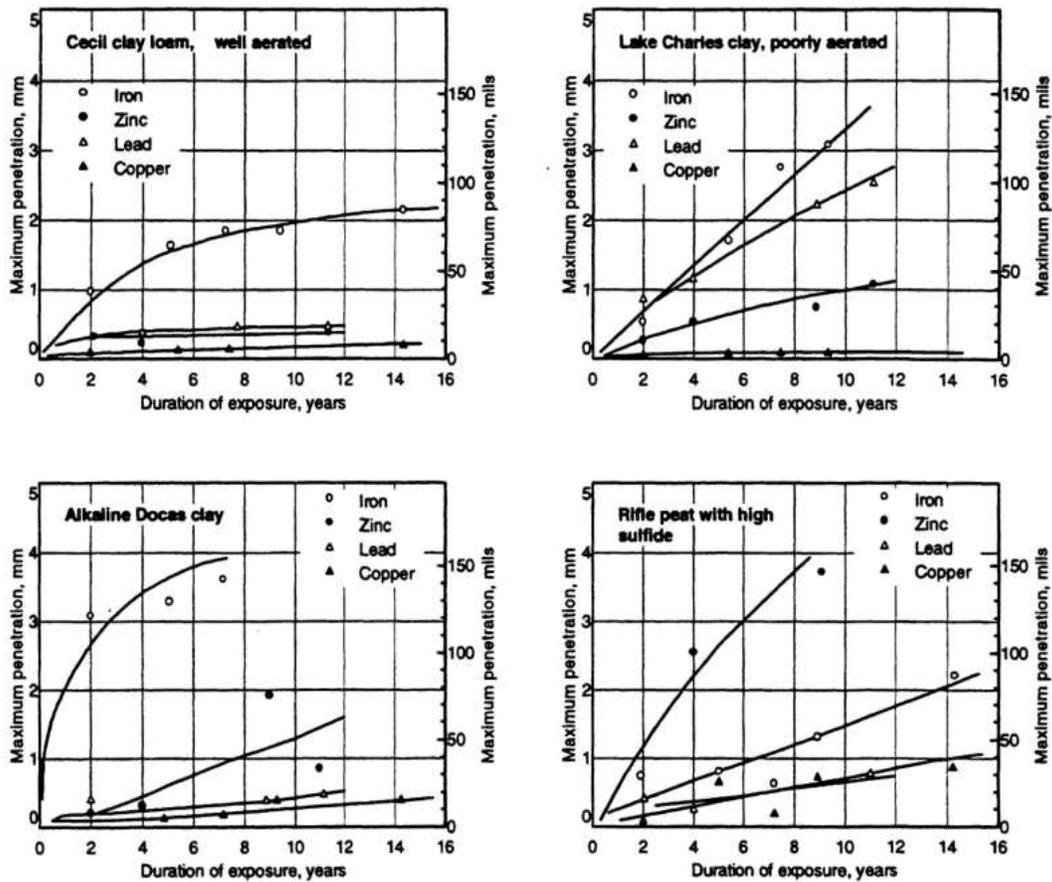
Figure 2 Corrosion of copper, iron, lead, and zinc in four different soils³⁶.

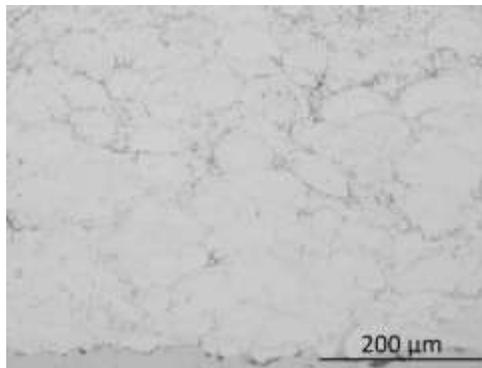
Figure 3 shows the microstructure of copper coating deposited using HVOF technique. The lamellae type structure is visible and coating is uniform. The coating thickness was approximately 800 μ m. Image analysis showed existence of only 3% porosity within the microstructure, indicating a dense coating. Thus, the effect of the porous structure to its mechanical property may be negligible for thermally sprayed Cu coating, which needs further approval. In addition, a good cohesion between copper splats was indicated from the microstructure.

Figure 3 Optical micrograph of copper coating deposited using HVOF technique.

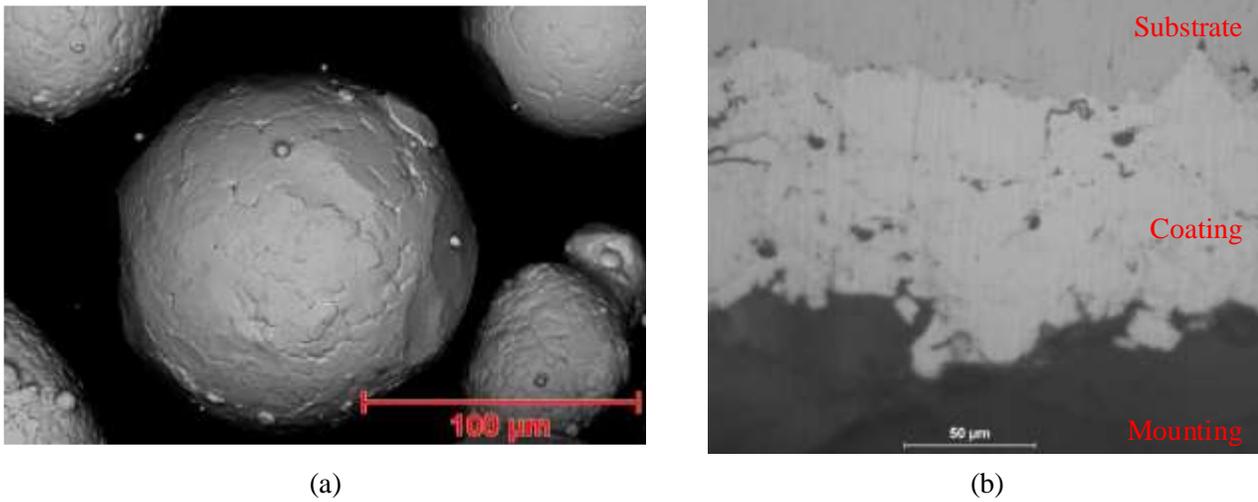
Figure 4(a) shows the SEM image of the Cu-Al Bronze powder (Diamalloy™ 1004) used for thermal spraying. The Diamalloy™ 1004 powder is golden-colored, and fabricated by gas atomization technique in inert gas environment. Table 2 shows the chemical composition of this powder presented by the manufacturer (Oerlikon Metco). Aluminum is considered as major alloying element along with other alloying elements such as iron for this type of bronze alloy.

Figure 4 (a) SEM image from Diamalloy™ 1004, and (b) Optical micrograph of HVOF deposited Cu-Al-Bronze coating.

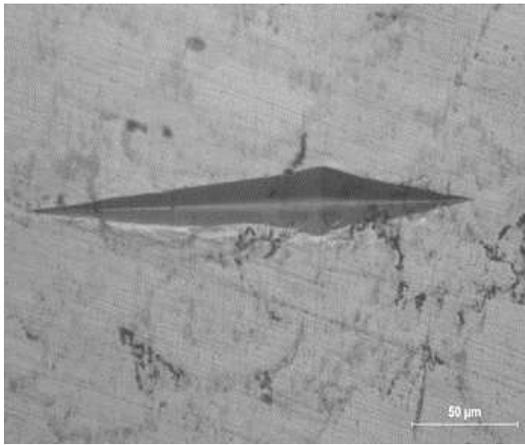
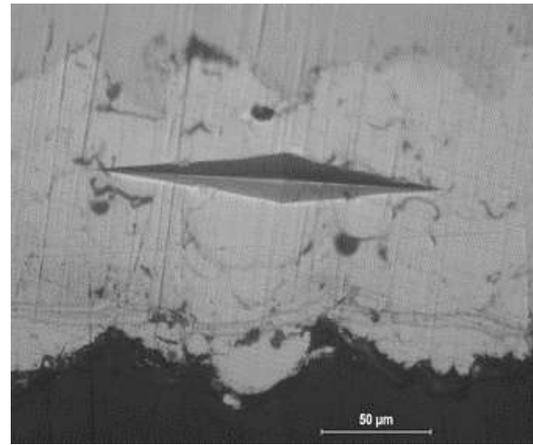
For thermally sprayed Cu coating, hardness tests were performed based on ASTM E2109-01. Figure 5(a) shows the indentation of the Cu coating. The average hardness of the Cu coating is 96.5 HK ($\approx 83\text{Hv}$). For the thermally sprayed Cu-Al Bronze coating, hardness tests were carried out on the coatings cross section based on ASTM E384 -11. Figure 5(b) illustrates the Knoop indentation on Cu-Al Bronze coating. The average hardness of the Cu-Al Bronze coating was estimated near 139.4HK ($\approx 125\text{Hv}$) from 10 hardness measurement which was higher than the Cu coating. Thus, no reduction of mechanical property was identified for the Cu and Cu-Al Bronze coatings.

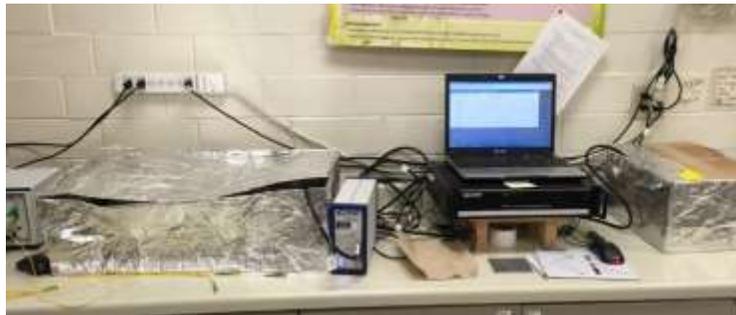
Figure 6 Equipment Set-up for Electrochemical Accelerated Corrosion Test.

After testing the microstructure and hardness of the HVOF deposited coatings of Cu and Cu-Al Bronze, the corrosion resistance of the two different coatings and the bare steel (low carbon steel) were studied and compared. The corrosion performances were tested through accelerated corrosion test using electrochemical method, specifically, the Potentiodynamic Polarization Technique. The accelerated corrosion tests were performed by placing the coated and uncoated steel samples in 3.5% NaCl solutions. A Gamry Reference 600 Potentiostat-Galvanostat-ZRA instrument as shown in Figure 6 had been used to analyze the corrosion performance. Figure 7 shows the corrosion current measured for all the three different materials.

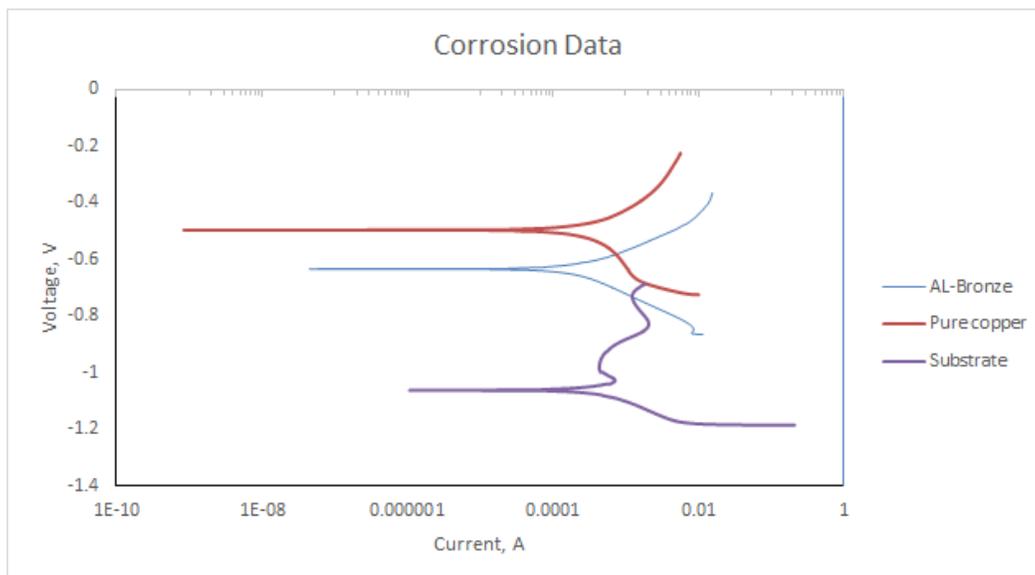
Figure 7 Measured corrosion current for both coated and uncoated samples.

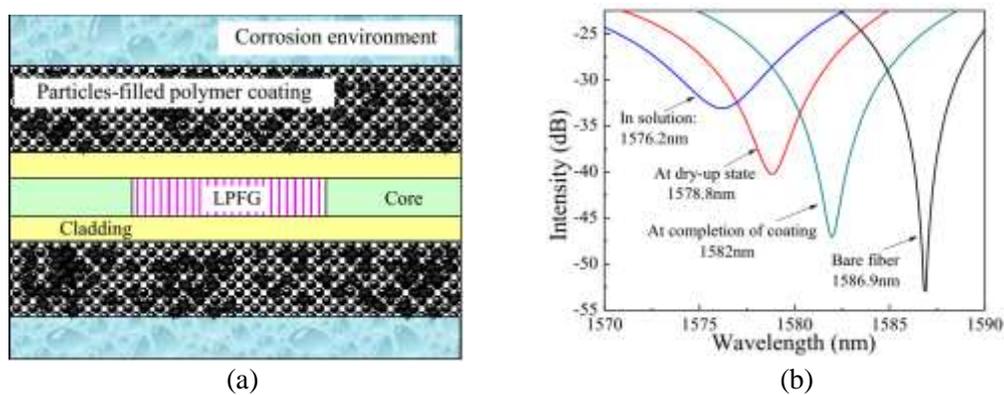
The LPFG based corrosion sensor shown in Figure 8(a) operates by monitoring the corrosion induced optical property change of the coated iron-particle thin film. The effective refractive index of the fiber cladding and the thickness of the coated thin film change when the coated iron particles are corroded. As a result, the resonant wavelength of the LPFG changes correspondingly. Therefore, monitoring of the change in the resonant wavelength of the LPFG sensor provides key information about the mass loss and the material property change of the iron particles over time in a corrosive environment. Figure 8(b) shows the LPFG spectrum changes during its entire fabrication process⁴⁶.

Figure 8 (a) Illustrative structure of an LPFG sensor coated with nano iron particles and (b) LPFG spectrum change during the coating process⁴¹.

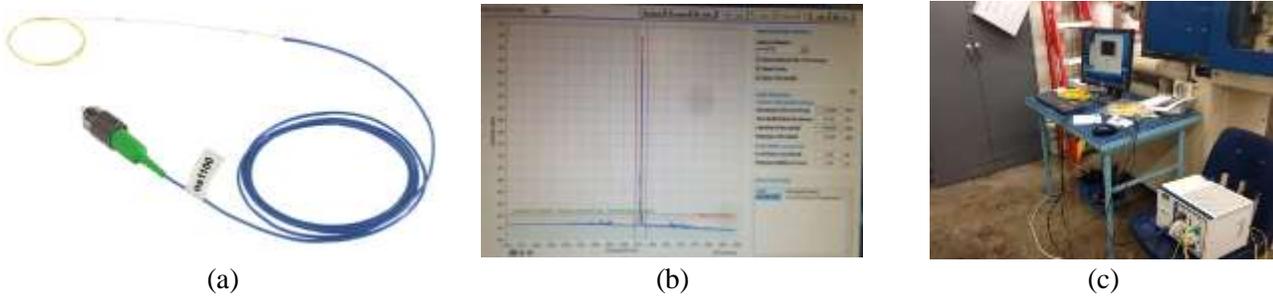
Figure 9 (a) Typical FBG (Os1100), (b) reflected spectrum, and (c) sensing system setup in Lab.

Fiber Bragg grating (FBG) sensors were selected to be embedded inside the coating due to their unique advantages of non-sensitivity to surrounding chemical environments, compactness, immunity to EMI and moisture, capability of quasi-distributed sensing, and long life cycle, *etc.* Figure 9(a) shows the typical bare FBG sensor (Os1100 from Micro Optics, Inc.), Figure 9(b) shows the reflected light spectrum of a FBG sensor, and Figure 9(c) shows the sensing system setup in Lab for experiments. The NI PXIe-4844 Optical Sensor Interrogator was used in this research for FBG data acquisition. Before embedding the fiber optic sensors inside the coating through the thermal spraying coating process, sensor calibration tests were performed before embedment including strain and temperature calibrations.

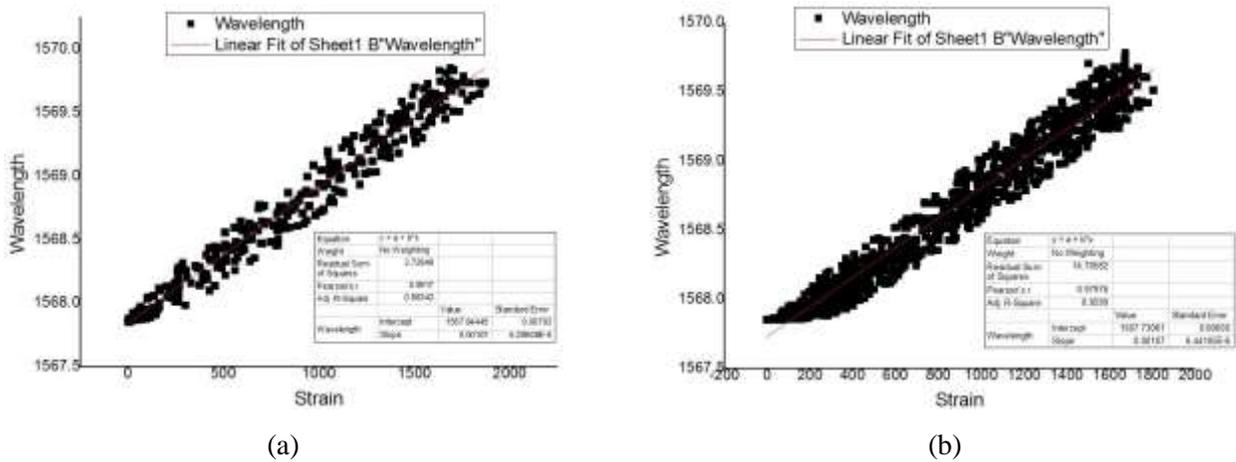
Figure 10 Results from strain calibration test (a) test #1 and (b) test #2.

The FBG sensors (both strain and temperature sensors) used in this project were purchased from Micro Optics, Inc. Sensor calibrations for strain (Os1100) and temperature (Os4200) have been performed in Lab. Figure 10 and Figure 11 show the strain and temperature calibration of the fiber optic sensor, respectively. As shown in Figure 10 for s repeated strain sensing of two times, the FBG strain sensor has a strain sensitivity of $1.07\text{pm}/\mu\epsilon$. Figure 11 shows that the temperature sensitivity is around $9.5\text{pm}/^\circ\text{C}$ in room temperature. Due to the large temperature sensitivity, a temperature sensor is needed on the side of the strain sensor to compensate the temperature effects.

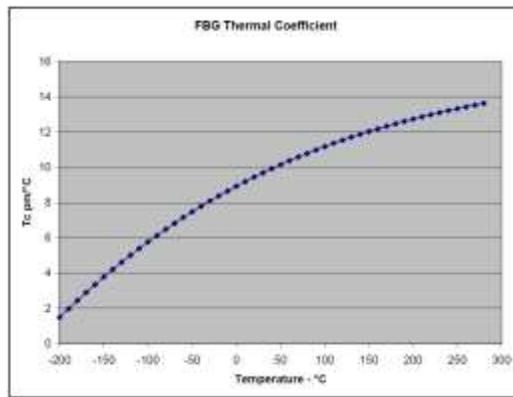
Figure 11 Results collected from temperature calibration test (Courtesy of Micro Optics, Inc.).

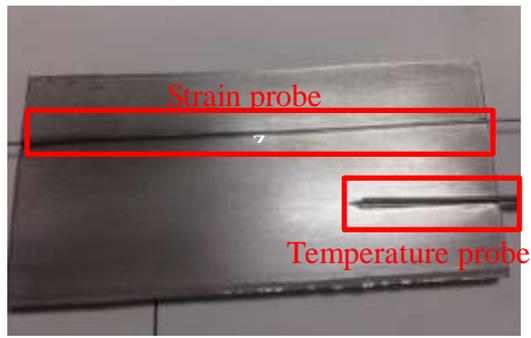
Figure 13 Temporary protection for sensors as second technique used in this project.

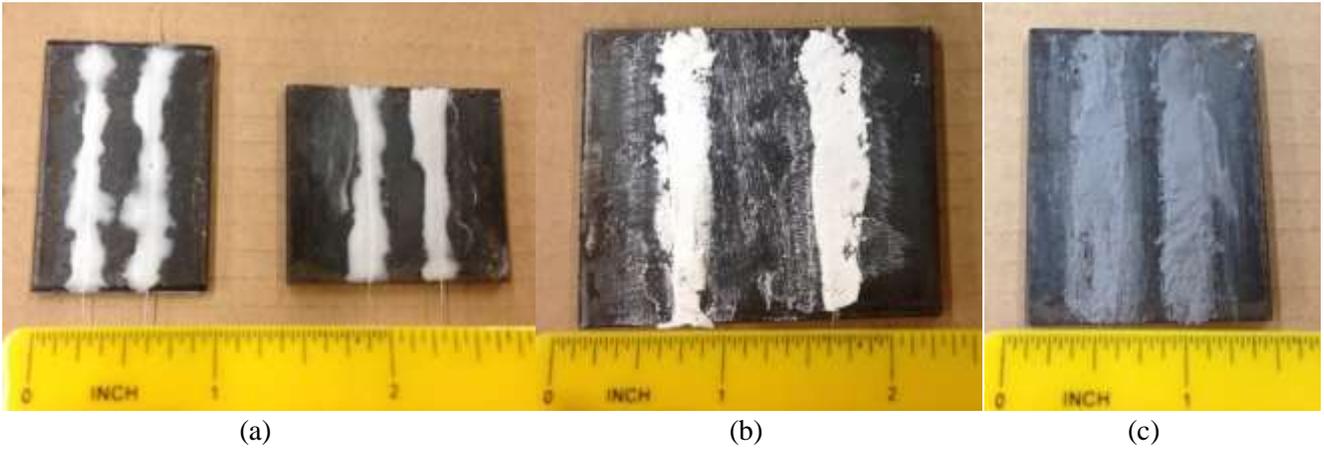
Figure 14 Coated samples using (a) high temperature epoxy (Minco Epoxy), (b) nickel-based metallic adhesive (Durabond 952), and (c) stainless-steel-based metallic adhesive (Durabond 954).

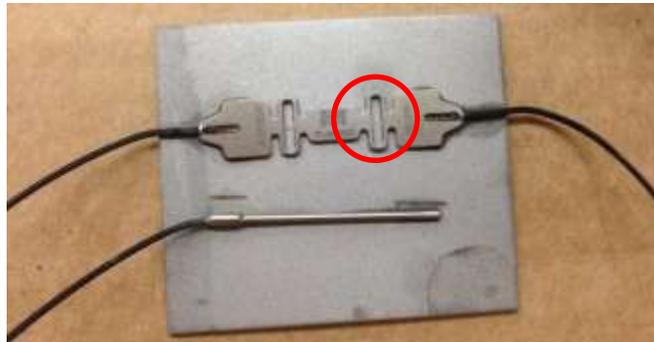
Figure 15 Strain sensor after spray process in plan 1).

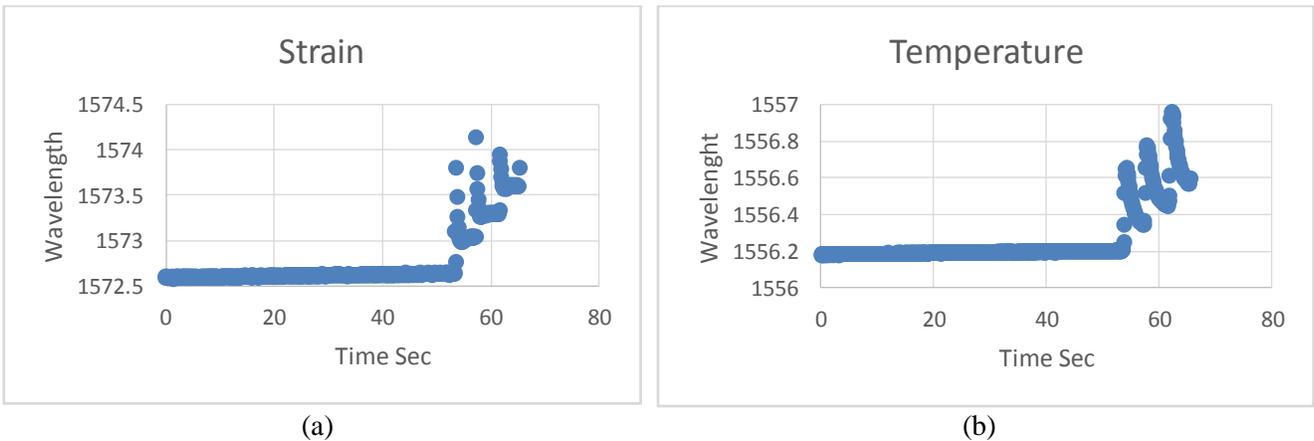
Figure 16 Collected wavelengths during the second run of spraying (a) strain and (b) temperature.

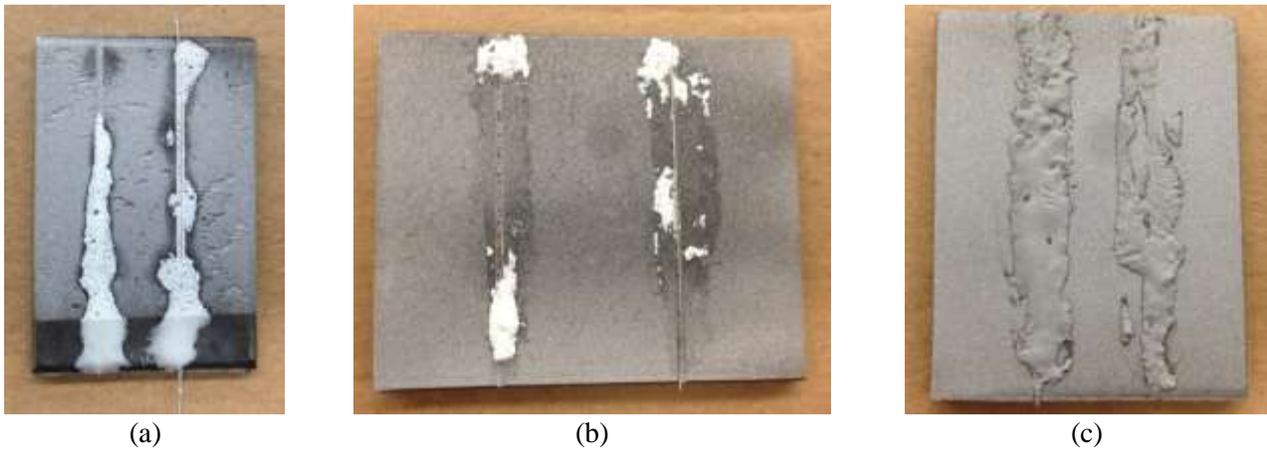
Figure 17 Coated samples after sand blasting process (a) high temperature Minco Epoxy, (b) nickel-based adhesive (Durabond 952), and (c) stainless-steel-based adhesive (Durabond 954).

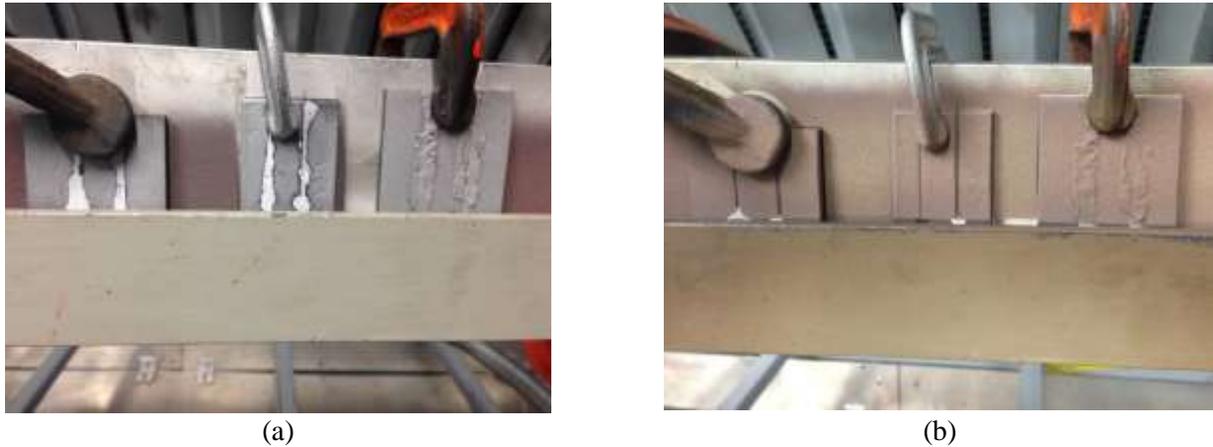
Figure 18 (a) Spraying samples for various adhesive before coating and (b) after spraying deposition.

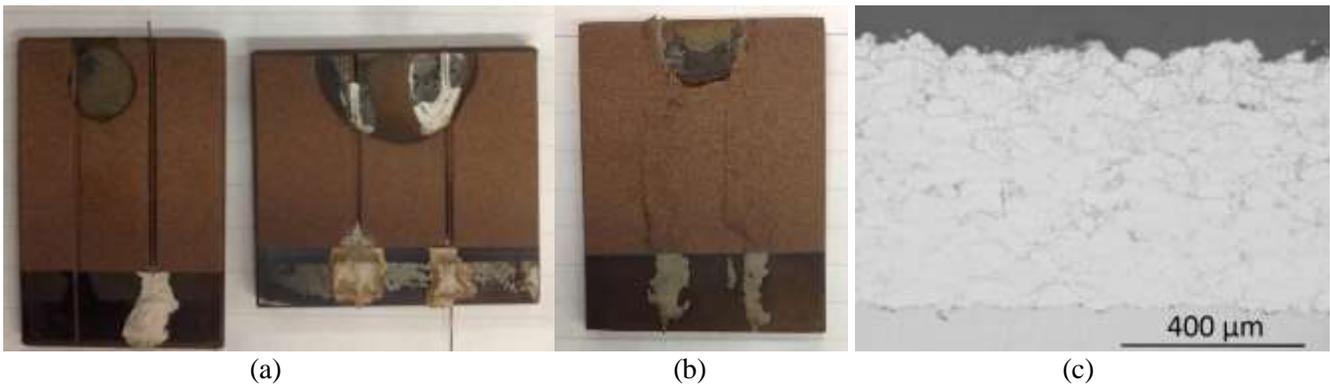
Figure 19(a) and (b) show a more detail view at higher magnification of three samples after HVOF spraying process. The stainless-steel-based metallic adhesive successfully survived the thermal spray coating process as shown in Figure 19(b). The copper coating was successfully deposited on top of the adhesive and sensor at the thickness of 0.55 mm. Microstructure of the deposited coating and its thickness is shown in Figure 19(c). The optimization of the stainless-steel-based metallic adhesive embedded coating will be performed to make a smoother surface of the adhesive and test its sensing behavior after coating deposition.

Figure 19 Sample condition after coating deposition (a) with high-temperature epoxy, (b) with stainless-steel-based metallic adhesives, and (c) cross-section of thermally deposited copper coating

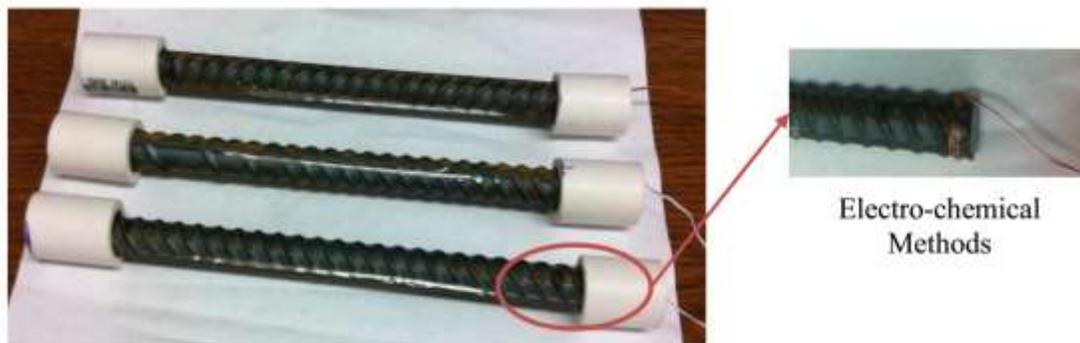
Steel bar was selected as the investigating subject in this study to investigate the LPFG based surface corrosion environmental sensor. Figure 20 shows the preparation of the test steel bars^{46, 47}. With 0.383% carbon contained in the steel bar, the test specimen was categorized as mild carbon steel. To get a uniform corrosion in the middle of the bar, epoxy was applied to both ends of the steel rebar by placing the epoxy into a small section of PVC tubes. Channels on the surface of the steel bars were prepared for the installation purpose of the coated LPFG corrosion sensors and the associated environmental referencing LPFG sensors. At one end of the steel bar, electrical wires were installed to monitor the corrosion rate through traditional electro-chemical methods, in which a potentiodynamic test was implemented for the test steel bar for a corrosion rate estimation.

Figure 20 Prepared steel rebar samples for corrosion testing.

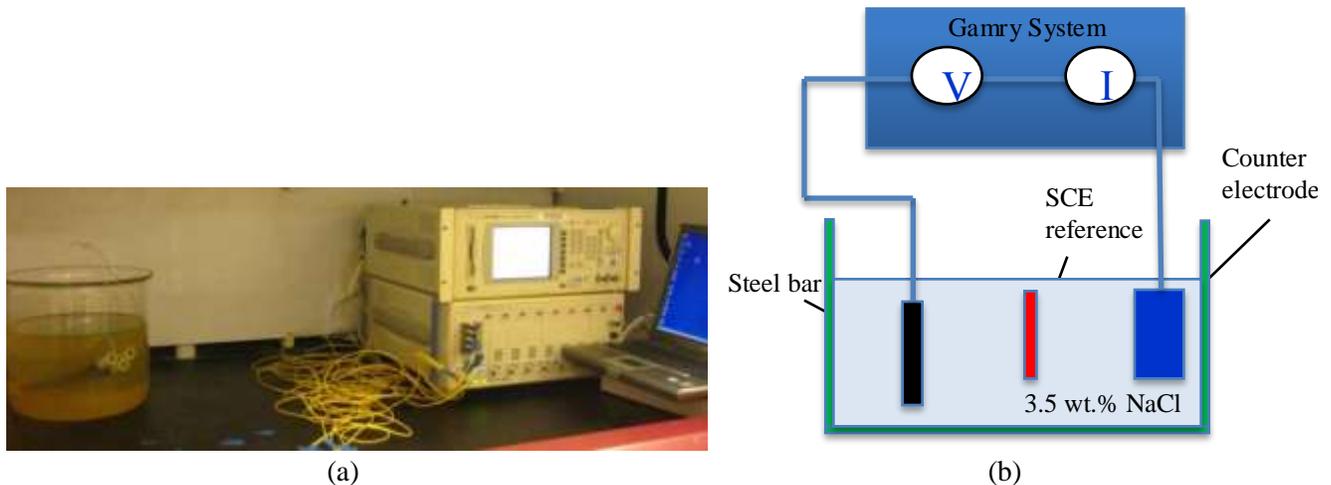
The three steel bars were placed inside a 3.5 wt.% NaCl solution. Two measurement methods were applied to monitor the corrosion of the steel bar samples including the optical and electrochemical measurements as shown in Figure 21(a, b). Three nano iron/silica particle coated LPFG sensors and one reference sensor were attached on the surface of the steel bar to monitor the corrosion together with the electrochemical methods.

Figure 21 Experimental setups for corrosion monitoring of three steel bars (a) for optical and (b) for electrochemical measurements.

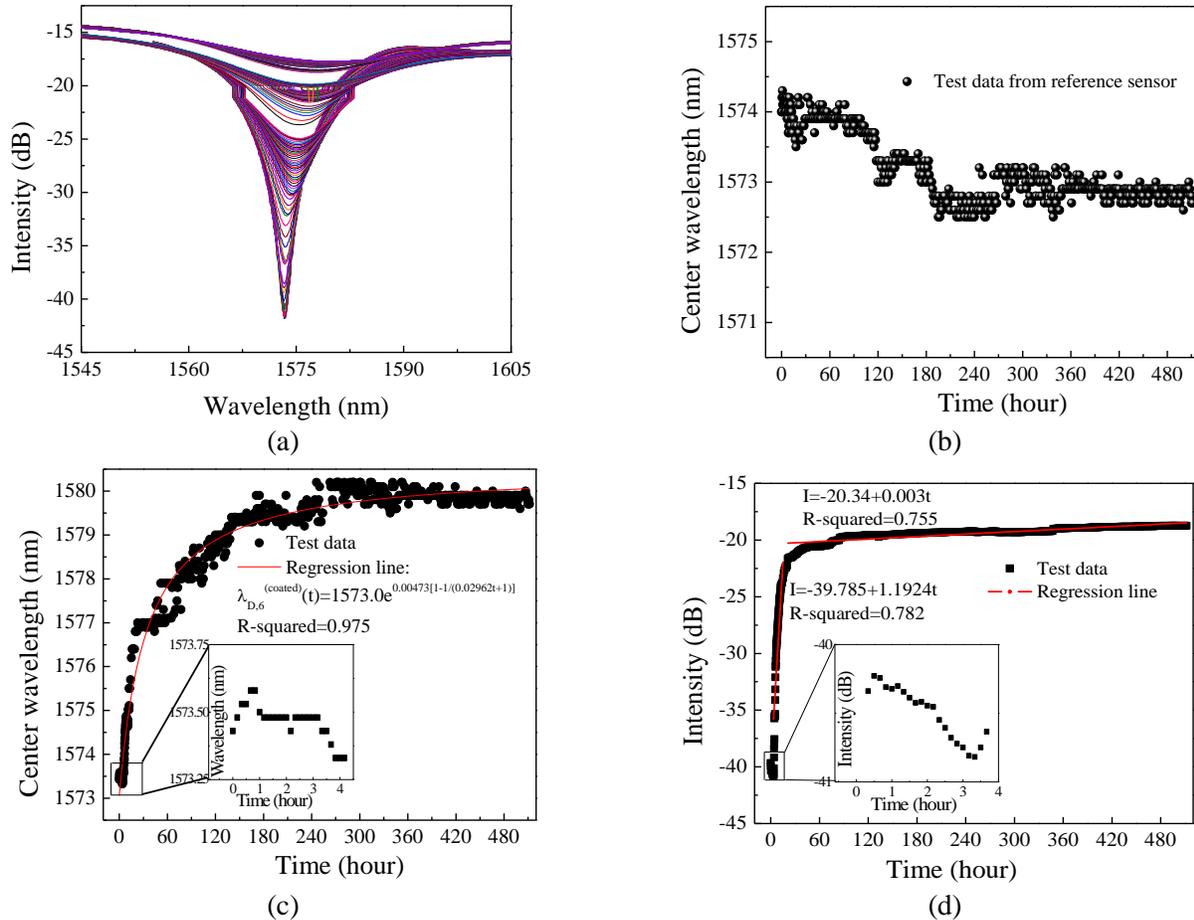
The tests were performed for 20 days (480 hours). Figure 22(a) illustrated the spectrum changes of the sensor. Figure 22(b ~ d) show the center wavelength changes of the reference sensor, the corrosion environmental sensor after reference correction, and the light intensity changes of the corrosion environmental sensor. As the immersion time increased, both the resonant wavelength and the peak intensity of the coated LPFG#1 sensor first increased rapidly and then approached an asymptotical value. Specifically, the resonant wavelength dramatically changed from 1573.3 nm to approximately 1580.2 nm during the first two weeks of laboratory corrosion tests, whereas most of the change in peak intensity from -40.5 dB to -20 dB occurred within the first three days of corrosion tests. Similar responses were observed for the other two samples as indicated in Figure 23(a, b).

Figure 22 Spectrum changes of the surface corrosion environmental sensor in 3.5% salt solution for (a) one month, (b) center wavelength changes of reference sensor, (c) compensated center wavelength changes, and (d) light intensity changes of the surface corrosion environmental LPFG sensor #1.

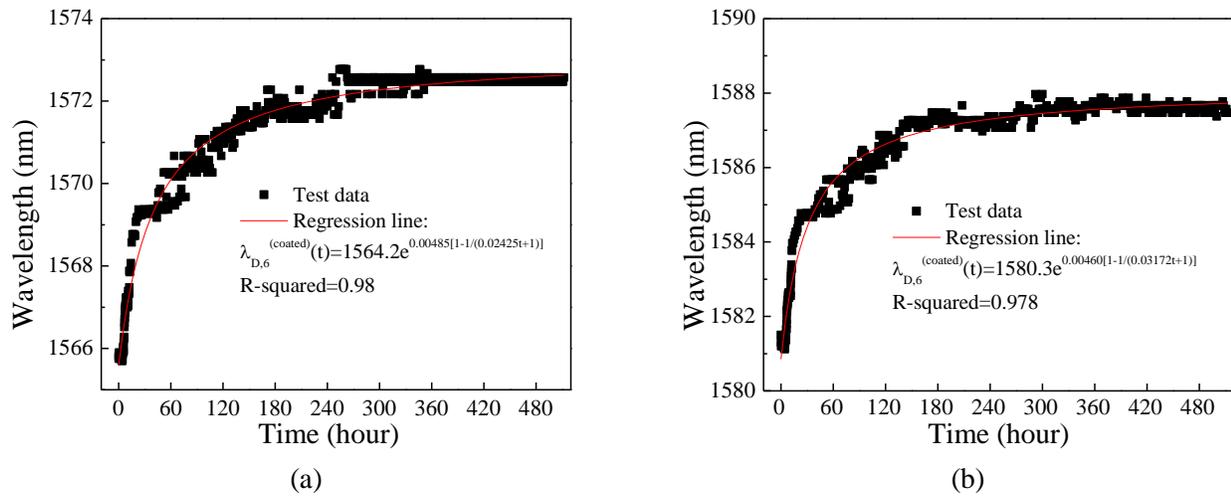
Figure 23 Compensated center wavelength changes of (a) LPFG #2 and (b) #3.

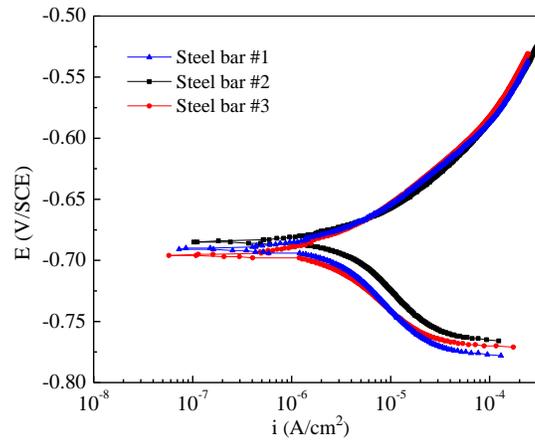
The corrosion rate of the steel bar was also measured using electrochemical method. Figure 24 shows the measured results for the three steel bars. The predicted corrosion rates using Equation (5) by three LPFG sensors and the measured corrosion rates by potentiodynamic tests, were compared in Table 5 together with their differences. The developed surface sensor measured the corrosion rate to be 0.0373mm/year and that from the electrochemical method were 0.0345mm/year. Table 5 also listed the average and the coefficient of variation (C.O.V.). The corrosion rates obtained from the potentiodynamic tests were for the mass loss of three steel samples. The corrosion rates obtained from the three LPFG sensors were for the mass loss of nano iron particles on the sensors after 130.5 hours of immersion time. It can be observed from Table 5 that the maximum difference between the LPFG prediction and its corresponding potentiodynamic measurement was 0.0087 mm/year, corresponding to a relative error of $0.0087/0.0295=29\%$. The average difference was 0.0028 mm/year, corresponding to a relative error of $0.0028/0.0345=8\%$. This comparison validated the accuracy of the proposed sensing technique for steel corrosion monitoring. In addition, the C.O.V. values of the three predicted and their corresponding measured corrosion rates were 0.049 and 0.115, respectively. These results indicated that the proposed sensing technology was more repeatable and reliable than the potentiodynamic tests in terms of the evaluation of corrosion rate.

Figure 24 Monitored potentiodynamic polarization curves for the three test samples.

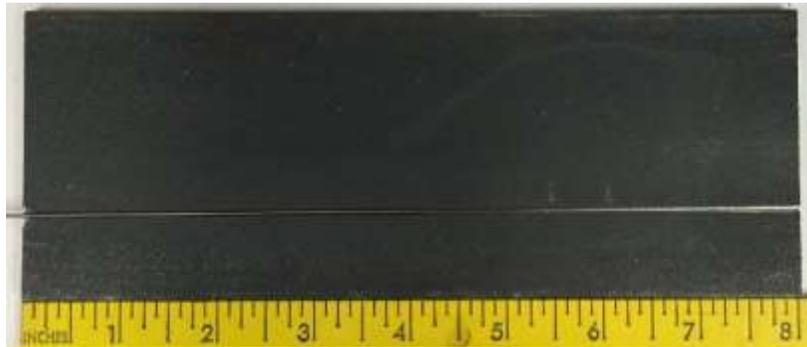
Figure 25 shows the samples with embedded sensors ready for HVOF process. The dimensions were 8 (length) \times 4 (width) \times 0.25 (thickness) inches. A small groove has been made in each sample to embed fiber optic sensors inside the samples. The sensors were enclosed in hypodermic tubes for protection and embedded using stainless-steel-based metallic adhesive (Durabond 954).

Figure 25 Steel substrate prepared in this quarter with embedded sensors before spraying process.

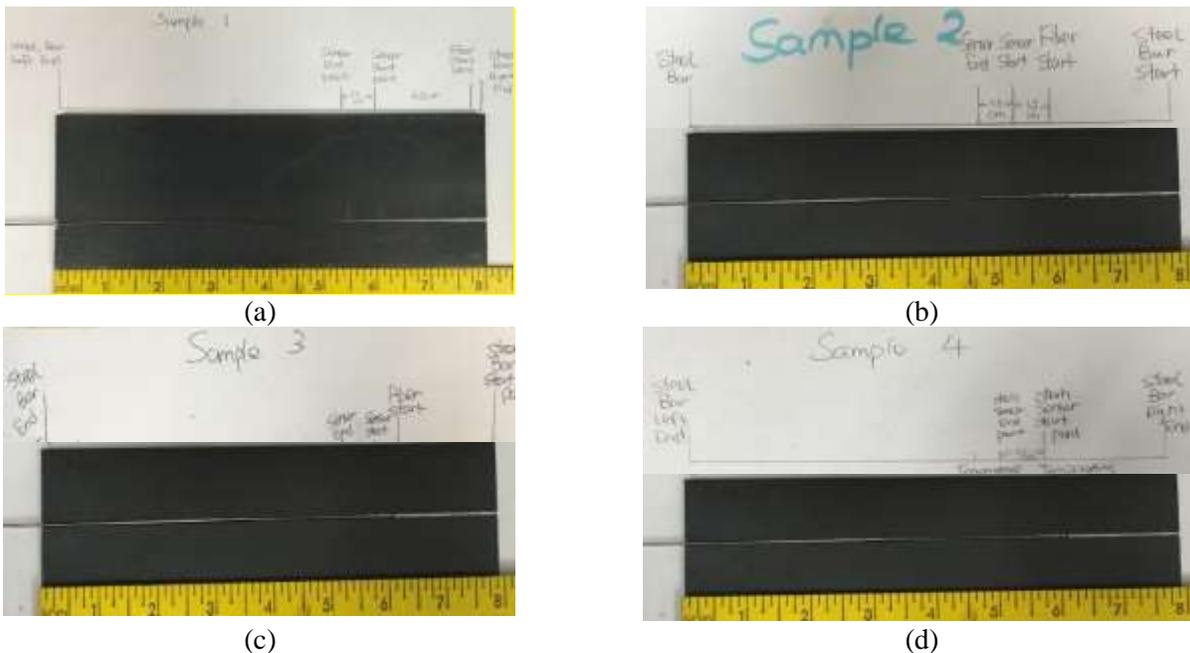
Figure 26 (a ~ c) show the accurate location of embedded sensors in all four coated samples. To ensure a successful protection of the fiber optic strain sensors during the HVOF process, hypodermic tubes at two different sizes were used here. A smaller-diameter hypodermic tube was used to protect the sensing unit with 0.006 in. of inner diameter and 0.010 in. of outer diameter. A slightly larger diameter hypodermic tube was used to protect the communication optical fibers from the high speed velocity of HVOF thermal spraying process with an inner diameter of 0.028 in. and an outer diameter of 0.0425 in. For fiber optic temperature sensor, since a relative thicker steel tube was applied by manufacturers for sensor protection, no future protection was taken. As shown in Figure 26, therefore, in samples #1 to #3, each sample had one embedded fiber optic strain sensor (OS1100 single FBG sensor). In sample #4, one fiber optic strain sensor (OS1100 single FBG sensor) and one fiber optic temperature sensor (OS4210 FBG temperature sensor) were placed for temperature monitoring during thermal spraying process which will also be used as reference for corrosion monitoring in future corrosion testing. Figure 27(a) shows all the prepared samples and Figure 27(b) shows the samples after sand blasting process. As it can be seen from Figure 27(b), only the top half of the samples where the sensors located will be coated by Cu-Al Bronze alloy.

Figure 26 (a-d) Sample preparation with sensor location for Sample #1- 4.

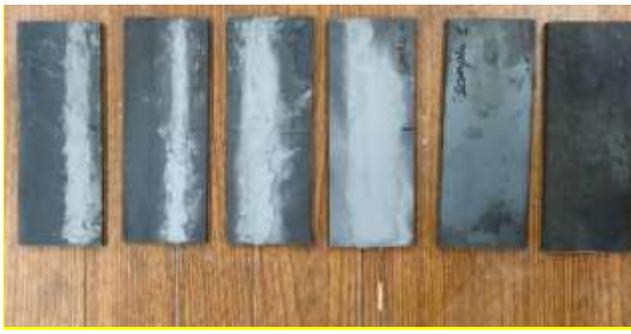
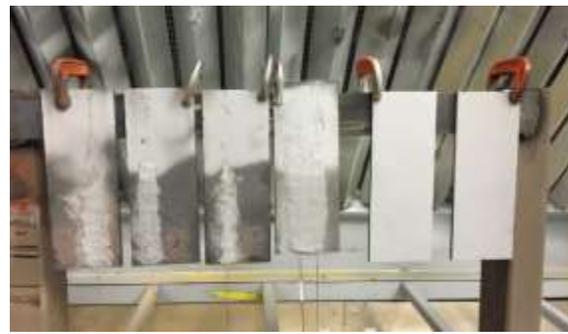
Figure 27 (a) Prepared samples after sensor embodiments, and (b) after sand blasting.

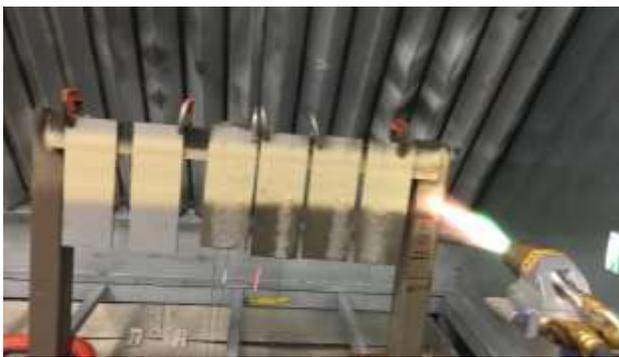
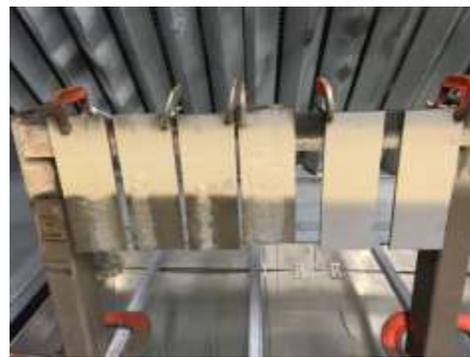
Figure 28 (a) Thermal spraying process and (b) Samples after successful thermal spraying.

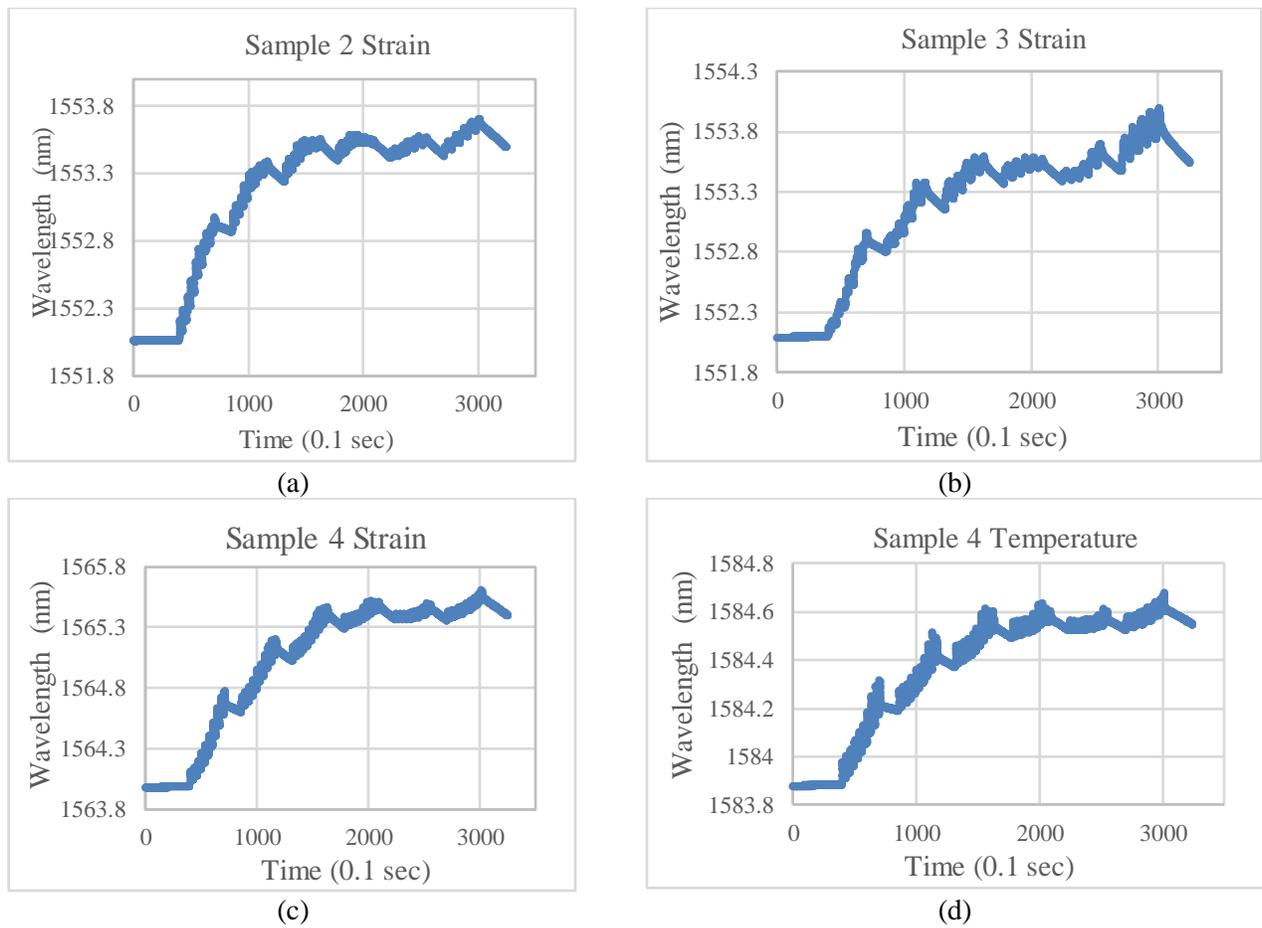
Figure 29 Sensor recording during the thermal spraying process for (a) Sample #2, (b) Sample #3 (c) Sample #4 strain sensor and (d) Sample #4 for temperature sensor.

Table 7 listed each sensor's responses right after coating and after cooling. An average center wavelength change of 1.425 nm was observed during the coating process for the fiber optic strain sensors and a center wavelength change of 0.663 nm was observed for the temperature fiber optic sensor. It is indicated that an average of thermal strain of $1,329 \mu\epsilon$ and a temperature increase of $70 \text{ }^\circ\text{C}$ was introduced by the elevated temperature during the coating process. After cooling down, the environmental temperature drops $6.3 \text{ }^\circ\text{C}$ before the coating and the coating had a thermal residual strain of an average of $192 \mu\epsilon$ in compression with the entire processes considered.

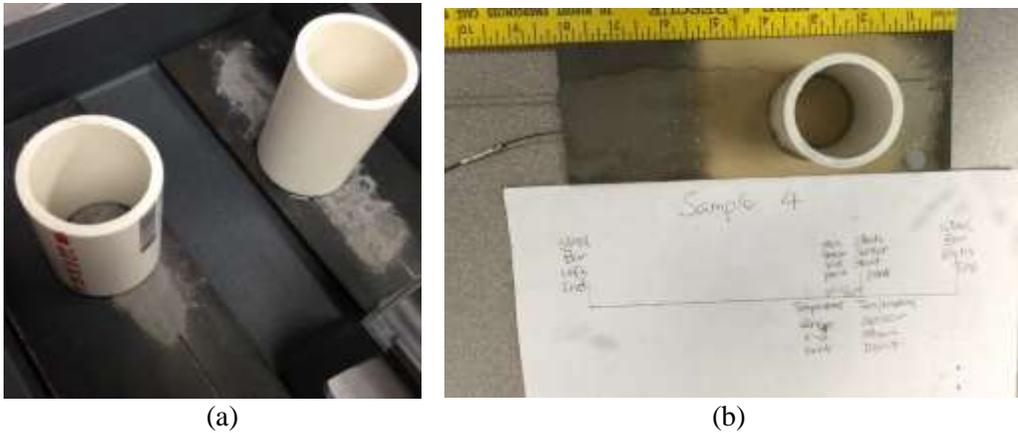
for hosting the testing solution. The diameter of PVC pipe was approximately 40.5 mm as shown in Figure 30(a) for uncoated sample with embedded sensors and Figure 30(b) for coated sample with embedded sensors. A 24-hour curing time in room temperature was used to let the adhesive reaching its maximum strength.

Figure 30 (a) A PVC glued uncoated and (b) coated samples with embedded sensor ready for corrosion tests.

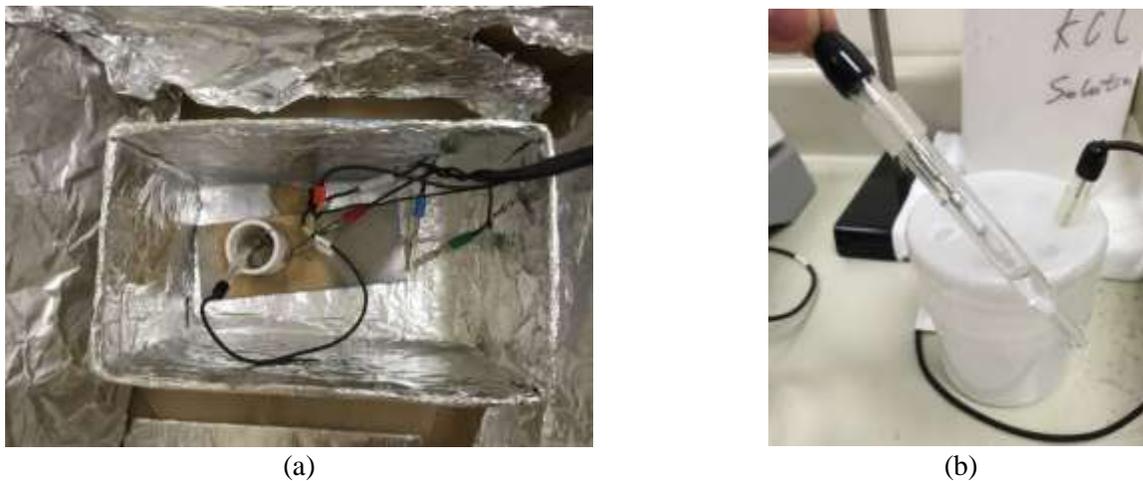
After preparation of the test set-up, 3.5wt.% NaCl solution was poured in the PVC pipes for electrochemical accelerated corrosion tests in an enclosed space. Proper connections must be provided as shown Figure 31.

Figure 31 (a) Electrochemical accelerated corrosion test setup and (b) Electrodes used in tests.

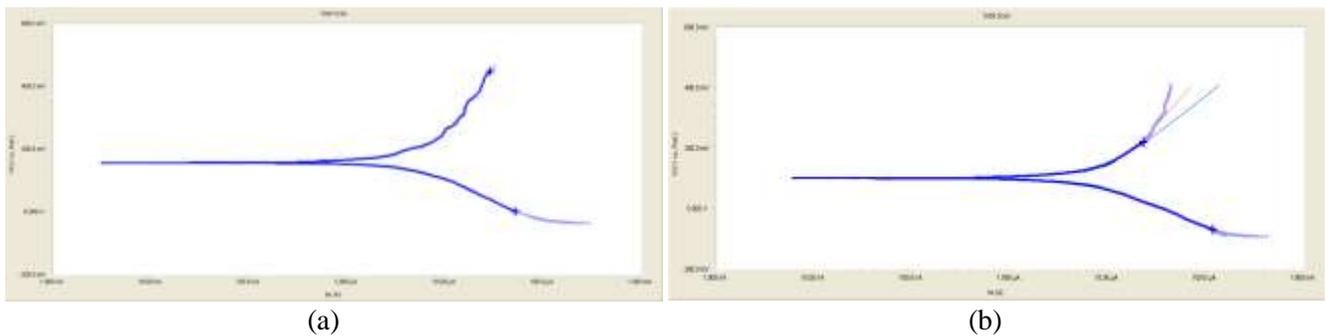
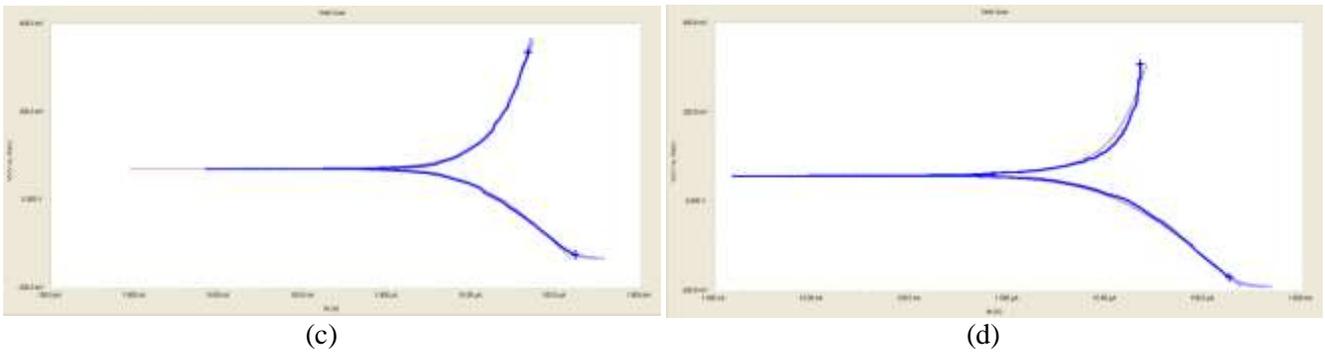
After proper connection between leads and samples, the polarization resistance test was performed on all the four coated samples with embedded sensors. The area, density, and equivalent weight of samples were measured and input into the software for testing. All the test procedures were strictly following the standard of ASTM G59 manual. With the polarization resistance, the Tafel tests were performed for each sample. Figure 32(a~d) show the voltage (in Y axis) versus log-scale current (in X axis) for the four samples with embedded sensing system, respectively.

Figure 32 Voltage vs current changes from Tafel tests for (a) Sample #1, (b) Sample #2, (c) Sample #3, and (d) Sample #4.

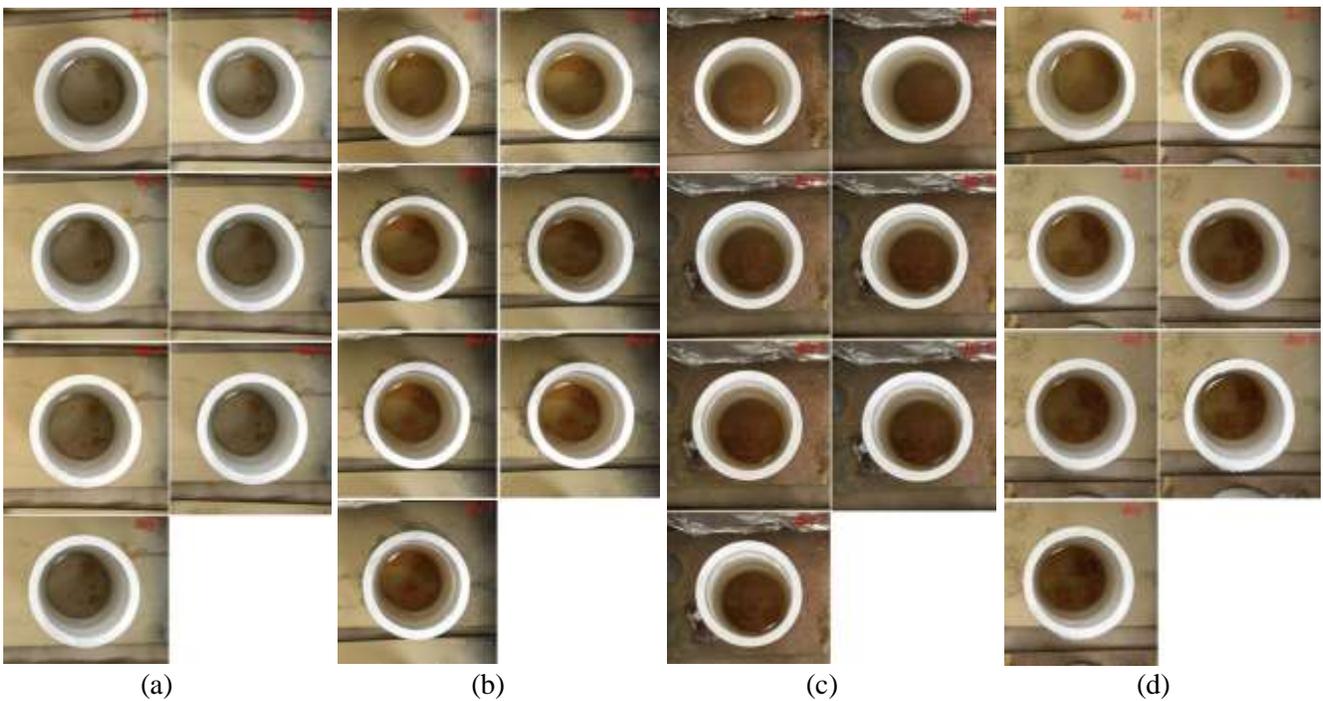
After the accelerated corrosion tests using electrochemical methods, another series of corrosion tests were performed on the four samples with embedded in-line FBG sensors by emerging them in PVC tubes filled with 3.5% NaCl solution for 21 days. The wavelength changes of four samples had been recorded continuously for entire test time with a sampling frequency of 10Hz. Figure 33(a~d) show the photos had been taken of each sample every day for seven days for visual inspection. Comparison of the visible changes in the samples as seen in Figure 33 helps to better understand the corrosion propagations. For Sample #2 and Sample #4, the corrosion area is exactly above the embedded sensors. The corrosion area of Sample #1 is close to the embedded sensor but not exactly right above it. Since Sample #3 had been corroded before corrosion test, the corrosion area is larger than other samples. The corrosion area was increased rapidly, and it was shadowed which represents the magnitude of corrosion level is serious.

Figure 33 Corrosion test after seven days on (a) Sample #1, (b) Sample #2, (c) Sample #3, and (d) Sample #4.
