Date of Report: <November 15, 2015>

Project Title: <Composite Self-Sensing Thermal Sprayed Coatings for Pipeline Corrosion Prevention and Mitigation>

Prepared by: <North Dakota State University>

(b) Draft Final Report

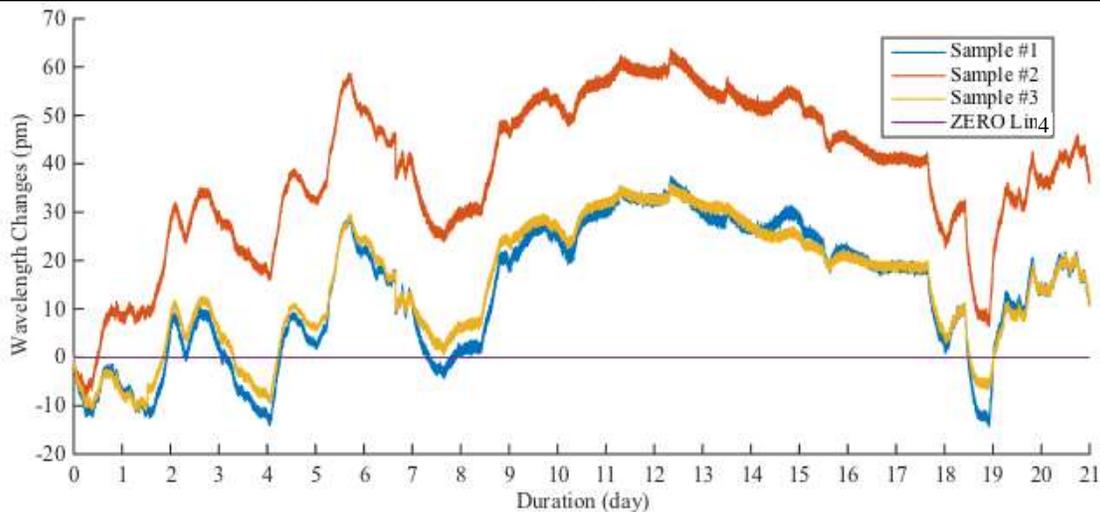
Figure 34 The variation of changes in the center wavelength of the embedded sensing system during 21 days in the NaCl solution (Sample #1~#4).

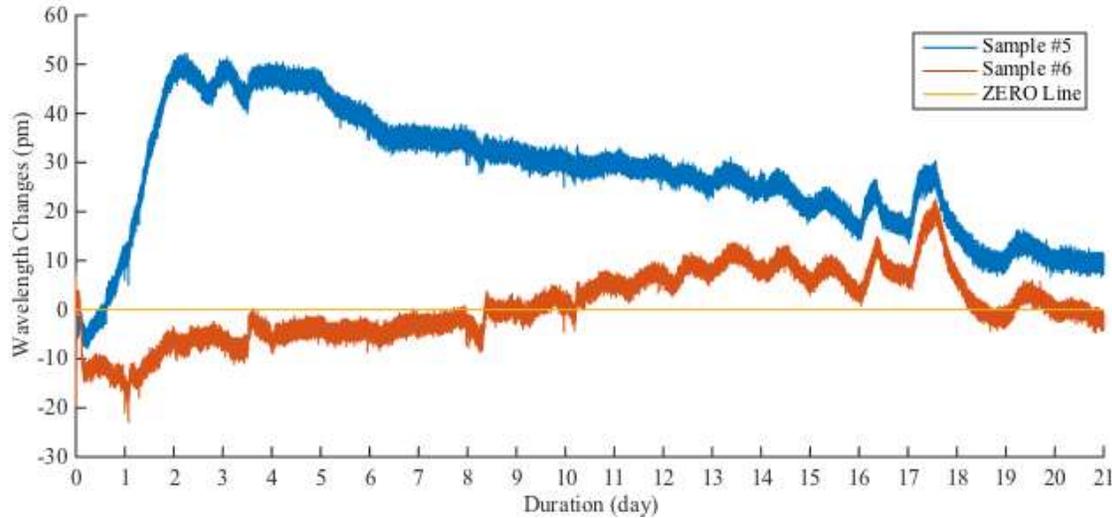
as previous test, the wavelength changes of samples had been recorded continuously for entire test time with a sampling frequency of 10Hz. Table 10 shows the wavelength change at the end of experiment and the maximum wavelength change during test.

Figure 35 The variation of changes in the center wavelength of the embedded sensing system during 21 days in the NaCl solution (Sample #5,#6).

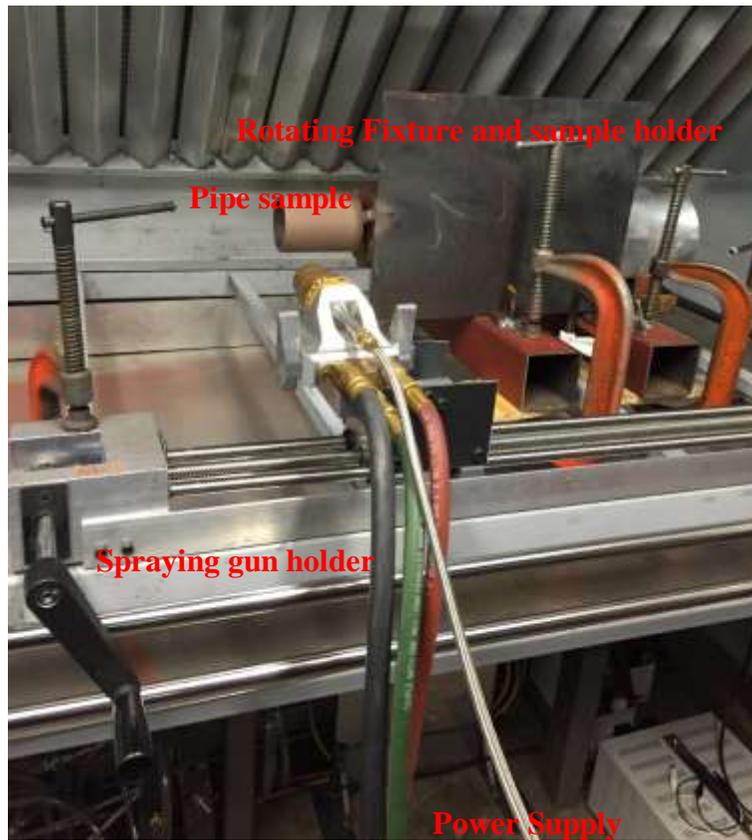
A new rotating fixture was designed by two undergraduate students, A. Perrault; C. M. Ferreira, and one graduate student, Babak Jahani, to hold pipe samples in front of spraying nozzle for coating deposition. Figure 36 shows the spraying set-up for spraying process. It includes several parts: an adjustable pipe fixing holder, a rotational axle connected to a speed-control instrument, and a manually movable spraying gun holder. Pipes with inner diameter from 1 inches to 12 inches can be placed on the holder for spraying. The pipe can rotate at various speeds which is adjustable from low to high speed during the spraying process to meet the requirement for different spraying thickness. The spraying gun holder is designed to move horizontally at constant speed to provide a uniform deposition on the surface of the pipe samples.

Figure 36 Spraying set-up for HVOF spraying of pipe samples.

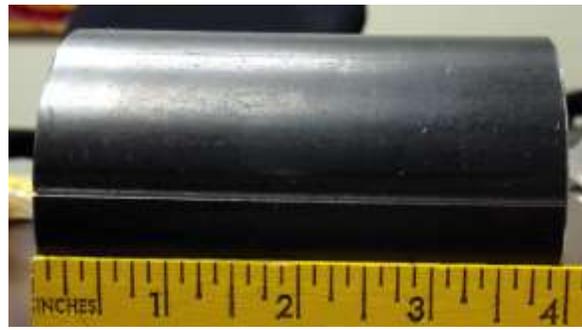
Two pipe samples were prepared for HVOF deposition by the Ph. D. student, Fodan Deng. Each steel pipe sample had an outer diameter of 2.5 inches, a thickness of 0.203 inch, and a length of 4 inches as shown in Figure 37. Similar sensor embedment technique as used for steel plates in previous reports was applied to the steel pipe samples. One groove with 0.0625-inch width and approximately 0.0625-inch depth was made on each steel pipe sample in order to embed an OS1100 FBG strain sensor, which is also shown in the Figure 37.

Figure 37 Steel Pipe Sample

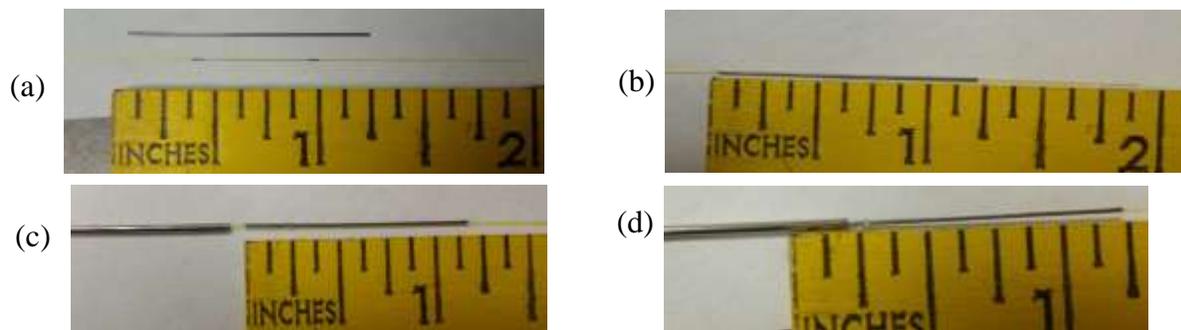
Two types of hypodermic tubes were used to protect FBG strain sensor and the communication fiber from damage during the HVOF spraying process. The hypodermic tube with an inner diameter of 0.01225 inch as shown in Figure 38(a), was used to protect the FBG sensing unit. M-Bond 200 epoxy was used to attach the sensing unit to the hypodermic tube as shown in Figure 38(b). The other type of hypodermic tube had an inner diameter of 0.028 inch, which was used for protecting communication fiber of the sensor, as shown in Figure 38(c). In order to provide a comprehensive protection for FBG strain sensors, an overlap of quarter inch length was made in each embedment, as shown in Figure 38(d). Overlap section of two types of tubes were attached to each other with M-Bond 200 epoxy as adhesive to make sure that there has no sliding between two types of tube.

Figure 38 FBG Sensor Protection Process, (a) 0.01225 inch Hypodermic Tube, (b) FBG Strain Sensor with Protection, (c) Fiber Optic with Protect, and (d) Overlap of Two Types of Hypodermic Tubes.

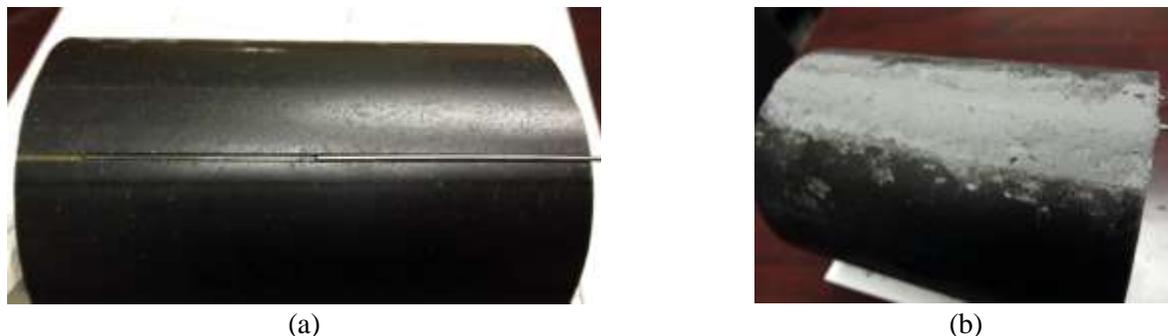
The packaged fiber optic FBG sensor then was embedded inside the pre-fabricated groove on the surface of the pipe samples as shown in Figure 39(a). As mentioned in steel plate sample preparation section above, the metallic-stainless steel based adhesive (Durabond 954) was applied to attach the packaged sensor on the pipe surface. A 24-hour curing period was applied for the Durabond 954 adhesive before sandblasting, as shown in Figure 39(b).

Figure 39 Steel Pipe Sample Preparation, (a) Sensor Embedment on Steel Pipe and (b) Steel Pipe Samples with Durabond 954 Adhesive.

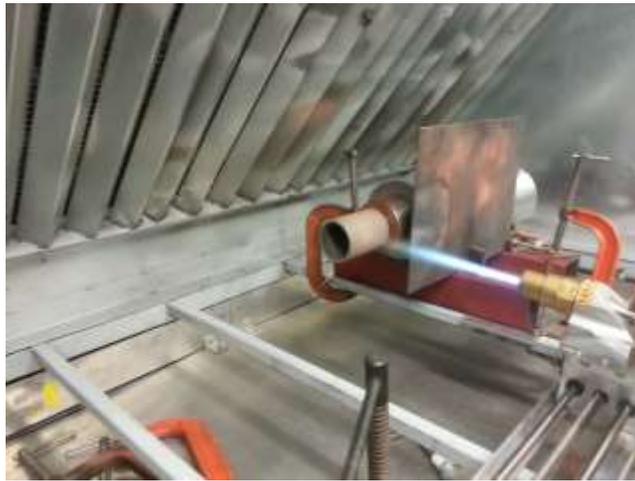
Figure 40 HVOF thermal spraying process for pipe samples.

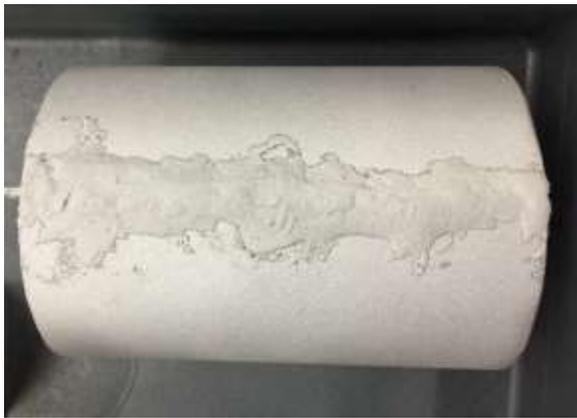
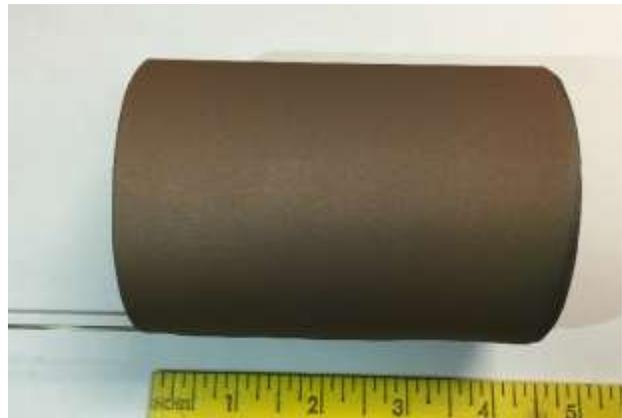
uniformly on the surface of the pipes. It is worth mentioning that copper was selected as optimum coating. Figure 41(b) shows the pipe after spraying copper coating.

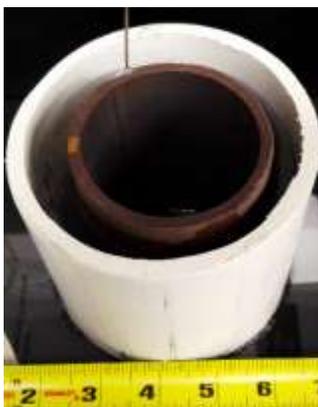
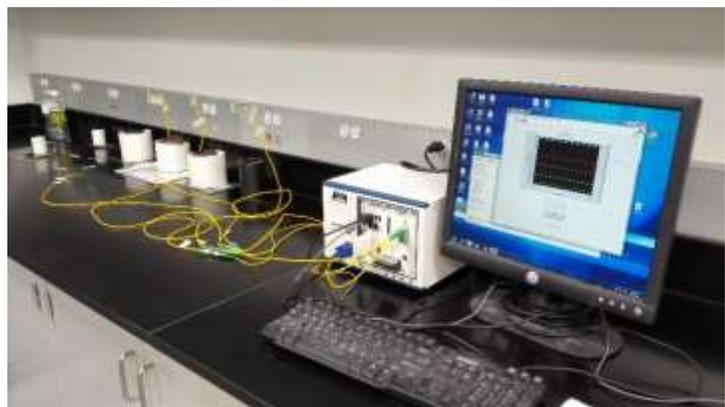
Accelerated corrosion tests for steel pipe samples were performed by the Ph. D. student, Fodan Deng, through emerging samples to emerging them in PVC tubes filled with 3.5% NaCl solution for 21 days. The test set-up is shown in Figure 42. The wavelength changes of four samples had been recorded continuously for entire test time with a sampling frequency of 10Hz (shown in). After 15 days of monitoring, the wavelength change of Sample #2 suddenly reached 2,000 pm and it was exceeded the range of monitor instrument so that the curve for Steel Pipe Sample #2 was cut off around on the day 15. The wavelength change at the end of experiment and the maximum wavelength change during test are shown in Figure 43 and values are listed in the Table 11.

Figure 42 Test Set-Up Of Accelerated Corrosion Test For Steel Pipe Samples.

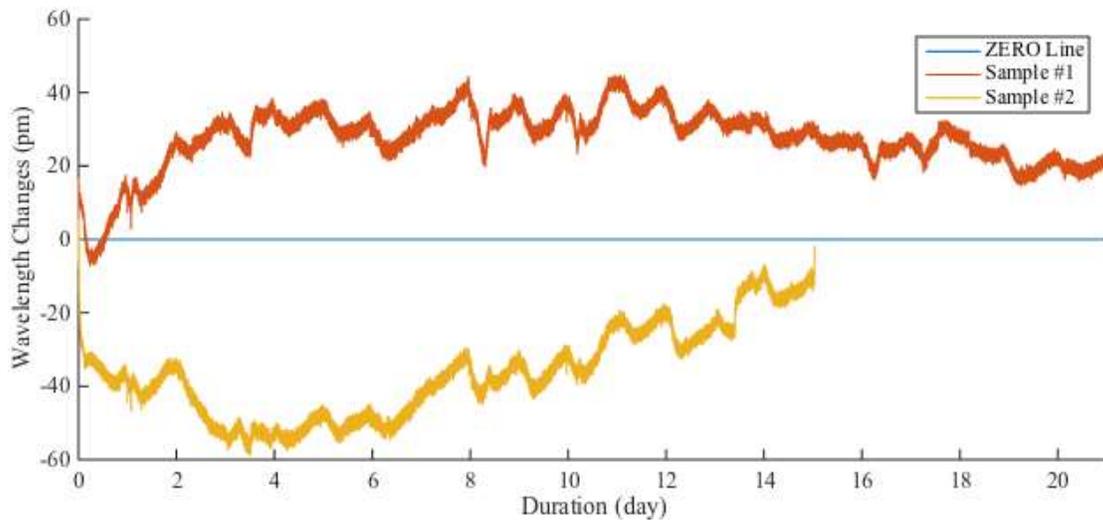
Figure 43 The variation in the center wavelength of the embedded sensing system during 21 days in the NaCl solution (Steel Pipe Sample #1,#2).
