GRI Contract: 8715
DOT Contract: DTRS 56-04-T-001

**Nonlinear Harmonic-Based Mechanical
Damage Severity Criteria for Delayed
Failures in Pipelines**

**Presentation by Al Crouch
Southwest Research Institute
San Antonio, Texas
to
DOT Project Review**

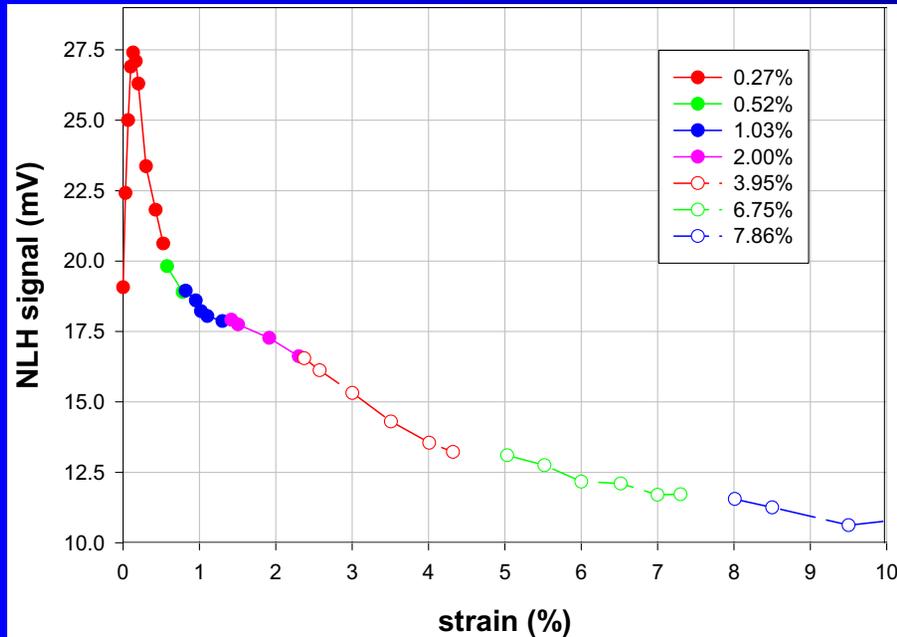
NLH Response to Strain (GRI 8076 and SwRI IR Program)

NLH signal increases at small (elastic) strains, peaks (while strains still elastic) and decreases with increasing (plastic) strains.

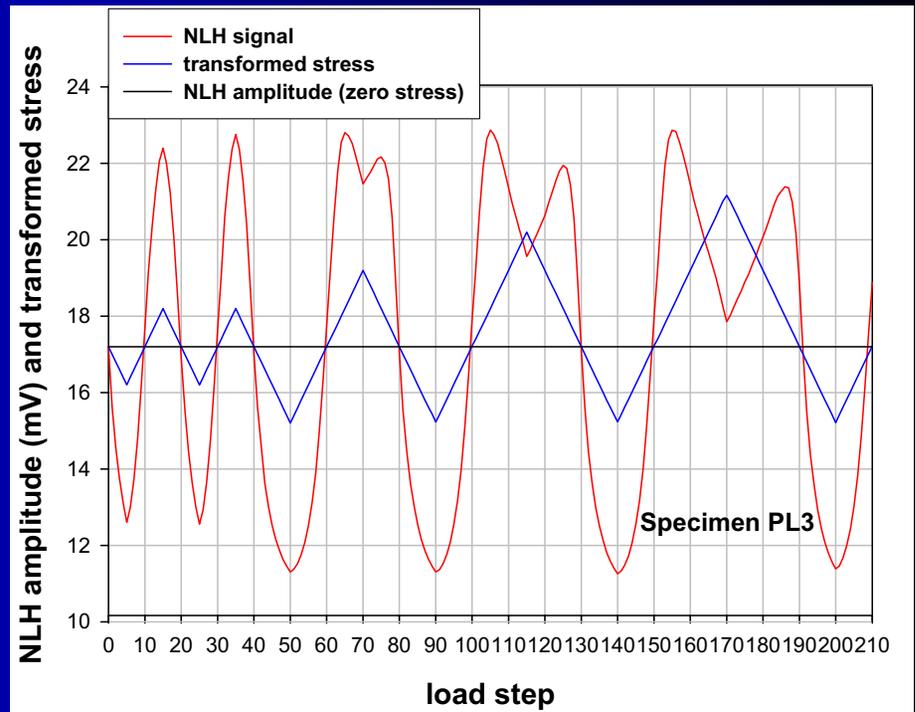
NLH signals (red) respond to cyclic changes in strain (blue)

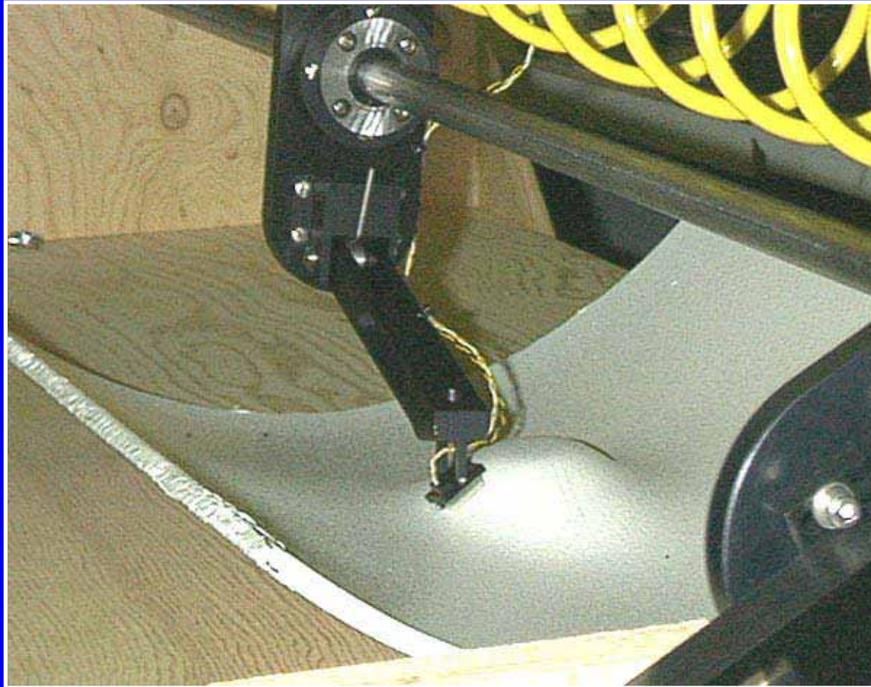
NLH Scanner:

Gimbal mounting facilitates scan over defect imprint on inner surface

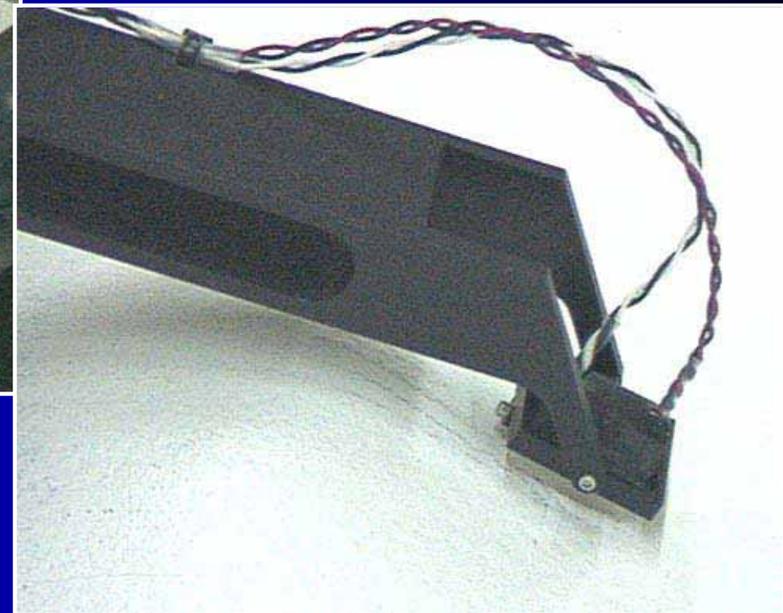
AC magnetic field causes production of odd-numbered harmonic frequencies in pipe surface by magnetic induction

NLH measures amplitude of third harmonic frequency

Strain changes magnetic properties and hence NLH signal amplitude

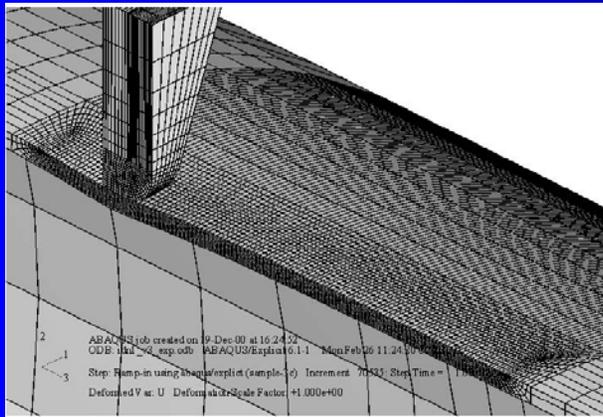
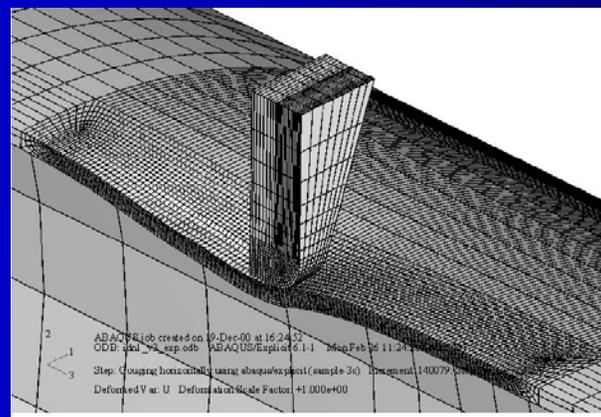
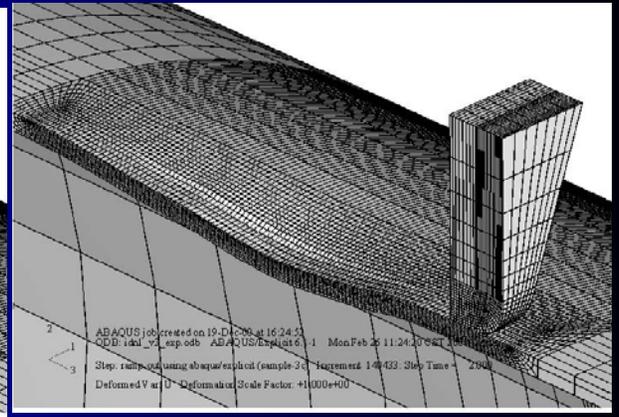
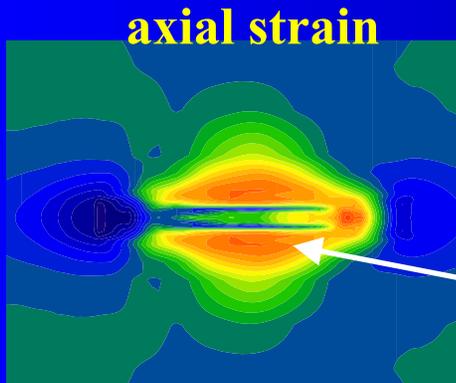
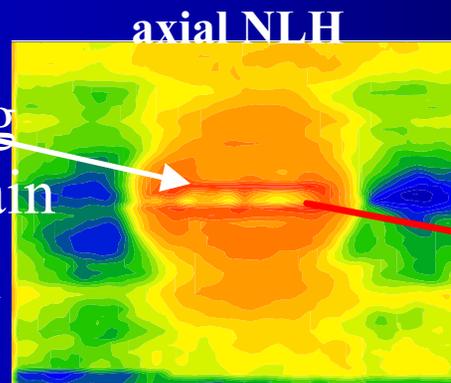
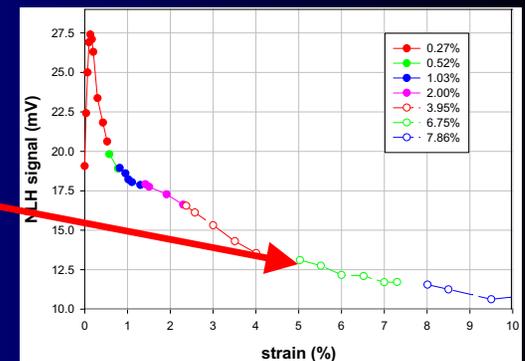
NLH Signals and FEA Predicted Strains due to Gouging (GRI 8076)

signal
corresponding
to intense strain
intense strain

2.5% OD, 6-inch long, rectangle gouge tool

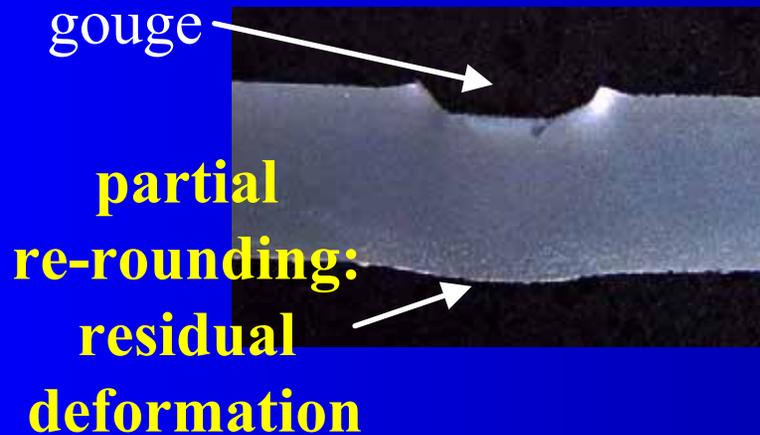
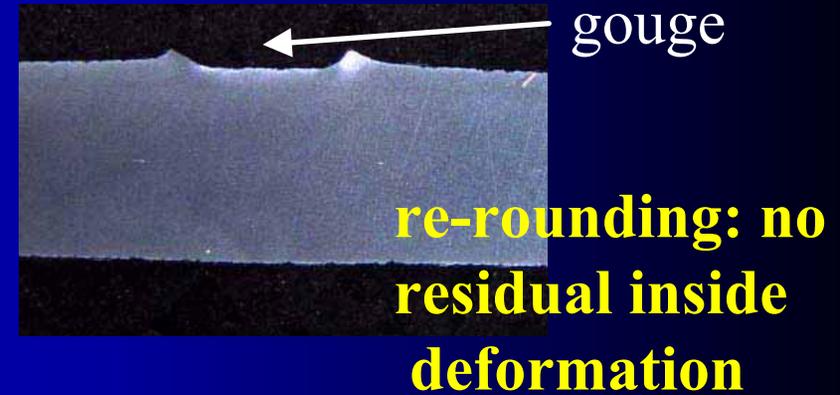
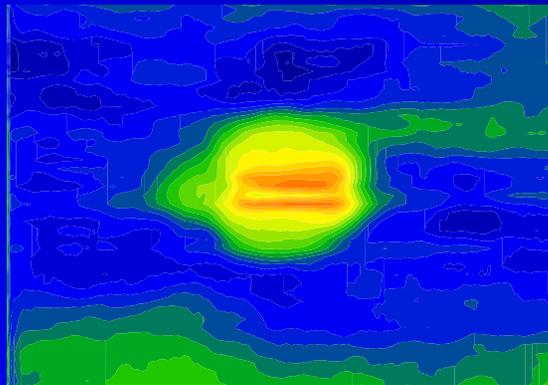
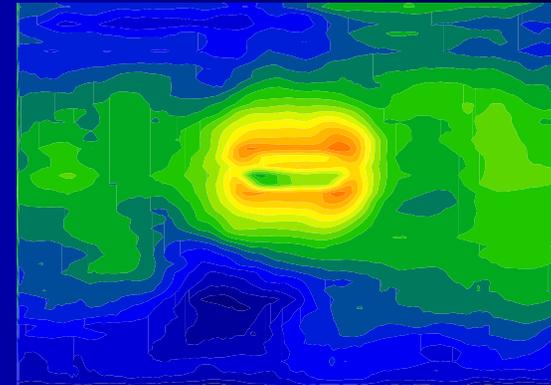
NLH signals detect strain anomalies due to gouging (GRI 8076)

NLH scans on inside surfaces of pipes detect strain anomalies due to defects on outside surfaces even if residual deformation is absent

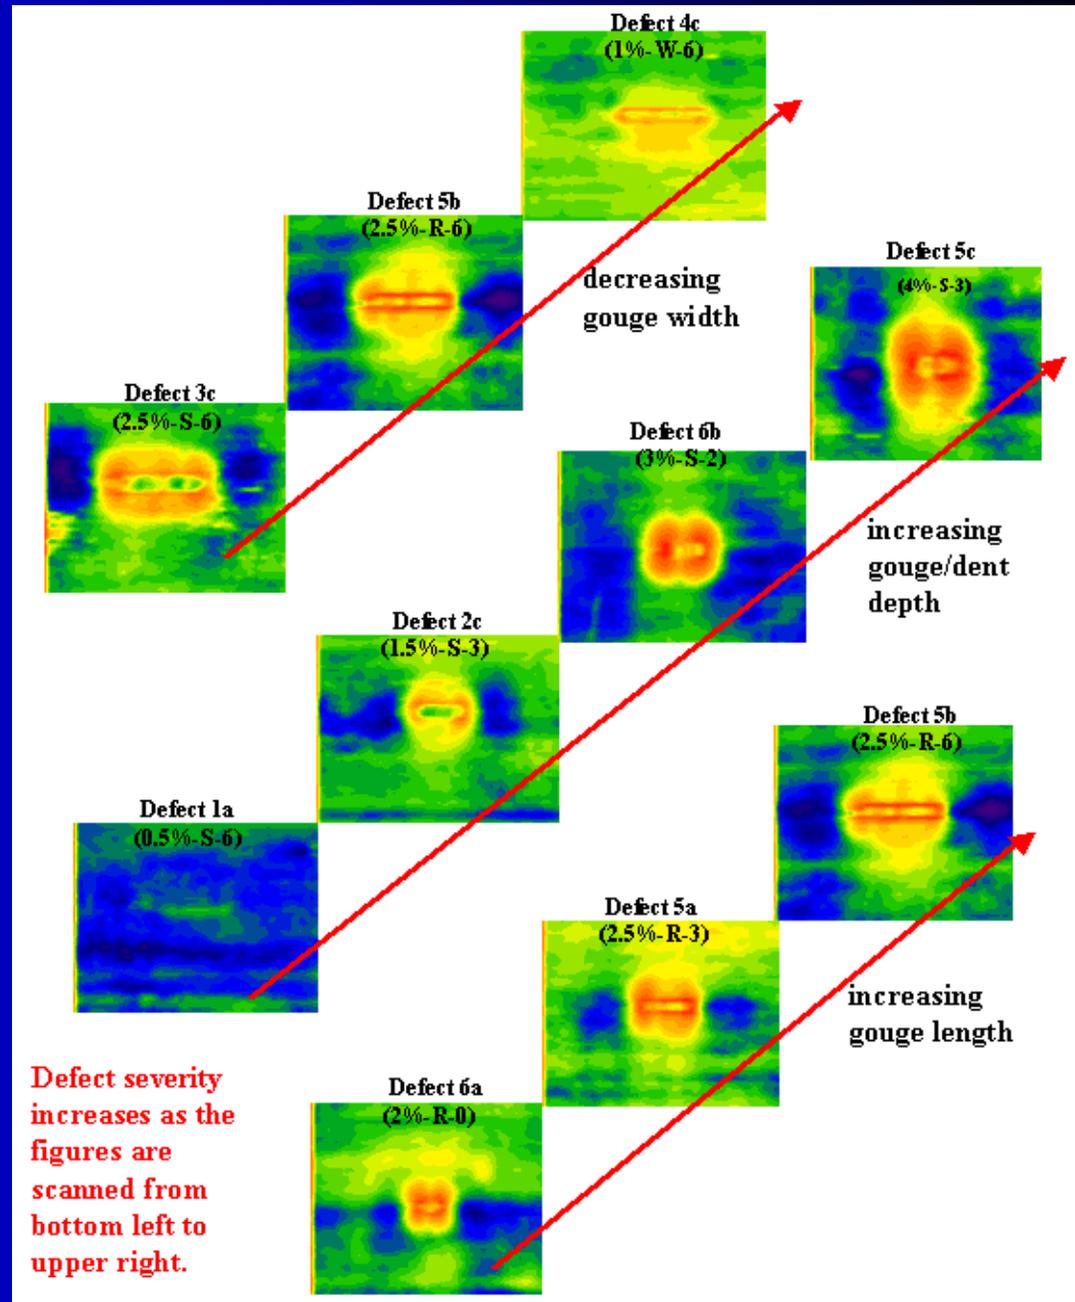
NLH-Based defect severity criteria (GRI 8076)

NLH signals indicate:

- length of gouge
- width of gouge
- depth of gouge

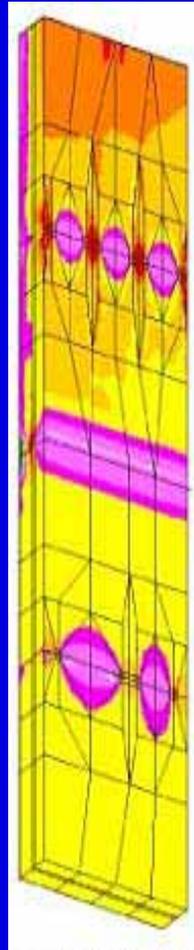
**FE Model:
front face
showing
cracks**

NLH Signals Measured on Cracked Coupons Compared to Finite Element Analysis Results: SwRI IR Program

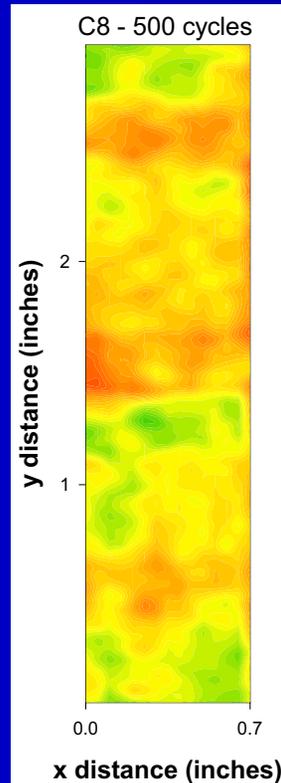
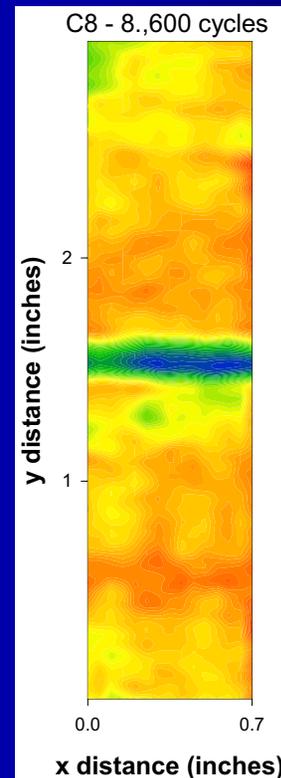
NLH scans on back face

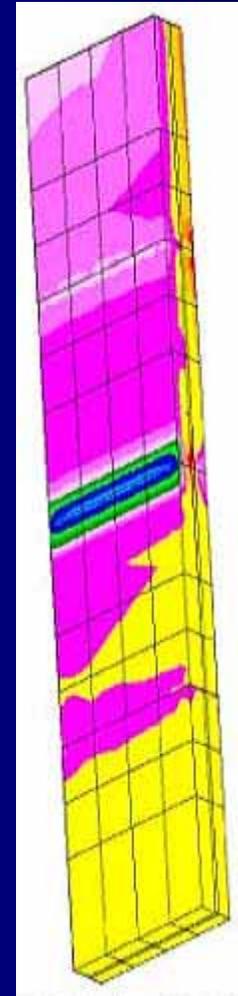
**FEA Model:
crack-free
back face**

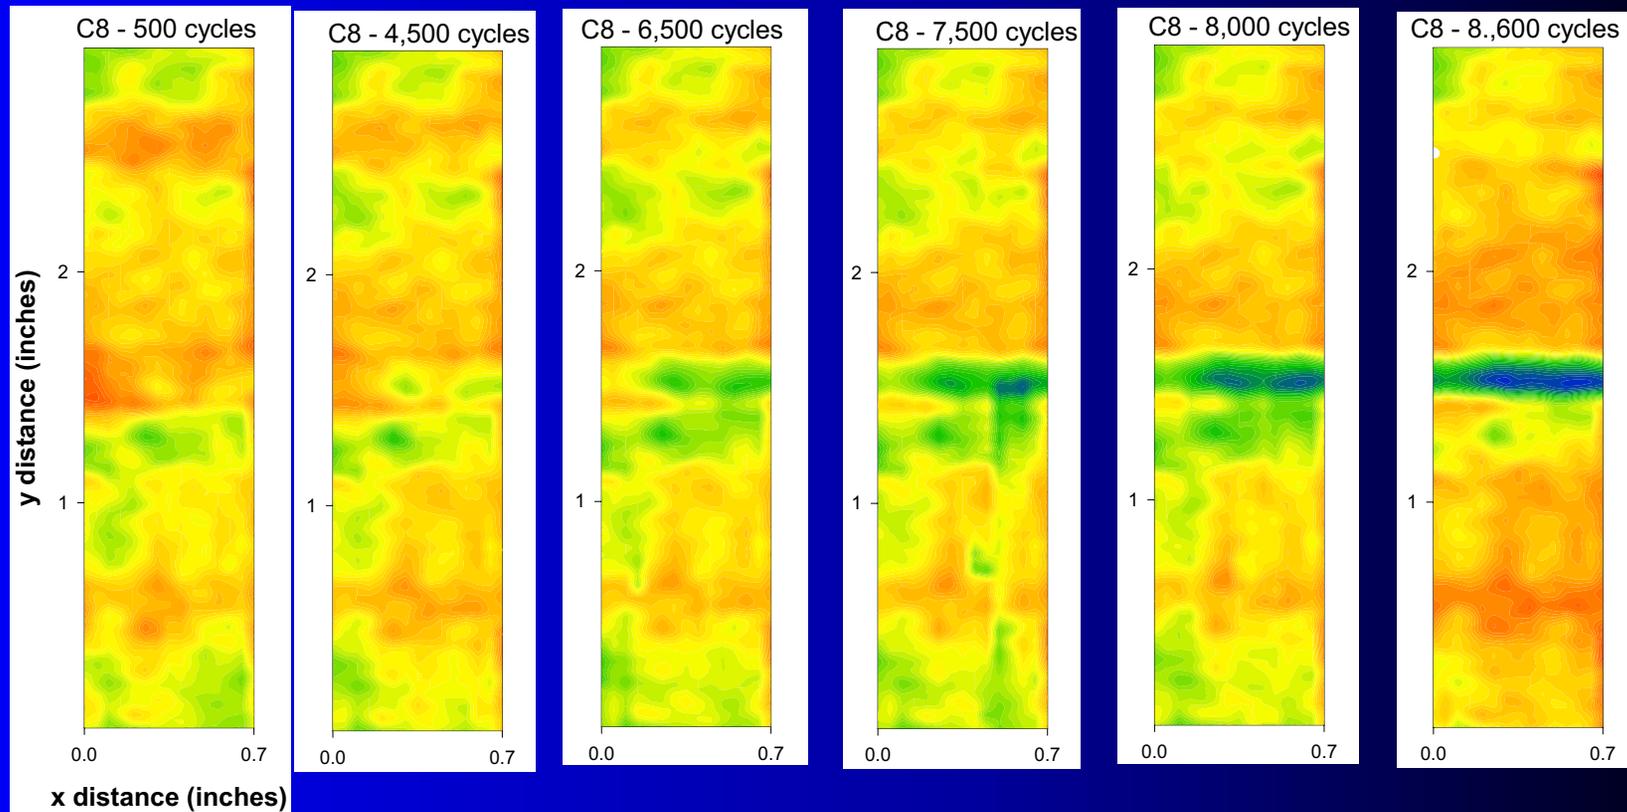
NLH Signals Indicate Fatigue Crack Growth in Laboratory Tests: SwRI IR Program

→
increasing number of load cycles

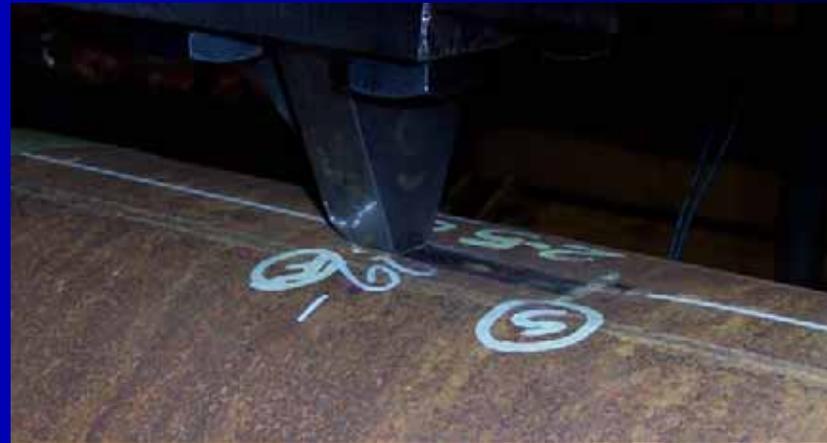
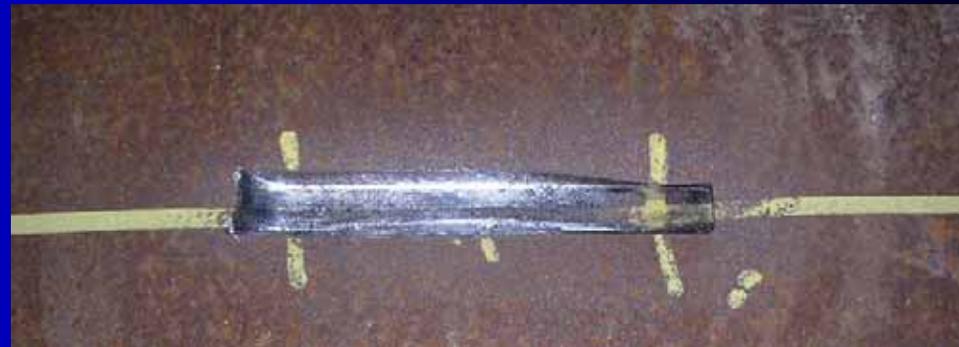
Task 1: Pipe Procurement and Fabrication of Defects

Pipe Material:

X52/X60

Pipe Dimensions:

OD 12.75 inches

Thickness 0.25 inches

Five 6-foot pipe samples

Six gouging defects in each of four samples

50 EDM notches in one pipe sample

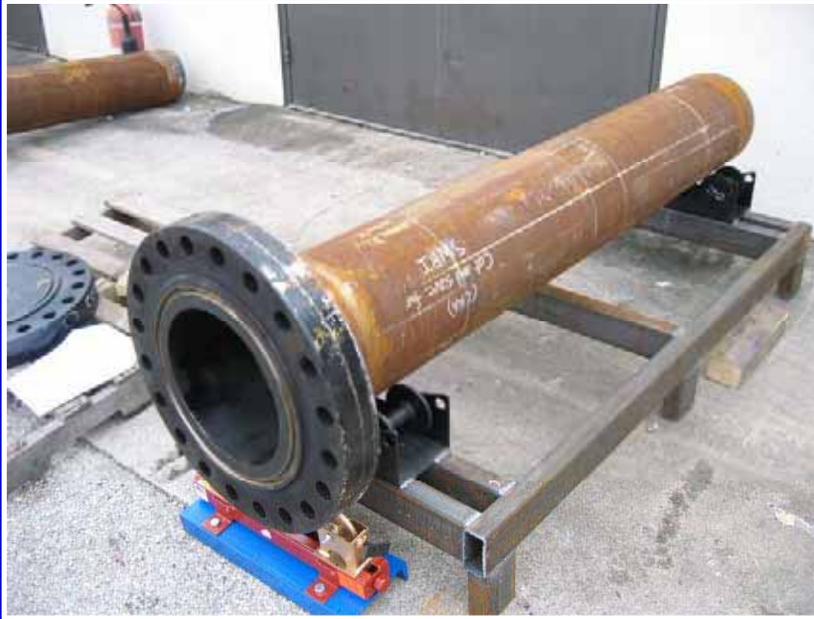
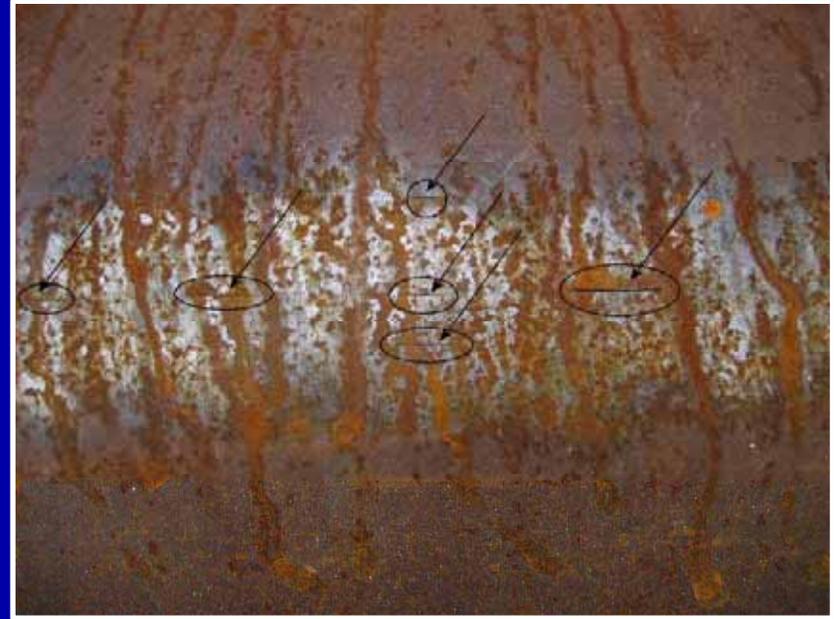
Task 1: EDM Notches Fabricated

Clusters of notches (simulating SCC) fabricated on outside of pipe.

In Task 3: NLH scans will be performed on inside of pipe at various static pressures.

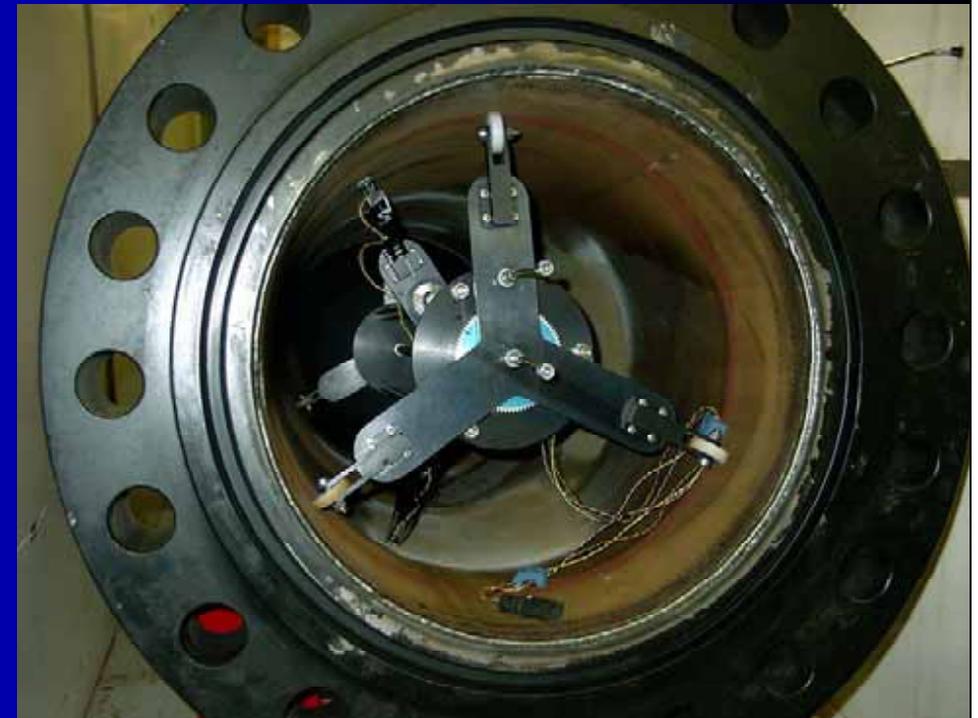
**NLH sensor
on US dime**

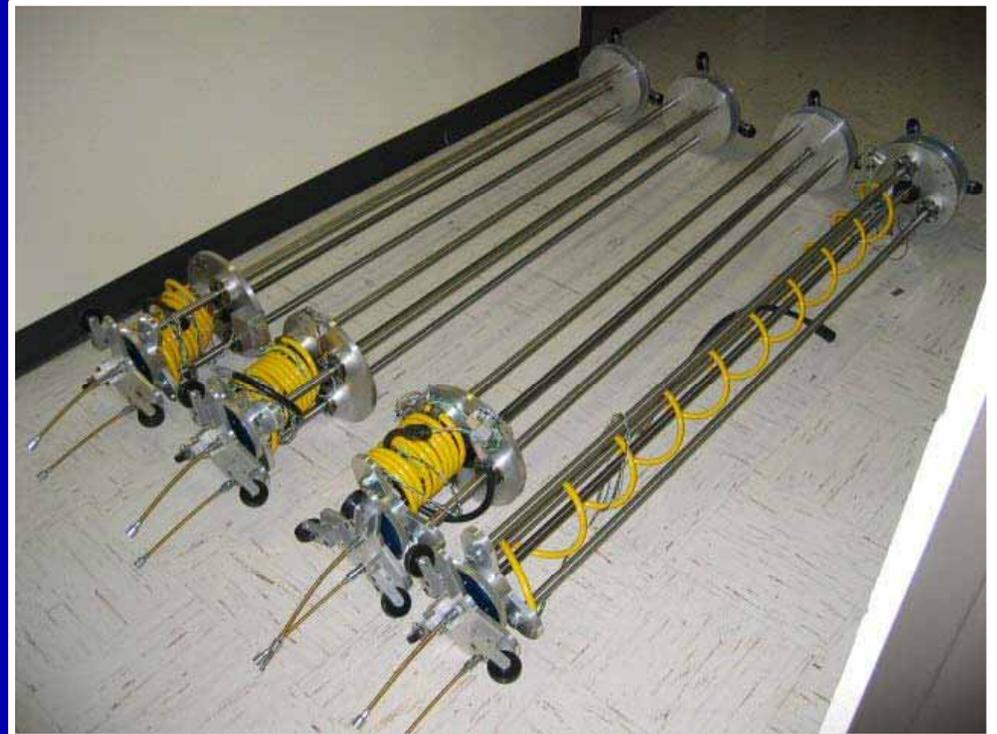
Task 2: Fabrication of NLH Scanners

Four NLH scanners designed and fabricated.

These will be inserted in the four damaged pipes and remain inside during cyclic pressure testing (800psi to 1400psi).

In Task 3, NLH scans will be made periodically as pipes fatigued to failure. Failed defects will be weld repaired.

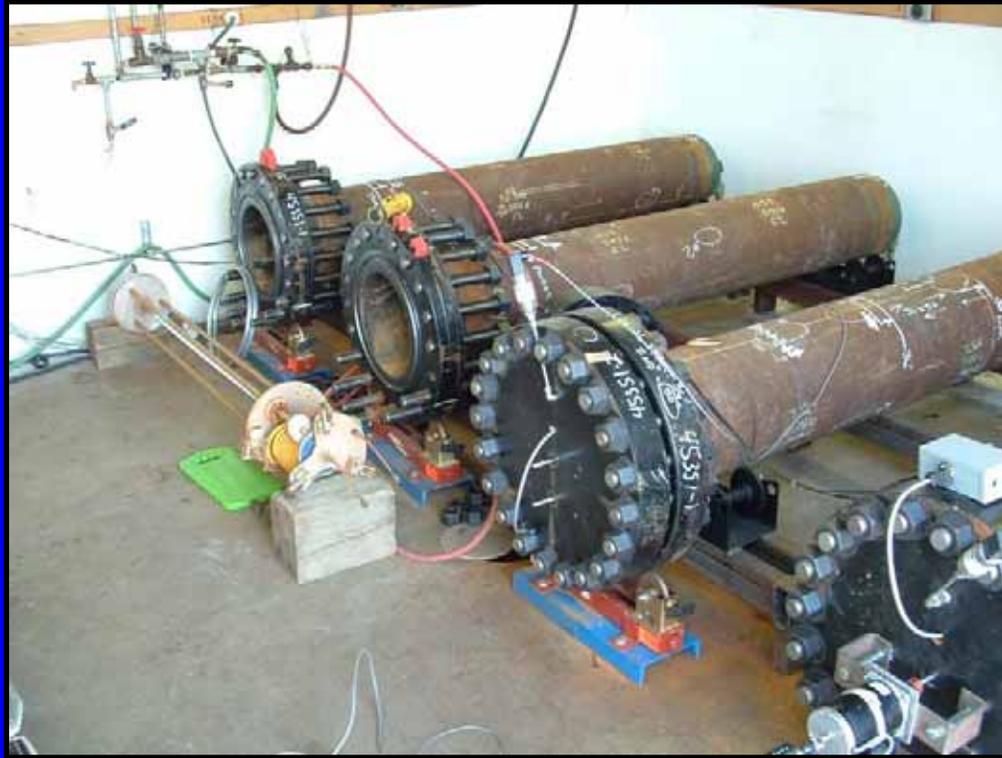
Test Chambers

Instrumentation

- **Perform NLH scans of EDM notched pipe at various pressures up to 2000 psi**
- **Cyclically pressurize gouged and dented pipes between 800 psi and 1400 psi while periodically performing NLH scans under pressure**
- **Weld repair defects that fail and continue cycling until all defects have failed**
- **Analyze NLH scan results on gouged pipes as they become available**
