Development and Demonstration of an Integrated Tool for Mapping, Sizing and Evaluation of SCC for Remaining Strength Prediction

DOT Contract DTPH56-08-T-000005

FINAL REPORT

July 8, 2011

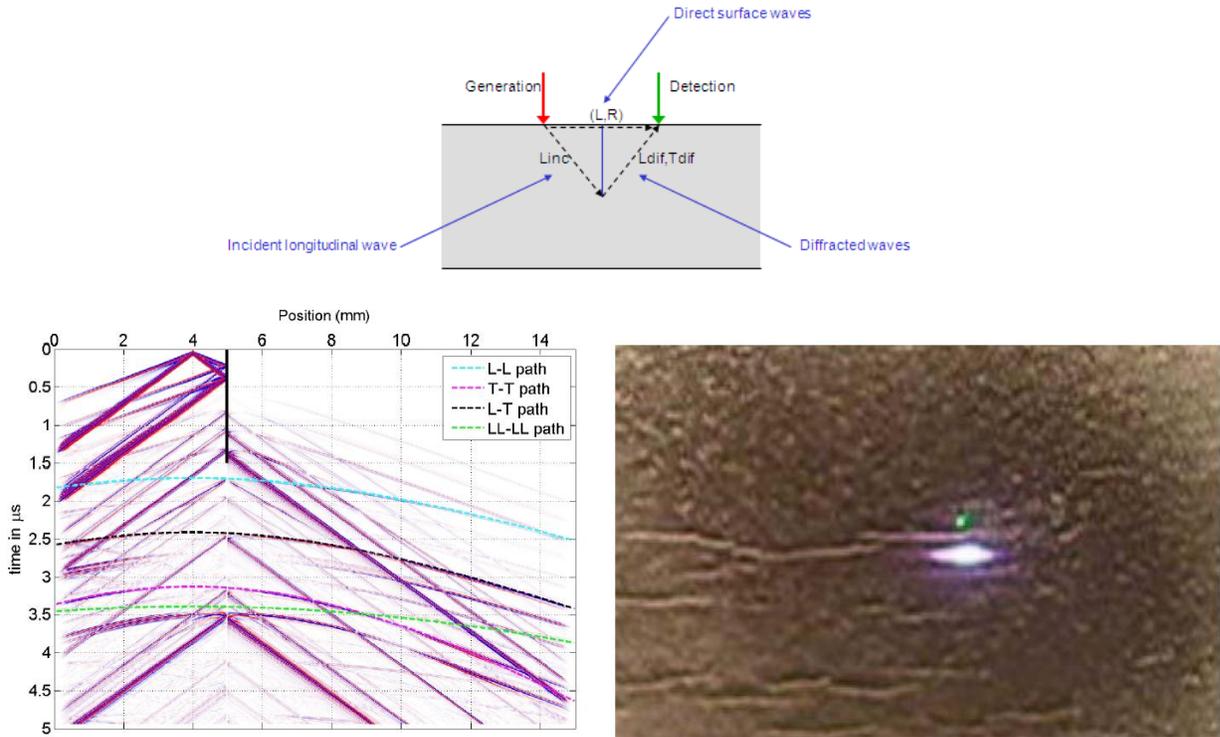
Figure 1: Position of generation and detection lasers with respect to a crack with a B-Scan plot of the normal surface velocity as a function of detection spot position. The photograph shows the laser spots on the surface of a test piece on both side of an SCC crack.

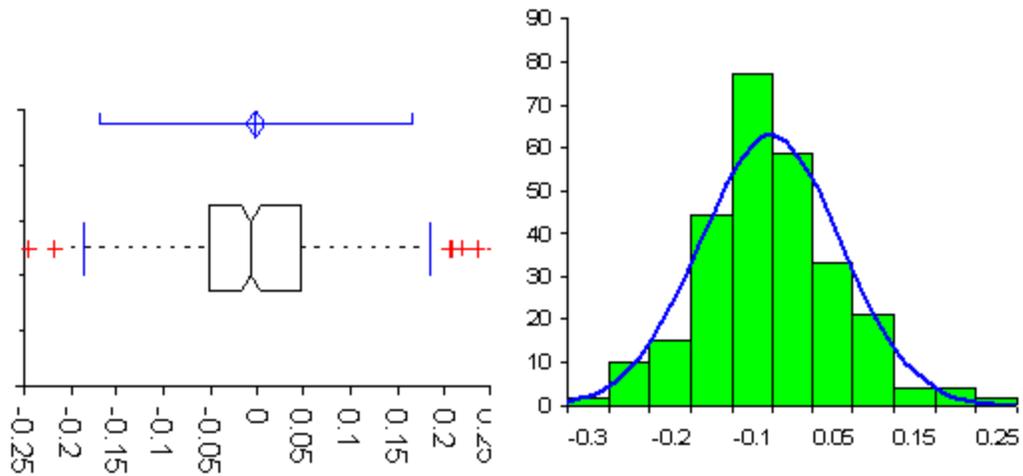
Figure 2: Error distribution for MPI vs MWM-Array crack length measurements.

to crack depth will vary with crack morphology (i.e. width). Preliminary experiments conducted involving the scanning of pipe samples with SCC using the JENTEK FA28 MWM-Array sensor, consecutively grinding, re-scanning the samples with MWM-Array and observing changes in the conductivity scan. This data will be used to support further development of the MWM-Array crack depth capability. Separate DOT funded research was reported by JENTEK relating to development of a deep penetrating very low frequency array probe that should enable crack measurements to depths greater than 0.1 inches. Multiple trials by Applus RTD with the JENTEK MWM-Array documented the detection limits for SCC cracks compared favorably with black on white MPI [2]. A comparison of results from MPI with MWM-Array is shown in **Figure 2** showing 95% of the time the error was between -0.017 and 0.003 inches.

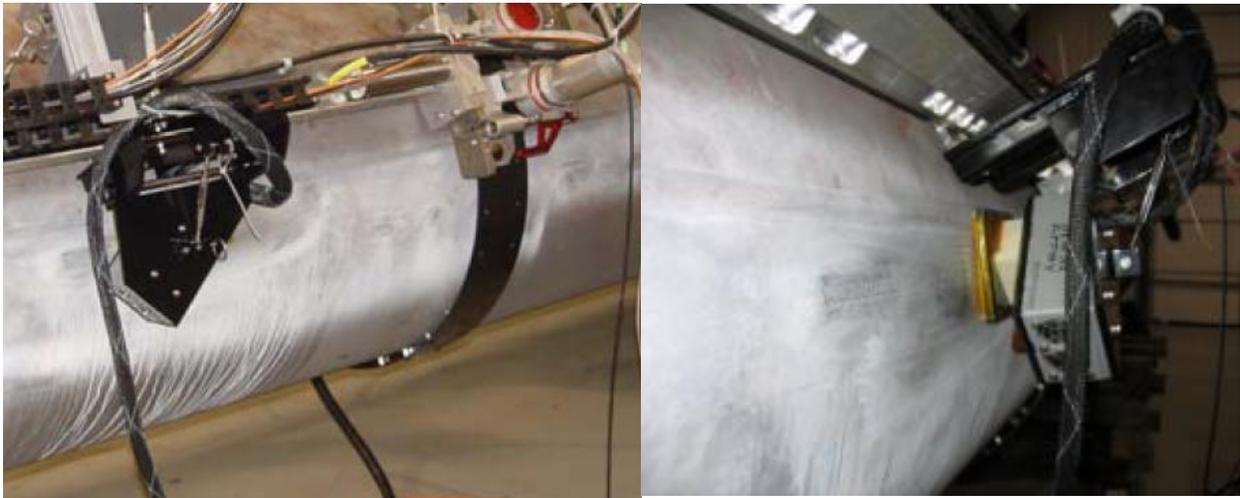
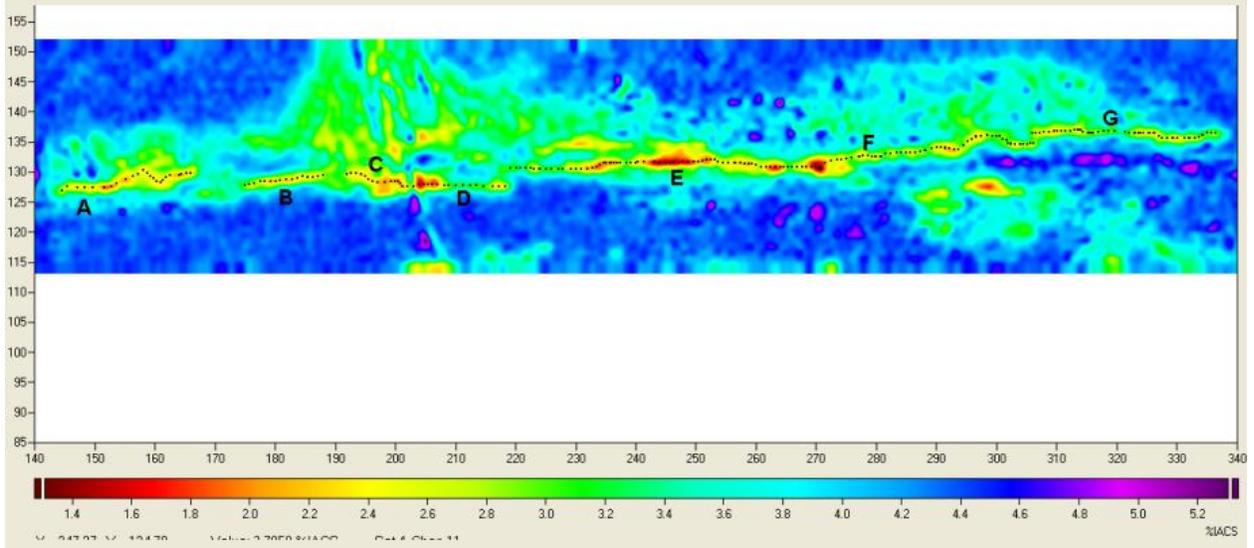
Figure 3: MWM-Array scanning to map surface SCC cracks. A crack map for pipe 10A is shown with the crack centreline tracking

The MWM-Array sensor was integrated into a scanning platform as shown in **Figure 3** which enables scanning in both circumferential and axial directions on the external pipe surface. The MWM-array creates a digital record of crack indication centerline coordinates thus providing a source of tracking coordinates for use by LToFD for necessary precise spacing from cracks.

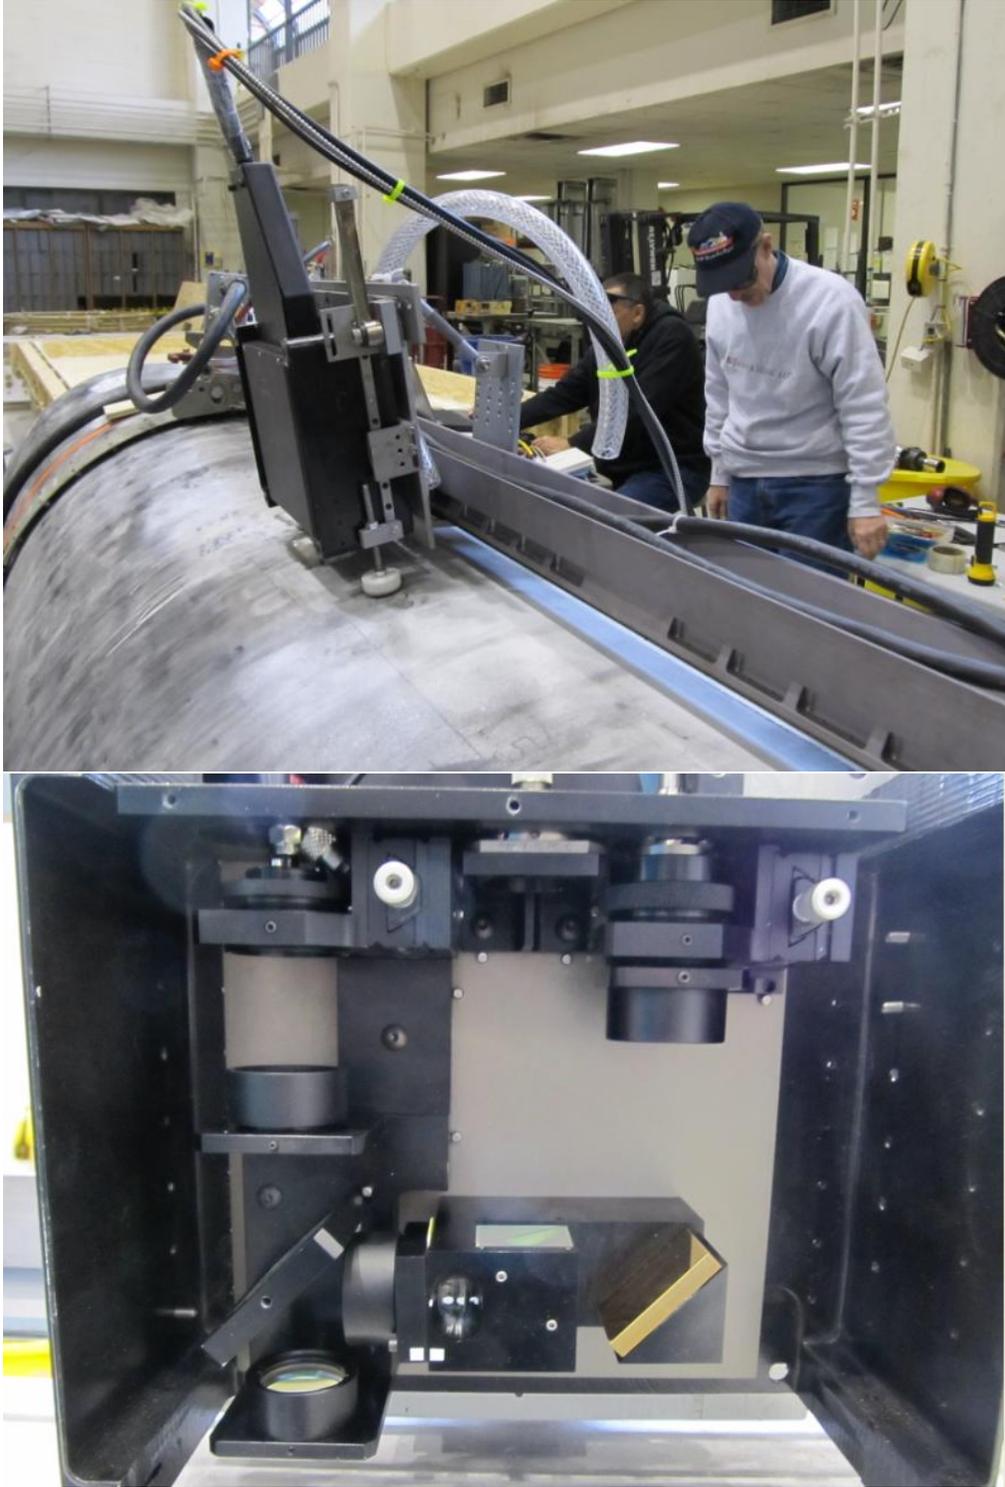
Figure 4: Photographs of the improved inspection head and fiber optic cable bundles. The inspection head travels axially along the lead screw rail shown and is driven circumferentially by actuator motors clamped to bands at each end of the lead screw rail.

motorized lead screw is mounted onto the scan rail drive and provides axial motion for the sensor packages. A motor controller is programmed with crack centerline coordinates obtained from a MWM-Array scan of a pipe surface segment. Since SCC cracks are known to coalesce into non-axial configurations it was necessary to provide a motor controller capable of accepting and following high resolution coordinates, both axial and circumferential from the MWM-Array in order to keep the LToFD beams optimal beam offset of 1.25 to 1.5 mm from the crack centerline. A data conversion routine was required for the transfer of MWM-Array data to the scanner motor controllers. Repositioning repeatability of the scanner must be maintained to within +/- 0.75mm in order to maintain beam spacing along the crack path. **Figure 4** contains photographs of the improved inspection head and fiber optic cable bundles.

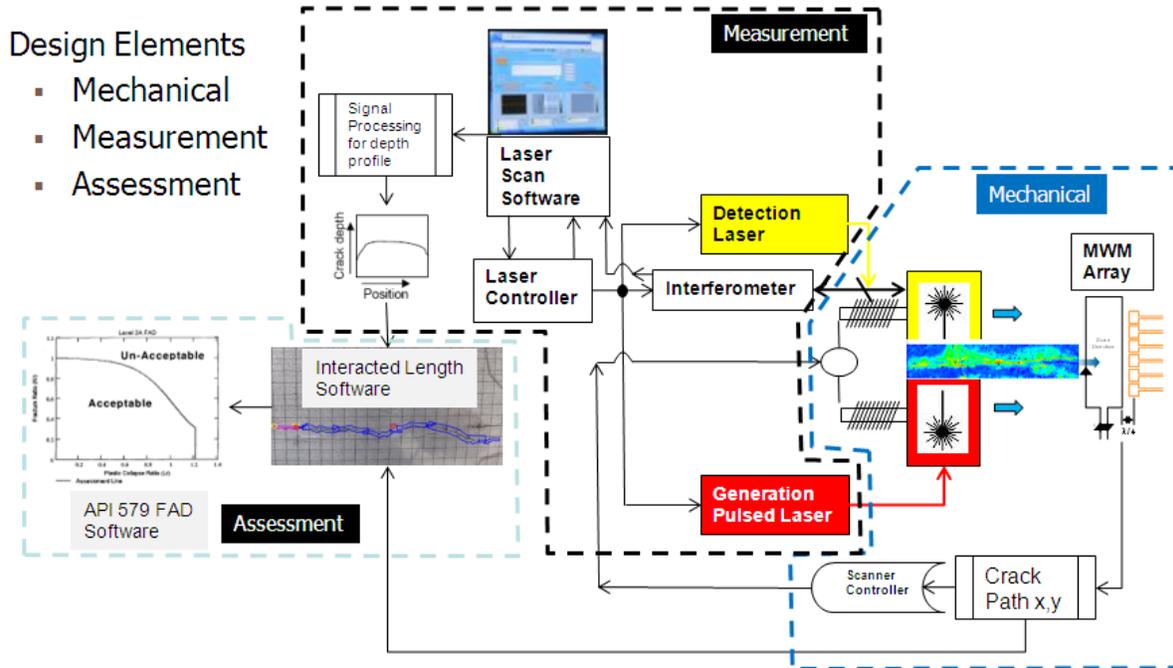
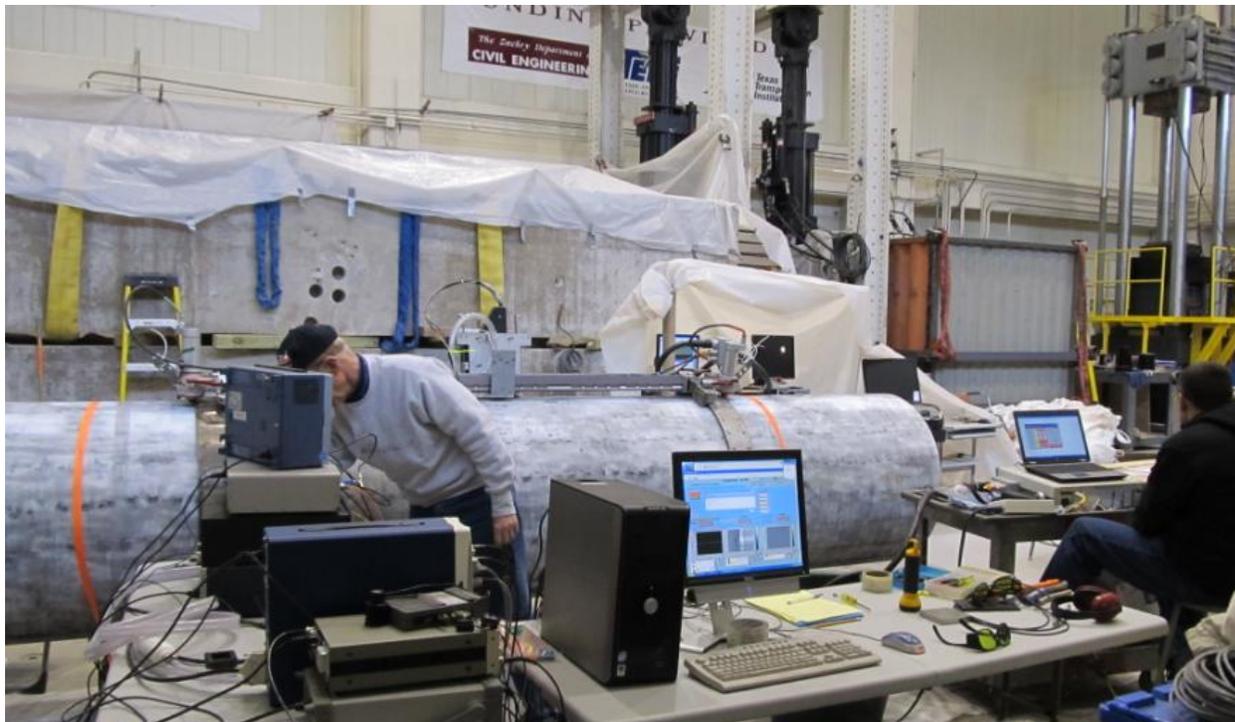
Figure 5: Functional illustration of the integrated tool process including the mechanical, signal analysis and integrity assessment elements. A photograph of the integrated tool set up at the field SCC trials is also shown. The scanner rail with laser measurement head is shown mounted on pipe with the signal analysis and Laser Scan™ software shown in the foreground. The hydrostatic test cell is shown in the background.

A schematic illustrating the integrated tool functional specification consisting of crack surface mapping, LToFD measurement and crack assessment is shown in **Figure 5**.

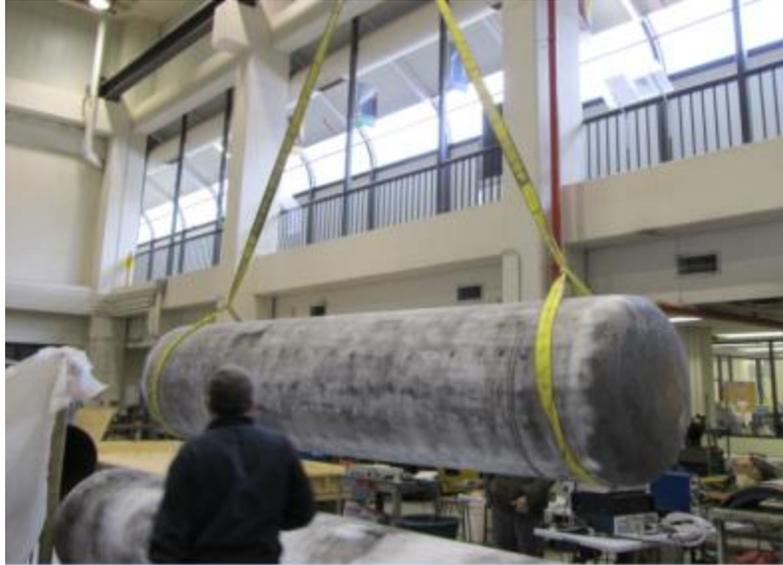
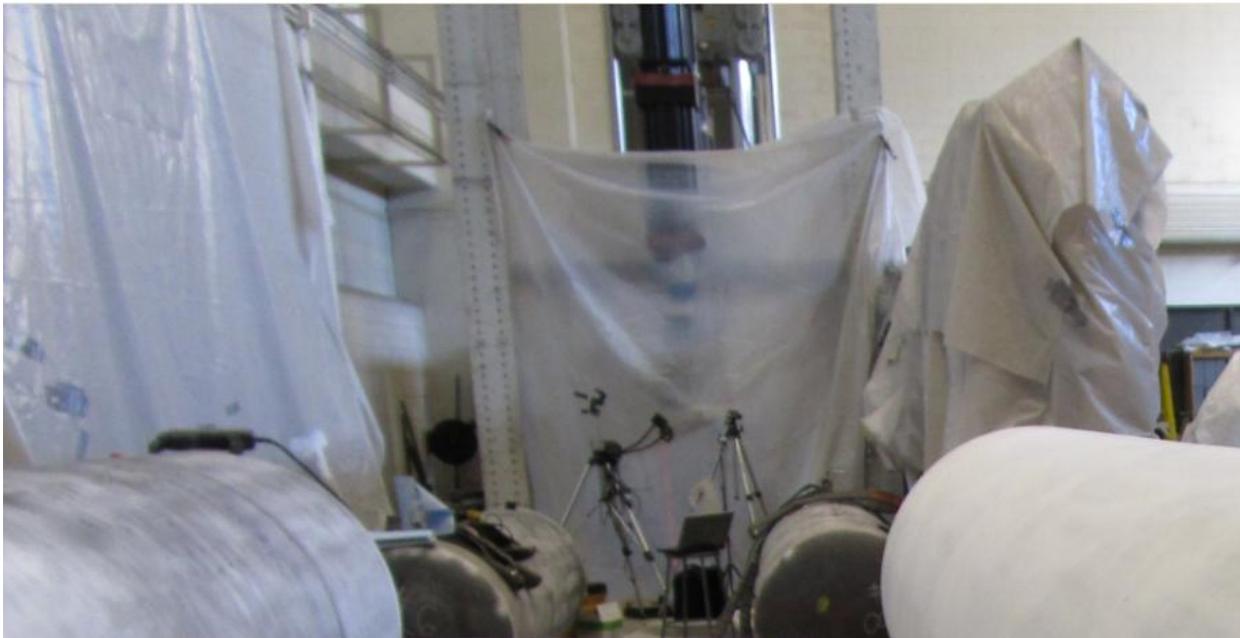
Figure 6: Photographs of typical configuration prepared for the hydrostatic pressure-to-failure test sample pipes and their arrangement within the pressure test cell at Texas A&M University Structural Engineering Laboratory.

The inspected pipes containing the SCC indications had their ends closed off by butt-welding of dished end caps and the assemblies were filled with water and subjected to increasing internal hydrostatic pressure until the assemblies leaked or ruptured. The most severe crack location, identified by the screening process, on each test sample was instrumented by strain gauges and observed using high speed videography. Figure 6 shows the configuration for pipes prepared for hydrostatic test and the

arrangement of pipes within the pressure test cell at Texas A&M University who conducted all pressure test-to-failure under the direction of Blade Energy Partners, Ltd. **Table 1** summarizes the results from the hydrostatic tests.

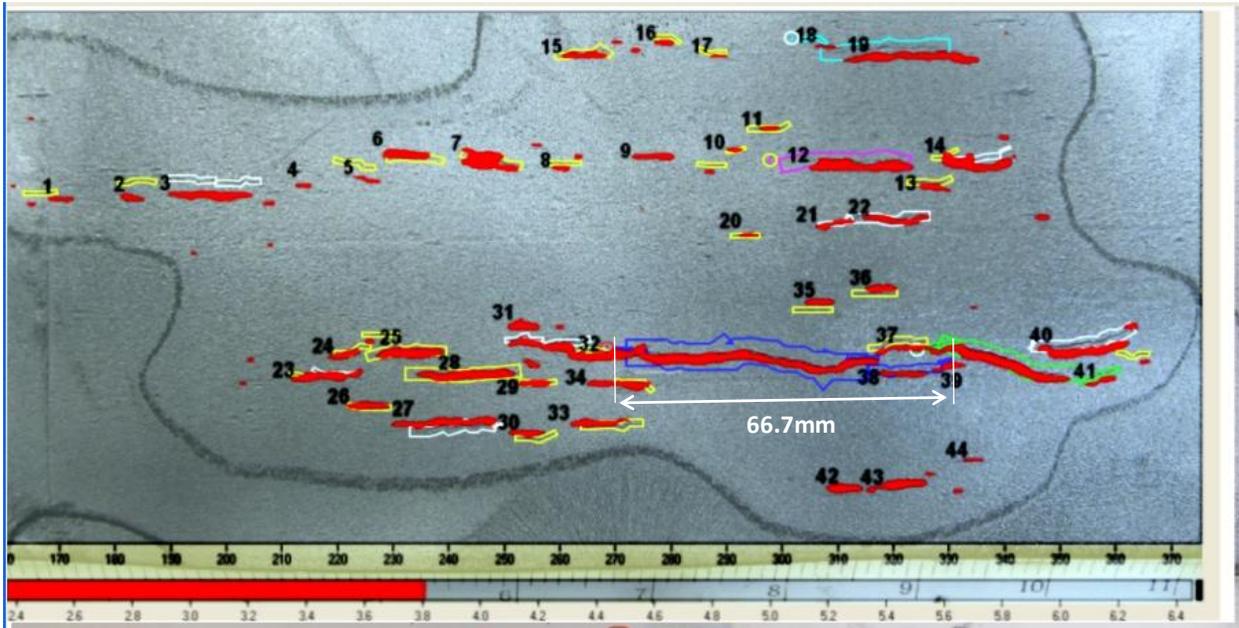
Figure 7: MWM-Array crack map from pipe #4 with NACE/CEPA interaction criterion applied measuring a maximum crack length of 66.7 mm. These measurements combined with depth screening by PA ultrasonic were evaluated by API 579 FAD to identify the most significant cracks within the colony for sizing by LToFD.

Figure 7 shows the MWM-Array crack map from the most significant SCC crack field found on Pipe # 4 together with the maximum crack length predicted by the extent of axial interaction determined in accordance with the NACE/CEPA criterion. Based on the maximum crack length measurements and PA ultrasonic depth screening the most severe interacted crack was identified based on API RP 579 FAD criterion and noted as the target crack #32 in Figure 7. LToFD depth measurement was performed on the target crack and the ablation track from the generation laser in relation to the target crack are shown in **Figure 8** together with the depth results obtained from LToFD, PA screening and the actual depth profile for SCC obtained from the fracture surface resulting from the hydrostatic test to failure.

The maximum interacted crack length was determined by using the crack tip to tip and end to end separation specified by NACE RP0204 using commercially available software where digital representations of the crack fields (either MWM or MPI) can be scaled and interacting cracks identified. **Figure 10** is a unity plot comparing the predicted interacted crack lengths with the actual maximum crack length observed on the fracture surfaces from the test pipes. Photographs of the fracture surfaces are provided in Annex A and interacted maximum length determined by measurements from both MPI and MWM-Array crack surface maps shown in **Figure 7** for Pipe 4 and the other test pipes also provided in Annex A.

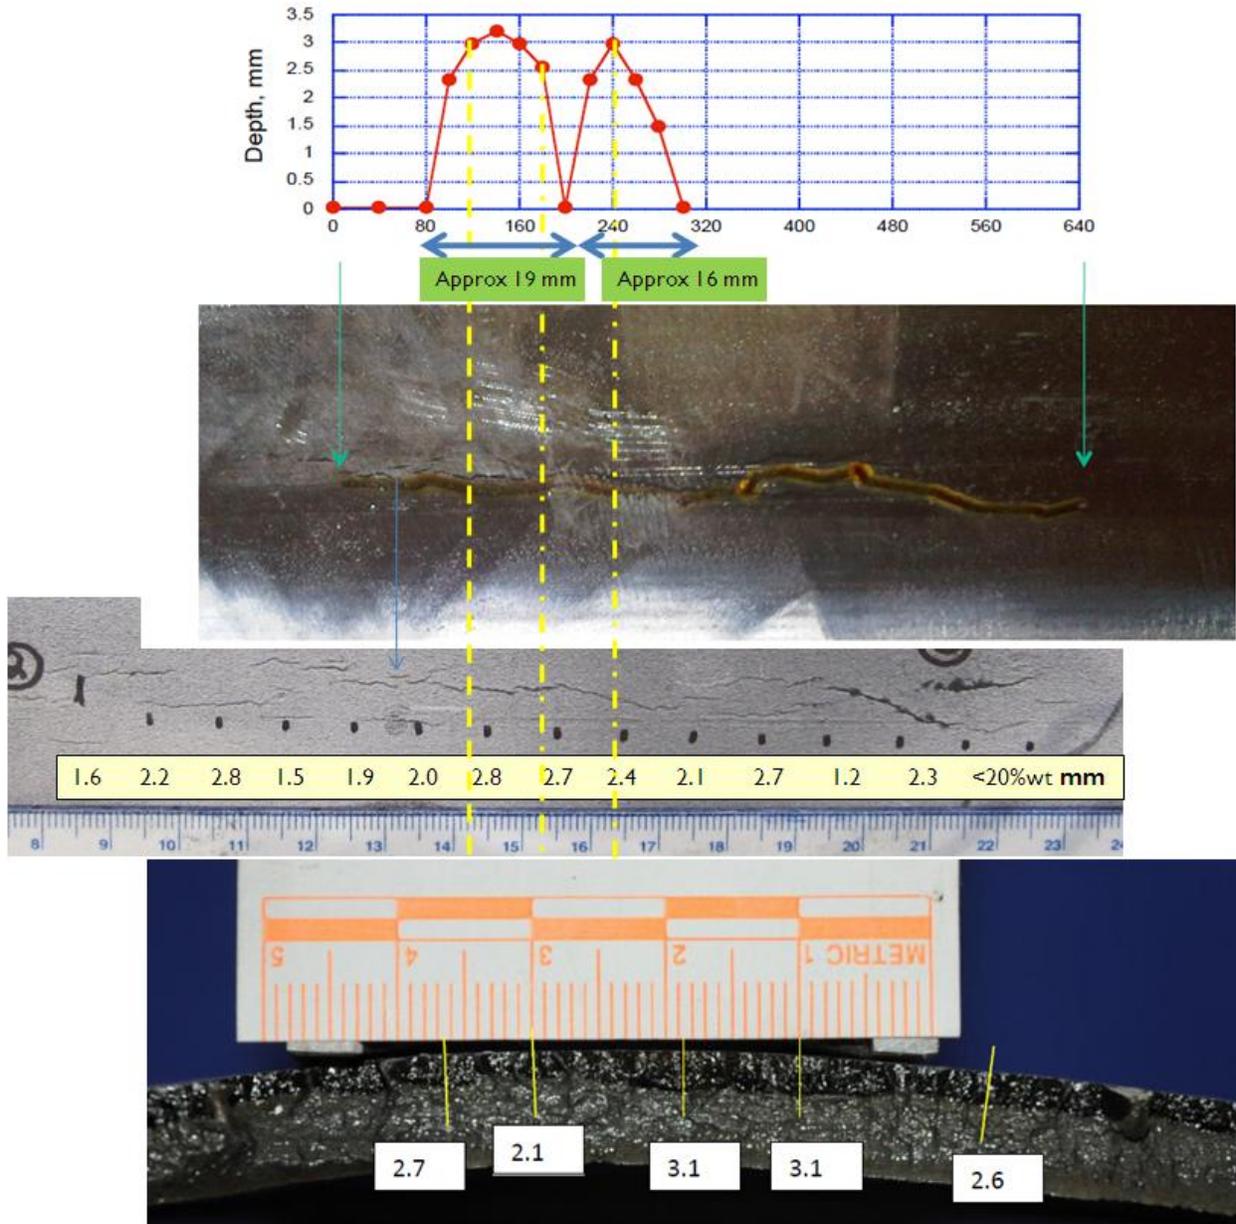
Figure 8: Results of LToFD depth sizing performed on target crack from Pipe # 4 showing good agreement between predicted depth and actual SCC depth determined from fractures surfaces obtained after hydrostatic test to failure.

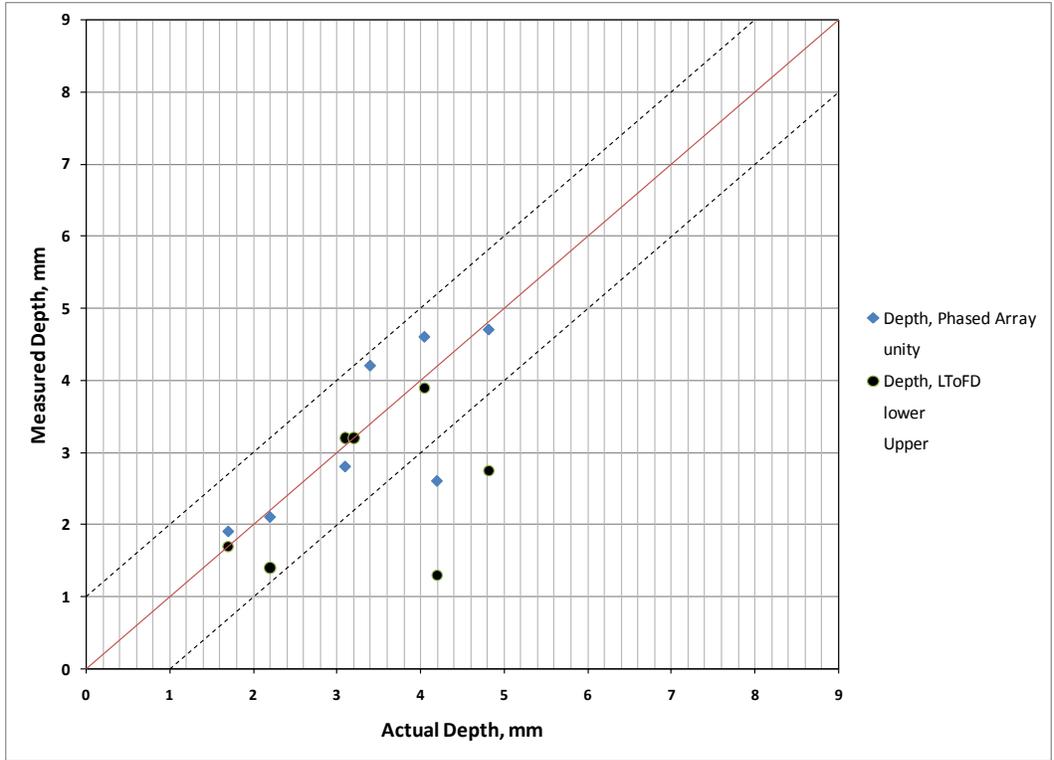
Figure 9: Crack depth unity plot comparing NDE measurements with actual crack depths measured from fracture surfaces.

A unity plot comparing the LToFD and PA depth size predictions is shown in **Figure 9**. The mean error (ILI-Actual) for the test population was non-conservative for both PA and LToFD (-0.08 mm for PA and -0.83 mm for LToFD influenced by the presence of two non-conservative outliers. Pipe #13, crack 13A represented the most significant undercall for both PA and LToFD. Pipe #10A exhibited a comparison outside of +/- 1.0mm for LToFD while PA estimated the depth well for the significant SCC crack. It was

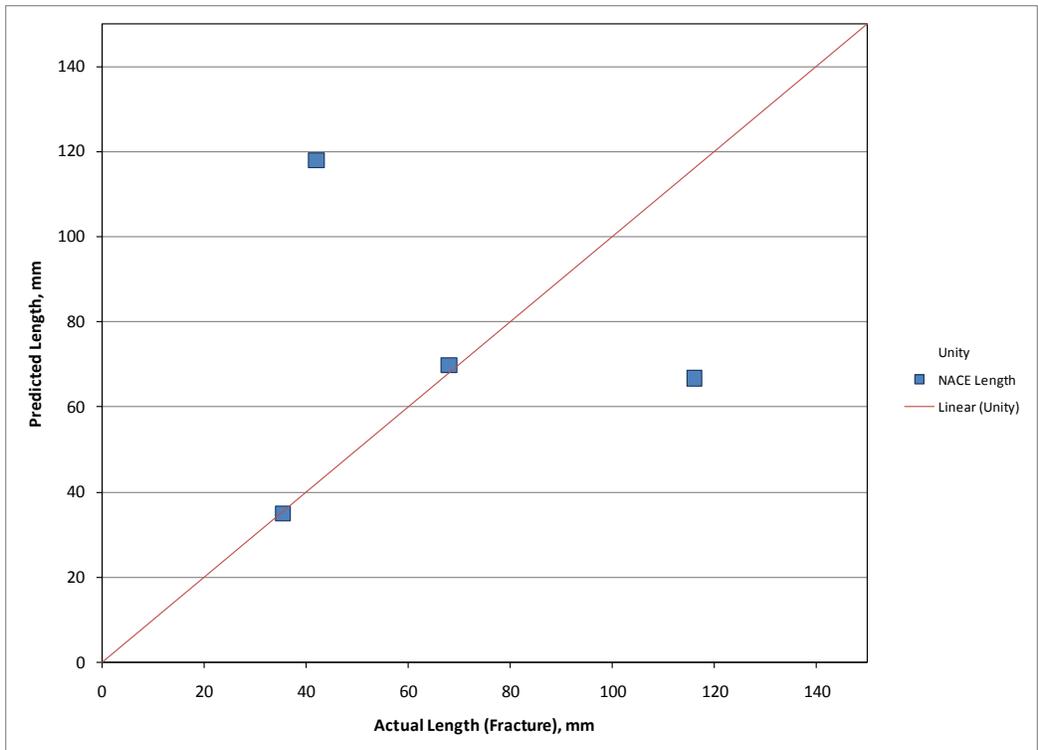
Figure 10: Comparison of actual interacted crack length from fracture surfaces with predicted maximum interacted length from NACE criterion.

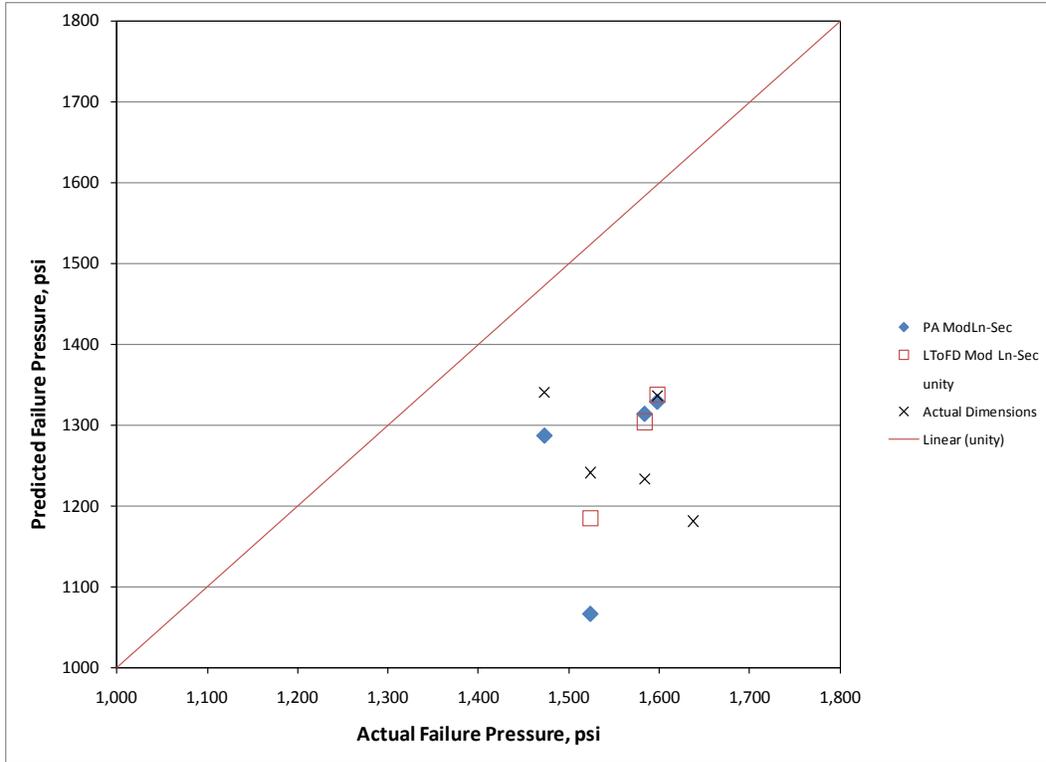
Figure 11: Failure pressure unity plot, NG-18 Mod Ln-Sec compared with actual hydrostatic test failure pressures.

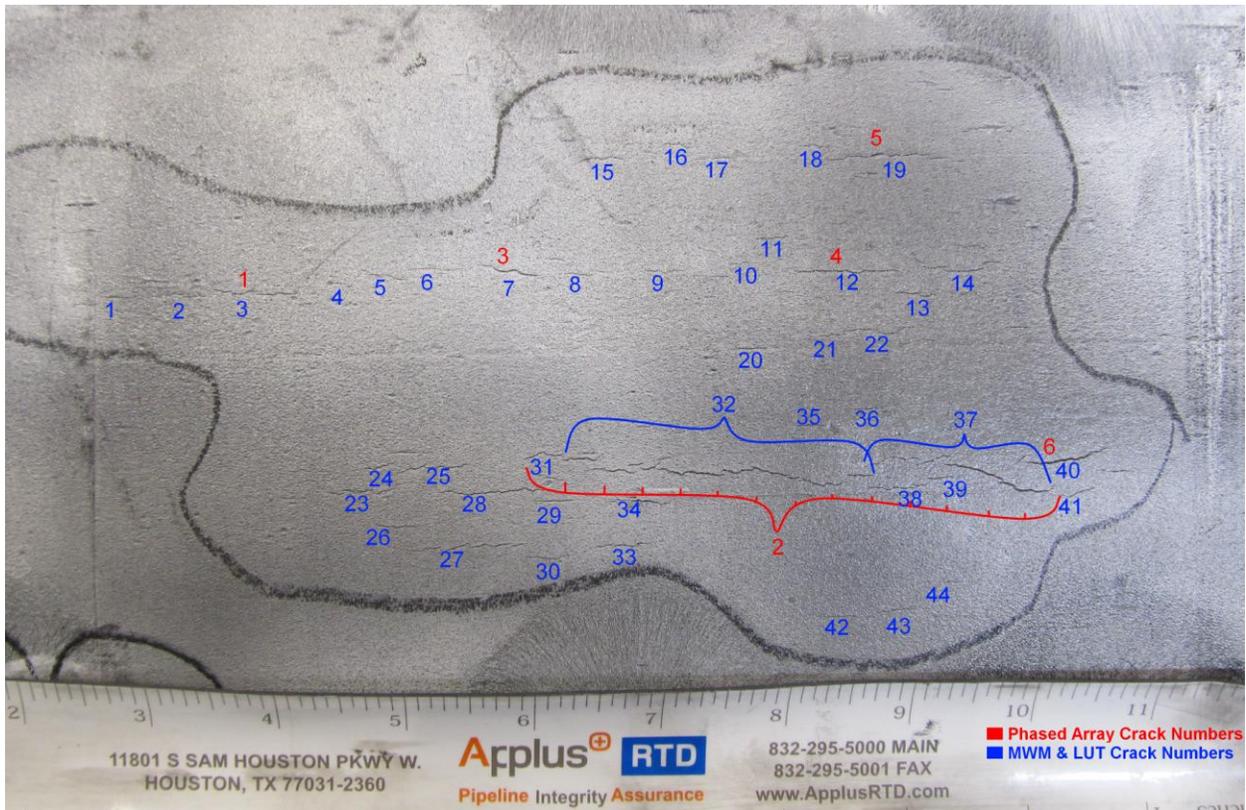
Pipe 4-MPI photo of SCC colony with MWM numbering (blue)

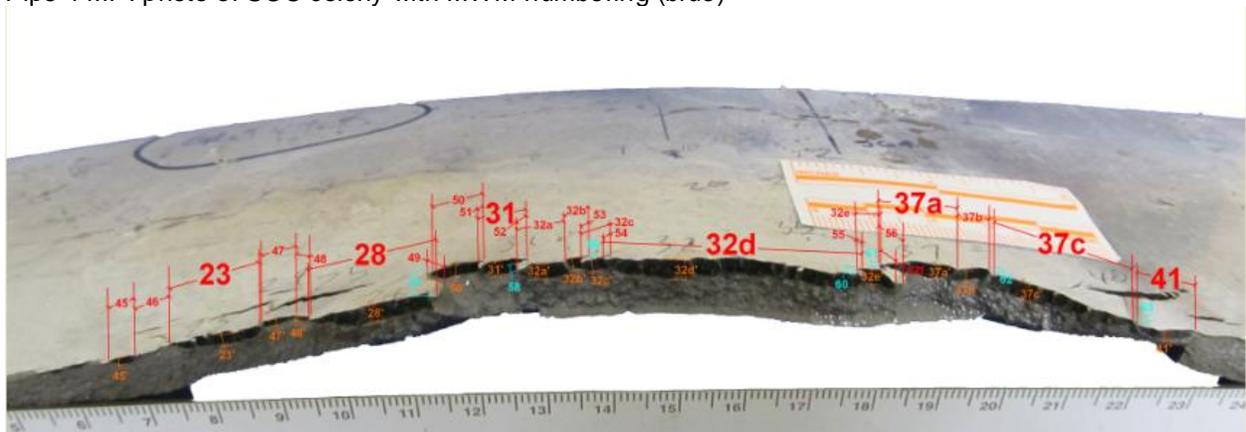
Pipe 4- Fracture surface after rupture at 1584 psi.

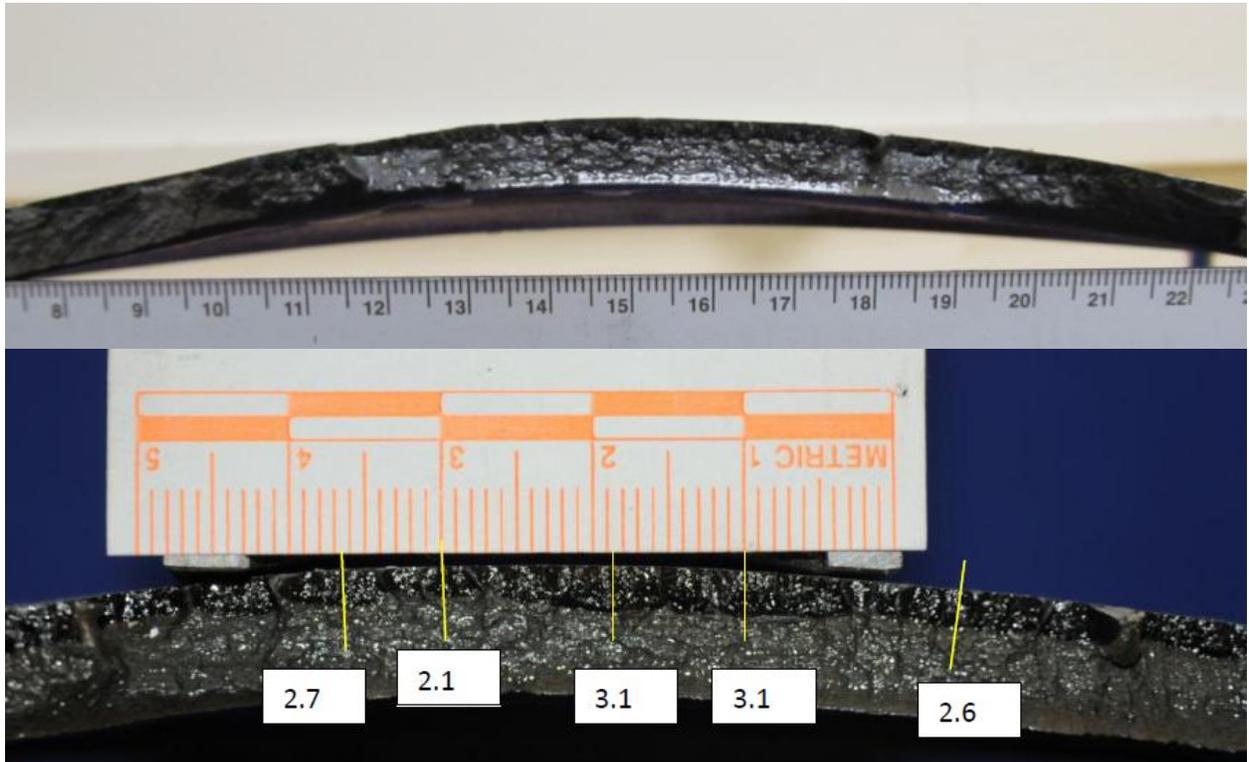
Pipe 4: Detailed measurements of interacted SCC crack profile after rupture at 1584 psi.

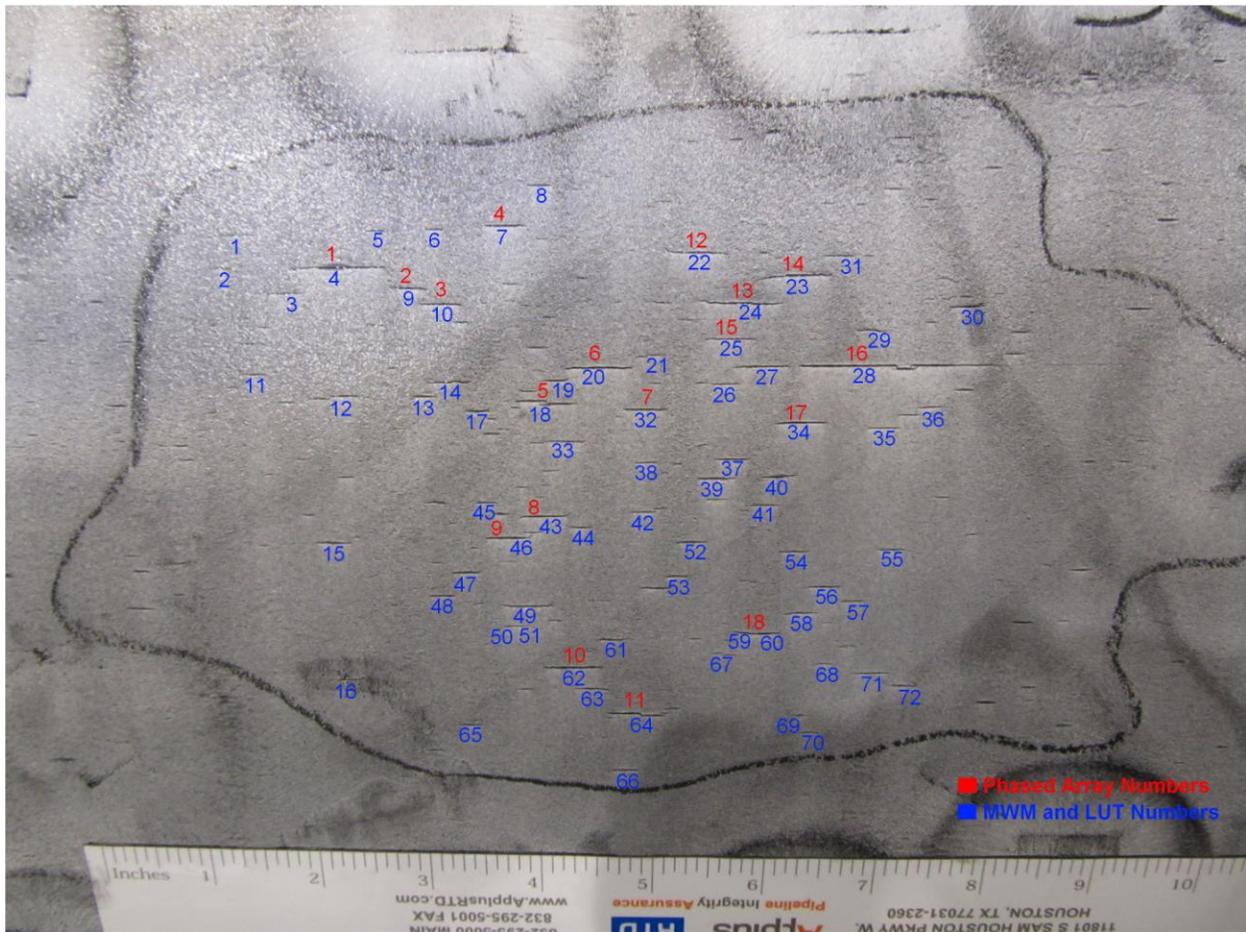
Pipe 5: MPI photo of SCC colony with MWM numbering (blue)

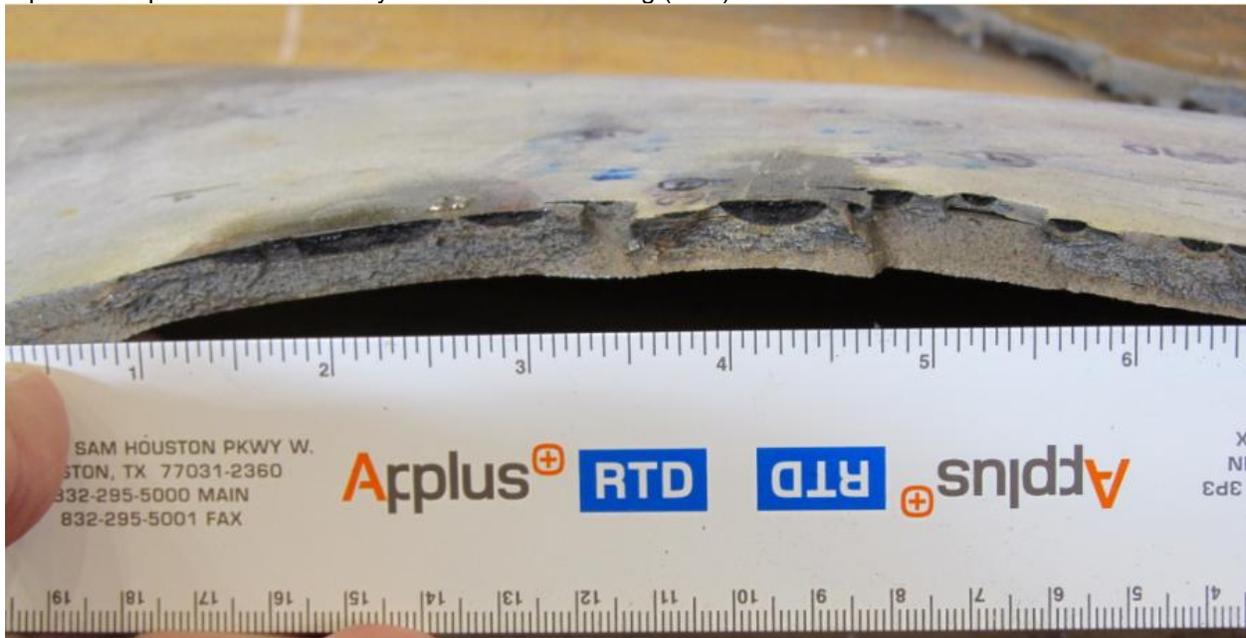
Pipe 5: Fracture surface after rupture at 1473 psi.

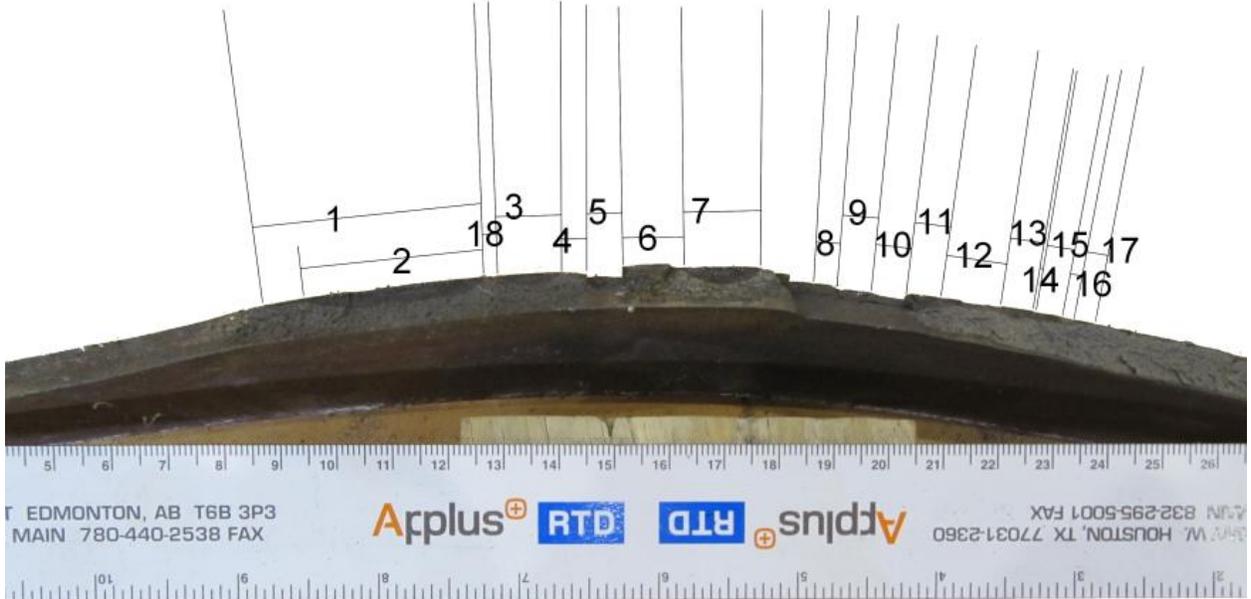
Pipe 5: Complete fracture surface after rupture at 1473 psi

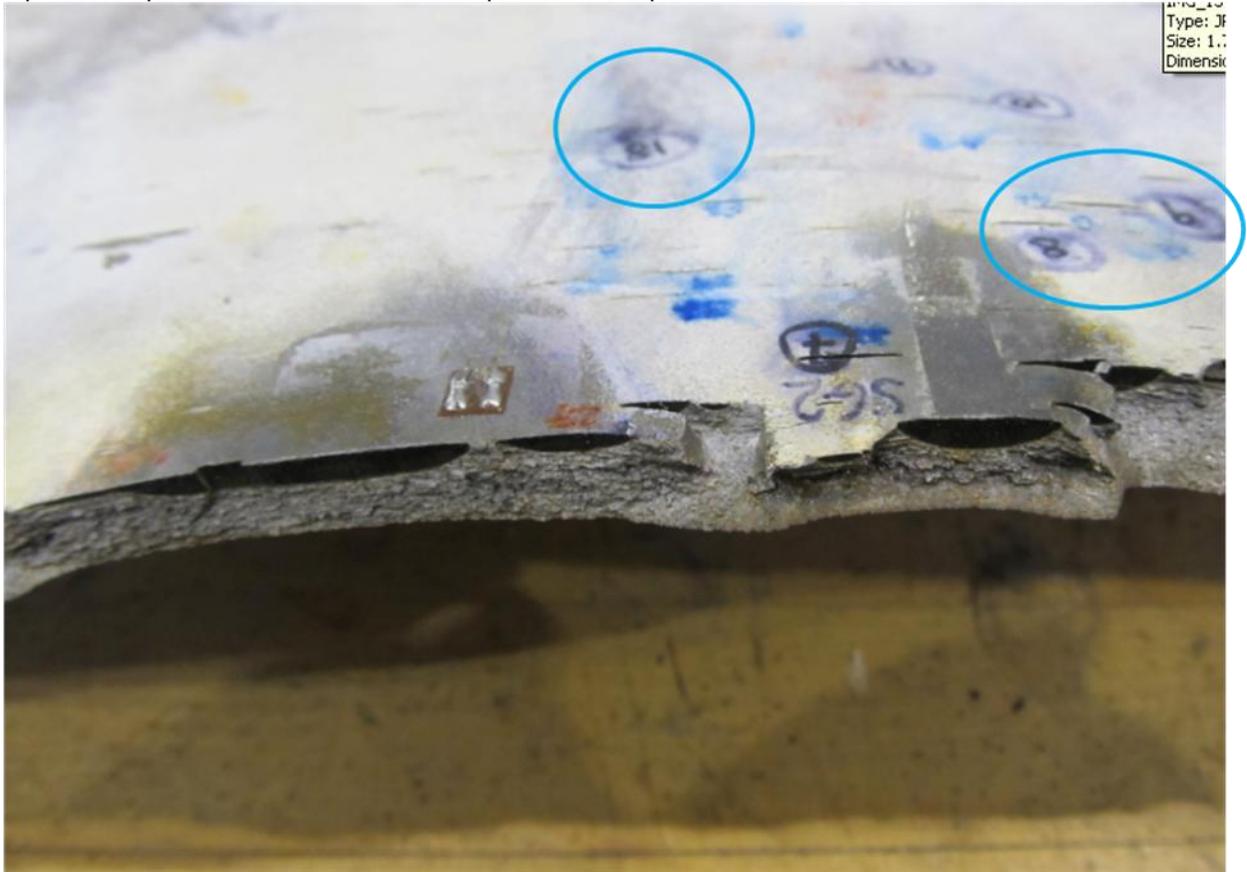
Pipe 5: Fracture surface showing reference markers for orientation with the red phased array crack markers.

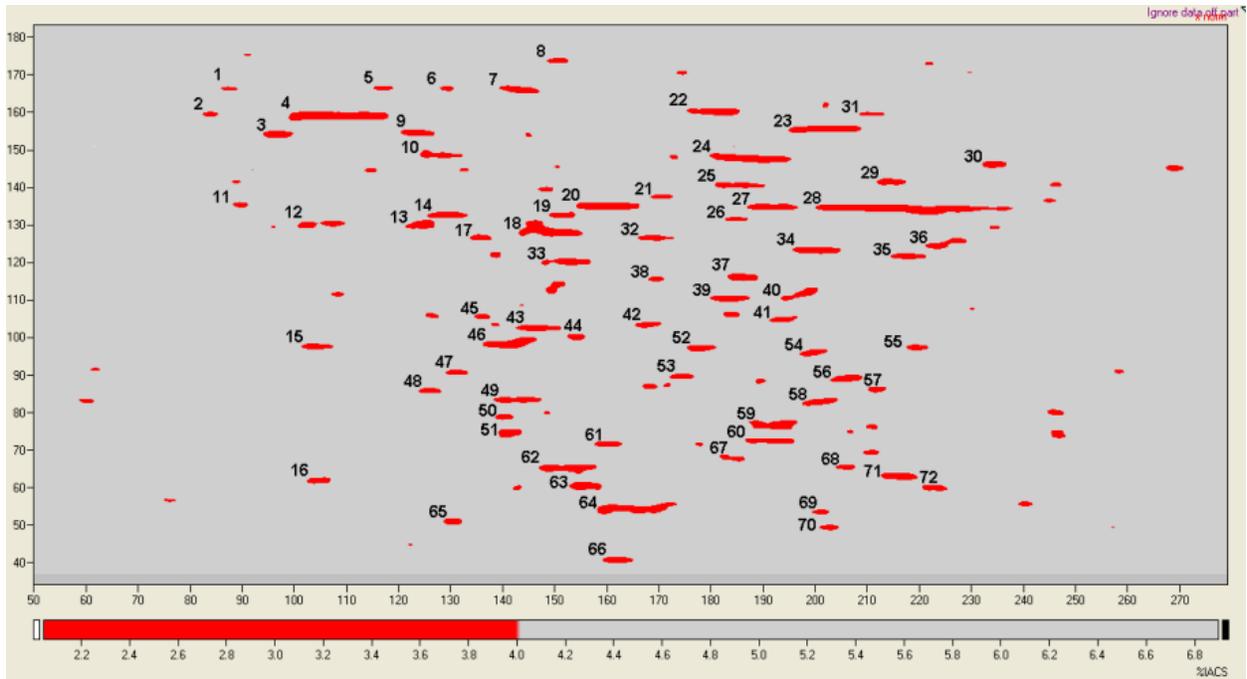
Pipe 5: MWM-array surface crack mapping

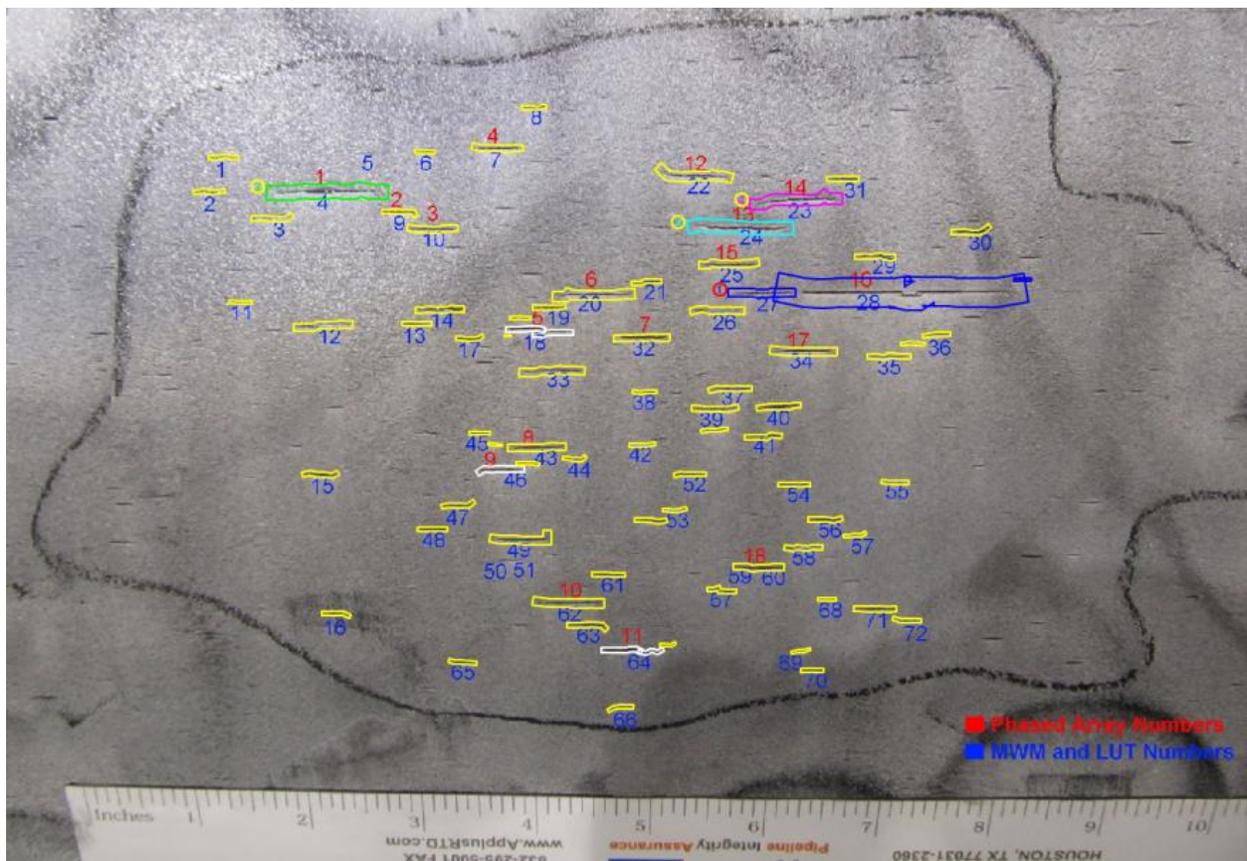
Pipe 5: NACE crack interaction program tracks overlain on MPI photograph

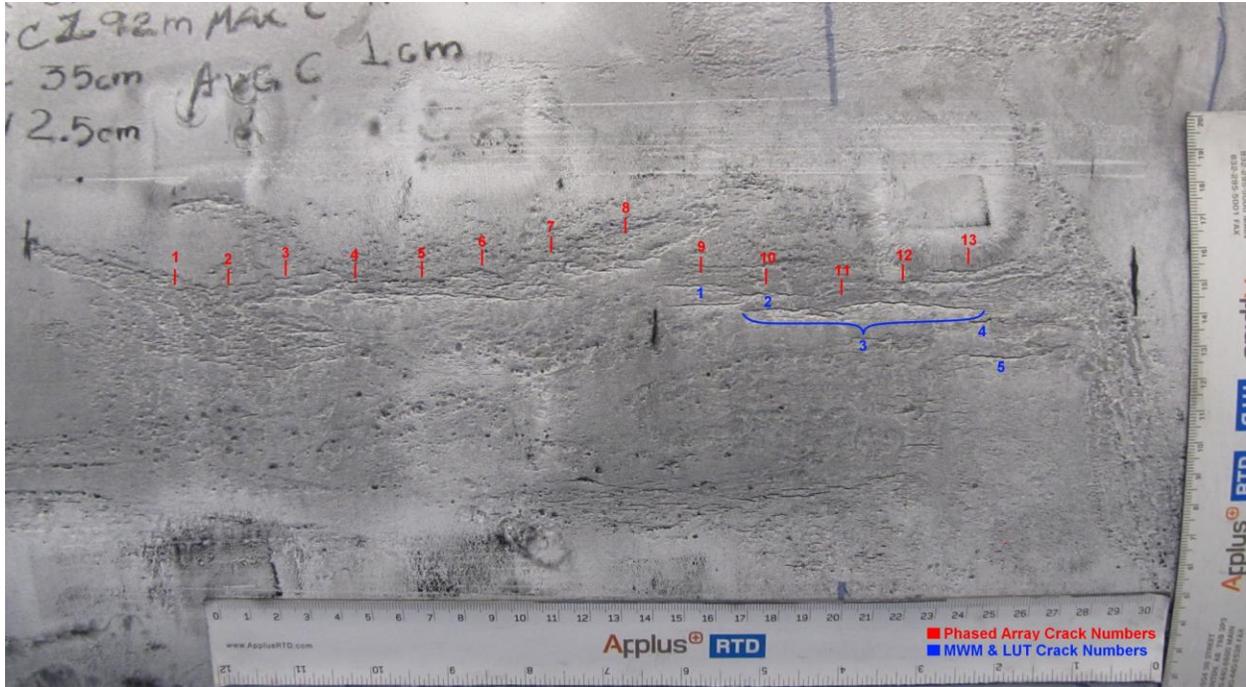
Pipe 10A: MPI photo of SCC colony with MWM numbering (blue)
