Development and Demonstration of an Integrated Tool for Mapping, Sizing and Evaluation of SCC for Remaining Strength Prediction

DOT Contract DTPH56-08-T-000005

FINAL REPORT

July 8, 2011

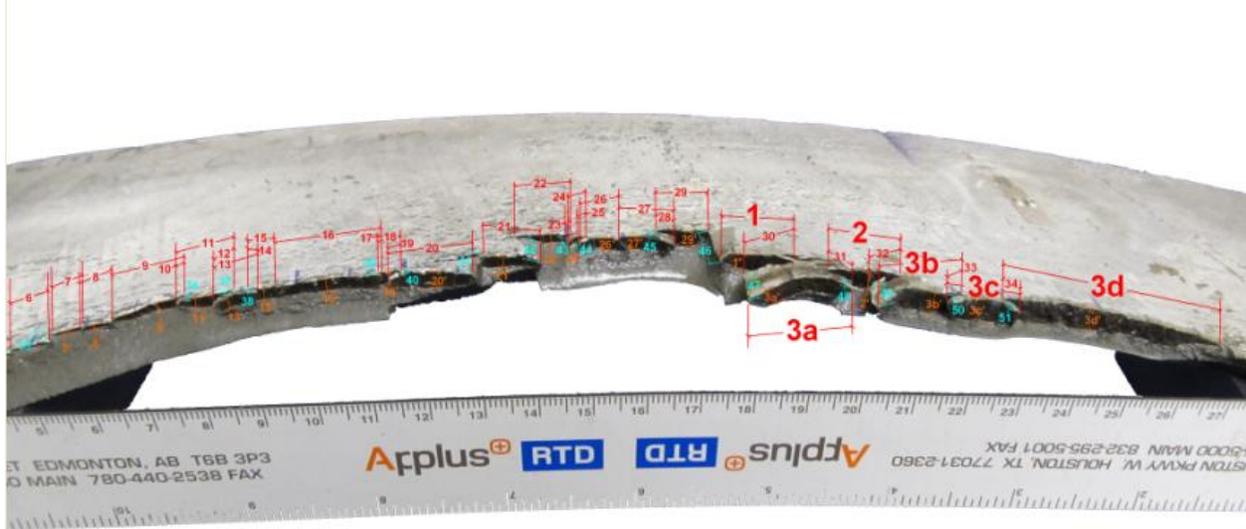
Pipe 10A: Complete fracture surface after rupture at 1524 psi

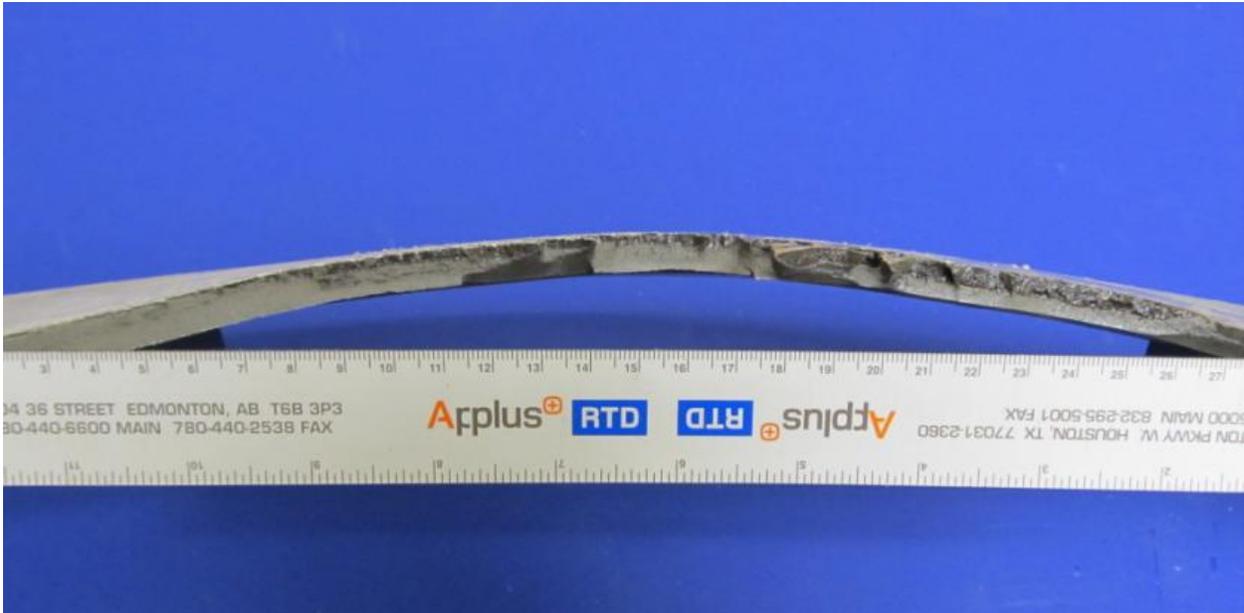
Pipe 10A: Duplicate fracture surface photo after rupture at 1524 psi.

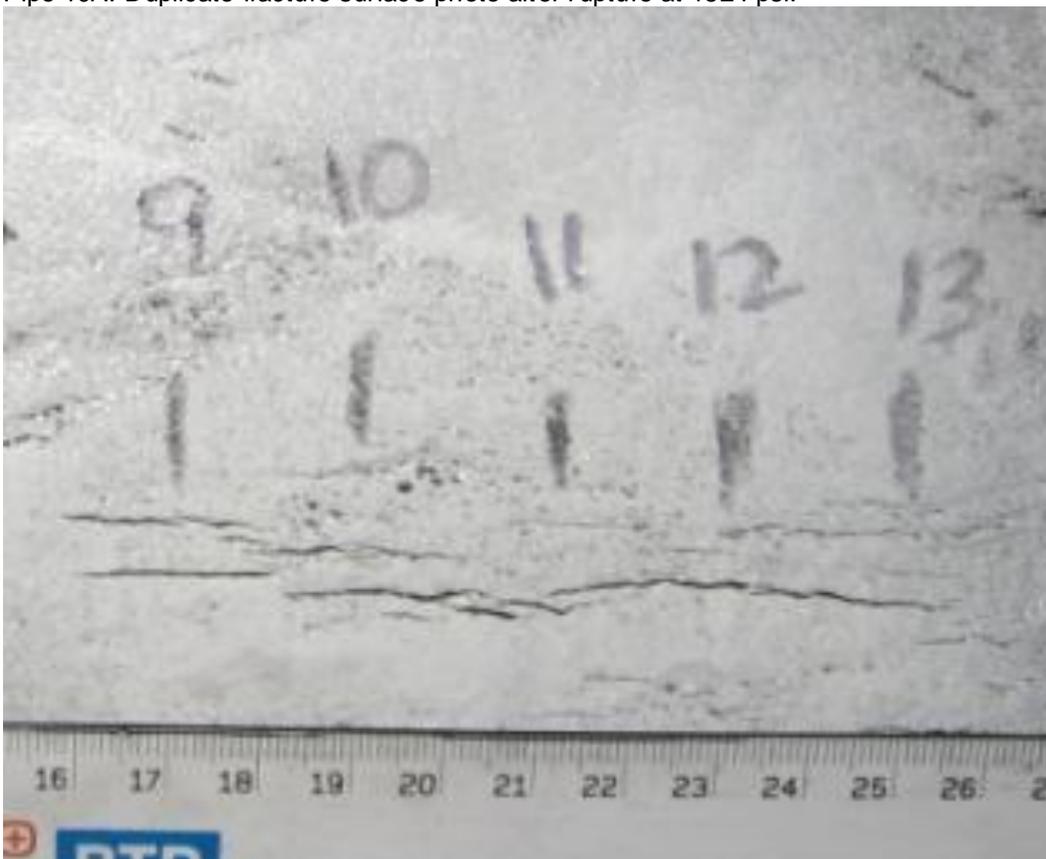
Pipe 10A: MPI Close-up view of crack MWM 3 with PA index marks

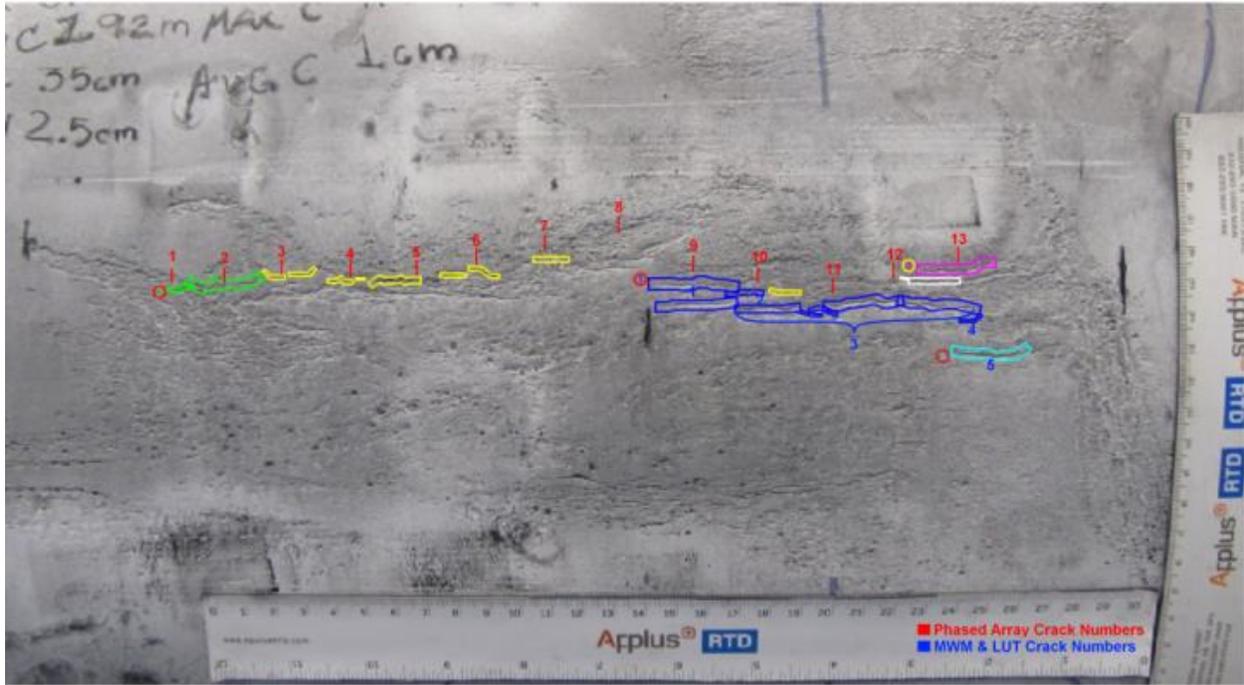
Pipe 10A: NACE crack interaction program tracks overlain on MPI photograph

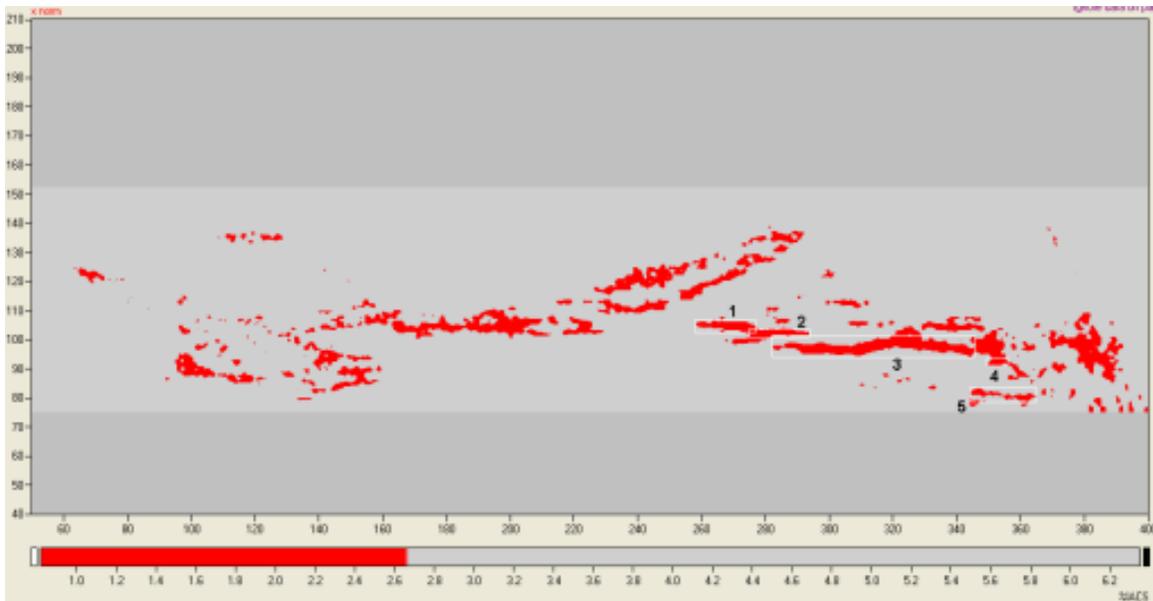
Pipe 10A: MWM-Array surface crack map showing MWM crack 3

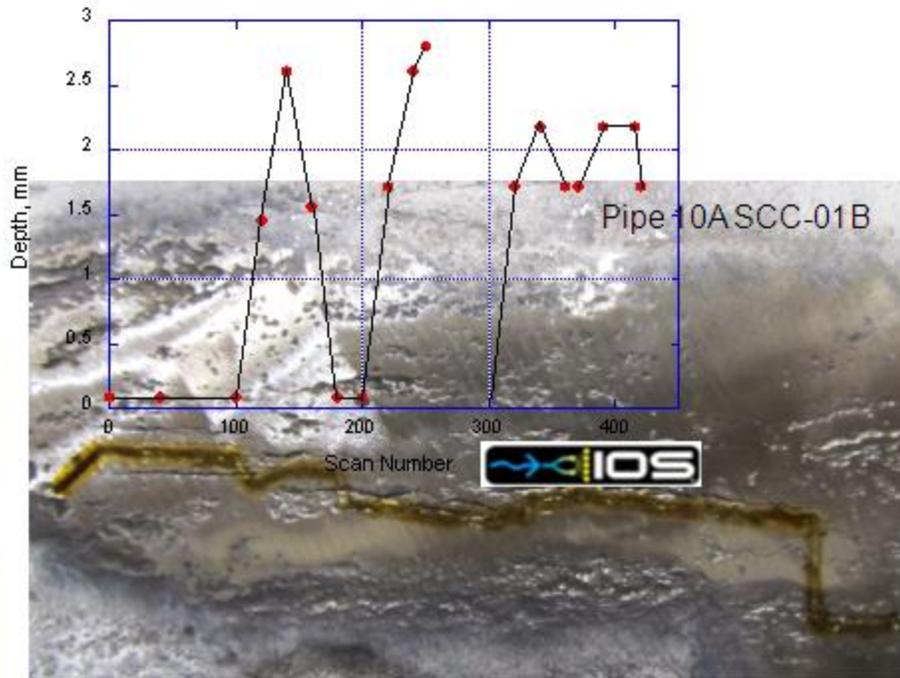
Pipe 10A: Significant target crack in SCC colony (MWM 32) showing ablation track of generation laser with LToFD sizing overlain.

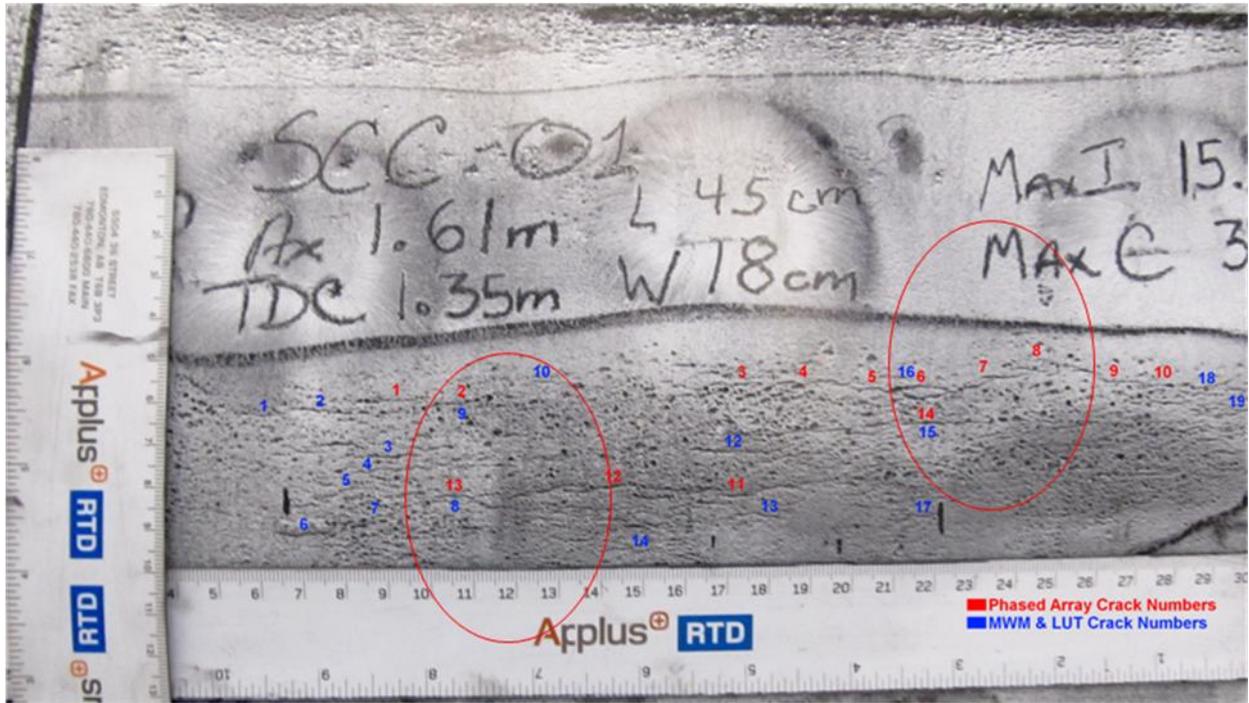
Pipe 10B: MPI photo of SCC colony with MWM numbering (blue), red circles indicate LToFD target locations

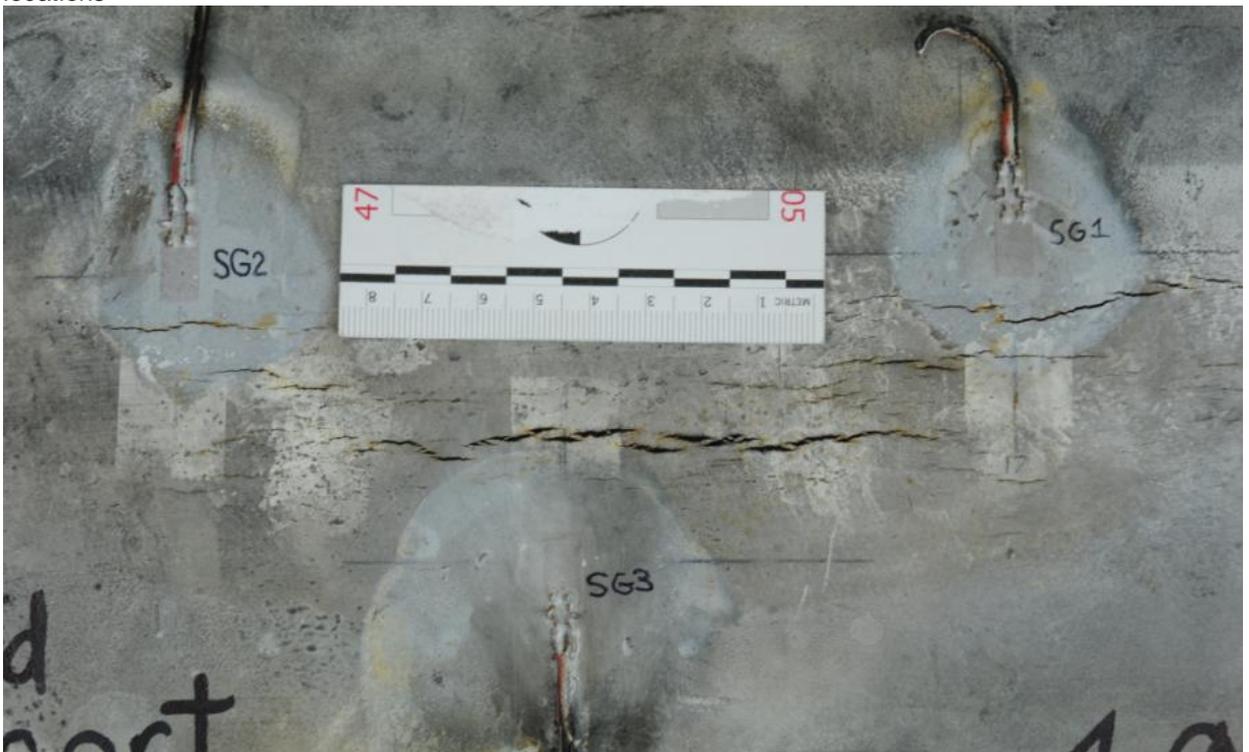
Pipe 10B: Target locations after leak at non-target location; 1638 psi

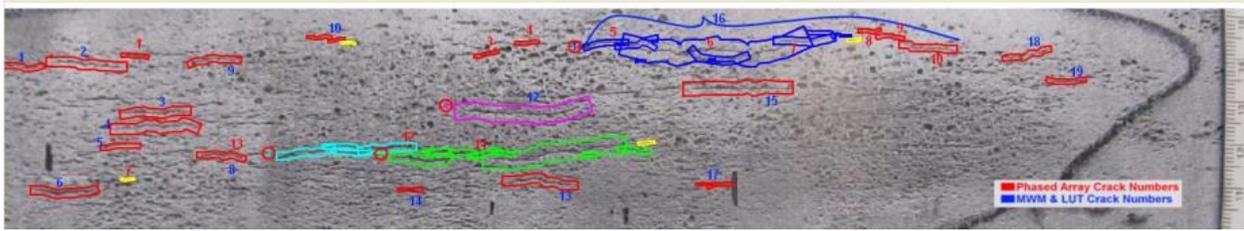
Pipe 10B: NACE crack interaction program tracks overlain on MPI photograph

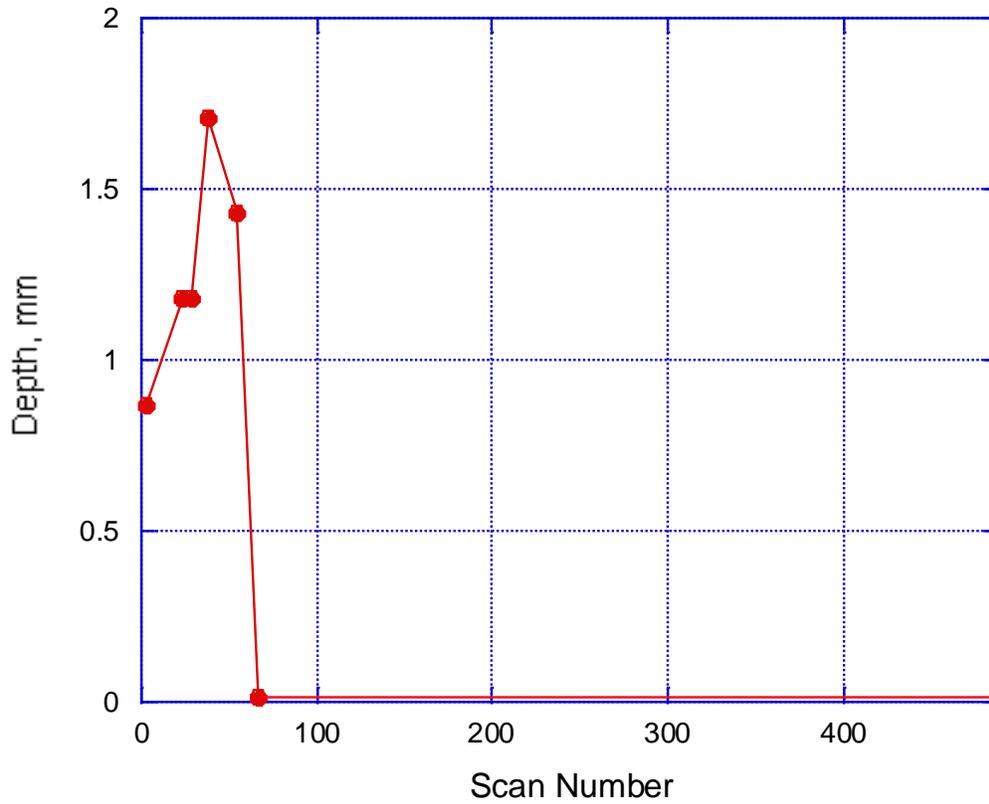
Pipe 10B: Depth sizing data for target MWM 8

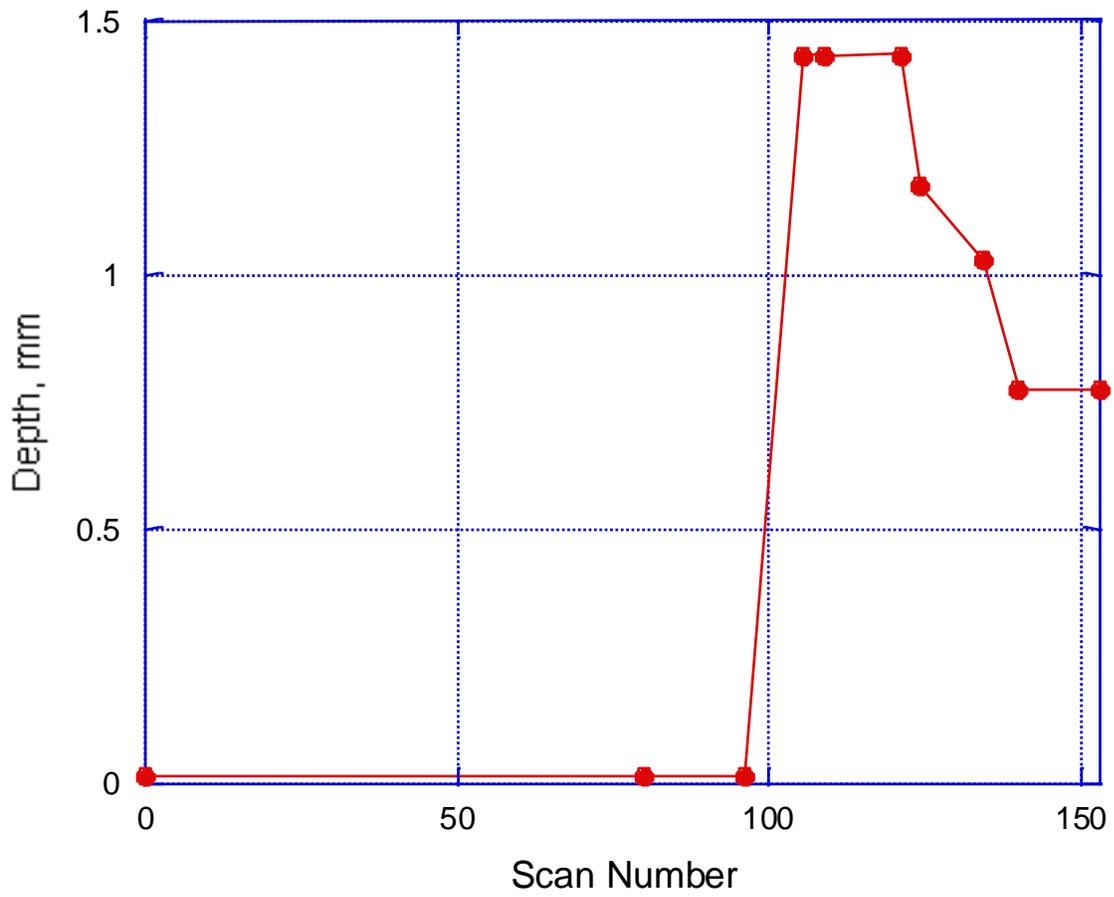
Pipe 10B: Depth sizing data for target MWM 16 (PA 6,7,8)

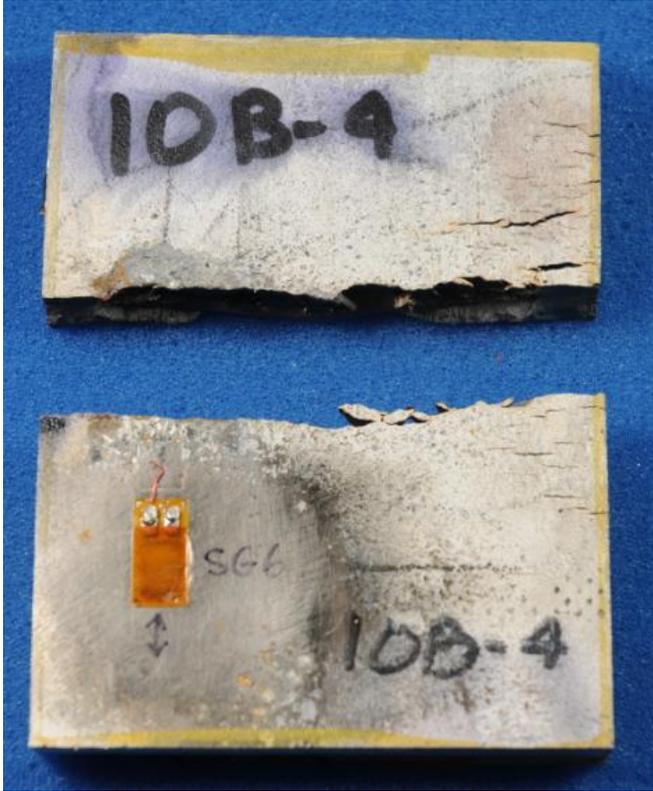
Pipe 10B: Pipe surface at non-target leak location

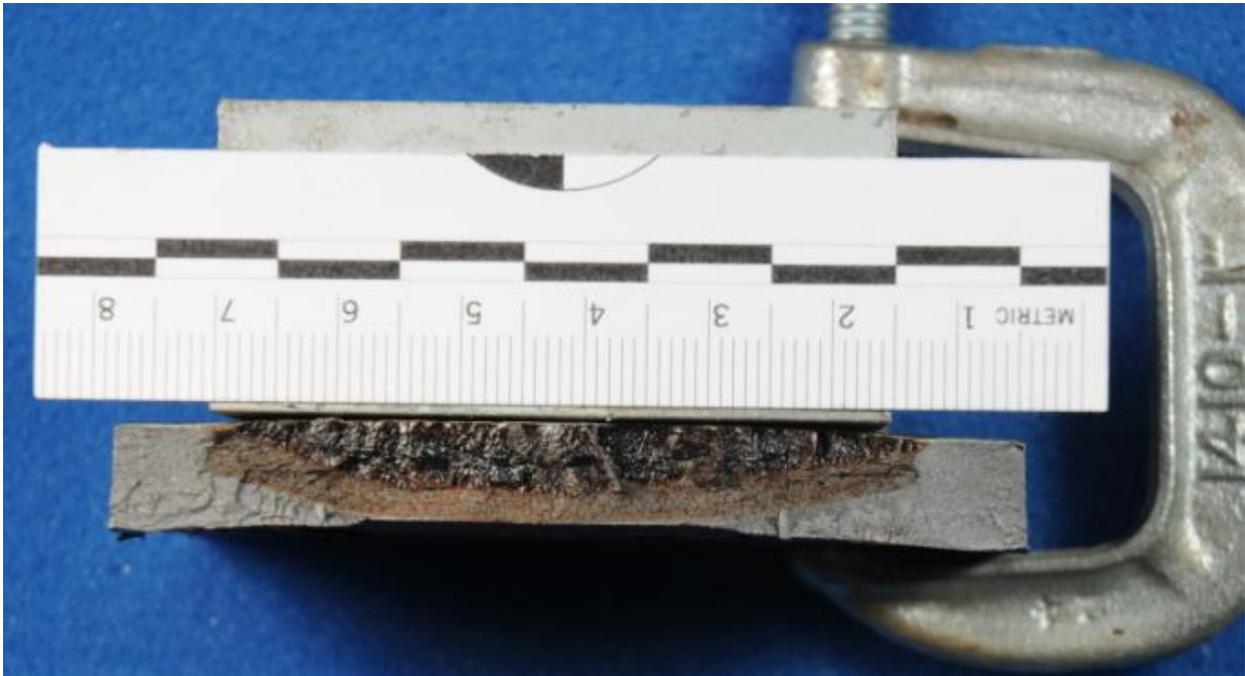
Pipe 10B: Non-target leak location at 1638 psi

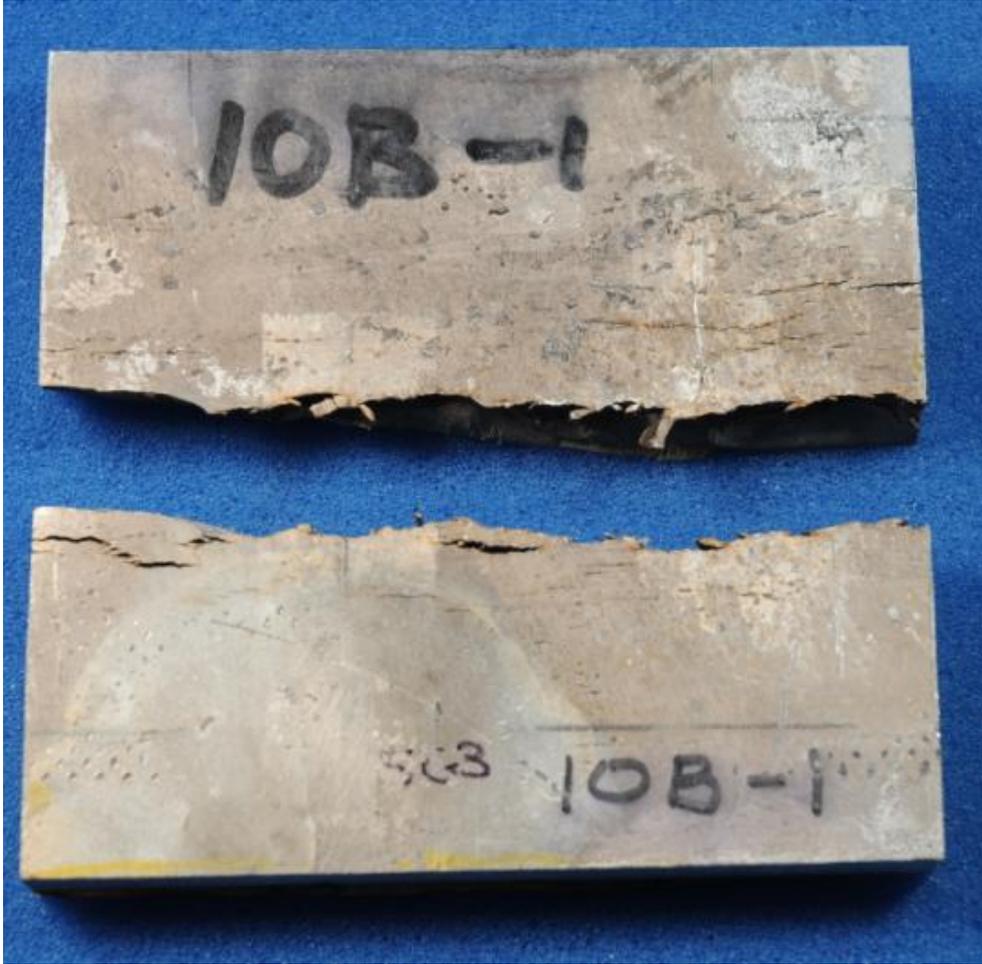
Pipe 10B: Target location 10B-1 (MWM 8, PA 12)

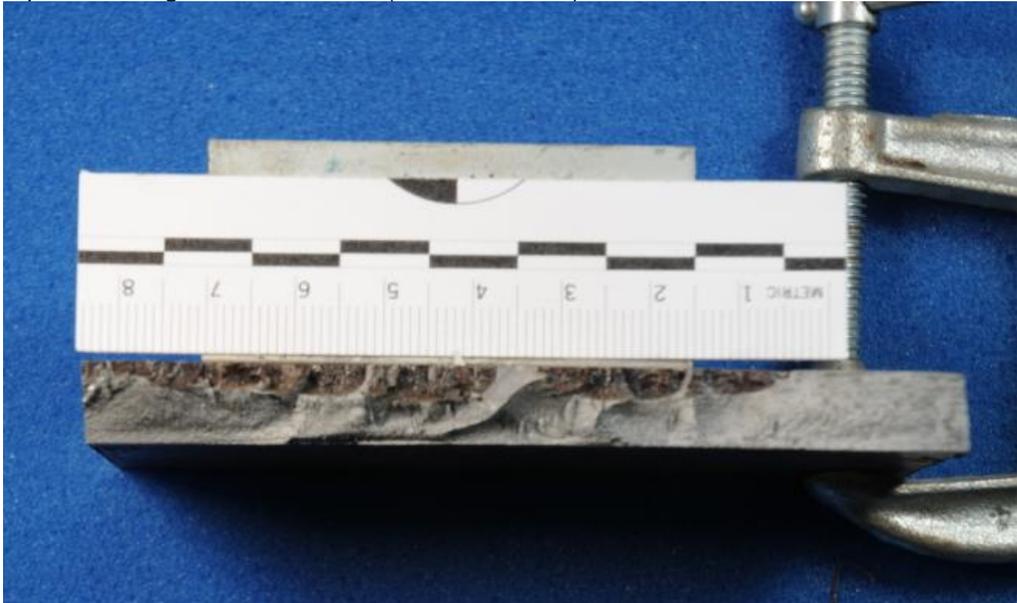
Pipe 10B: Target location 10B-1 Fracture surface, frozen by liquid nitrogen and broken after leak at off-target location.

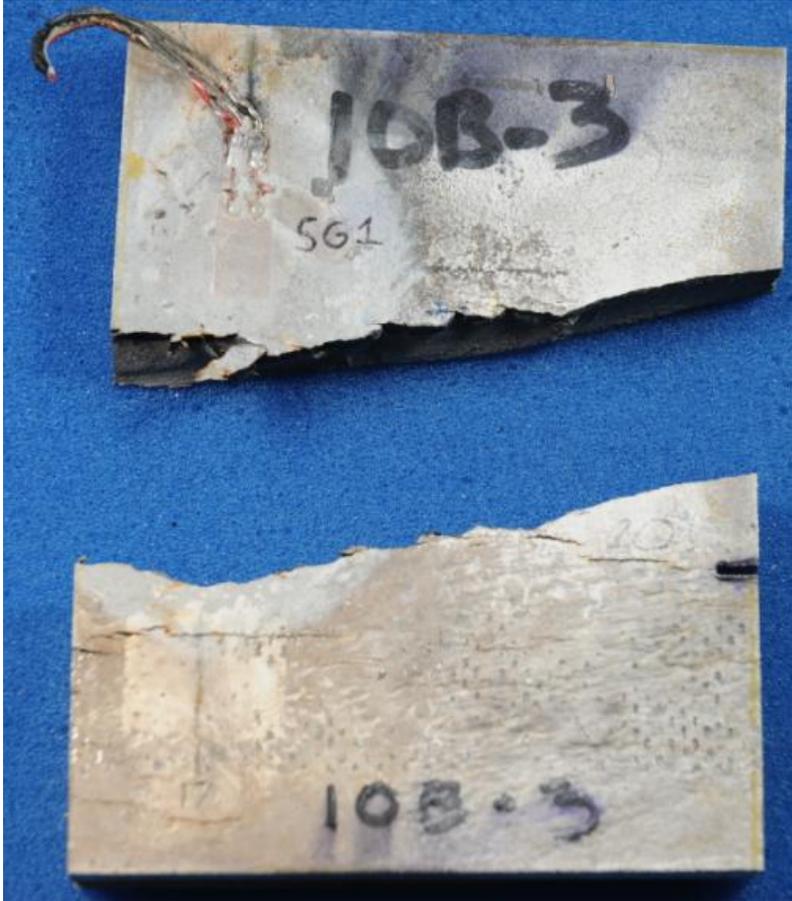
Pipe 10B: Target location 10B-3 (MWM 16, PA 3-9)

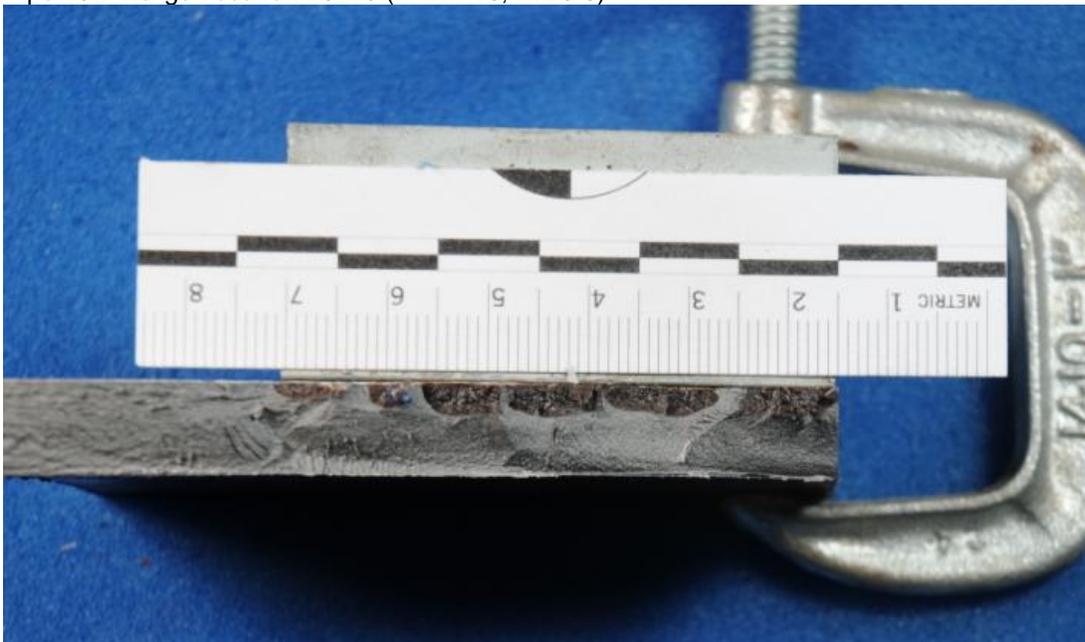
Pipe 10B: Target location 10B-3 fracture surface frozen by liquid nitrogen and broken after leak at off-target location.

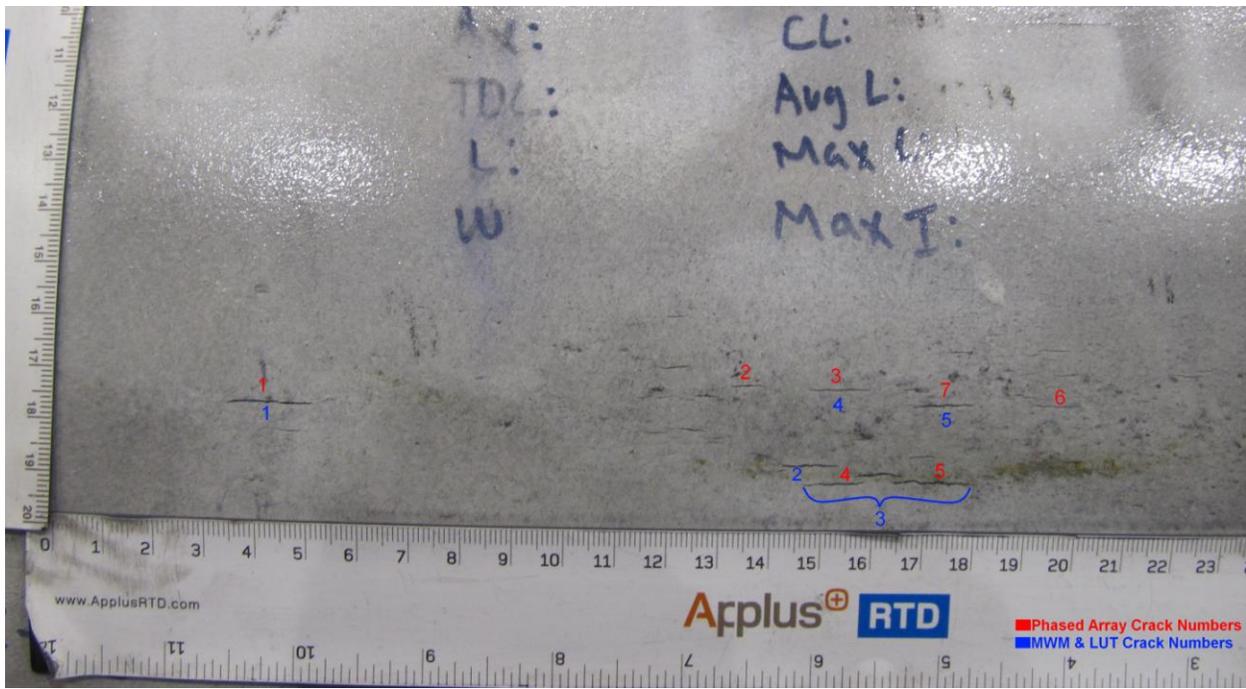
Pipe 13: MPI photo of SCC colony with MWM numbering (blue)

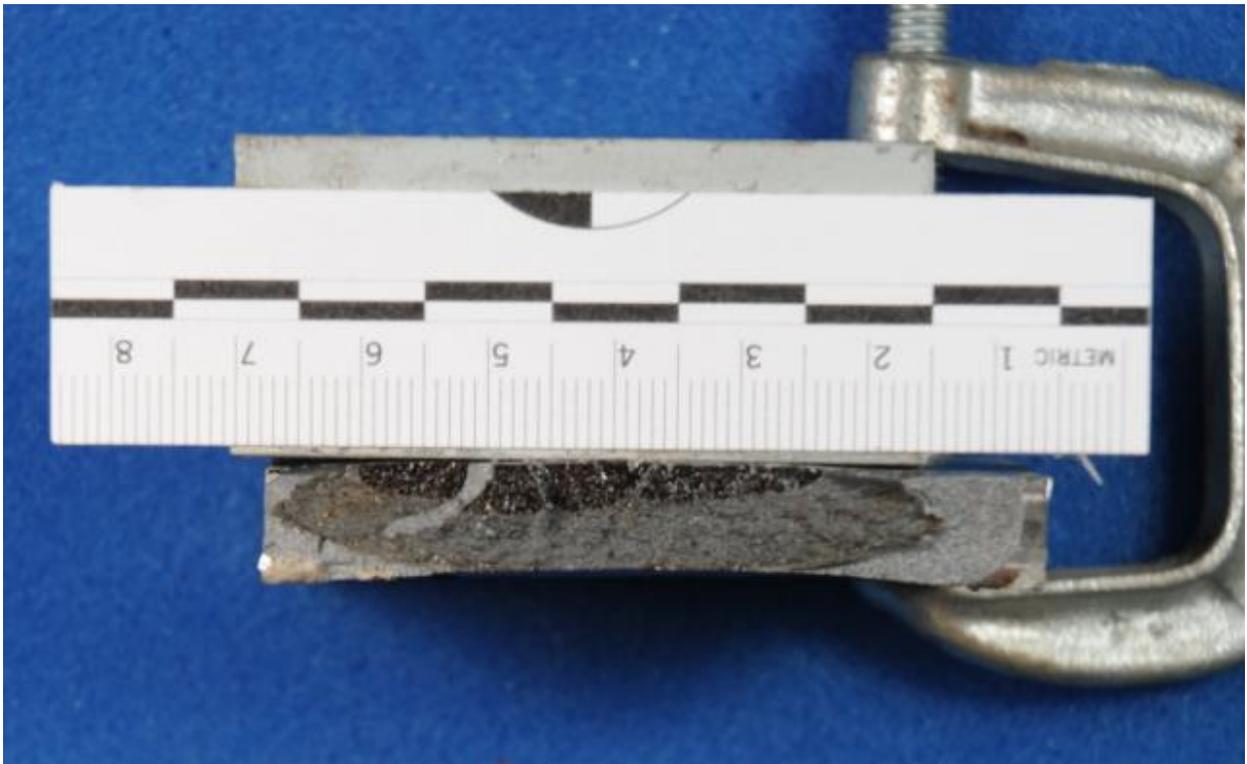
Pipe 13: Fracture surface at MWM 3 leak location (1598 psi), frozen using liquid nitrogen and broken.

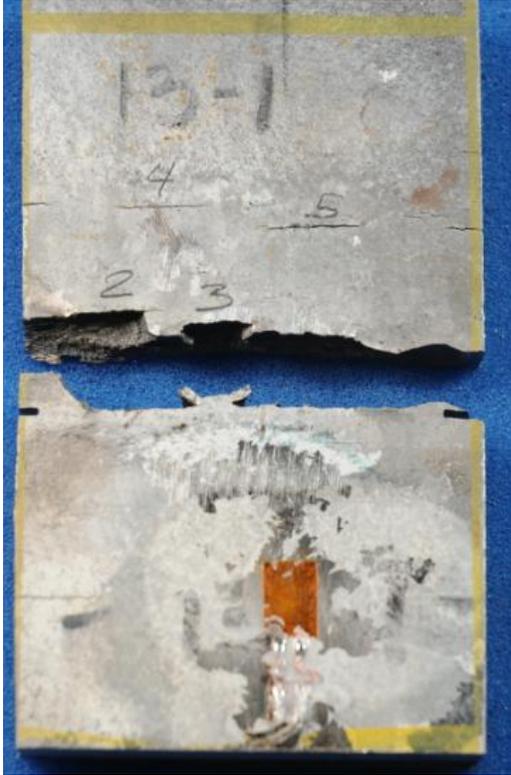
Pipe 13: MWM location 3 after leak at 1598 psi

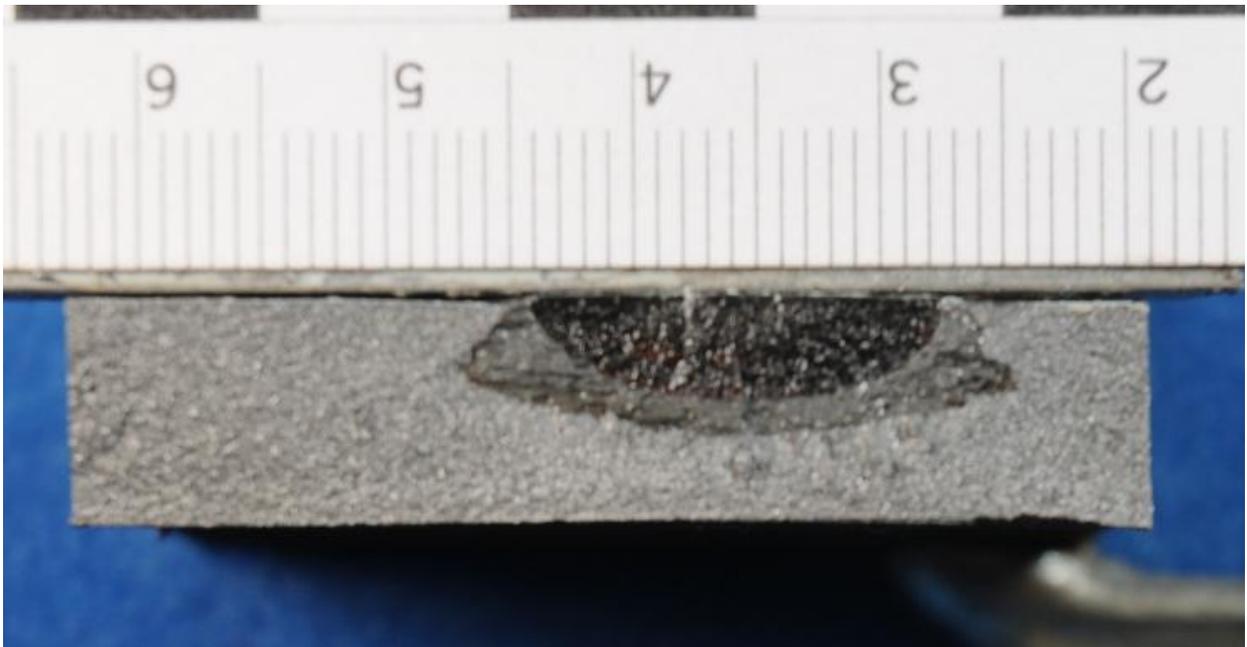
Pipe 13: location 13A after leak at location MWM 3 at 1598 psi

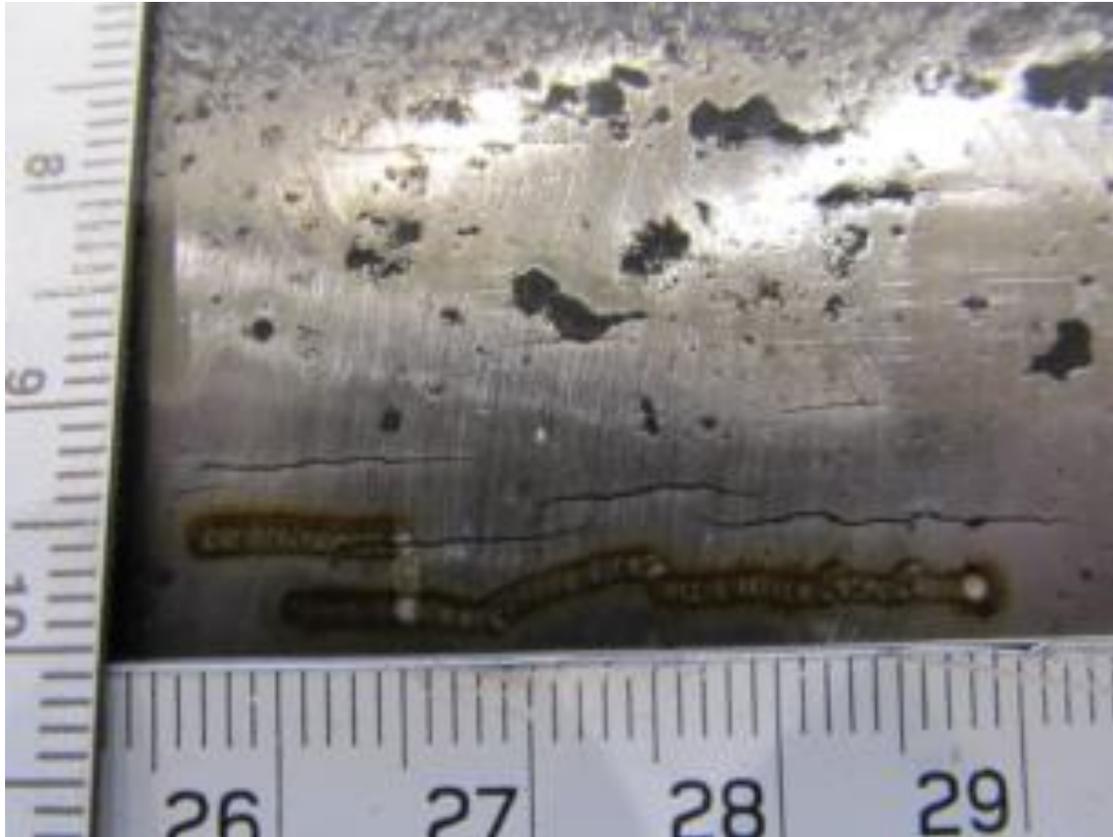
Pipe 13: LToFD tracking (ablation track) of MWM crack 3 and MWM crack 2.

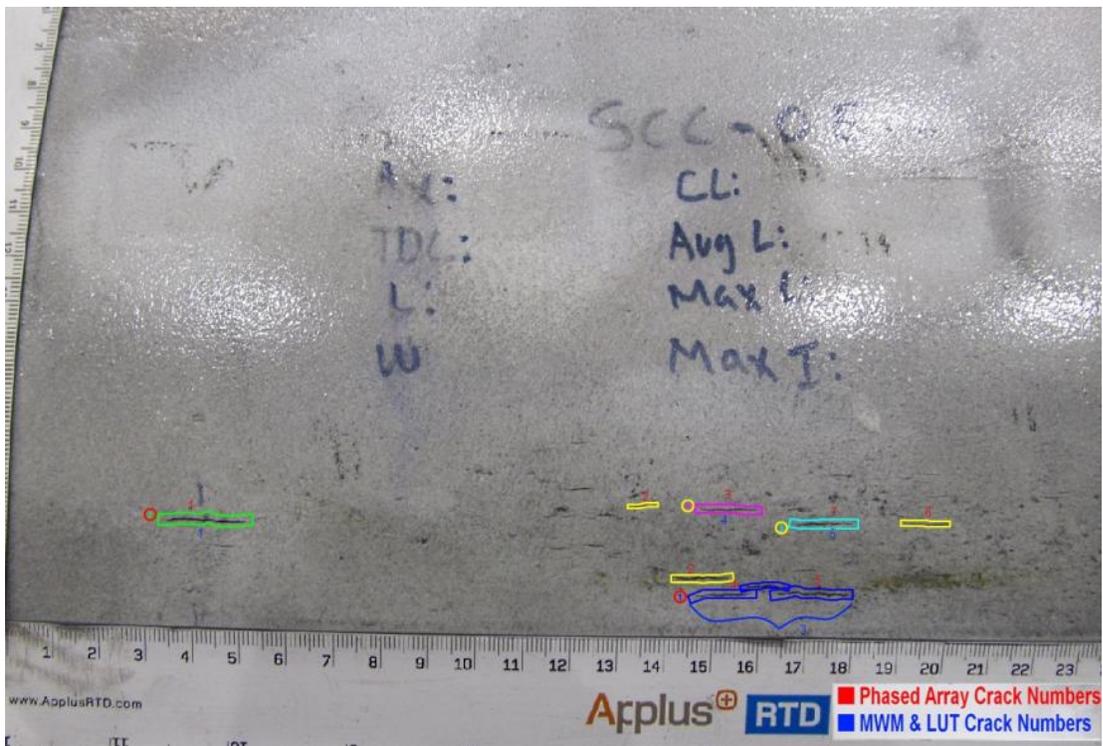
Pipe 13: NACE crack interaction program tracks overlain on MPI photograph

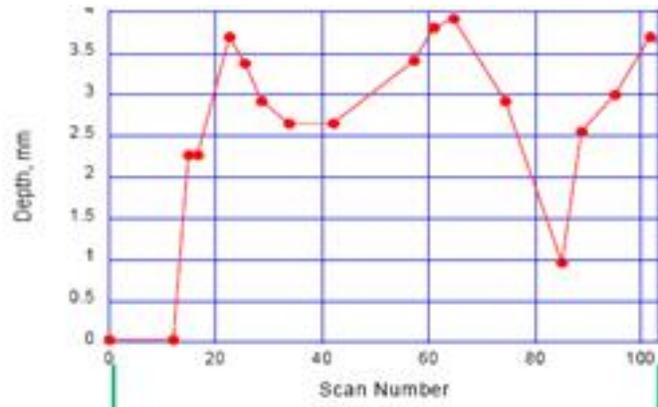
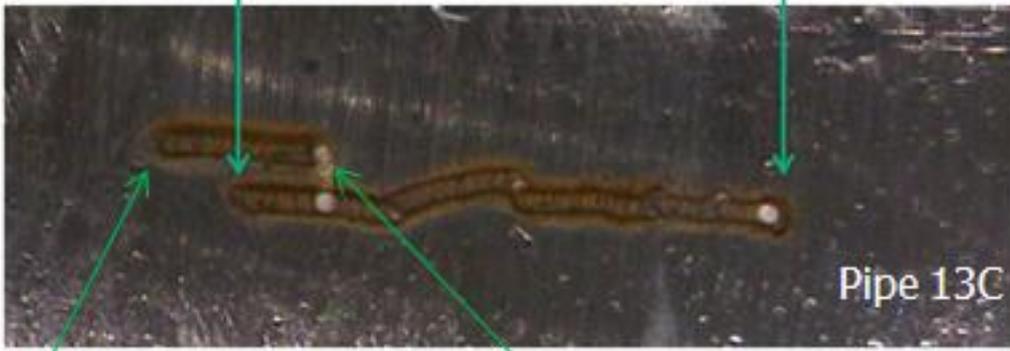
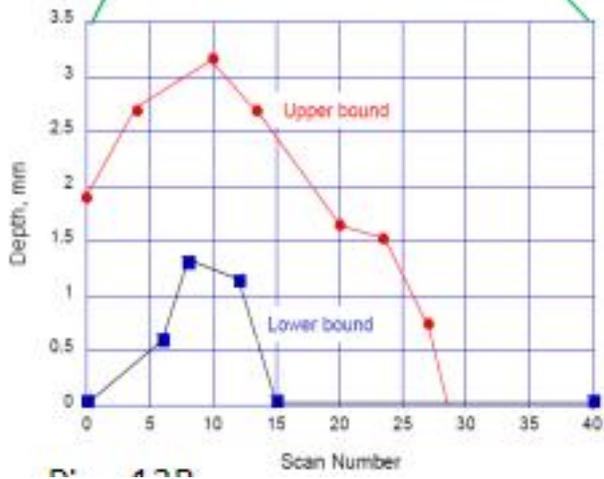
Pipe 13: LToFD sizing at target location, 13-C that leaked at 1598 psi and loc B.

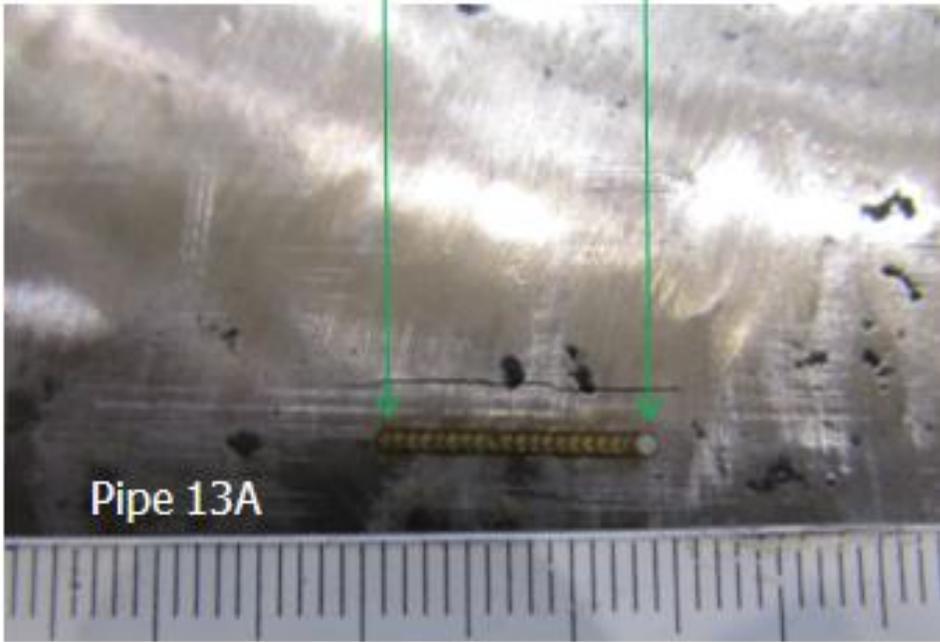
Pipe 13: LToFD sizing opportunity at location 13-A (MWM 1)
