A QUANTITATIVE NON-DESTRUCTIVE RESIDUAL STRESS ASSESSMENT TOOL FOR PIPELINES

PHMSA SBIR Final Project Review: January 10, 2012

Generation 2 Materials Technology, LLC

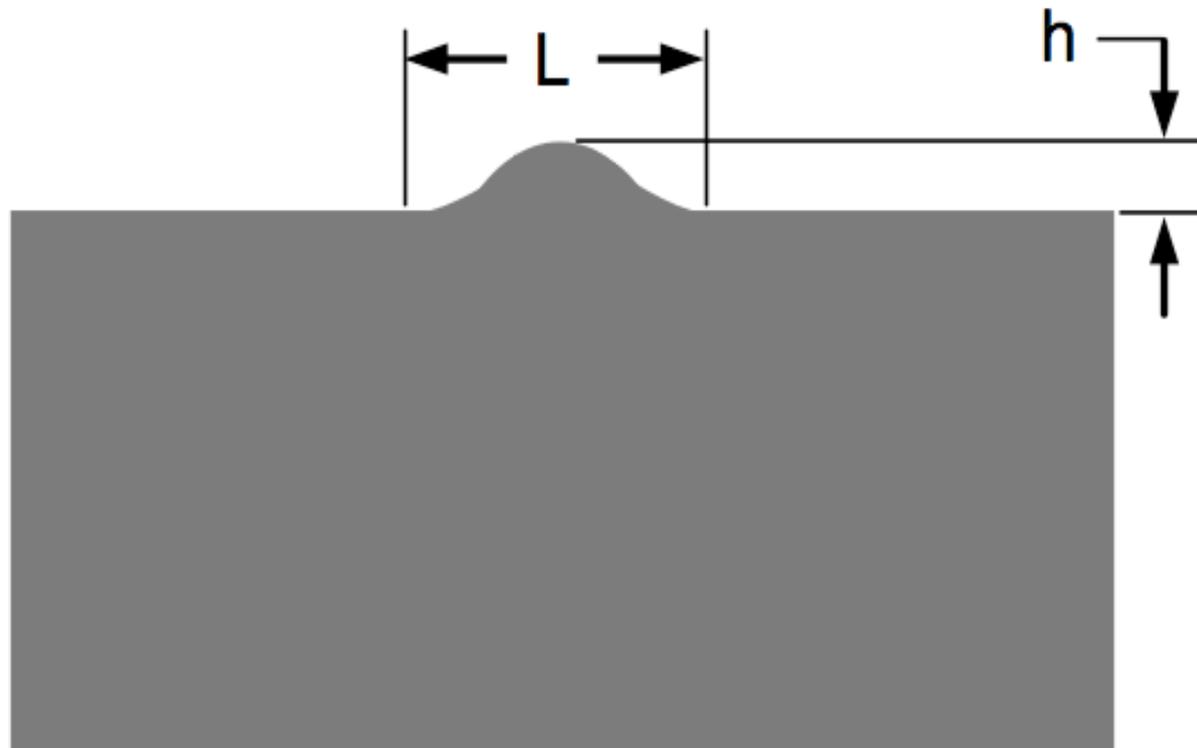
EXISTING WRINKLE BEND CRITICALITY CRITERIA

Height/Width Ratio $\equiv h/L$

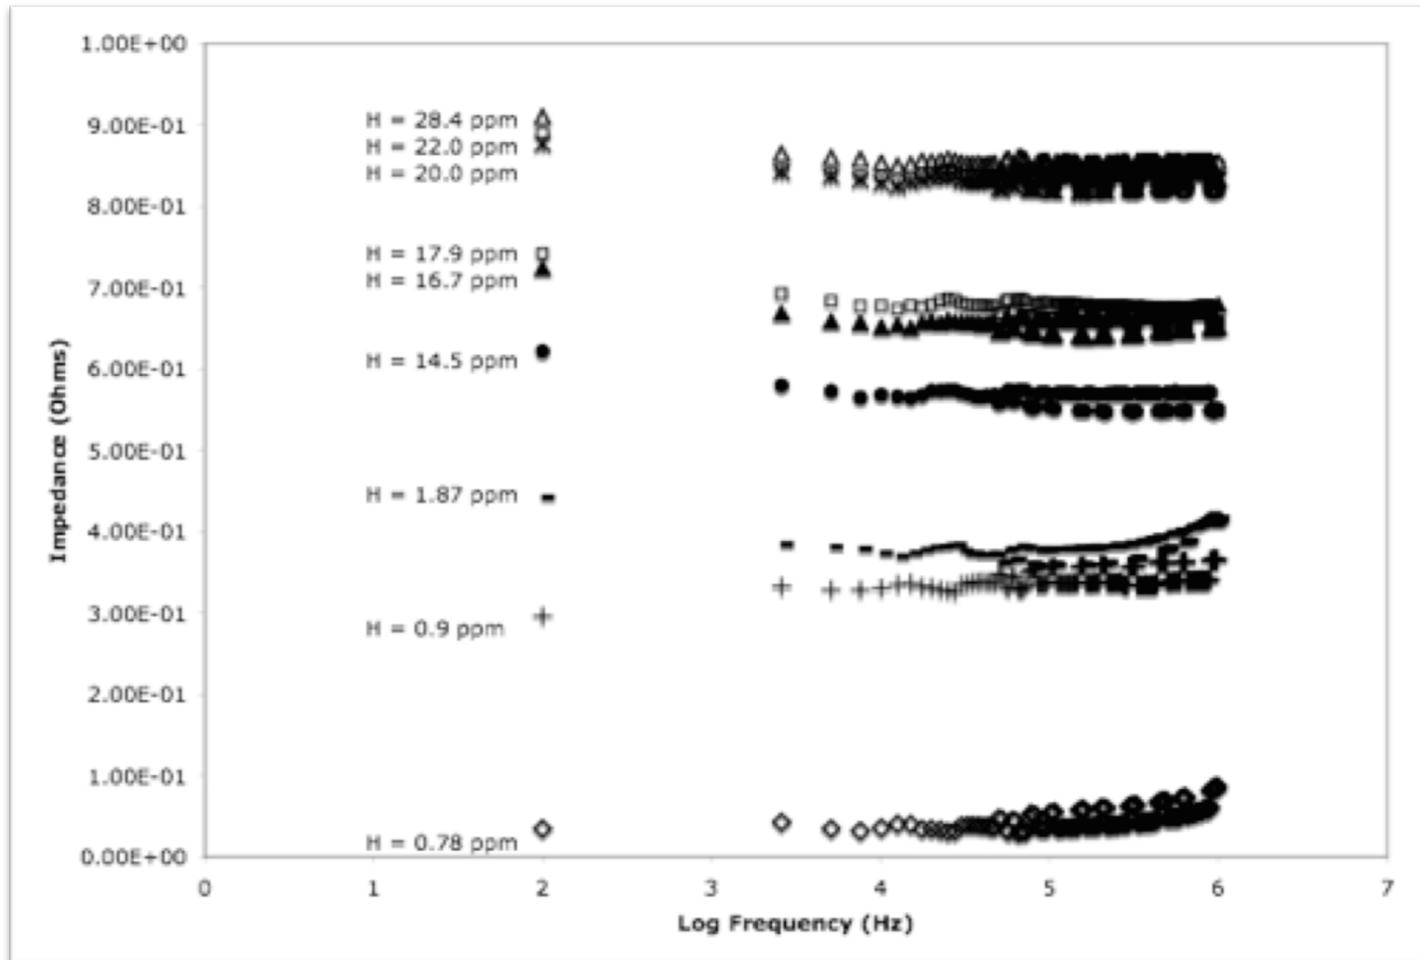
Electromagnetic Hydrogen Measurements On Pipeline Steel

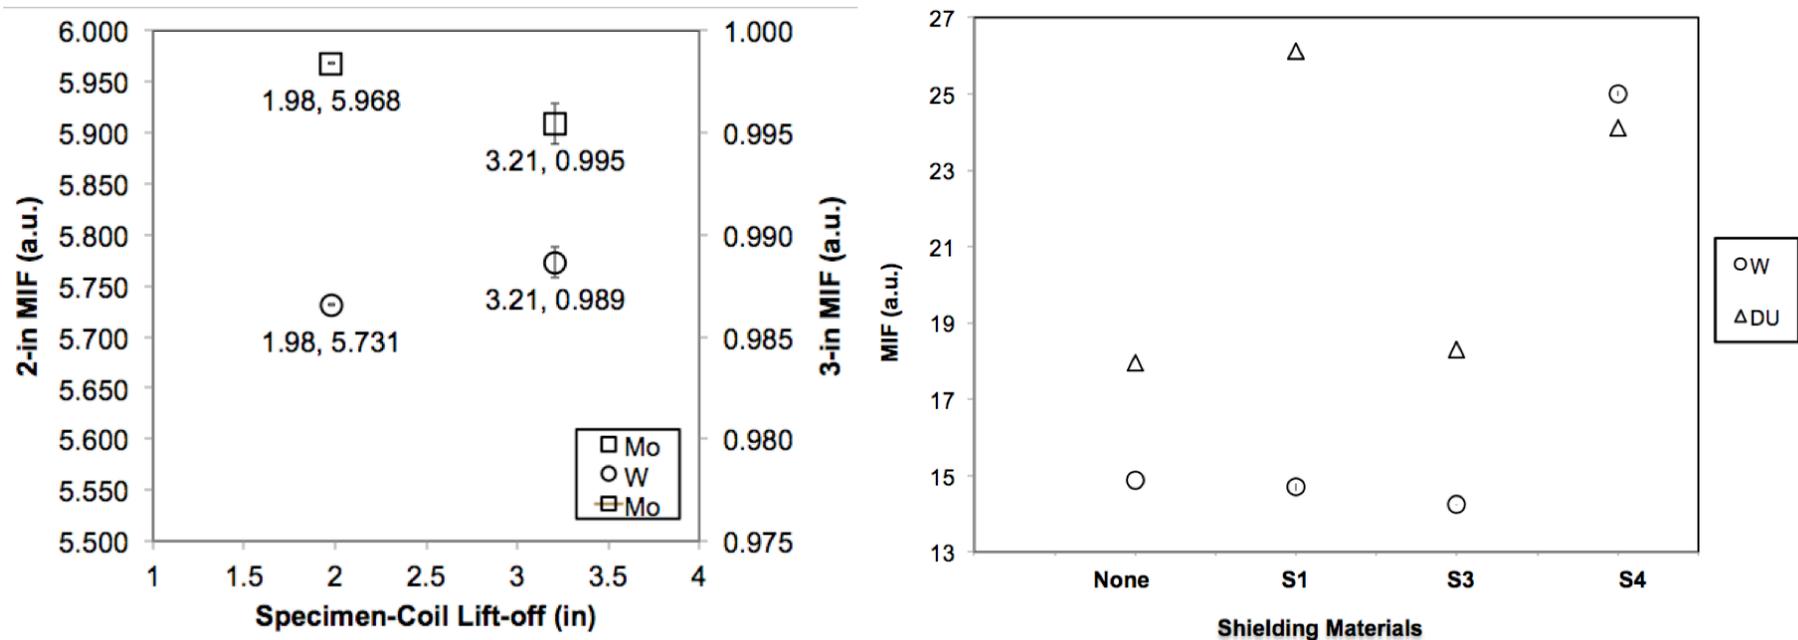
Figure 1: (a) Electromagnetic measurements on tungsten and molybdenum at two different stand off distances of 2 and 3 inches with austenitic stainless steel shielding. (b) Shielded electromagnetic measurements on molybdenum, tungsten, and depleted uranium using three different shielding materials with standoff of approximately 1.25 inches.

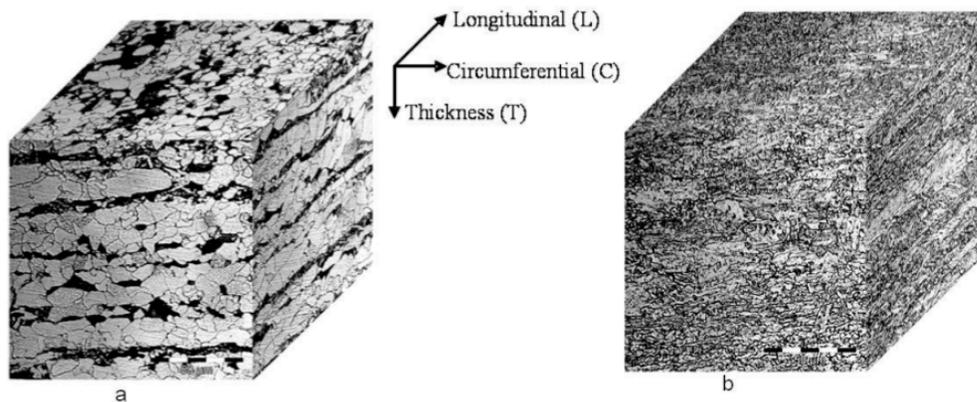
Figure 1. Microstructure (magnification 458 times) of: (a) grade X65 and (b) grade X100

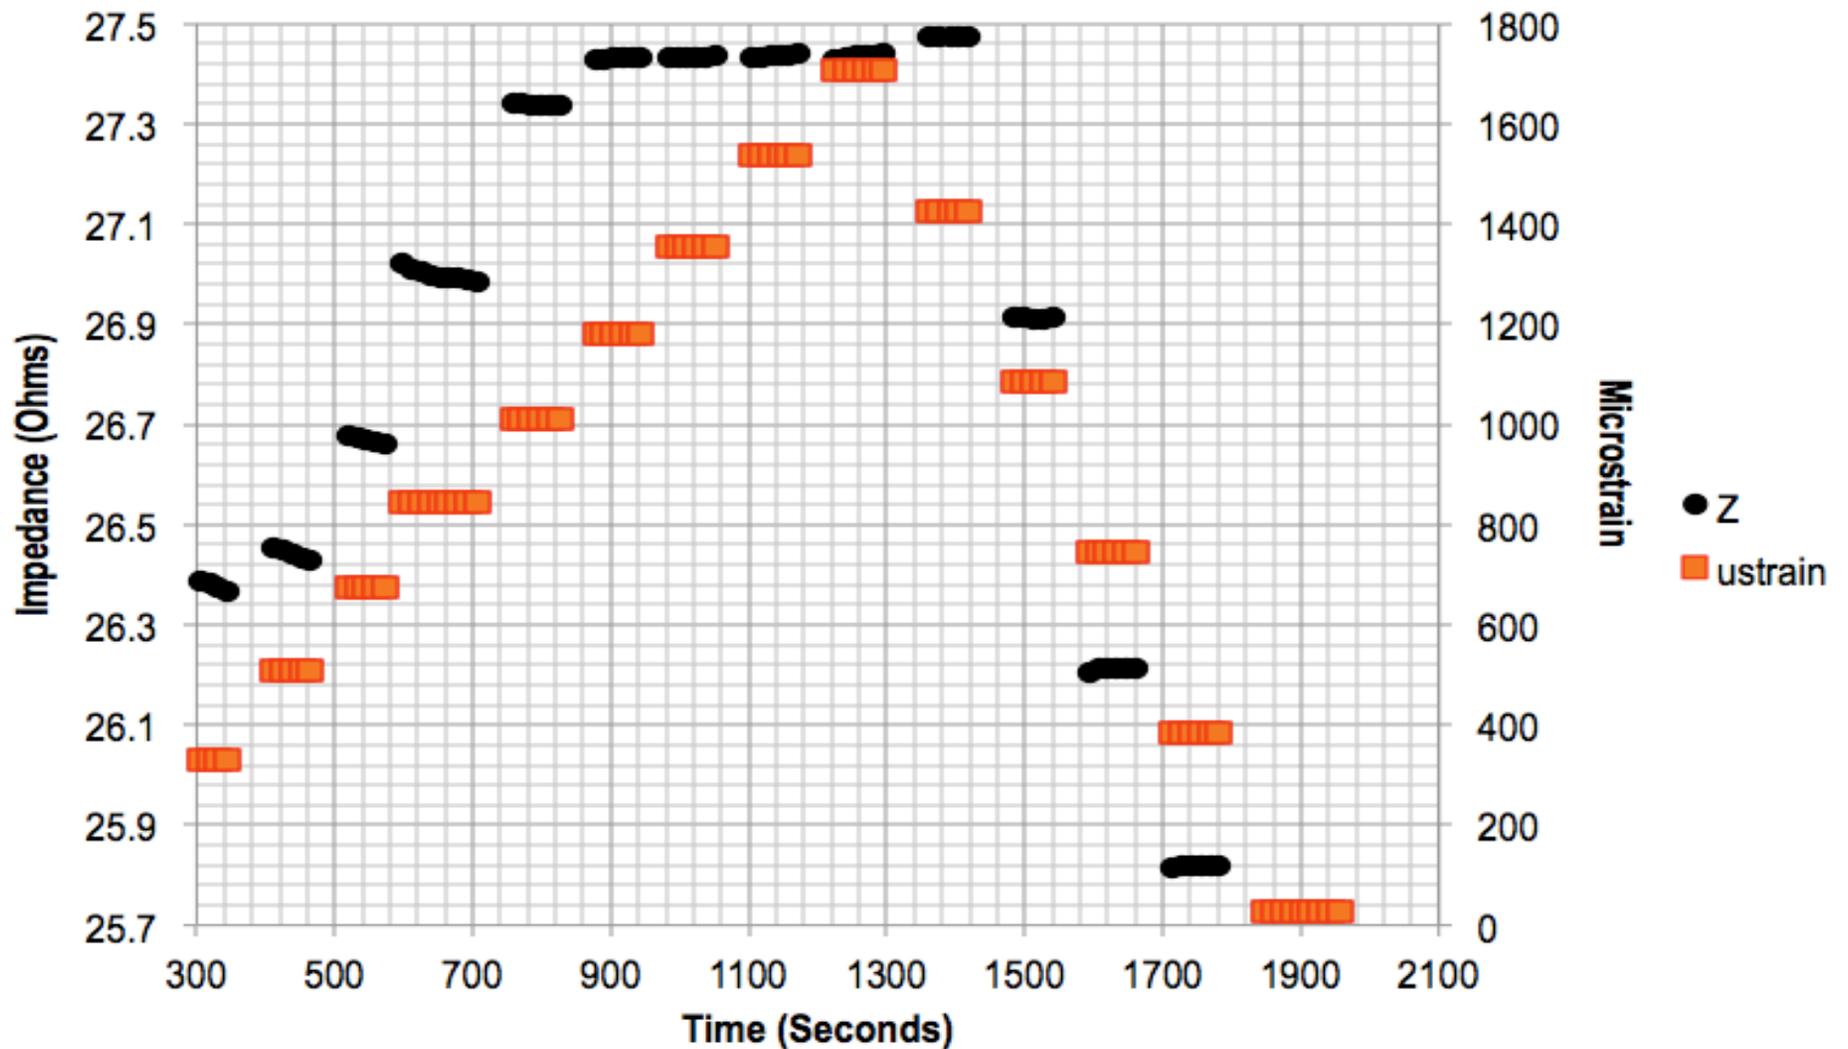
FOUR POINT BEND TENSION

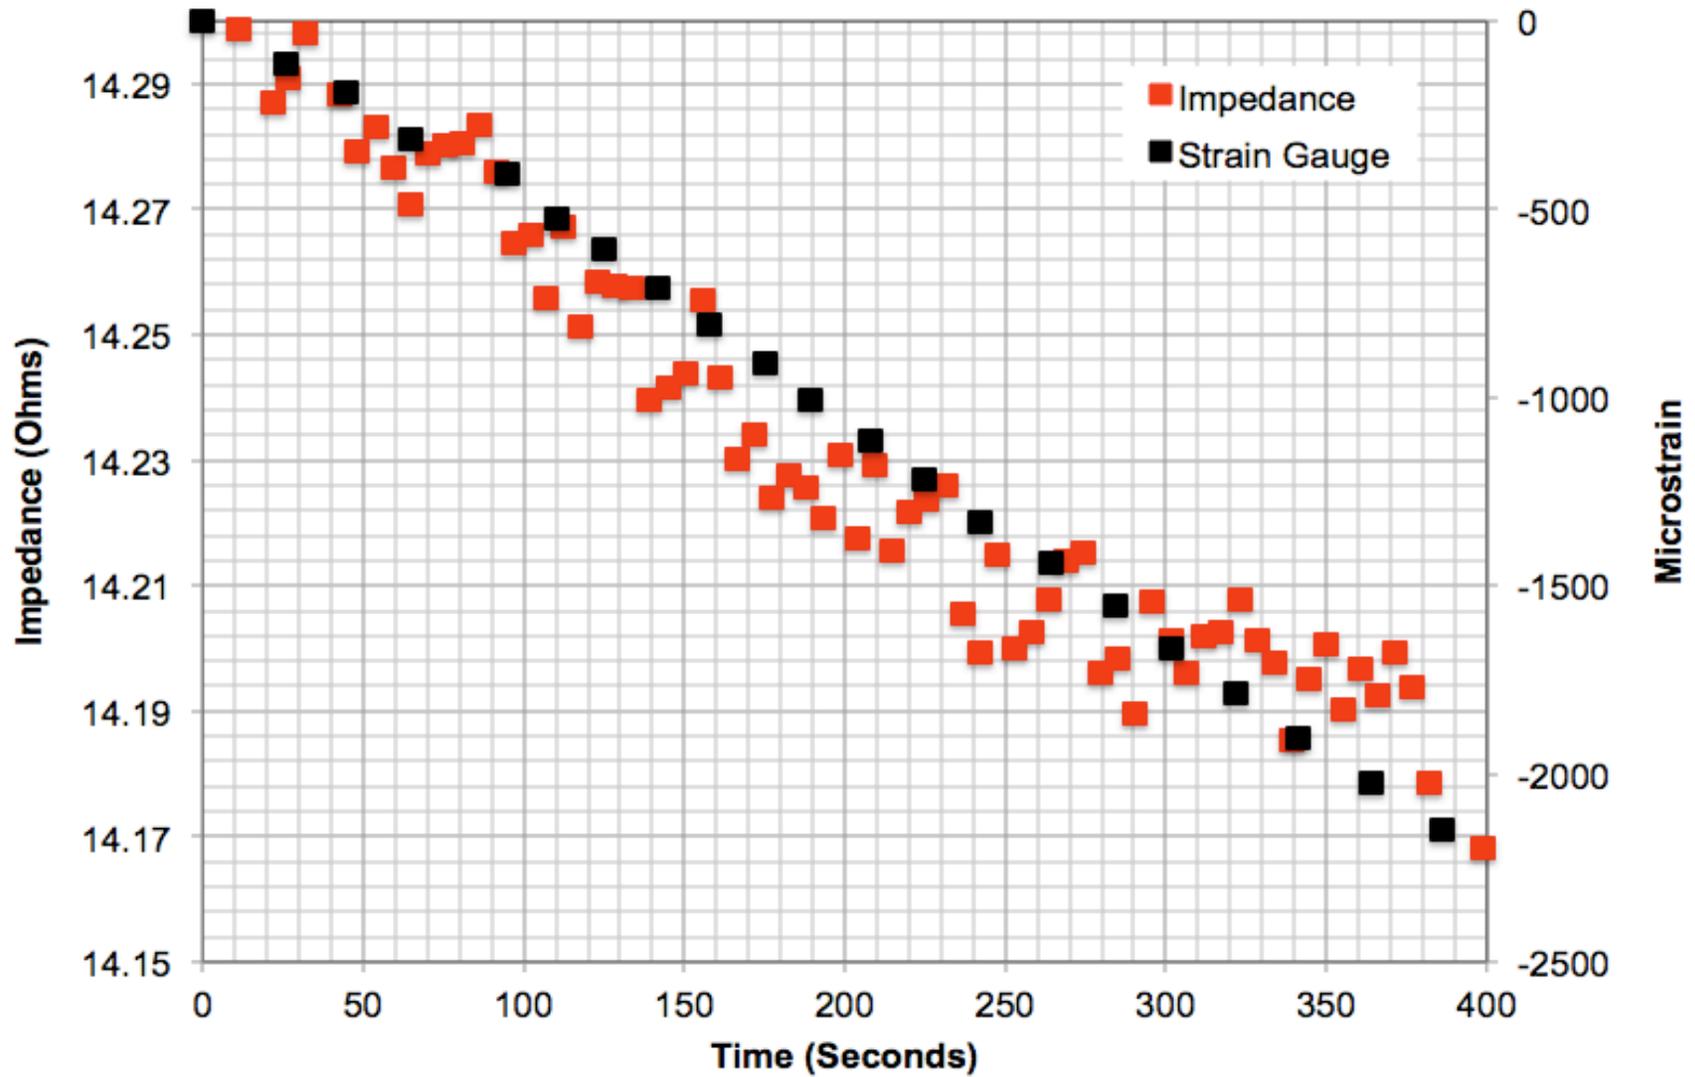
FOUR POINT BEND COMPRESSION

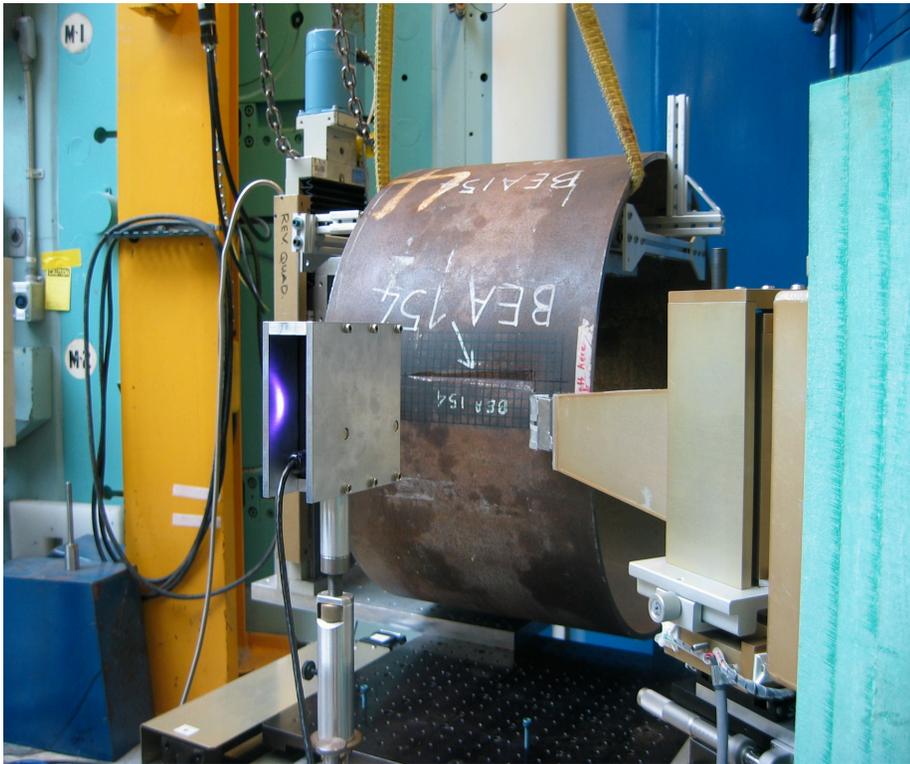
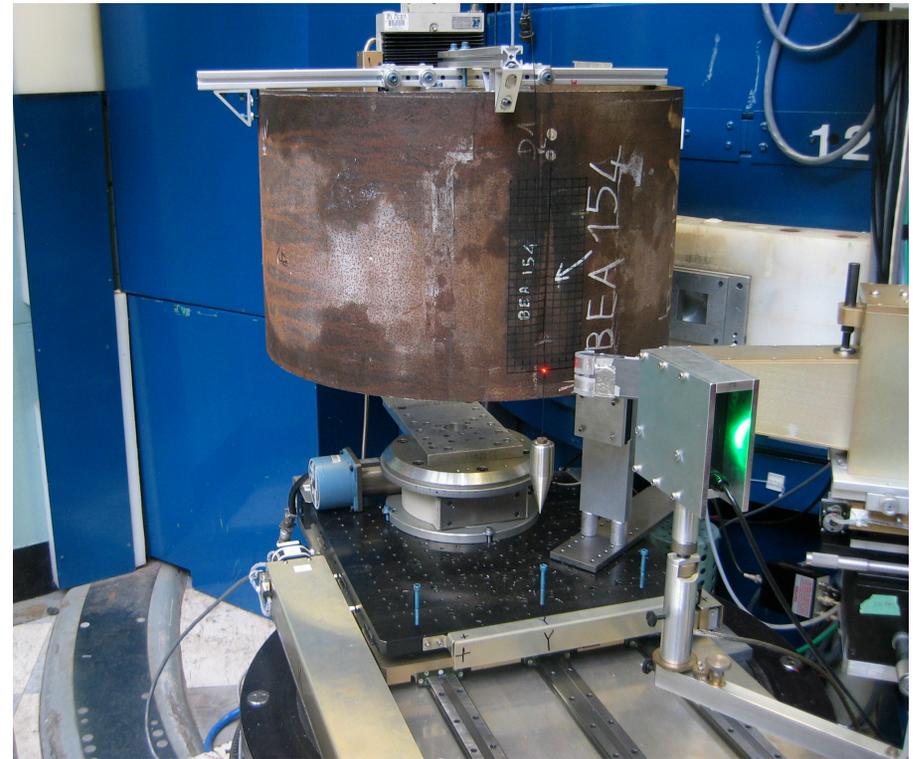
- Neutron diffraction is the only method comparable to an electromagnetic residual stress sensor to determine residual stress as a function of depth into the material.
- X-ray diffraction type measurements are insufficient because only provides surface residual stress measurement.

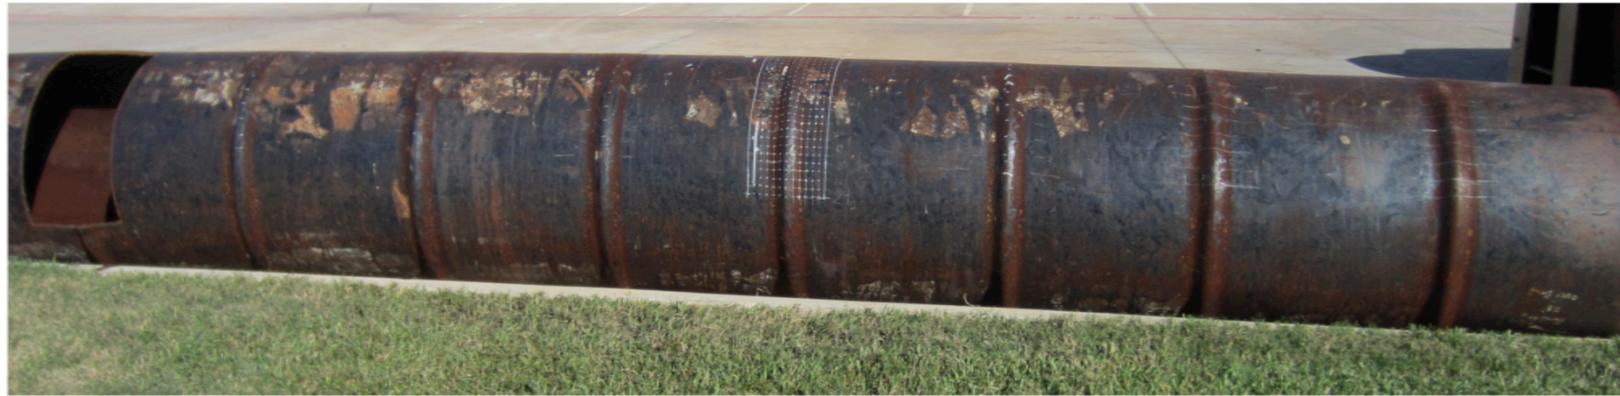
- Diameter of Pipe: 30 inches
- Length of all seven wrinkle bends: 48 inches
- Height of all seven wrinkle bends: 0.75 inches
- Width of all seven wrinkle bends: 4 inches
- h/L (height to width) ratio for all seven wrinkle bends: 0.1875

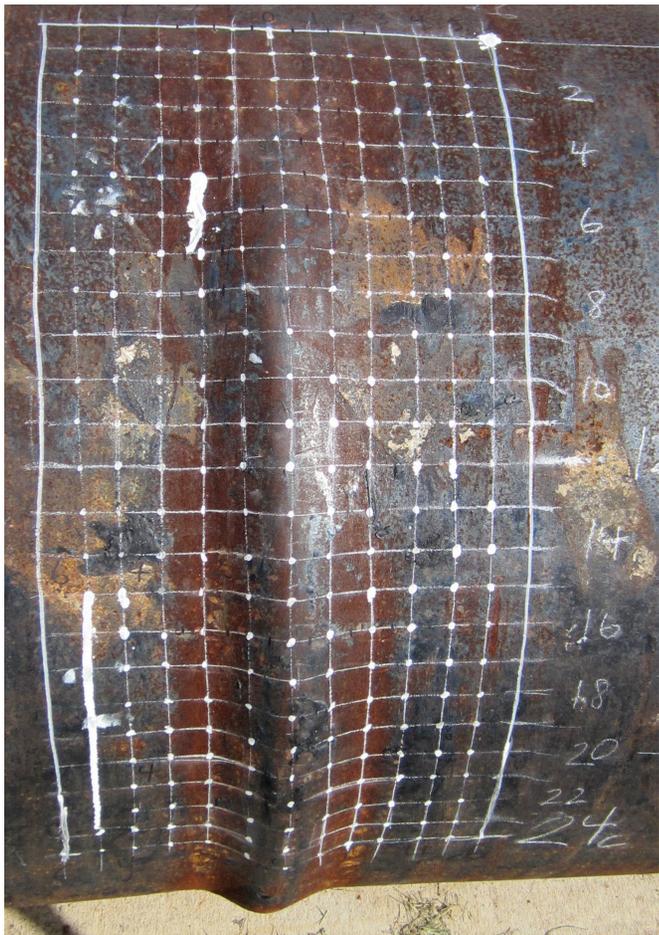
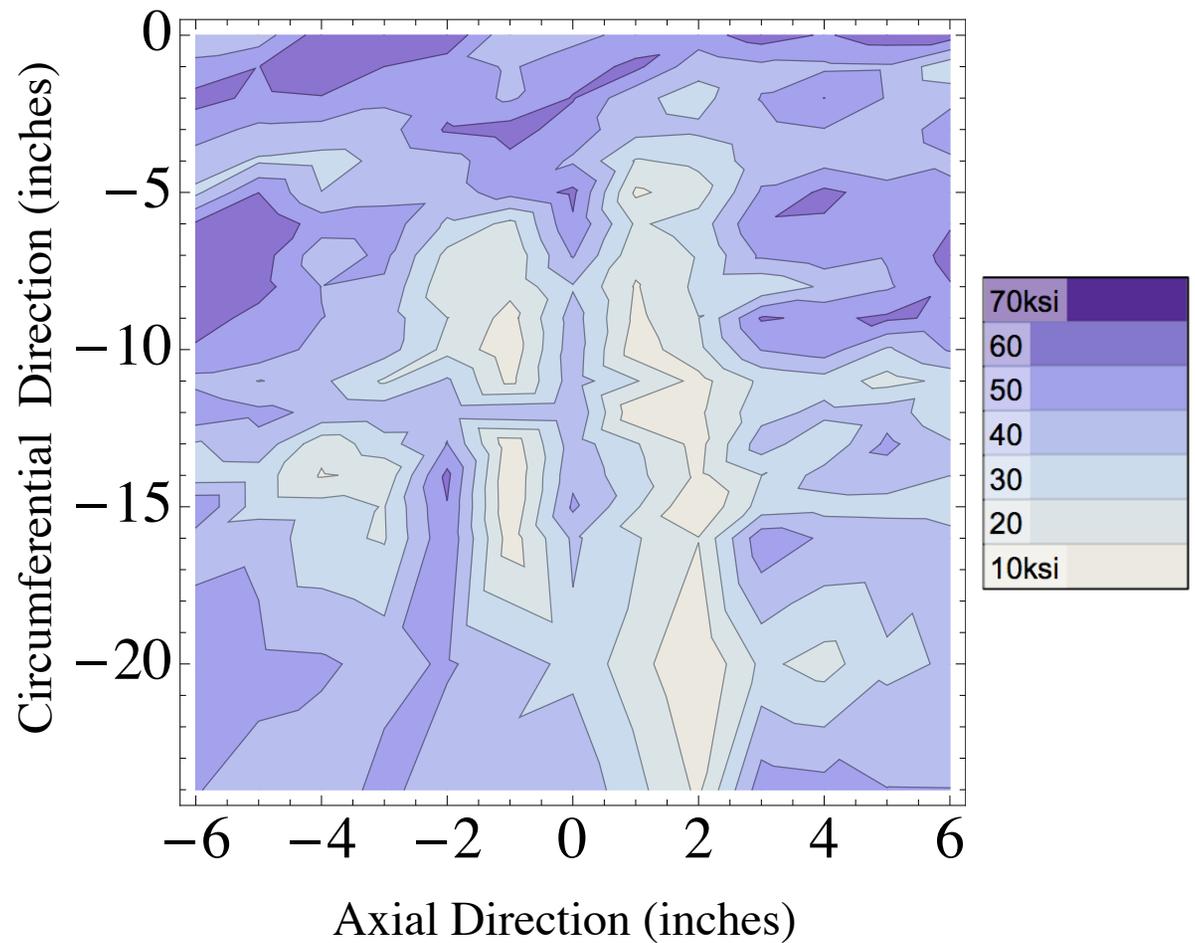
Residual Stress Map at the Surface of Wrinkle Bend #5

- Comparison of the residual stress results for seven different wrinkle bends indicated that:
 - There is a large residual stress gradient along all of the wrinkle bends.
 - There is a significant difference in maximum residual stress levels between the seven geometrically identical wrinkle bends.
 - The difference in residual stress levels can be used to determine the criticality of the mechanical damage.
 - The presence of hydrogen (coming from inner diameter) dramatically increased the impedance towards the inner diameter of the pipe.
 - Geometric and shape based measurements would predict the same criticality for all seven wrinkle bends which differs dramatically from residual stress measurements.

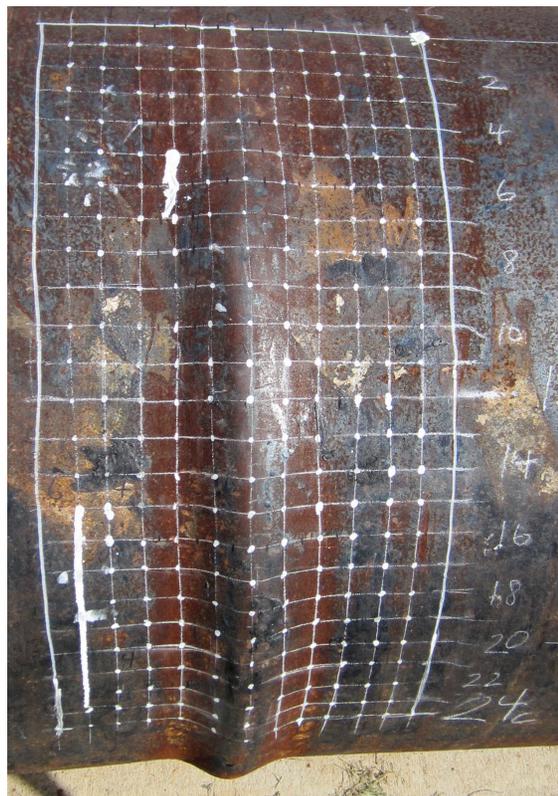
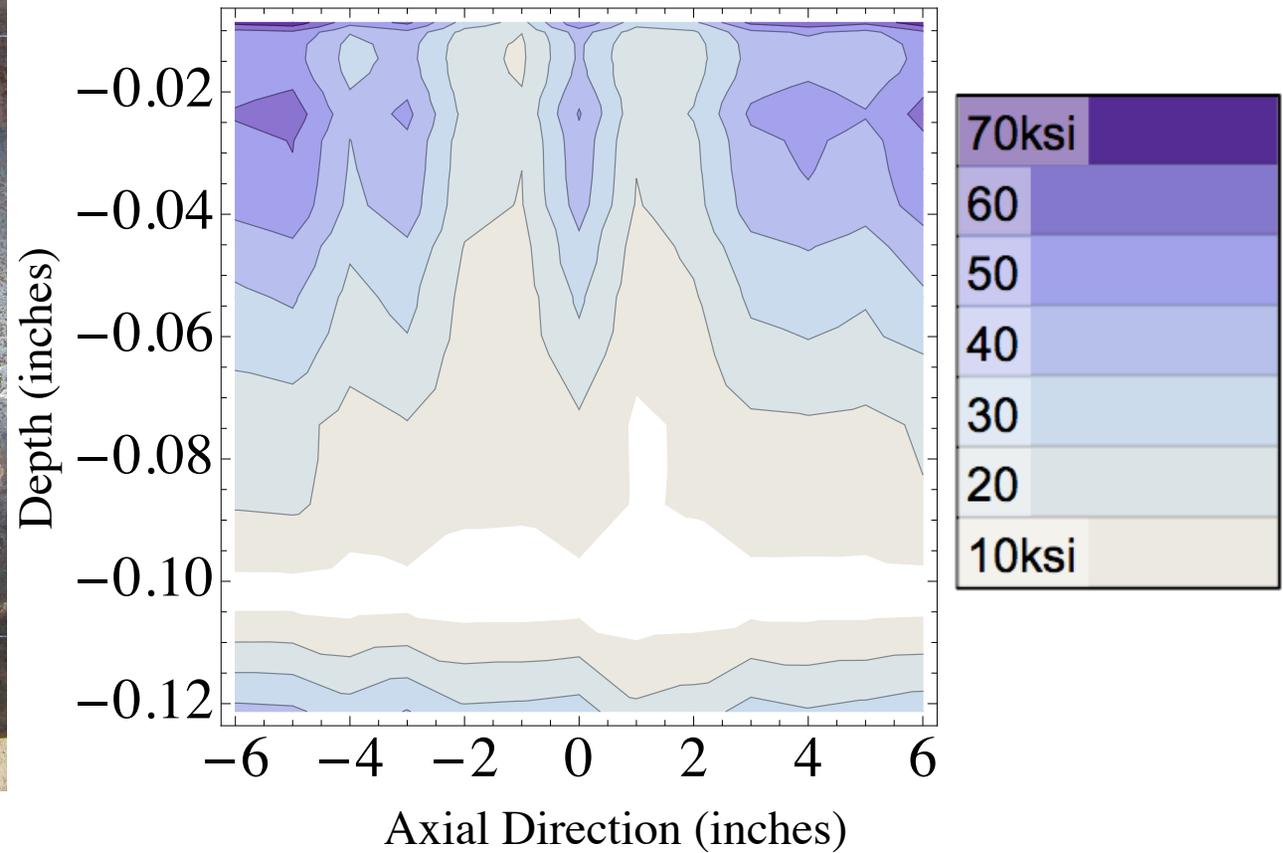
Residual Stress Map of Cross Section of Wrinkle Bend #5
